BACKBARROW IRONWORKS

Cumbria

Assessment and Evaluation Report

Report no 1998-99/006/AUA7796

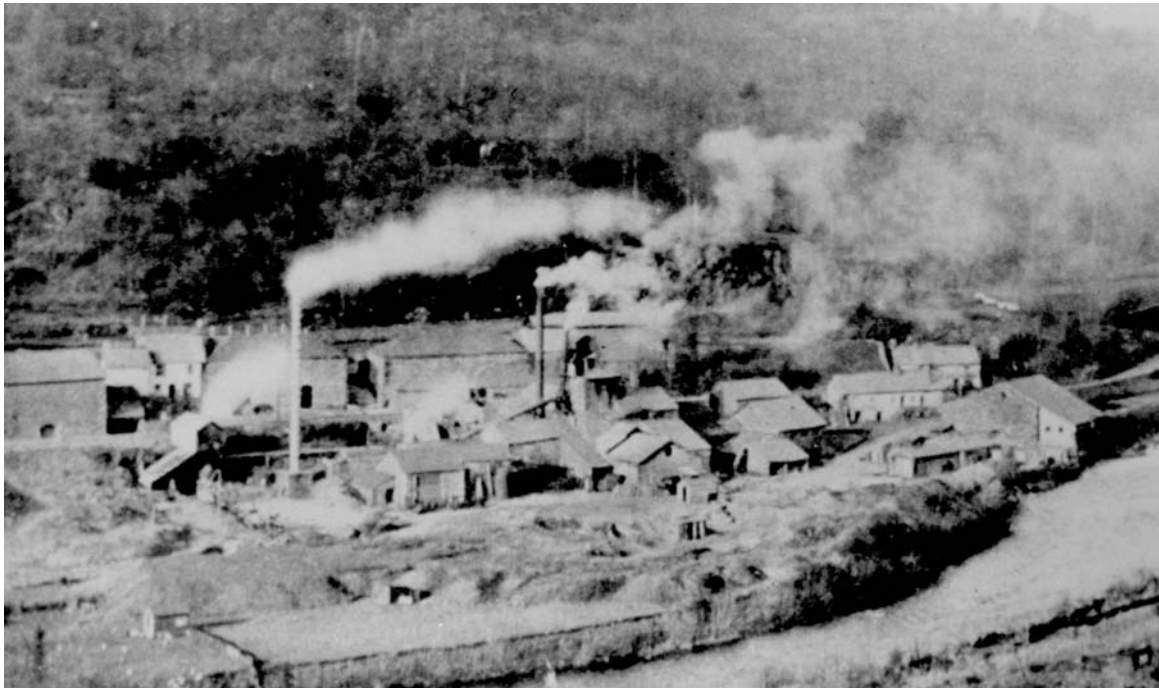
Fig 8 Photograph of the Backbarrow site from the south-east – c 1920 prior conversion of the furnace to coke (While DA)

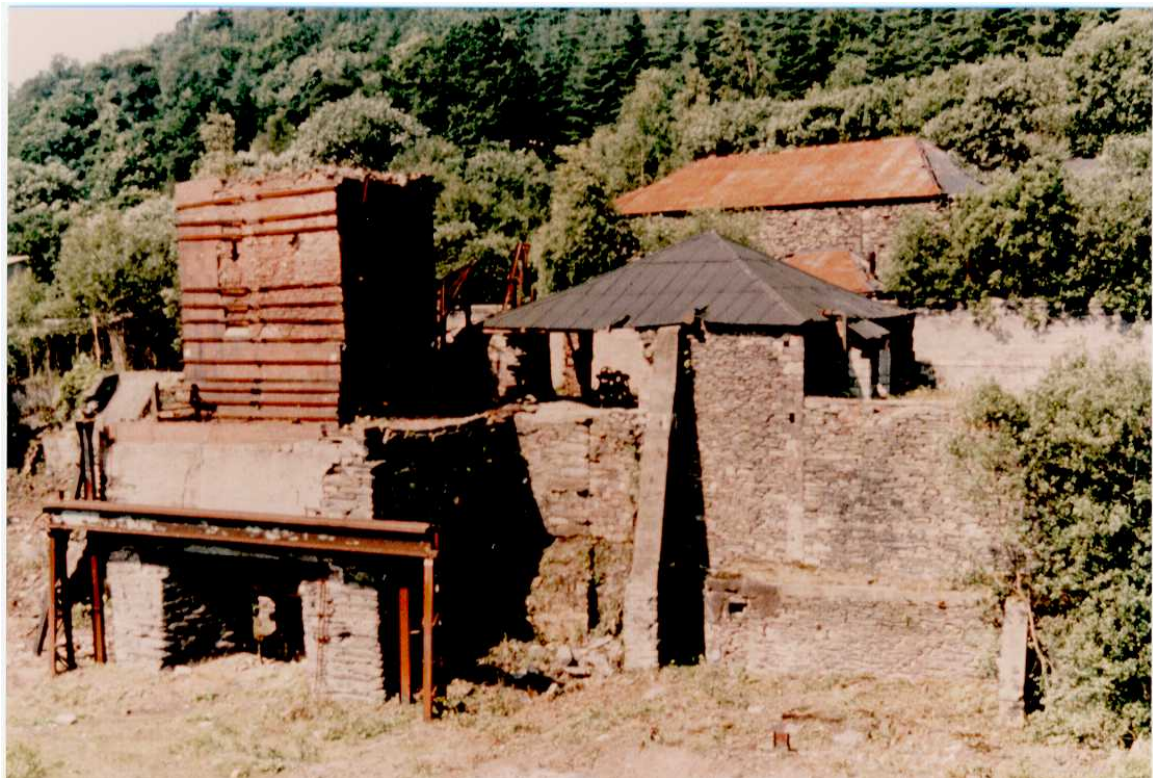
Fig 13 Photograph of the furnace during the 1992 survey

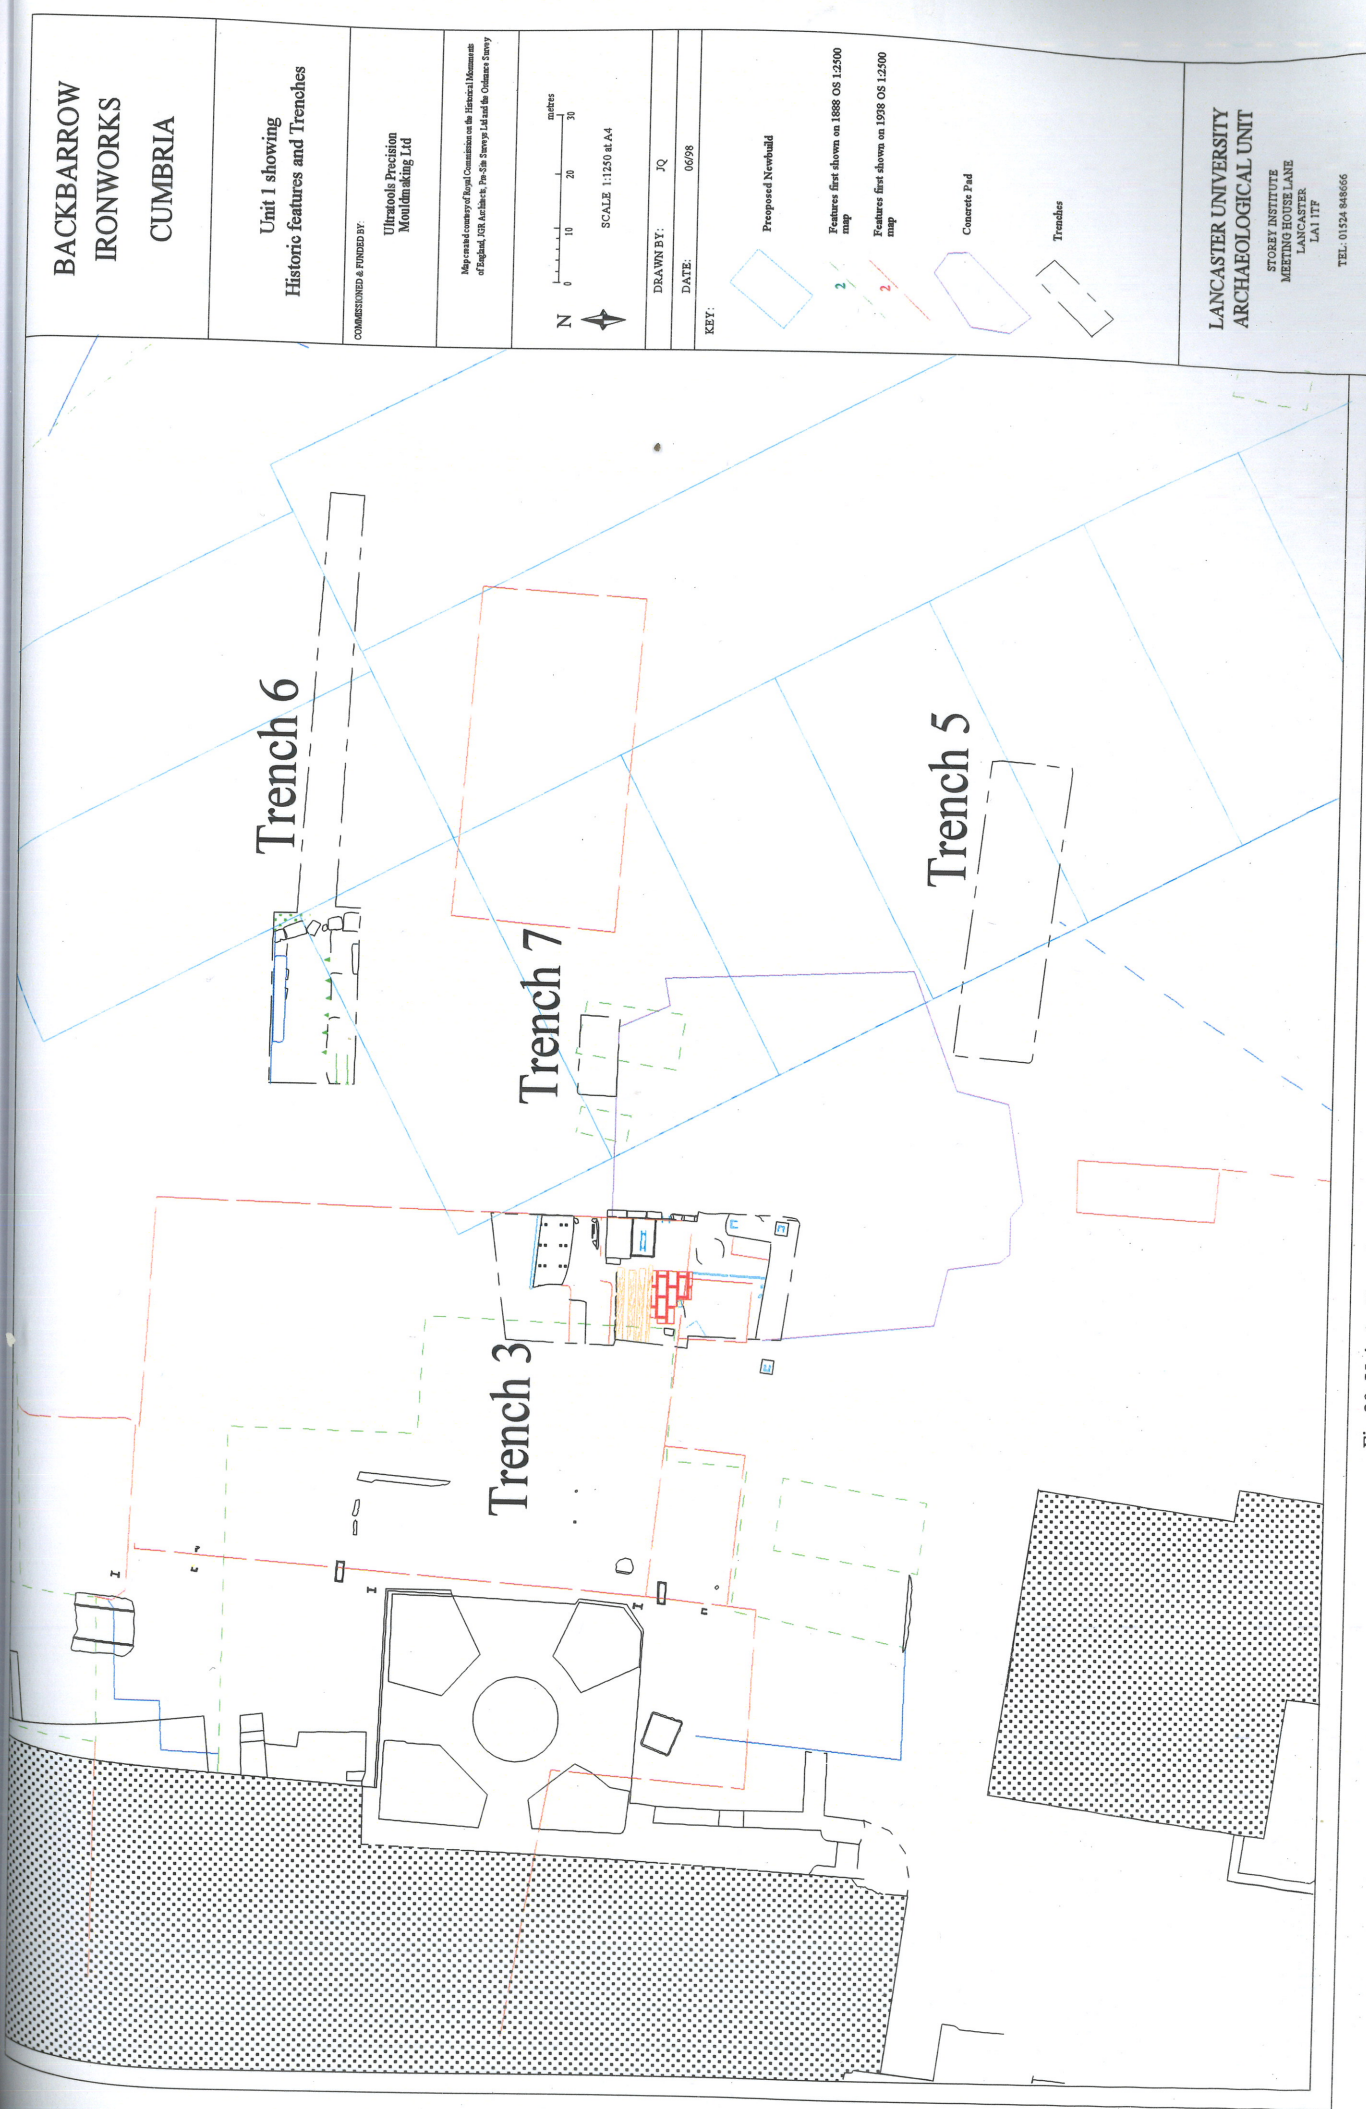
Fig 20 Unit 1 - Trenches and Historic Features

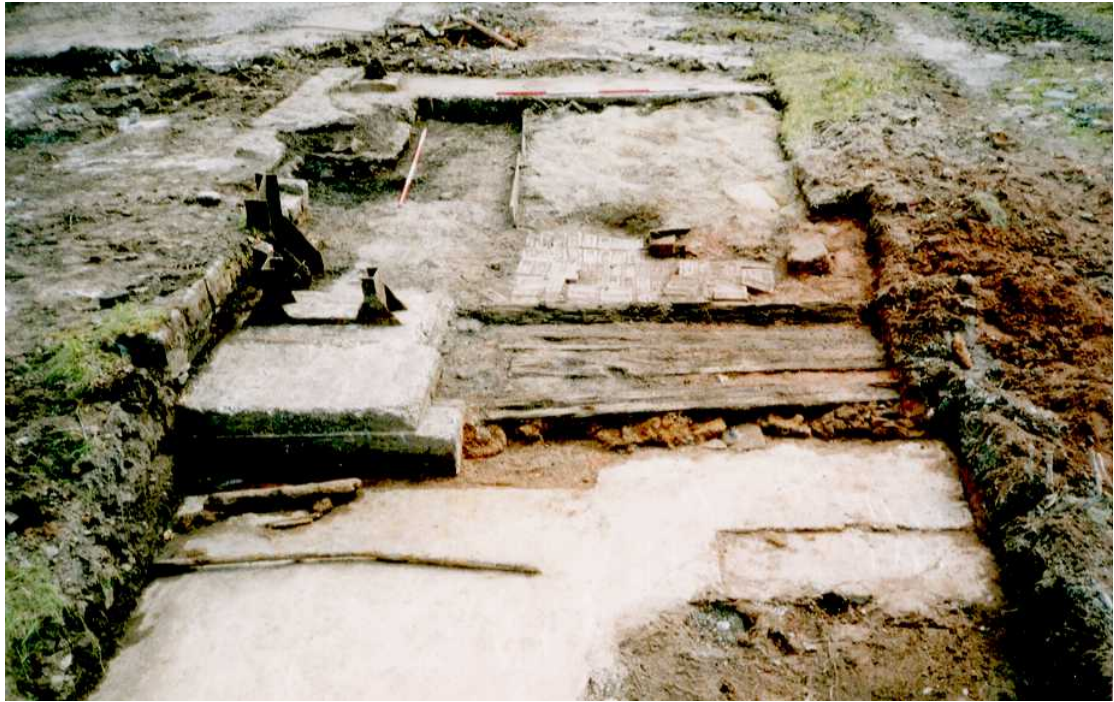
Figure 26 Photograph of Trench 3 from the North

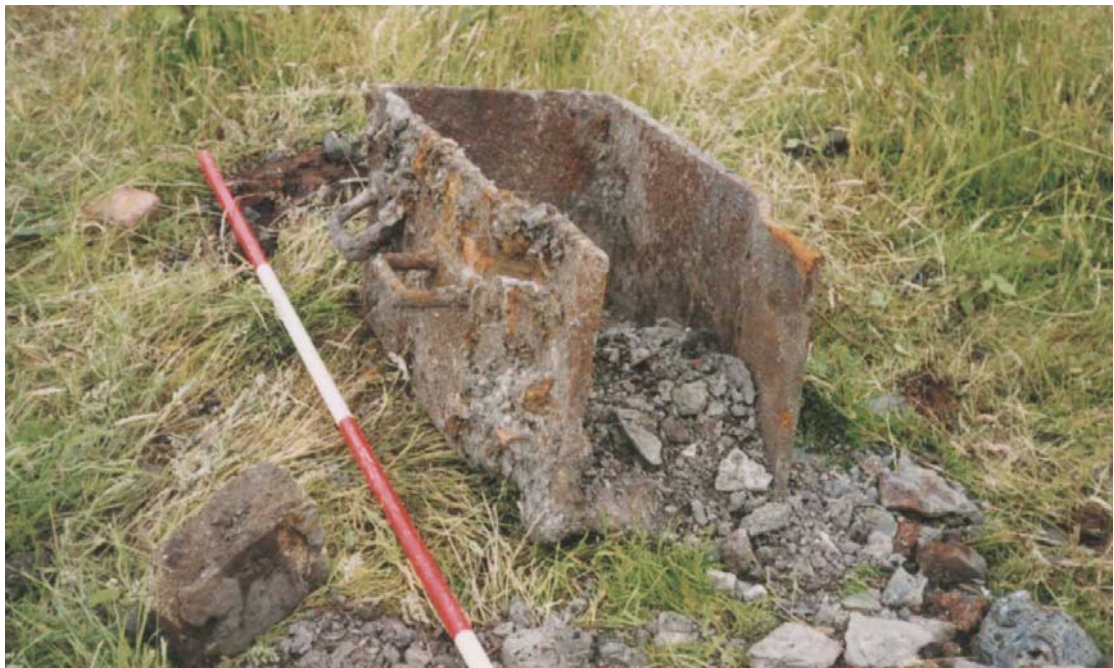
Figure 27 Photograph of casting bucket from Trench 1
