Nautical Catering College, Liverpool Fabric Survey - Interim Report

January 2006

Oxford Archaeology North

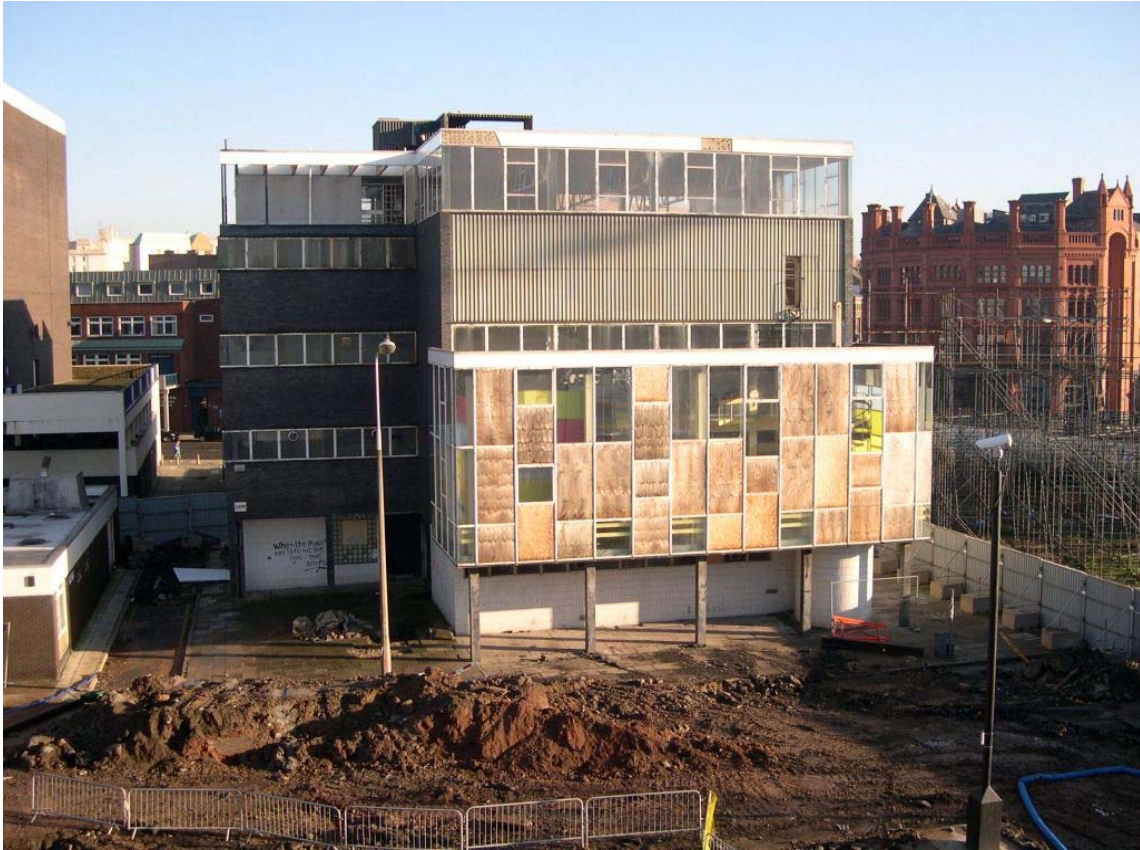
- 3.2.3 The first and second floor projection, from the western face, was supported on black concrete columns which continued through into the interior of the building as far as the concrete ring beam around the roof (Plate 1). The first and second floors were fully glazed within the steel frames, which were large rectangular lights with square pivot windows

(horizontal). Many of the windows had been replaced with plywood boarding at the time of survey. The third floor of the west elevation had a corrugated external face with steel framed windows to the level above. The flat roof of the main part was supported on cantilevered steel trusses. The original intention of the flat roof was to enable the construction of a further storey if required at a later stage (NCC 1965), but in the event was never constructed.

Plate 1: West external elevation of the Nautical Catering College

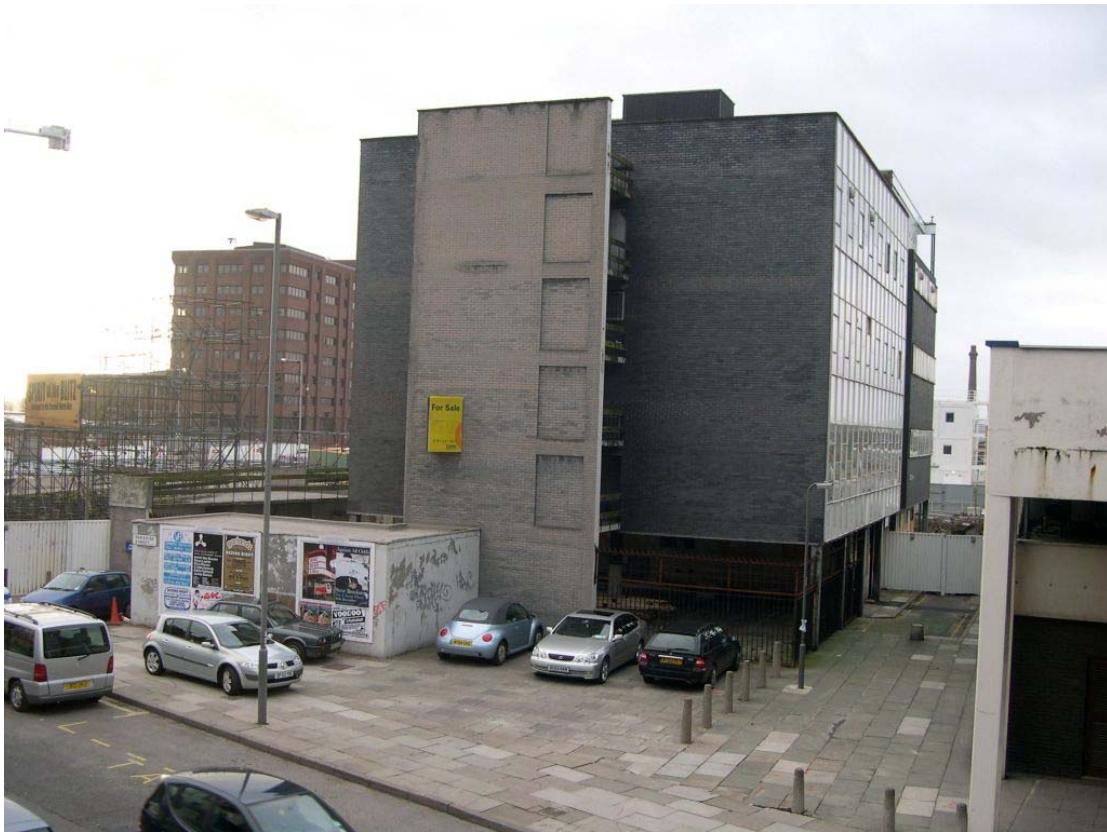
- 3.2.1 The building had several main components but was essentially a five storey, ten bay, brick structure with a projecting lift tower above the flat roof. The east wall had an adjoining fire escape tower of brick and concrete construction (Plate 2). The western side of the building was wider with an additional three bay, L-shape component, which was of similar height to the rest of the building. The north and west elevations at the corner had smaller continuous windows (Plate 3), as did the second floor of the west elevation of the main projection. The south and north elevations comprised large steel windows with concrete mullions.

Plate 2: East external elevation of the Nautical Catering College

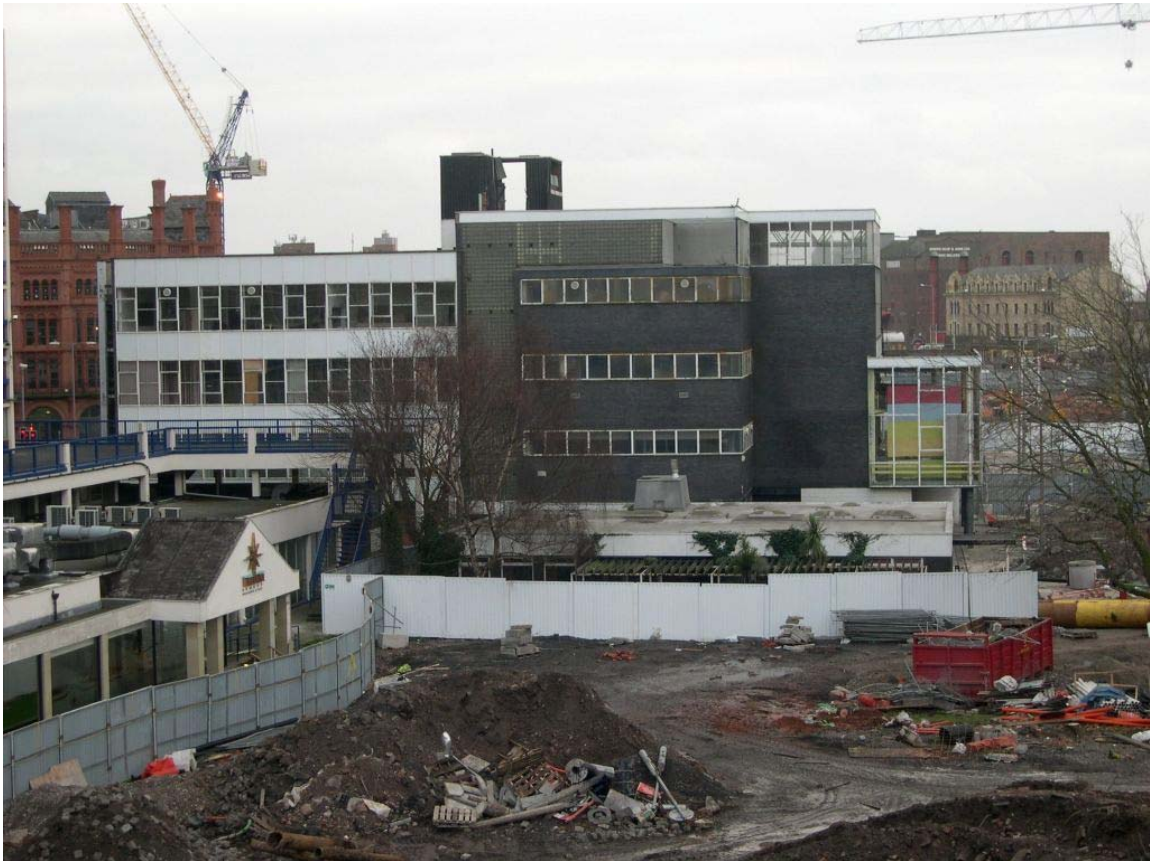
- 3.4.1 The overall form of the building was basically functional as was specifically designed as a teaching facility. The outline of the building was reminiscent of a ship's bridge profile (Plate 3) and as such is similar to other buildings that have been specifically designed to evoke ship shapes which include The Lowry, Salford Quays, Manchester (1988); Keele University Students Union, the Chile Haus, Hamburg (architect Fritz Höger) and the Ballroom at the Pontins Camp, Heysham. A common feature for the exterior of twentieth century buildings designed to resemble ships are the staggered balconies / mezzanine floors to look like ship decks and bow. Within the Nautical Catering College the internal flourishes also served to reinforce the ship theme, most noticeably in the monochrome mural, but also in elements such as the circular air vents within larger windows, that are similar to port holes (Plate 20).

Plate 3: The exterior of the Nautical Catering College, looking south, showing the profile reminiscent of a ship's bridge

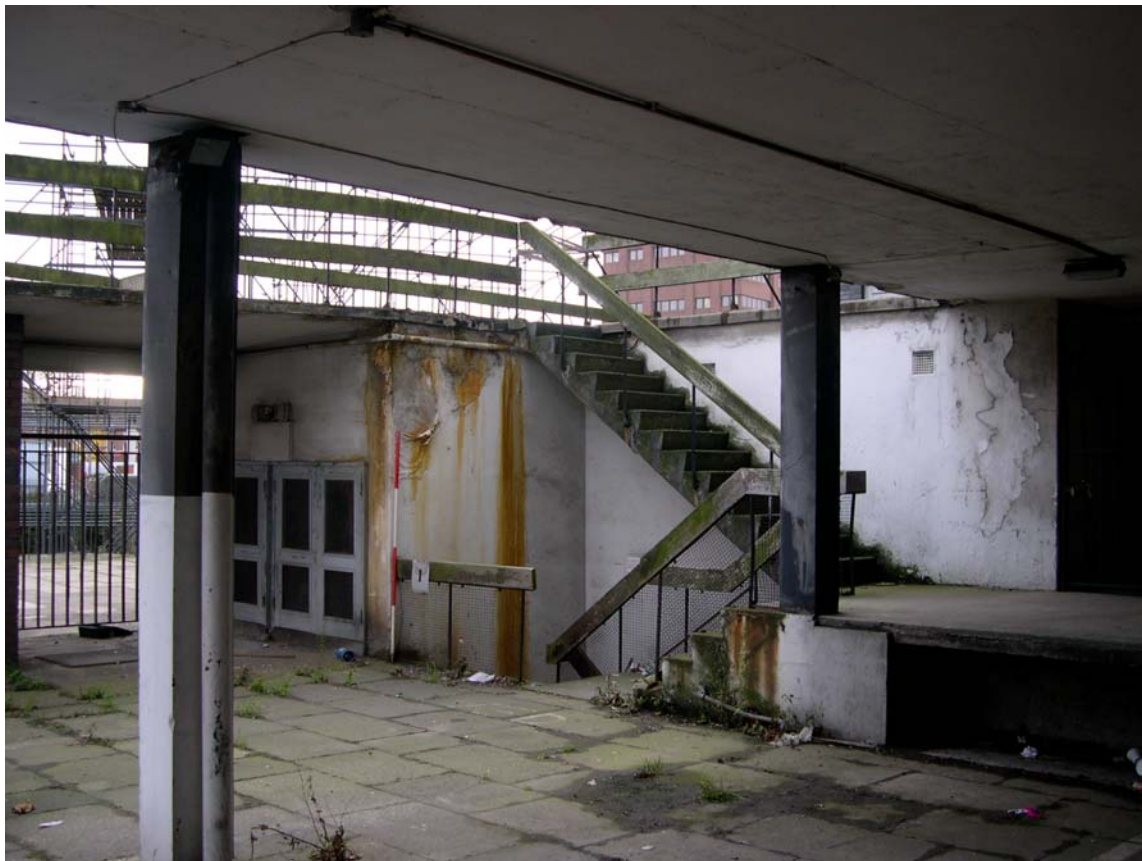
- 3.2.4 The main door, which was mostly of glass and within roller shuttering, was located in the re-entrant and positioned in the north-west corner of the building. There was a second entrance in the south-east corner that was raised above the Paradise Street level and was reached by a flight of concrete steps; this consisted of double timber doors. The external area around the footprint of the structure was paved with concrete four foot paving slabs (Plate 4) and at the north-west corner a large metal anchor was embedded into the ground surface.

Plate 4: South-west aspect of the Delivery Area

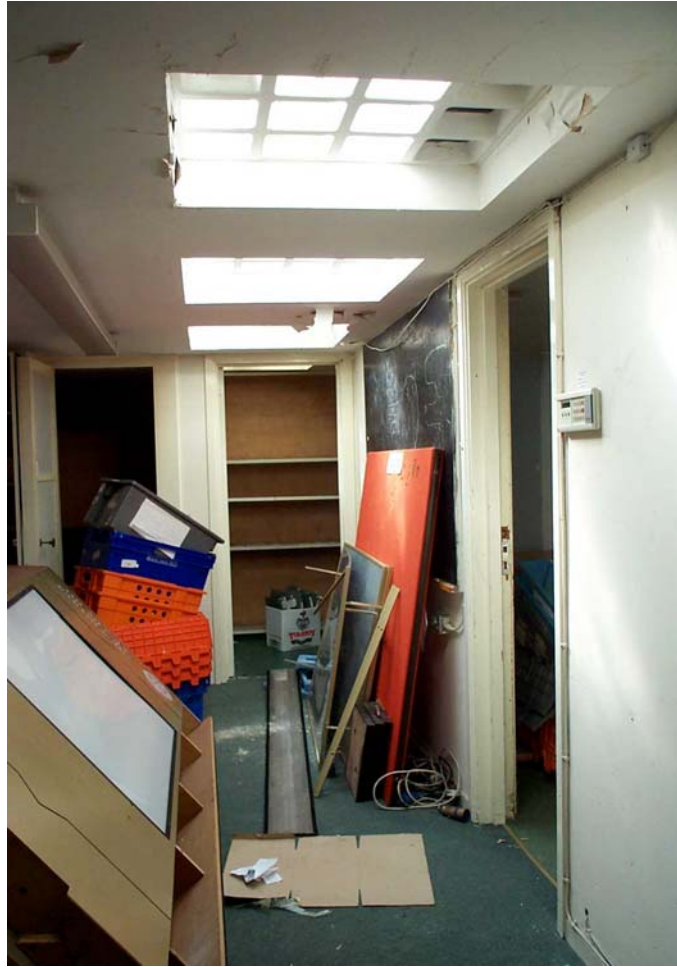
(Room 10), general cold goods (Room 07, Plate 5) and equipment (Room 09). An essential element in the catering industry is to store goods correctly for health and safety reasons and as part of good general practice. This can be seen by the separation of the different types of goods and was exemplified by different fish, meat and dairy stores (as per the original plans). In the south-western quarter of the ground floor, were the main teaching facilities, including the lecture theatre which still retained tiered seating (Room 15, Plate 10), and the exam kitchen (Room 16). On the south side, in between the storage and the teaching area was a kitchen specifically in use as a bakery (Room 12).

Plate 5: South aspect of Store Room (Room 7), Ground Floor

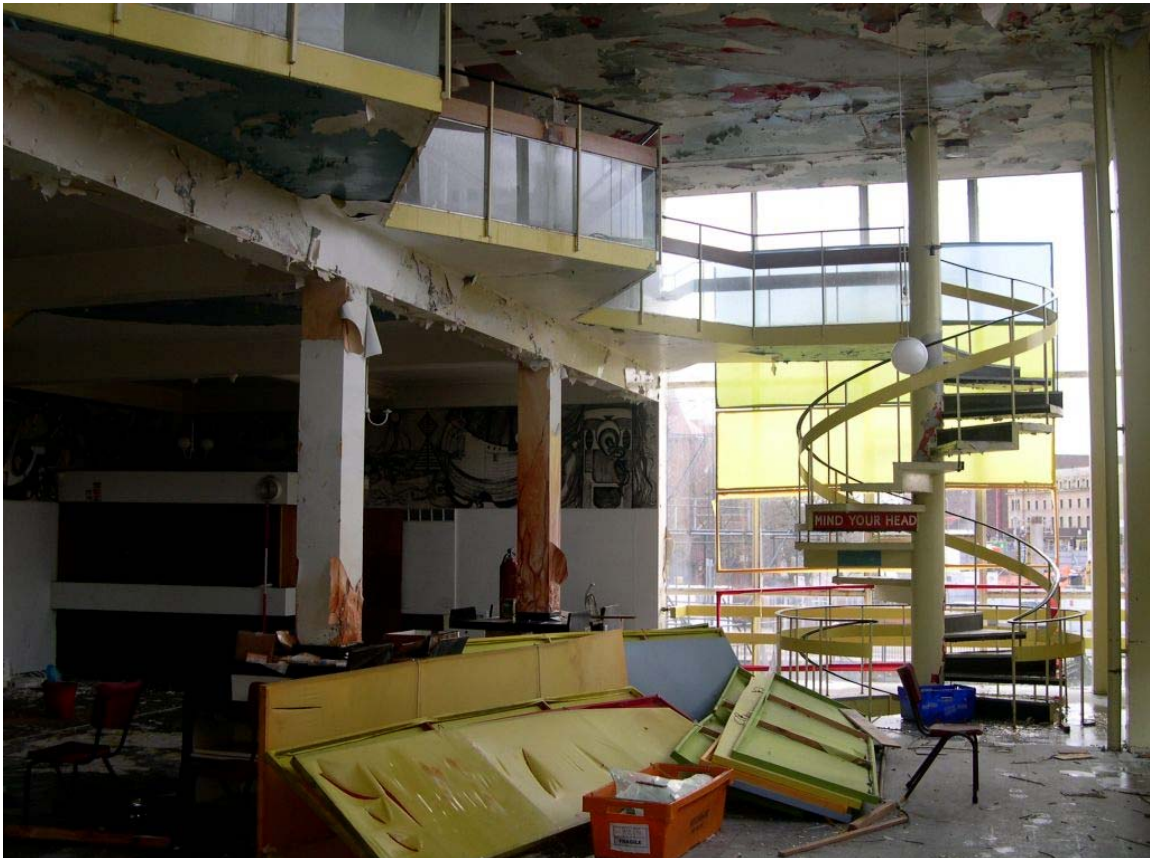
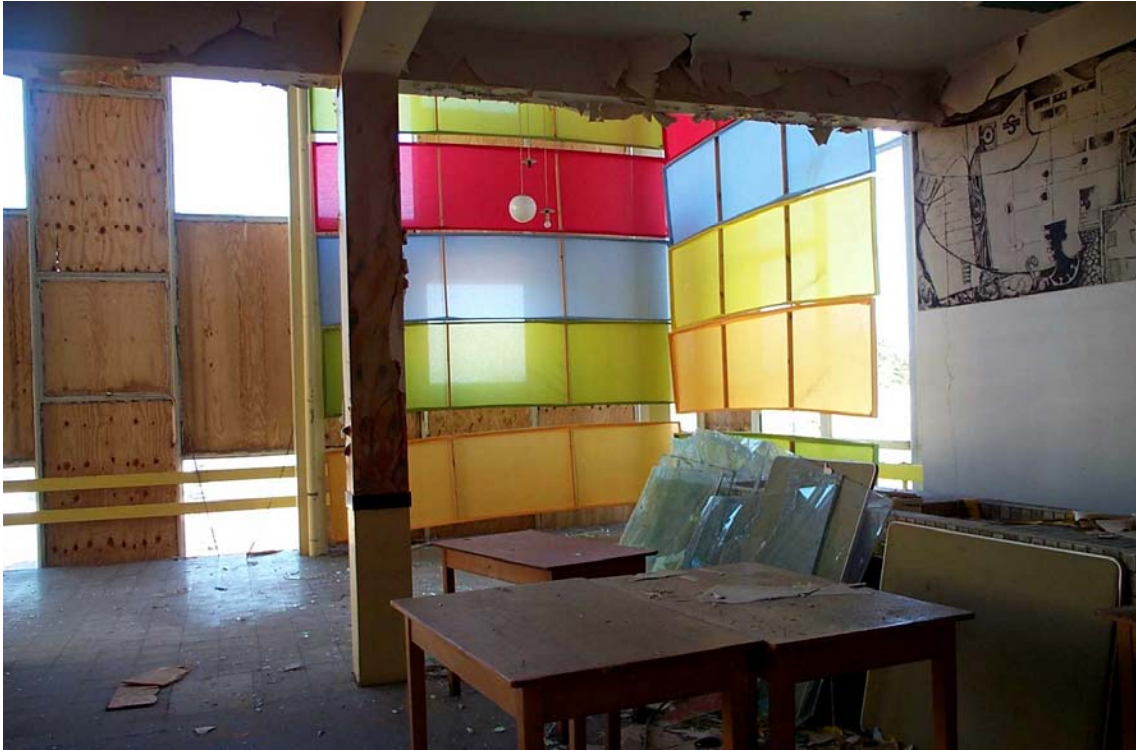
- 3.3.5 Adjacent to these two main kitchens, along the western edge of the building, was the main dining salon (Room 110, Plates 8 and 9), which was where the food was served en masse to the public as part of the catering training. This area was light and spacious, and was achieved by having a large open area with a glass fronted western wall, that used large panels within steel frames. The room also had a small bar in the south-east corner and a tiled servery at the north end of the east wall, from where the food was dispensed in addition to any brought in through the swing doors from the kitchens. There was an open spiral staircase in the south-west corner of the room, which led down to a fire escape exit on the ground floor, and also up to the second floor. The room contained a long monochrome mural around the north, east and south walls, positioned above head height (Plates 11-13). The mural, which had a nautical theme throughout, was present at the time of survey and was carefully removed and retained for future use.

Plate 8: East aspect of the main dining salon (Room 110), and spiral staircase, First Floor

Plate 9: North-west aspect of the main dining salon (Room 110), First Floor

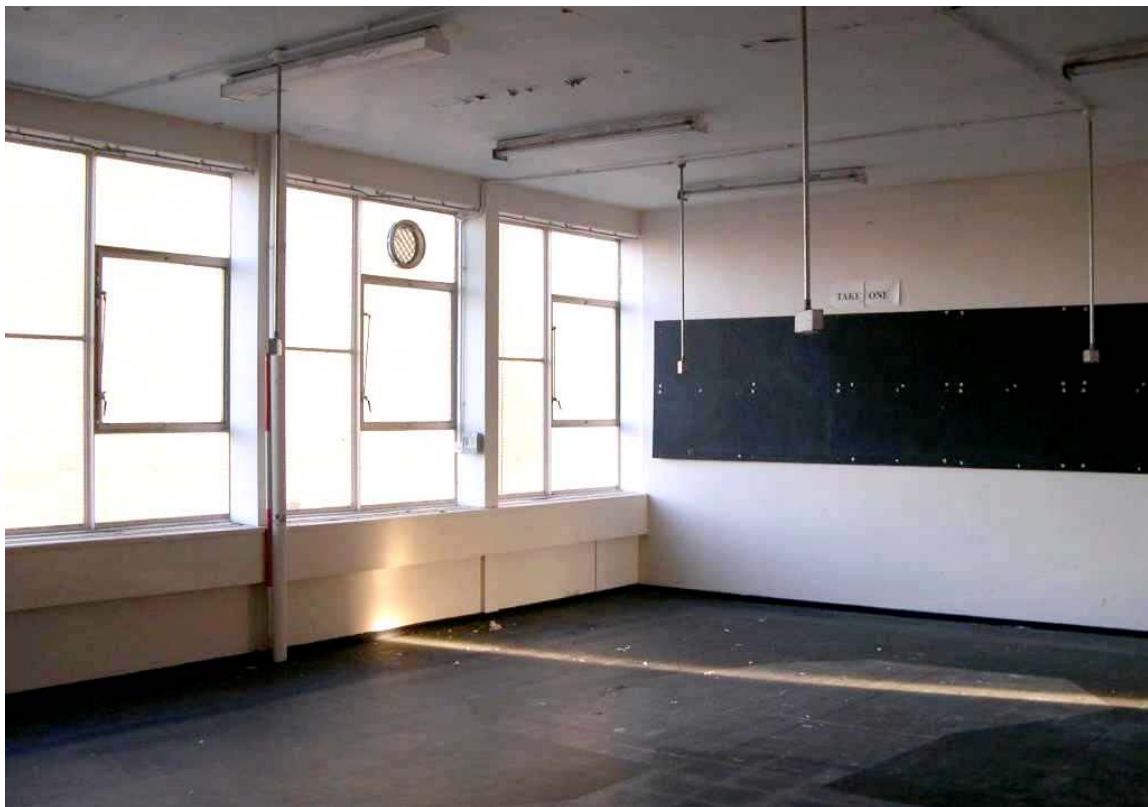
- 3.3.12 The rest of the third floor consisted mainly of three large rooms, three smaller rooms and appeared to have a similar function, in that it provided recreational facilities. This included Room 300 which was a senior common room, and was located adjacent to the main stairs and lift. Again, the function of each of these rooms may have changed over time, as the multiple sockets in Rooms 301 and 302 (Plate 17) were indicative of cookers or other appliances having been once installed.

Plate 17: North-east aspect of Room 302, Third Floor

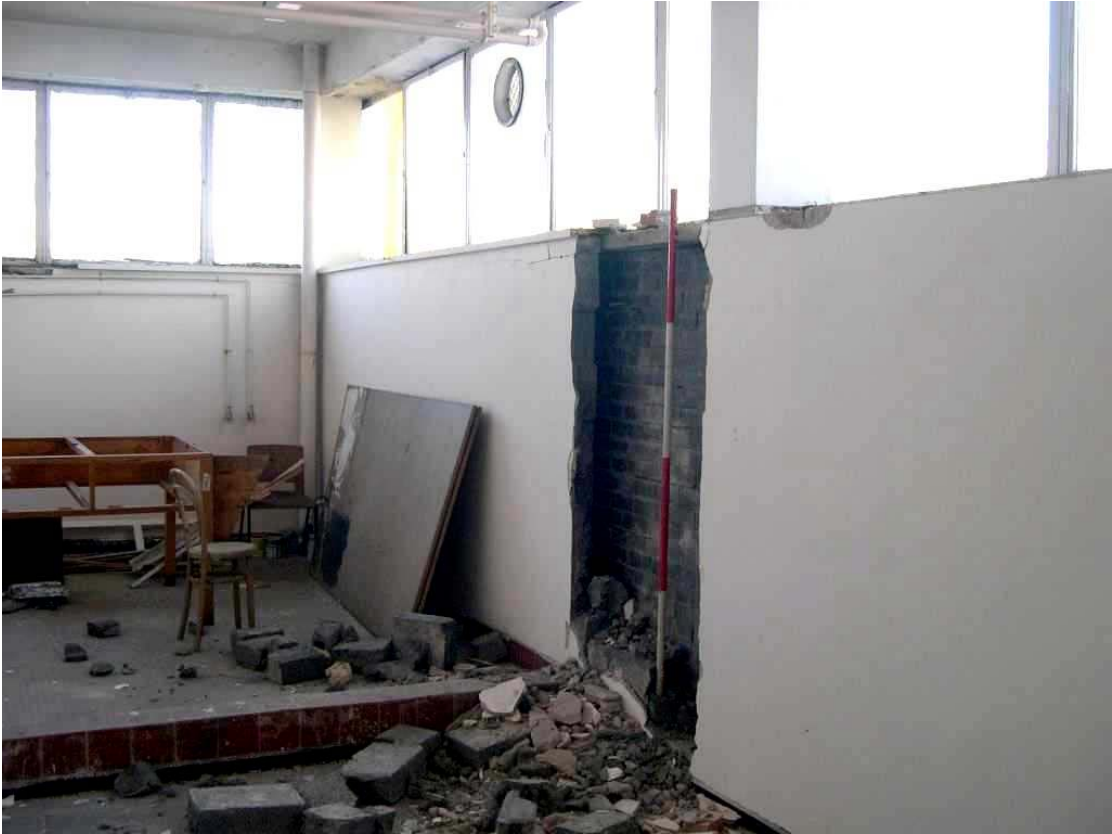
Plate 20: North-west aspect of Room 306 (Third Floor) showing the detail of external wall construction

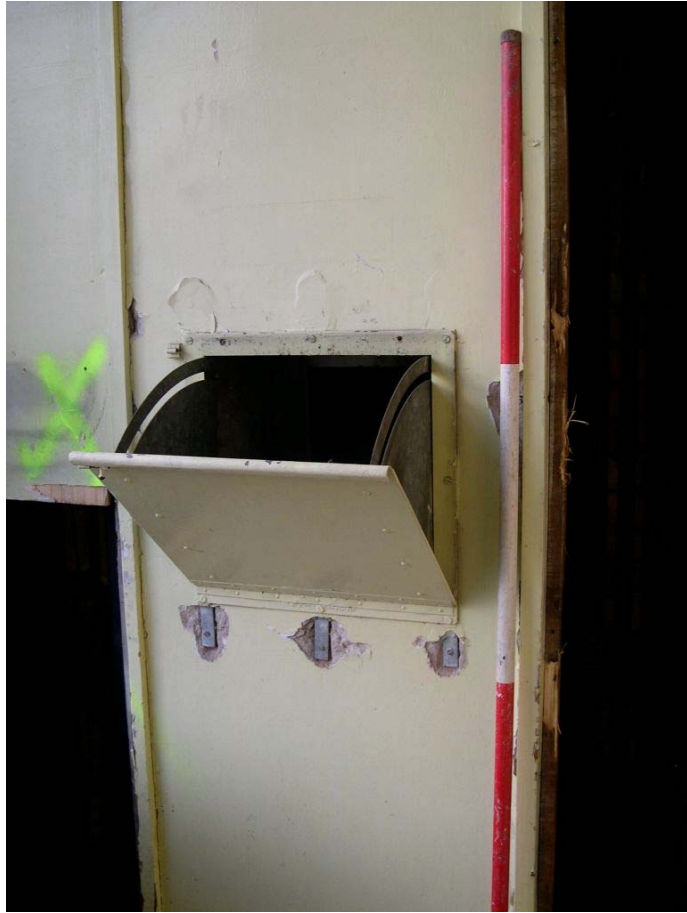
ventilation and piping was concealed within vertical boxes and overhead areas above false ceilings. The building had a heating system which was intrinsic to the building fabric except where the radiators and heaters interfaced with the rooms (Plate 23). There was also an internal waste system for rubbish, which was highly expedient (Plate 22).

Plate 22: Example of a waste chute

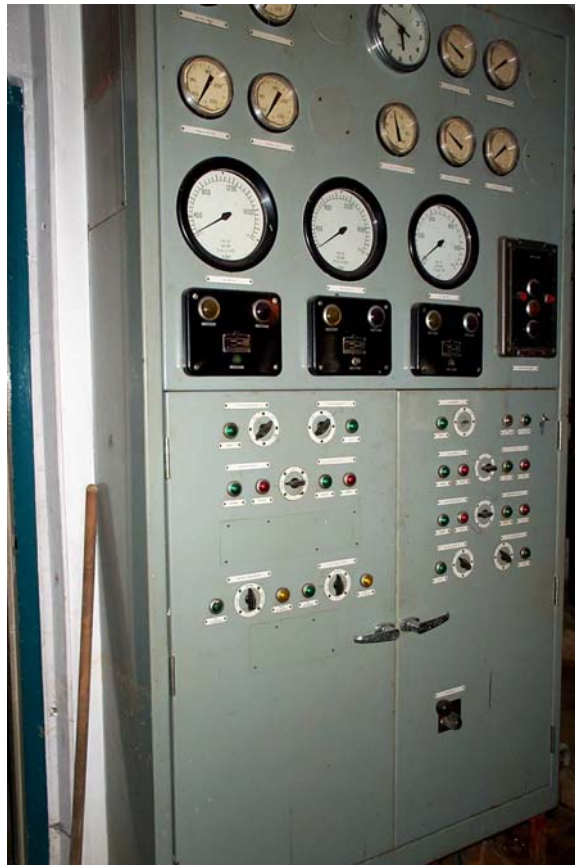
Plate 23: Thermostat, located on Ground Floor
