New Front, St Hilda's College, Oxford

Archaeological Mitigation Report

July 2019

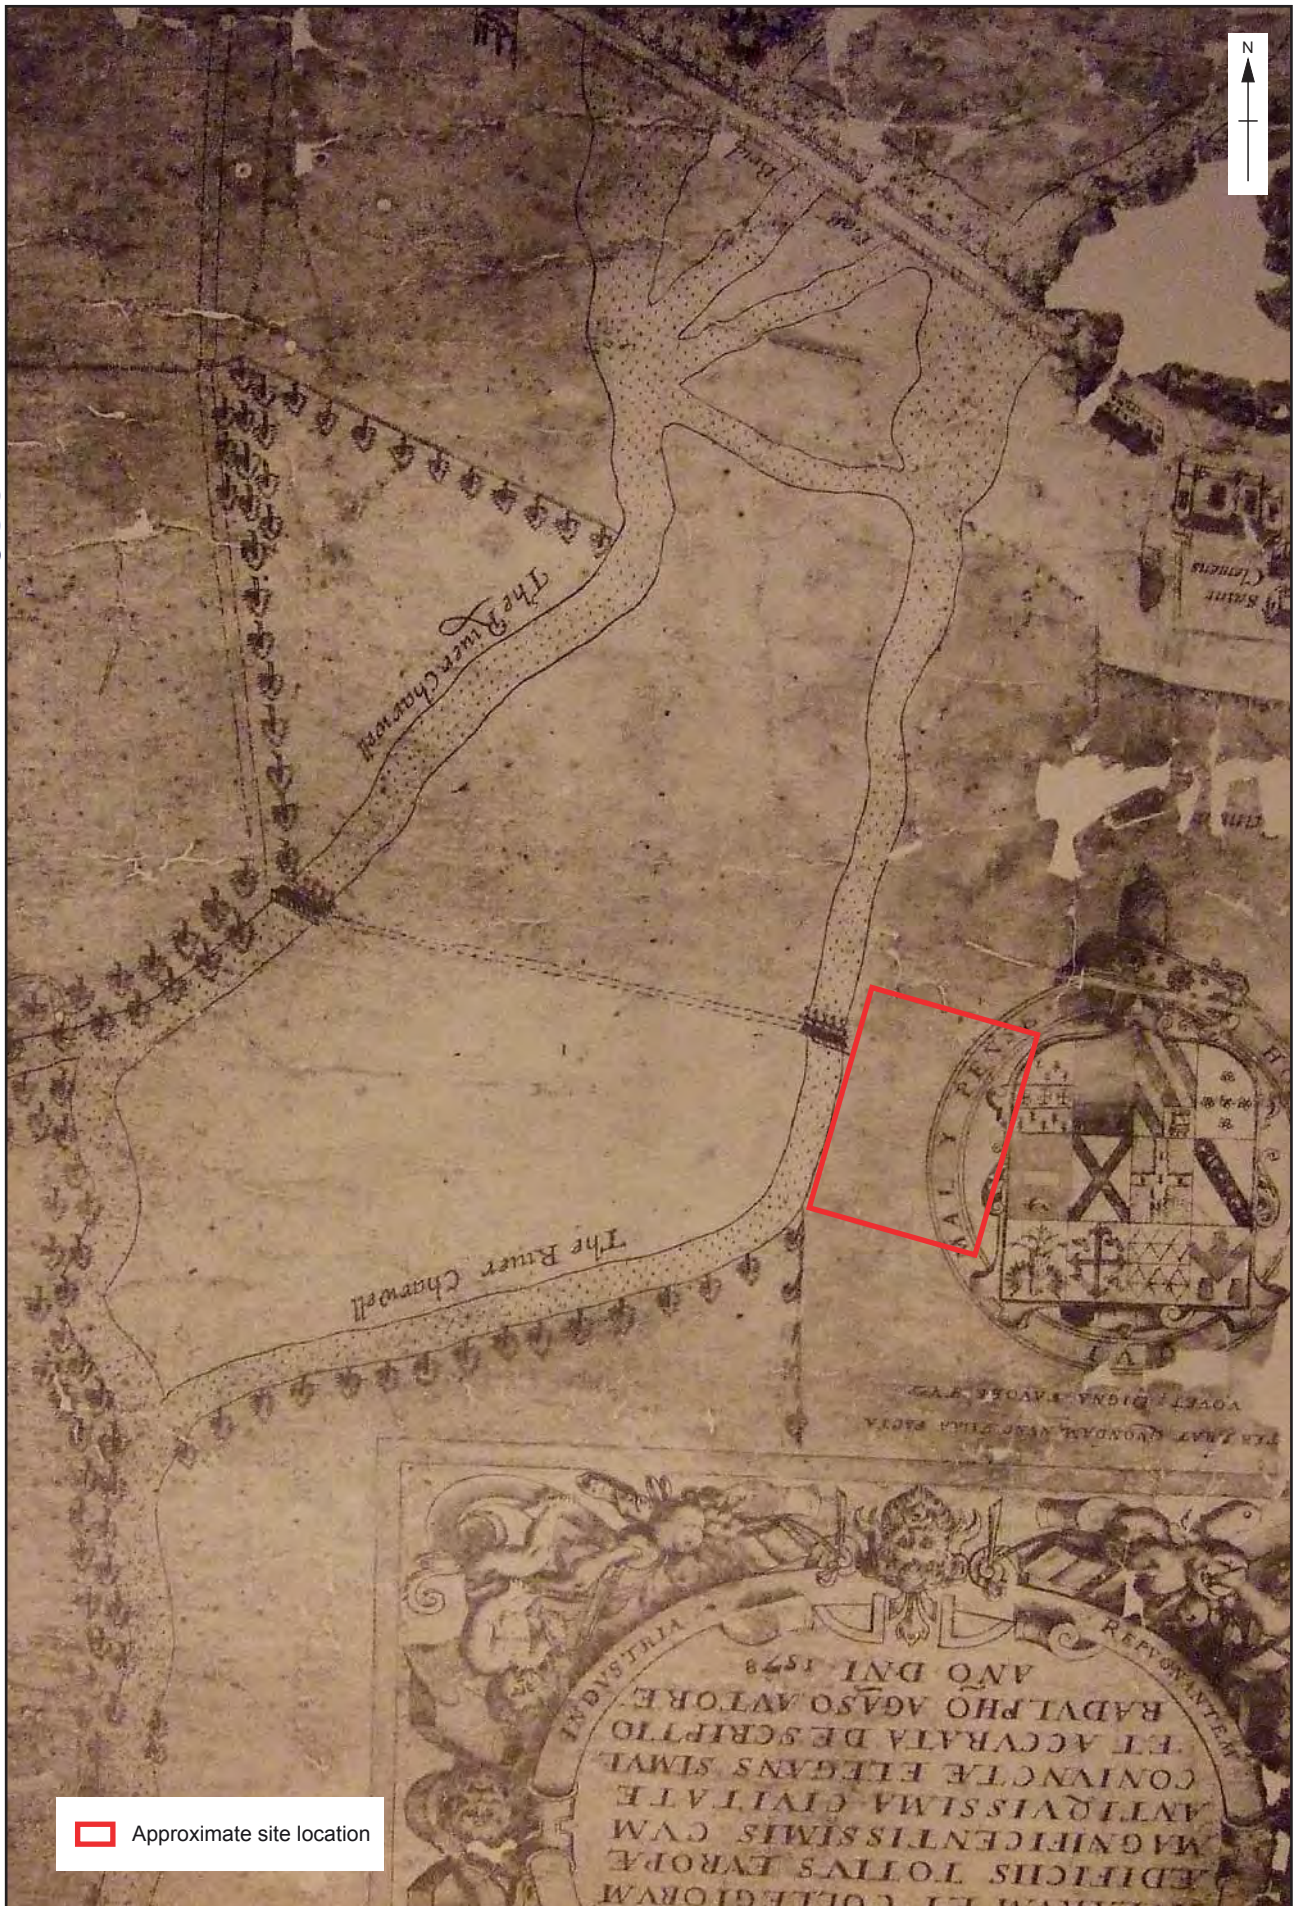
Figure 2: Agas's map of Oxford 1578

- 1.3.5 During the post-medieval period there is likely to have been a crossing point over the River Cherwell and Milham to the west of the site. The two bridges and the path between them are clearly shown on Agas's map of 1578 (Fig. 2), though he does not show any details of Cowley Place or the ford. Loggan's map of 1675 (Fig. 3) shows a single bridge (just north of Milham Ford) and by implication the site of the ford at the south end of the properties in Cowley Place. No bridge is shown on Taylor's 1750/51 map of Oxford, or on Faden's 1789 reworking of Taylor's map, though Hoggar's 1850 map (Fig. 5) and the tithe map of 1865 (Fig. 6) clearly shows a bridge at the south-west corner of the garden of Cowley House. This bridge was no longer extant by the 1876 Ordnance Survey large-scale town plan (Fig. 7.).

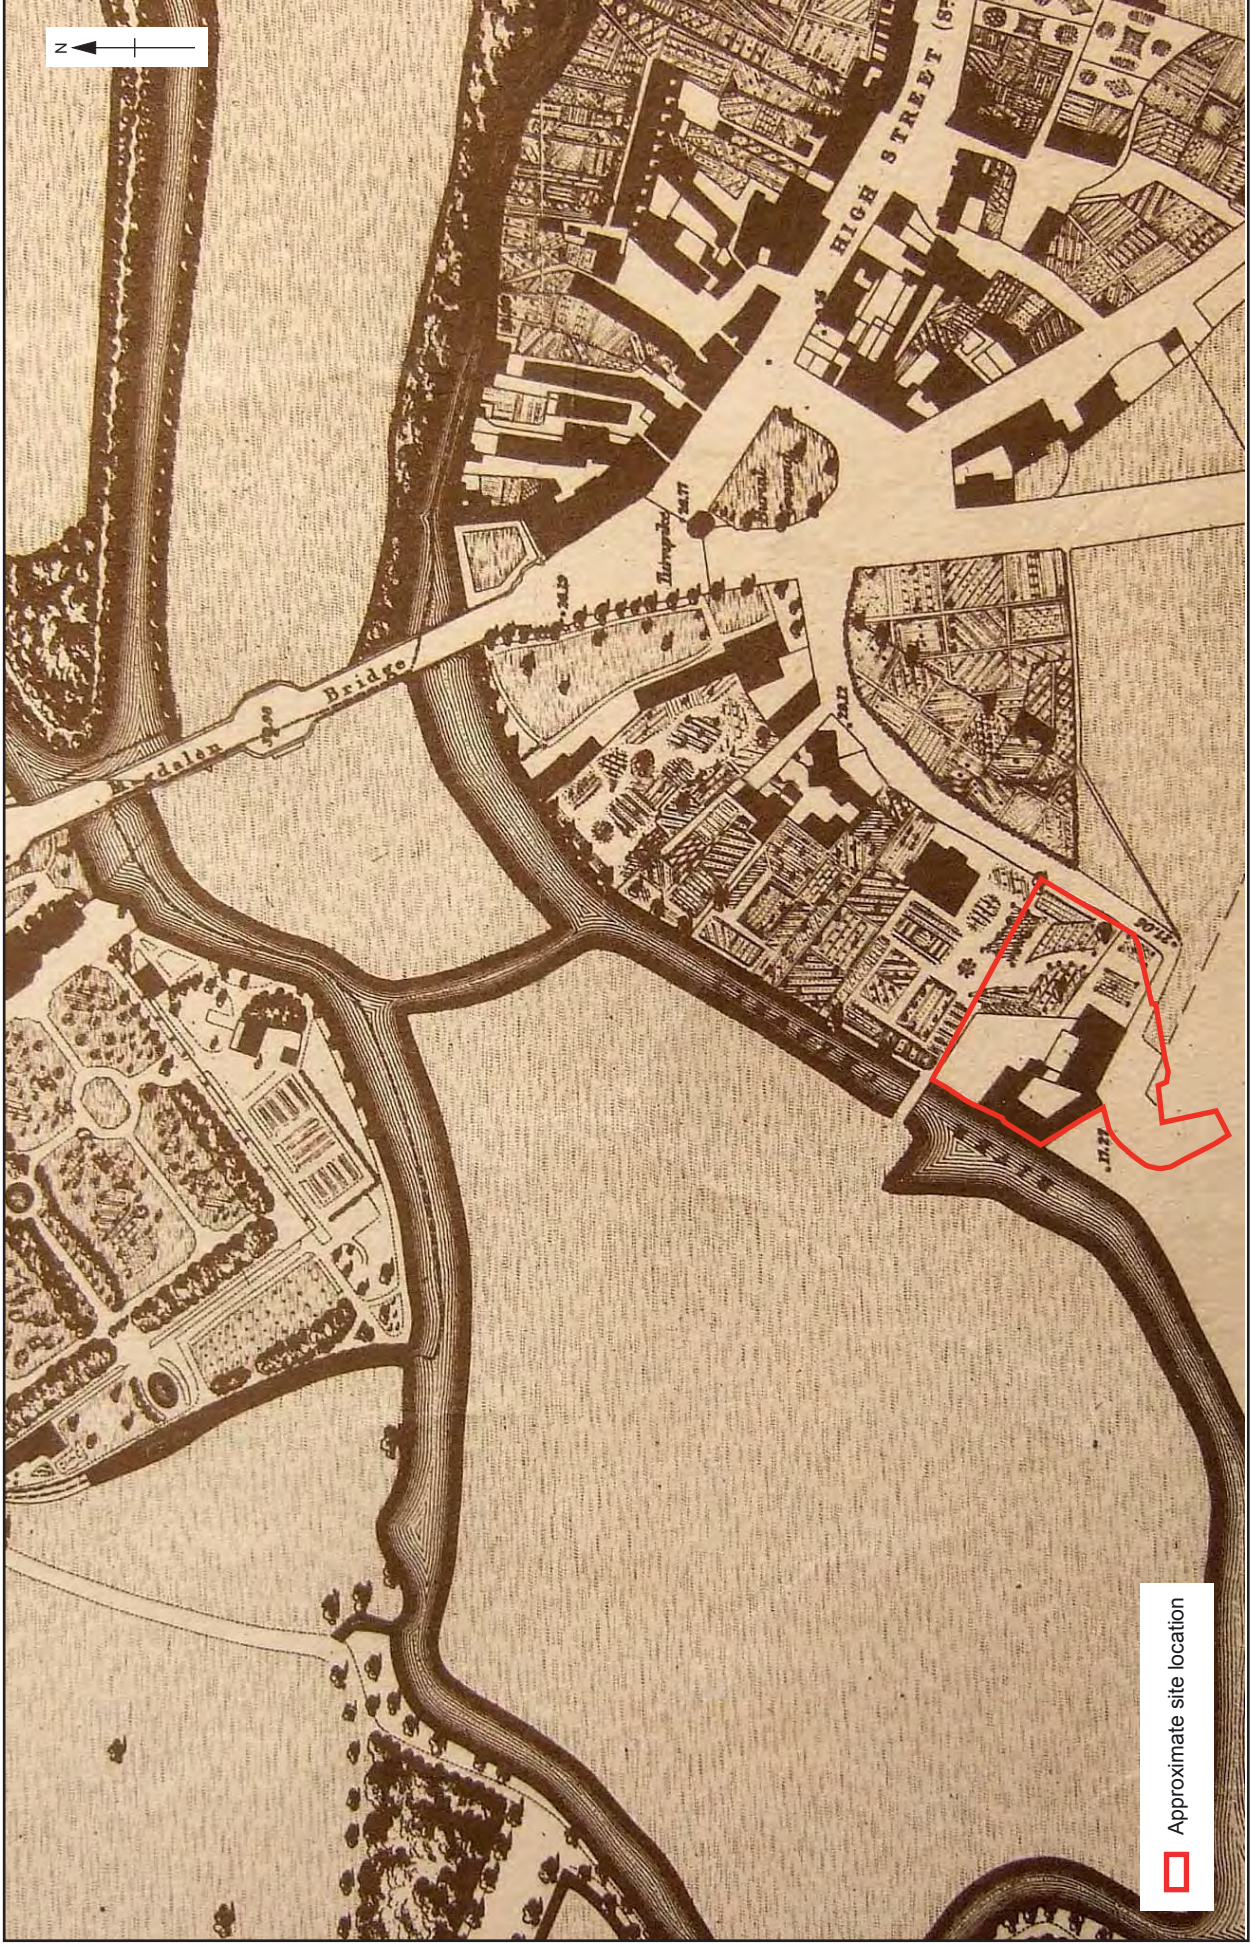
Figure 5: Hoggar's map of Oxford 1850

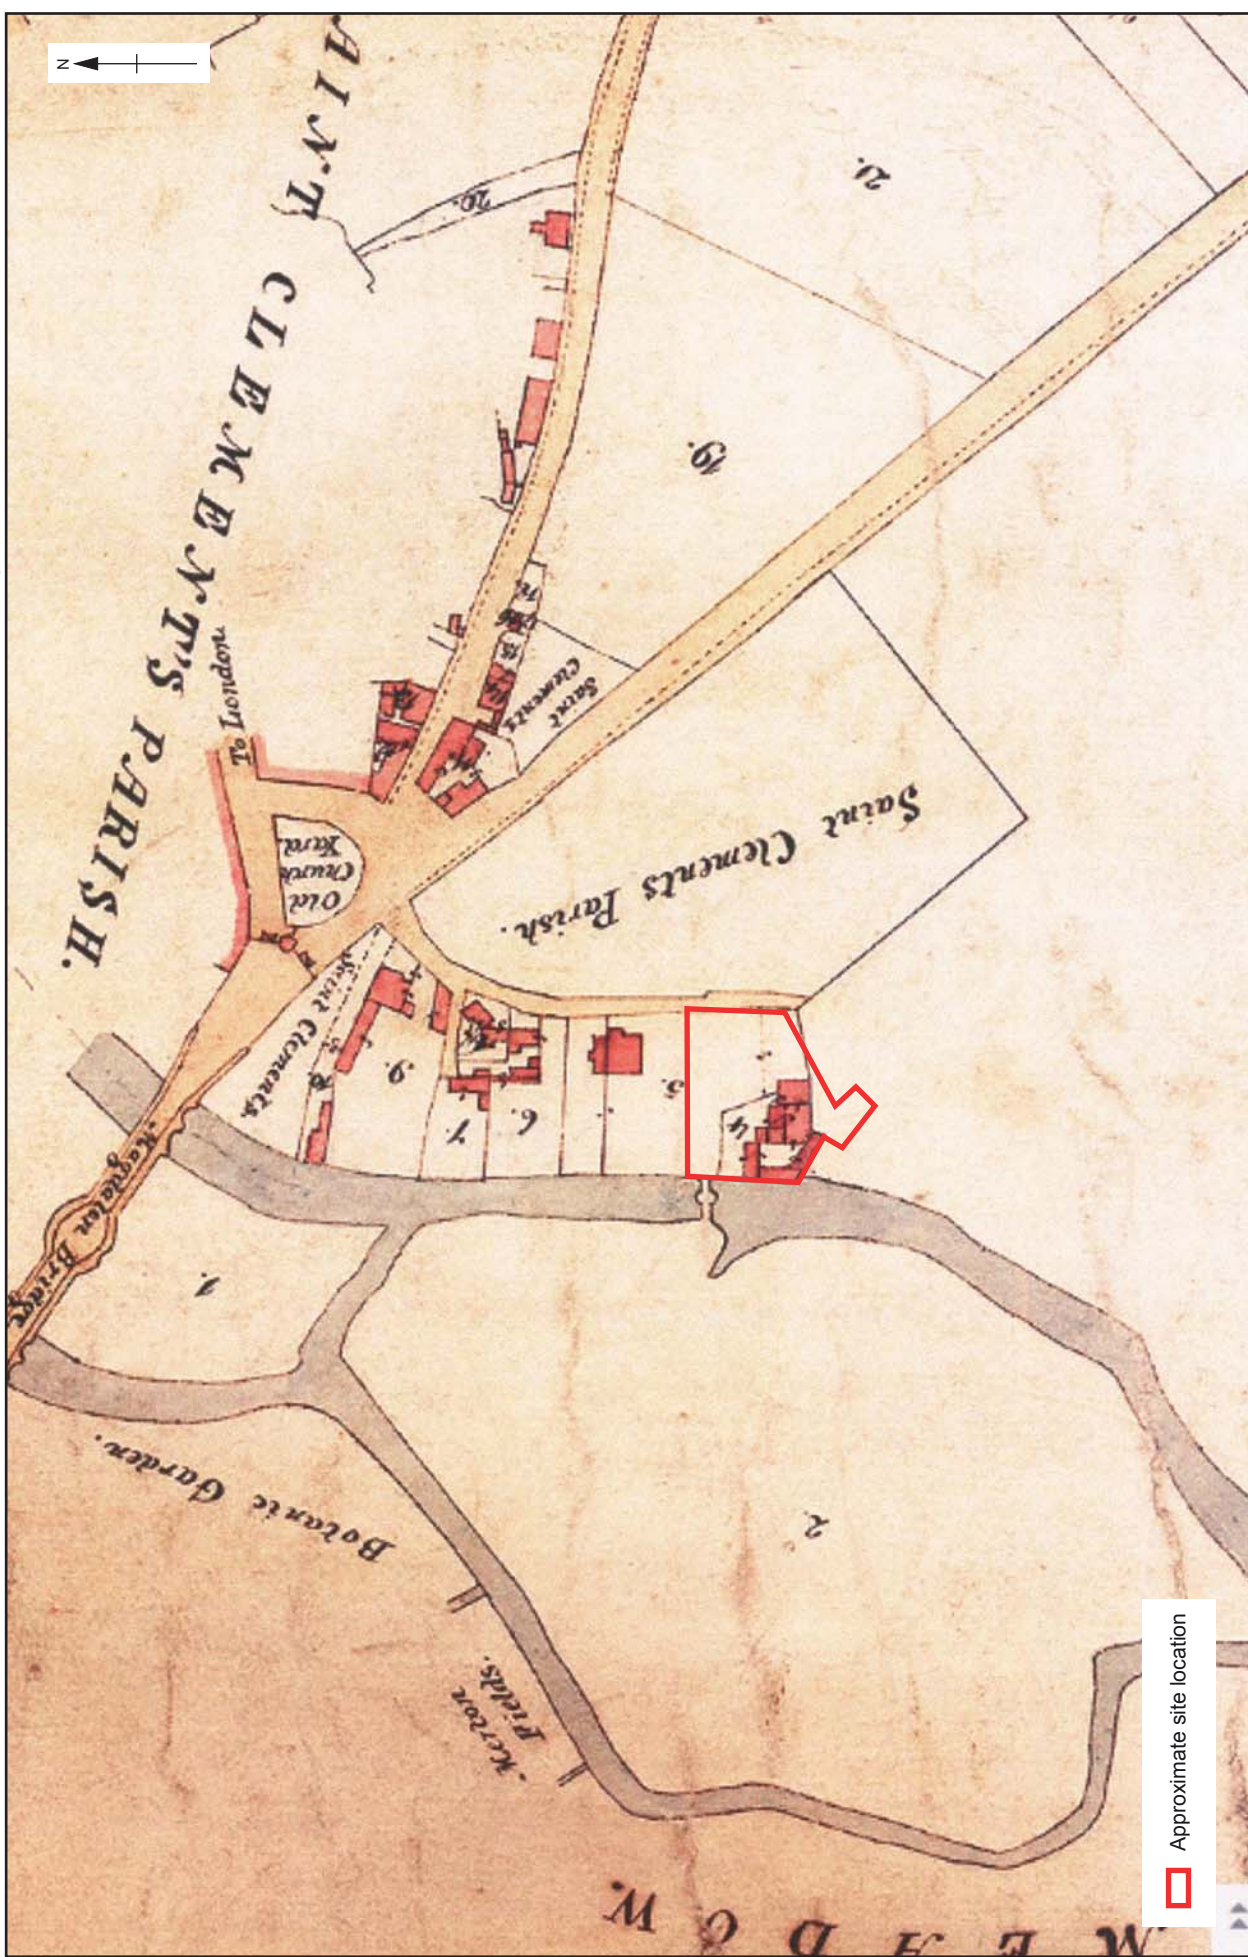
Figure 6: Cowley 1865 Tithe map (Oxford History Centre, 112/M)

- 1.3.9 The Iffley tithe map of 1847 and the Cowley tithe map of 1864 (Fig. 6) reveal more detail about the site and some of the buildings in the vicinity. In the area of the site, specifically the Milham Ford Building, are three buildings arranged in a C shape adjacent to the River Cherwell. The 1847 tithe map designated the site as plot 9 and the award notes that the plot belonged to John Greening and was in use as a house, farm and farmstead with an allotment. Hoggar's map of Oxford of 1850 (Fig. 5) reveals more detail as to layout of the formal gardens associated with Cowley House to the north of the site. The Cowley tithe map of 1864 (Fig. 6) shows the same three buildings in a C pattern as on the 1847 tithe map and with an additional three buildings to the

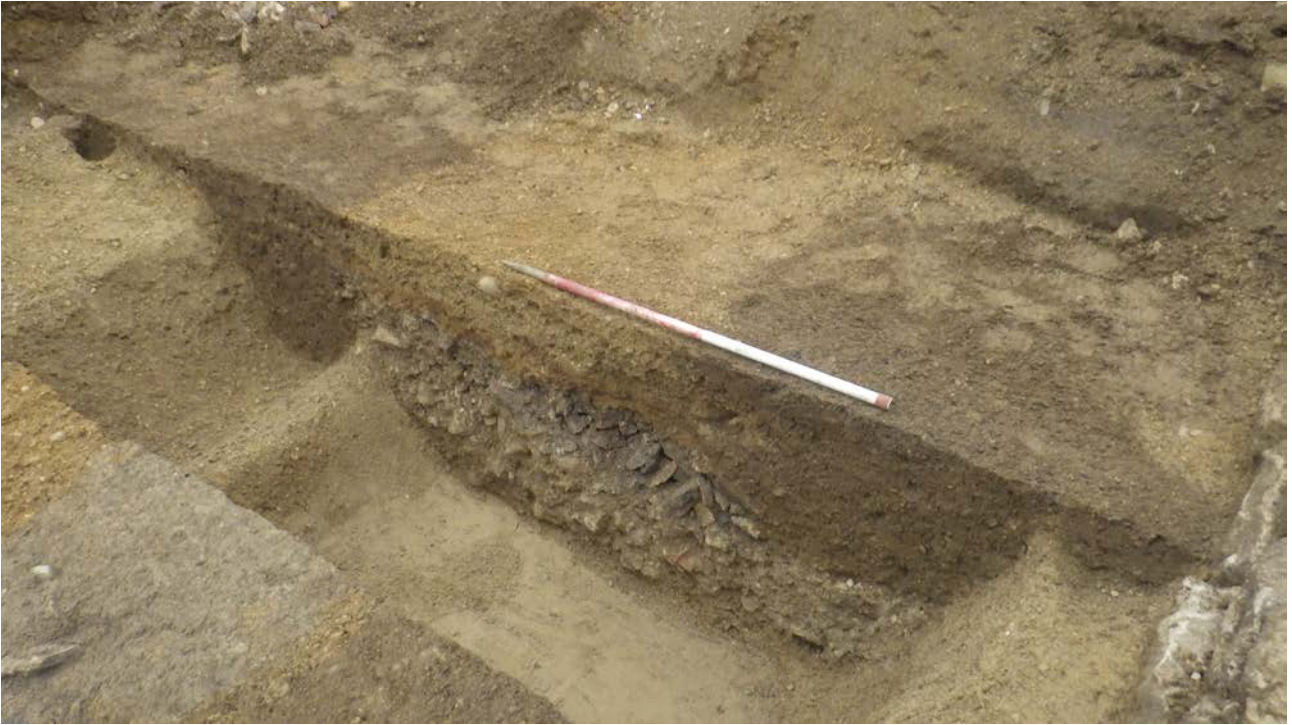
3.2.2 The earliest features were three postholes, all of which were truncated by later ditches (Plate 1). Two postholes were identified on the eastern side of the area and one on the western. Of these three, two were excavated, 122 and 124 (Fig. 10, Section 100), neither of which contained any dating evidence. The postholes were heavily truncated and measured 0.27m and 0.30m in diameter and 0.18m and 0.16m deep respectively. The third, unexcavated posthole was also truncated by ditch 108.

3.2.3 Ditch 120 was north-south aligned with a narrow concave base and a flared edge at the top of its western side, giving it a distinctive profile. It measured 1.50m wide and 0.66m deep. The ditch was truncated by a later ditch (108) on its eastern side and a modern service trench on its western side. It contained only a single fill of grey-brown silty, sandy clay, probably natural silting. Clay tobacco pipe dated to 1650–1725 and pottery of possible 18th-century date was recovered from the fill.

3.2.4 Later ditch 108 was aligned north-south and measured 2.80m in width and was 0.76m deep. Like ditch 120 had a flared edge on its western side, but had a wide flat base and a straight steep edge on the eastern side. It contained a thin grey-brown silt sand fill (118) at its base, possibly derived from weathering of its western edge. This ditch had clearly been deliberately backfilled with rubble deposits (116 and 117) as well as dumps of redeposited natural sand and gravel (e.g. 115 and 112). Pottery dated to c 1670–1750 and brick fragments of 18th- or 19th-century date were recovered from rubble fill 117 and clay tobacco pipe of late-18th- or 19th-century date was recovered from later fill 111.

Plate 1: Ditches 108 and 120, view NW

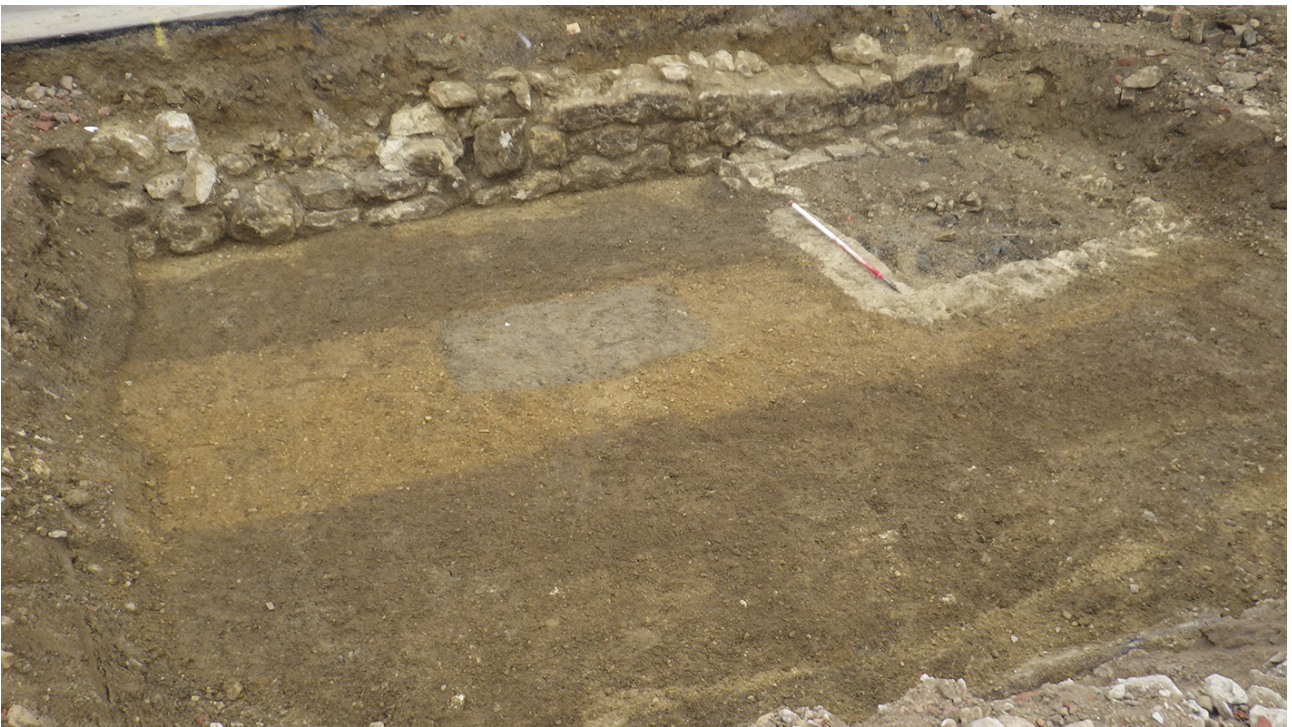
3.2.5 Wall 105 (Plate 2) ran parallel and immediately to the east of ditch 108 and partially truncated earlier posthole 124. Only its west edge was exposed, but it measured at least 0.65m in width and was exposed for a length of 5.80m. It was trench-built with roughly coursed unhewn and roughly hewn blocks of limestone with a sandy lime mortar.

Plate 2: Area 1 under excavation, showing boundary wall 105 and stone-lined pit 101, view SW

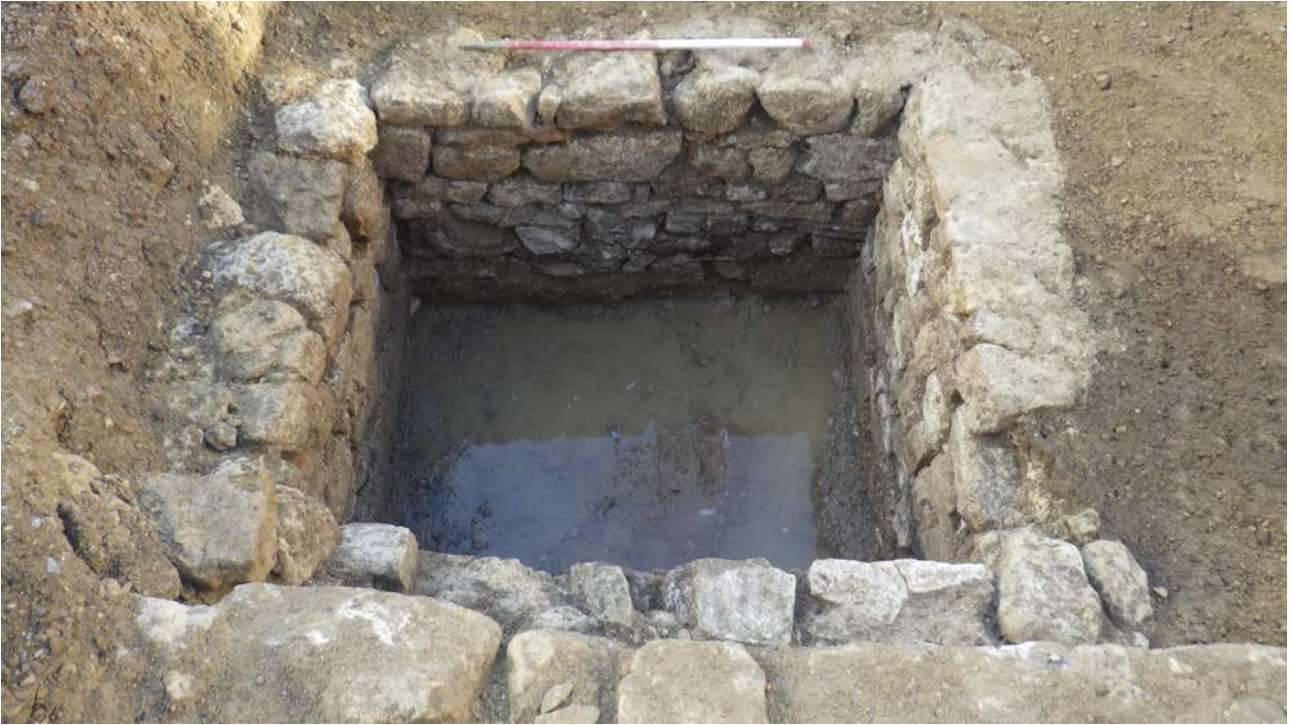
3.2.6 Abutting the west side of wall 105 and cutting into ditch 108 was square stone-lined pit 101 (Plate 3). The stone lining was constructed with similar material and mortar to the wall suggesting the two structures were contemporary. The shaft measured 1.75m x 1.60m and was 1.20m deep. It was filled entirely with a modern rubble backfill that contained tarmac, frogged and unfrogged brick and modern window glass. Recovered from the fill was a small decorative mother of pearl buckle of probable 19th-century

or later date and a bone seal. There was a mould-like black stain, probably derived from ground water, running around the base of the stone lining, suggesting that the pit was used as a soakaway.

Plate 3: Stone-lined pit 101, view W

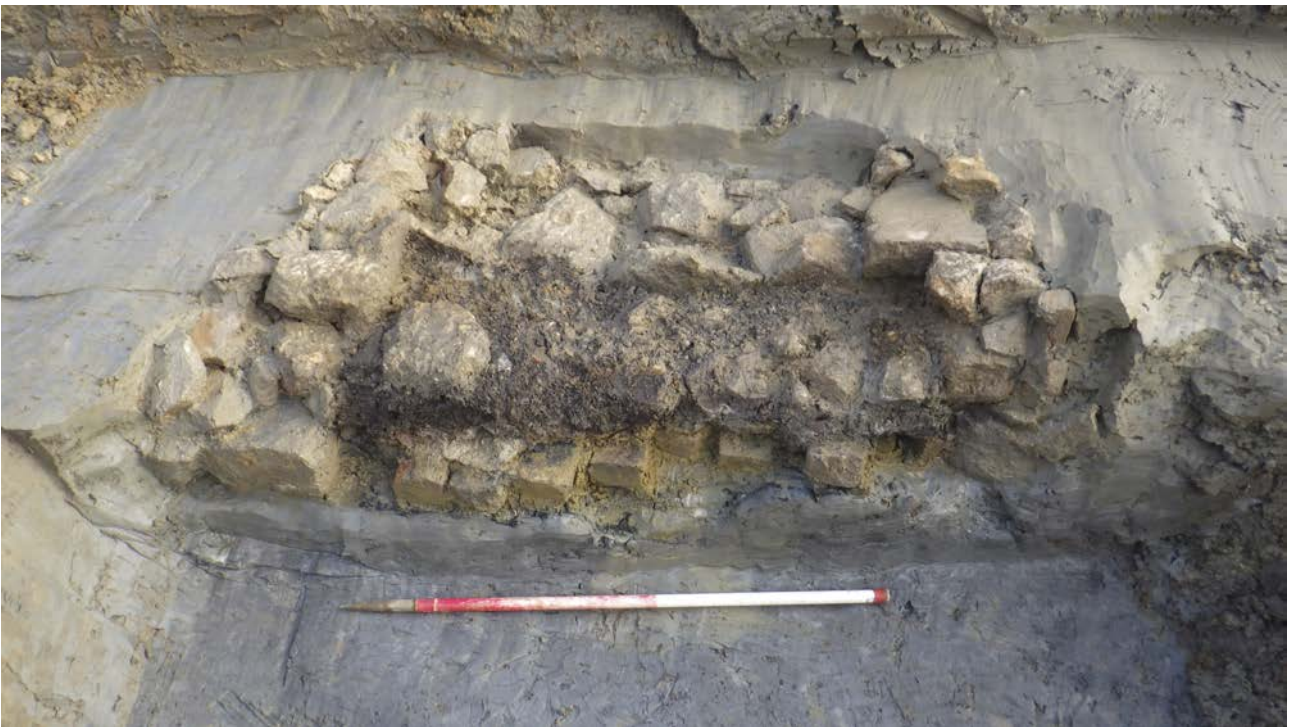
- 3.3.2 Layer 203 was up to 0.76m thick and was probably deliberately deposited to raise the area above the underlying floodplain deposits. It contained no finds. It was cut by three pits (204 and 206). Pit 206, possibly circular, was partially exposed against the northern edge of Area 2 and measured at least 10.0m x 2.1m across and 0.67m in depth. It was filled with mid-dark grey silty loam (207) that contained a brick fragment, possibly dating to the 15th–16th century. Rectangular pit 204 was located immediately to the south and measured c 1.50m x 1.20m and was 0.80m deep. It contained a single fill of organic dark grey clayey silt (205) that contained pottery dating to c 1780–1830. A third pit (210) was square and located at the southern end of the south slot. It was lined with roughly hewn limestone (209) with a sandy lime mortar bond (Plate 4). It had a floor of reused broken unfrosted red brick with the same bonding material which also overlay the bricks. This surface had been stained green suggesting the pit had been used to deposit cess or was used as a soakaway. The shaft measured 1.2m x 1.0m internally and was 0.36m in depth. Its basal fills (211) comprised ashy grey sandy silt containing pottery dated to 1780–1830 which was overlaid by a thick organic deposit of purple-black silty sand (212) that contained pottery dating to c 1830–60. The pit was levelled with rubble.

Plate 4: Stoned-lined pit 209, view ESE
