July 1998

**PLATTS HALL**  
**NORTHWICH**  
**Cheshire**

**ARCHAEOLOGICAL EVALUATION**

Report no 1997-98/(096)/AUA~~7801~~  
7801

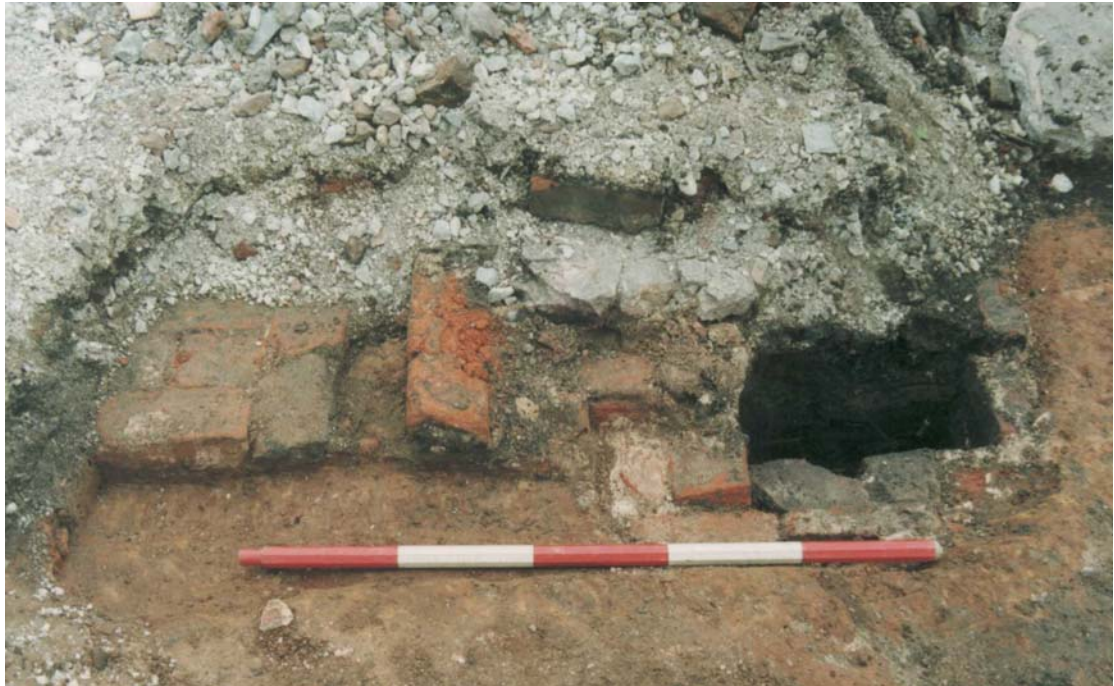
Fig 5 Photograph of hearth area at western end of Trench D

- 4.2.3 Evidence was also revealed for the brick fireplace known to have been inserted into the timber-framed east wall of the West Wing. The brick surface at the west end of the trench was most probably a brick hearth area for the Little Parlour at the north of the West Wing. The

bricks appeared to be hand-made, and the feature, though undated, may relate to the earliest fireplace inserted into the Little Parlour. The bricks may formerly have been covered by stone slabs.

- 4.2.4 It is clear that the brick-lined feature to the east was an ash box. It was located to the east of the fireplace structure recorded during the building survey and was blocked by mortar and brick rubble, both suggesting that it was part of an earlier fireplace. However, its position, c 0.4m east of the line of the wall of the west wing, suggests that it related to the north-west room of the East Wing rather than to the Little Parlour and may have been in use during the early twentieth century. This is suggested because the interior edge of the lining on the west side was on the same alignment as a rectangular aperture in the concrete slab. The slab itself was most probably inserted during alterations in the 1920's (W J Smith, pers comm). If these two fireplace structures related to different rooms, it is possible that the central line of bricks aligned north/south was the base of a brick wall dividing the two fireplaces.

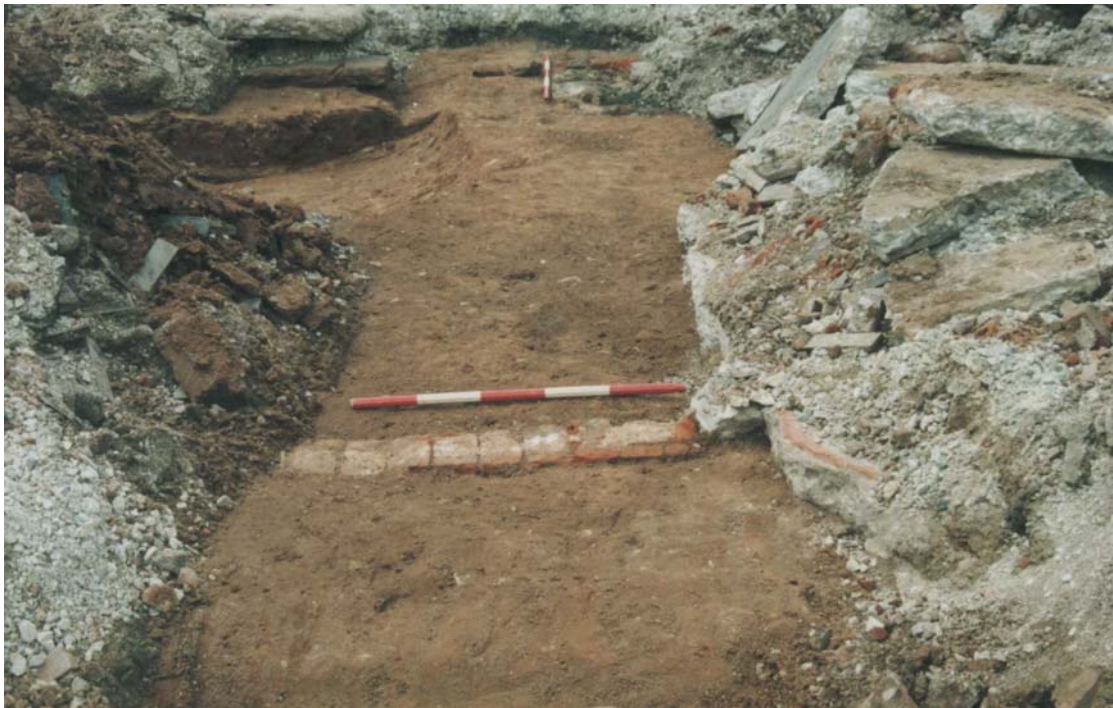
Fig 6 General view of Trench D from East

- 3.5.1 Trench D was roughly cruciform in shape, and measured 7.85m east/west x 6.00m north/south. It was excavated by mechanical excavator through a depth of *c* 0.25m of roadstone and recent demolition debris, below which a concrete slab was revealed; this contrasted with the earlier phase of evaluation of the West Wing, where the concrete slab had been removed during the demolition process. A large proportion of the concrete was removed using the excavator so that the evaluation could proceed. The survival of the concrete slab slowed down excavation, but meant that the deposits below had been better protected from the demolition process than those below the West Wing.
