Land North of Old Elstead Road Milford Surrey

Archaeological Evaluation Report

Land north of Old Elstead Road, Milford, Surrey

ARCHAEOLOGICAL EVALUATION

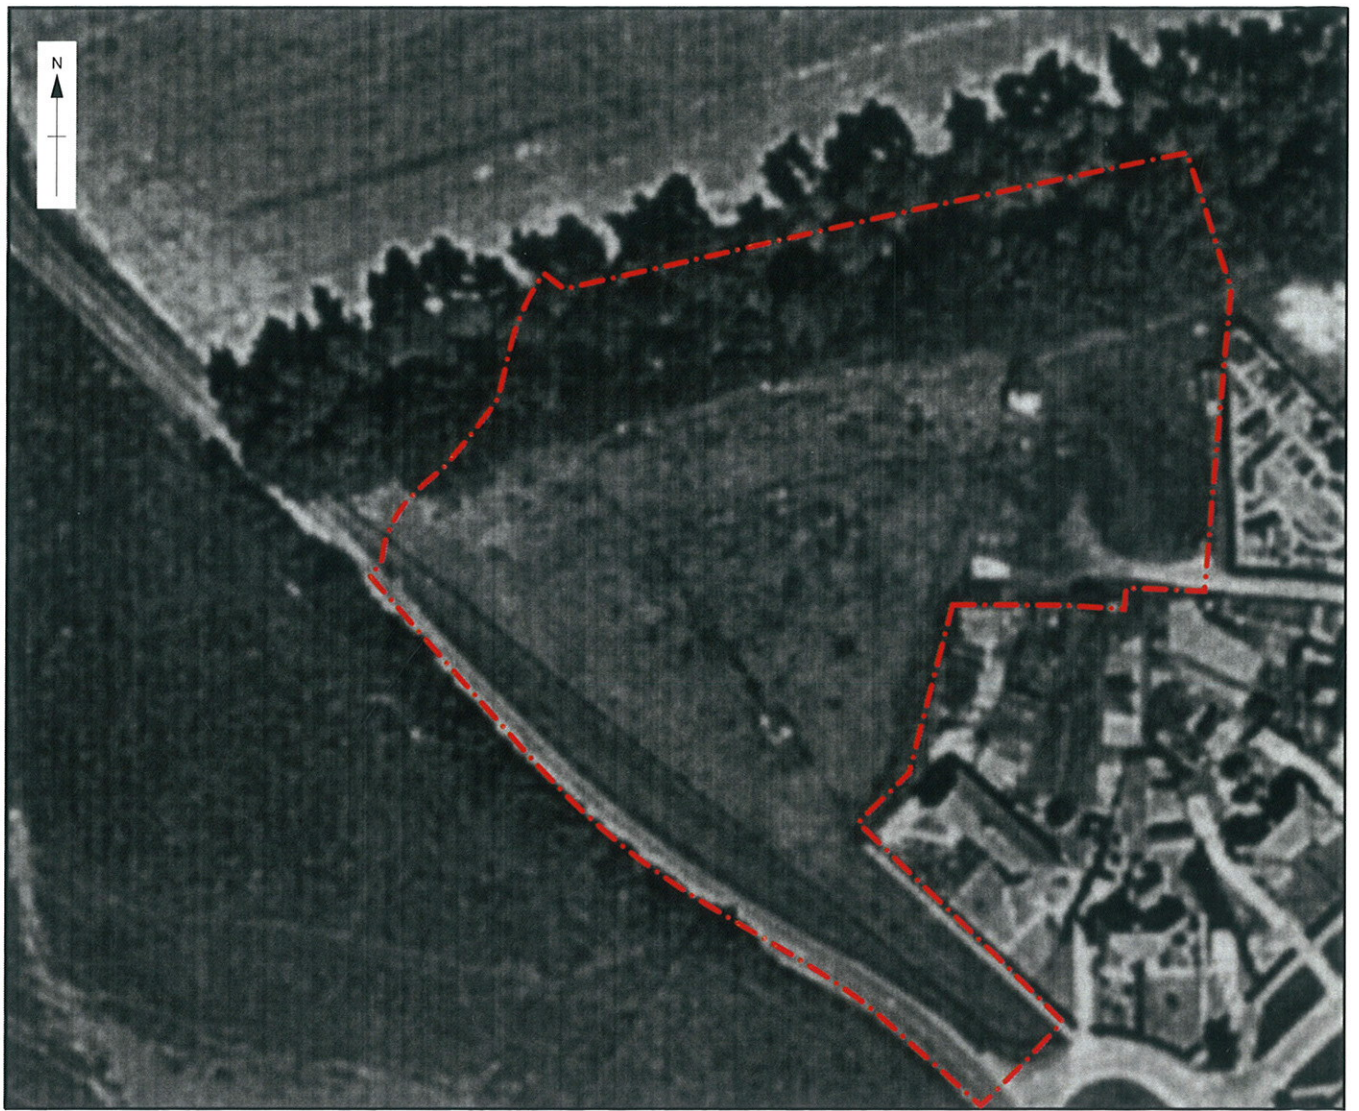
Figure 2: Details of RCHME Aerial Photograph showing cropmarks (OA 22)

- 6.2.3 The features suggested by the aerial photography (Fig. 2) were not encountered. The linear features shown in the AP may represent paths across the field and the circular features may possibly be the result of geological anomalies or surface depressions. The western N-S aligned linear feature, shown in the AP, corresponds to a bank separating the field from the houses.

- 3.1.1 Six trenches were excavated, Trenches 1 to 4 measured 30 m by 1.6 m and Trenches 5 and 6 measured 15 m by 1.6 m (Fig 3). The overburden was removed under close archaeological supervision by a JCB mechanical excavator fitted with a toothless bucket.
- 3.1.2 The trenches were targeted on linear and other cropmarks visible on aerial photographs and in areas that contained circular cropmarks indicative of small archaeological features (Fig. 2).

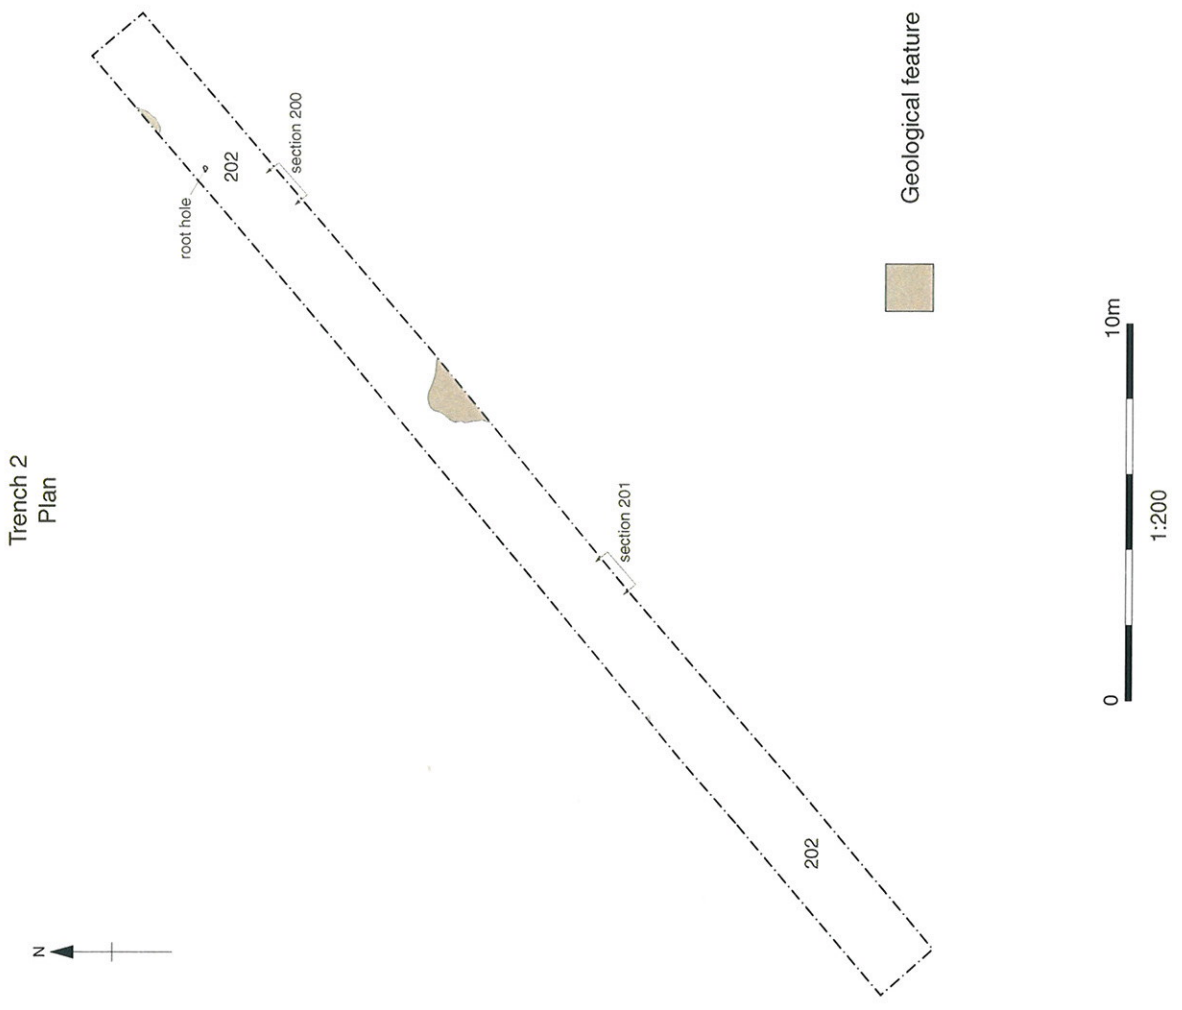
Figure 5: Trench 2 Plan and Sections

- 5.1.2 Trench 2 measured 30 m by 1.6 m and was aligned NE-SW. In the SW of the trench natural sand (202) was revealed at 48.80 m OD and in the NE of the trench at 50.03 m OD (0.70 m bgl). It was overlain by a layer of colluvium (201) below a topsoil (200).
