LANCASTER
UNIVERSITY
ARCHAEOLOGICAL
UNIT

KENDAL CASTLE
CUMBRIA

FABRIC HISTORY DOCUMENTARY SURVEY

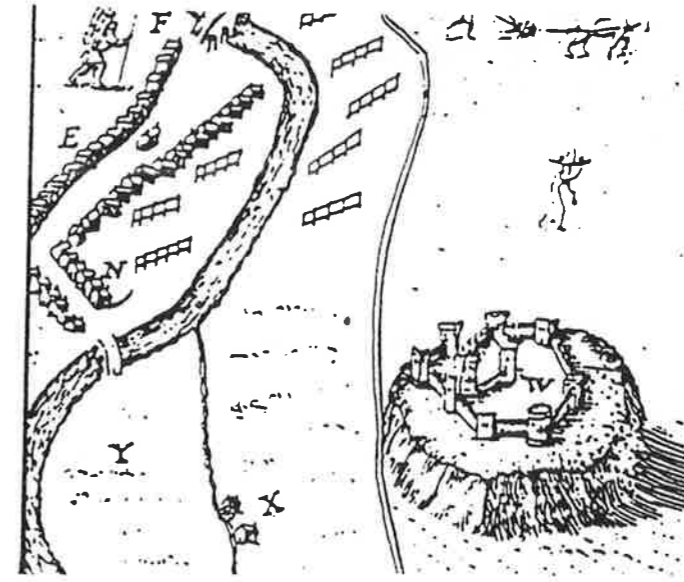
Fig. 1 Detail of Kendal Castle from map by John Speed *c*1610.

From this time, there is little information regarding the condition of the castle's fabric for two centuries. The map of Kendal published by John Speed (**Fig. 1**) around the year 1610 is schematic and appears to be inaccurate in points of detail, though it may contain some information of value. Eight towers or bastions are depicted in the curtain wall, whereas only six are currently known from the standing fabric and from excavation. Moreover, the situation of the castle on its drumlin is indicated, but there is no sign of the moat. However, the structures shown within the *enceinte* may be supported by archaeological evidence. That to the left may be an attempt to indicate the position of the hall whereas the building standing in the centre of the enclosure appears to be connected by walls at both ends to the curtain wall. This appears to have been a chapel block (SLDC 1993, 5) and though other historic plans show it to be completely free-standing, walls excavated in 1971 may suggest that the building was connected to others by a corridor. It is also notable that the castle, as drawn by Speed, appears to be wrongly oriented by 90°. No structures or field boundaries in the park are shown by Speed, though he depicts ploughing in the area to the north of the castle.

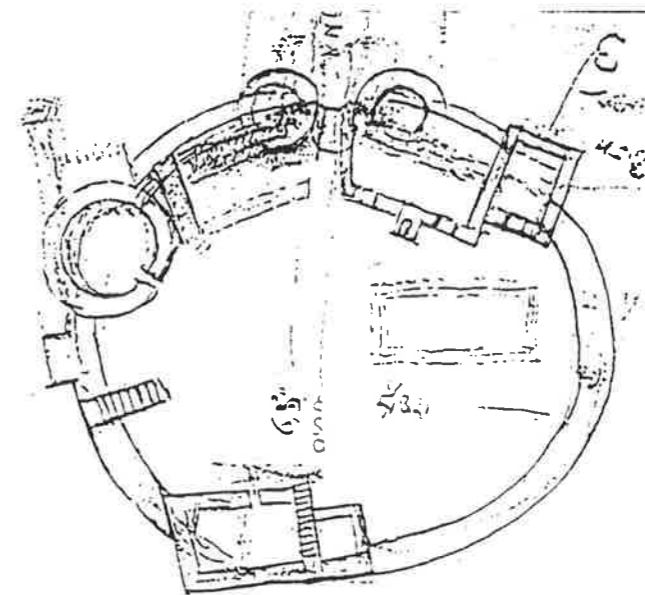
Fig. 2 Detail of plan of Kendal Castle by Thomas Machel *c*1690.

There exists a drawing of the castle from around 1690 by Thomas Machel (the original of which is kept in the Carlisle Record Office in the volume Machel MSS 2) and is basically a sketch ground plan with some annotated dimensions (**Fig. 2**). In the cases of several buildings, an indication of the appearance of the superstructure is shown. As with Speed, the curtain wall is depicted as intact around the perimeter and the indication of stairs on the bottom left corner may suggest that in this area at least, the ramparts survived *in situ* or that the walls survived to rampart height. Machel's depiction of the hall block (with southern porch) and adjoining north-east tower, the south tower block (with two chambers) and the round tower are generally in accordance with the evidence of standing and excavated fabric, albeit out of scale. He also shows a north-west range to the west of the gatehouse, mirroring the hall block: this has not been confirmed by excavation but is suggested by a surviving stub of wall to the east of the circular tower. More problematic is his depiction of the gatehouse with flanking drum towers: as shall be seen, this was not supported by the archaeological investigations of the twentieth century. Machel also clearly shows the bastion on the western side of the *enceinte* as rectilinear, whereas the present structure is round. One other building is shown within the enclosure: as mentioned above, this is the 'chapel block', which Machel's and subsequent depictions of the castle show as free-standing. This may be an inaccurate rendering or may genuinely reflect what was visible above ground at the end of the seventeenth century.

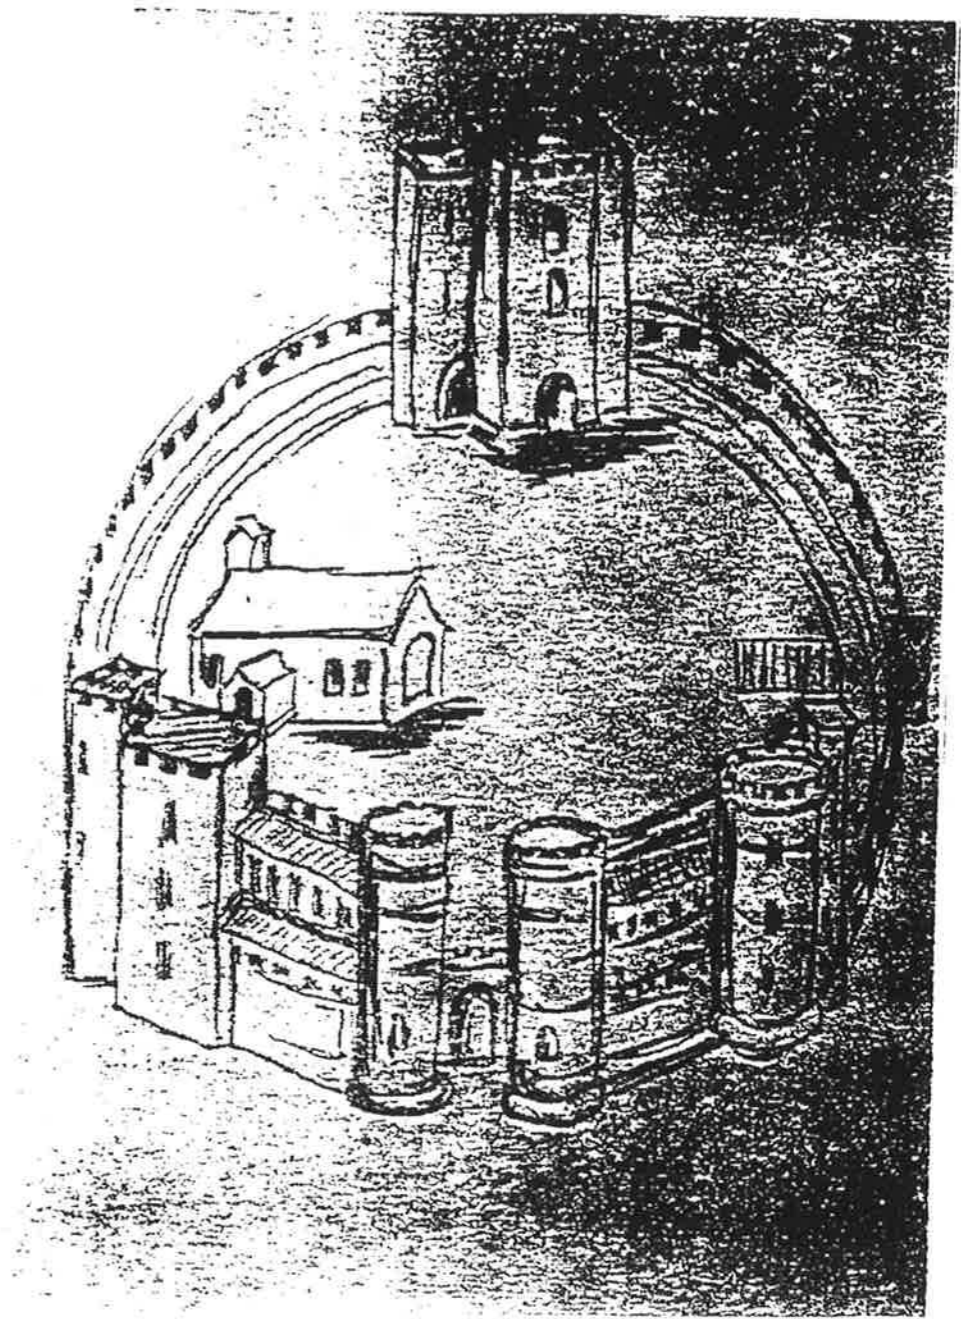
Fig. 3 Sketch of Kendal Castle by Thomas Machel 1890.

Another drawing from the Machel MSS 2 (**Fig. 3**) is reproduced in several modern sources, (including Spence 1951, Fig. 8). This drawing is taken from the north and instead of a plan, shows the buildings of the castle as upstanding and intact. Particularly prominent are the gatehouse with drum towers and associated ranges, the south tower, shown as a three-storey block with a subsidiary turret on its eastern side and a freestanding chapel inside the castle. The idea that the south tower may originally have been more imposing than at present appears to be largely a product of this drawing; it is shown as far less impressive on the other Machel sketch (**Fig. 2**). Examination of the original manuscript reveals an

annotation in a hand which appears to be that of Machel himself; it reads "This is too big a tower". The curtain wall is drawn as relatively low but with battlements still *in situ*. The hall itself is shown in the copy reproduced as **Fig. 3** as a sophisticated architectural composition apparently aisled and clerestoreyed with crenellations only on the eaves facing into the courtyard. This is completely at variance with the evidence of the standing structure and it is felt that any wide inference from this version of Machel's drawing would be ill-advised.

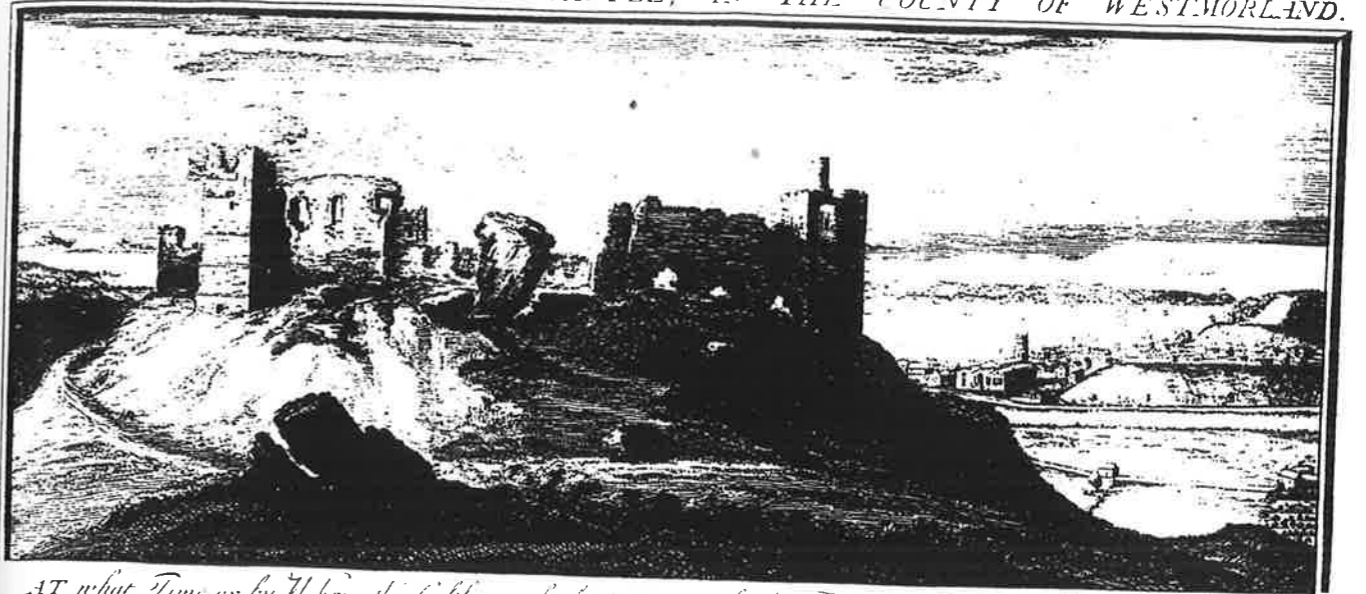
Fig. 4 Kendal Castle by the Buck brothers, 1739.

The Buck brothers published an engraving of the "East View of Kendal Castle" in March 1739 (**Fig. 4**): the view in fact appears to be from the North. The principal structures are clearly recognisable, including the hall with two round-headed windows and fragments of a third, the north-east tower with at least four and possibly five offsets. This appears to be in a good state of repair, although the topmost storey is shown as ruined and covered with vegetation. The round tower seems particularly well-preserved, with battlements, a turret on the southern side and a north-facing large two-light window (which may possibly be an oriel). The section of the curtain wall running eastwards from this tower is upstanding to a considerable height, although it contains three large holes at ground level. In the far distance, the south tower is visible and this too appears to be substantially intact to the level of the battlements. However, there are also signs of falling masonry, notably in the foreground (in the vicinity of the gatehouse), where a very large section of the curtain wall is leaning outwards at an angle of forty-five degrees. Another section of the north curtain appears to have already fallen down the slope. The bank on which the castle stands is relatively accurately portrayed, but there appears to have been only a rudimentary attempt to show the deep moat which surrounds it. With this exception, and allowing for artistic licence, there is no reason to doubt the testimony of the engraving which shows that in the mid-eighteenth century, the castle, though ruined, retained substantial upstanding fabric in many of its principal structures.

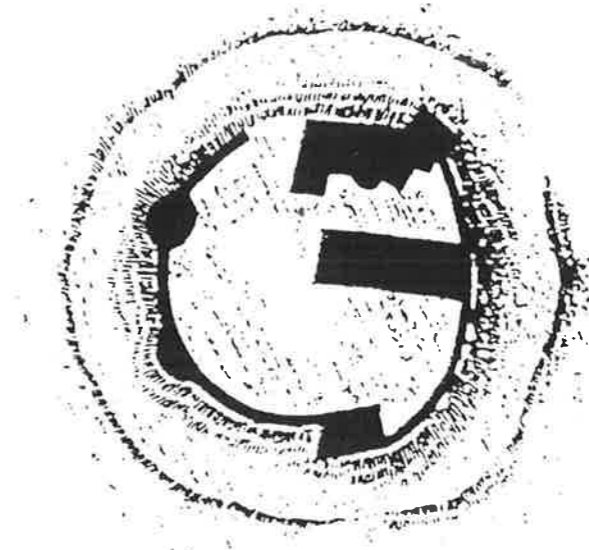
Fig. 6 Plan of Kendal Castle by Todd. 1787.

A plan of the castle in a map by Todd in 1787 (**Fig. 6**) presents all structures as solid shaded entities, as if they were buildings still in use. This convention is unhelpful in interpreting which structures are depicted, particularly in the hall/north-east tower complex, which is shown as a complicated undifferentiated mass. The southward projection on the south-western corner of the hall does not appear on previous plans of the castle and is not easily identified with any excavated structure. The 'chapel block' is shown as connected at its eastern end to the curtain wall. The only break in the wall is shown in the area of the gatehouse, but there is no indication of any towers, bridge abutments or other structures in this area. However, other features are portrayed reasonably accurately, such as the western bastion, which is basically as at present. This plan of the castle (and the shading convention) are followed exactly by Wood in a map of 1833 (SLDC 1995, M4). Todd also provides a depiction of the castle from the south-west (**Fig. 7**). The masonry of the wall is shown as ashlar rather than coursed rubble, but with this exception, the drawing appears to be credible in its essentials. The castle is

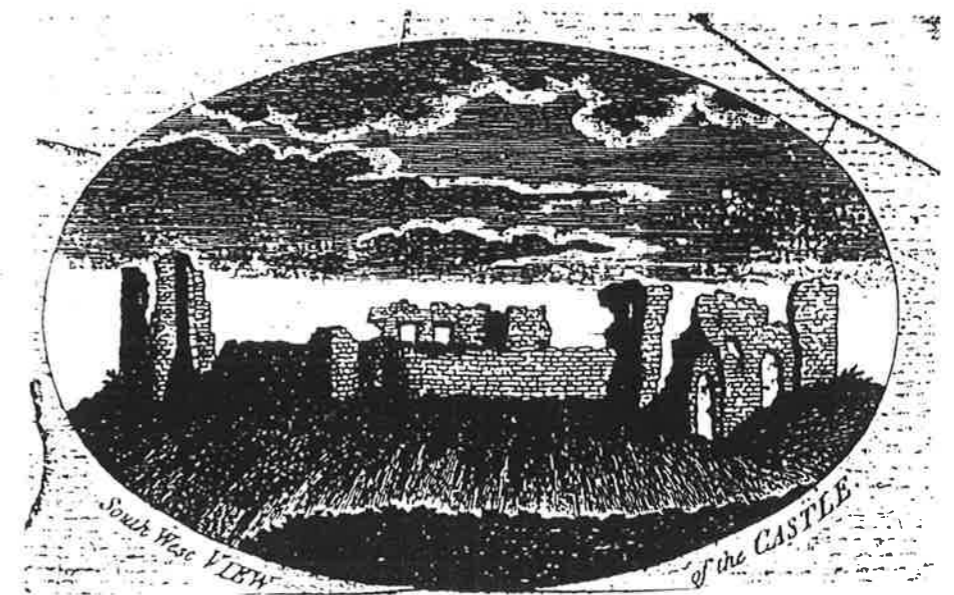
Fig. 7 Drawing of Kendal Castle by Todd, 1787.

shown on its bank, with the round tower, western bastion and the south tower in the foreground: in the background are the north and east wall of the hall block, together with the north-east tower. No trees are shown in the area of the castle.

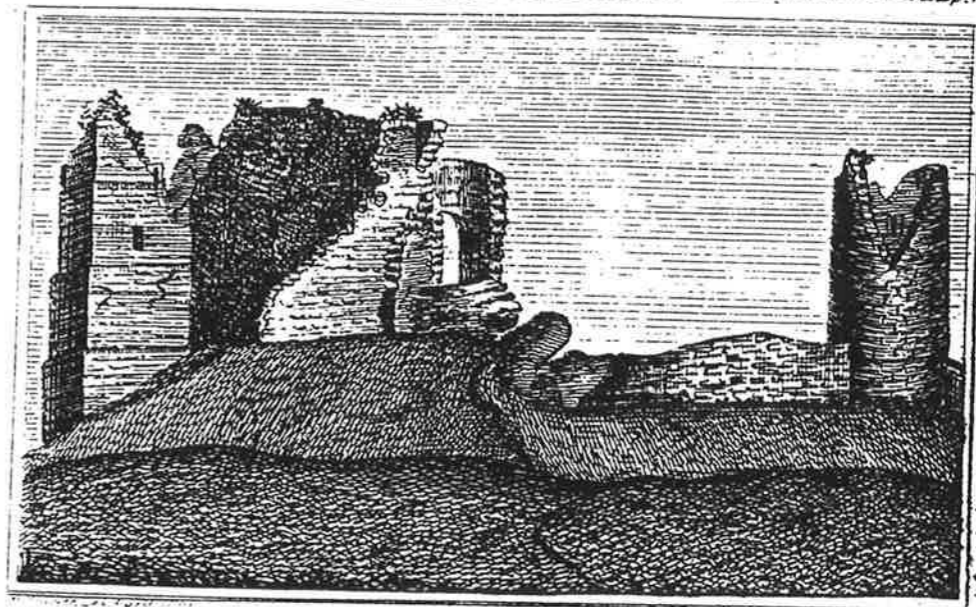
Fig. 8 Engraving of Kendal Castle from the North by J. Hopper, 1800.

In the *Gentleman's Magazine* of December 1800, there is an engraving by J. Hopper of the castle from the North (**Fig. 8**). This shows the hall with tall upstanding masonry, probably covered with ivy; the north-east tower is depicted with four storeys and with the top storey very badly decayed. The round tower is shown without battlements or a turret and with a very large crack in the masonry on the north side. The earthen bank on which the castle stands is shown and there is an attempt to show fragments of isolated masonry leaning drastically. The northern curtain appears to be in a very poor condition. However, there is no attempt at perspective and the engraving is stylised in the extreme: for example, the masonry as depicted has the appearance of dressed ashlar.

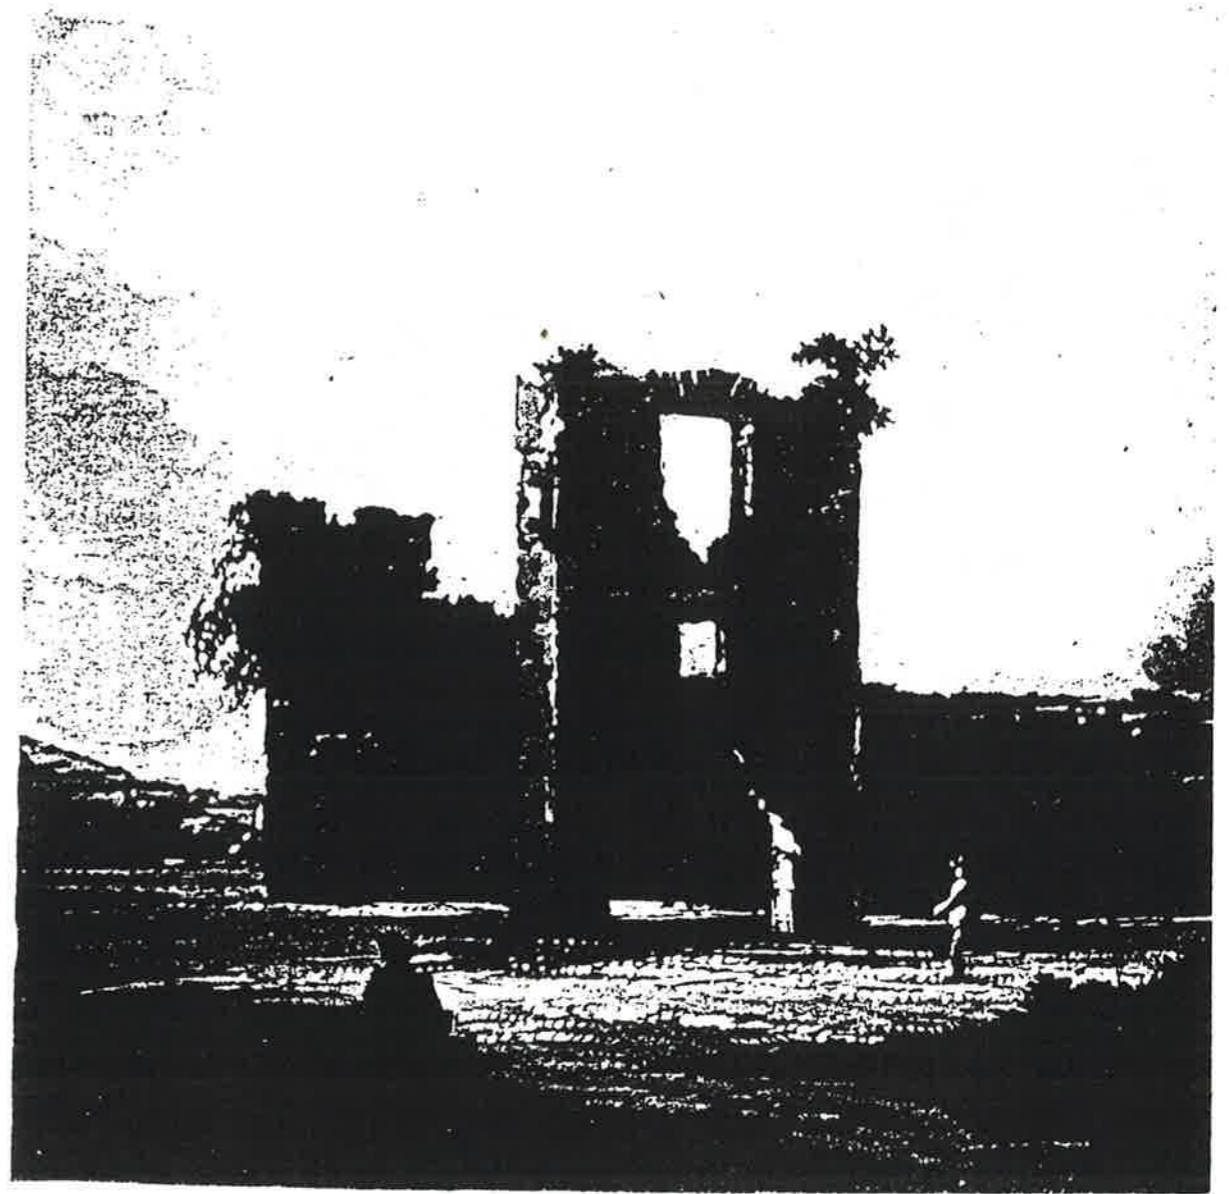
Fig. 9 Aquatint of Kendal Castle by T. Fielding, 1822.

This presents something of a contrast to an aquatint by T. Fielding in 1822 (**Fig. 9**), in which the grass is short, the ground relatively level and the masonry in good condition and free of vegetation. It is not possible to state with certainty which part of the castle is depicted. However, the closest visual similarities are with the southern portion of the site and the picture raises the intriguing possibility that substantial parts of the south tower were upstanding in the nineteenth century.

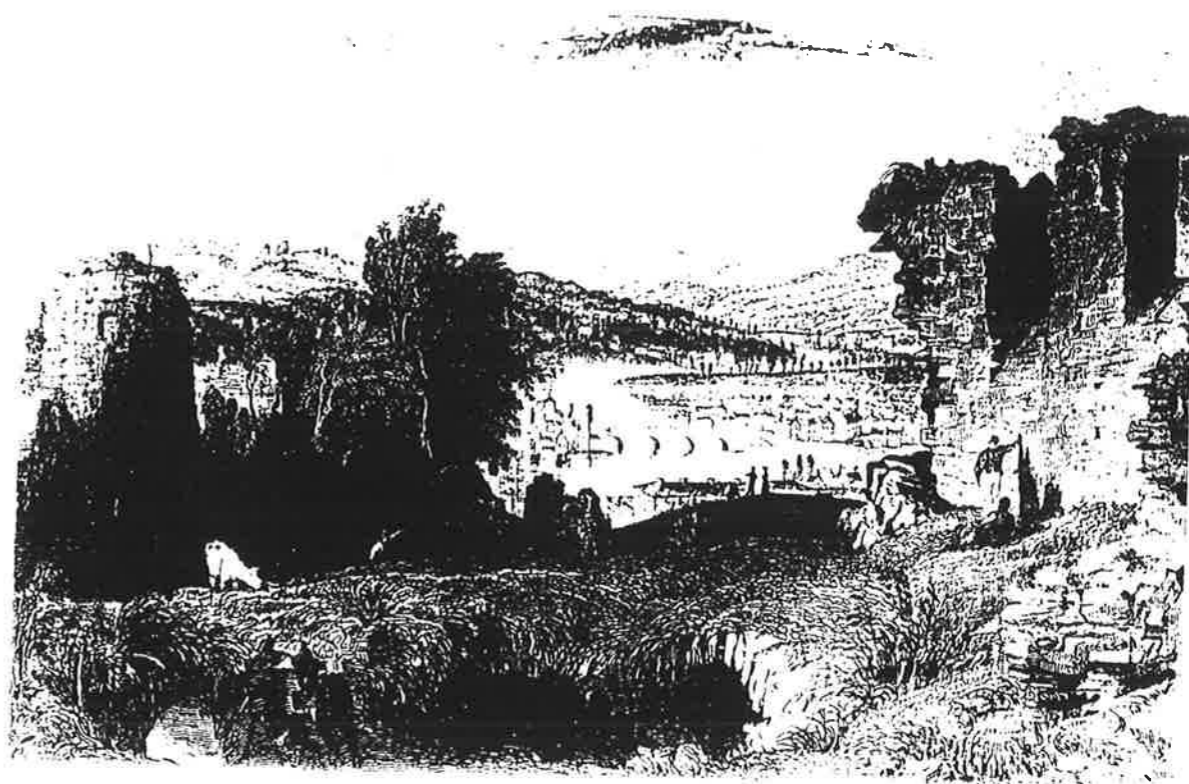
Fig. 10 Engraving of Kendal from the Castle by Thomas Allom. 1832.

In 1832, an engraving by Thomas Allom entitled 'Kendal from the Castle' was published (**Fig. 10**). This view is taken from the site of the Great Hall looking westwards with the arches of the hall cellars in the foreground and the round tower on the far side of the *enceinte*. The curtain wall appears to have largely disappeared and both the hall and the west tower are shown in a very dilapidated condition. The interior of the castle is shown as overgrown and uneven, with cattle grazing.

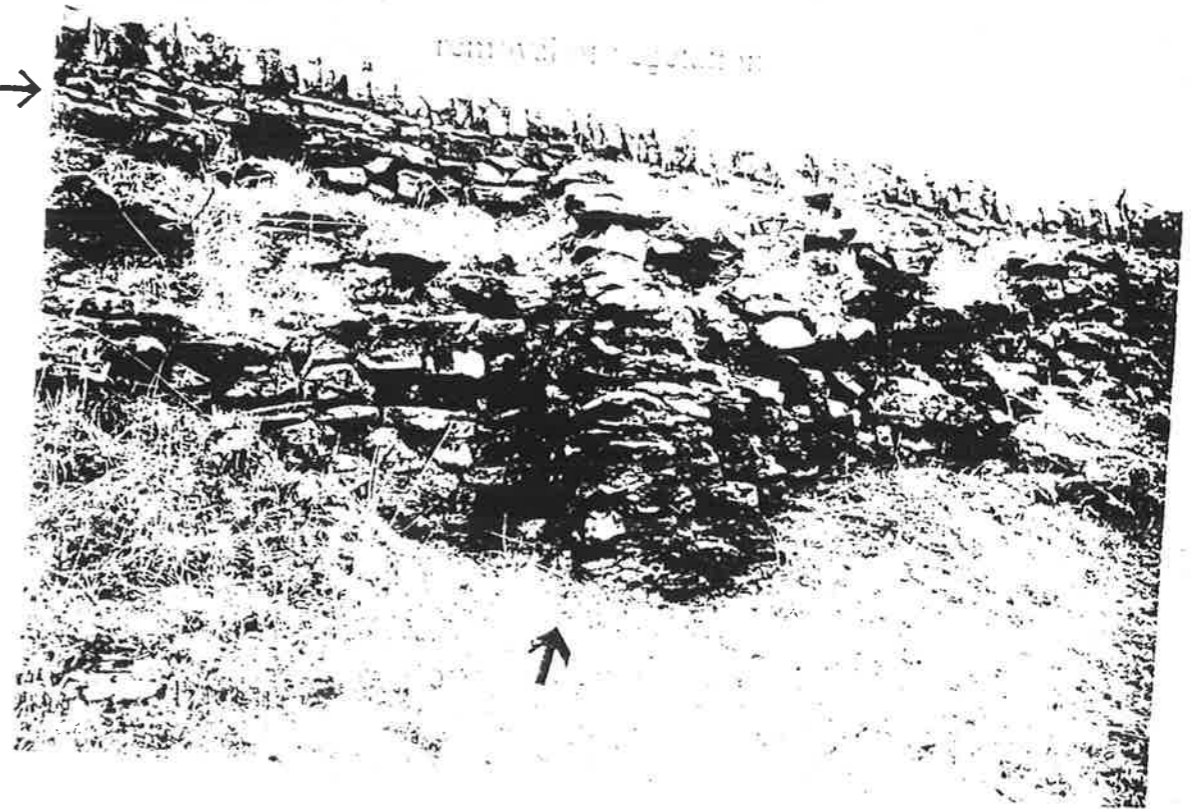
1

East Curtain Wall

repair of
19c infill →

- i) east curtain - repair of smaller pockets in the 19c infill wall
- ii) east curtain - removal from the dry moat of a pile of historic stones and provision of suitable storage
- iii) north curtain/gatehouse - small amount of slipped masonry and consolidation
- iv) postern gate - remedial work required to vertical joint and walltop. A small area of wallbase (1-2m) to be rebuilt.

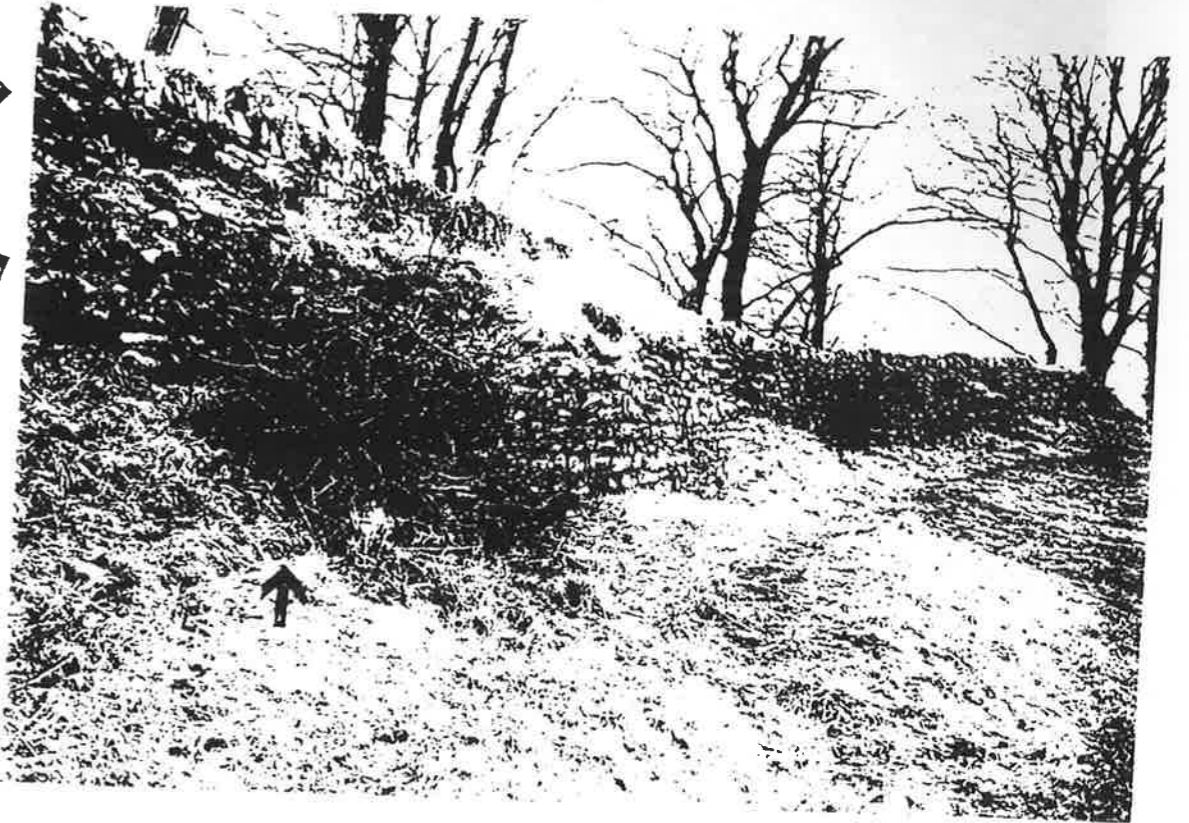
2

repair of
19c infill wall →

consolidation
of stonework →

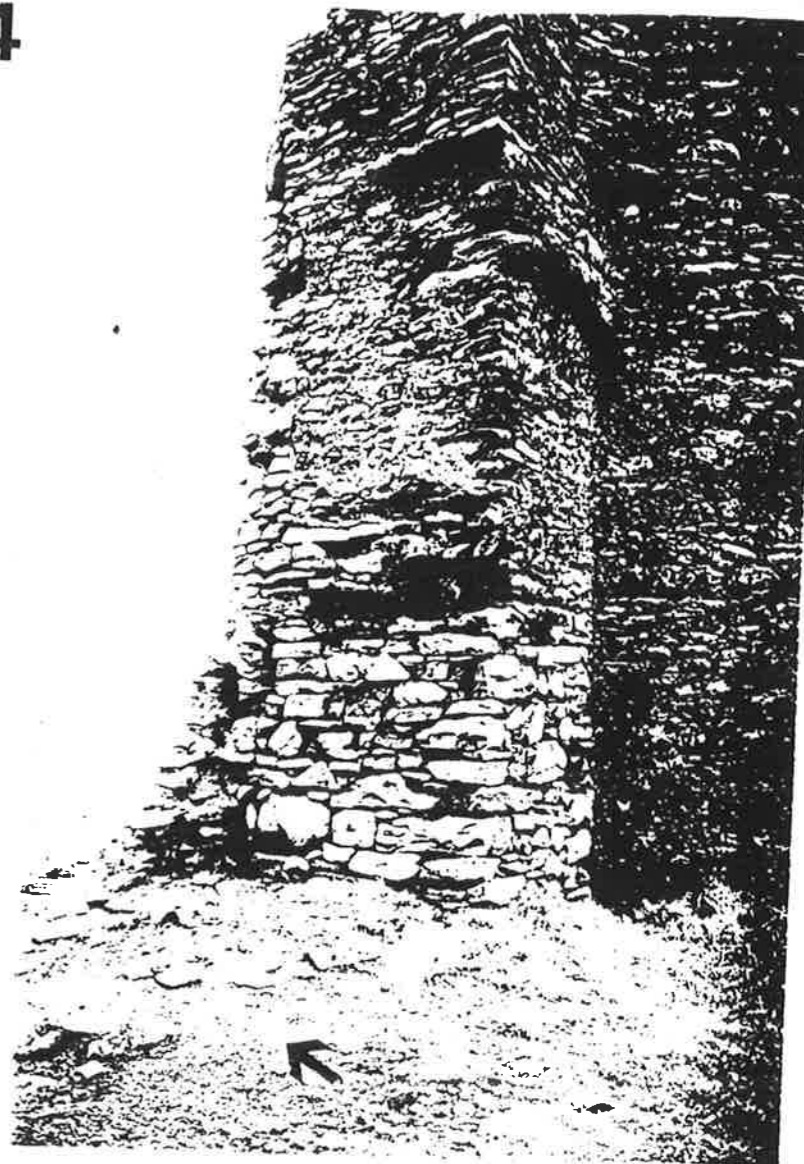
4

rebuild wall

North West Tower

North-west tower: A large part of this standing structure survives but it is in poor condition having suffered abuse from visitors and weather erosion.

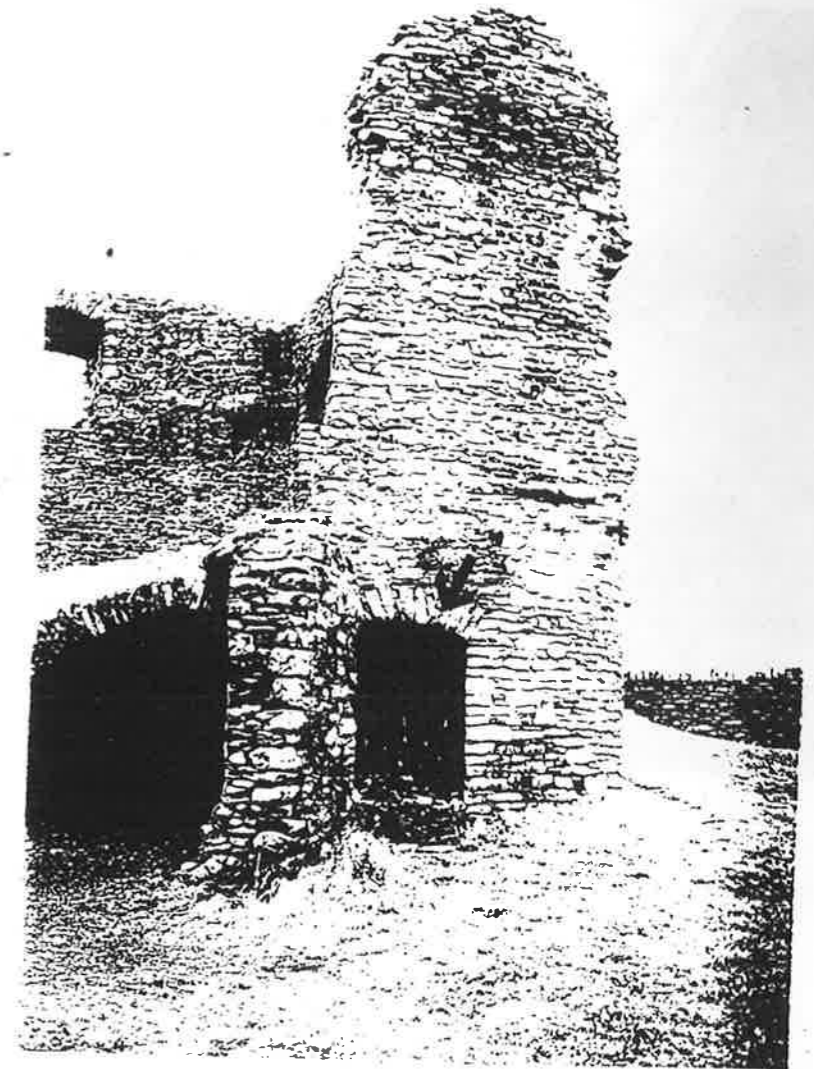
7

Cellar area to Hall Block

investigate water ingress
at high level

consolidation of
openings

Hall block: Of concern are the vaulted cellar areas, below where little or no work appears to have been undertaken. This area is covered with grass and soil and water filtering into the stone and the joints results in calcification on the underside of the vaulting. The structure is thoroughly saturated but in particular water penetration was noted at the springing point from the east wall in the vicinity of the fireplace.

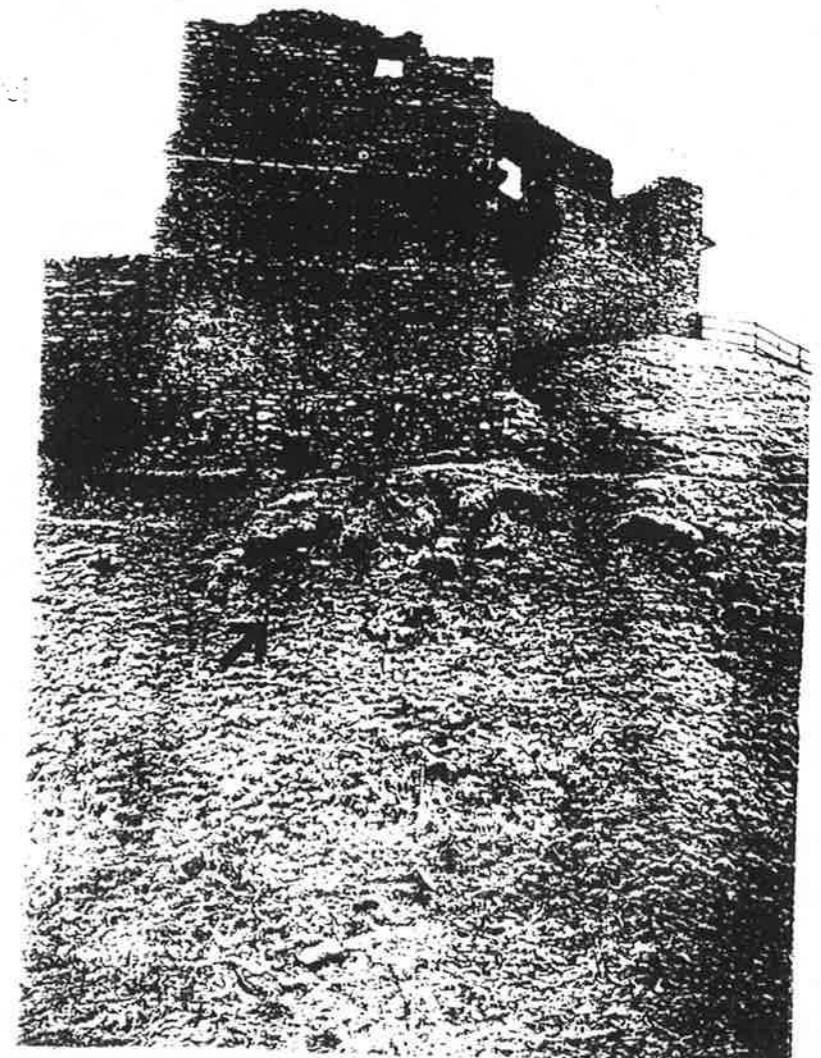
11

reinforcement at areas of
instability and severe erosion
