No.17 Norham Gardens, Oxford

Historic Building Investigation and Recording

August 2023

Client: St Edmund Hall, Oxford

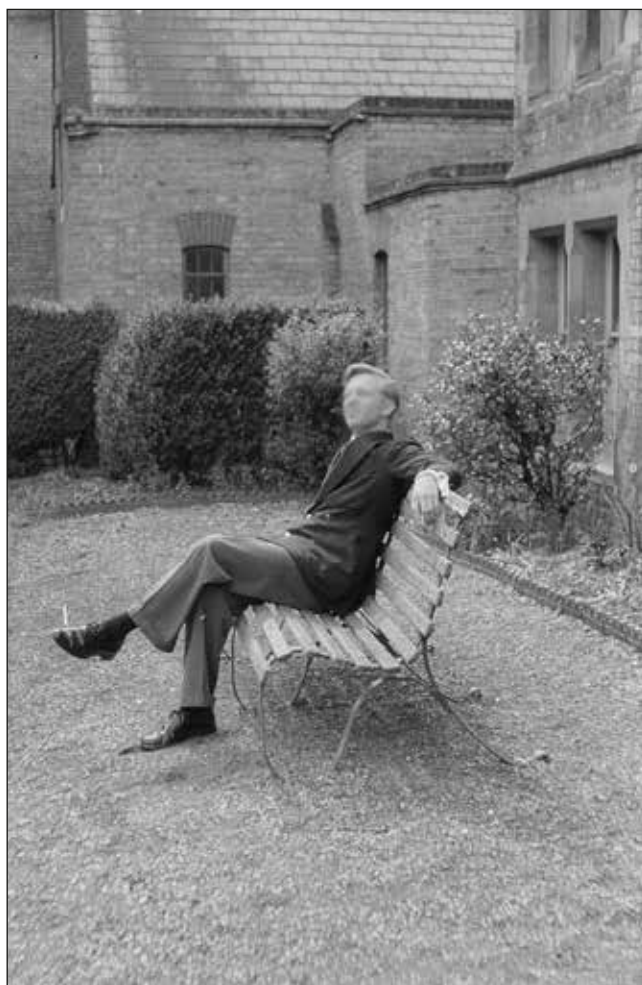
Figure 5: Photo from the late 1950s before the extension of the chancel (source: St Stephen's House)

- 2.3.4 A photograph (fig. 5) that appears to have been taken in the late 1950s or early 1960s shows the south end of the chapel before its extension. The east porch and sacristy are shown and the parapet of the original building is lower than it is at present.

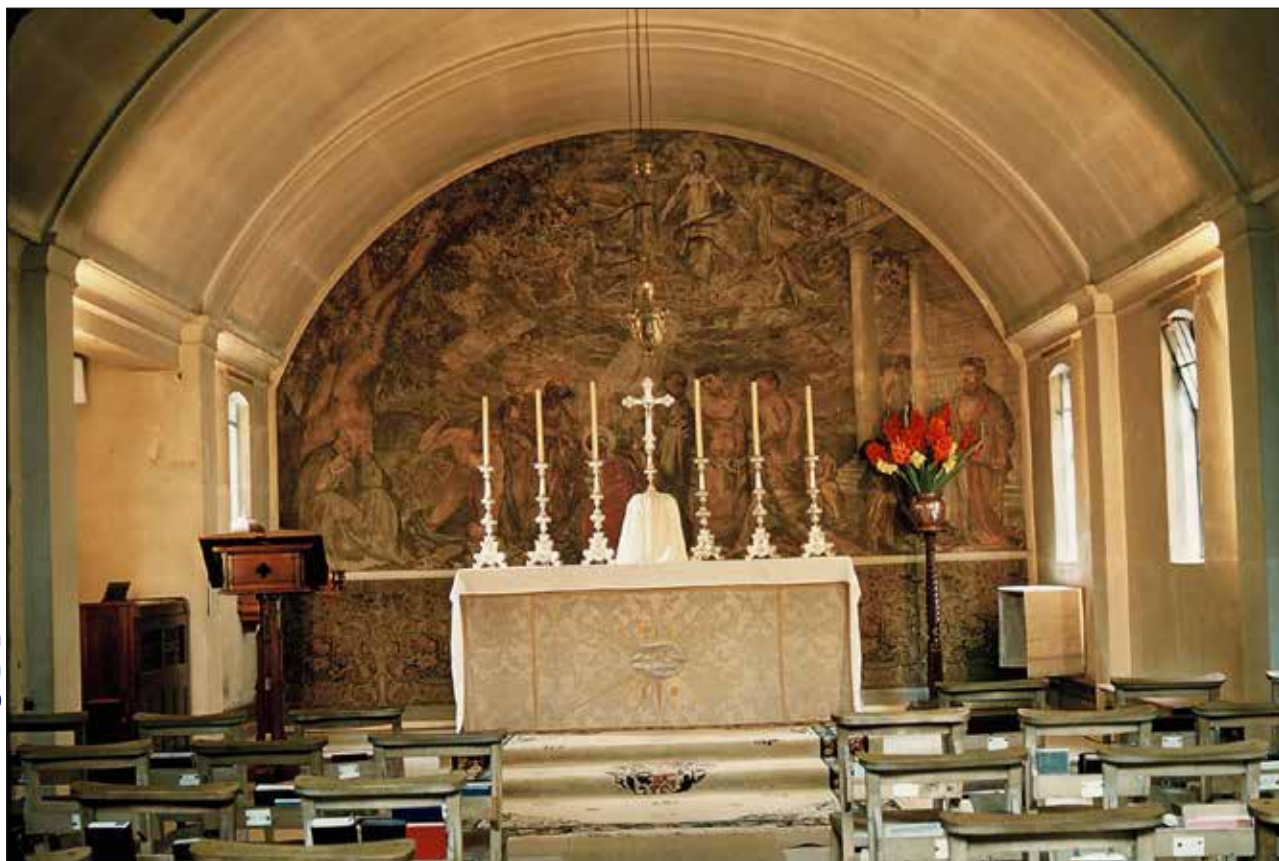
Figure 6: The interior of the Chapel in the late 1950s (source: St Stephen's House)

- 2.3.5 Another photograph (fig. 6) from the same period shows the chapel interior before the extension of the chancel, which occupies one bay and is only distinguished from the nave by two concrete steps. Behind the altar, the entire south wall is covered by a reredos depicting the Martyrdom of St Stephen above a dado rail and stylised floral pattern below. This was an oil painting on canvas and the upper part of the image now hangs in the Founder's Chapel at the present St Stephen's House.

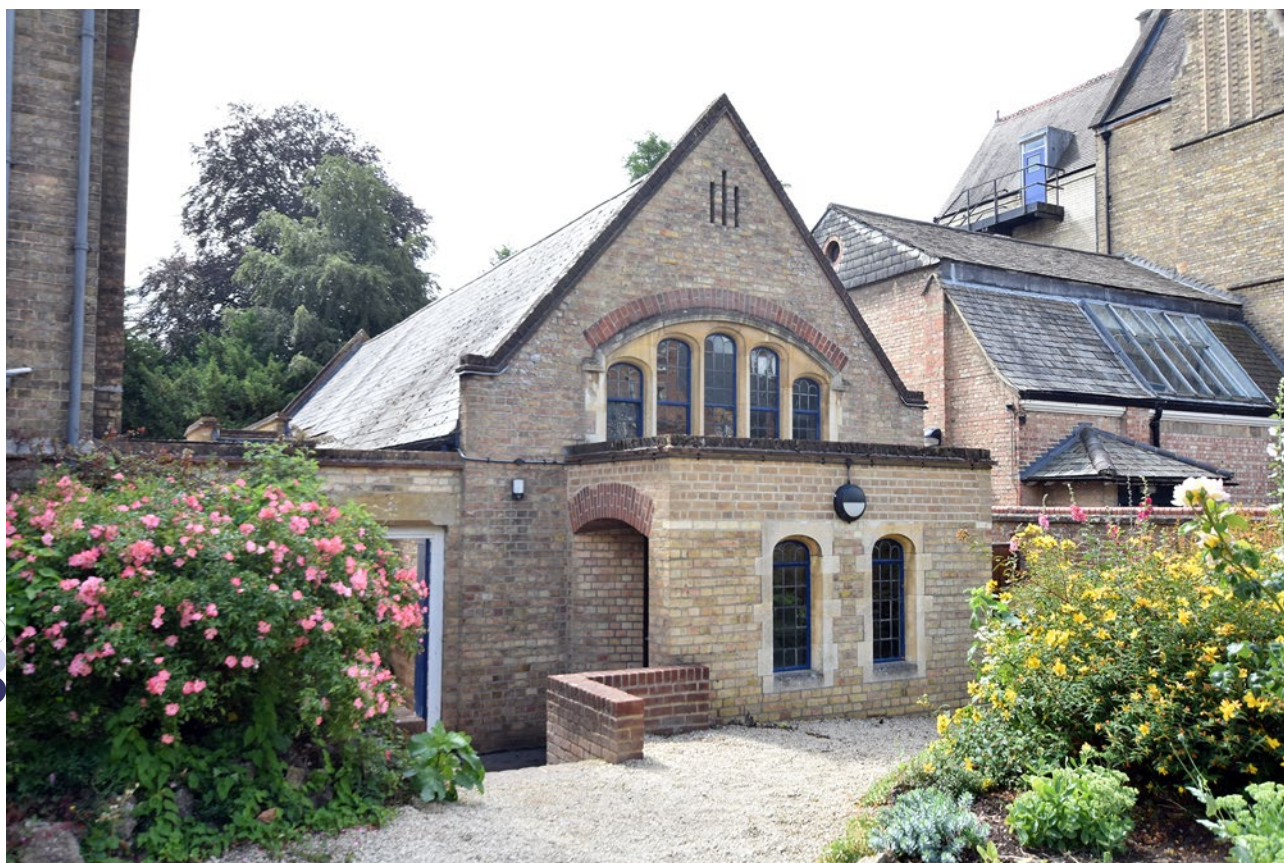
Plate 3: The north elevation of the chapel

- 3.2.2 The main body of the chapel, containing the nave and chancel, is a rectangular structure orientated north-south (pl. 3). It has a slate covered gable roof and is one and a half storeys at the gable ends. The original part of the structure is formed of yellow bricks, with some uneven buff colouring, laid in an English bond. The bricks measure 9 inches long, 4 inches wide and 2 ½ inches high and have a lot of texture with frequent kiln stack marks and finger prints observed (pl. 4).
