Parkside Link Road, Newton-le-Willows, St Helens

Historic Building Recording and Watching Brief

February 2023

Client: The Environment Partnership

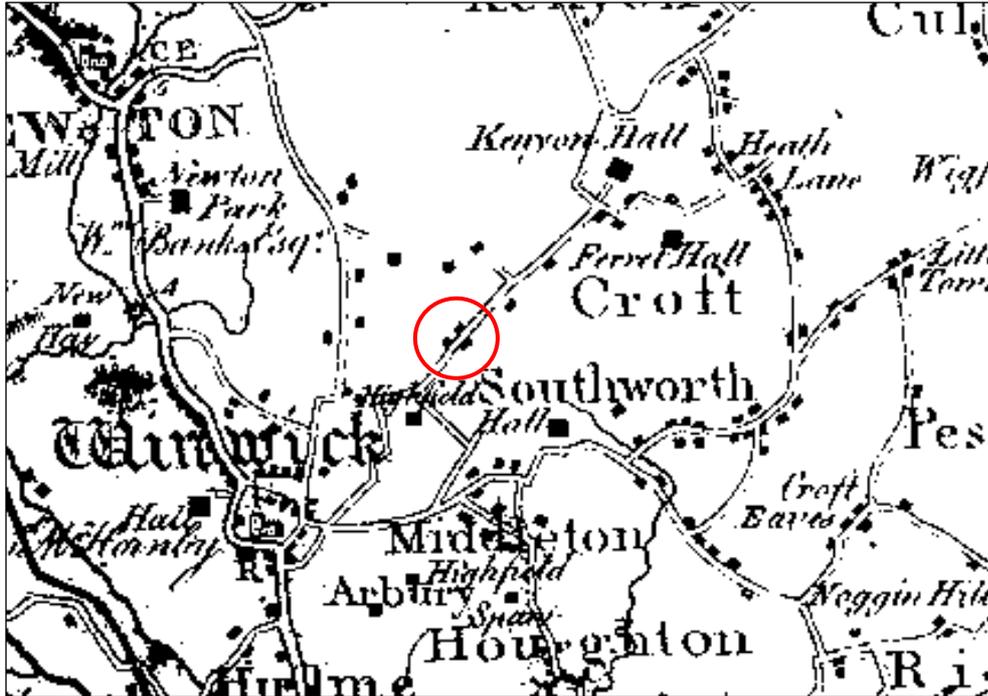
Plate 2: Extract from Map of the County Palatine of Lancaster, Yates 1786

- 3.4.3 **Yate's 1786 Map of Lancashire and Hennet's Map of 1830:** Yate's map is the first to depict the area in any detail and shows a network of smaller roads converging upon Winwick and the major turnpike route to the north connecting the villages of Winwick and Newton (Plate 2). The boundary of Newton Park can be identified as a slightly sinuous lane broadly parallel and to the east of the turnpike (today known as Parkside Road), while Winwick Lane is depicted as one of the minor lanes extending in a northeasterly direction towards Kenyon Hall. Although not mentioned by name it is possible to identify several structures in approximately the position of Rough Farm, suggesting it had already been established by this date. The farm is named for the first time on Hennet's Map of 1830 (not shown), although the detail is insufficient to identify specific buildings with any certainty.

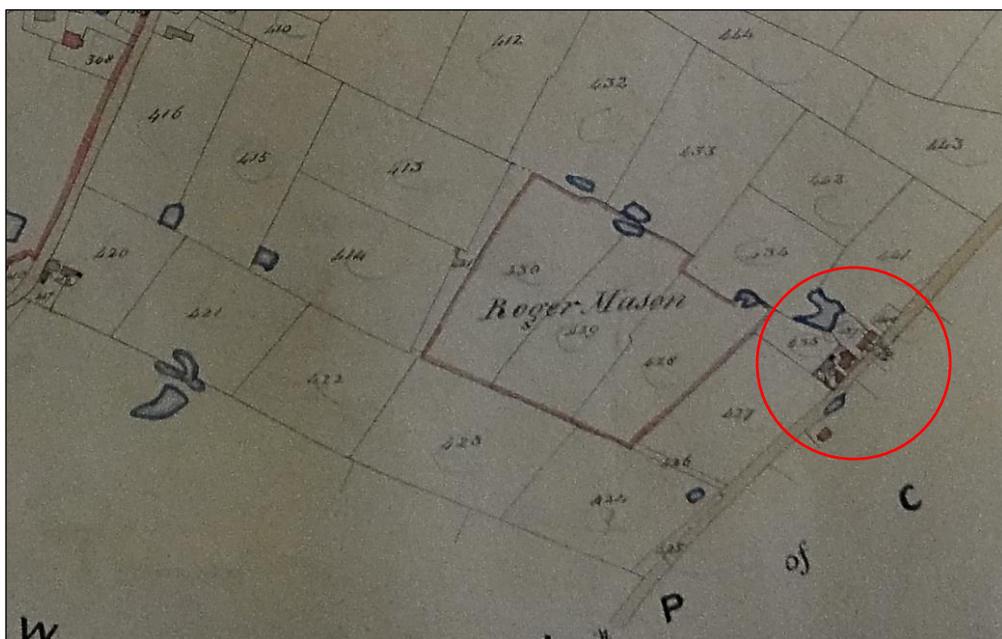
Plate 3: Tithe Map of Newton in Makerfield 1839

Tithe Map of Newton 1839: the tithe map of Newton reveals a pattern of small regular fields, with ponds set into the corners and boundaries (Plate 3). Rough Farm can be identified to the east, with four buildings adjacent to the northern-western edge of Winwick Lane. The largest at the centre probably represents the original farmhouse, with a smaller roughly L-shaped structure to the south facing the road and another uninhabited structure to west, in the position of the surviving barn. The fourth structure lies to the north within its own enclosure, and is a rectangular elongated structure aligned to the road and of similar proportions to the Rough Cottage. It is denoted as being inhabited.

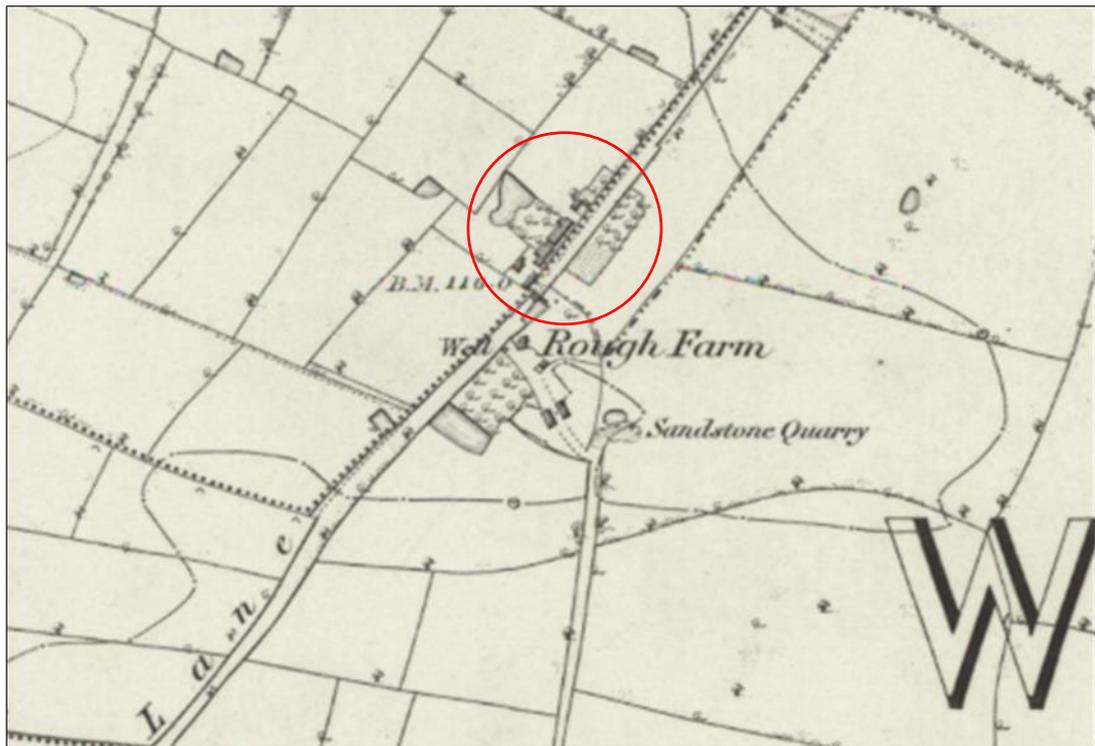
Plate 4: Lancashire Sheet CIX; Surveyed: 1845 to 1847, Published: 1849, 1:10,560

3.4.4 **First Edition Ordnance Survey 1849, 1:10,560**: depicts a network of regular field boundaries set upon a north-east/south-west-alignment that extends from the eastern boundary of Newton Park to Winwick Lane, at this time known as Back Lane (Plate 4). The pattern of enclosure to the south of Winwick Lane is more variable and perhaps of a slightly earlier date. The fields are punctuated by a series of small ponds and there is a sandstone quarry immediately to the east of the farm and another to its west. Rough Farm is shown as a series of rectangular structures, with what is probably the Farmhouse at its centre, the cottages to the north, and a yard to south defined by a rectangular building fronting the road to the east and another smaller range to the west. The smaller of these structures is likely to be the surviving Barn. An orchard and pond lie to the west of the cottages and farmhouse.

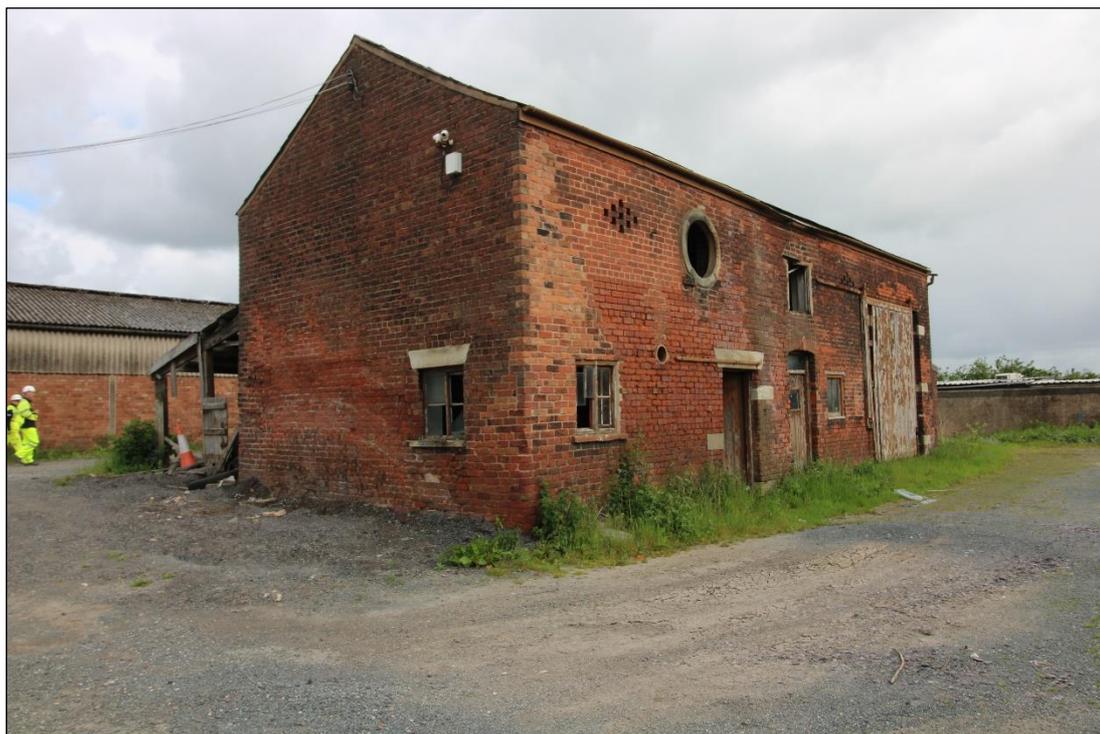
Plate 8: Exterior of Barn, facing north-west, note rebuilding of south-eastern corner

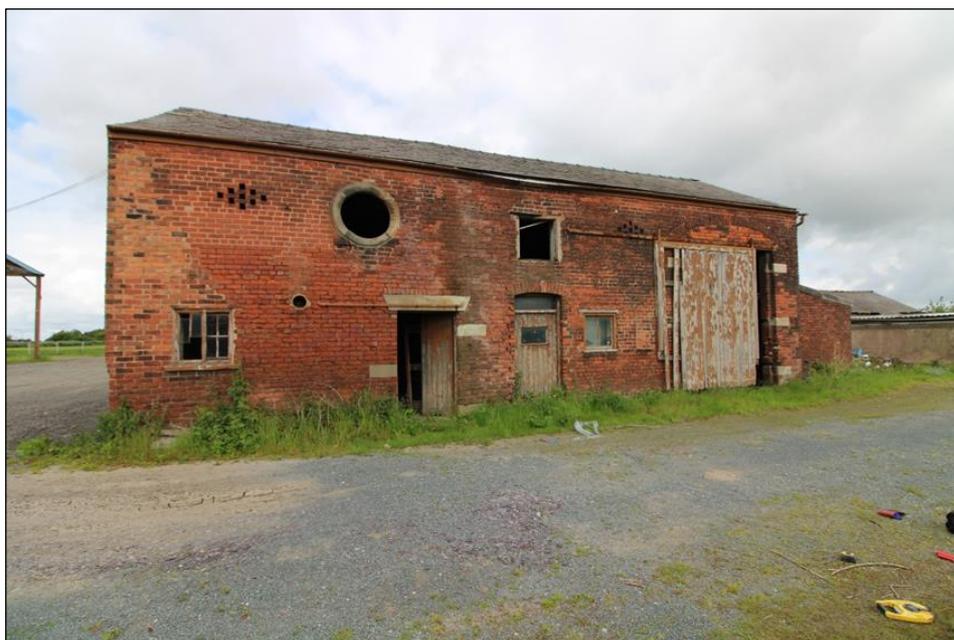
4.2.2 **Eastern elevation:** was constructed from hand-made red brick laid in a lime mortar with areas of repointing in cementitious mortar (Plate 10). It had a double height entrance at the northern end beneath a three-centred brick arch, although the upper arch had been later infilled in brick upon the conversion of the opening to accommodate a sliding timber door with a horizontal steel lintel (Plate 11). The mounting points for the original doors were indicated by the presence of iron pintle hinges set into three sandstone blocks arranged at regular intervals upon each jamb (Plate 12). The jambs were recessed to receive the doors and a square notch cut into the lowest sandstone block to affix the threshold during threshing. The same block carried an OS benchmark on its external face.

Plate 10: Eastern elevation, facing west

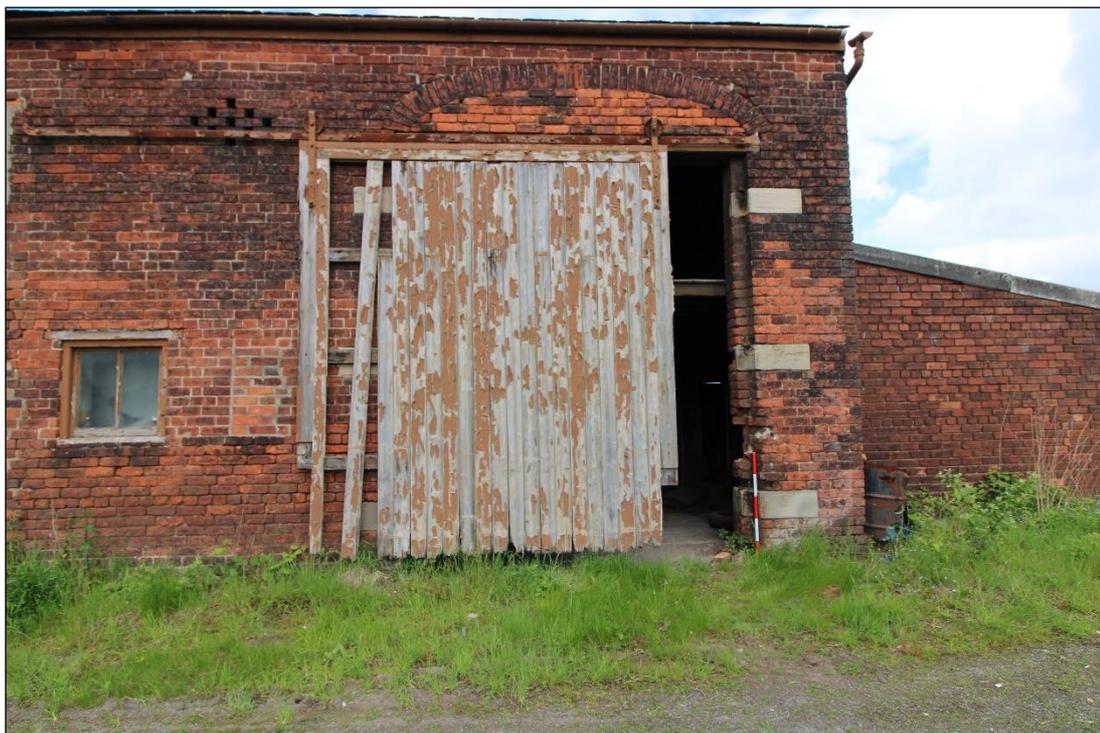
Plate 11: Double height entrance at northern end of eastern elevation, facing west, with 1m scale

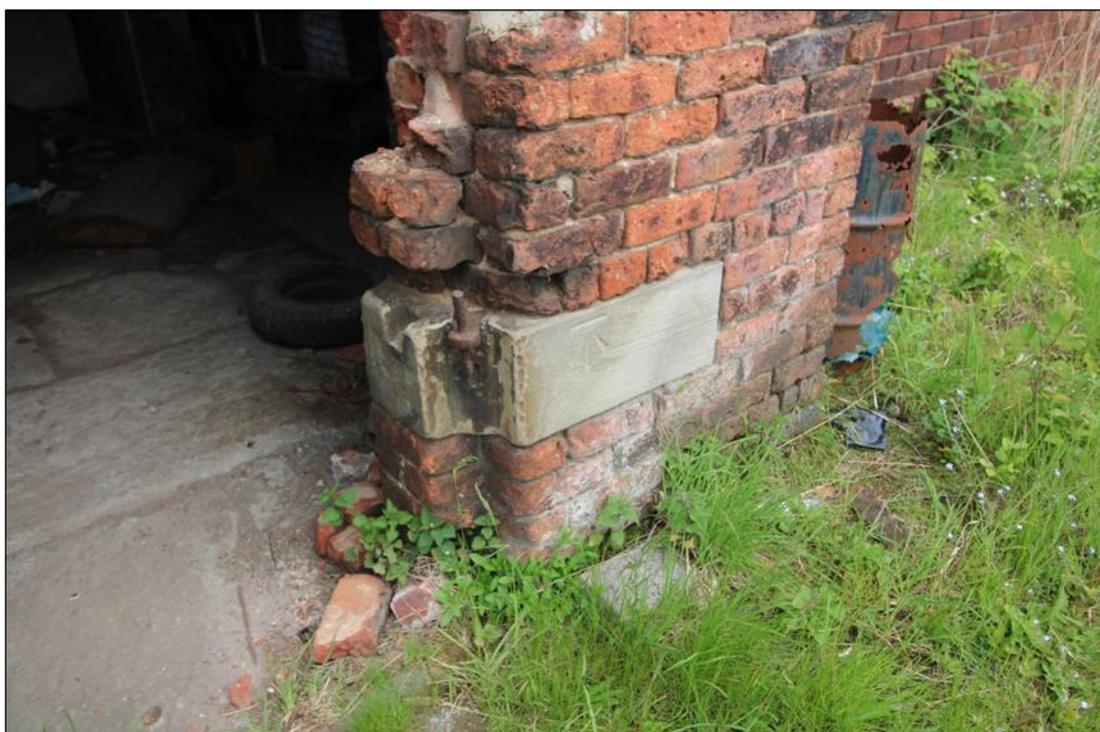
Plate 12: Pintle hinge, with threshold notch to left and OS bench mark to right, facing west

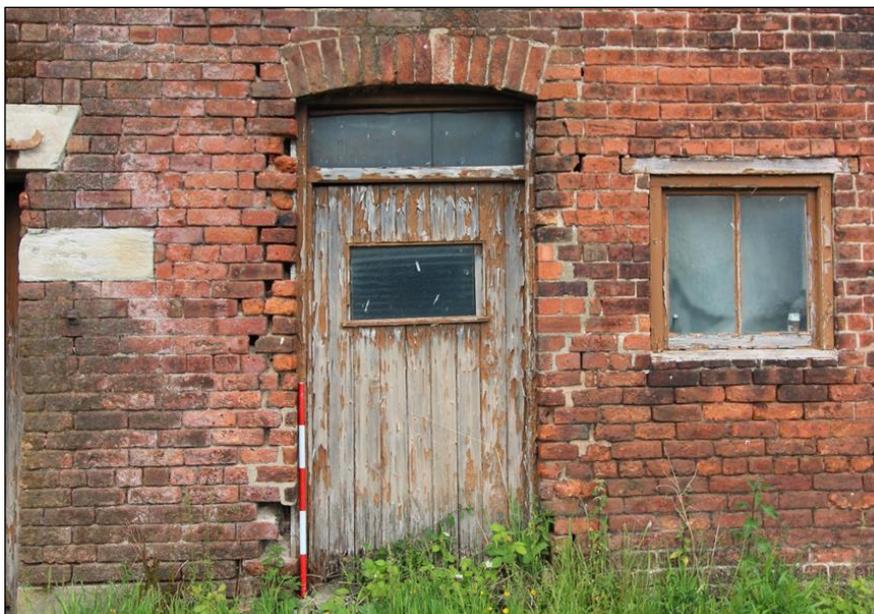
Plate 13: Pedestrian entrance at centre of eastern elevation, facing west with 1m scale

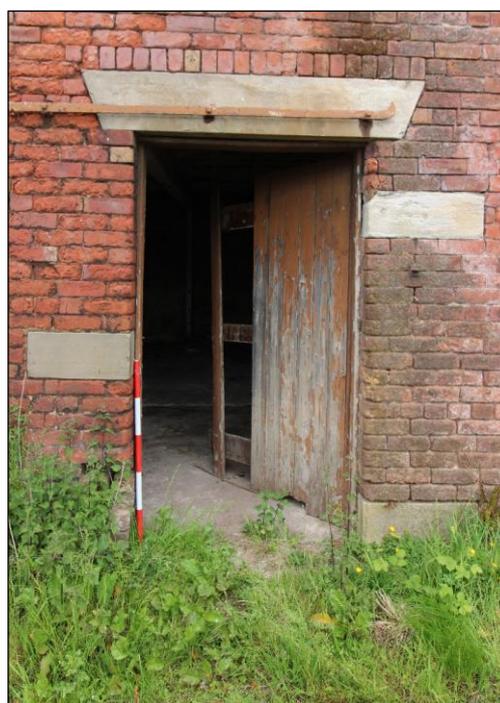
4.2.4 To the south of centre lay a third doorway, slightly wider than the last and set beneath a horizontal, tapered sandstone lintel (Plate 14). The northern jamb featured a sandstone block at the top and bottom, again to receive the pintle hinges upon which the timber door was mounted. A third block on the opposing jamb was presumably located to receive an attachment point for a latch of some kind. The present door was evidently a replacement and a horizontal iron rail affixed to the lintel indicated the former presence of an earlier sliding door which would itself have been a replacement.

Plate 14: Southern entrance on eastern elevation, facing west with 1m scale

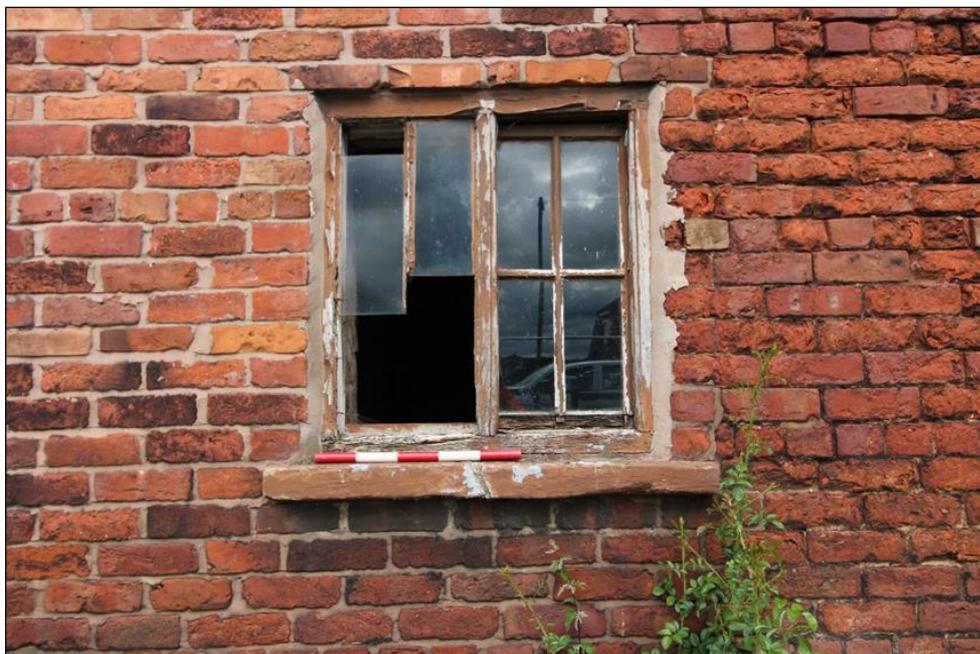
- 4.2.5 At the southern end of the elevation there lay a window with a central mullion dividing a pair of four-light, sliding sashes over a projecting sill (Plate 15).

Plate 15: Sliding sash window at southern end of eastern elevation, facing west with 0.5m scale

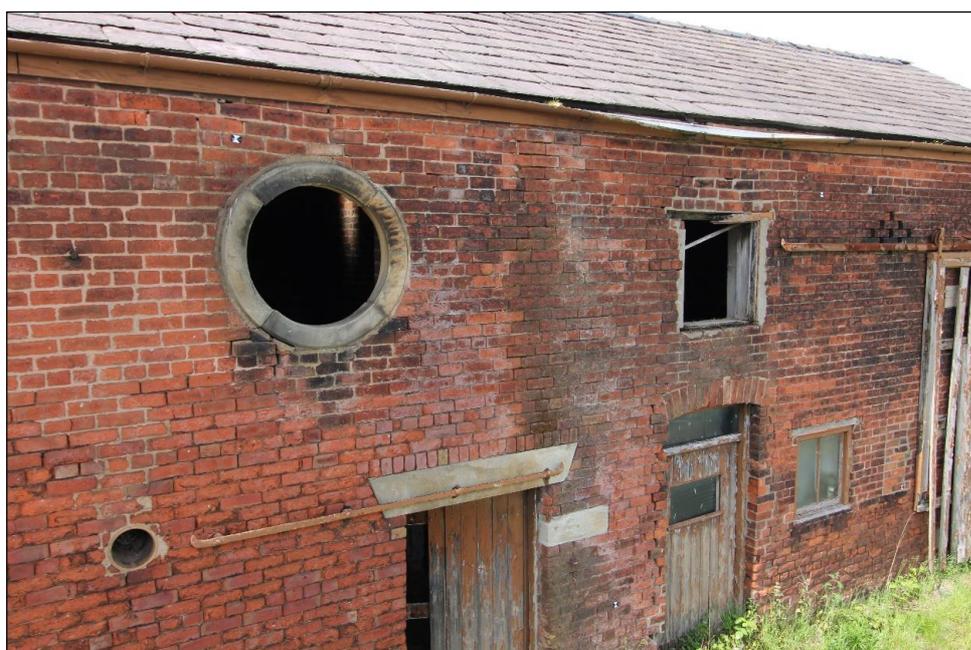
- 4.2.6 At first floor height there was a rectangular pitching hole to the north of centre with a timber frame, and to the south a circular opening framed in sandstone surrounds (Plate 16). A ventilation loop lay to the north of the former and south of the latter opening, both formed during construction of the wall by omitting headers to create a diamond pattern (Plate 17). There was evidence at the south-eastern corner of the building to suggest this corner of the structure had been extensively rebuilt (Plate 8).

Plate 16: First floor apertures on eastern elevation, facing north-west

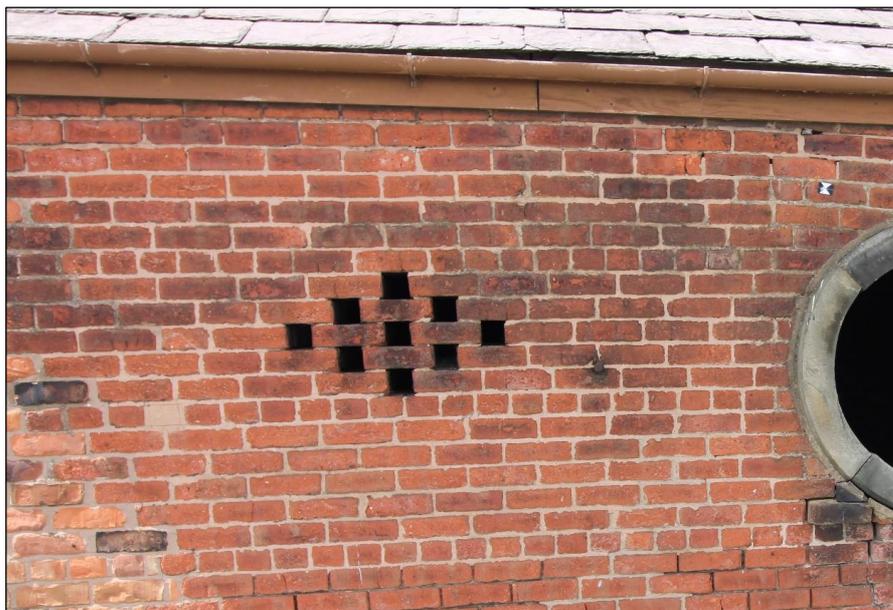
Plate 17: Diamond pattern ventilation loop at southern end of eastern elevation, facing west

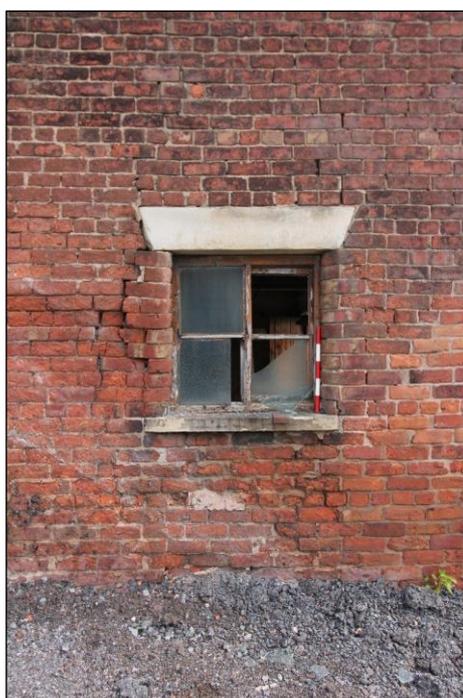
4.2.7 The southern gable elevation featured a single, ground floor, horizontal sliding sash window of four lights at its eastern end (Plate 18). It was topped by a tapered sandstone lintel and incorporated a projecting sandstone sill. The jambs employed bull-nosed bricks, the western of which was separating from the wall. The southern western corner of the elevation also showed signs of progressive structural failure and the lower third of the wall preserved a series of stain lines indicating the probable location of a midden or gravel heap (Plate 19). Power entered the building at the apex of this elevation via an overhead cable.

Plate 18: Horizontal sliding sash window at eastern end of the southern gable

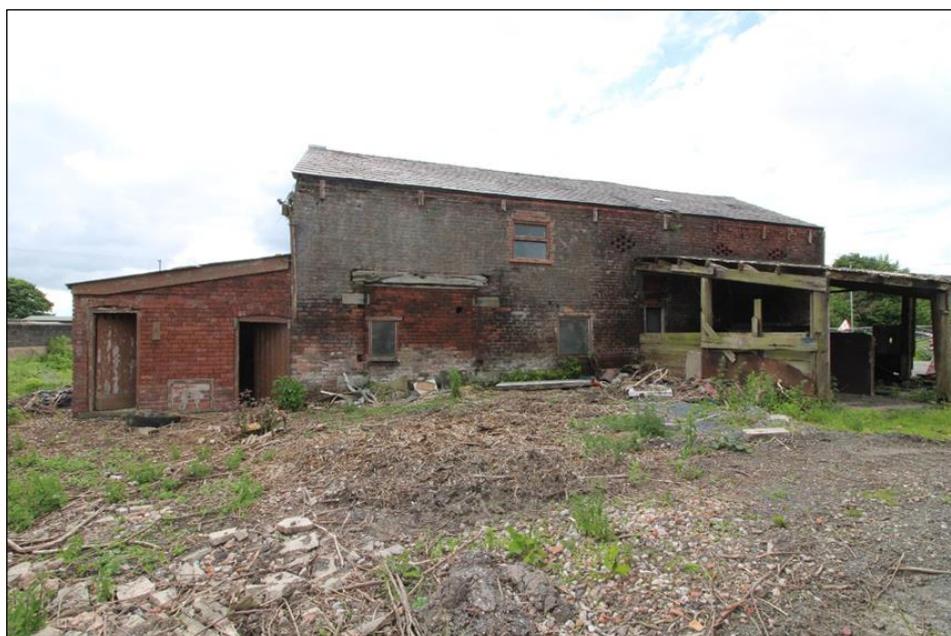
4.2.8 The western elevation (Plate 20) had a double-width entrance at the northern end, opposing that on the eastern elevation (Plate 21). It too had brick-recessed jambs and externally-mounted pintle hinges set into sandstone blocks, but unlike the eastern example, it did not extend to double height and had a horizontal timber lintel above. The entrance had been infilled with handmade red brick and a vertically-arranged rectangular window inserted into its northern end. This window had a timber frame supporting a single large pane of glass.

Plate 20: Western elevation, facing east

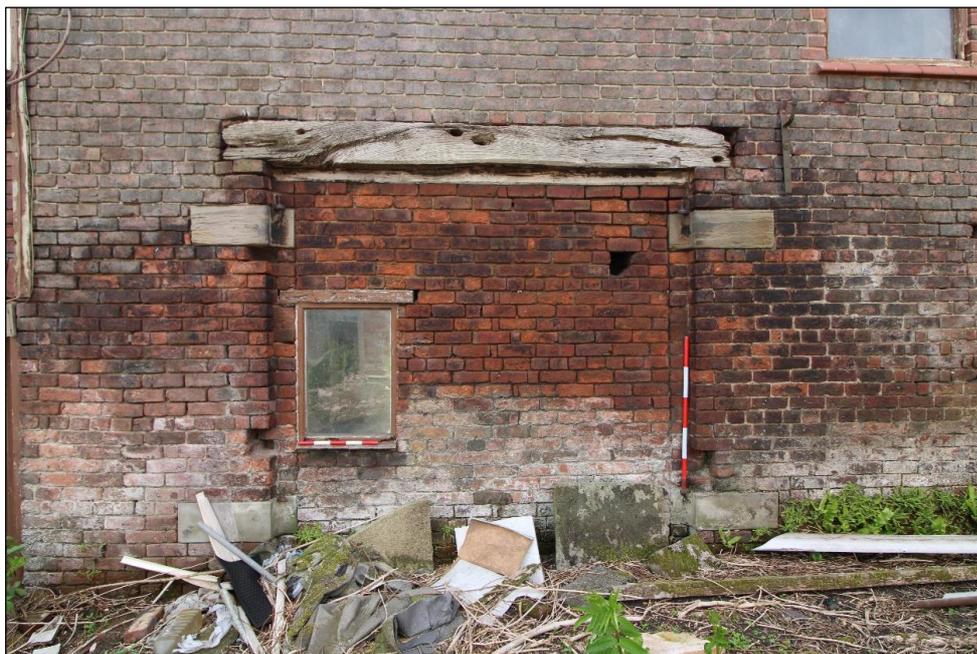
Plate 21: Blocked double width entrance on western elevation, facing east with 1m scale

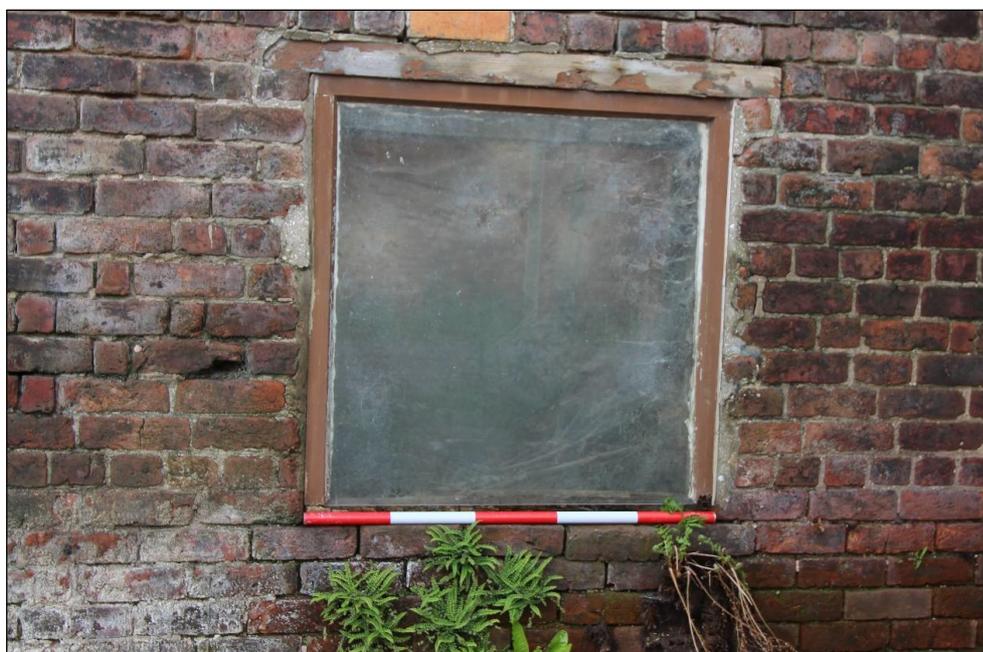
- 4.2.9 A window of similar character but slightly larger dimensions occupied a position at the centre of the elevation and was, to judge by the form of its brick jambs, a later insert into the existing wall (Plate 22). A third single pane window with timber surrounds had been crudely inserted into the wall to the south of centre (Plate 23). A partially blocked aperture immediately above suggested that this window may have been adapted from an earlier opening with a timber lintel into what may have been an existing opening.

Plate 22: Inserted window at centre of western elevation, facing east with 0.5m scale

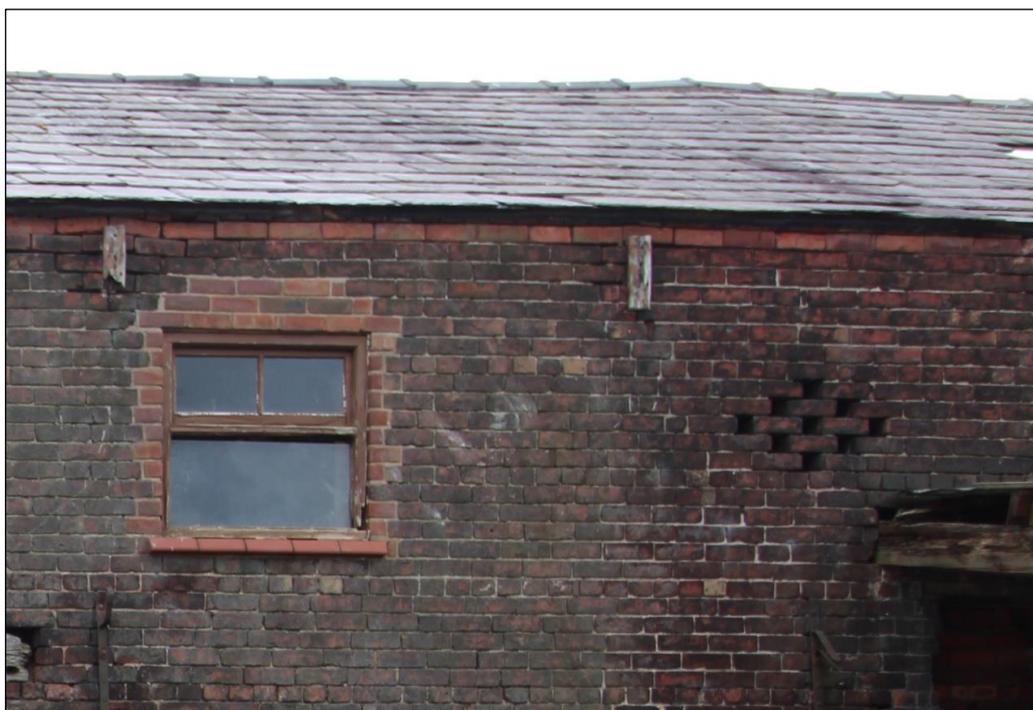
4.2.10 At first floor height there were three more diamond-pattern ventilation loops distributed at intervals across the southern half of the elevation and to the north of centre a fixed-frame window with timber surrounds incorporating a ventilator above and projecting brick sill beneath (Plate 24). The character of this opening's brick surrounds demonstrated that this window was a later insertion.

Plate 24: Inserted first-floor window on western elevation, with ventilation loop to right, facing east

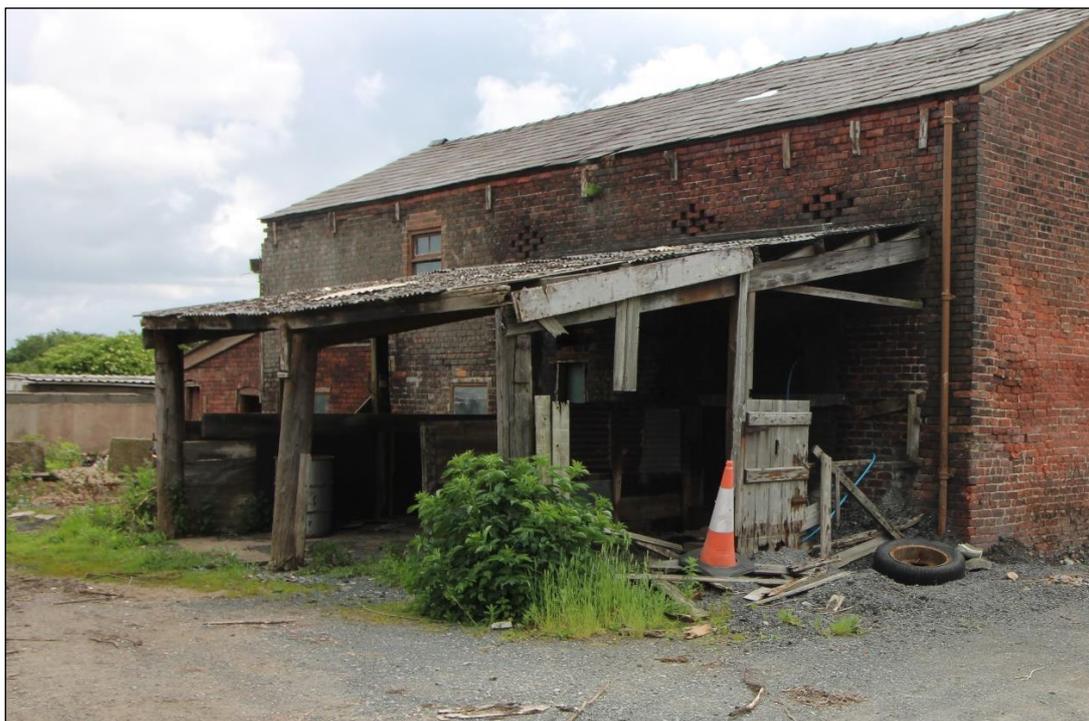
4.2.12 At the southern end an open-sided lean-to had been erected in reused timber to project in a westerly direction from the elevation (Plate 25). It had a corrugated iron roof and was internally subdivided by a central half-height partition.

Plate 25: Lean-to structure at southern end of western elevation, facing north-east

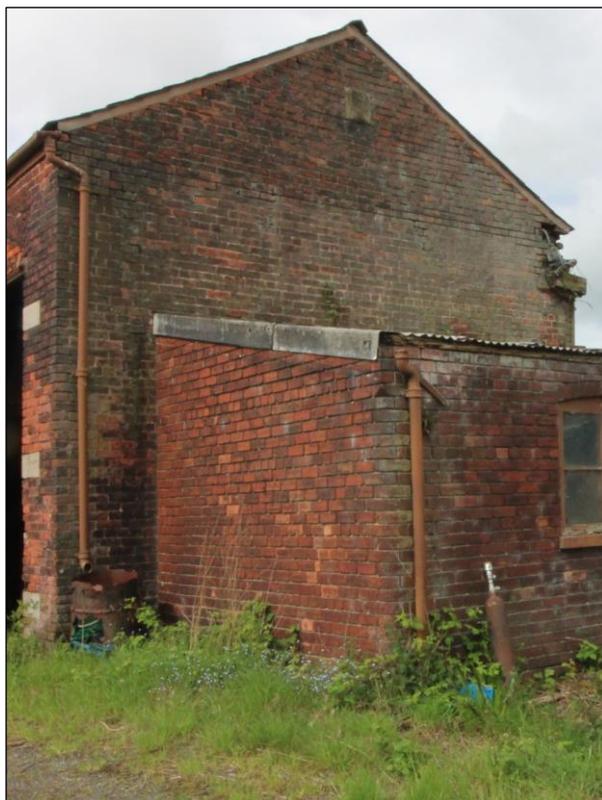
Plate 26: Northern elevation, facing south

4.2.13 The lower half of the northern elevation had been obscured by the erection of a single-storey brick-built lean-to and the only externally visible feature of interest was a small square date stone that was set into the wall just beneath the apex (Plate 26). The stone was incised with the date 1843 below the initials BM (Plate 27). Just beneath eaves height at the north-western corner of the elevation there appear to be an external light fitting, partially detached from the wall. Behind it several bricks had been displaced and lay scattered across the floor beneath (Plate 26).

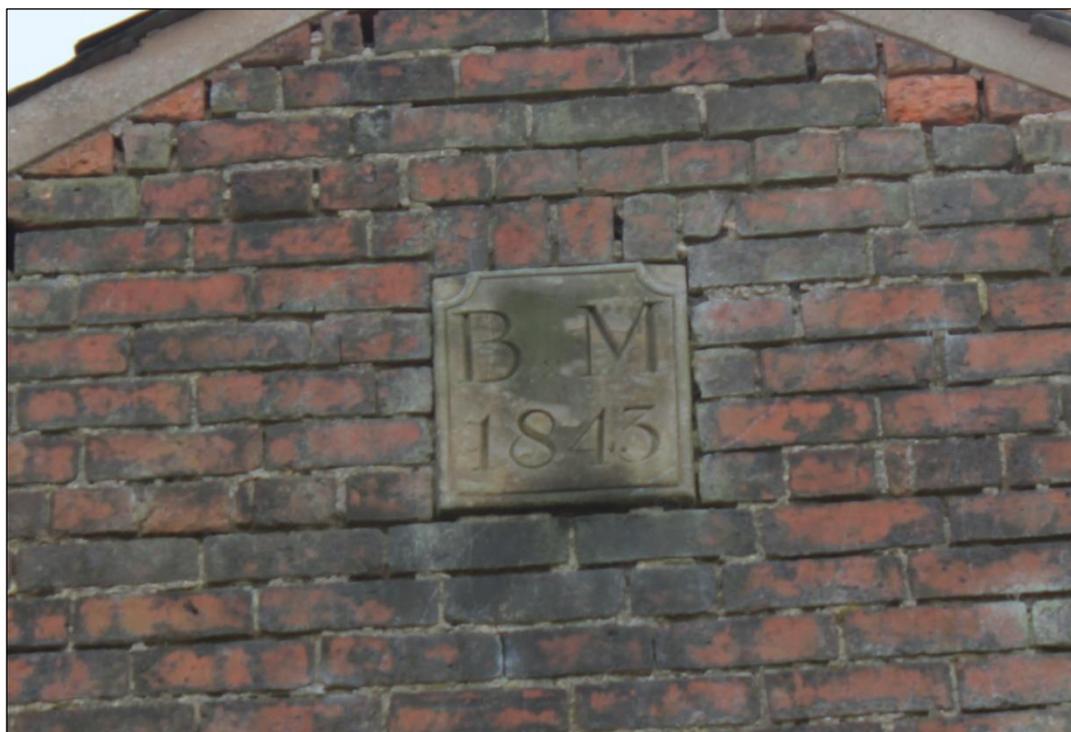
Plate 27: Date stone at apex of northern elevation

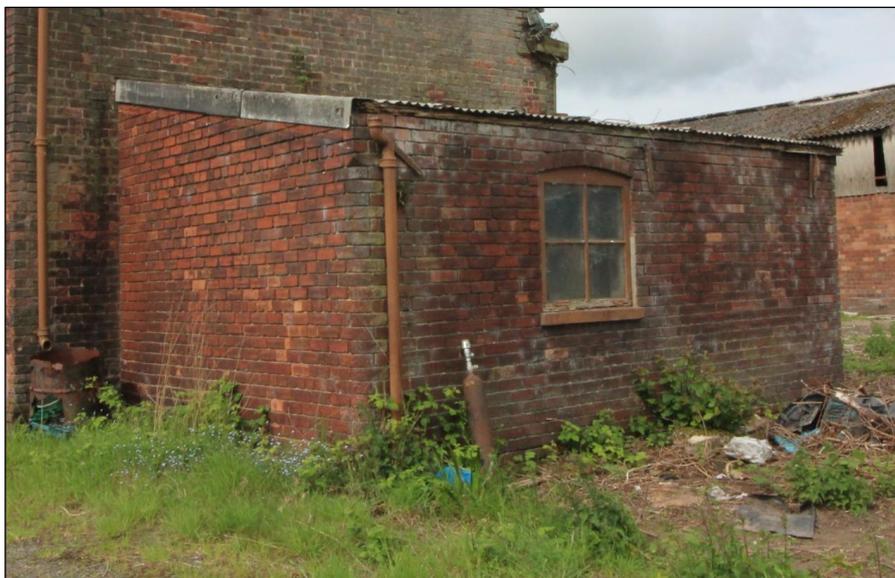
Plate 28: Northern extension, facing south-west

4.3.1 The northern extension was constructed from machine-made brick of between 5-6 stretcher courses to each course of headers and had a single pitch roof with a covering

of corrugated iron (Plate 28). The building's only window lay upon the northern elevation, positioned to the east of centre, it was of four lights set within a fixed timber frame with a cambered brick arch above and a projecting stone sill beneath (Plate 29). A cast-iron downpipe was attached to the eastern end of this wall but the gutter had been lost, leaving only the timber battens in place.

4.3.3 The eastern elevation had no openings, but its north-eastern corner carried a radius to protect it from the passage of livestock (Plate 28). Unlike the opposing elevation, the original barge board had been removed and a later covering applied associated with the replacement of the roof. A diagonal stain across the brick work however denoted its former position.

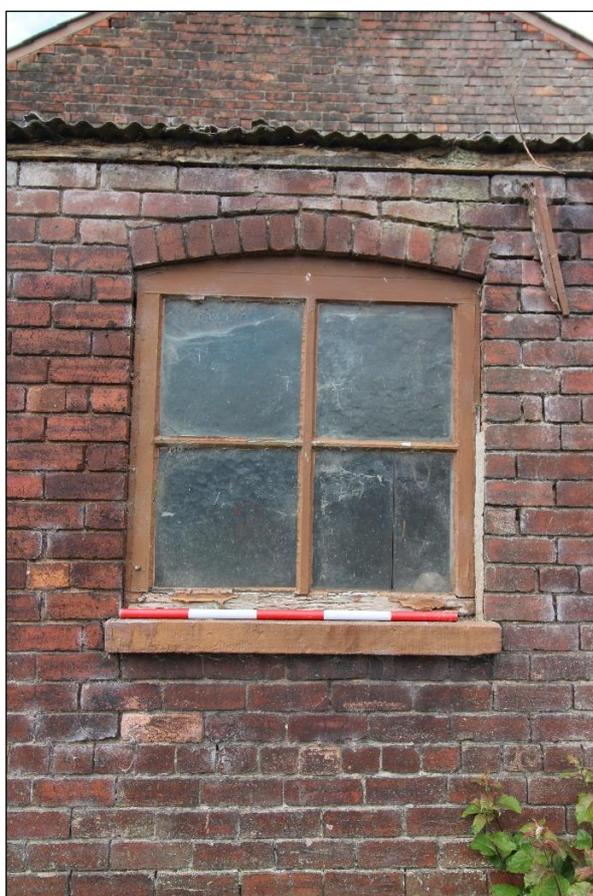
Plate 29: Four-light fixed-frame window at centre of elevation, facing south with 1m scale

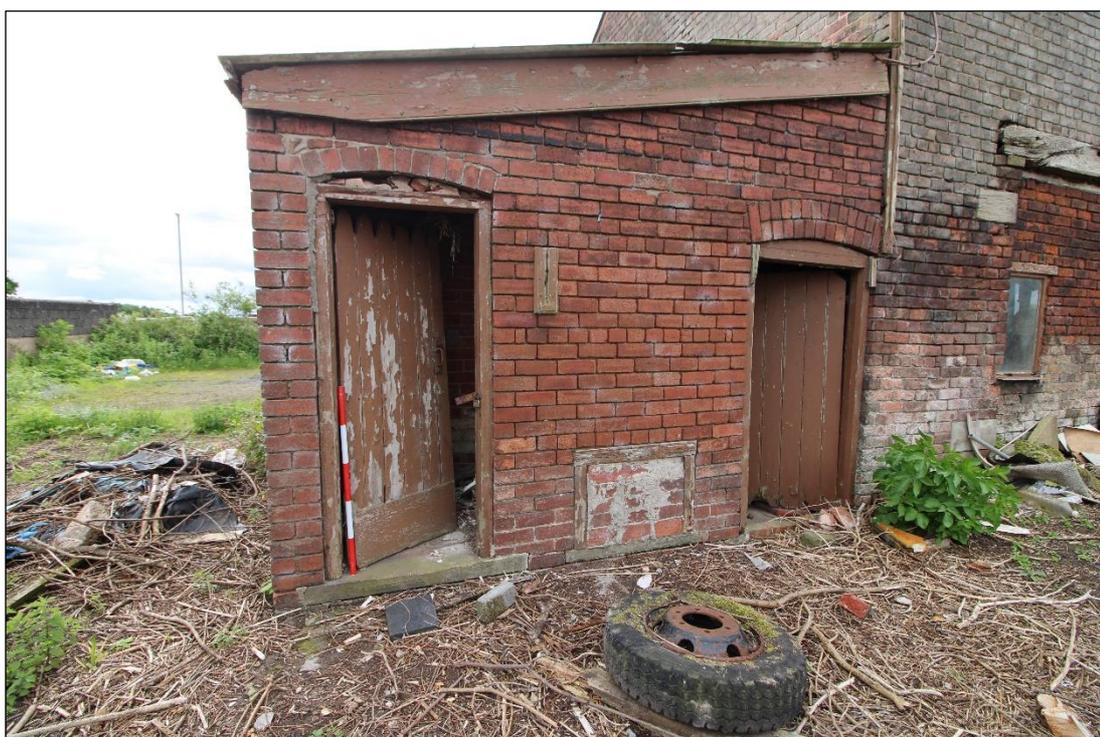
Plate 30: Western elevation, facing east with 1m scale

4.3.2 The western elevation had a door at each end, both topped by a cambered brick arch and provided with timber surrounds and a vertical plank and batten door mounted upon pintle hinges (Plate 30). The tops of the planks in the northern door were rounded to leave ventilation between the planks and there was a stone step at the foot of the opening. A chamfered timber block was attached to the wall immediately to the south of the opening at head height, probably an attachment point for an external light. The southern entrance was slightly lower, its arch constructed of a double row of headers, and the threshold was lower to ease the entry of livestock. Between the two doors there lay a small rectangular aperture, set just above the ground with a stone sill and timber surrounds (Plate 31). The opening had been bricked up but almost certainly once provided a hatch for the removal of night soils. A barge board was attached to the head of the wall beneath the roof.

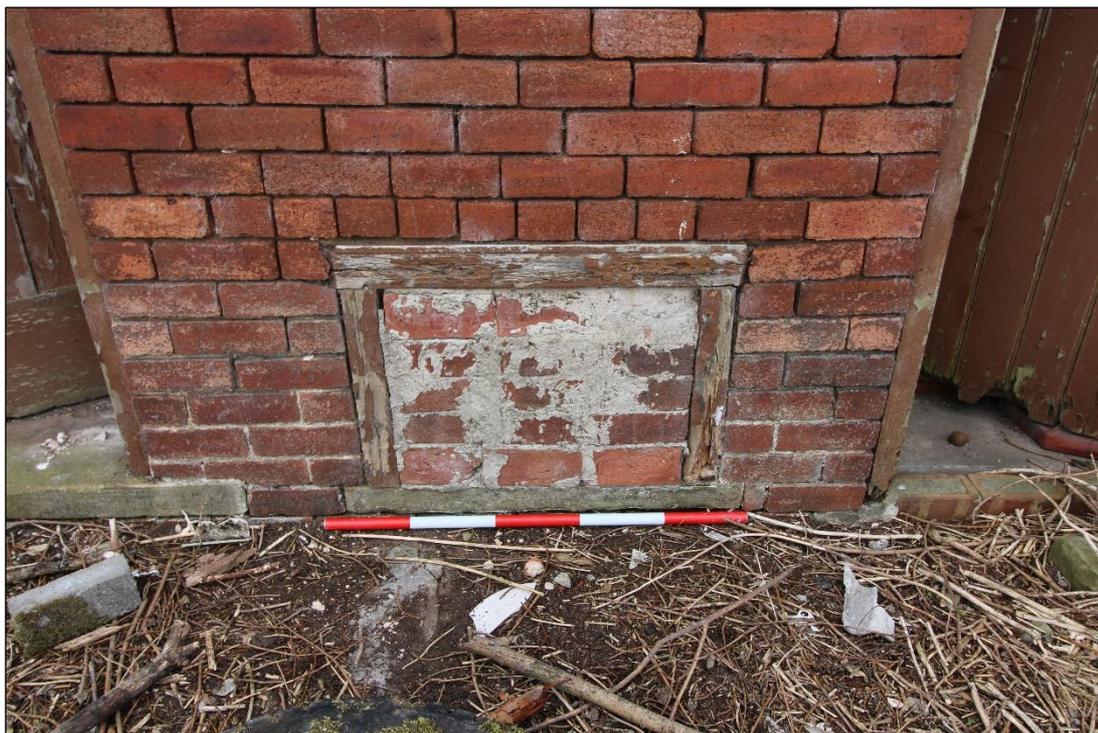
Plate 31: Blocked aperture at base of wall, with 1m scale

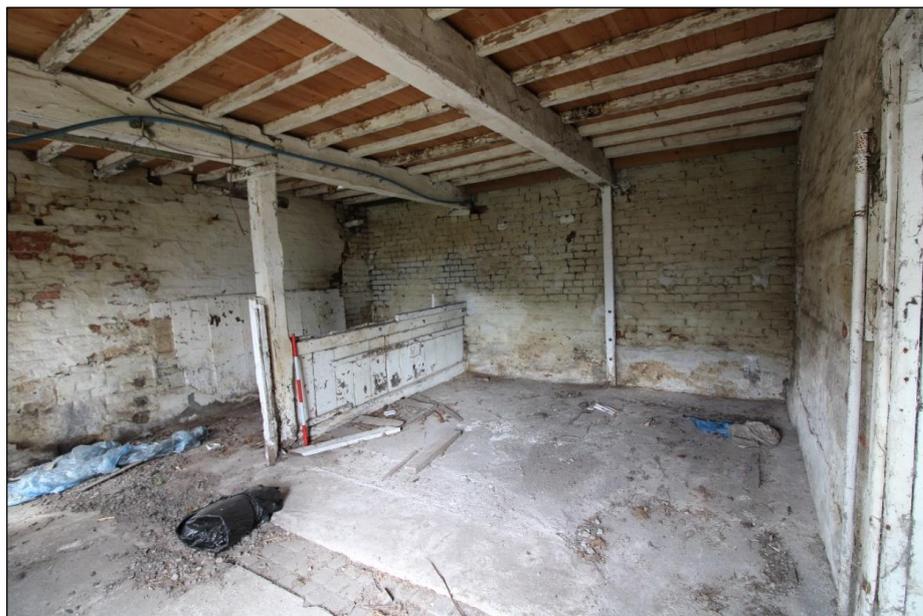
4.4.2 The southern cell was entered from the east and had exposed brick walls coated in limewash and a modern concrete floor that preserved a cobbled drain running longitudinally across its centre (Plate 32). A low timber partition projected at right angles from the western wall, terminating at a substantial, vertical post that rose to the underside of the southernmost first-floor joist. A row of timber panelling had been attached to the southern wall to mirror this partition and protect the wall from rub. There may once have been a second partition beneath the northern floor joist but the replacement of the floor in concrete obscured any conclusive evidence for it.

Plate 32: Interior of the southernmost cell, facing west with 1m scale

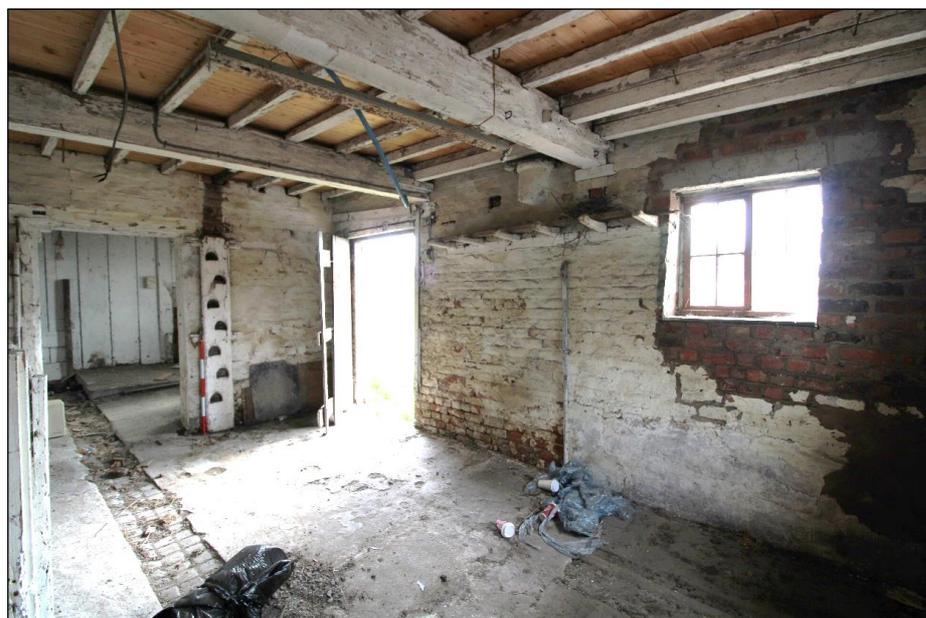
4.4.3 On the eastern wall a row of timber pegs projected from a horizontal plank mounted upon the wall at head height, probably associated with the storage of tack equipment (Plate 33). On the northern partition wall, a wide doorway to the east of centre internally connected the Stable to the central cell. Immediately to the east of this doorway a series of foot holes had been cut into a vertical plank attached to the wall to serve as a basic ladder. The replacement of the floorboards above had removed the floor hatch and the upper three-quarters of the ladder appeared to have been truncated at this time. At the western end of the northern wall a diagonal scar and truncated timber beam were all that remained of the hayrack that had once spanned the western wall (Plate 34).

Plate 33: Southern cell, facing north-east with 1m scale. Note the timber pegs to right and ladder to left

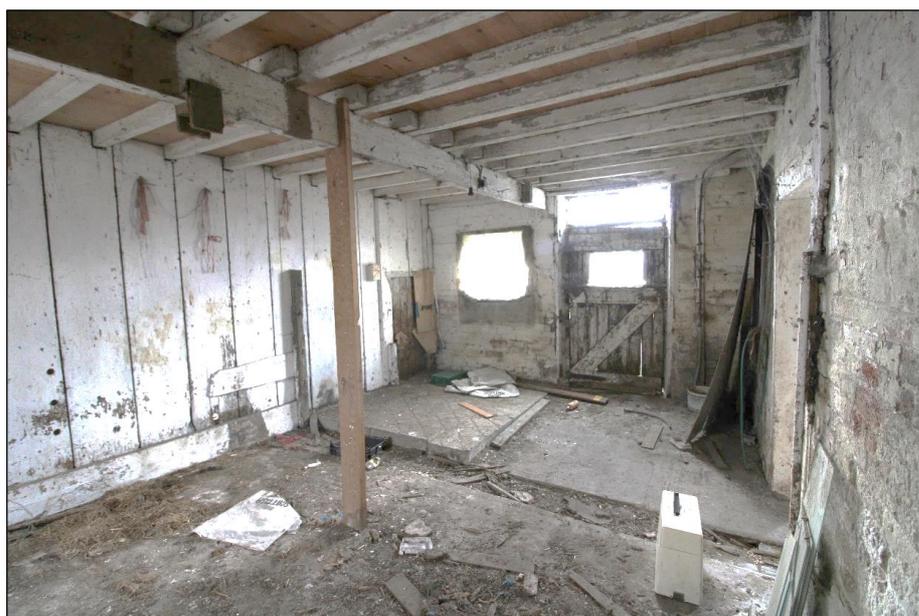
Plate 35: Central Cell, facing east

4.4.4 The central cell had an external entrance to the east and was lit by a window on the same wall and two more on the western wall (Plate 35). The concrete wall and drain continued across this floor in the same character, although it incorporated a low, raised platform in the north-eastern corner. Three of the four walls were of lime washed, exposed brick with the fourth constructed in vertical timber planks and featured a low doorway at the eastern end fitted with a door of regular softwood vertical planks (Plate 36).

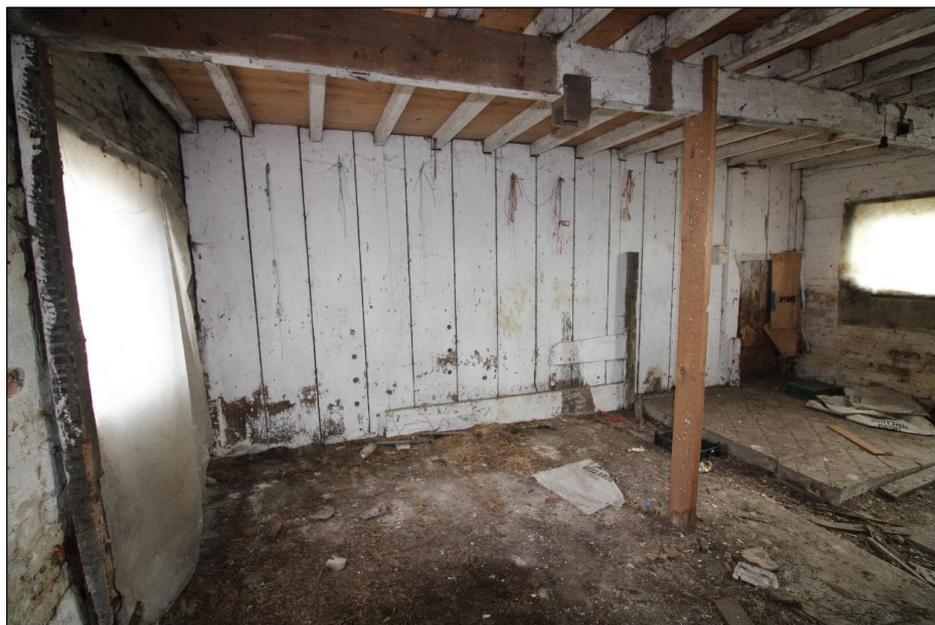
Plate 36: Northern partition, constructed in vertical timber boards, facing north with low door to right of frame

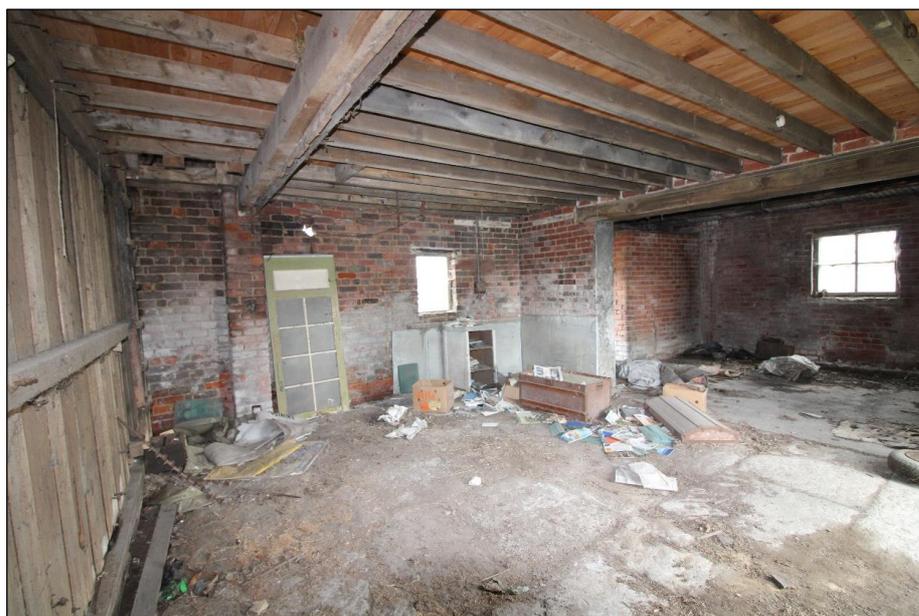
Plate 37: Interior of northern cell, facing west

- 4.4.5 The ceiling was divided in two by a lateral central joist and was supported at its centre by a modern softwood post. A second post was attached to the western wall and, although no partition survived, there was some evidence from the face of this post and the underside of the beam to suggest there had once been one. In addition, the continuation of the longitudinal drain into this cell would support such a hypothesis.
- 4.4.6 The walls of the northern cell did not appear to have been lime-washed but a concrete render had been applied to the lower third of the north-western corner (Plate 37). The floor had been laid in stone slabs to create a durable, hardwearing surface and based on the height of the original eastern entrance a first floor had been inserted into what had previously been a room open to the roof.
