Parkside Link Road, Newton-le-Willows, St Helens

Historic Building Recording and Watching Brief

February 2023

Client: The Environment Partnership

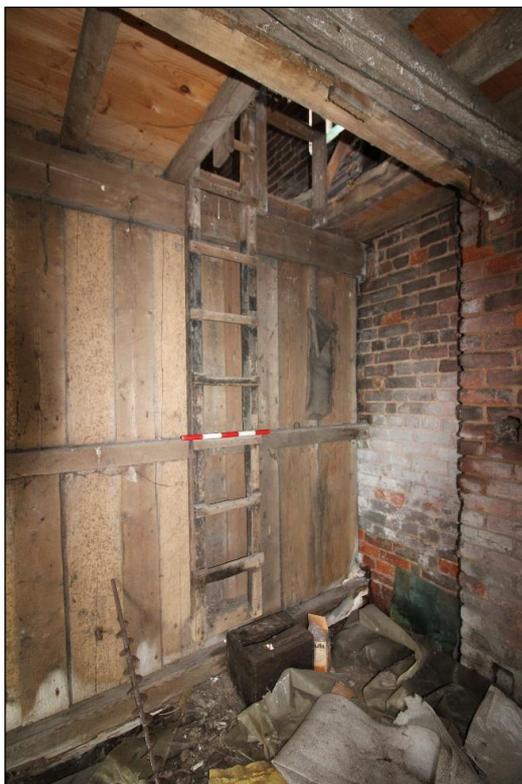
4.4.7 A timber ladder attached to the western end of the room's southern partition ascended to the first floor through a hatch in the floor, but a timber trimmer to its north-east indicated the former presence of another floor hatch since sealed by the replacement of the floorboards (Plates 38 and 39). The only external entry to the northern cell lay to the east through the double height doorway but, following the infilling of the opposing doorway, additional light had been provided with the incorporation of the rectangular window identified externally (*Section 4.2.8*).

Plate 38: Ladder in south-western corner of northern cell, facing south-west with 0.5m scale

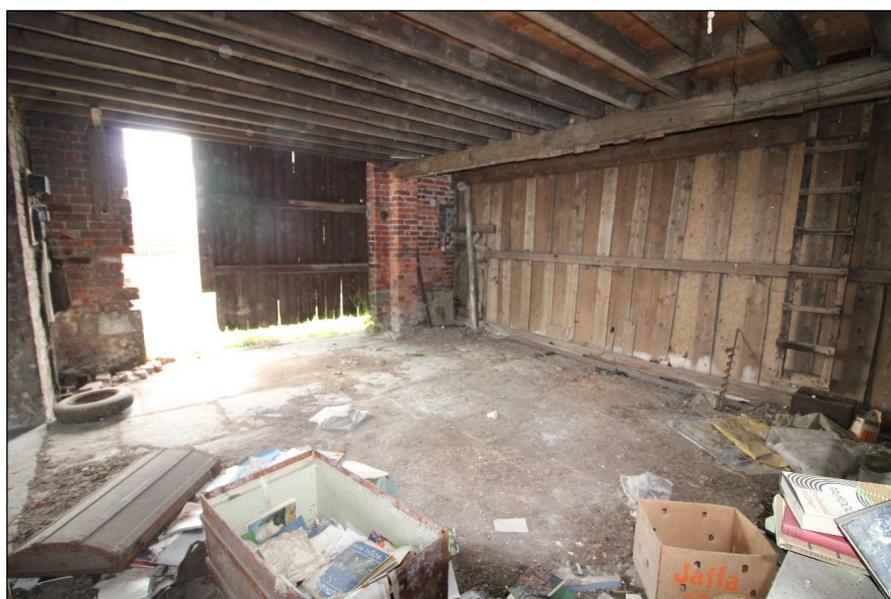
Plate 39: Interior of northern cell, facing south-east. Note the trimmer in the ceiling to right of frame indicating the position of a former floor hatch

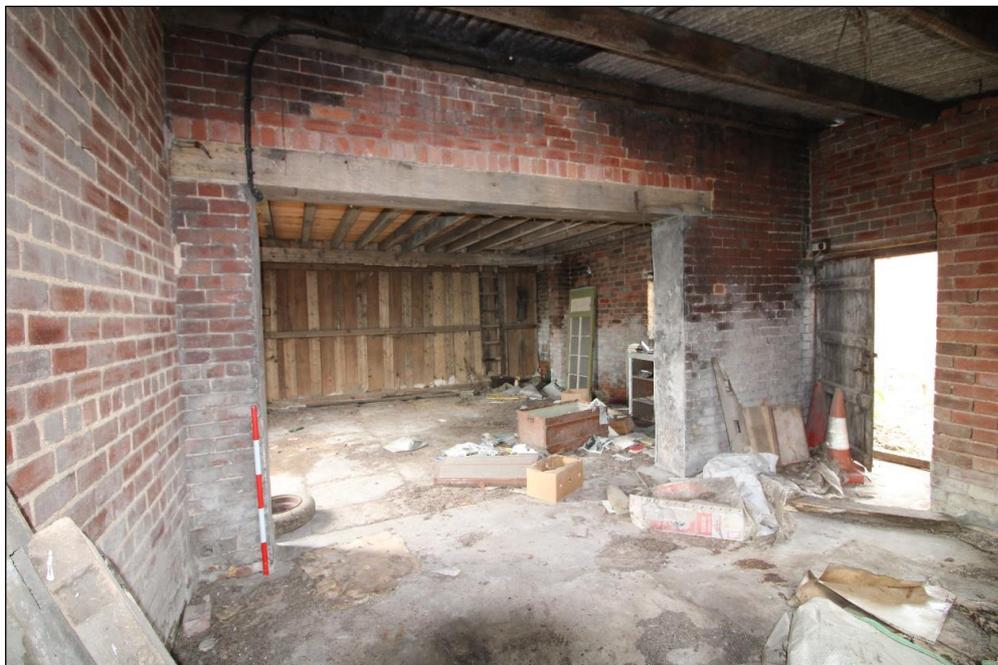
- 4.4.8 At its northern end a large aperture had been cut through the centre of the wall and a substantial timber lintel installed to support the wall above (Plate 40). The jambs of the opening had been rendered in concrete. This opening connected the northern cell of the original barn with the interior of the northern extension.

Plate 40: Interior of the northern extension, facing south with 1m scale

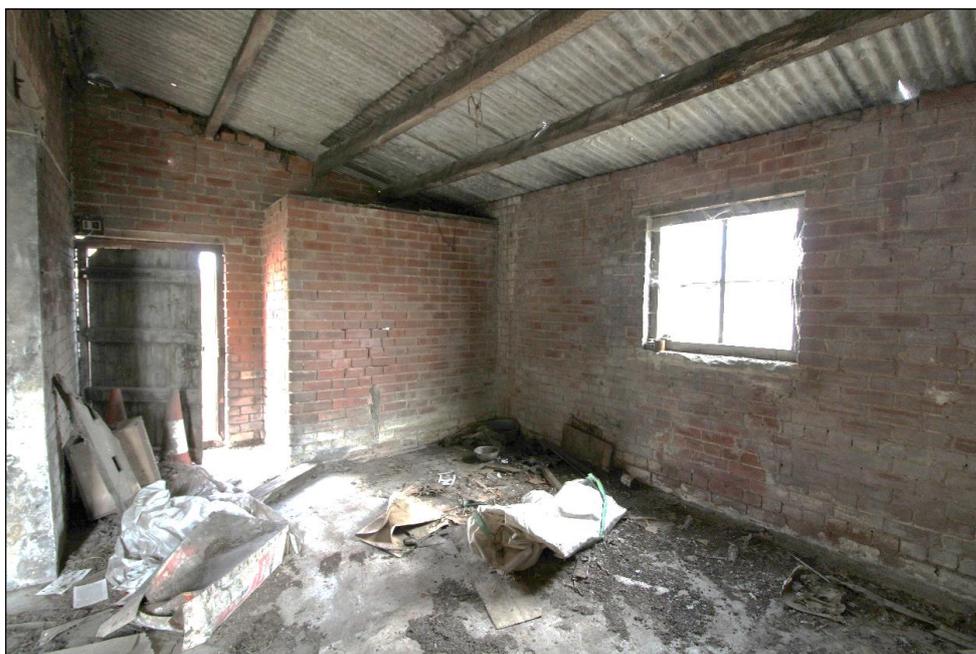
Plate 41: Interior of northern extension, facing north-west

- 4.4.9 The interior of the northern extension was an elongated rectangular space with an external entry point to the west and a window on the northern wall to the east of centre (Plate 41). The exposed brick walls showed no evidence of having been lime-washed or rendered and the floor formed a single concrete slab. The exposed roof was supported upon three timber purlins that spanned the full width of the structure.

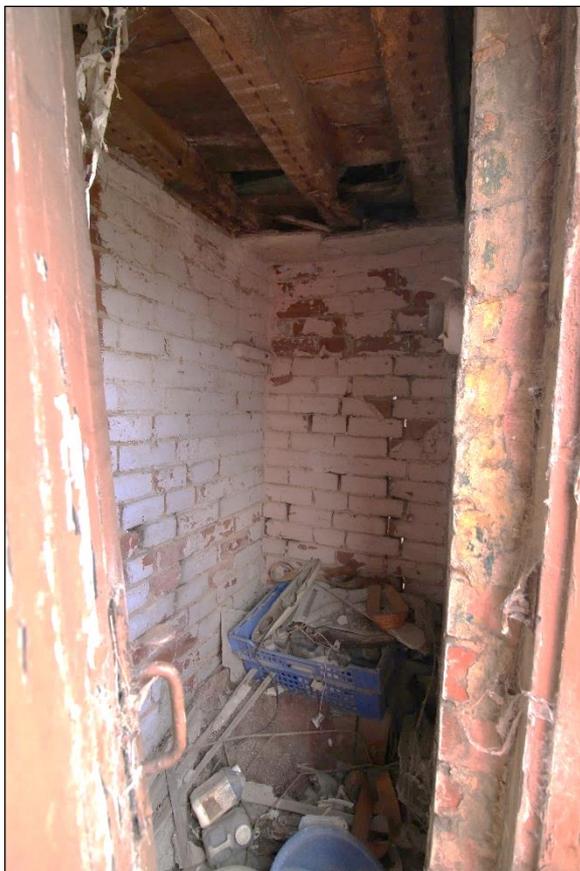
4.4.10 The north-western corner of the room had been partitioned off to form a small brick cell with independent entry from the exterior (Plate 42). The shared character of the bricks and relationship between the wall junctions indicated that the partition was contemporary with the northern extension.

Plate 42: Internal view of small brick cell in north-western corner of northern extension

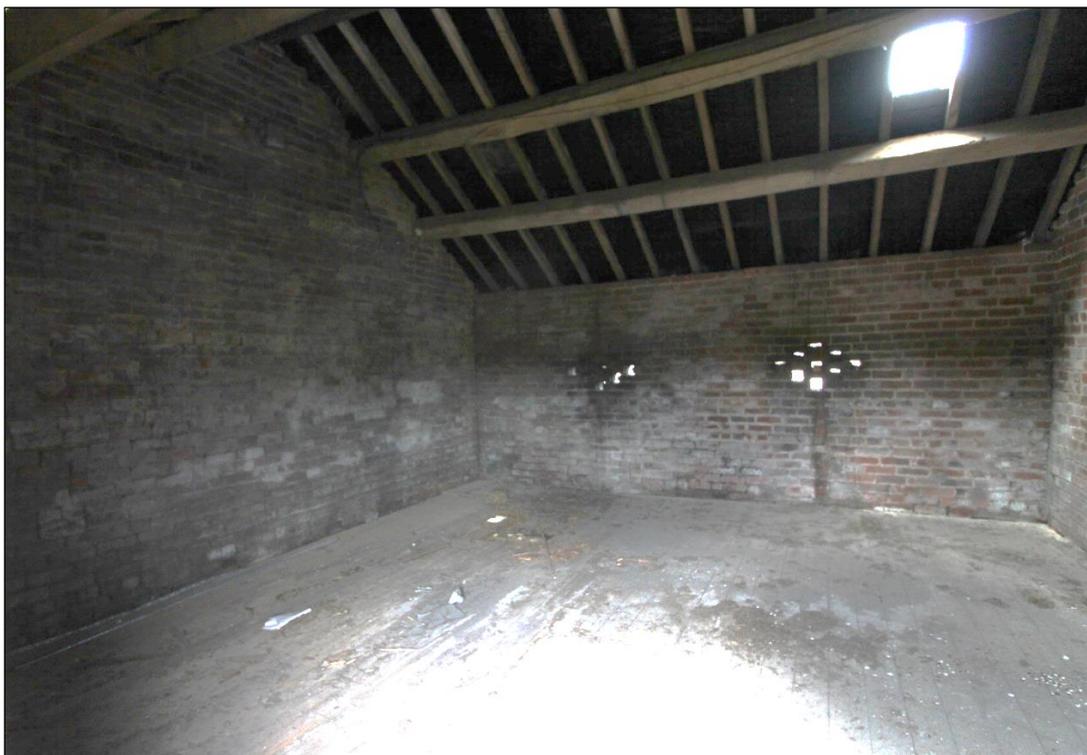
Plate 43: First floor of southern cell, facing west

4.5.1 The first floor of the barn was divided into a larger northern cell and a smaller southern cell by the continuation of the brick partition described on the ground floor (Fig 3). A doorway at the centre of this partition connected the two cells together and neither cell showed any evidence for the application of a render or lime wash. The southern cell was lit by the oculus window and a diamond vent to the east and by two more diamond ventilation loops to the west but otherwise revealed no additional features of interest (Plate 43).

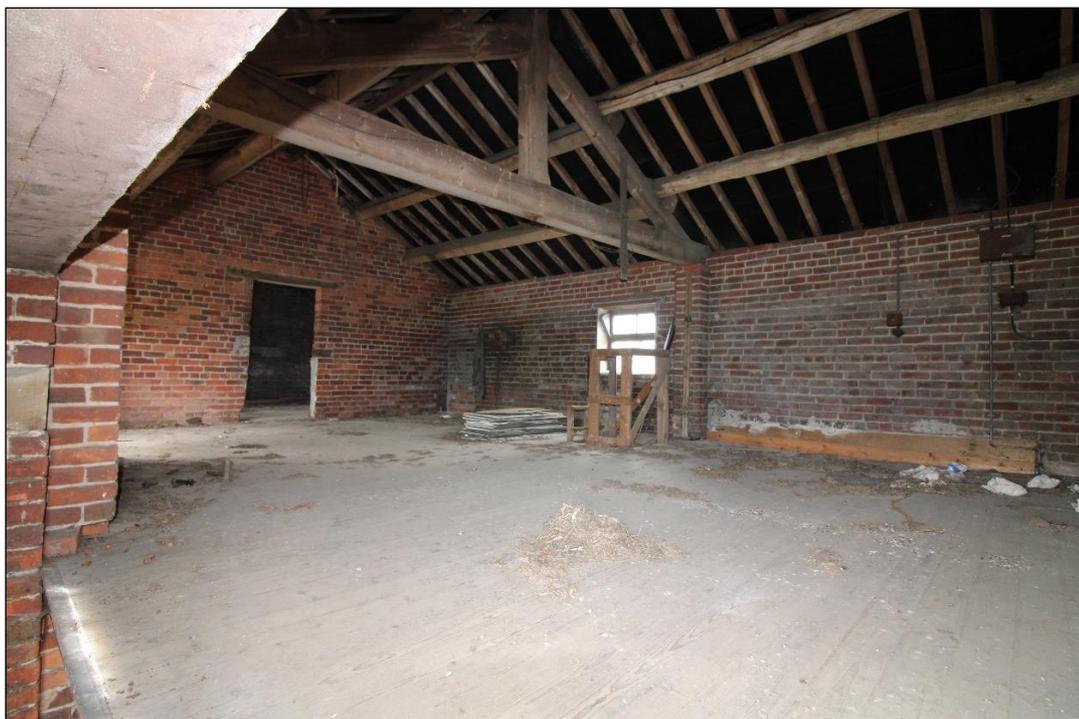
Plate 44: First floor, northern cell, facing south-east

- 4.5.2 The northern cell had a rectangular window and a diamond ventilation loop to the east, with a further ventilation loop at the southern end of the western wall and a larger rectangular window to its north (Plate 44). It was similarly scant of detail, but at the northern end of the western wall there lay a steel electrical box which distributed power to the remainder of the building.

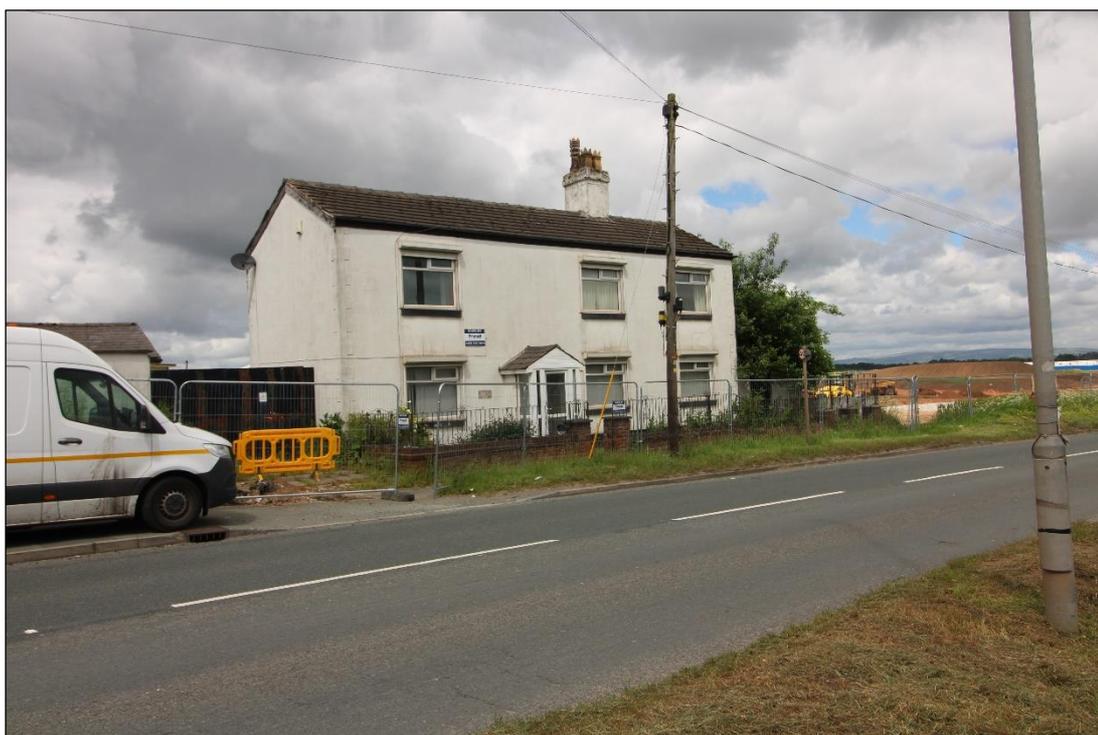
Plate 45: Rough Cottage, facing north-west

5.1.1 The Cottage was a two storey, rectangular building predominantly of brick construction but with a textured cement render applied to all four elevations and over the alternating quoins at each corner (Plate 45, Fig 7). It had a gable roof with a covering of ceramic tiles, a single-storey modern extension projecting from the northern end of the western elevation and a modern conservatory attached to the southern end of the same elevation. A single axial chimney projected from the roof.

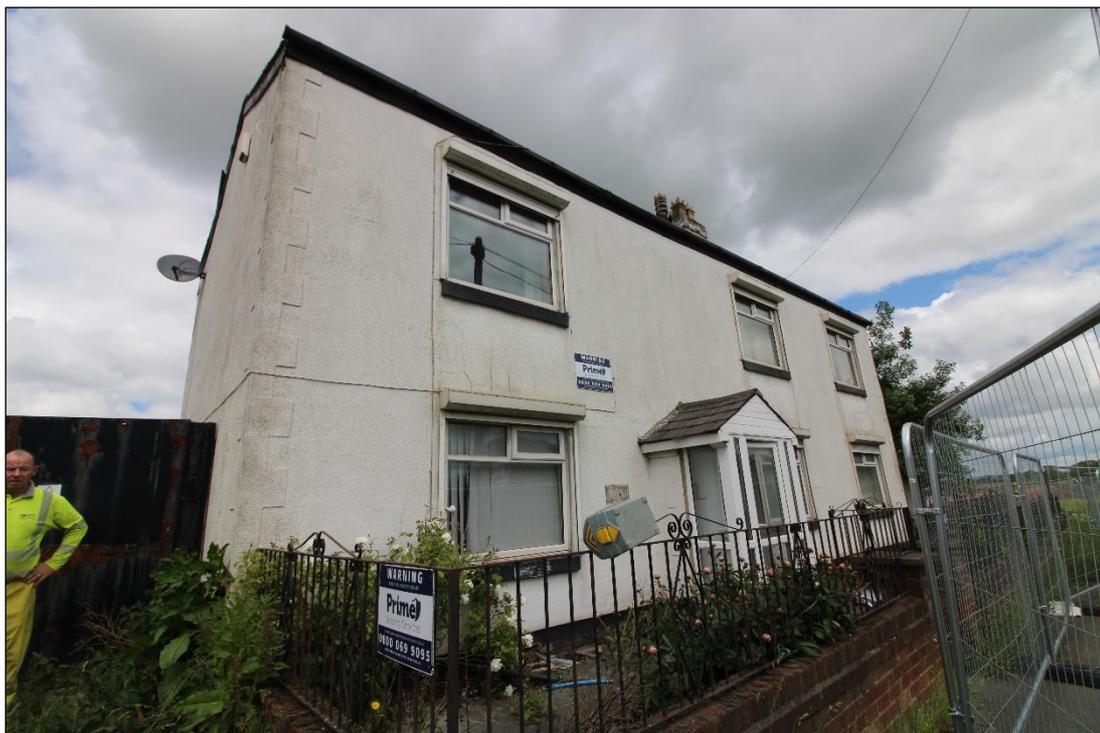
Plate 46: Eastern elevation, facing north-west

5.1.2 The principal elevation lay to the east and was divided into four equal bays, with a modern porch under a tile roof enclosing the buildings main entrance within the penultimate southern bay of the ground floor (Plate 46). The remaining three bays of the ground floor displayed large rectangular windows fitted with uPVC double glazed units, all of identical character. Each window was fitted with a top-mounted steel shutter. Only at the base of the elevation was there any evidence to hint at an earlier origin where render had been omitted from the lower portions to leave three courses of red brick coated in black paint (Plate 47). At the base of the north-eastern corner the quoins were also exposed to reveal their stone construction

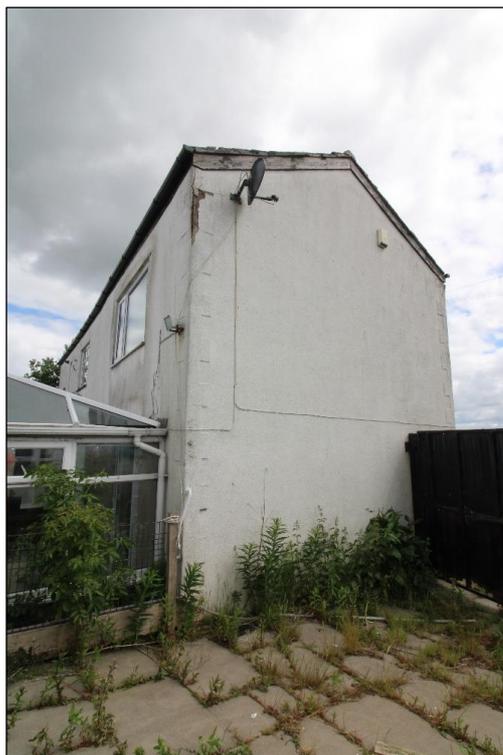
Plate 48: Southern elevation, facing north

5.1.3 This exposed brick course continued around on to the southern gable elevation unbroken and had no openings of any kind or other features of potential historic interest save for its timber barge boards beneath the eaves (Plate 48).

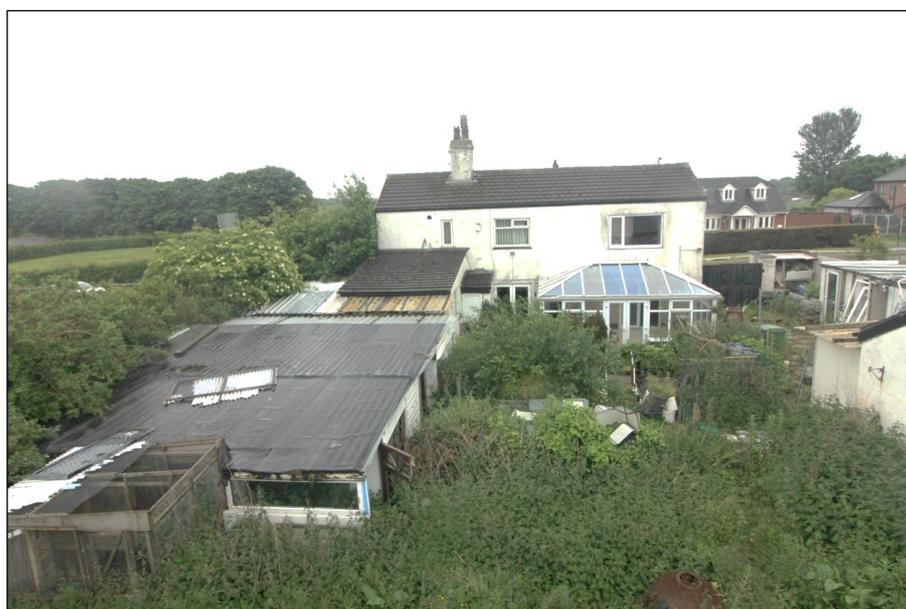
Plate 49: Western elevation, facing east

5.1.4 The ground floor of the western elevation was encumbered by the later single storey extension to the north and conservatory to the south, leaving only a pair of modern uPVC patio doors exposed between the two (Plate 49). At first-floor level there was a large modern window occupying the centre of the southern half of the elevation, another slightly smaller unit to the north of centre and a narrow uPVC window to the north of this. A plastic gutter ran across the head of the elevation mounted upon a timber fascia.

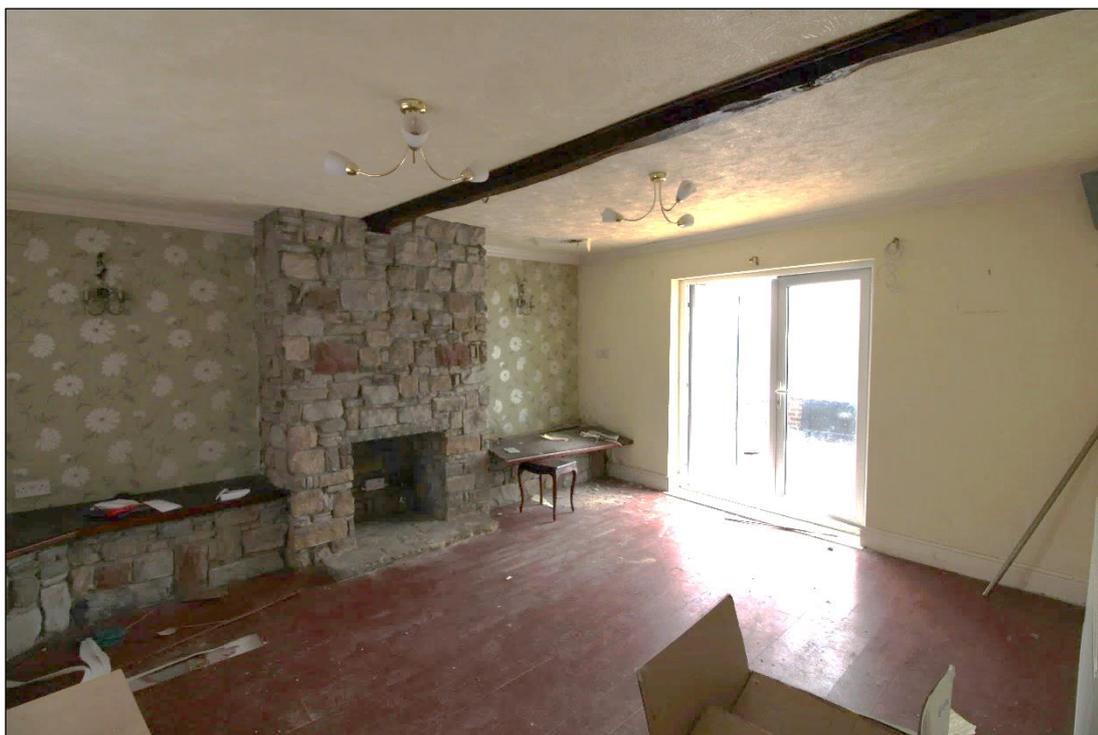
Plate 50: Living room, facing south-west

- 5.2.2 The principal entry from the east led into a small lobby entrance, with the stairs leading to the first floor to the west, a doorway into the living room to the south and another to the north leading into the dining room. The living room was a large rectangular space lit by a window on the eastern wall and with a set of double uPVC doors to the west opening into the modern conservatory beyond (Plate 50). A stone-clad chimney breast projected from the centre of the southern wall flanked to the east and west by a low shelf or bench clad beneath in the same stone. The ceiling and walls had all received modern finishes, with a faux waney-edge timber beam projecting longitudinally from the centre of the ceiling. To the west of this beam the ceiling was slightly higher, and an inspection hole revealed its lathe and plaster construction perhaps indicating the presence of a false ceiling to the east (Plate 51). A moulded coving had been latterly applied to the junction of the wall and ceiling, with a skirting board, possibly of greater antiquity, attached to the base of the wall. The floor was covered in a modern laminate.

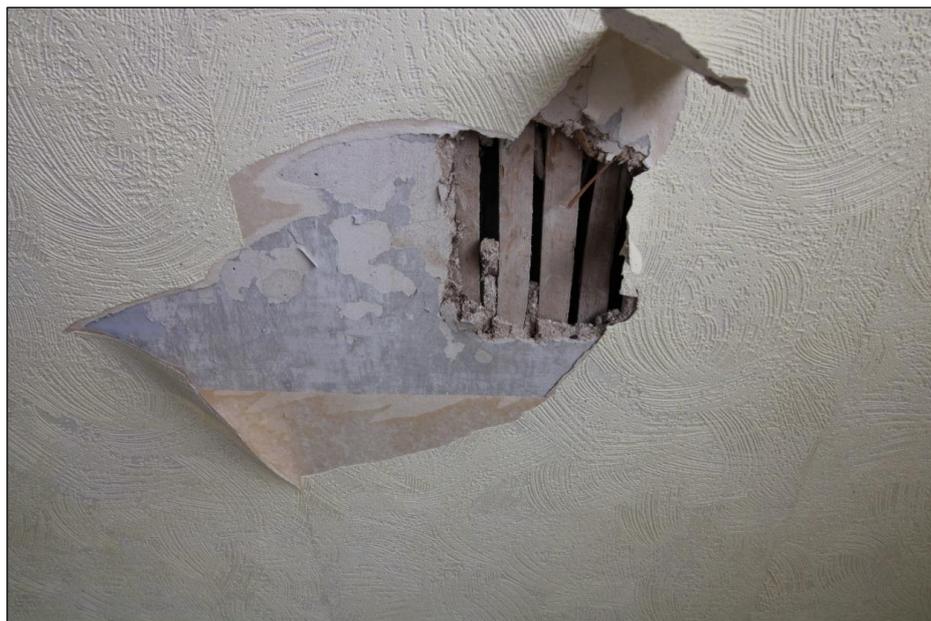
Plate 51: Lathe and plaster revealed in inspection hole to west of ceiling beam

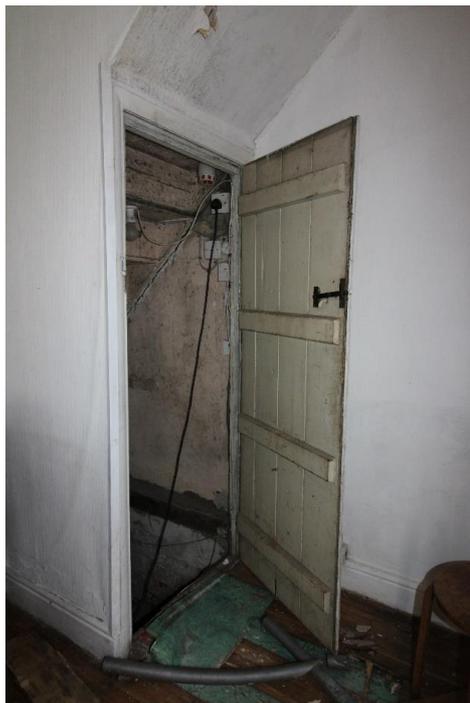
Plate 53: Plank and batten door to cellar, facing south-east

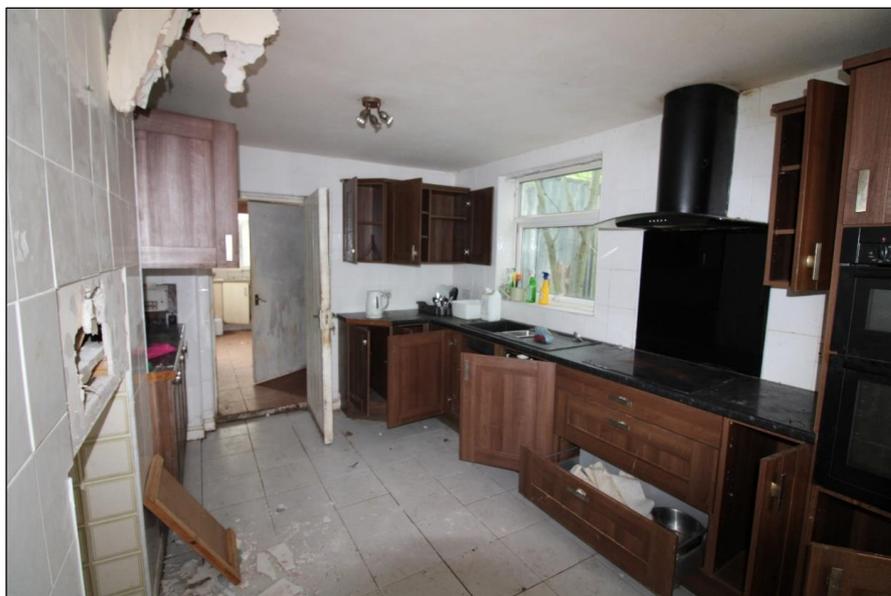
Plate 54: Kitchen, facing west

5.2.4 The kitchen was an elongated rectangular room lit by windows to the north and east and with a door at the southern end of the western wall leading into a modern extension (Plate 54). A chimney breast projected from the centre of the southern wall. No historic elements were noted save for the presence of a lathe and plaster ceiling, exposed behind a modern plaster finish during the asbestos survey inspection.

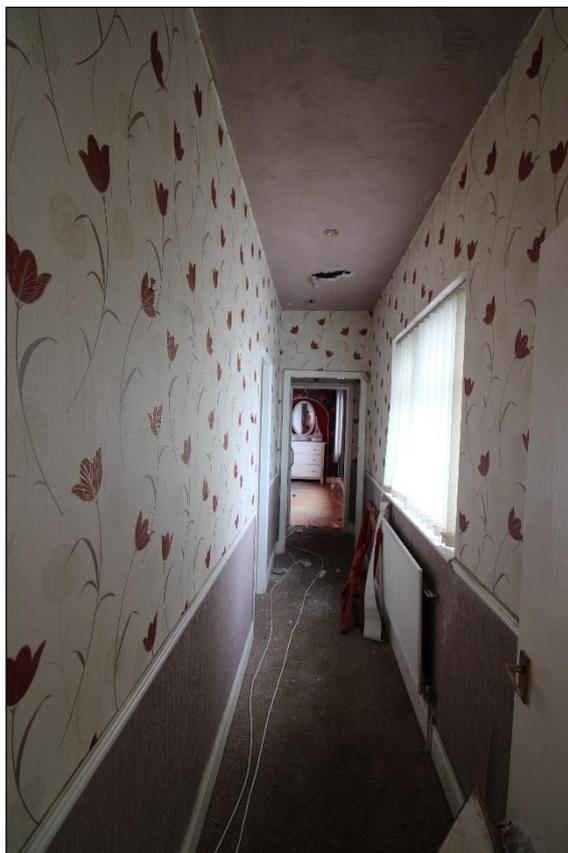
Plate 55: First floor corridor, facing south

5.2.6 At the top of the staircase a corridor extended north along the western side of the house with an entrance into the master bedroom to the south and access to the remaining rooms to the north (Plate 55). The corridor was illuminated by a large window on its western side and had modern finishes throughout.

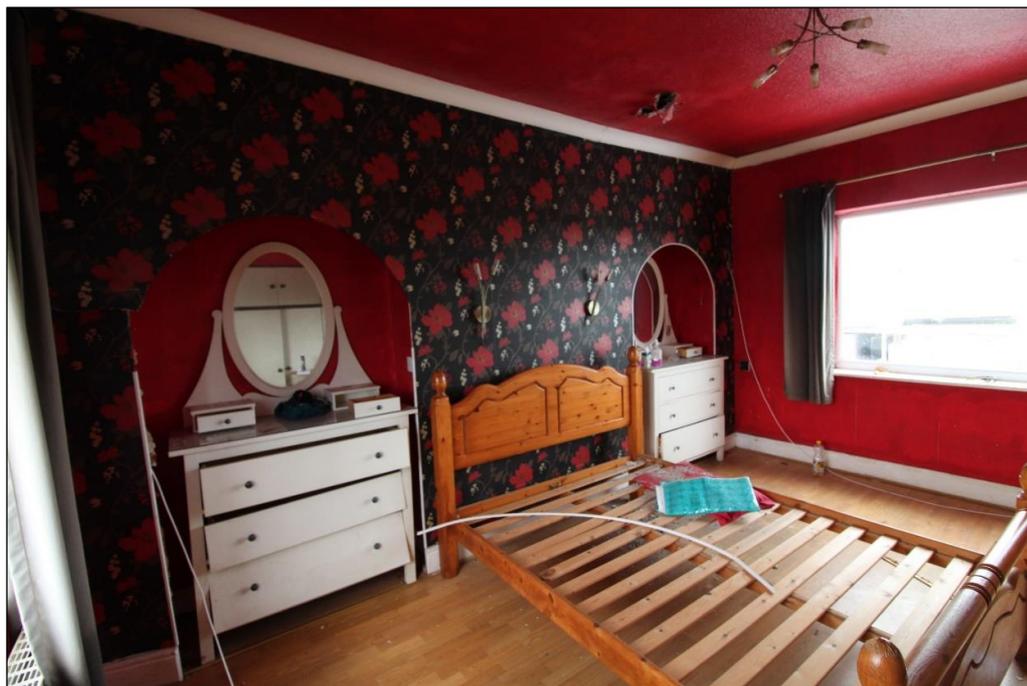
Plate 56: Master Bedroom, facing south-west

5.2.7 The master bedroom was illuminated by windows on the eastern and western walls and had a set of built in cupboards set against the eastern half of its northern wall. There appeared to be a second chimney breast located against the centre of the southern wall, with an arch-topped alcove on either side (Plate 56). Modern finishes had been applied to the walls and ceiling, although again an inspection hole had revealed lathe and plaster construction behind the textured ceiling finish. The coving was also modern, but the door architrave and skirting boards may have been of nineteenth century date. The floor was covered in laminate, with floorboards beneath.

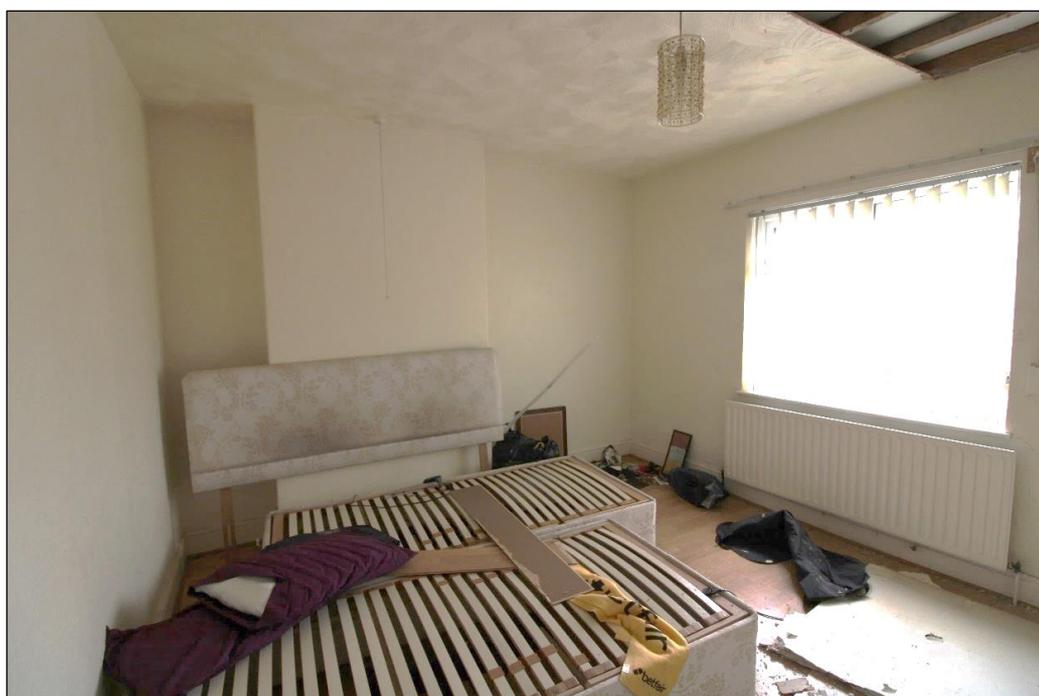
Plate 57: Bedroom Two, facing north-east

5.2.8 Bedroom two was accessed via a doorway part way along the western corridor and was a large square room lit by a window on its eastern wall (Plate 57). It had a modern built-in cupboard on its southern wall and a blocked projecting chimney breast on its northern wall. The ceiling had been lowered with the application of modern plasterboard sheeting on to a secondary row of battens attached to the original ceiling and the skirting board may have been original, but all other finishes were modern in character.

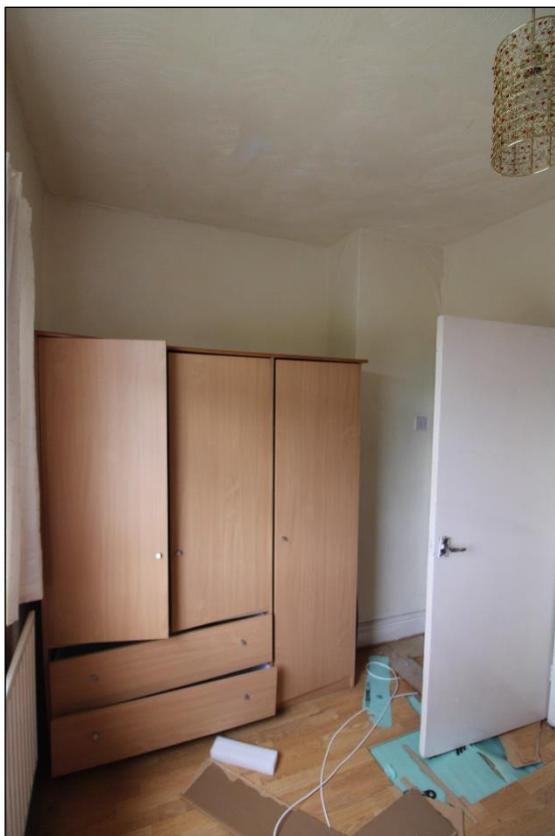
Plate 58: Bedroom Three, facing south

5.2.9 At its northern end the corridor turned to the east, where it was lit from its western wall by a narrow window. A doorway on the opposing wall opened into bedroom three, the smallest of the bedrooms and illuminated by a large window to the east. The only feature of note was a projecting chimney breast on the southern wall that continued into the corridor and had been intersected by the bedroom's western wall, which was probably a later stud partition (Plate 58). All other wall, floor and ceiling finishes were modern.

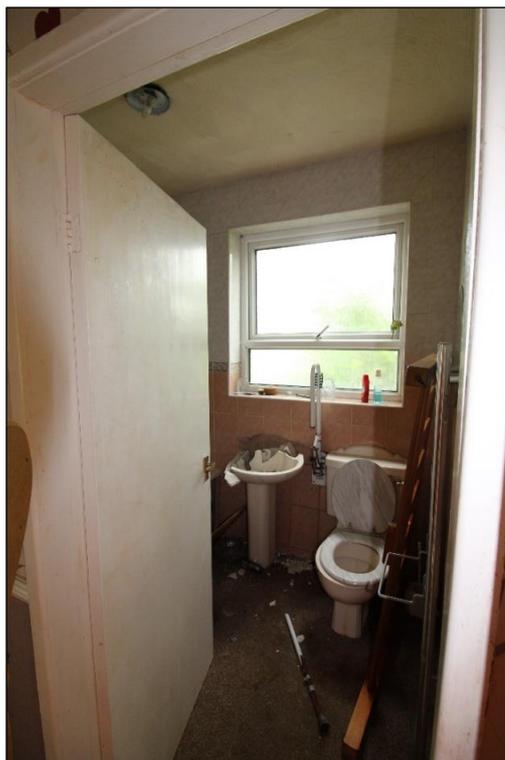
Plate 59: Bathroom, facing north

5.2.10 The bathroom lay to the west of bedroom three and was a small room entered from the south and with a window in the opposing wall (Plate 59). Its southern and eastern walls were modern stud partitions, reflecting the later insertion of the room to create an internal bathroom and all visible finishes were modern.

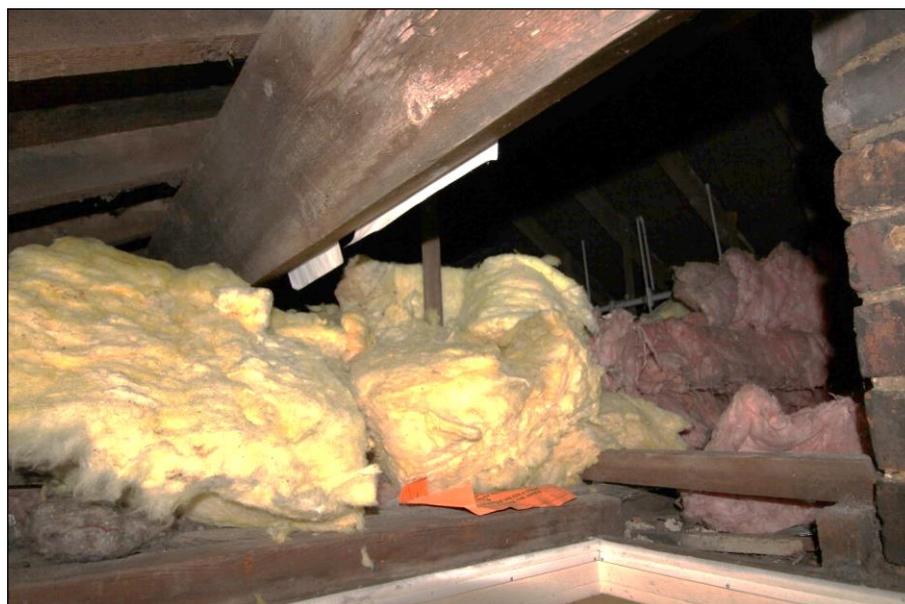
Plate 60: Limited view in the roof space, facing north

- 5.3.1 A hatch in the corridor ceiling outside the bathroom provided the only access to the roof space and the insertion of a remotely operated camera revealed only limited information as to its construction (Plate 60). It was evident that the roof structure used machine-cut softwood and likely consisted of pairs of purlins spanning between the gable ends and intermediary brick-built partition walls. The common rafters were nailed to the backs of the purlins and tiles attached to these in turn.

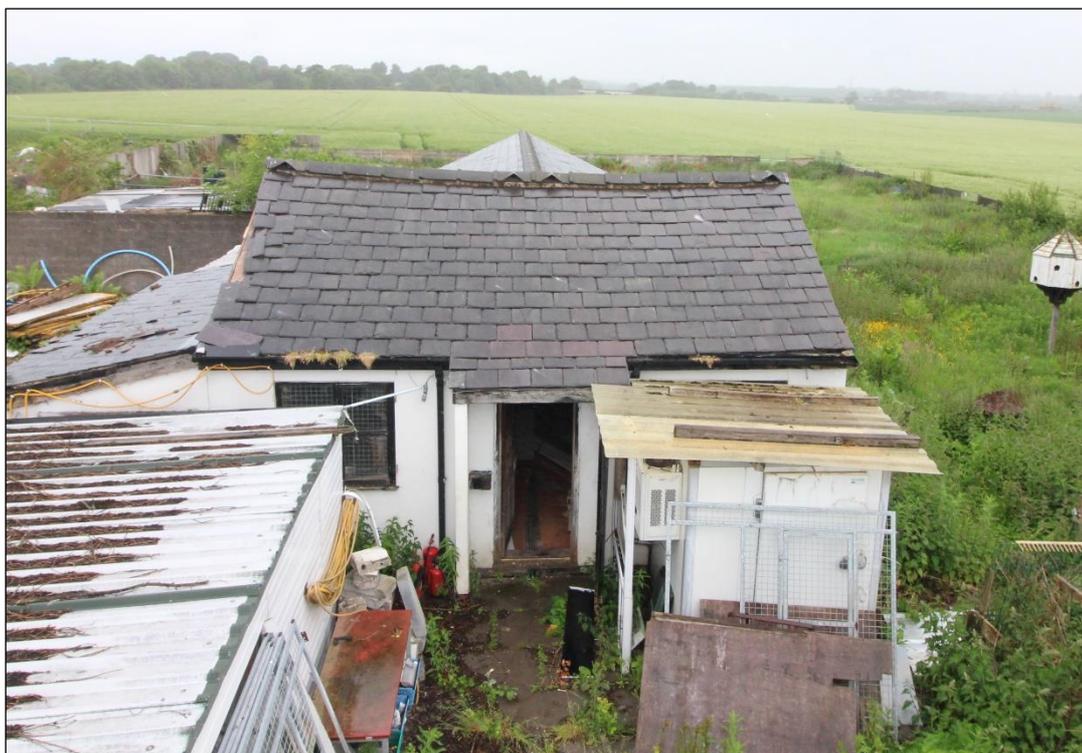
Plate 61: Outbuilding, facing west

5.4.1 The Outbuilding lay to the west of the Cottage and north-west of the Barn and was a small single storey structure with a shallow pitch gabled slate roof (Plate 61). Originally a rectangular building, modern extensions to the south and west had obscured its original plan form. Its eastern elevation had a central door covered by a shallow open side porch and fixed-frame timber windows to the north and south.

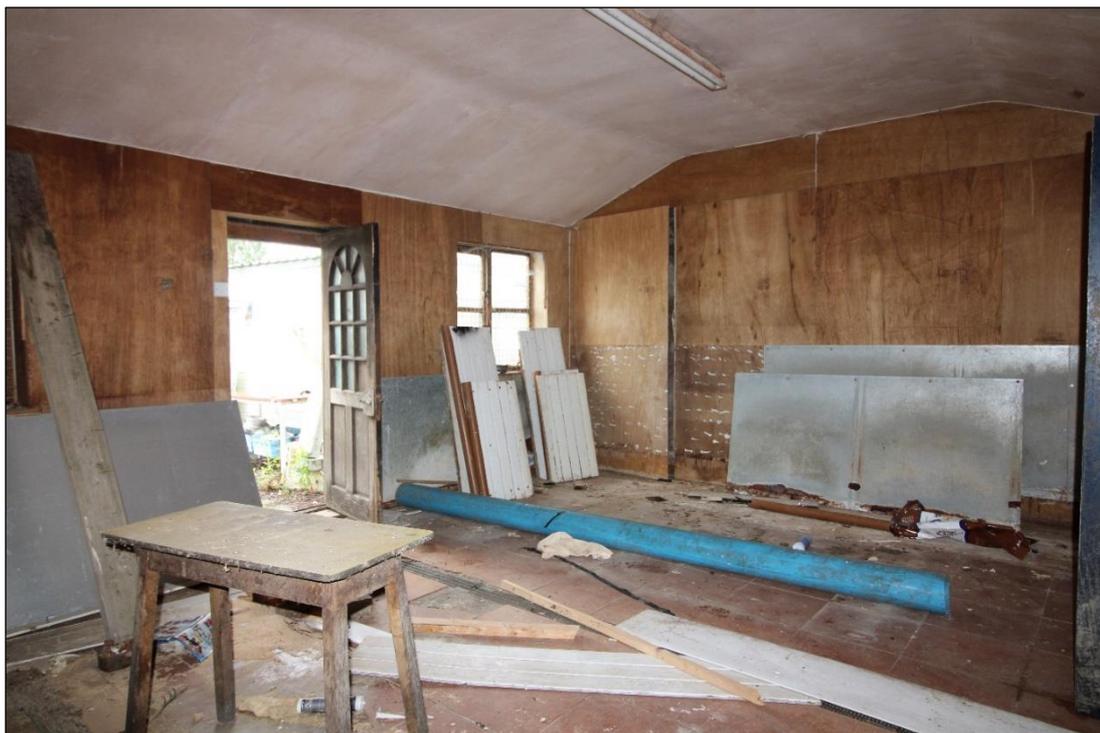
Plate 62: Interior of Outbuilding, facing south-east

5.4.2 Internally, there was little to indicate its original character with modern finishes to the ceiling and the majority of the walls clad in modern plywood sheeting (Plate 62). The floor had a covering of modern ceramic tiling with a narrow, covered drain running east/west along its centre. A second doorway at the centre of the western wall led into a modern extension, but an examination of the jambs indicated that this opening was not original and had been cut through perhaps contemporary with the construction of the extension. The exposure of these jambs however did allow an inspection of the brick used in the building's construction which was elsewhere hidden by render, and they appeared to be of late nineteenth century date (Plate 63).

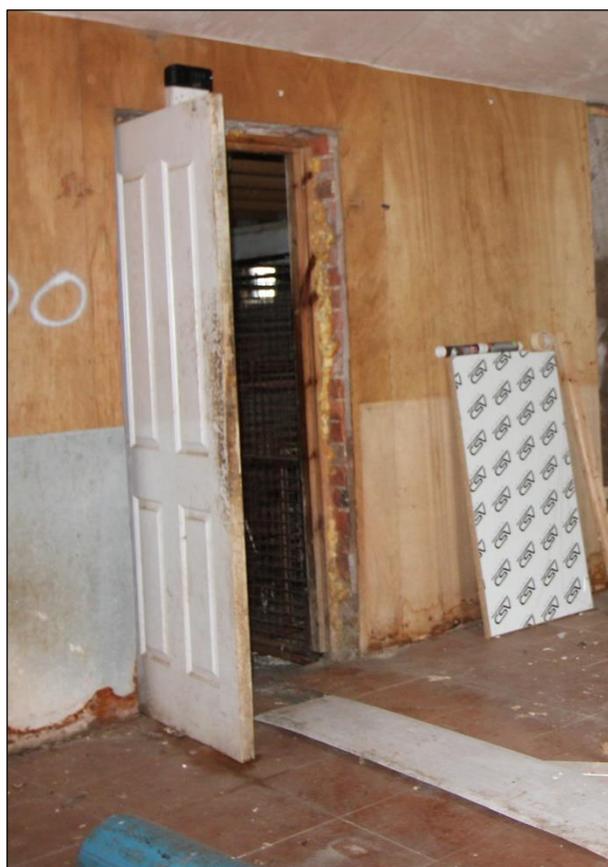
Plate 63: Western doorway, showing brick jambs in cross-section, facing north-west

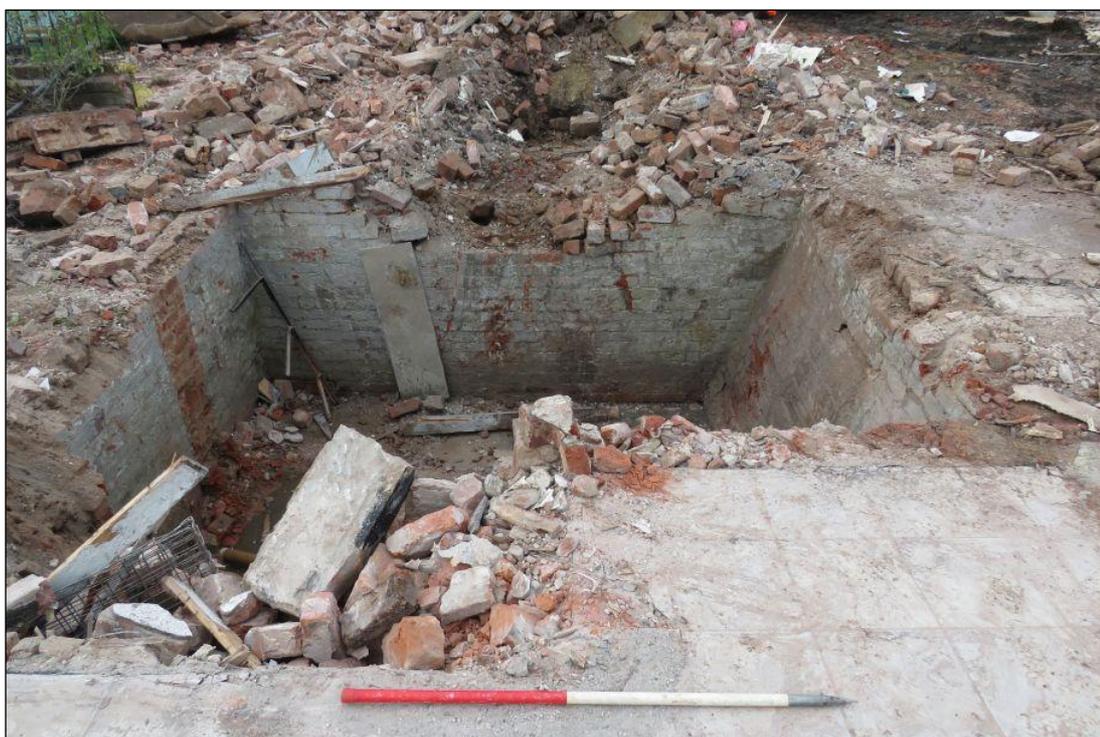
Plate 64: West-facing view of cellar, 1m scale

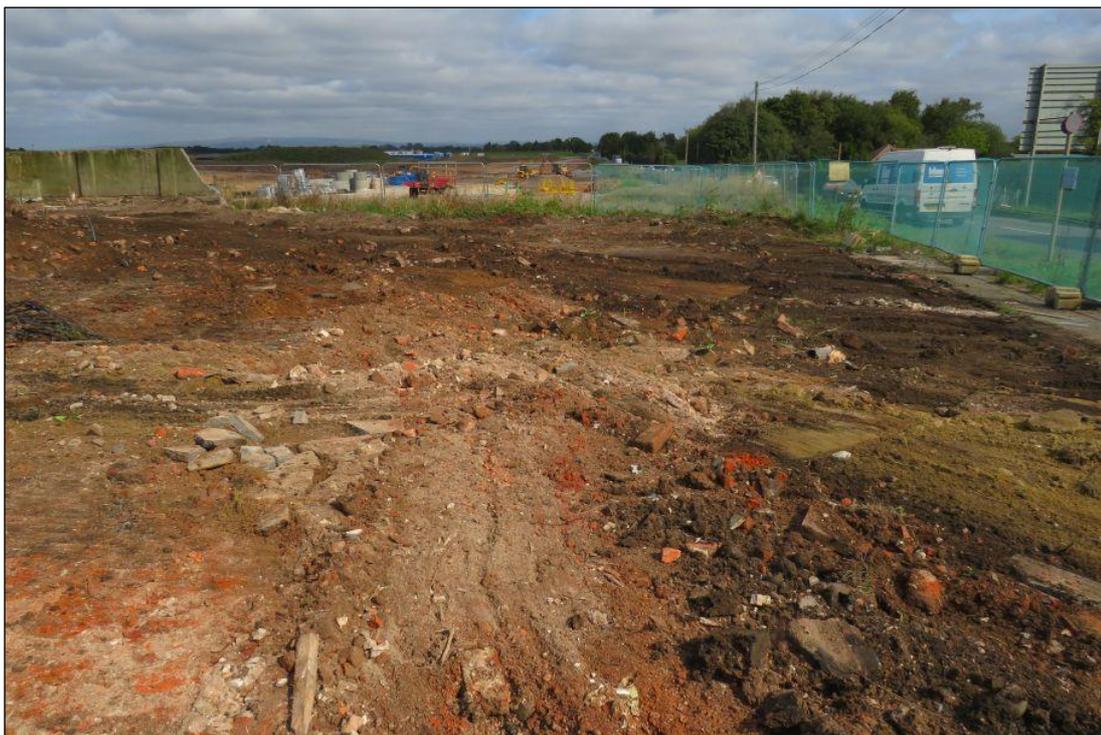
Plate 65: Location of Rough Cottage following its demolition and removal of ground floor slab, looking north-east

- 6.1.3 There was no evidence of any earlier structural remains on the sites of either Rough Cottage or Rough Barn. Natural geology, of yellow sandy clay, was identified in both locations, overlain by a thin layer of made ground, approximately 0.2m thick, below the ground floor slabs of the structures (Plate 65 and 66).
