CHESTER NORTHGATE REDEVELOPMENT

Archaeological Desk- based Assessment

Oxford Archaeology North

May 2016

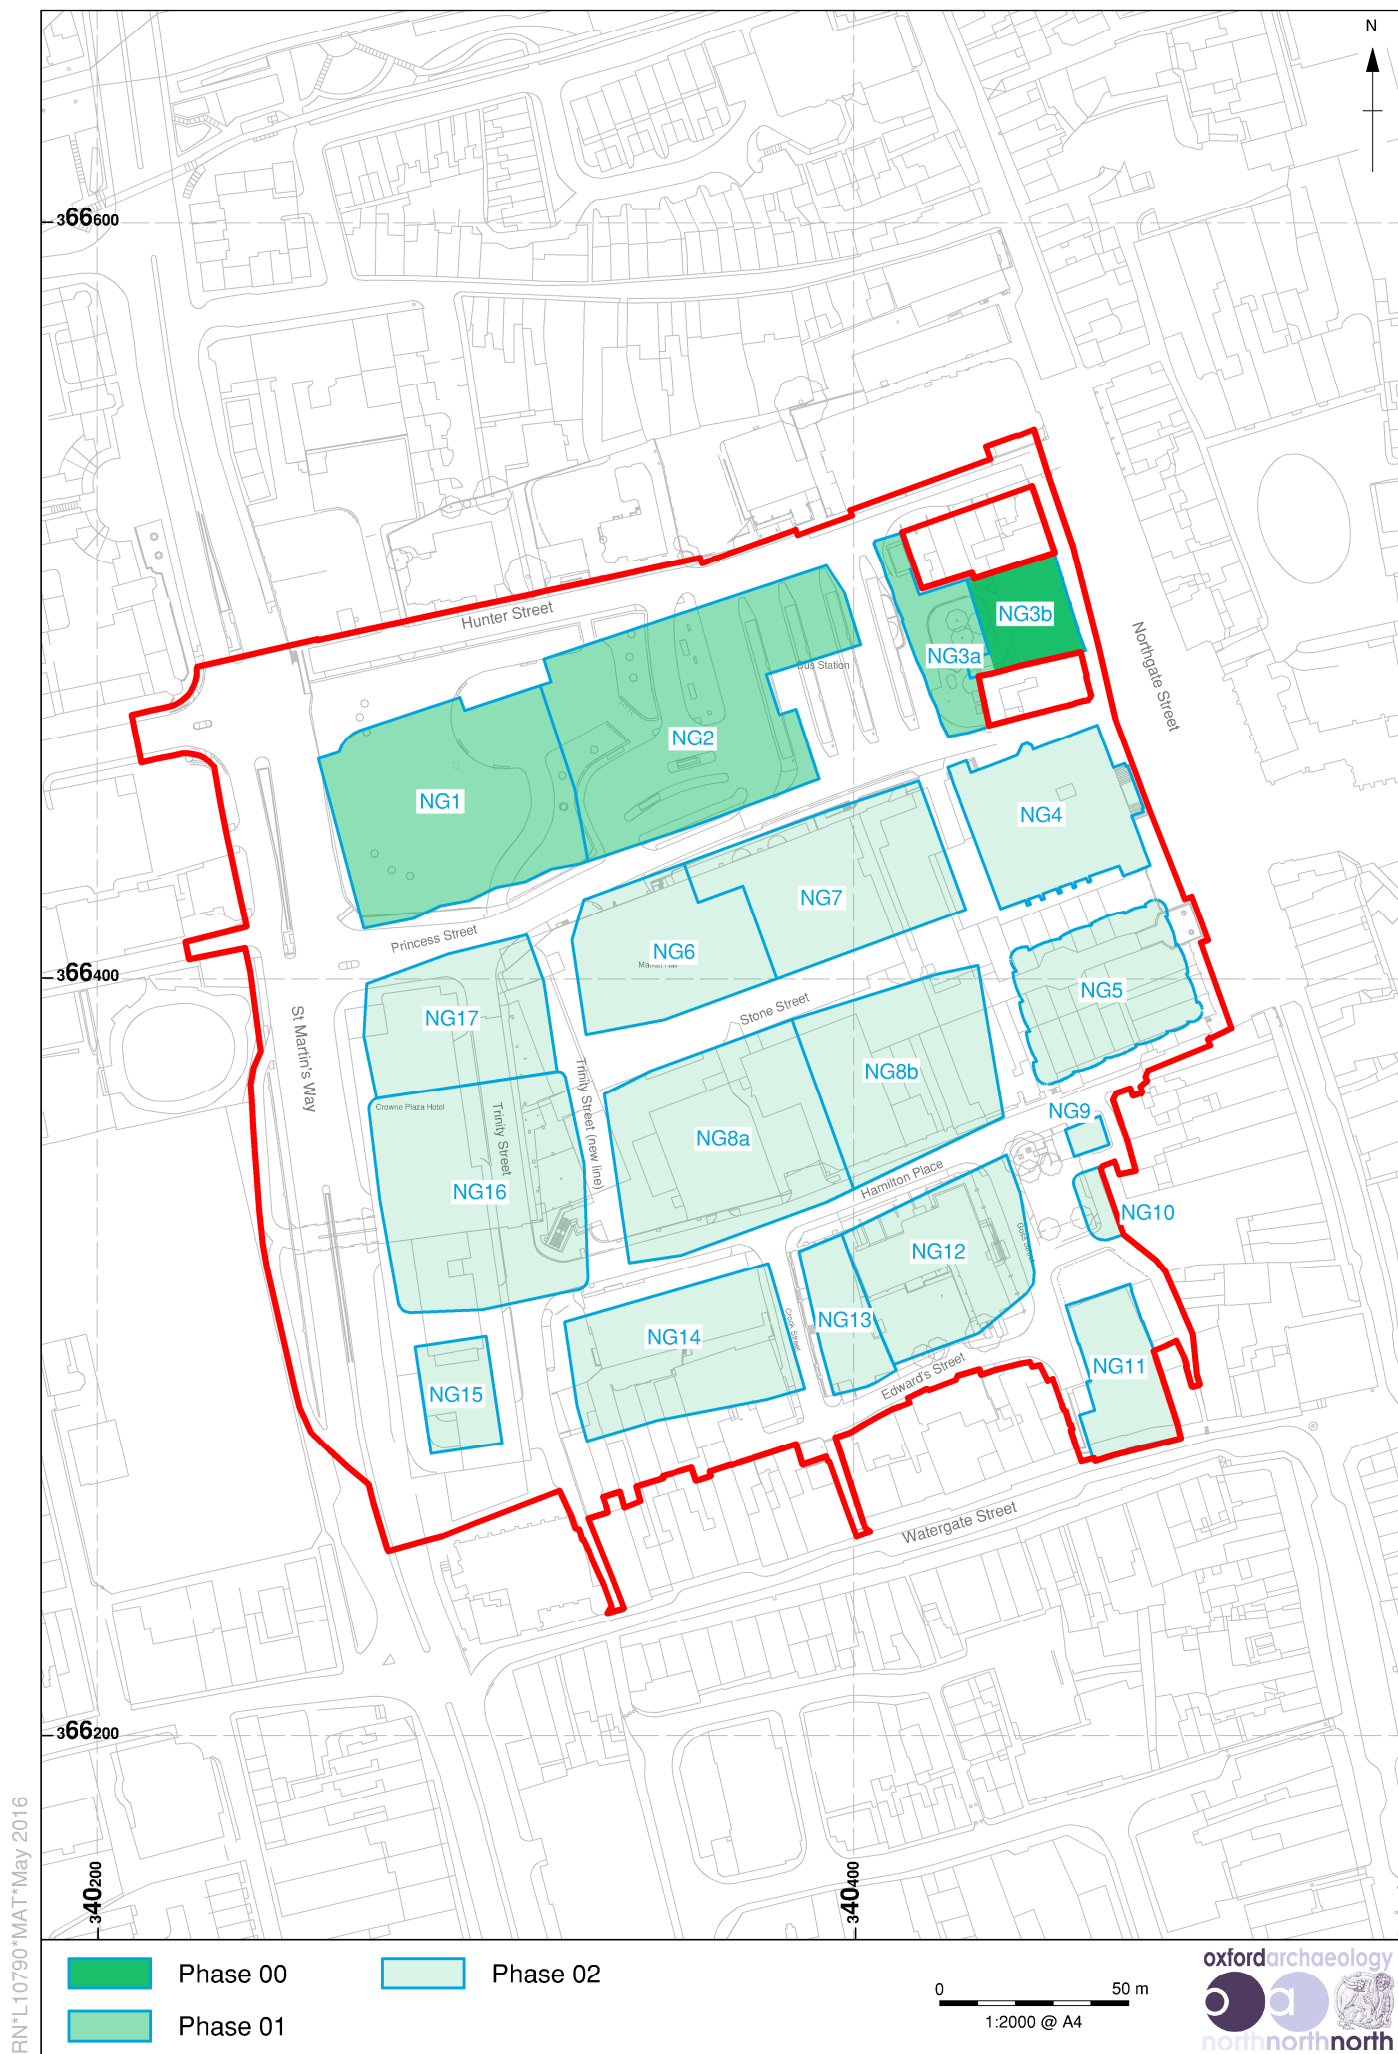
Figure 2: Plan of proposed development blocks, showing construction phases

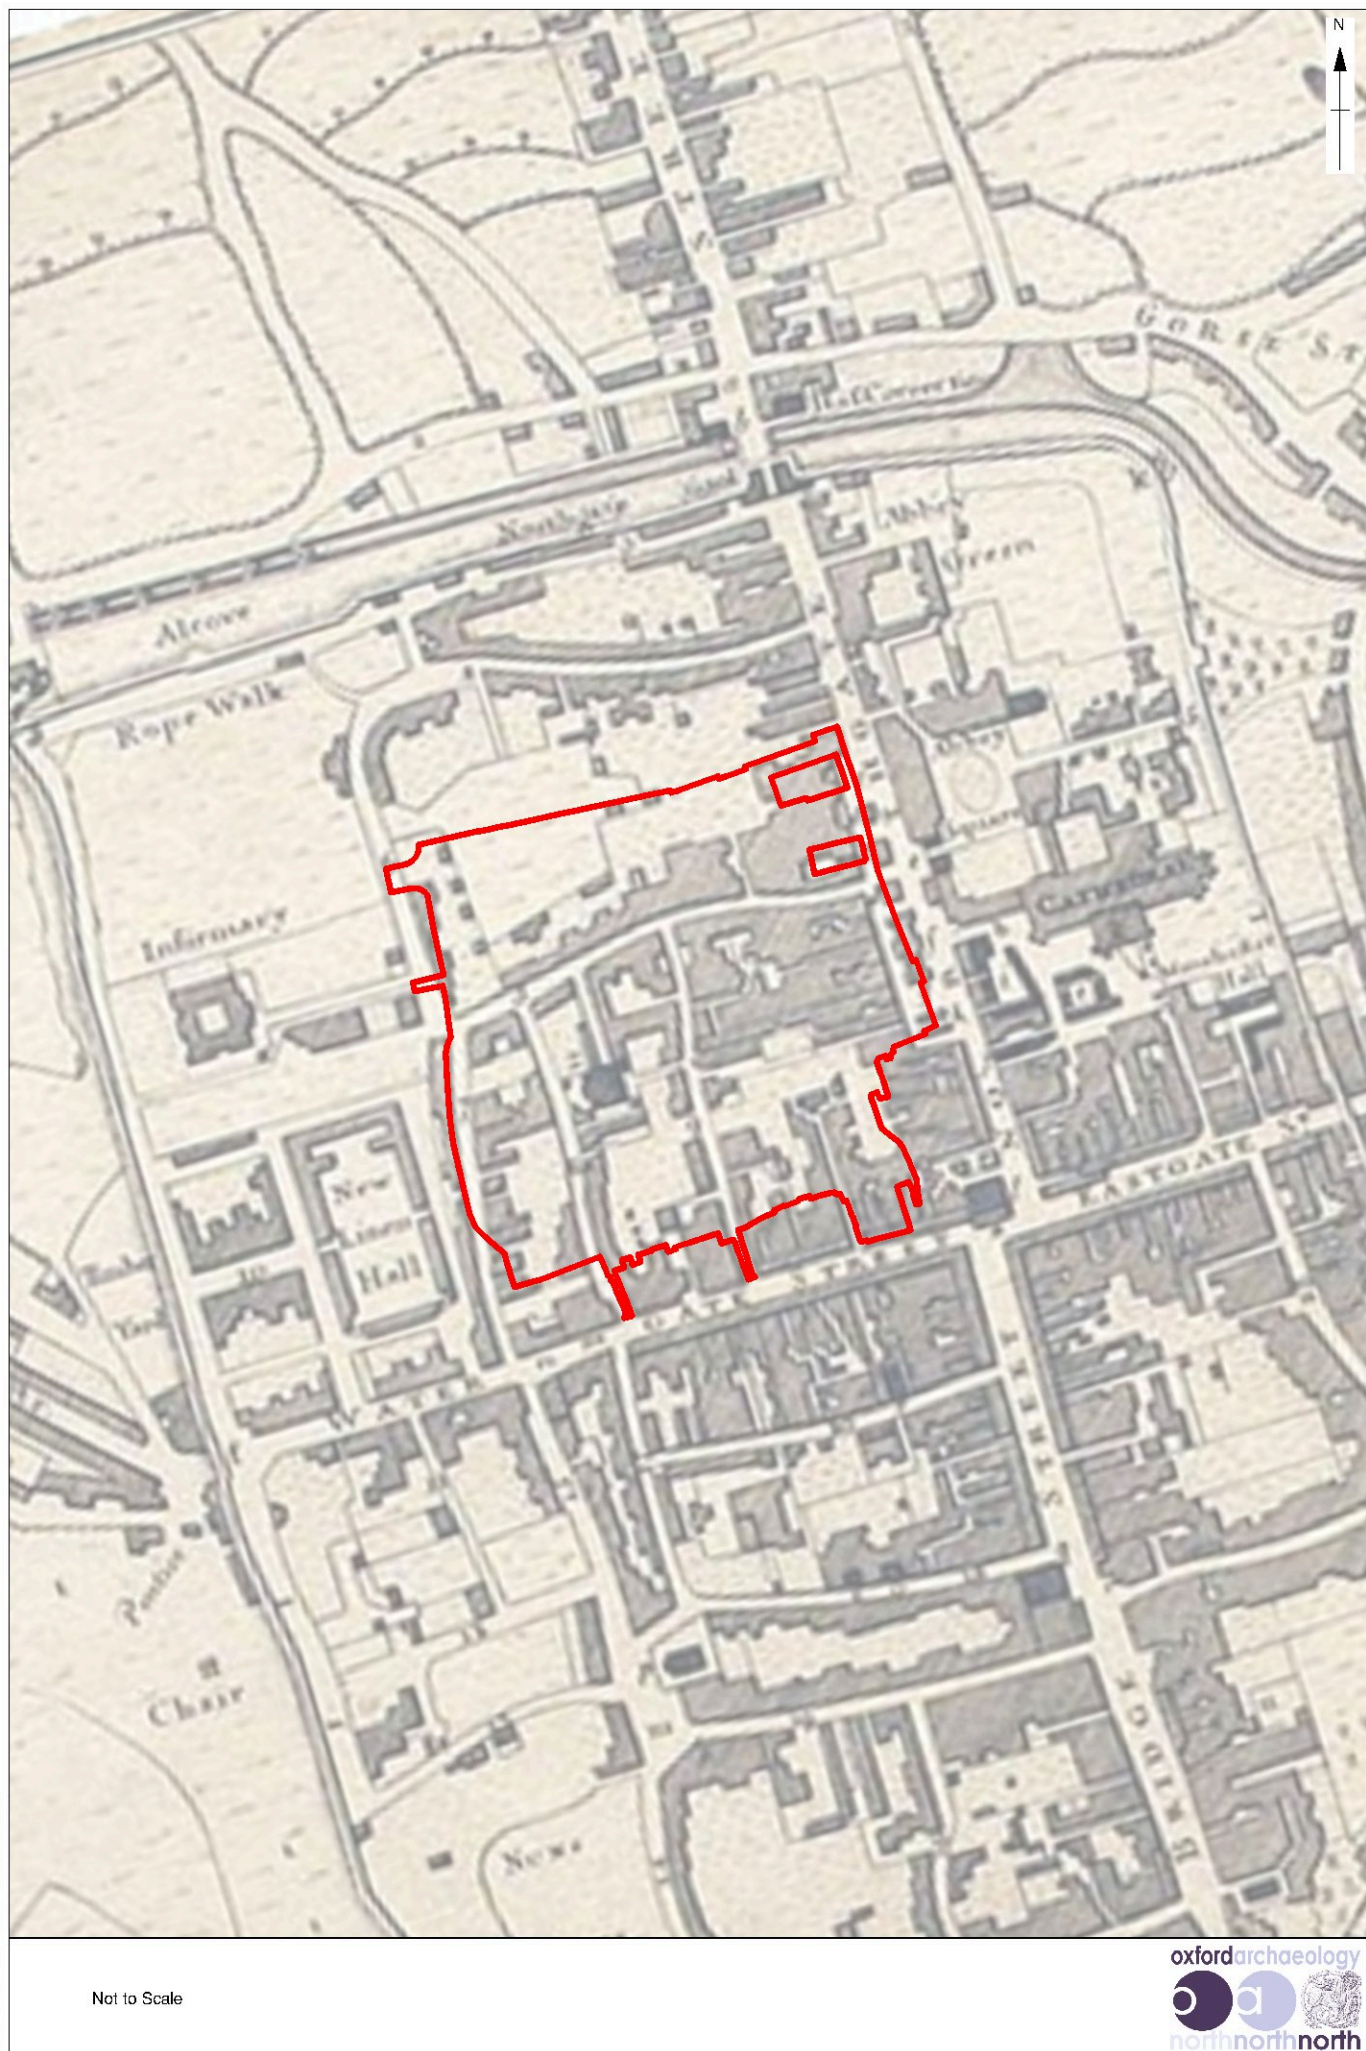
Figure 12: Lavaux's map of Chester, 1745, and detail showing the 'Dissenter's Chapel' (Monument 10055) on Trinity Lane (now Trinity Street)

- 3.7.7 The first really detailed map of Chester, published by the engineer and surveyor, Alexander de Lavaux in 1745 (Lavaux 1745; Fig 12), is broadly consistent with the earlier plans in showing the street frontages within the development site as being densely built up, with much of the area to the rear of the properties on Parson's Lane/Princess Street still being occupied by formal gardens and orchards, as was the case over 150 years earlier. Relatively few individual buildings are shown in any detail. One of the few shown within the study area is the 'Dissenter's Chapel' (*Appendix 2*; Monument **10055**) between Trinity Lane (Trinity Street) and Crookes Lane (Crook Street). This was built *c* 1700 for the preacher Matthew Henry, but was extensively modified and refurbished during the nineteenth century (Sharpe 1901), remaining in use until it was demolished in the mid-twentieth century. Late nineteenth- to early twentieth-century maps depict burial grounds on the west and south sides of the chapel; the former, adjacent to Trinity Street, is also depicted in an illustration published in 1901 (*ibid*; Pl 2). Archaeological evaluation on the east side of Trinity Street in 2015 proved that some graves within the western cemetery remain *in situ*, having survived extensive twentieth-century disturbance (OA North 2015). It is not, however, known if anything of the southern burial ground, or of the chapel itself, survives beneath the modern surface.

- 3.7.8 Lavaux's map also clearly shows the positions of the Corn Market, the Exchange and the Shambles in what is now Market Square (*Appendix 2*), on the eastern edge of the development site. Much of the rest of the study area, away from the street frontages, appears to have been open, but by the time Stockdale's map was produced some 50 years later (Stockdale 1795; Fig 13) significant infilling of the development site was well underway. On the evidence of a series of similar maps produced in the late eighteenth- and early nineteenth century (*eg* Batenham 1816; Wood 1833), the greater part of the development area saw little substantive change in the 40-50 years following the publication of Hunter's plan. All consistently show the area south of Princess Street as densely built up, contrasting with the area to the north, large parts of which remained open throughout the nineteenth century (*eg* Ordnance Survey 1872), with infilling only commencing following the construction of Hunter Street (*eg* Ordnance Survey 1910). The eastern end of this street was in existence, in the form of a lane or alleyway running west from Northgate Street, by 1833 (Wood 1833), but it was not extended westwards to St Martin's Fields (now St Martin's Way) until the very end of the nineteenth century (Ordnance Survey 1899; Ward 1994, 43). Hunter's Walk was also in existence by 1833, extending south to Princess Street from the western end of the lane that subsequently became Hunter Street (by the end of the nineteenth century, it linked Hunter Street and Princess Street), but it was moved westwards to its present position in 1981 (Emery 1995a, 4).

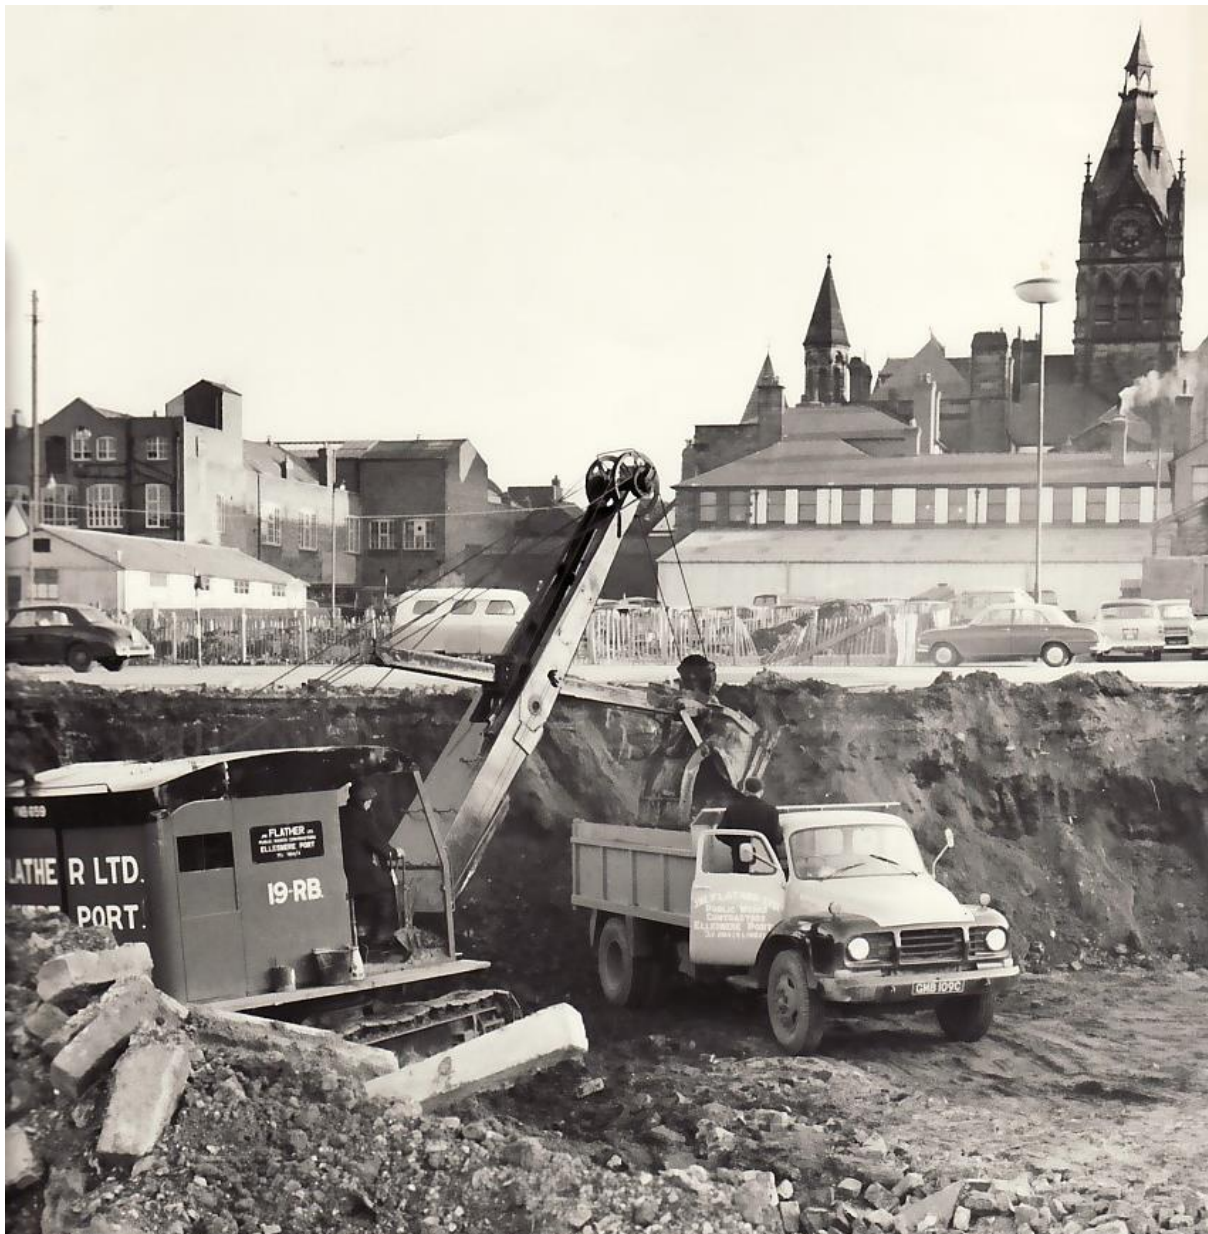
Plate 3: The Princess Street redevelopment site, c 1965, looking north-east to the Town Hall, showing the depth of excavation in the area of the present Market Hall

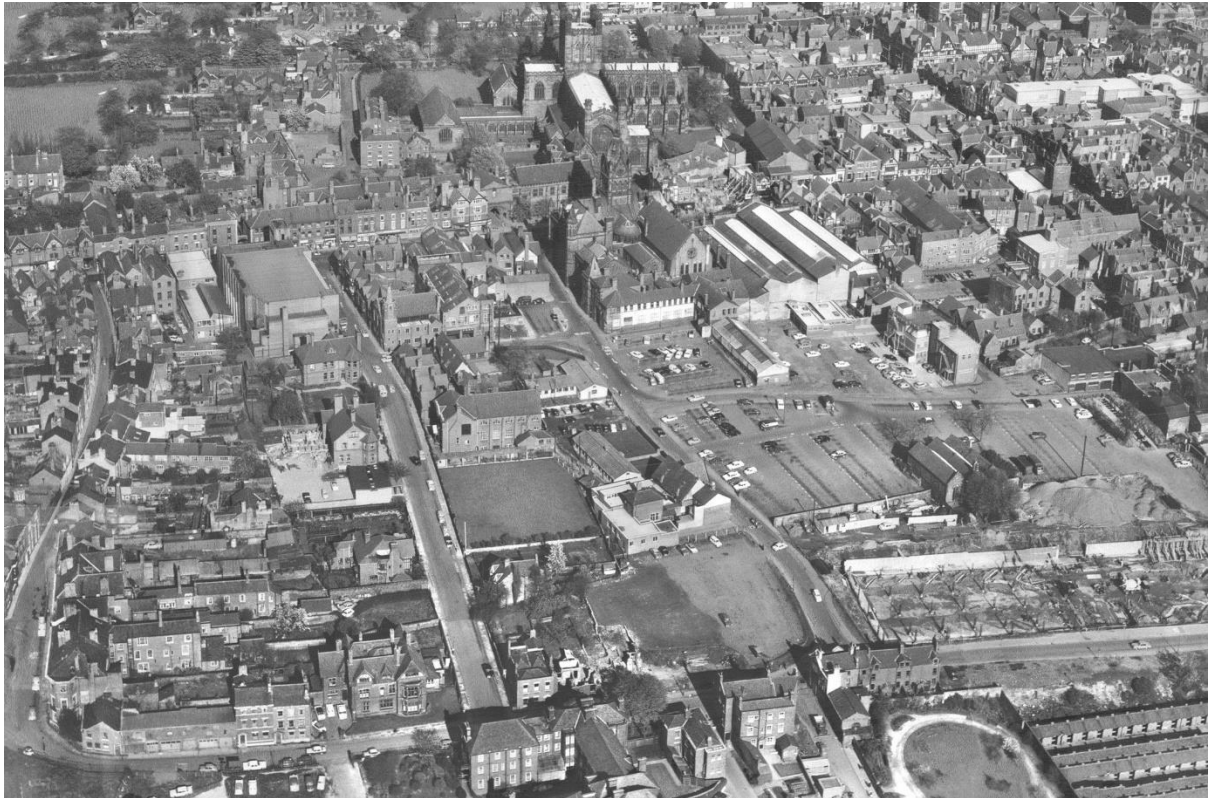
Plate 6: Aerial photograph of central Chester in the early 1960s, looking east across the Northgate area. The multi-storey car park, replaced in the 1980s by the Crowne Plaza Hotel, is under construction at bottom right

- 4.4.3 Also in the central part of the site, but further to the west, construction of a large, multi-storey car park in the early 1960s (visible under construction at the bottom right of Plate 6), which was also provided with a subterranean level, resulted in the widespread destruction of archaeological deposits between Trinity Street and St Martin’s Way, though some excavation was undertaken on the southern part of the site in 1961-2 (Thompson 1969). This structure was demolished in the late 1980s and replaced by the current Crowne Plaza Hotel (itself ear-marked for demolition as part of the present scheme), which also incorporated a basement car parking level.

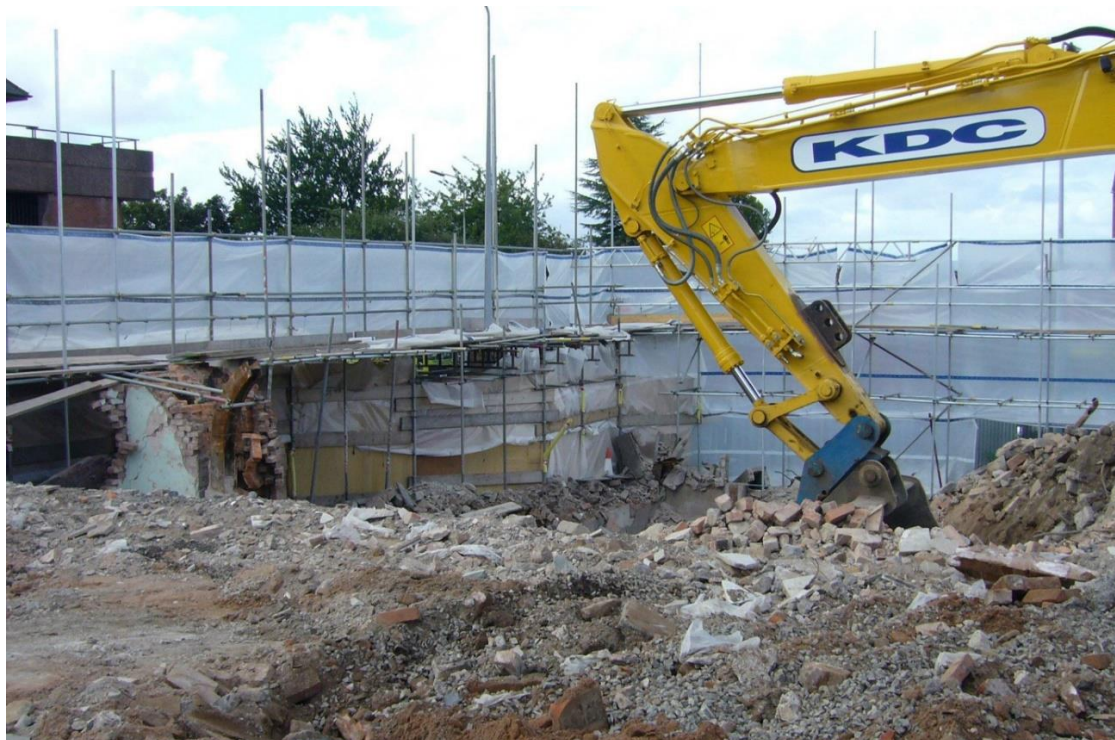
Plate 7: Demolition of St Martin's House, at the junction of Hunter Street and St Martin's Way, 2007, looking south to Princess Street, showing the deep basements beneath the building

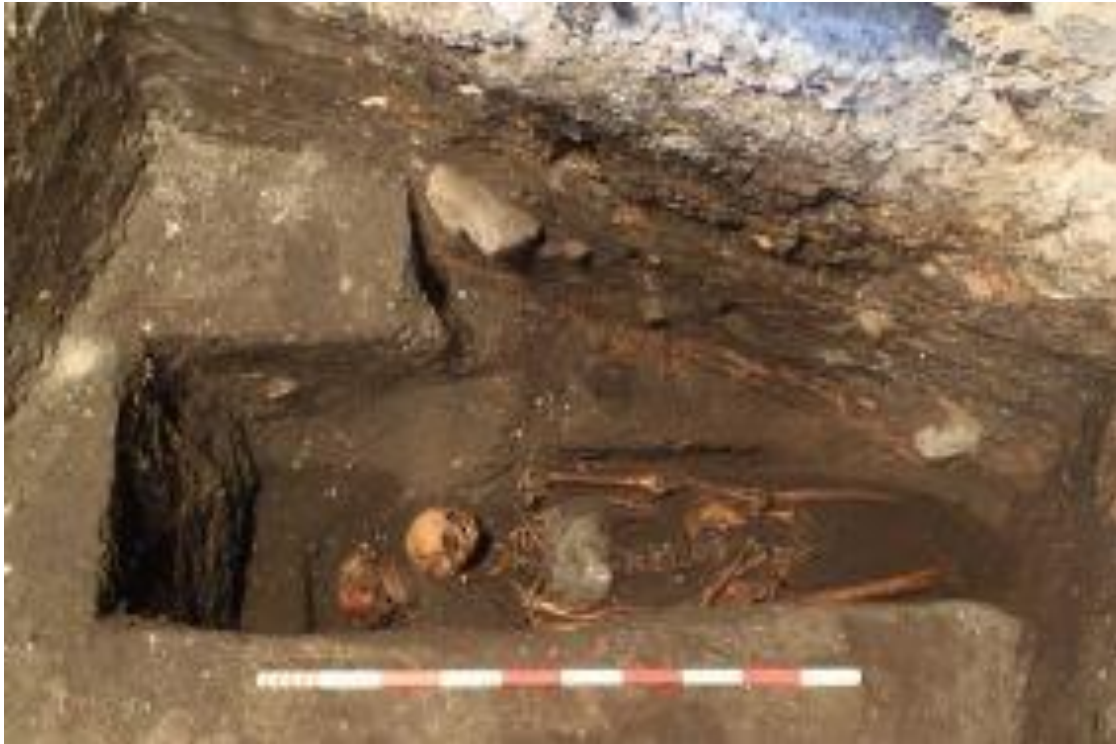
Plate 10: Apparently early nineteenth-century grave in the burial ground on the west side of Matthew Henry's chapel, exposed in 2015 during archaeological evaluation on Trinity Street

chapel that existed from *c* 1700 to the mid-twentieth century on the east side of Trinity Street (*Section 3.7.7*) survive in this area; a small section of probable Roman walling was also found. In the two trenches where graves were certainly found (Trenches 9 and 11; Table 9), the tops of the grave cuts were (respectively) 0.46m and 0.76m below the present surface, whilst the possible Roman wall fragment in Trench 8 lay 0.97m below the surface. In view of the fact that it is proposed, as part of the new development, to construct a subterranean access route through Area D, linking areas of basement car parking on either side of Trinity Street, the archaeological deposits recorded will need to form the subject of an appropriate mitigation strategy.
