# Car Park 14 and adjacent land, Laindon Link, Basildon, Essex

## Archaeological Evaluation Report

April 2023

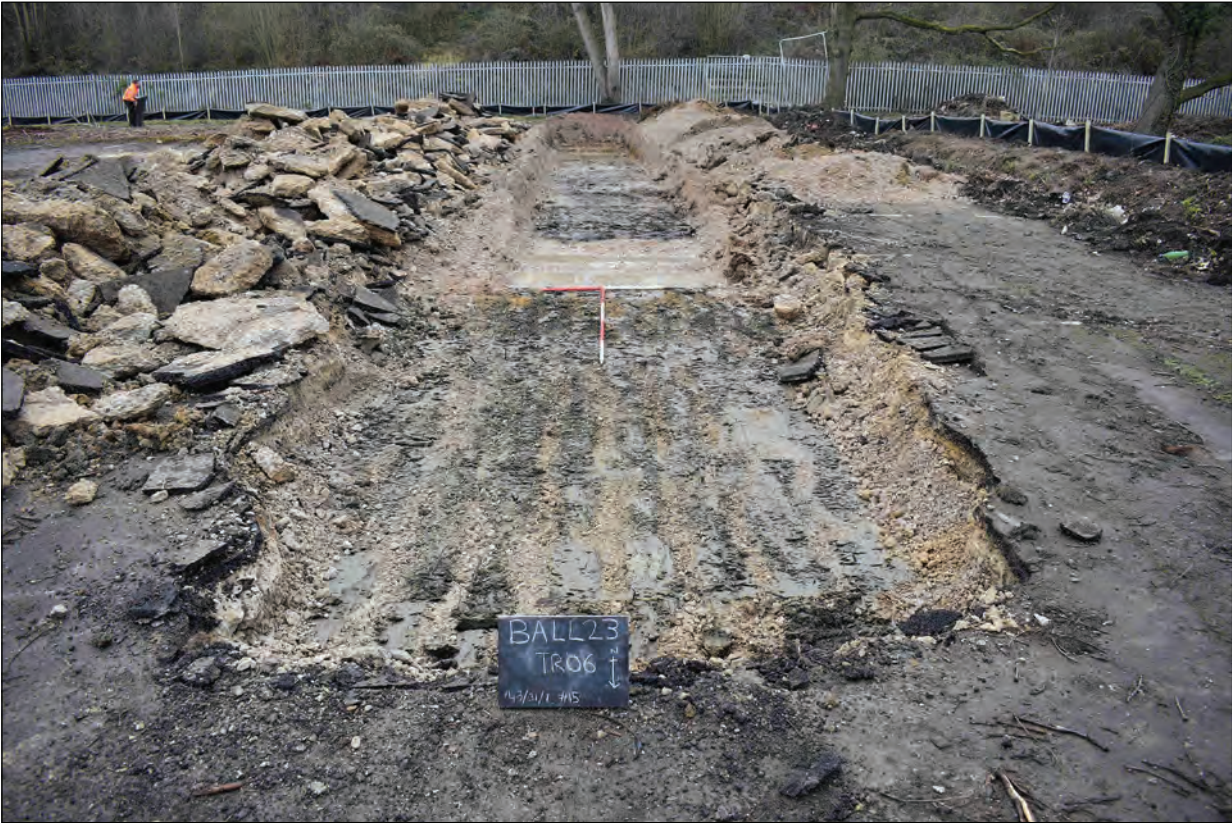
Plate 1: Trench 6, looking south

3.2.1 The soil sequence in the trenches was fairly uniform. The natural geology of clay, bedrock of the London Clay Formation, was overlain by levelling materials in the form of sand and 'crush', which in turn was overlain by tarmac (Plates 1-4). Only Trench 6 differed with a layer of concrete underlying the tarmac. The levelling material varied in thickness across the site from 0.27-0.63m.

Trench 6						
<b>General description</b>					<b>Orientation</b>	NNW-SSE
Trench devoid of archaeology. Consists of tarmac overlying concrete, crush and sand onto the natural geology.					<b>Length (m)</b>	30
					<b>Width (m)</b>	1.8
					<b>Avg. depth (m)</b>	0.39
<b>Context No.</b>	<b>Type</b>	<b>Width (m)</b>	<b>Depth (m)</b>	<b>Description</b>	<b>Finds</b>	<b>Date</b>
-	-	-	-	-	-	-

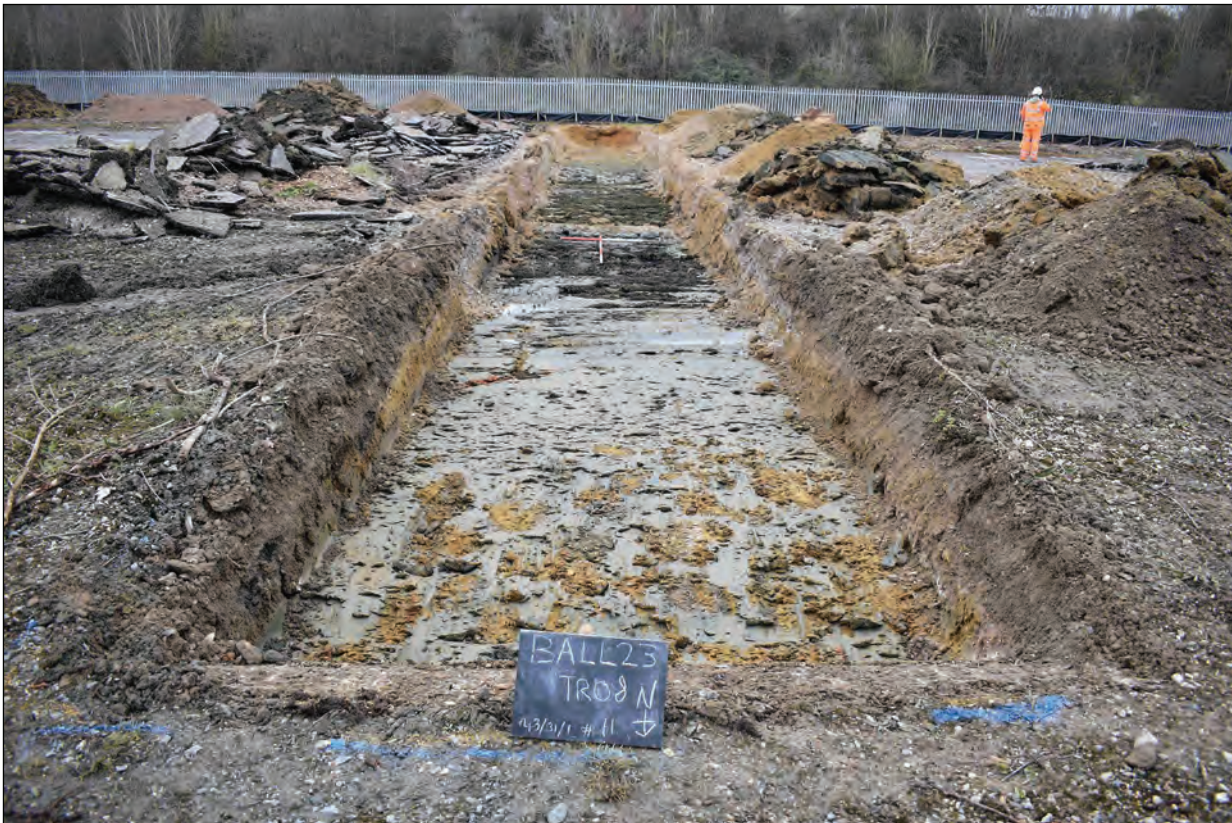
Plate 2: Trench 8, looking south

Trench 8						
<b>General description</b>					<b>Orientation</b>	NNW-SSE
Trench devoid of archaeology. Consists of tarmac overlying crush and sand onto the natural geology.					<b>Length (m)</b>	30
					<b>Width (m)</b>	1.8
					<b>Avg. depth (m)</b>	0.5
<b>Context No.</b>	<b>Type</b>	<b>Width (m)</b>	<b>Depth (m)</b>	<b>Description</b>	<b>Finds</b>	<b>Date</b>
-	-	-	-	-	-	-

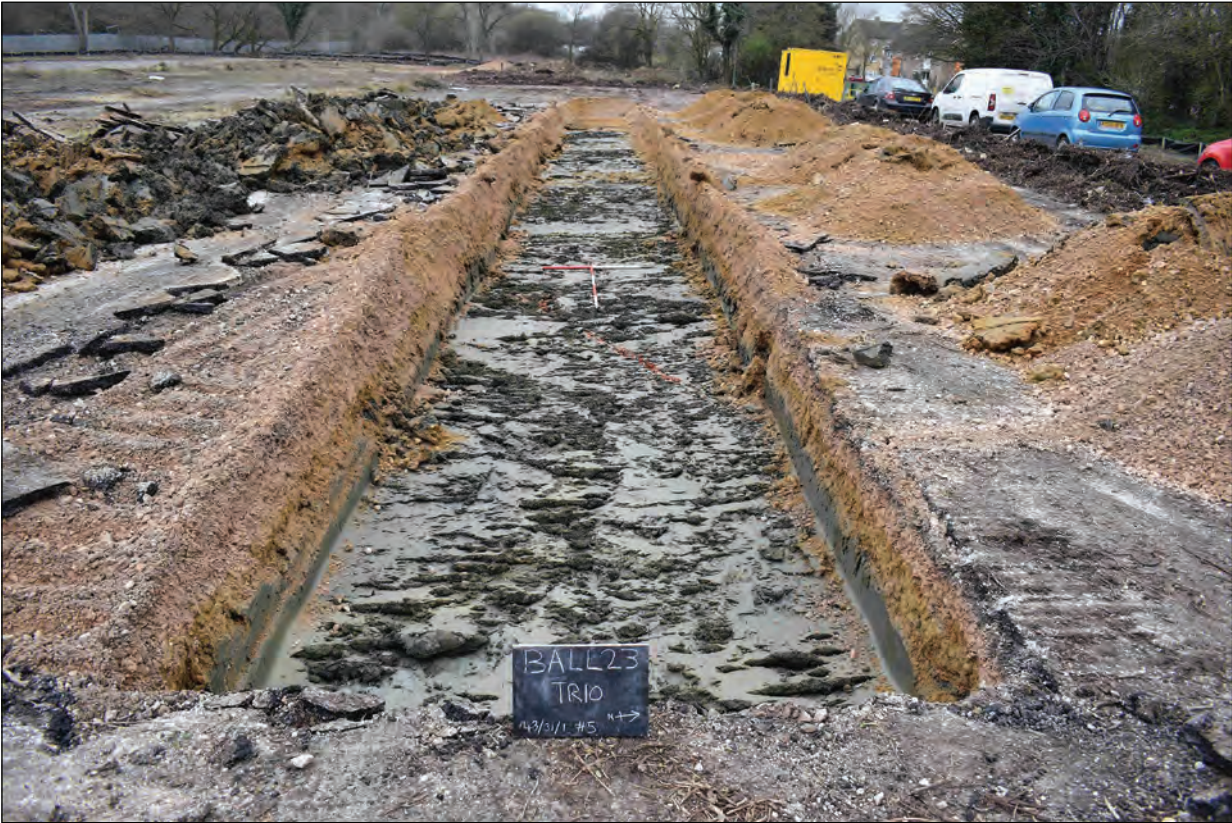
Plate 3: Trench 10, looking west

Trench 10						
<b>General description</b>					<b>Orientation</b>	WSW-ENE
Trench devoid of archaeology. Consists of tarmac overlying crush and sand onto the natural geology.					<b>Length (m)</b>	30
					<b>Width (m)</b>	1.8
					<b>Avg. depth (m)</b>	0.43
<b>Context No.</b>	<b>Type</b>	<b>Width (m)</b>	<b>Depth (m)</b>	<b>Description</b>	<b>Finds</b>	<b>Date</b>
-	-	-	-	-	-	-

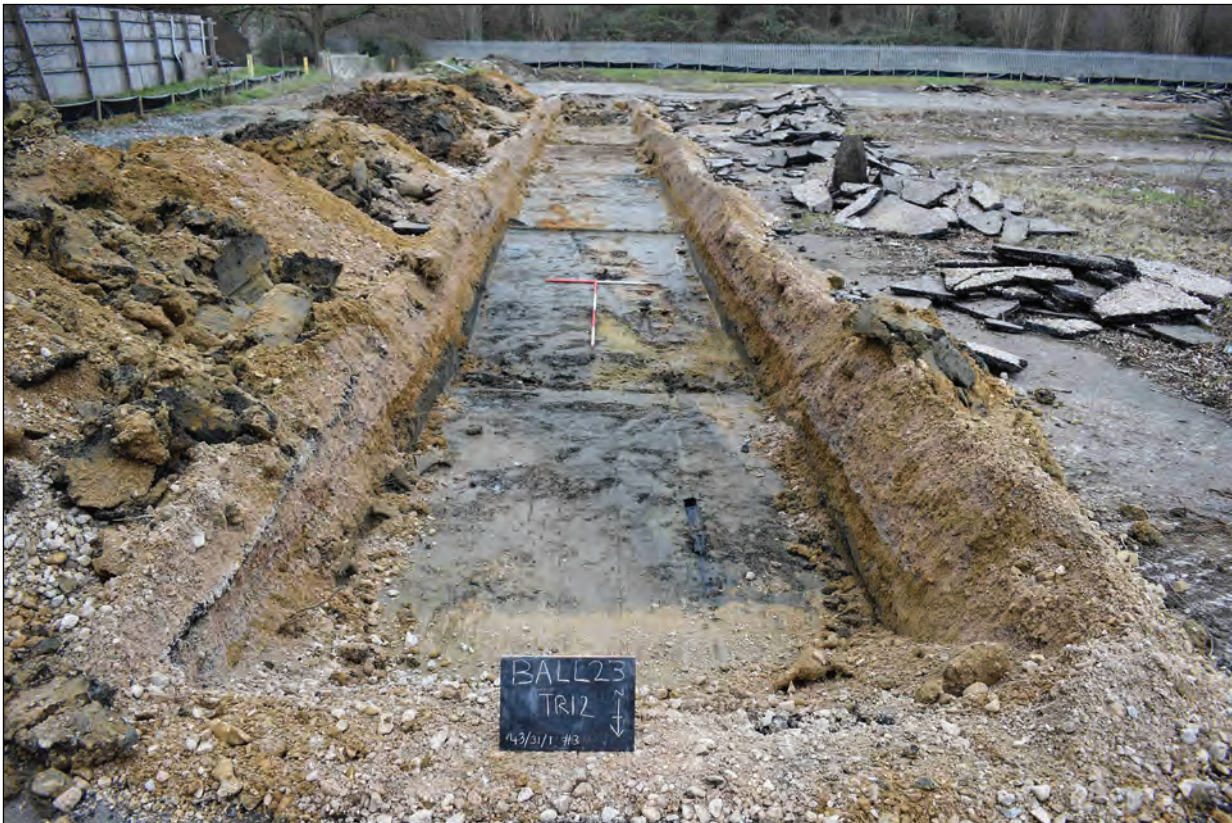
Plate 4: Trench 12, looking south

Trench 12						
<b>General description</b>					<b>Orientation</b>	NNW-SSE
Trench devoid of archaeology. Consists of tarmac overlying crush and sand onto the natural geology.					<b>Length (m)</b>	30
					<b>Width (m)</b>	1.8
					<b>Avg. depth (m)</b>	0.63
<b>Context No.</b>	<b>Type</b>	<b>Width (m)</b>	<b>Depth (m)</b>	<b>Description</b>	<b>Finds</b>	<b>Date</b>
-	-	-	-	-	-	-
