Trentham Gardens

Staffordshire

Historic Building Assessment

HISTORIC BUILDING ASSESSMENT

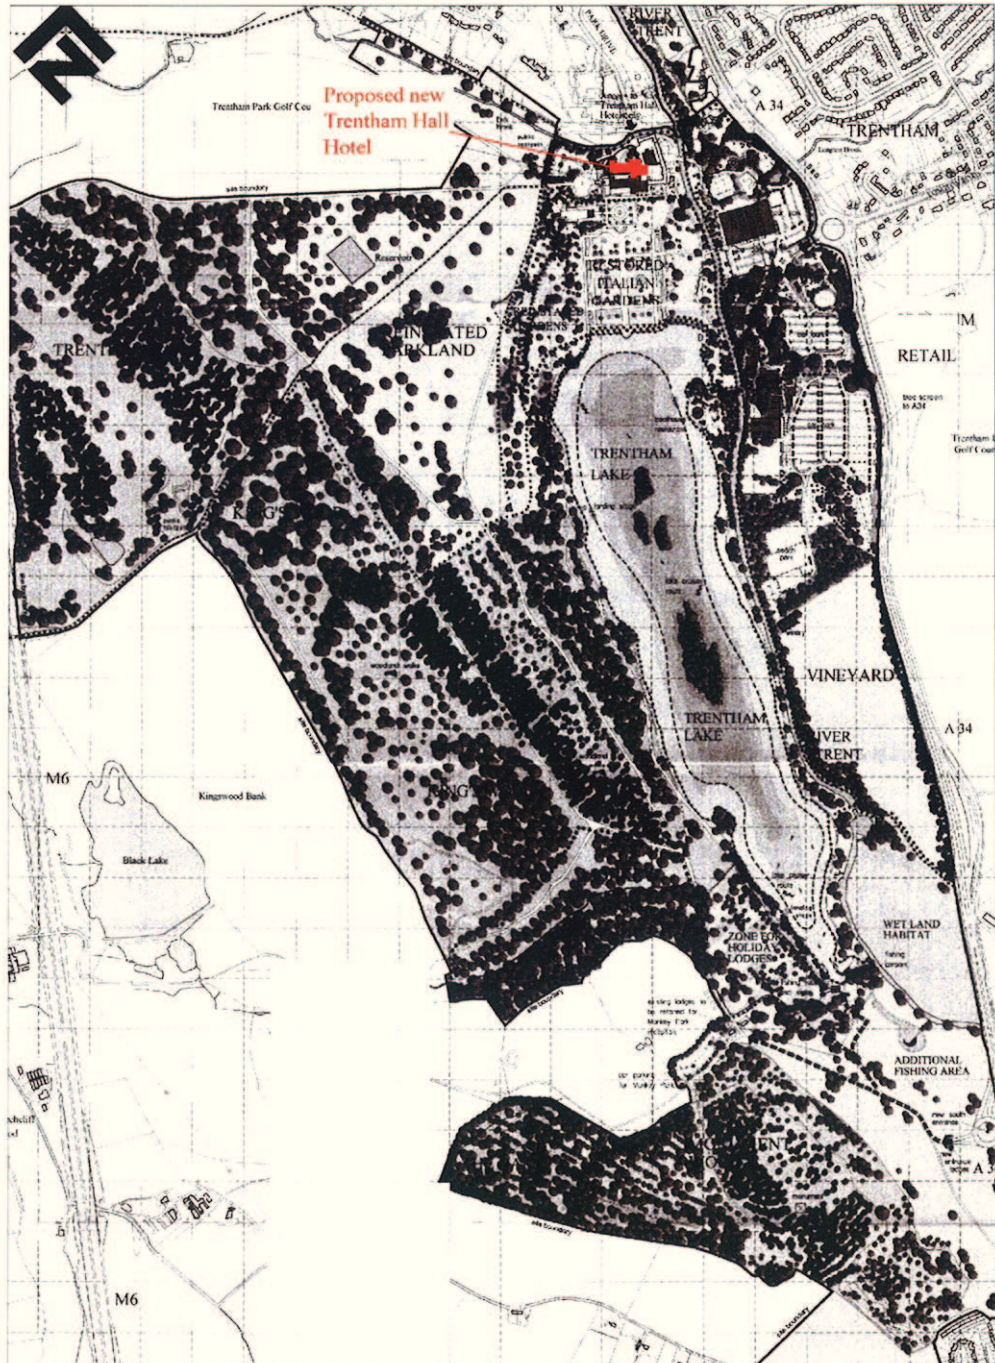
Figure 2: The Trentham Gardens Estate showing proposals for renovation and rebuilding

- 1.4.1 The brief required evaluation of a number of different proposed developments around the Park: the new pool complex in the courtyard adjacent to the Orangery; the new fishing lake at the south end of Trentham Lake; the restoration of the Italian Gardens to the south of the Hall; and the new Hotel, to be built on the site of the former Hall. The assessment of the Hotel area is to be undertaken in seven stages. This report contains the results of Stage 1.

- 1.4.2 Stage 1 involved assessing the extent of infilling, state of preservation and nature of the ceilings and walls of the ground floor/basement, by gaining access through a number of blocked doorways at the eastern and western ends of the range. The ground floor/basement lies to the south of the church, between the entrance corridors at the west and the Orangery at the east (Figs 3 and 4), and is currently covered by a lawn, with paths and flower beds.

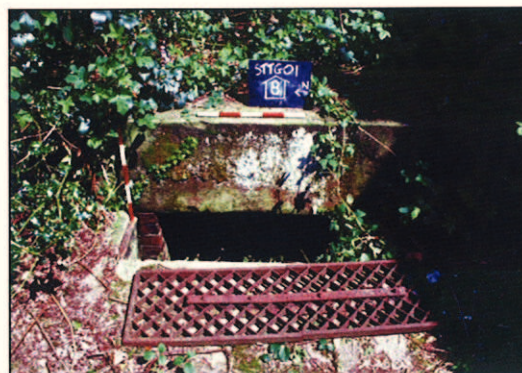
3.2.1 The existence of passages at the western end of the ground floor/basement range had already been highlighted by members of the Trentham Gardens staff, who had in the past explored the area. It was initially intended that access was to be gained through a blocked entrance adjacent to the Parish Hall (Fig. 4), but on further inspection a grill (Plate 1) was found just to the north of the entrance corridors, which provided easier access, and removed the need to destroy the blocking.

Plate 1: Access to Site A; possible light well / shute

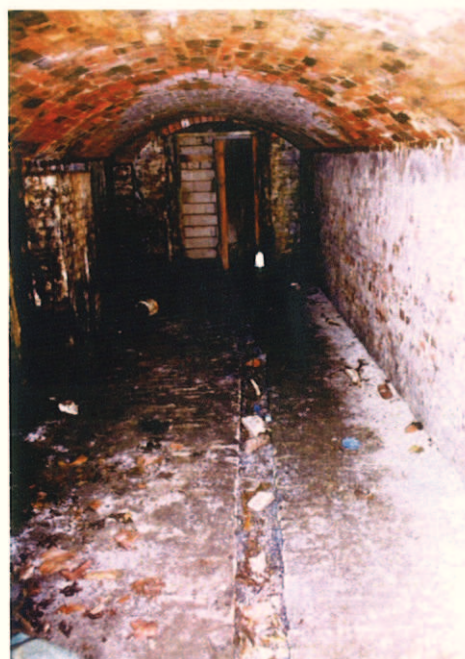
3.2.3 Plate 2 shows the internal face of the entrance initially proposed for access. Within the vault patches of lighter orange brickwork are visible, including an arch over a breeze block wall. The lighter orange brickwork represents fairly modern repair, and it is therefore clear that the passage was in use until quite recently. The passage at this point is 2.4 m wide and 2.02 m high.

Plate 2: Northern limit of main passage, with blocked doorway

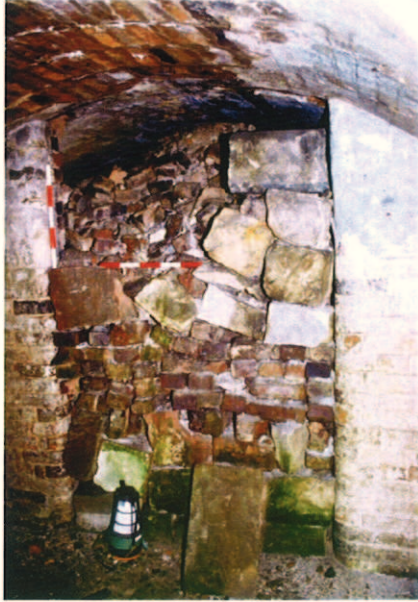
3.2.4 Further to the south, there are three passages which branch off at right angles to the main passage, one running eastwards and an opposed pair, forming a slightly staggered crossing point. The northernmost passage (Plate 3), opposite the grill entrance, is blocked to three quarters of its height by roughly dressed stone blocks and bricks forming a wall; they are obviously reused, probably from elsewhere on the site.

3.2.5 Similar blocking was seen at the entrances to the other side passages. Behind the blocking the passage is almost entirely filled with rubble, with the vaulted brick ceiling being visible for some two metres. At the furthest visible extent of the

vaulting, the roof appears to have collapsed, though the extent of this collapse is not clear.

Plate 3: Northernmost side passage

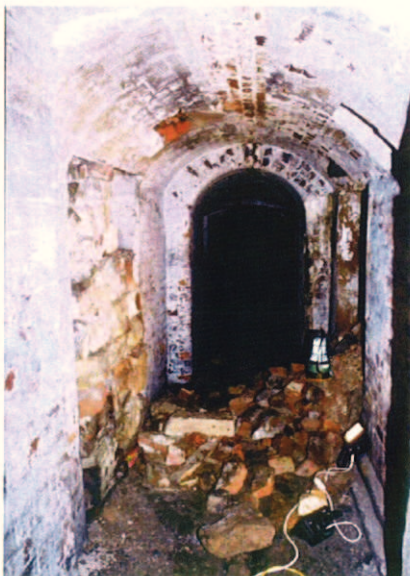
- 3.2.7 Further south the passage narrows to 1.5 m, but is still 2.2 m high. The high quality brickwork in the passages is still in very good condition (Plate 5).
- 3.2.8 Further south again are the pair of side passages already mentioned (Plate 5). The western passage (Plate 6) has only a small section of dry stone retaining wall intact, and the rubble infill has spilled out into the main passage. The lack of an intact retaining wall and the disturbed infill is almost certainly due to recent excavations by the staff of Trentham Gardens, who remember digging material out some time ago, but giving up after only a short distance. The vaulted ceiling of the passage is intact as far back as is visible, and it can be seen that the passage curves to the south.

Plate 5: The pair of side passages

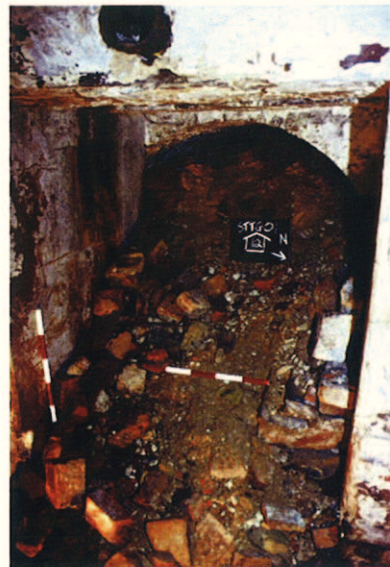
Plate 6: The western side passage

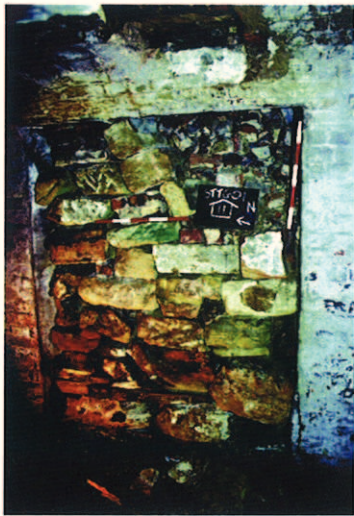
- 3.2.9 Plate 7 shows the entrance to the opposed side passage, which is almost fully blocked by its dry stone retaining wall, but forms an opening off the main passage with similar dimensions to the one it opposes.
- 3.2.10 To the south of the opposed side passages, the main passage continues for approximately 10 metres, at the same width and height (Plate 8), until blocked by a large pile of earth. External inspection, in the garden within the Western Entrance Corridors revealed an access point for a large and deep drain which has cut into the passage. The concrete rings for the access hole are just visible at the top of the pile of earth in the passage. The line of this drain was traced in the lawn and is shown on Figure 4.

Plate 7: The eastern side passage

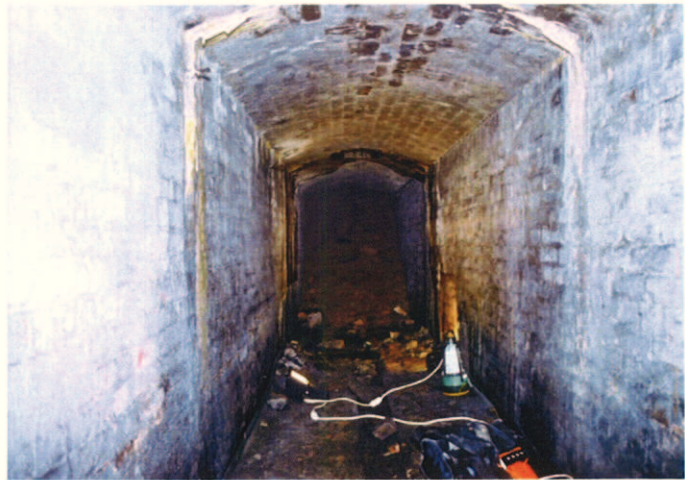
Plate 8: The southern limit of the main passage, with pile of earth

- 3.2.11 Having talked to Rob Bailey, a member of the staff at Trentham Gardens for many years, it has become clear that the passages stretched for some way beyond the point now blocked by the drain. Mr Bailey remembers the passages opening out into a kitchen with ranges still intact, and a chimney running up one of the corner pillars in the entrance corridors (note the room underneath the corridors on Fig. 3). It was not possible to confirm the presence of the chimney without access to the roof.
- 3.2.12 Plates 2, 3, 5 and 8 all show a small gully in the floor of the main passage, probably designed for drainage.

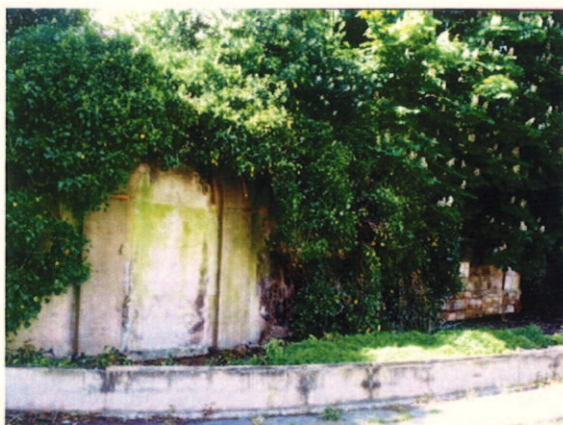
- 3.3.1 Within the wall which forms the eastern end of the ground floor/basement range, there is a group of three large arches. During investigations it was discovered that all three had been blocked (Plates 9 and 10). Having removed covering vegetation, the arches were investigated further and it was found that the top of the arch was visible from the lawn, on the opposite side of the wall; note the limit of the algae on the blocking in Plate 10, indicating the ground level on the reverse side of the wall. The height of the arch may suggest that it formed the entrance to an open area within the ground floor/basement.

Plate 9: Arch in eastern retaining wall

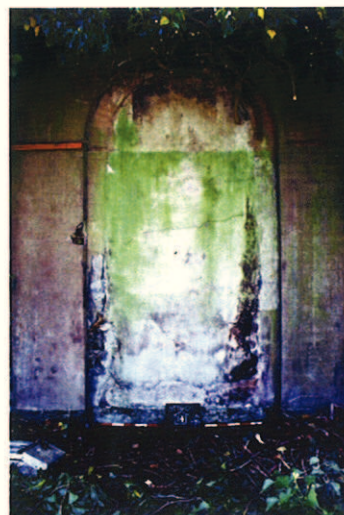
Plate 10: Close up of arch showing

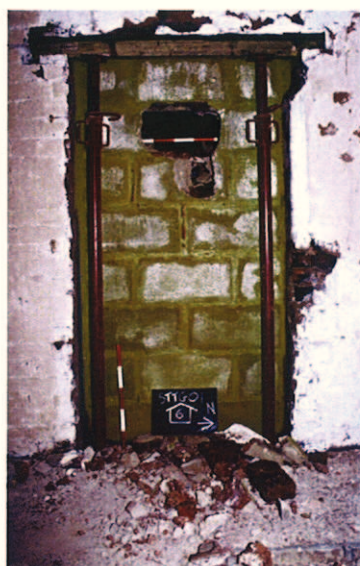
- 3.3.2 The next group of access points are located at the western end of the Orangery. At ground level a corridor runs east to west along the Orangery, and turns southward at its western end, leading to two blocked entrances: a small one to the west (Plate 11), and the continuation of the corridor to the south (Plate 12). Both of these are blocked using breeze block and they appear to be of similar date and construction.

Plate 11: Smaller blocked entrance at west end of Orangery

- 3.3.3 During investigations, holes were punched through both breeze block walls and rubble was encountered immediately beyond them. The smaller doorway has no lintel, and the wall (500 mm thick at this point) was only supported by loose rubble - hence the props visible in Plate 11.
- 3.3.4 The character of the vault beyond the larger entrance (Plate 12) was investigated by means of a very limited hand excavation of the gravel surface at ground level adjacent to the south-western end of the Orangery. This revealed that the vault was absent, and presumably had collapsed or been removed for a distance of 2 m south of the building (Rob Bailey remembers a collapse in this area some time ago). The ground floor/basement was filled with rubble.

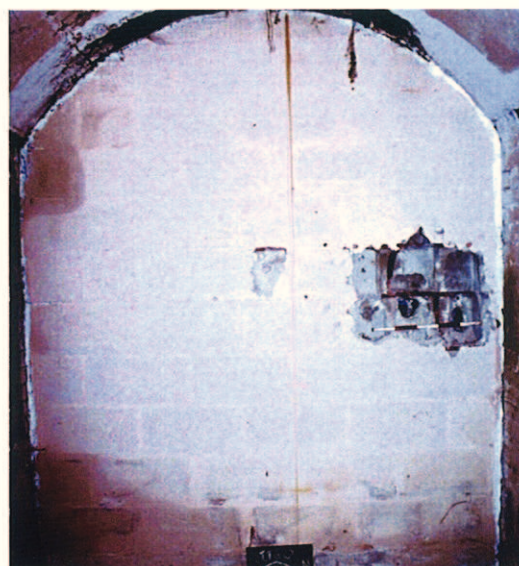
Plate 12: Blocked corridor at west end of Orangery

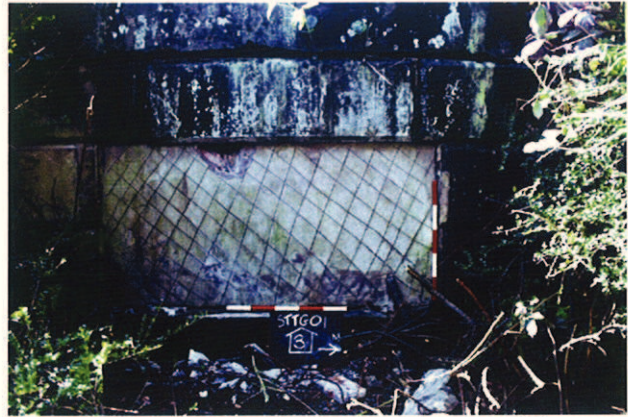
- 3.3.5 To the immediate south-east of this area of collapse, within the retaining wall forming the western limit of the ground floor/basement, there is a blocked window or access point similar to that shown in Plate 1 (Plate 13). This was cleared of vegetation and a small hole created in the blocking. Since the vault to which it probably gave access had collapsed, it was no surprise that this also revealed rubble.

Plate 13: Blocked window/light well at SW corner of Orangery

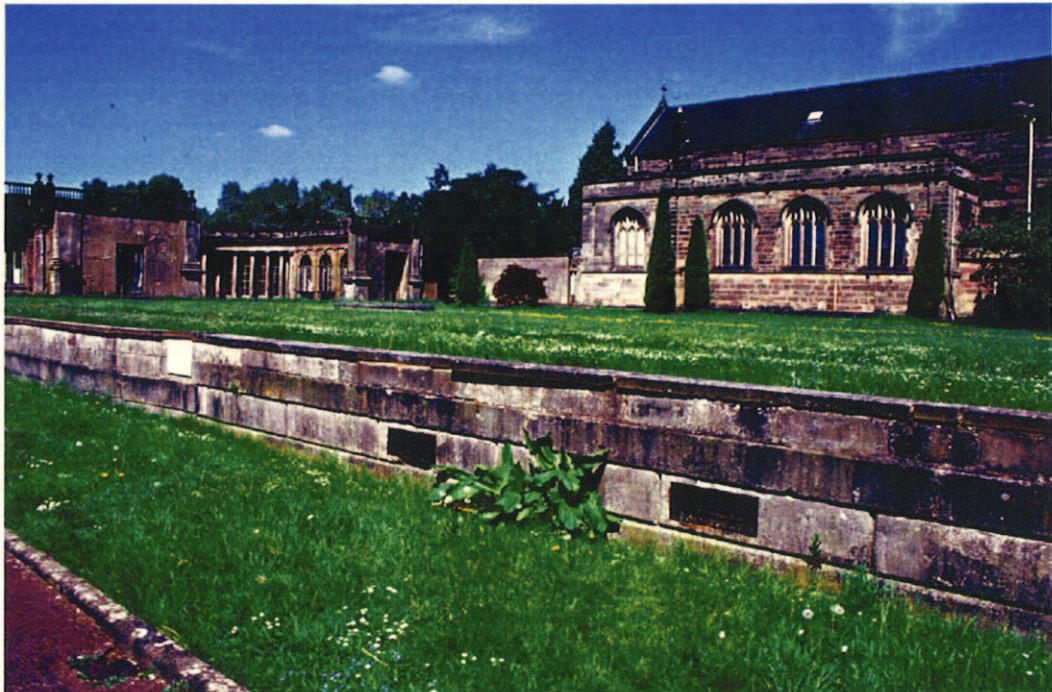
- 3.3.6 At the eastern end of the southern retaining wall a pair of vents were noted (Plate 14). One grill was removed and again rubble was revealed, suggesting that the ground floor/basement extends this far south at its eastern end, as suggested by Barry's plan of 1834 (Fig. 3).

Plate 14: Vents in retaining wall at southern limit of the ground floor/basement
