Trentham Gardens Trentham Staffordshire: The Italian Gardens

Archaeological Evaluation Report

Document Title: Trentham Gardens, Trentham, Staffordshire: The Italian Gardens

Document Type: Evaluation

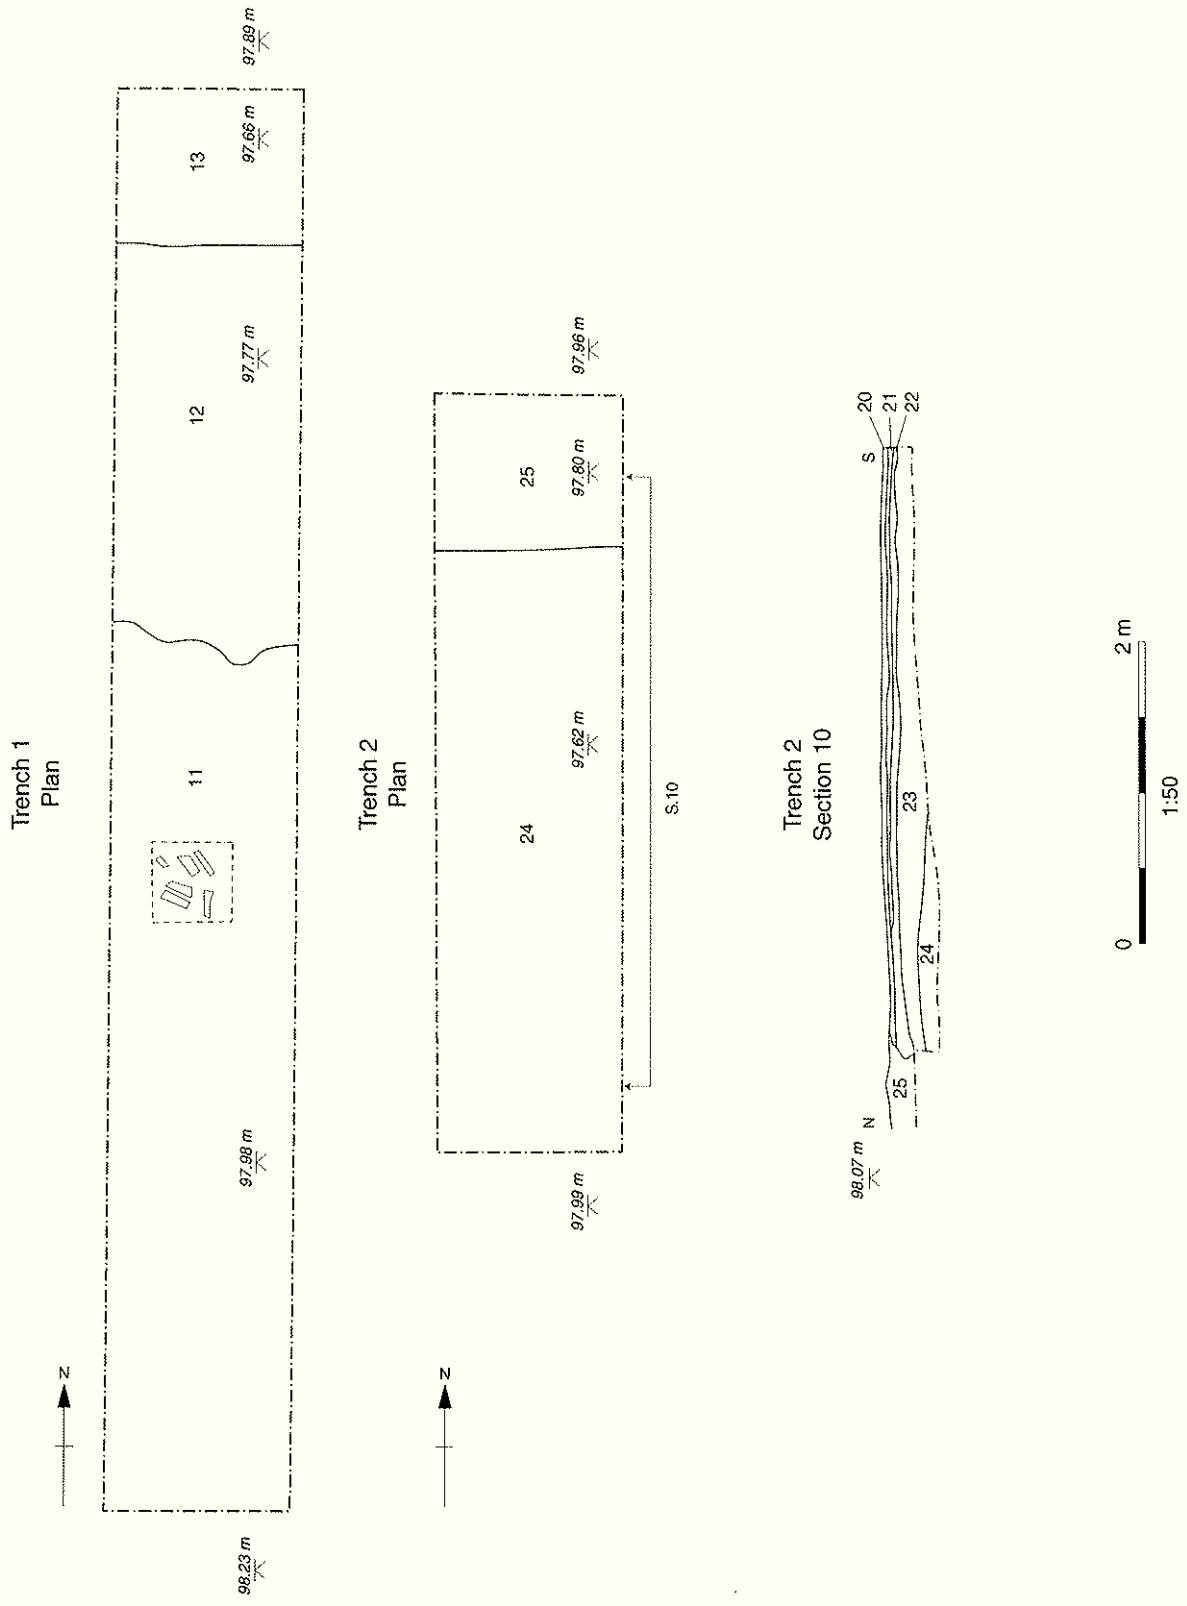
Figure 3: Trenches 1 and 2; plans and sections

- 3.2.3 The trenches varied in dimension, measuring between 5 m to 10 m long by 1.2 m wide, according to the variable width of existing path alignments that measure approximately 4 m, 7 m and 12 m wide. Trench 1 was excavated to examine the broad east to west aligned path situated at the southern end of the Lower Flower Garden, immediately adjacent to the lake (Figs 2 and 3). No natural geology was encountered within the trench as this area of the gardens appears to have been subject to considerable later disturbance. This later disturbance appears to be characterised by the deposition of demolition/building rubble consisting of burnt coal, coke, brick and slag deposits (context 11). This would appear to have severely truncated and removed any evidence of the former path surface, although some loose gravel deposits were recorded at the northern end of the trench (context 12), the nature and origin of which remains uncertain. Deposit 11 recorded throughout much of the trench is thought to have been deliberately dumped in order to raise ground level. It

- 3.2.4 Trenches 2 and 6 were excavated across the width of the more southerly of two internal east to west aligned paths within the Lower Flower Garden (Figs 2, 3 and 5). Natural geology was not revealed within either of the excavated trenches. The primary deposits recorded in both trenches comprised a coarse sandy gravel (contexts 24 and 64) that is thought to represent part of a sequence of deposits used in the construction of the original path. Deposits 24 and 64 were overlain by further gravel deposits 23 and 63. Deposit 23 comprised a coarse sandy gravel that was recorded to survive in depth to 0.20 m and is again thought to represent part of construction deposits associated with the original former path. Deposit 63, however, comprised a heavily compacted sandy gravel surviving in depth to 0.08 m that is interpreted as representing part of the surviving surface of the former path. Both these deposits were overlain by dark brown gravel deposits (contexts 21, 22 and 62) that form part of the construction sequence for the existing tarmac path surfacing laid above (contexts 20 and 60). Garden soil deposits 25 and 61 were shown to have been deposited against the later tarmac path surfacing and where visible (Trench 6) to overlie the earlier former path surface.

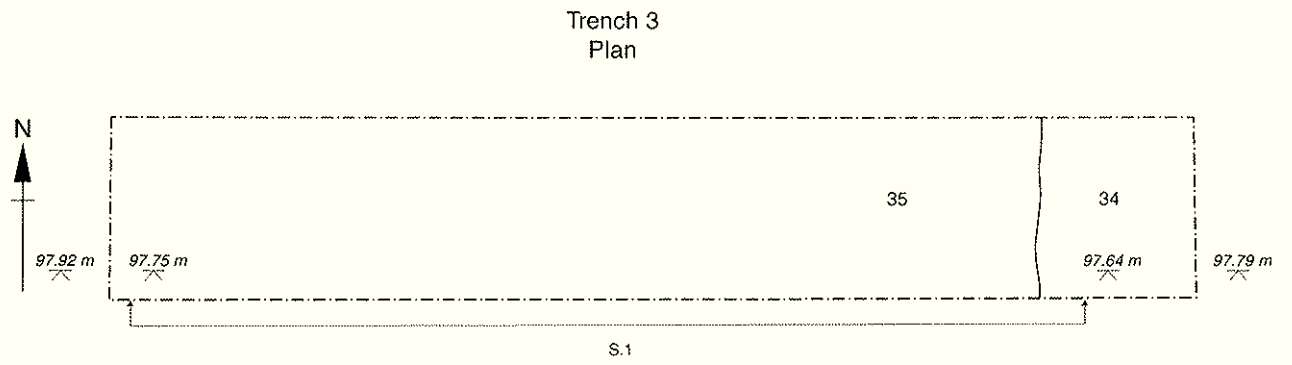
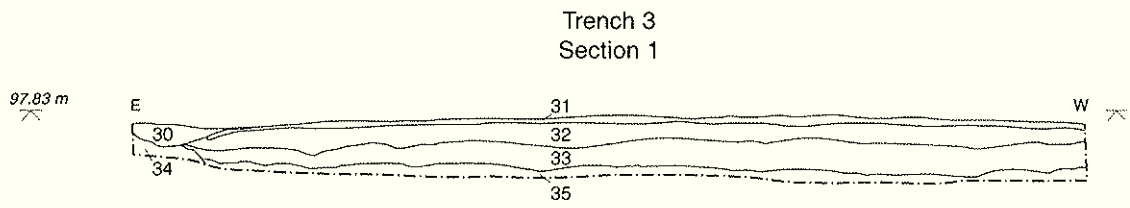
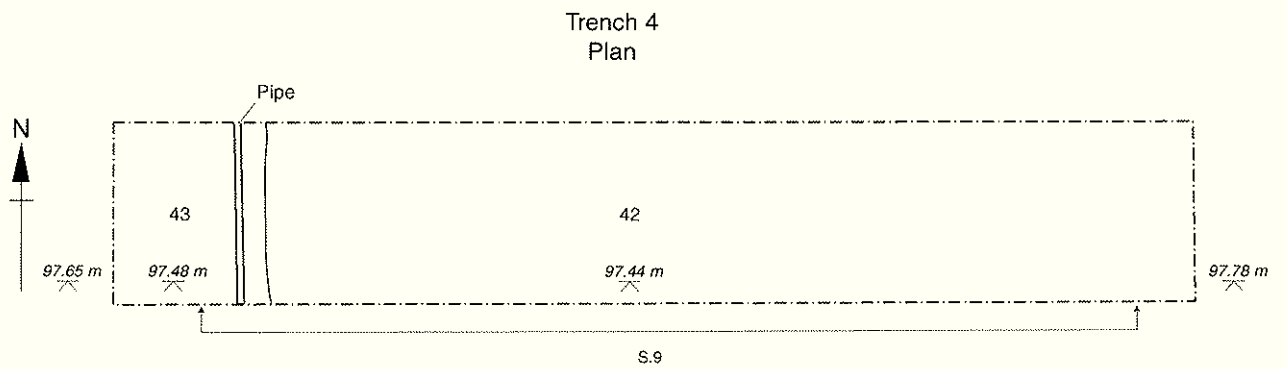
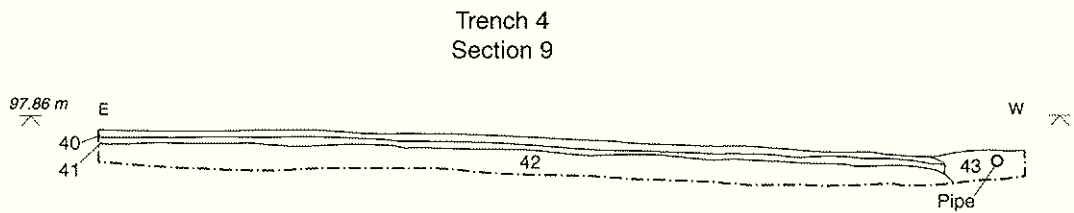
Figure 4: Trenches 3 and 4; plans and sections

- 3.2.5 Trenches 3 and 4 were excavated across the wide north to south aligned path that runs centrally through the Lower Flower Garden (Figs 2 and 4). Natural geology was not revealed within either of the excavated trenches. The primary deposit recorded comprised a buried garden soil (Trench 3; context 34) that was shown in section at the eastern extent of Trench 3 to be overlain/cut by construction deposits (context 35) representing the remains of the former path. Recorded construction deposits for the path varied in nature between excavated trenches. Trench 3 revealed a deposit of loose brown gravel clay (context 35) that was overlain by a 0.10 m deep deposit of compacted sandy gravel (context 33) that is thought to represent part of the former original path surface. Trench 4, however, revealed only the remains of a loose coarse sandy gravel (context 42), thought to represent part of a construction deposit for the path. Both deposits 33 and 42 were overlain by further gravel deposits (contexts 32 and 41) that form part of the construction sequence for the existing tarmac path surfacing laid above (contexts 31 and 40). The tarmac path was shown to be overlain by garden soil deposits along both its eastern and western verges (contexts 30 and 43), within which a north to south aligned iron water pipe was recorded in Trench 4.

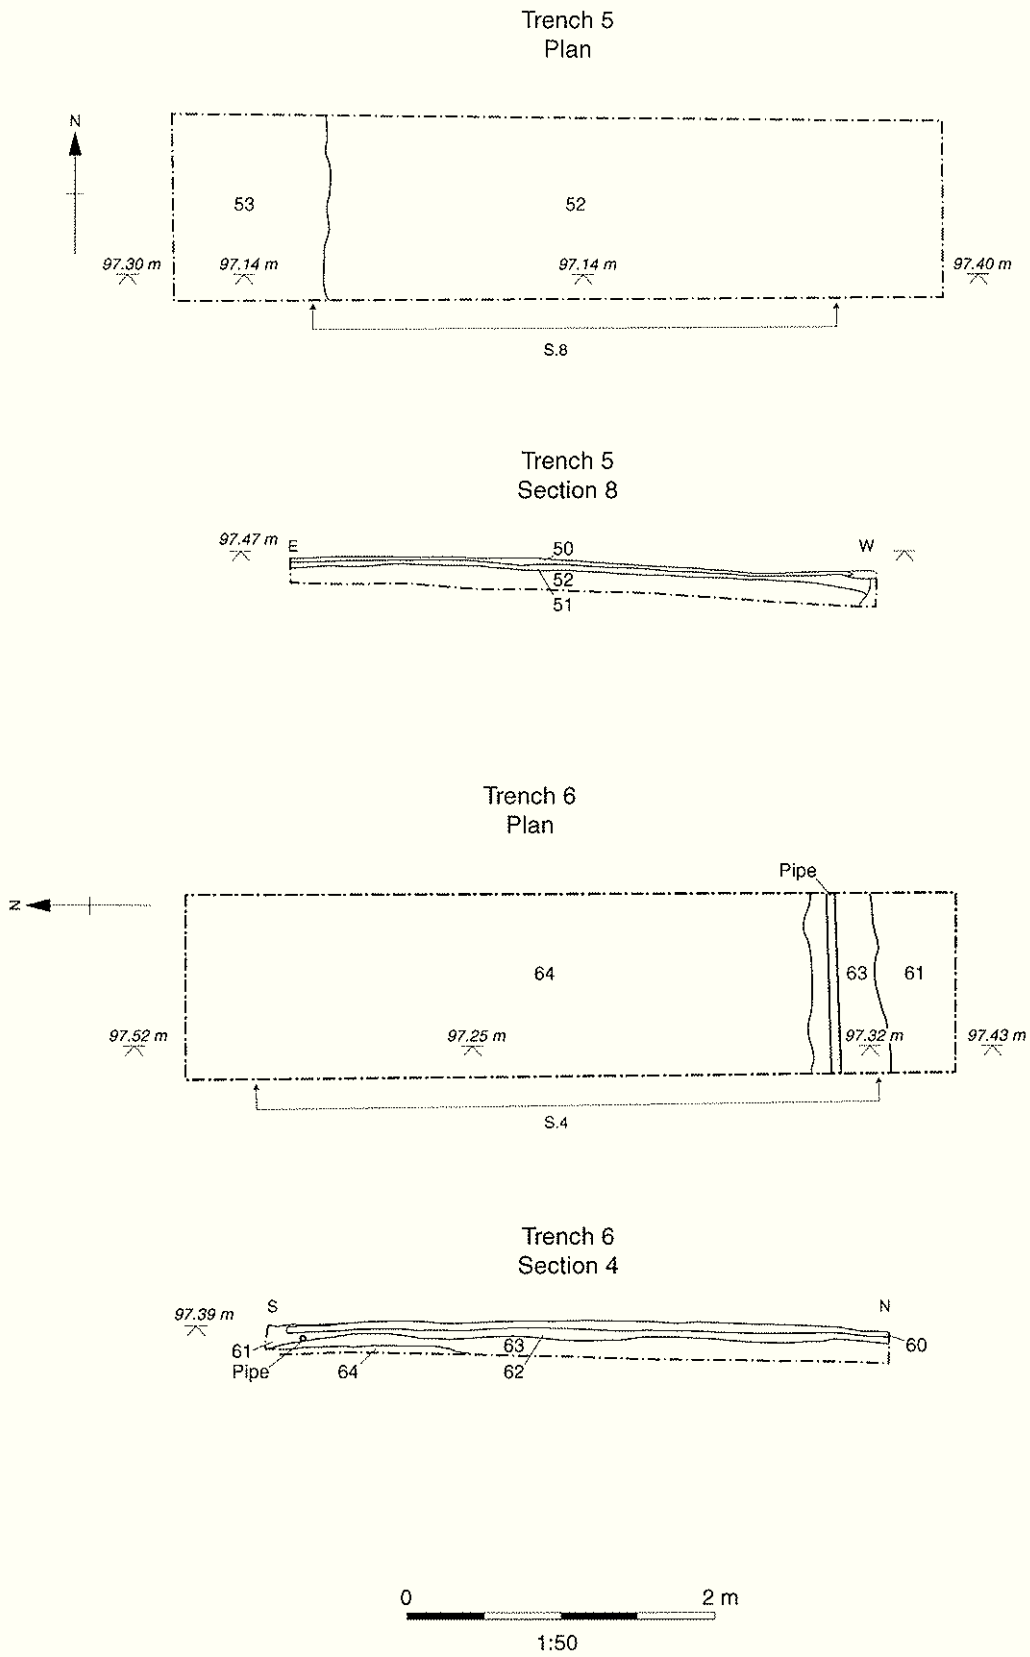
Figure 5: Trenches 5 and 6; plans and sections

- 3.2.6 Trenches 5 and 7 were excavated across the most easterly of two north to south aligned paths within the Lower Flower Garden (Figs 2, 5 and 6). Natural geology, comprising dark brown clay (context 73) was recorded at the base of Trench 7. In Trench 7 the natural clay (73) and buried soil (77) were shown to have been truncated by the construction cut (78) for the path. Cut 78 was primarily filled with a loose sandy gravel (context 72), a similar construction deposit (context 52) being

recorded in Trench 5, that was in turn overlaid by 0.04 m thick deposit of compacted gravel (context 71), believed to represent part of the original path surface. Deposits 52 and 71 were overlain by gravel construction deposits (context 51) for the existing tarmacadam path surfacing laid above (Contexts 50 and 70). The tarmacadam path surface was shown to be overlain by a series of later disturbance deposits recorded along its eastern verge in Trench 7. These comprise a sequence of thin layered deposits consisting of a 0.07 m deep layer of dumped ash (context 76) overlain by a 0.04 m deep layer of dumped coal (context 75), from which pottery and glass was recovered, that in turn was sealed by a 0.16 m depth of topsoil (context 74).

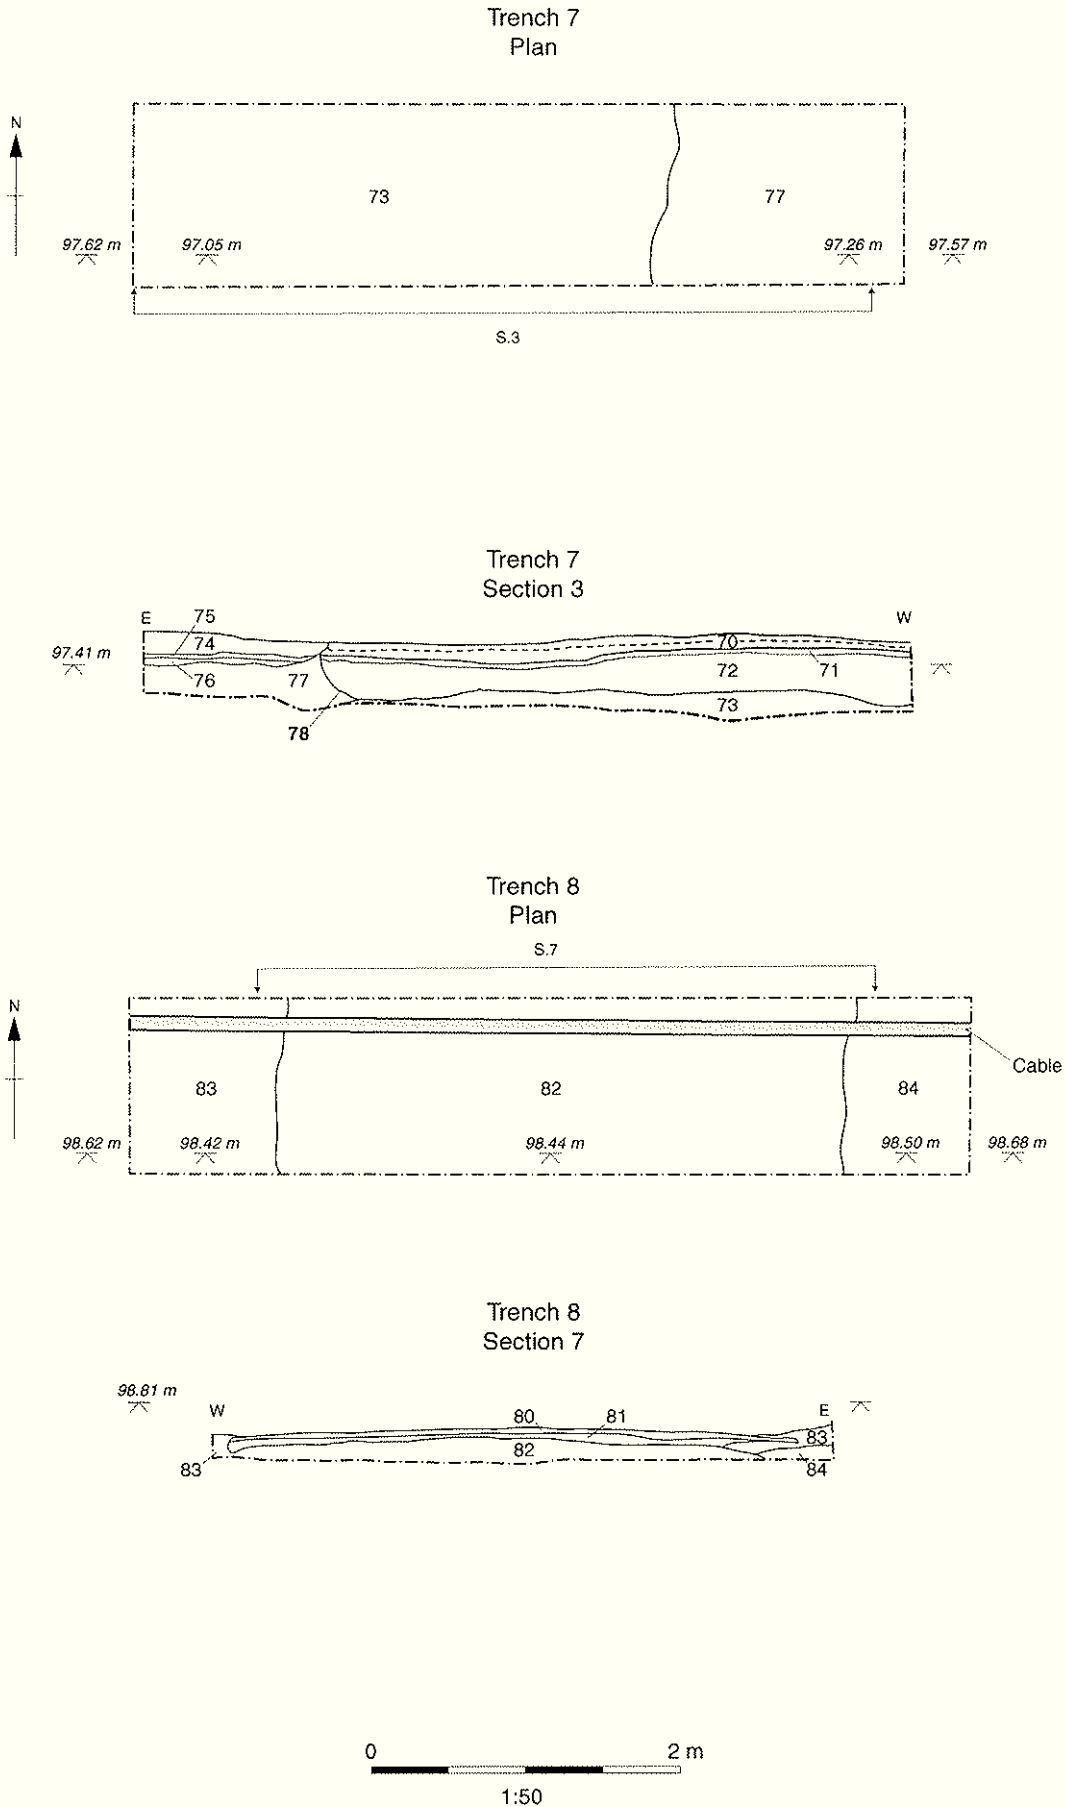
Figure 6: Trenches 7 and 8; plans and sections

- 3.2.7 Trench 8 was excavated across the full width of the north to south aligned path located at the eastern extent of the Lower Flower Garden and which formed part of the former Trellis Walk (Figs 2 and 6). Natural geology was not revealed within the excavated trench. The primary recorded deposit comprises a 3.60 m wide loose coarse sandy gravel (context 82) thought to represent the remains of construction deposits for the original path. The construction deposit 82 was overlain by a buried soil horizon (context 84) along its eastern verge, possibly representing the original former ground surface adjacent to the path. Buried soil horizon 84 was overlain by garden soil 83 which in turn was overlain by a dark gravel deposit (context 81) believed to represent a construction deposit for the existing tarmacadam path surfacing laid above (context 80). Exposed immediately beneath the tarmacadam surfacing was an east to west aligned service.

- 4.2.3 The recorded path deposits within Trench 7 perhaps provide the best illustration of the manner of the former paths' construction. The exposed northern section of the path is shown to have been constructed within a shallow cut that was initially filled with a 0.24 m thick coarse sandy gravel deposit, over which was laid a 0.04 m thick light red coloured compacted sandy gravel deposit, representing the surviving surface deposit of the former path. The path was also shown to have a distinct camber that would have served to aid the drainage of surface water away from it. The lack of any recorded associated drainage features is discussed in greater detail below. Similar primary coarse sandy gravel path construction deposits were recorded across all the trenches excavated (a possible exception being the sequence recorded in Trench 1), with a marked distinction being noticeable in the heavily compacted and red/brown colouration of the surviving gravel surface deposits of the former paths observed in Trenches 3, 6 and 7. The use of a reddish gravel deposit to define the surface of the former gravel paths may have influenced the later resurfacing of the paths using a red coloured tarmacadam, perhaps chosen in an attempt to preserve the character of the garden design as originally conceived.

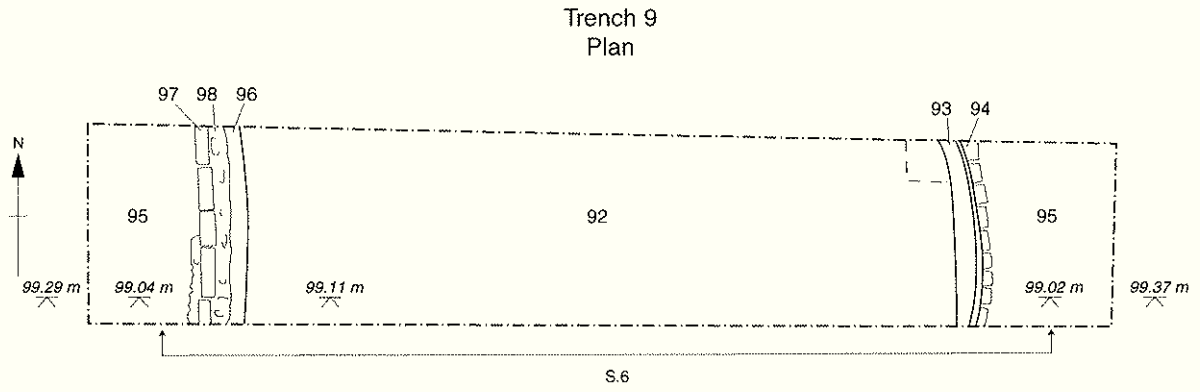
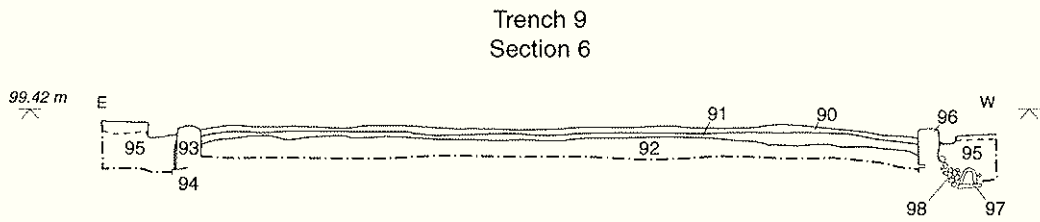
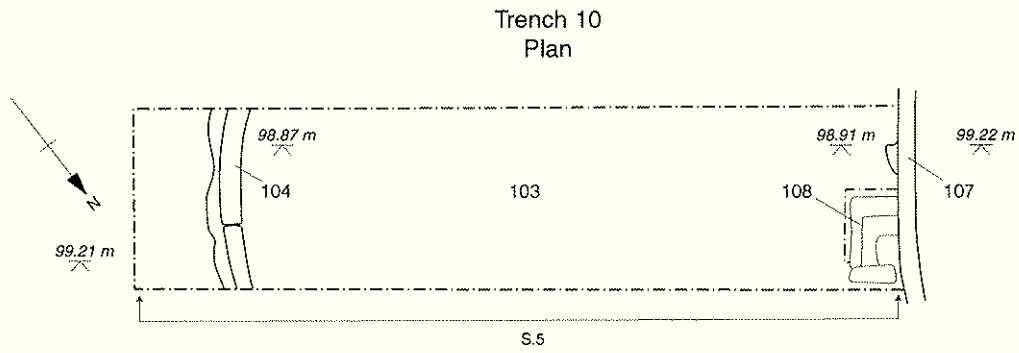
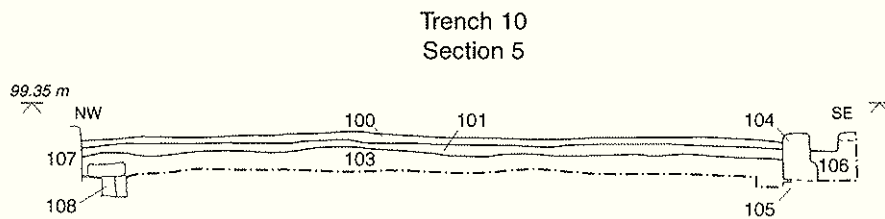
Figure 7: Trenches 9 and 10; plans and sections

- 3.2.9 Trench 9 was excavated across the full width of the north to south aligned path of the Upper Flower Garden which measures approximately 4.7 m wide (Figs 2 and 7). Excavation of the trench was undertaken between and either side of the two existing east and west kerbstones (contexts 93 and 96) of the path. The deposit sequence defined within the kerbstones comprised a primary deposit of loose coarse sandy gravel (context 92) believed to form part of the construction deposit of the original path. Deposit 92 was overlain by a 0.07 m thick deposit of darker gravel representing a construction deposit for the existing 0.04 m thick tarmacadam path surfacing laid above (context 90). Excavation to the west and east of the kerbstones revealed that the eastern kerbstone was set within the garden soil (context 95) placed on a blue brick foundation (context 94). A similar construction sequence was observed for the western kerbstone, however, a tile constructed French drain was recorded adjacent to the foundations of the kerb (context 97), sealed by a packing deposit (context 98) comprising sandstone and brick fragments with gravel, overlain by garden soil (context 95).

3.2.10 Trench 10 was excavated across the full width of the central circular path surrounding the former fountain within the Upper Flower Garden, that measures approximately 4.7 m wide (Figs 2 and 7). Excavation of the trench was again conducted between existing kerbstones (contexts 104 and 107) of the path and continued within the garden soils immediately to the south of the south-eastern kerbstone. The deposit sequence defined within the kerbstones comprised a primary drain structure 108, constructed from sand mortared brick, likely to have been contemporary with the construction of the kerb, that was abutted by a deposit of loose coarse sandy gravel (context 103), similar in composition to deposit 92 recorded in Trench 9, that is thought to represent part of a construction deposit of the original path. Deposit 103 was overlain by a 0.07 m thick deposit of dark gravel (context 101) believed to represent a construction deposit for the existing 0.05 m thick tarmac path surfacing laid above (context 100). Excavation to the south of the south eastern kerbstone revealed that the kerb had been set within the garden soil (context 106) on a brick foundation (context 105) similar in construction to the kerb foundations recorded in Trench 9. The drainage run located within the trench is likely to relate to a system of drains along the path indicated by the presence of a series of metal gridded drain covers situated along its western edge.

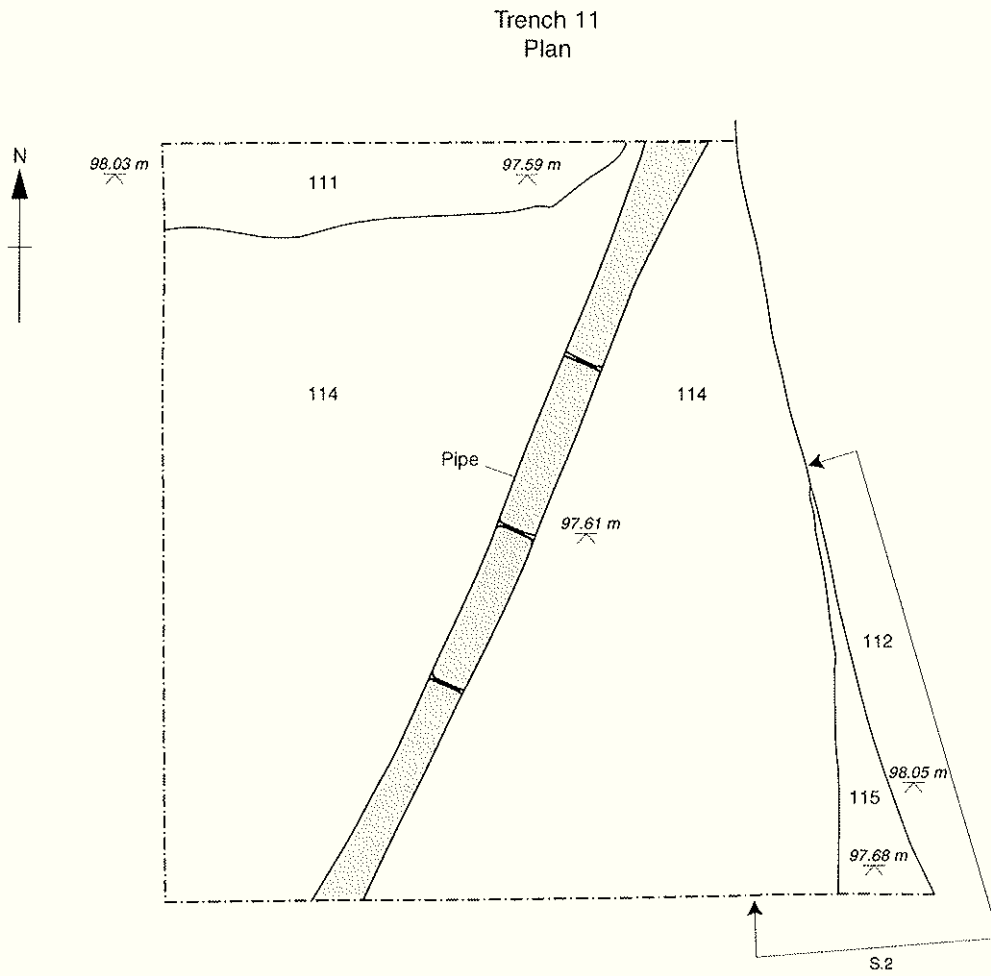
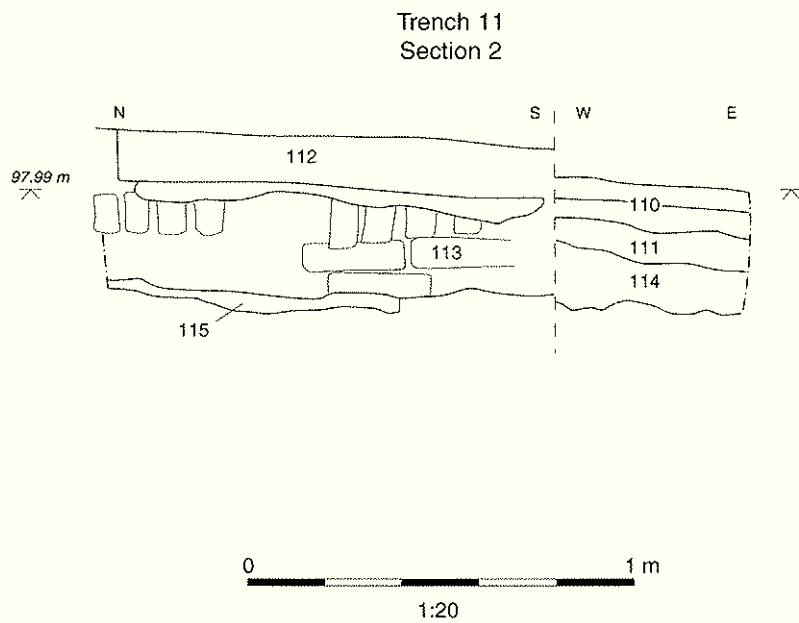
Figure 8: Trench 11; plan and section

3.2.12 A single trench (Trench 11) was excavated adjacent to the central semi-circular steps connecting the Upper and Lower Flower Gardens (Figs 2 and 8). The trench was excavated with the aim of establishing the precise dimensions, character, construction and state of preservation of former steps as originally constructed in the nineteenth century, since the later use of tarmac across the site was thought to have potentially altered or obscured former evidence of the original steps.

3.2.13 Trench 11 was situated immediately adjacent to the western side of the existing lowest step of the flight of semi-circular steps leading from the Lower Flower Garden to the Upper Flower Garden (Fig. 2). The final excavated trench measured approximately 2 m by 2 m (Fig. 8). The primary recorded deposits comprised of a compacted pebble and limestone mortared platform (context 115) that was constructed as a foundation platform for a three course sand mortared brick wall (context 113) that served as a footing for the basal step of the semi-circular flight of steps (context 112). Foundation 115 had no apparent construction cut suggesting that the ground surface around the steps had been open whilst the steps were constructed.

3.2.14 Abutting and overlying foundations 113 and 115 were a sequence of deposits representing the construction of the associated path. The primary path construction deposit comprised a coarse sandy gravel (context 114) that was overlain by a 0.07 m thick fine compacted gravel layer (context 111), believed to represent the surviving remains of the original path surface. This former path surface in turn was overlain by

make up deposits and tarmacadam (context 110), the tarmacadam surface being shown to abut the base of the existing steps. Exposed throughout the trench was a modern service that cut through path deposits 111 and 114.

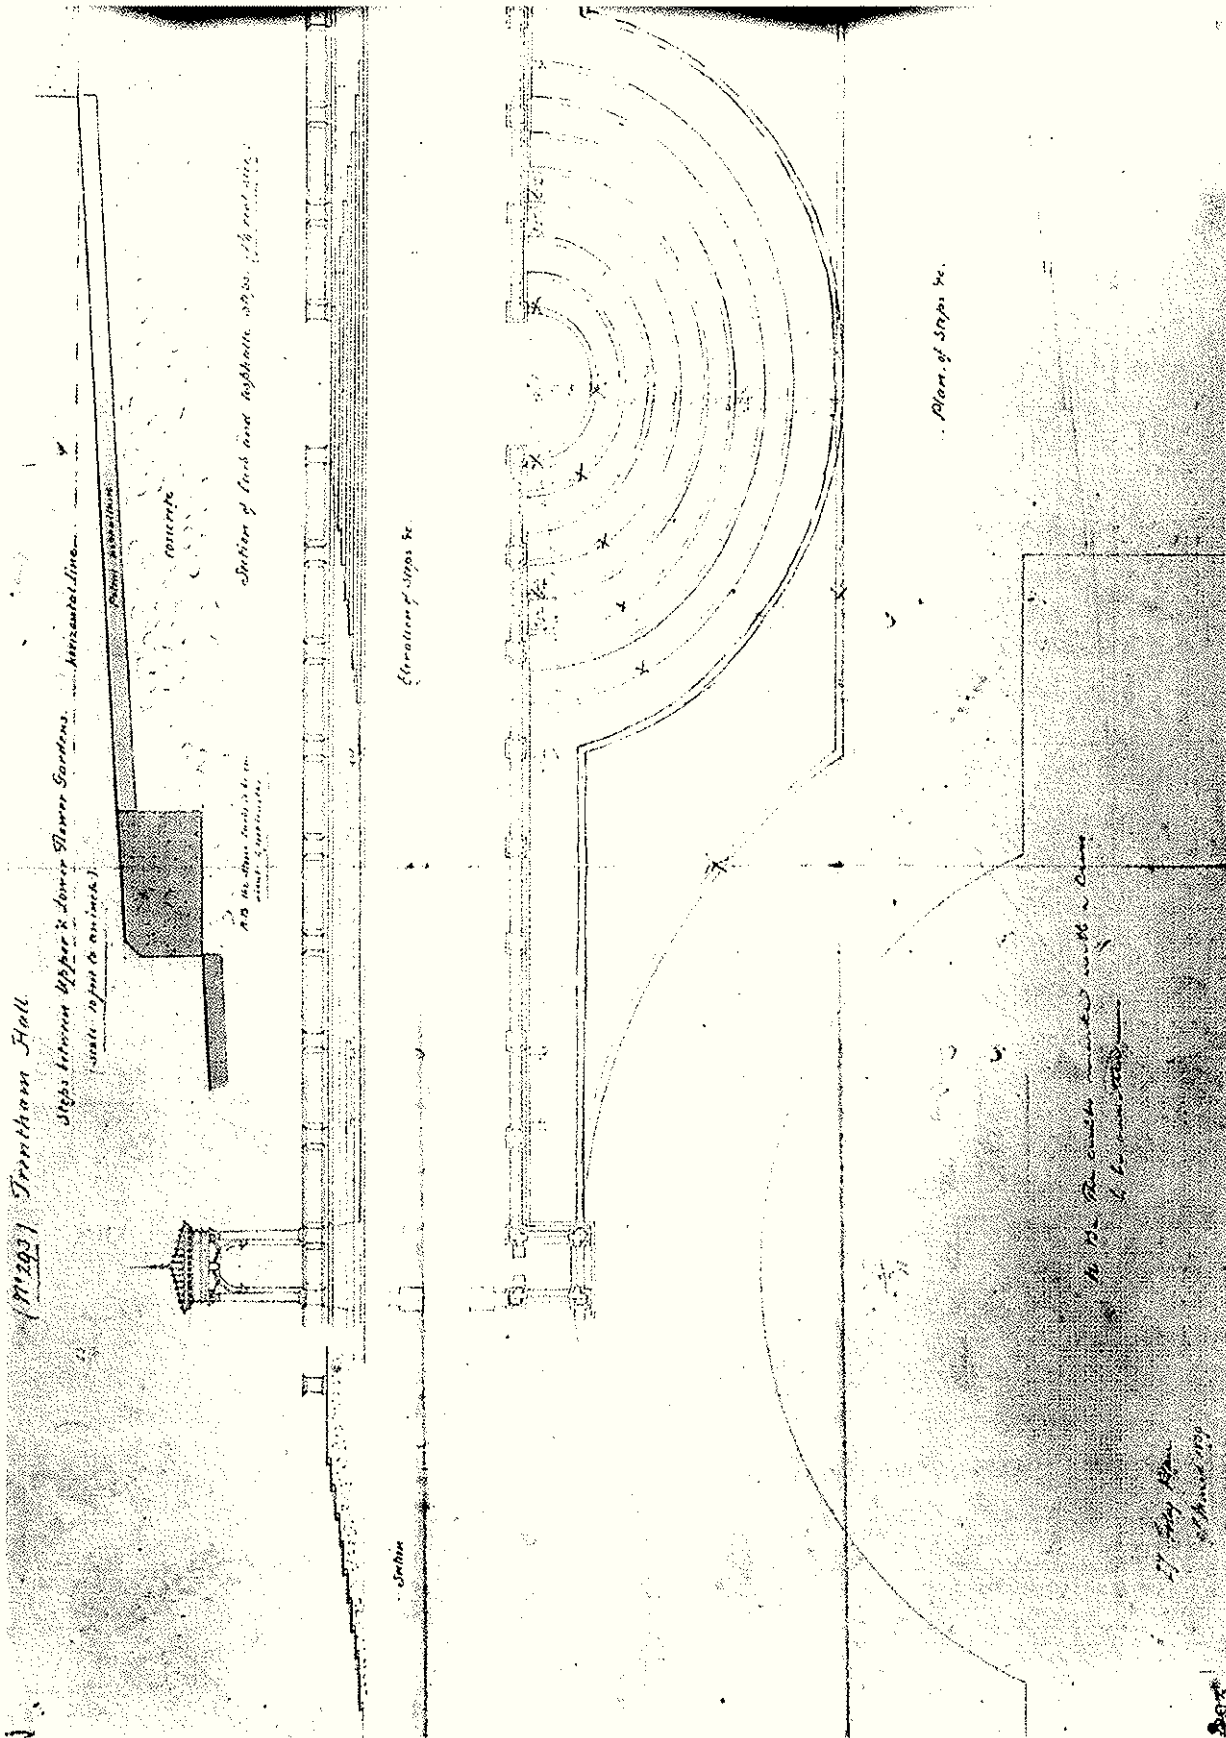
Plate 3: Design for pavilion and steps between upper and lower flower garden. Design by Barry, 1839

- 4.2.8 The existing semi-circular steps providing access from the Upper to the Lower Flower Garden comprises a flight of six steps surfaced by red tarmac. Original plans of the steps, as produced by Barry in 1839 (Plate 3; Blissett 1999b), indicate that the steps were originally designed to comprise a flight of nine steps, possibly suggesting that later 'reworking' may have altered their intended character.

- 4.2.10 The results of the evaluation adjacent to the steps would therefore suggest that Barry's original design for a flight of nine steps may never have actually been executed and perhaps as a later design adaptation or for financial reasons their extent was reduced.
