Trentham Gardens Trentham Staffordshire Works for a new Garden Centre and Italianate Gardens Restoration

Archaeological Watching Brief Report

November 2005

Works for a new Garden Centre and Italianate Gardens Restoration

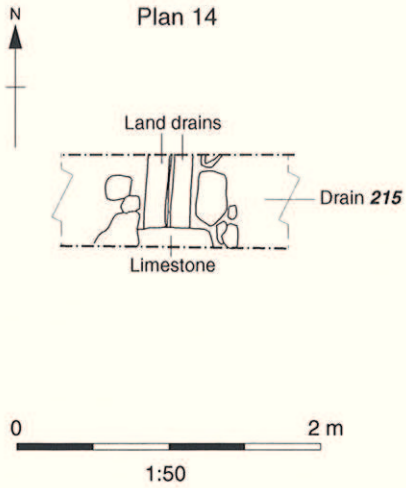
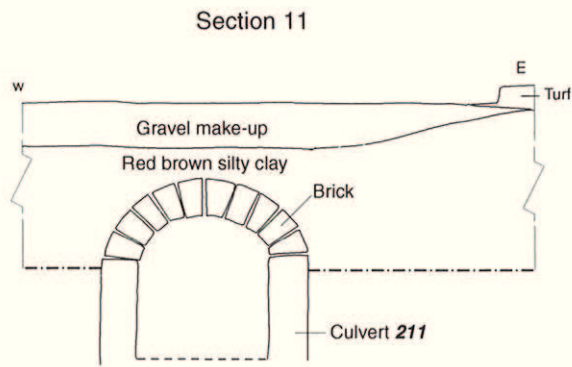
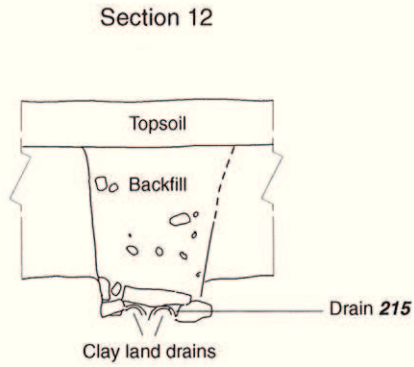
Figure 3: Elevations of drain types in Italianate Gardens

- 3.1.3 To the south in the area of the sunken gardens, a row of north-south aligned culverts was identified in a long east-west service trench. These culverts (ctx's 201-216 inclusive) were brick-built with parallel walls surmounted by brick arched roofs. All the culverts were in various stages of collapse and were partially silted. Culverts 208 and 211 appeared to be the best preserved of these (Plate.1, culvert 208 and Fig. 3,

elevation of culvert 211). Ceramic land drains typical of the type were also drawn (Fig. 3, elevation of drain 215).

- 4.1.1 The new drainage trenches in the Italianate Gardens revealed a complex and dense concentration of drainage structures and it is clear there were at least two phases of drainage installation here. The ceramic inverted 'u'-drains are possibly the oldest in the sequence, replaced later by ceramic pipes. The brick culverts are possibly contemporary with these. There was no precise dating evidence, though the earlier ceramic 'u'-drains may be of 18th century date, replaced in the 19th or 20th centuries with pipes.

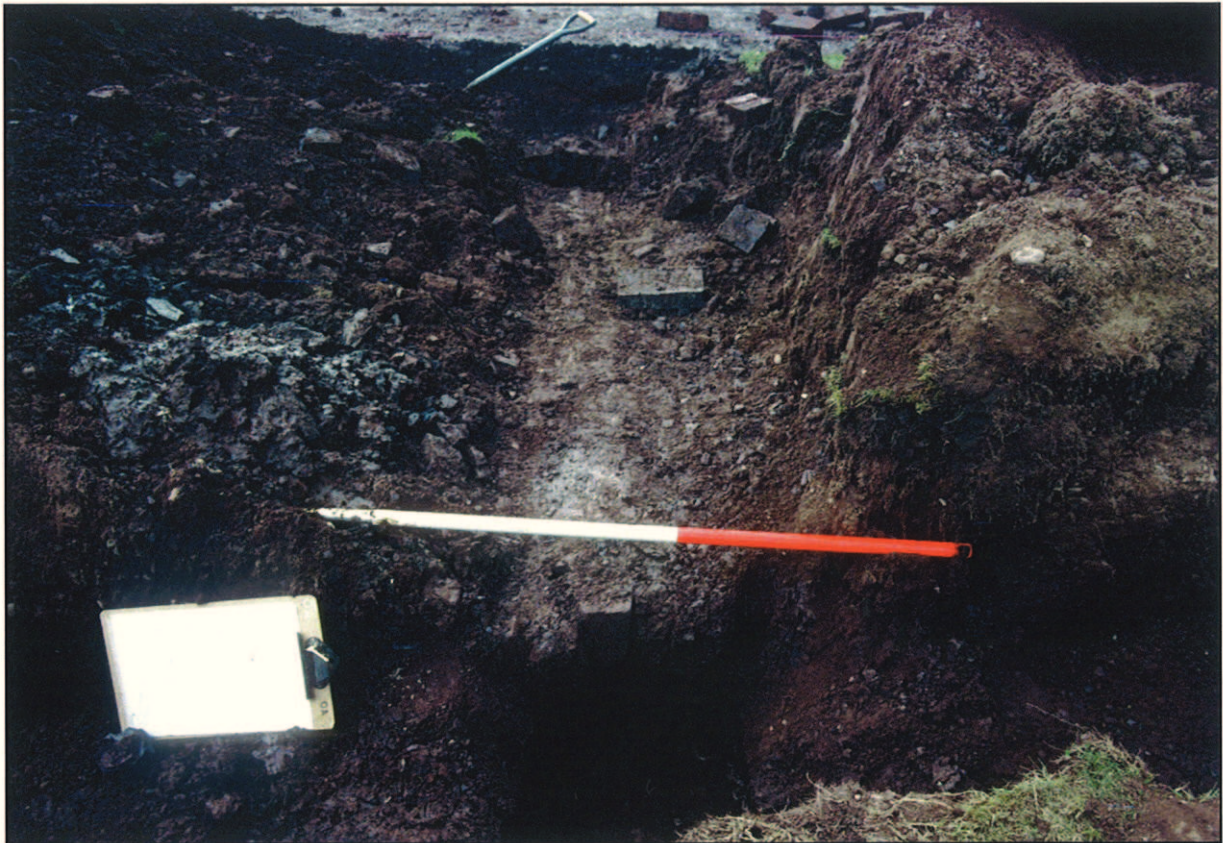
Plate 1: Culvert 208

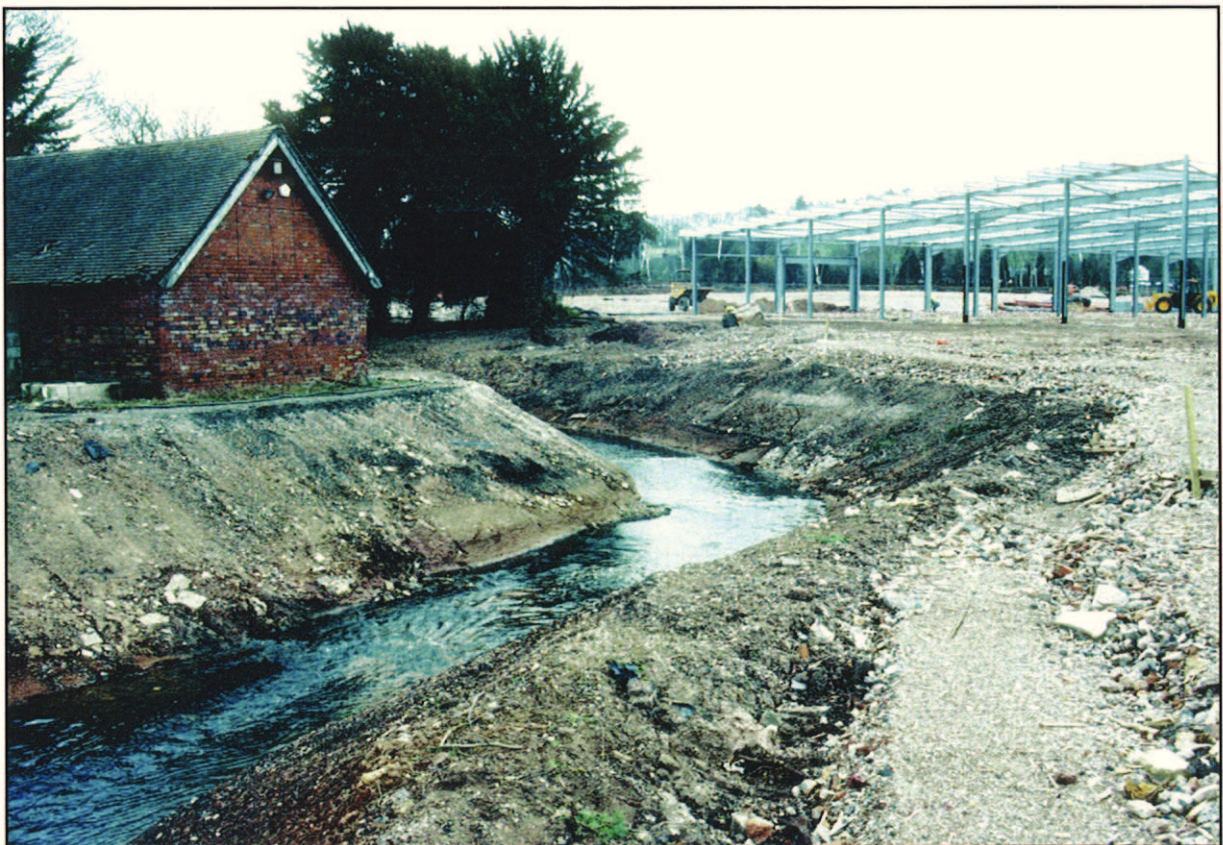
- 3.1.12 The watching brief here observed the construction of a new bridge carried across the diverted Longton Brook, north of the site of the new Garden Centre. The brook was diverted around the covered area set aside for the new garden centre (Plate 2). Two new foundation trenches for the bridge footings were observed (Figs 4 & 5, location and sections).

Plate 2: Longton Brook looking South-East

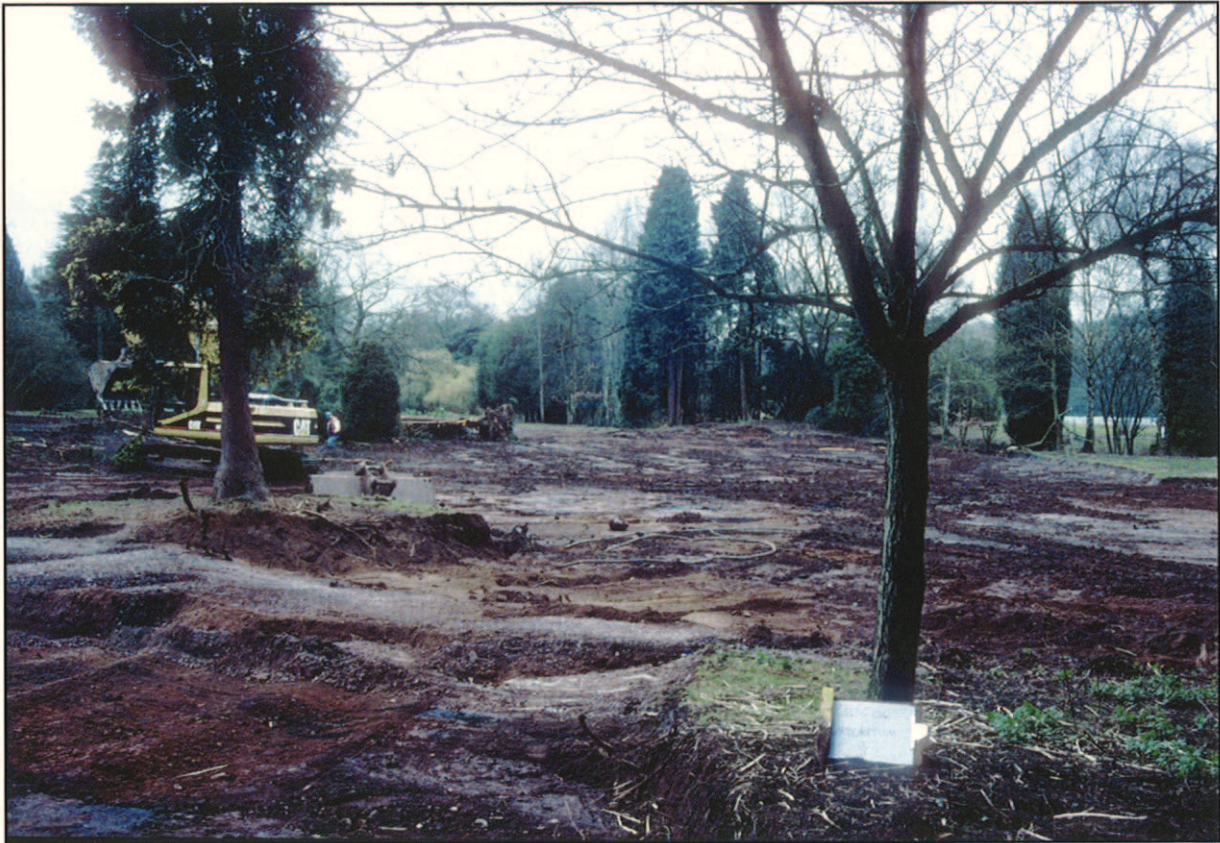
- 3.1.15 Works in the arboretum at the site of the new Garden Centre (Plate 3) were monitored - these involved landscaping and the excavation of a test pit. The only feature of note was a brick-built drain (300), though only the upper part of the structure was revealed (Plate 4).
- 3.1.16 The test pit was excavated through layers of soil and general make-up for the arboretum. No archaeological remains were observed across this part of the site.

Plate 3: Arboretum landscaping

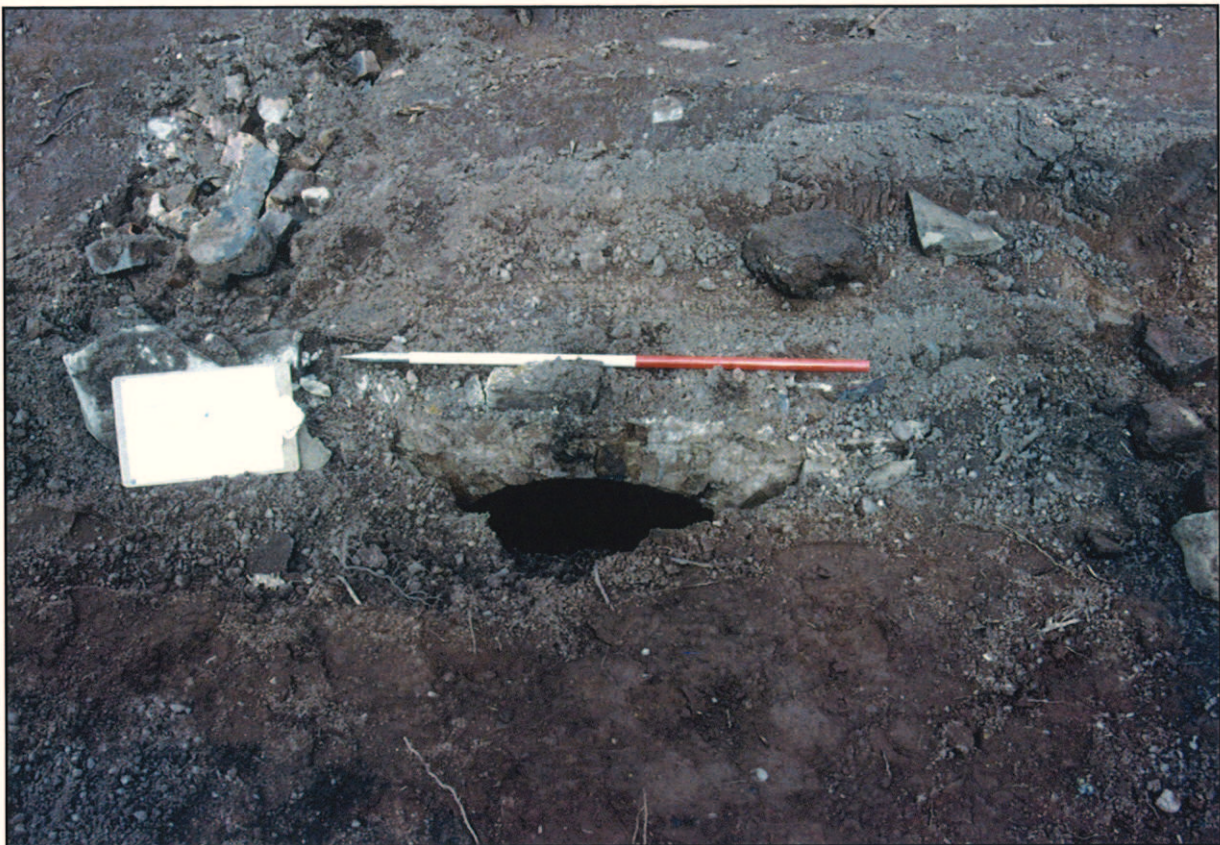
Plate 4: Culvert 300
