# Marcham Church of England Primary School, Marcham Oxfordshire

## Archaeological Watching Brief Report

May 2020

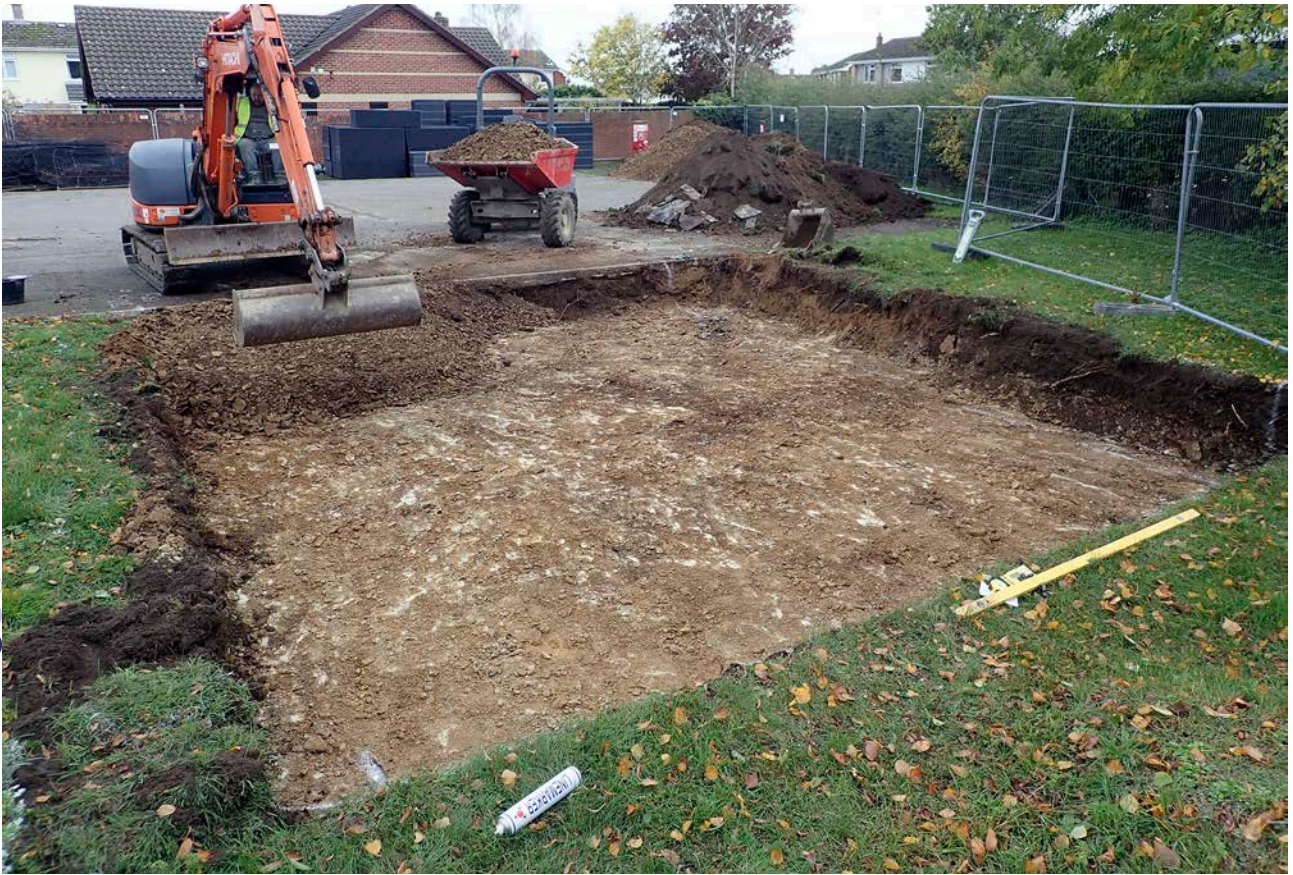
Plate 1: Area strip for soak-away

3.2.2 Beneath the soak-away the limestone geology was directly overlain by topsoil.

- 4.1.1 The watching brief did not identify any surviving archaeological features or deposits. The geological horizon was exposed in the soak-away (Plate 1), foundation and service trenches (Plates 2, 3). Modern rubble deposits were recorded at the northern area of the site, which appeared to indicate landscaping prior to the construction of the school.
- 4.1.2 Previous archaeological works at Anson fields (WA 2012), to the south of the site, recorded an Iron Age settlement. No evidence of this settlement was recorded during these works suggesting that the activity does not extend into the footprint of the school. However, given the limited scope of these investigations it can not be ruled out entirely.
