Templars' Retail Park

Between Towns Road
Oxford

Archaeological Evaluation and Building Recording Report

Evaluation and Building Recording Report

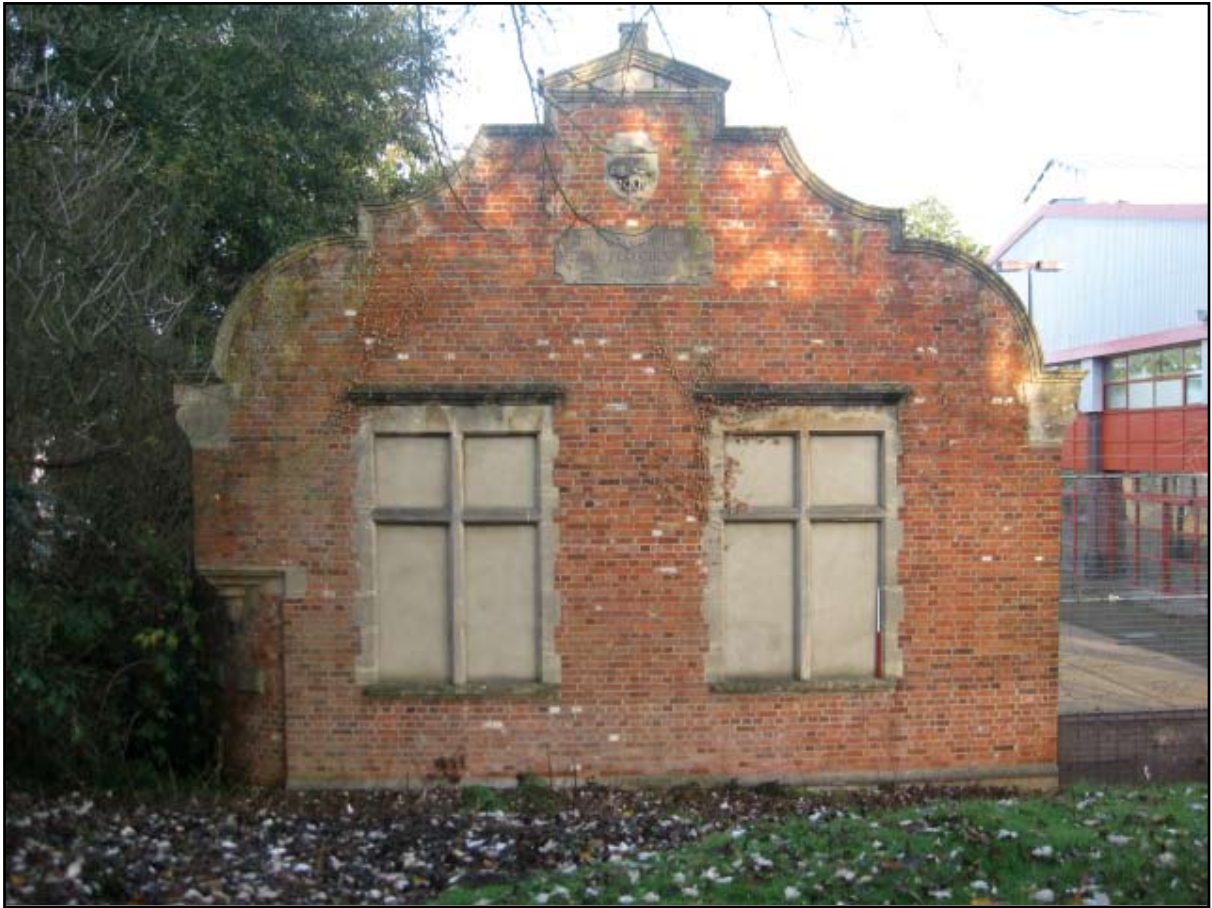
- 4.2.1 The red brick gable is built in the Dutch style, which experienced revived popularity in Britain in the late 19th and early 20th centuries (Plate 1). Each side features two curves, characteristic of Dutch or Flemish gables, the upper of which is inverted, and a central pediment at the top. The stone dressings are moulded with careful detailing and the pediment is simple and Classical. The gable sits on two large moulded cornices at either side of the wall. The red bricks are coursed in an English bond and the cement mortar is likely to have been applied when the wall was relocated.

Plate 1: South face of gable wall

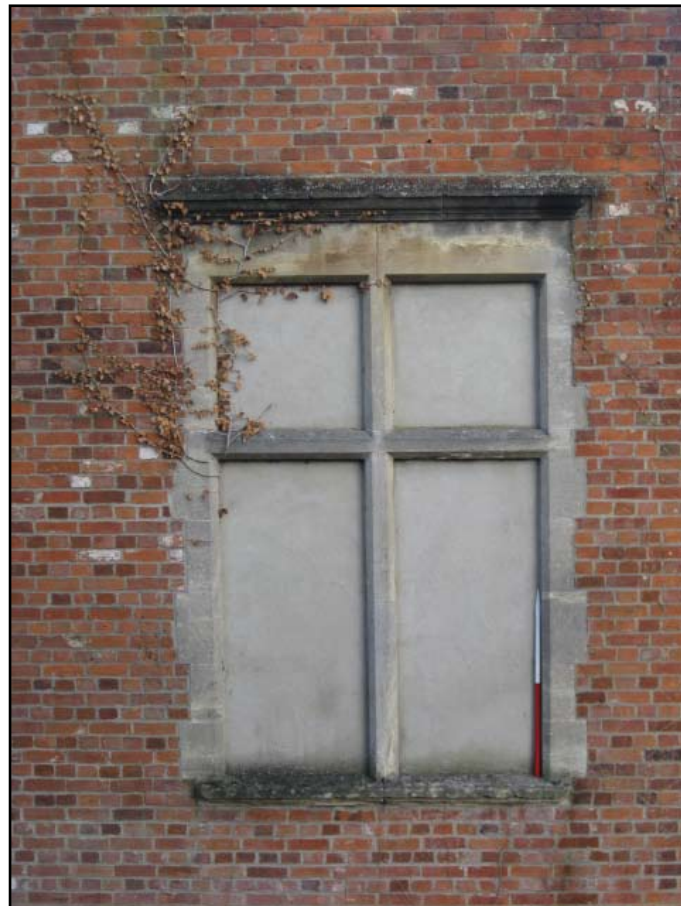
- 4.2.2 The gable features two large rectangular four light windows with stone quoining and cross mullions (Plate 2). They are simple with a moulded pediment and are in perfect symmetry with each other, reflecting Classical architectural forms. The lights have been plastered over with cement.

Plate 2: Window in south face of gable wall

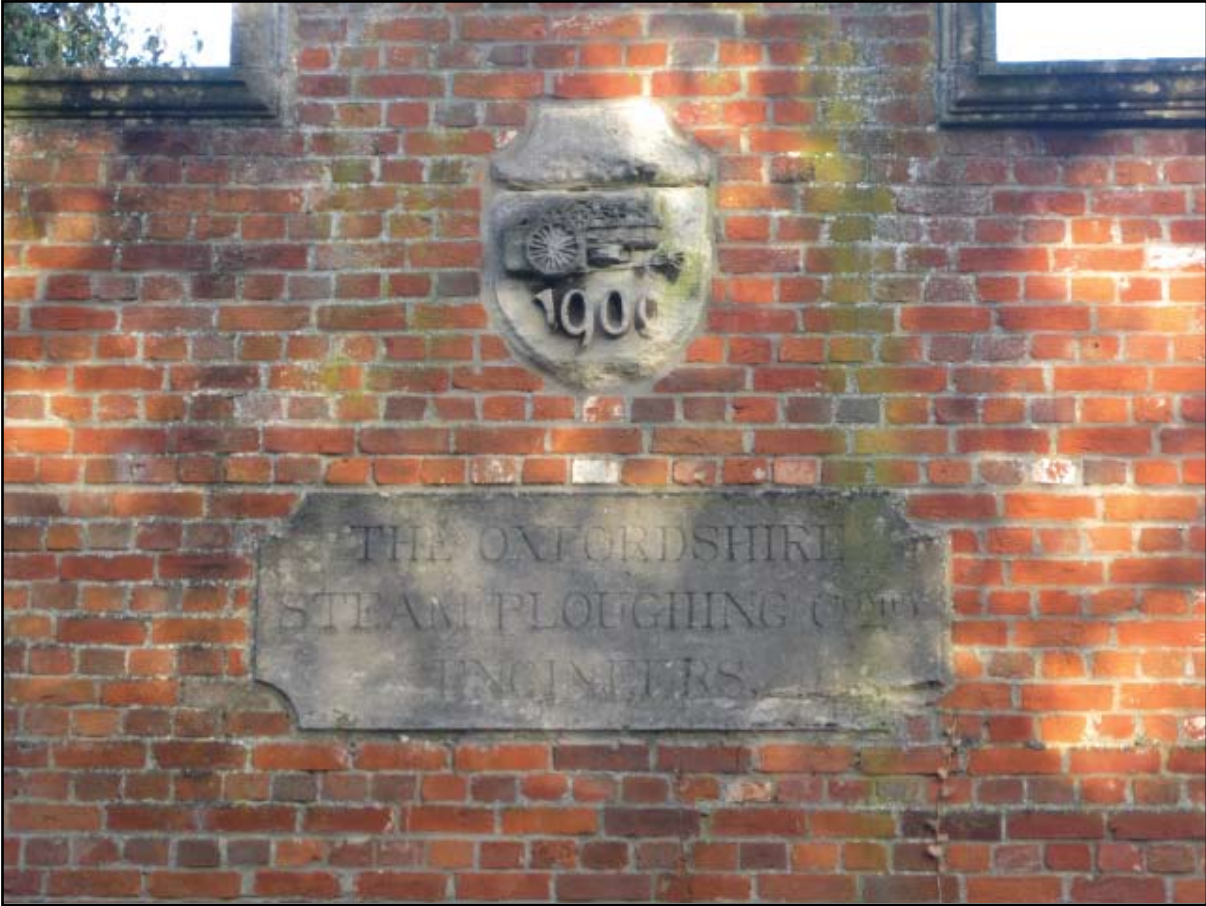
- 4.2.3 In the centre of the gable, over the windows is a plaque with the inscription "THE OXFORDSHIRE STEAM PLOUGHING COMpy ENGINEERS". Above this and below the pediment is a stone crest with the date 1900 and a detailed, high relief carving of a steam plough (Plate 3).

Plate 3: Commemorative plaque on south face of gable wall

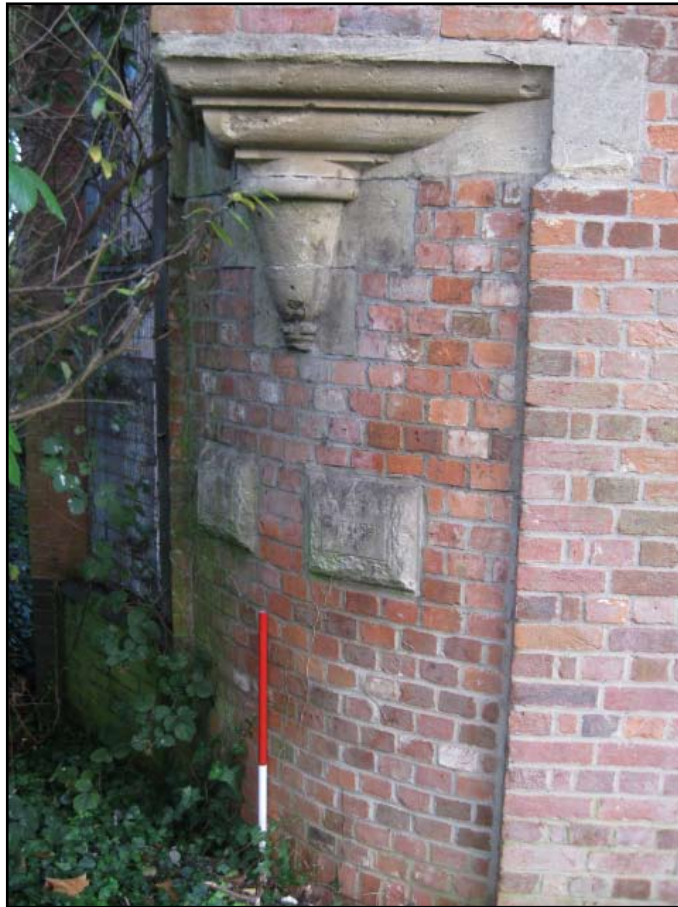
- 4.2.4 On the left hand side of the gable, what would have been the the corner of the building, is an indentation that appears to be like a chamfer for the accommodation of passing traffic but is rather more decorative than functional. The wall within the indentation is outwardly curves and it is surmounted with a moulded stone pendant decoration where the wall indents (Plate 4). On the curved wall are two small stone plaques with the inscriptions "E H J A AUG 1899" and "EXTENDED 1928" on them.

Plate 4: Corner feature on left side of south face of gable wall

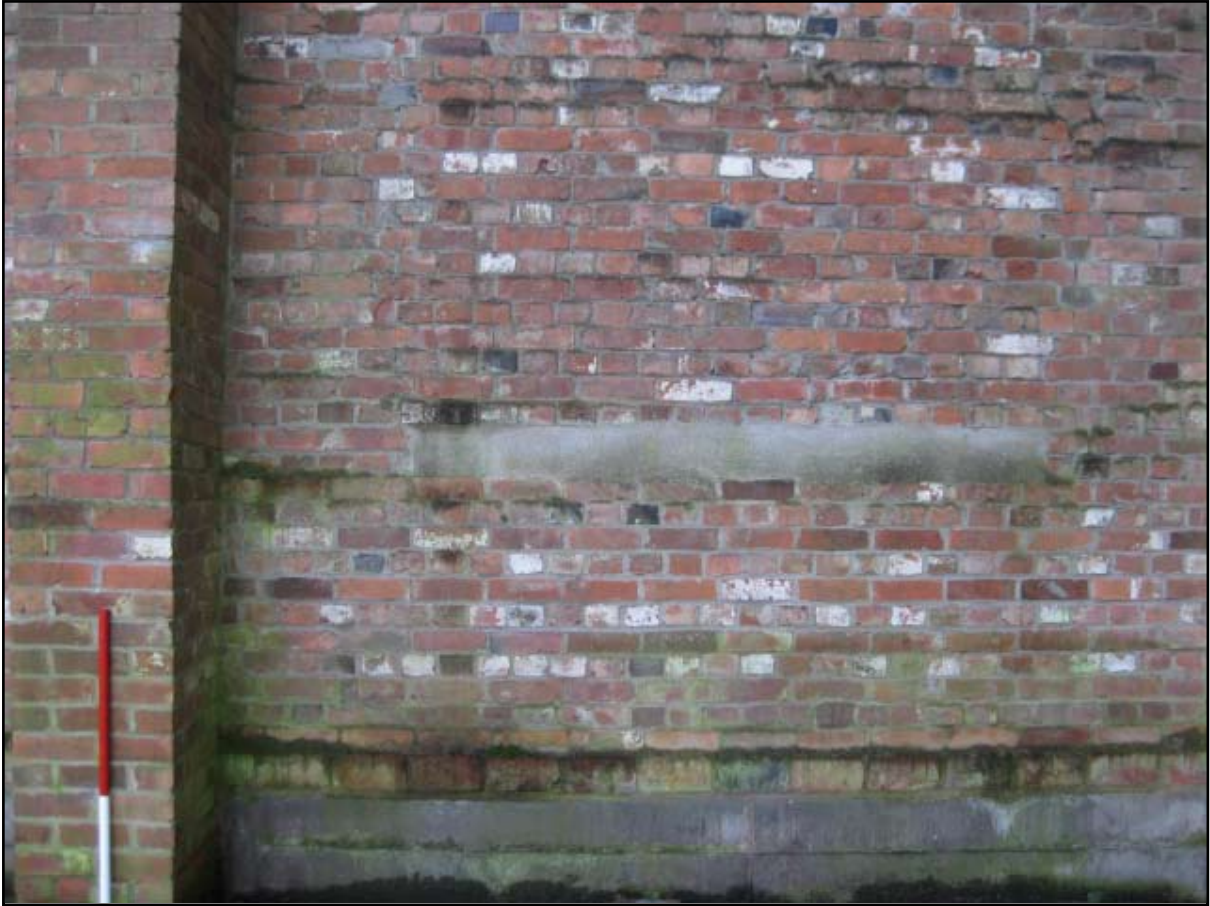
- 4.2.5 The north facing side of the wall is supported with three buttresses, which were presumably added when the wall was relocated. An outer skin of red bricks also covers the window openings on this side and it may be that the this was added to thicken the wall for support. This sits on a red brick and concrete plinth. There are concrete sills at sill level of the windows on the south face but the red brick skin bulges slightly in the areas of the window openings. The bricks are the same as those on the south elevation and are coursed in an English bond. It is very likely that they were reused from the remains of what once existed of the building after it was demolished. The red brick of the buttresses and a rounded solid pier on the right hand side that seems to support the curved wall on the south face (Plate 6), are both built with more modern bricks.

Plate 5: Buttress and plinth on north face of gable wall

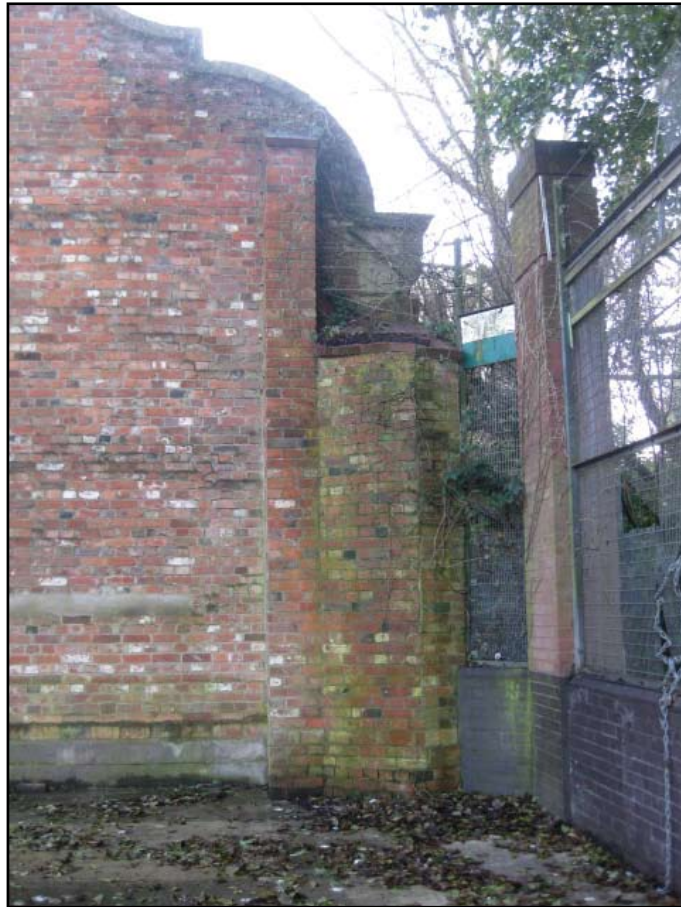
Plate 6: Buttress and corner pier on north face of gable wall

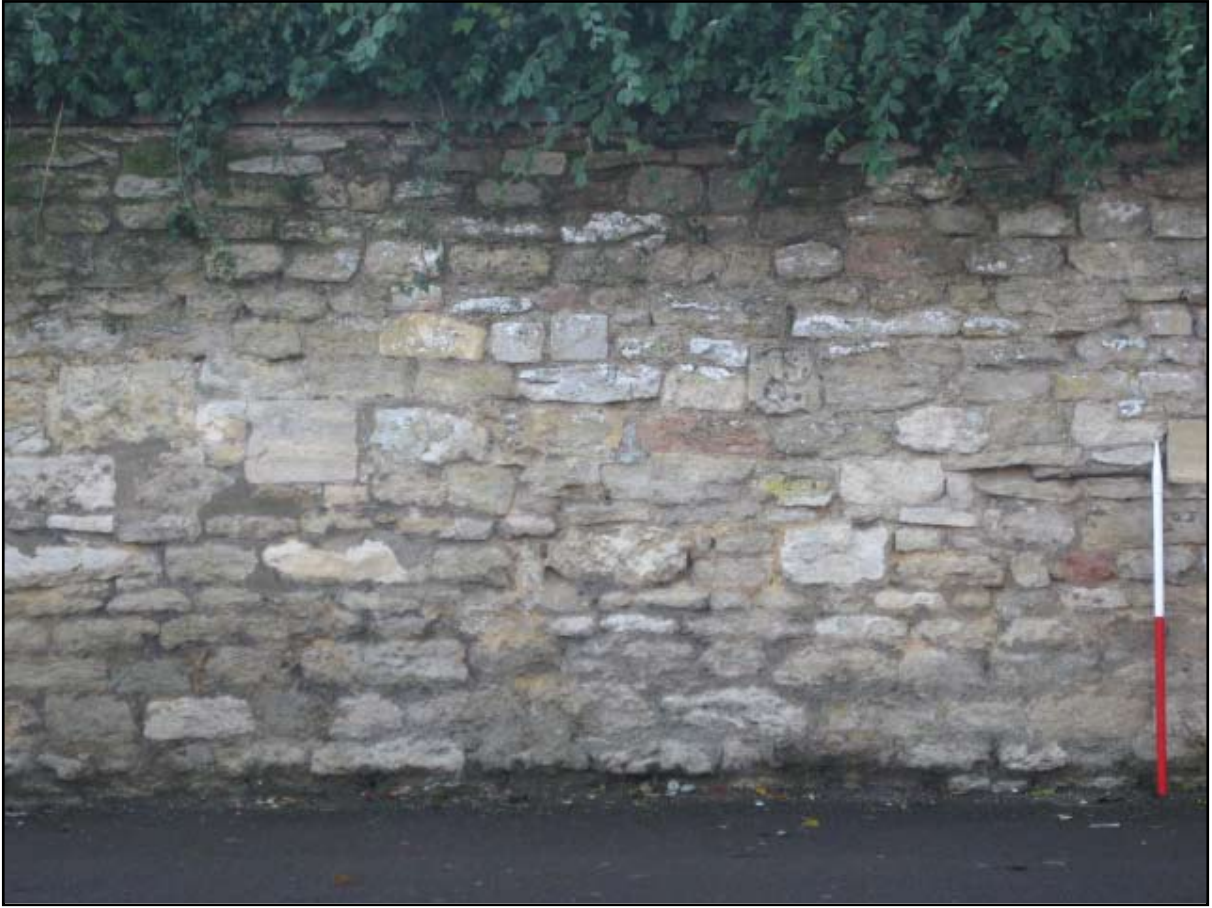
- 4.3.1 The west facing side is visible from Rymers Lane. It is a roughly coursed stone wall, approximately 1.8m in height (Plate 7). Stones are squared but of irregular sizes. What appears to be original mortar remains in large areas of the wall and it is a yellowish, gritty lime mortar.

Plate 7: West face of rag wall

- 5.3.5 The rag wall is more difficult to date. It is believed to date to the founding of the Oxford Steam Plough factory in the 1860s, but it remains possible that it could pre-date this.
