Nixon Street, Castleton, Rochdale, Greater Manchester

Archaeological Strip, Map and Record and Watching Brief Report

March 2023

**Client: Lanpro Services Ltd on behalf of Seddon
Construction**

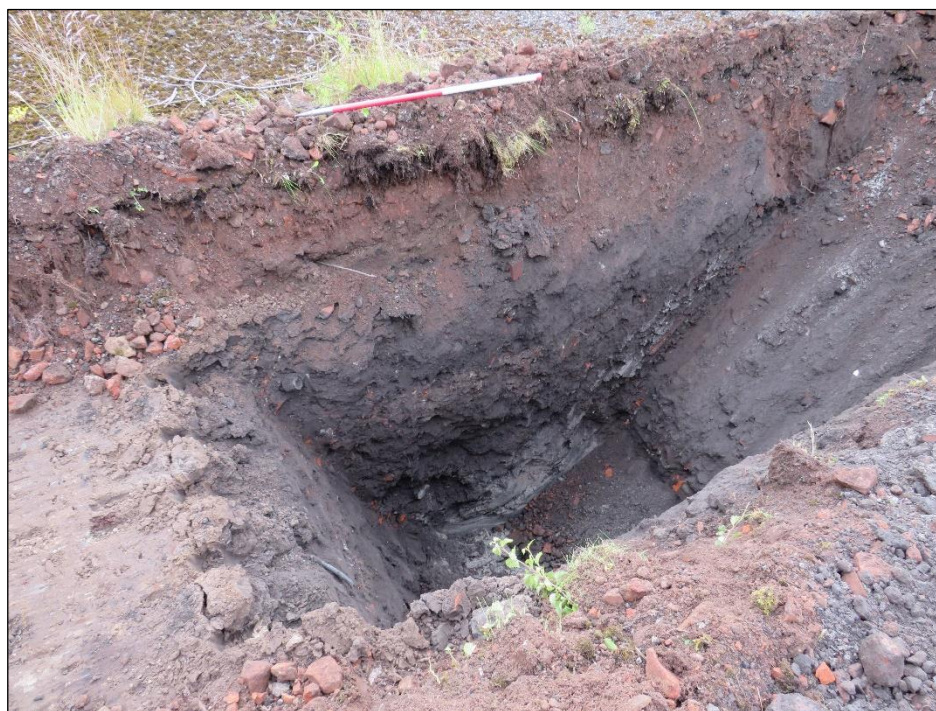
3.2.2 In Trench 1, the natural geology **103**, was overlain by approximately 2m of consolidation overburden, **102**, containing brick and concrete demolition material (Plate 1). This was overlain by a 0.20m-thick layer of compacted brick demolition (**101**) and capped with a 0.10m-thick layer of degraded tarmacadam and road planing, **100**.

Plate 1: Stratigraphy encountered in Trench 1, looking south-east (1m scale)

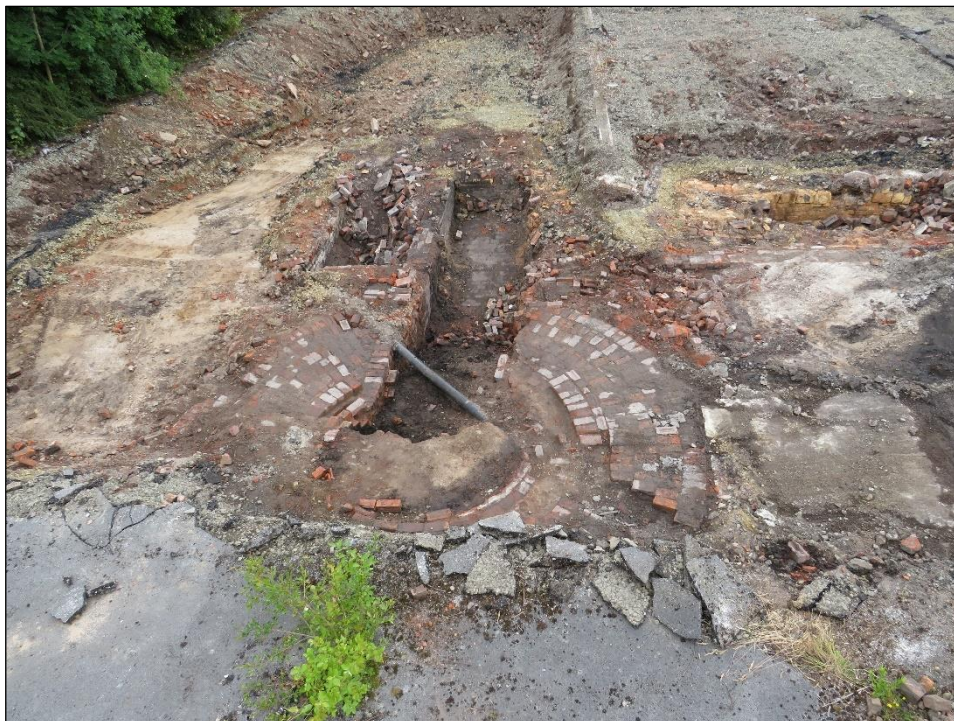
3.4.2 A chimney base (**206**) was encountered in the south-east corner of the trench (Fig 3; Plate 2). It was 6.70m in diameter and constructed of frogged, machine-made red bricks, bonded using a mid-grey cement, laid as headers approximately 2m wide. The internal flue was aligned east-north-east/west-south-west and measured 5.60m (total) in length, with a circular central opening measuring 2.20m in diameter, creating a 'keyhole' shape in plan. The internal flue comprised one-brick wide, frogged, machine-made, red brick walls constructed using an English Garden Wall (EGW) bond. These were faced with an internal skin of firebrick stretchers. Chimney base **206** was partially truncated by a shallow, modern service, aligned north-east/south-west.

Plate 2: South-east corner of Trench 2, looking west (no scale)

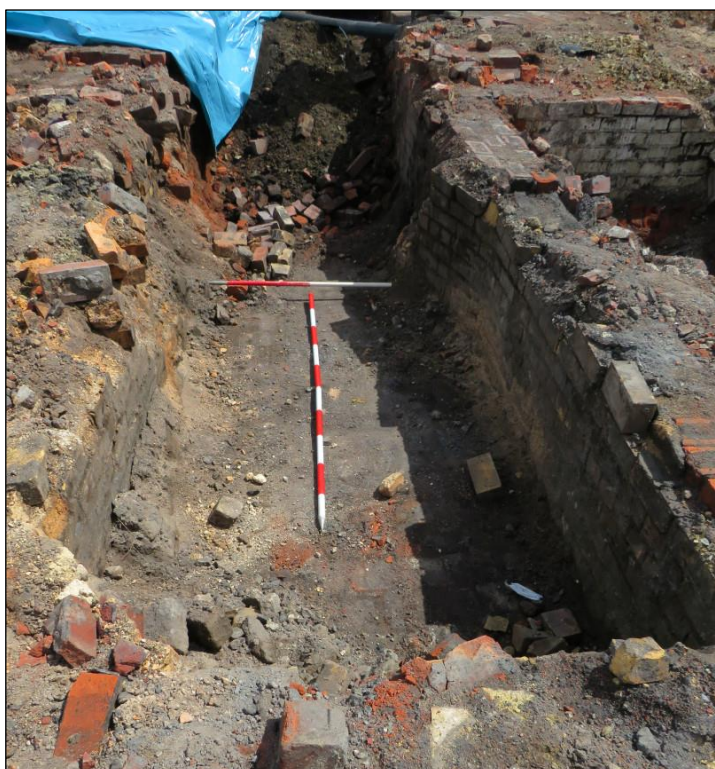
3.4.3 To the immediate west of chimney base **206** were rectangular structures **207** and **208**. Structure **208** was the most northerly and measured 5.5m long by 1.65m wide (Fig 3; Plate 3). This structure had no obvious boundary at its east extent, which appeared to have been truncated, and was bounded by brick walls to the north, west and south. The north and west walls were heavily truncated in places or were obscured by demolition debris, but were generally constructed using frogged, red bricks and internally faced with firebrick. The south wall, also part of structure **207**, was constructed using frogged, red bricks, one and a half bricks wide with an EGW bond and mortared with light grey cement. The north face of this wall was lined with half a bricks width of firebrick that curved northwards at its east extent where it was truncated. Remnants of a red brick floor surface were present with a graduated downwards slope towards chimney base **206**.

Plate 3: Structure 208, looking east (1m and 2m scales)

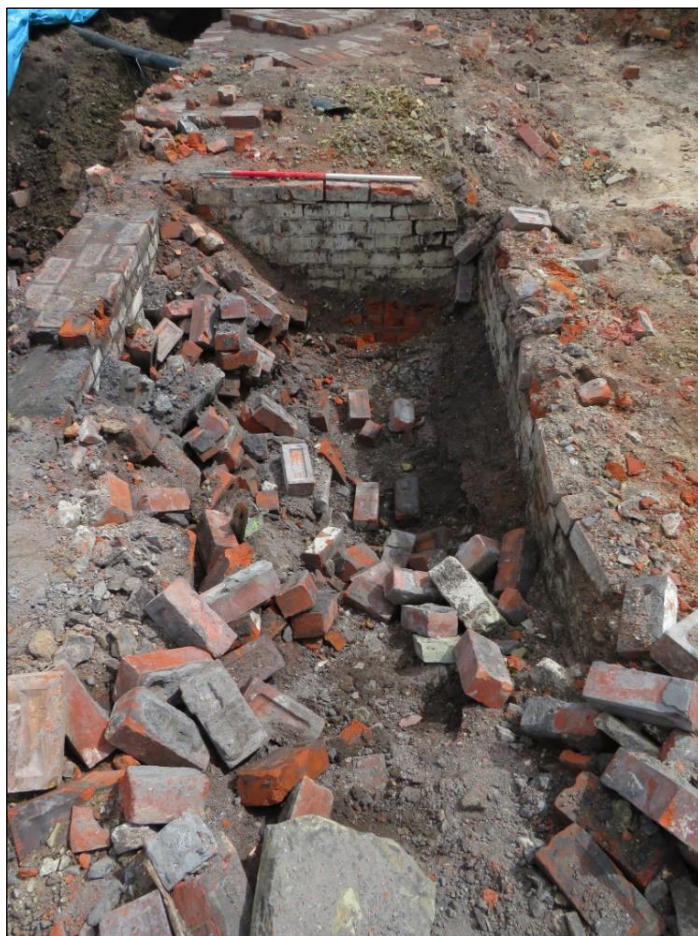
3.4.4 Structure **207** extended from the southern extent of structure **208** (Fig 3; Plate 4). The western extent of this structure had been truncated, but the south and east walls bounded an area measuring approximately 4.90m by 1.70m. The whole structure was constructed using frogged, red bricks with an EGW bond. The bricks were mortared with a light grey cement and painted on the internal faces with a lime or whitewash. The internal space, although largely obscured by demolition deposit **205**, contained a brick floor surface and a possible brick structure within the south-east corner. Several bricks from this structure were stamped: 'Newhey' and 'Shawforth BK Co Ld Nr Rochdale'.

Plate 4: Structure 207, looking east (1m scale)

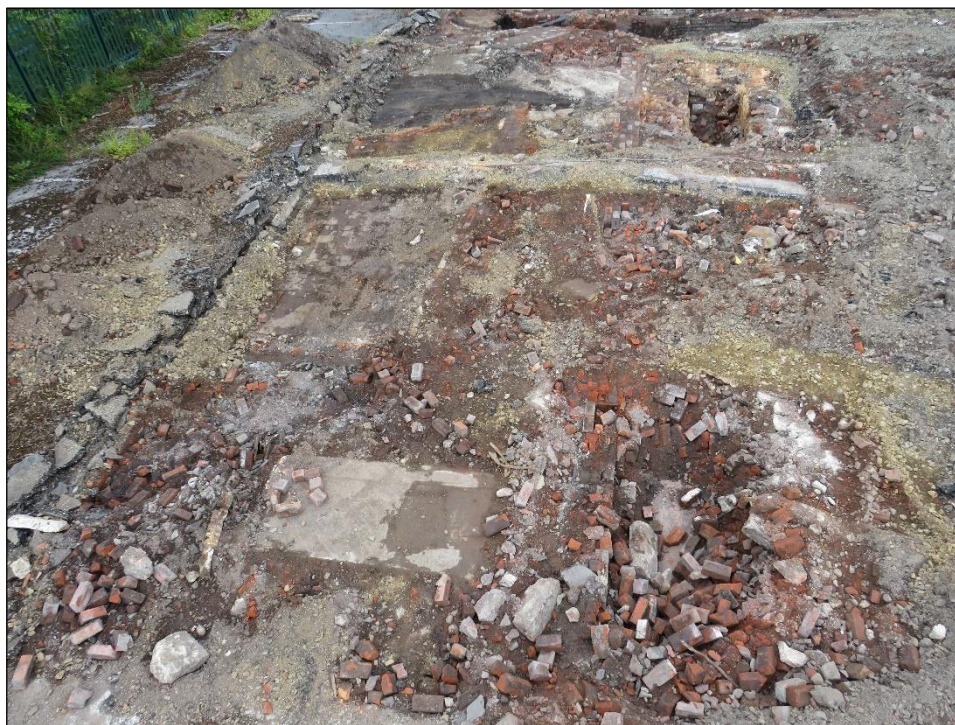
3.4.5 Other structures were uncovered during machine excavations to the north of structures **206** and **208** in the north-east corner of Trench 2 (Fig 3). However, this area was later covered due to the presence of asbestos and only partially recorded as a result. Identified features included the east and north perimeter walls of the boiler house, probable elements of boiler bases extending northwards from structure **208**, and the potential remains of an engine base (Plates 2 and 5). Only a single course of the northern perimeter wall of the engine house survived at a maximum depth of 0.95m. A brick floor surface and a large stone base were also noted in this area. These features correspond with the layout of a possible engine house and a square structure extending from its north-east corner of the boiler house as shown on the 1910 OS map (Fig 4).

Plate 5: Other structures uncovered in Trench 2, looking south (no scale)

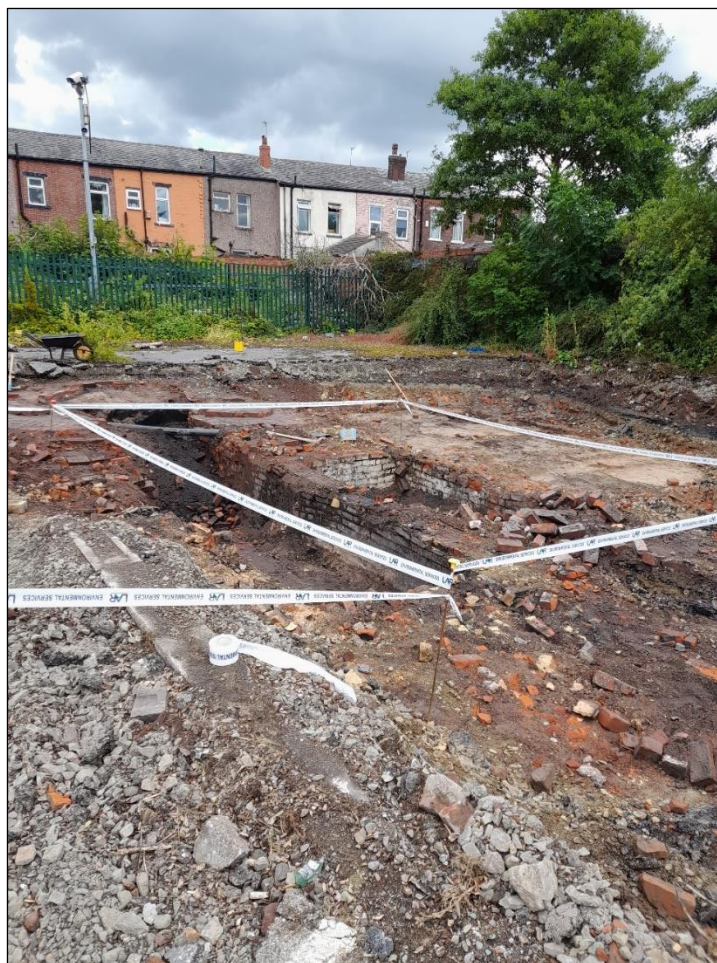
3.5.1 During the excavation of Trench 2, asbestos containing materials and deposits were uncovered in several areas, most of which were concentrated in the north and east (Fig 3). Therefore, excavation was stopped and only those archaeological remains exposed in the south-east were recorded (*Section 3.4*). As archaeological features were identified in the contaminated area, archaeological monitoring was undertaken during the removal of the structures as part of the redevelopment of the site.

3.5.2 The affected areas were cordoned off until the safe removal of the contamination deposits was undertaken (Plate 6). The contaminated soil was subsequently removed, disturbing some of the structures that remained. Nevertheless, further excavations in the south-east corner of the area exposed further structural remains relating to chimney base **206** and structures **207** and **208** (Fig 3). Excavations continued down to a depth of over 3m, revealing over 35 courses of machine-made brick of chimney base **206** (Plate 7). As the brick coursing was removed, large concrete blocks with brick inclusions were found at the base of the structures (Plates 8 and 9). These concrete blocks are likely to have formed part of the bed/base for a boiler(s) within the boiler room/engine house of Castleton Moor Mill.

Plate 6: Areas of asbestos contamination in Trench 2

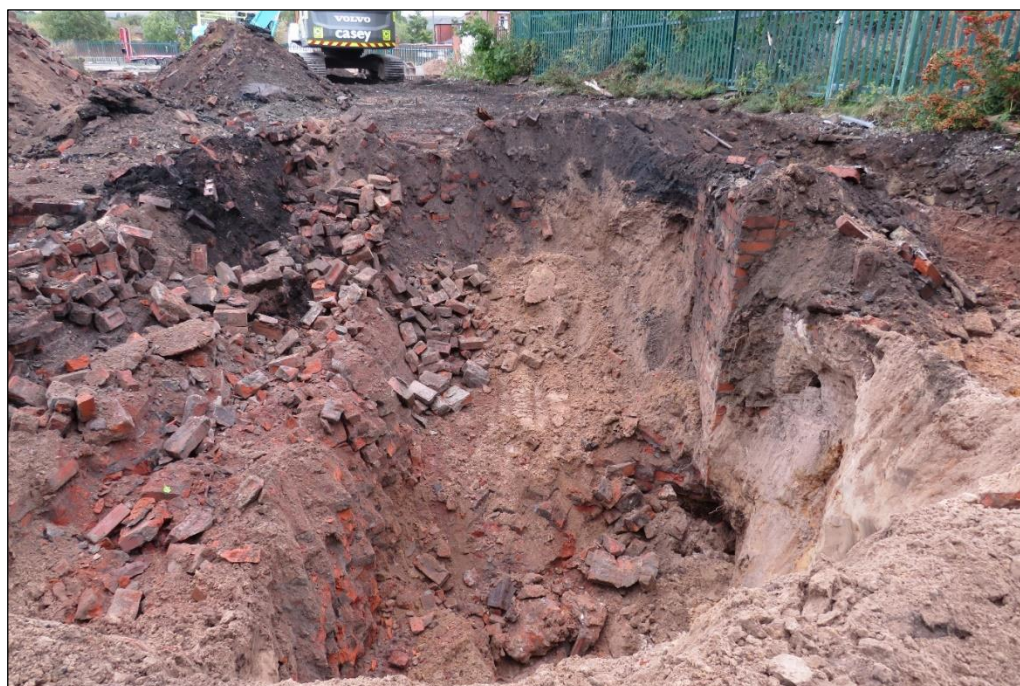
Plate 7: Excavated area following removal of chimney base 206, depth in excess of 3m (no scale)

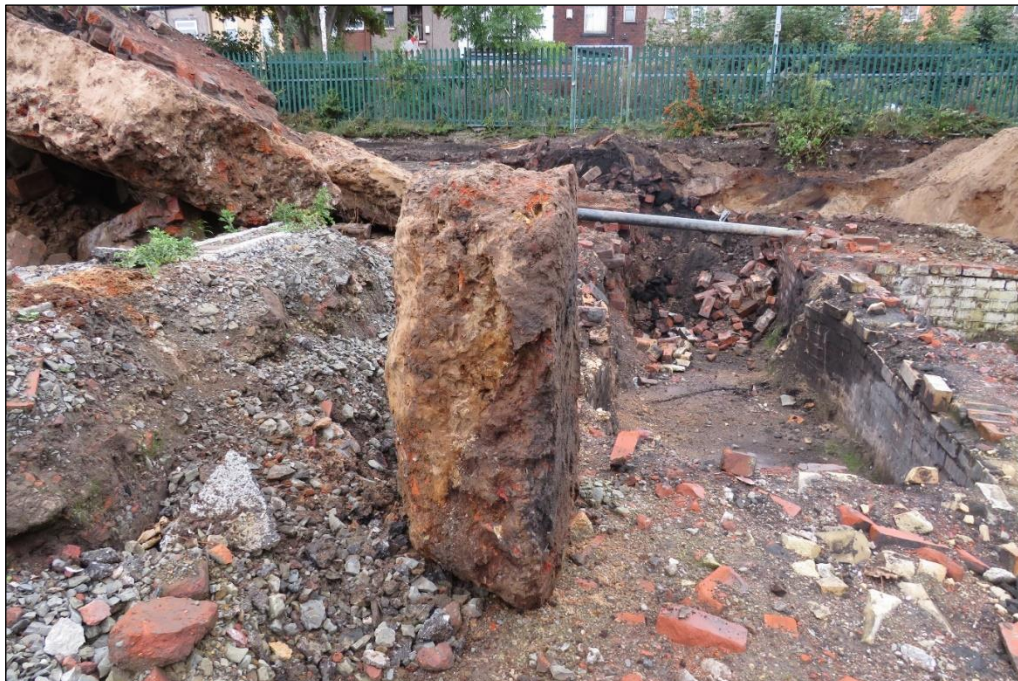
Plate 8: Example of large concrete block found during excavations in south-east corner of site, looking east (no scale)

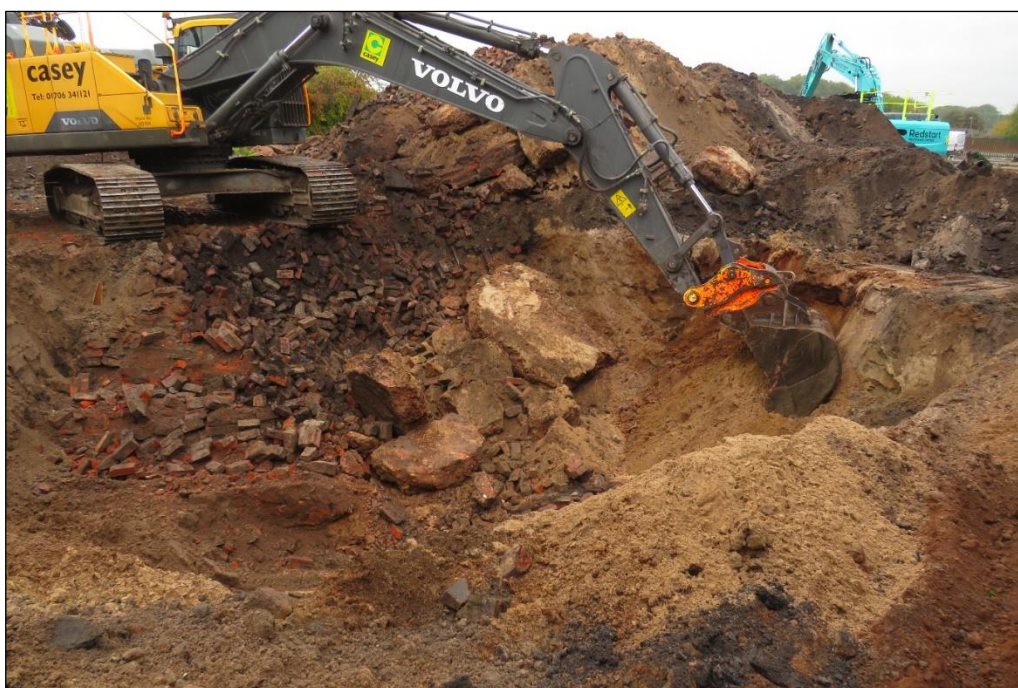
Plate 9: Working shot showing bricks, concrete blocks and natural sand (no scale)

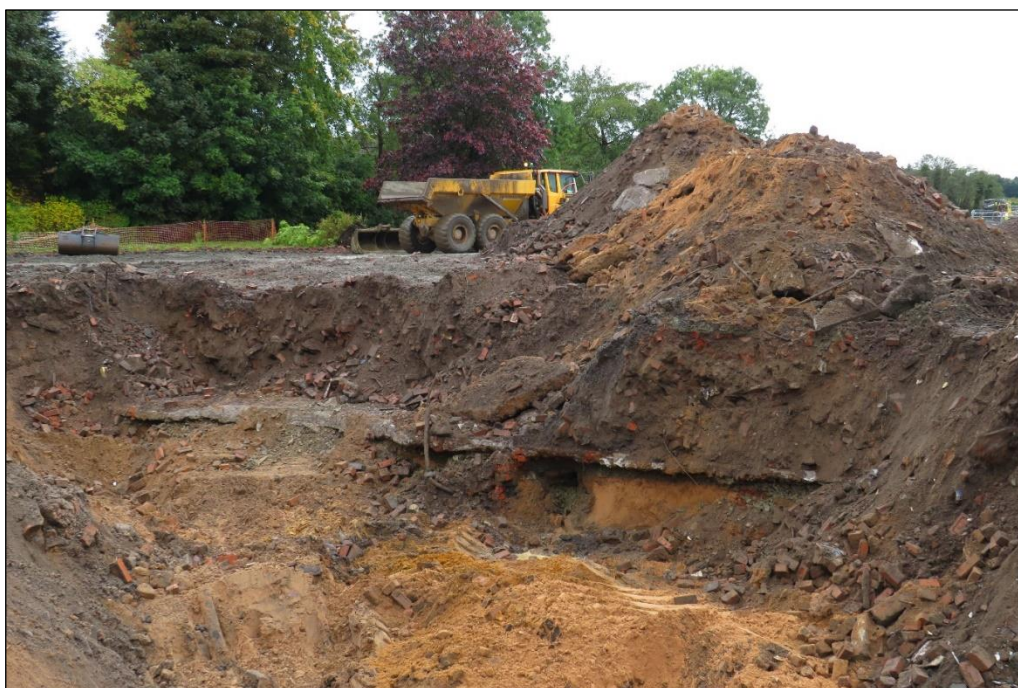
- 3.5.4 Towards the centre and west of the site area, some truncated structural remains were identified, comprising machine-made bricks, although once again it was impossible to determine their layout during the excavations (Fig. 3). Removal of these structures revealed a concrete layer, approximately 0.4m thick, which directly overlaid the natural sand (Plate 10); this formed a continuation of the concrete floor exposed in the sondage excavated in the western part of Trench 2 (*Section 3.4.6*). This concrete layer differed to the substantial concrete blocks found in the south-east corner of the site, where chimney base **206** and structures **207** and **208** were located. It is likely this concrete layer was related to a floor level of the boiler room, with the larger concrete blocks associated with foundations of the boilers.

Plate 10: Concrete floor towards west edge of the proposed location of Trench 2 (no scale)

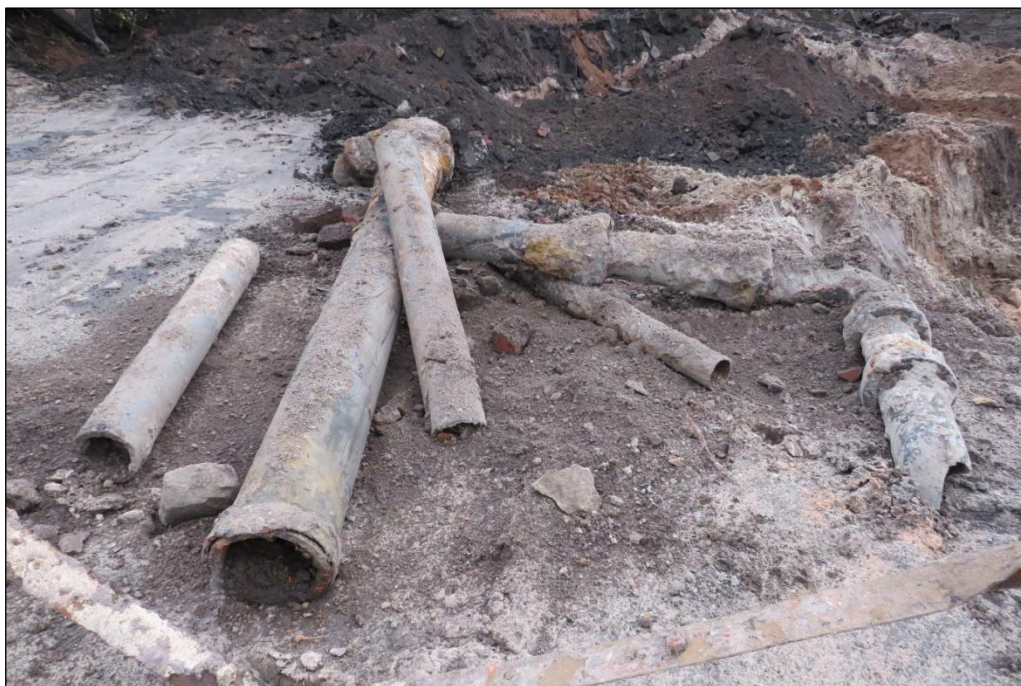
- 3.5.5 Extending from chimney base **206** and along the previously recorded flue system (structures **207** and **208**), metal piping was found, further establishing the character of the flue system (Plate 11). In addition, other finds relating to the function and use of the mill's engine house/boiler room were uncovered during the excavation and removal of the mill structures. Material included metal, metal wiring and plastic piping.

Plate 11: Example of metal piping found during excavations, most likely belonging to the flue system running west away from chimney base 206 (no scale)
