St Nicholas Church Nether Winchendon Buckinghamshire

Historic Building and Archaeological Recording and Investigation

Document Title: St Nicholas Church, Nether Winchendon, Buckinghamshire,
Historic Building and Archaeological Recording and Investigation

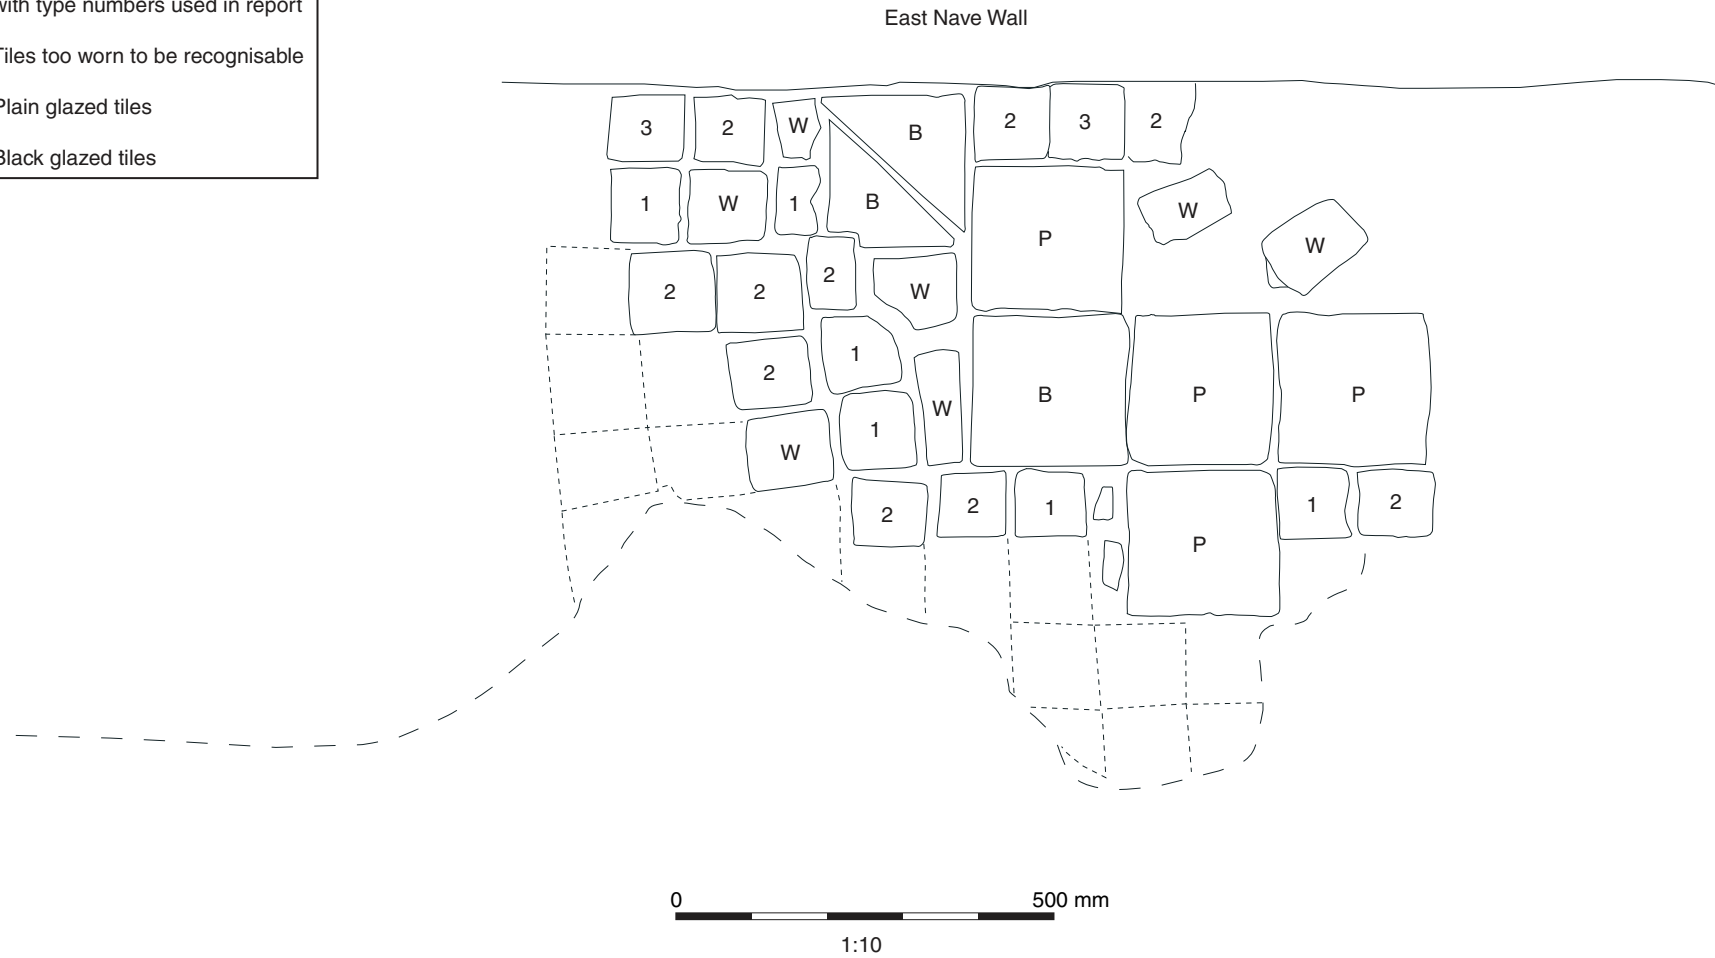
Figure 3: Plan of remnant tile floor at east end of nave

- 3.7.3 Removal of the pulpit revealed an unknown remnant of a tiled floor set in plaster against the east wall of the south side of the nave (plate 9). Immediately south of the present central tiled passage and reading desk was an area of cream coloured lime plaster approximately 0.6 m (n-s) x 1.0m (e-w) with the impressions of about 60, 0.1 m x 0.1m tiles, adjoining this to the south was an area of *in situ* tiles set in plaster (plate 10). The patch of tiles was approximately 1m (n-s) x 0.7 m (e-w), between the tiles and the south nave wall was an area of loose soil with no tiles or plaster remnants 0.8 m wide.

- 3.7.5 The tiled area contained small decorated square medieval tiles of 0.1m square of typical local manufacture possibly from Penn in Buckinghamshire and larger tiles c 0.2m square with plain black or reddish glaze. The tiles were not set in a pattern and the small ones were not following their original 4 or 8 tile decorative schemes also the floor incorporated many broken fragments of tile. It would appear therefore that the tiles were reused in this context. The tiled area seemed to be a different phase to the plaster with tile impressions which was a more consistent area of the smaller tiles. The latter was of a lighter firmer plaster in better condition and slightly higher and may have been later in date.

- 3.7.6 There were three distinct patterns of decorative tiles in the surviving floor, a fourth type was recovered loose from the area during the removal of the pulpit etc, and a fifth type was recovered from the deposits beneath the north pews during their removal. The tiles are described and discussed in greater detail in section 4 (plates 11-13).

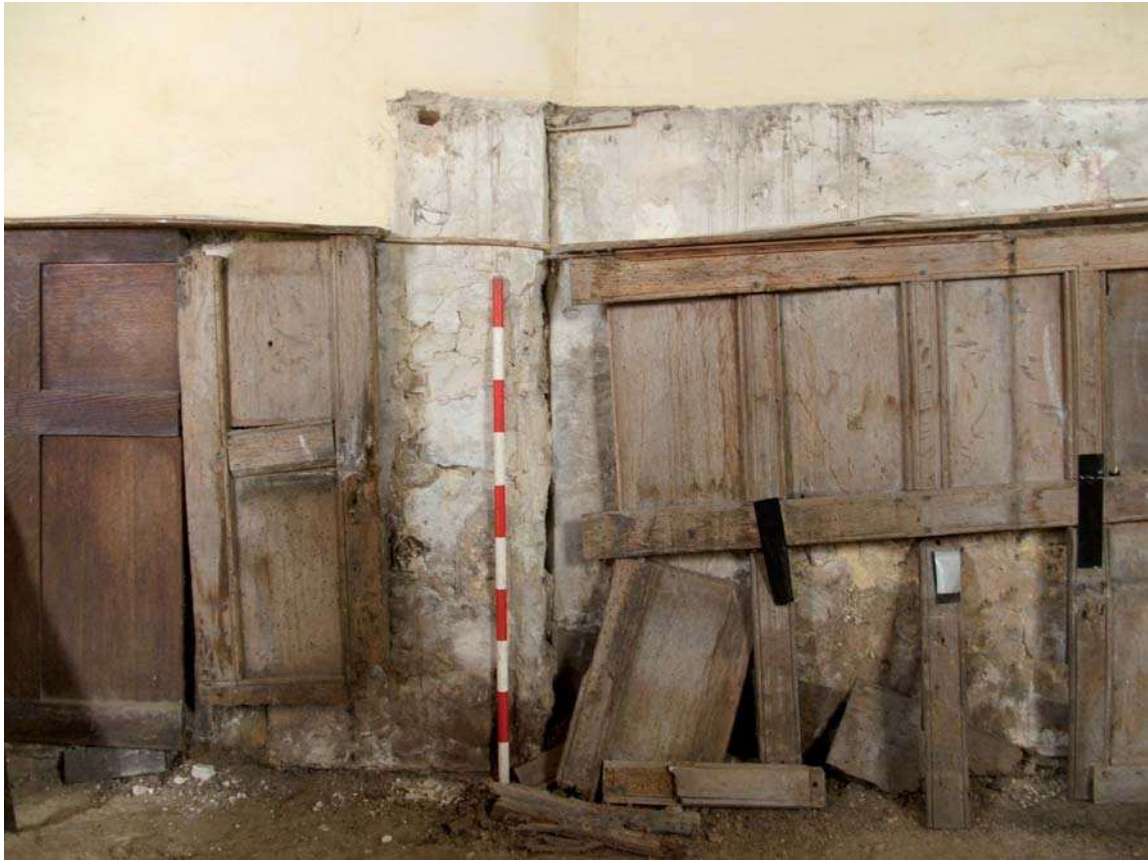
Plate 1: East jamb of blocked north door with panel 5 to right

Removal of the pew panels revealed the east jamb of the blocked north door. The lower south wall of the Nave exposed by removal of the pews appeared to be of one phase with no blocked or hidden features.

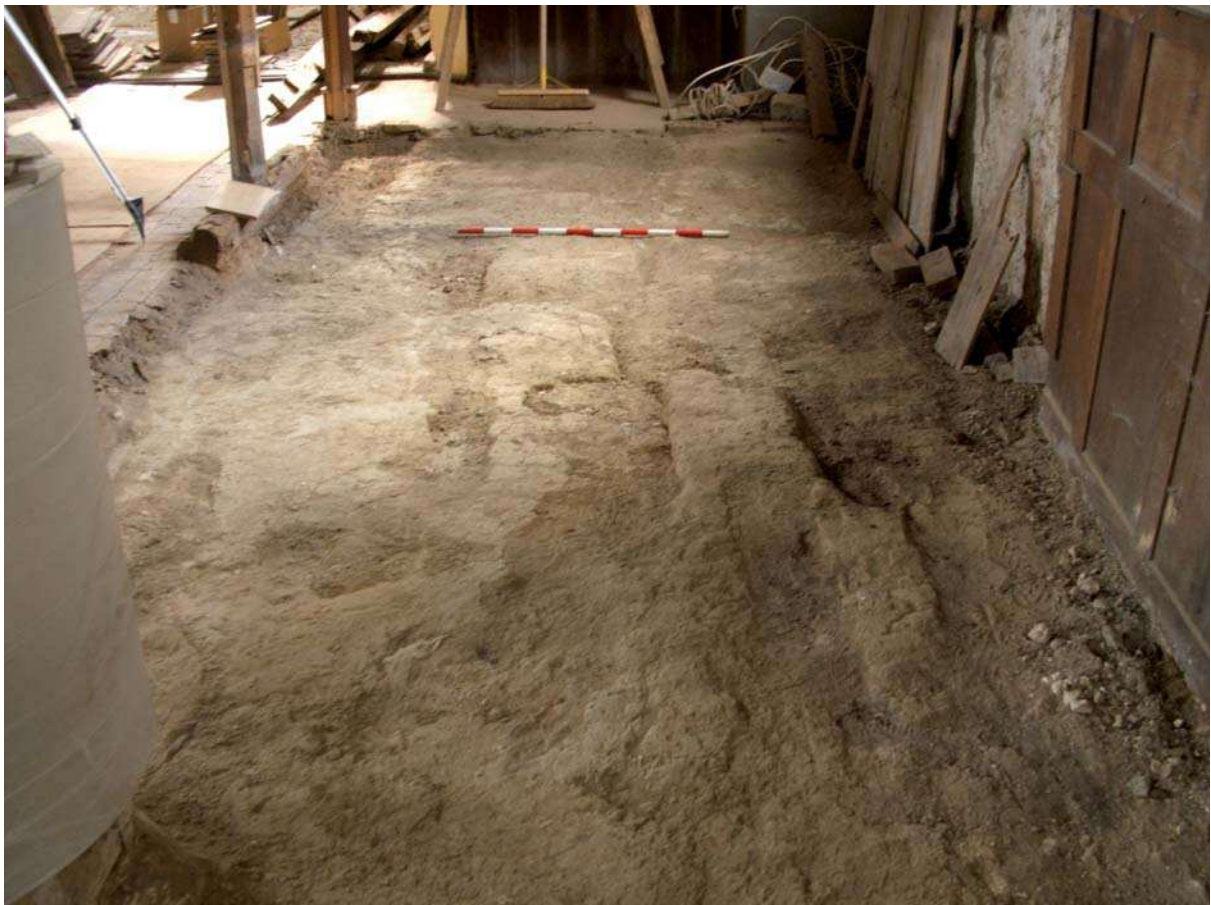
Plate 2: Earth floor on north side of nave showing probable grave cuts, looking west (1m scale)

An older hard earth surface was revealed below the pews, the existing font base was situated in a cut through this surface and an adjacent cut on the west may indicate an earlier font position. North-west of the font early grave cuts showed in the surface. In the central part of the south side of the Nave an 18th or 19th century brick burial vault was uncovered and seen to contain six lead coffins and probable remnants of decayed coverings.

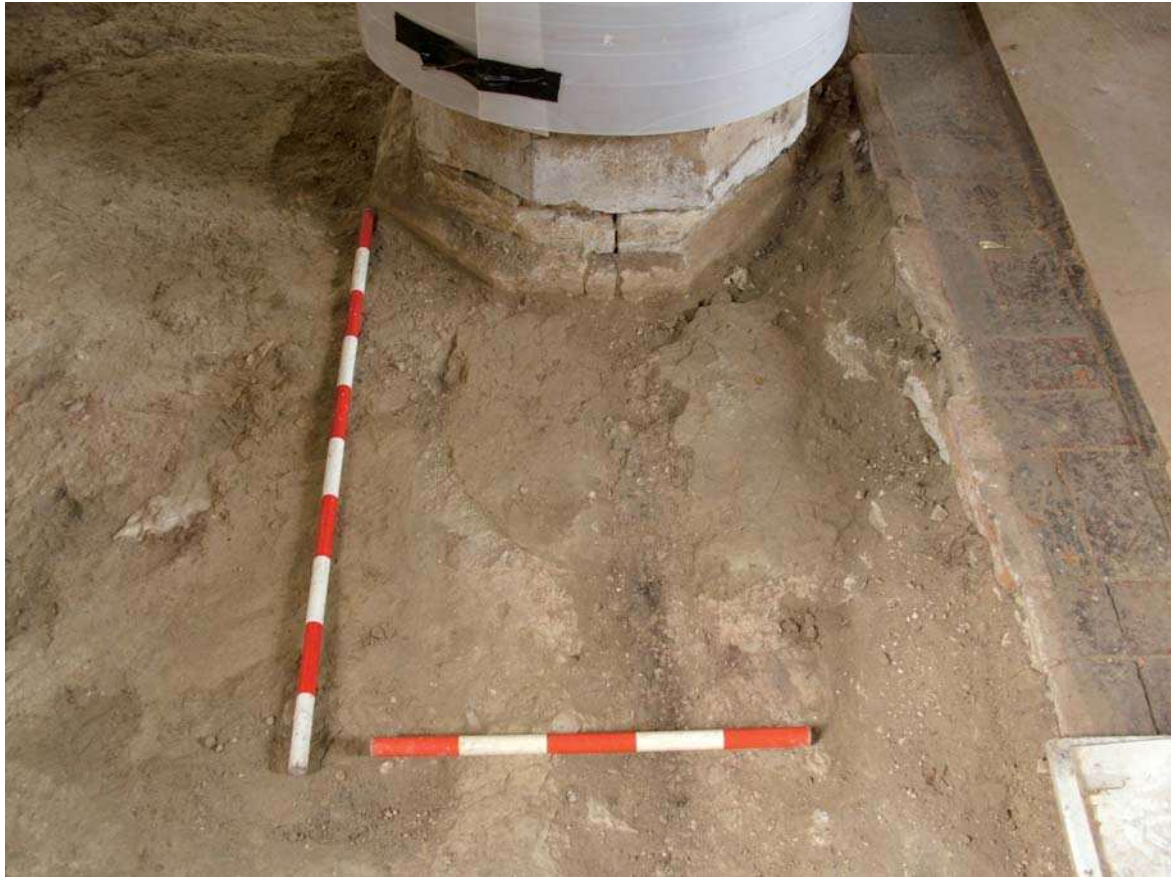
Plate 3: Font base cut into earth floor with smaller cut to west, looking east (1m and 0.5m scale)

- 3.3.2 Removal of the pews also exposed the stone base of the existing font which is located on the north side of the nave adjacent to the central tiled 'passage' and opposite the south door. The base is octagonal, at current ground level it is 0.7m wide and each side is 0.29m long. The base is set in a circular cut through the earlier hard earth floor surface. The cut has a looser fill of a similar deposit to the floor. This cut appears to truncate the east side of a smaller circular cut to the west. The smaller cut appears to be slightly smaller than the existing font base and may represent an earlier font position (plate 3).

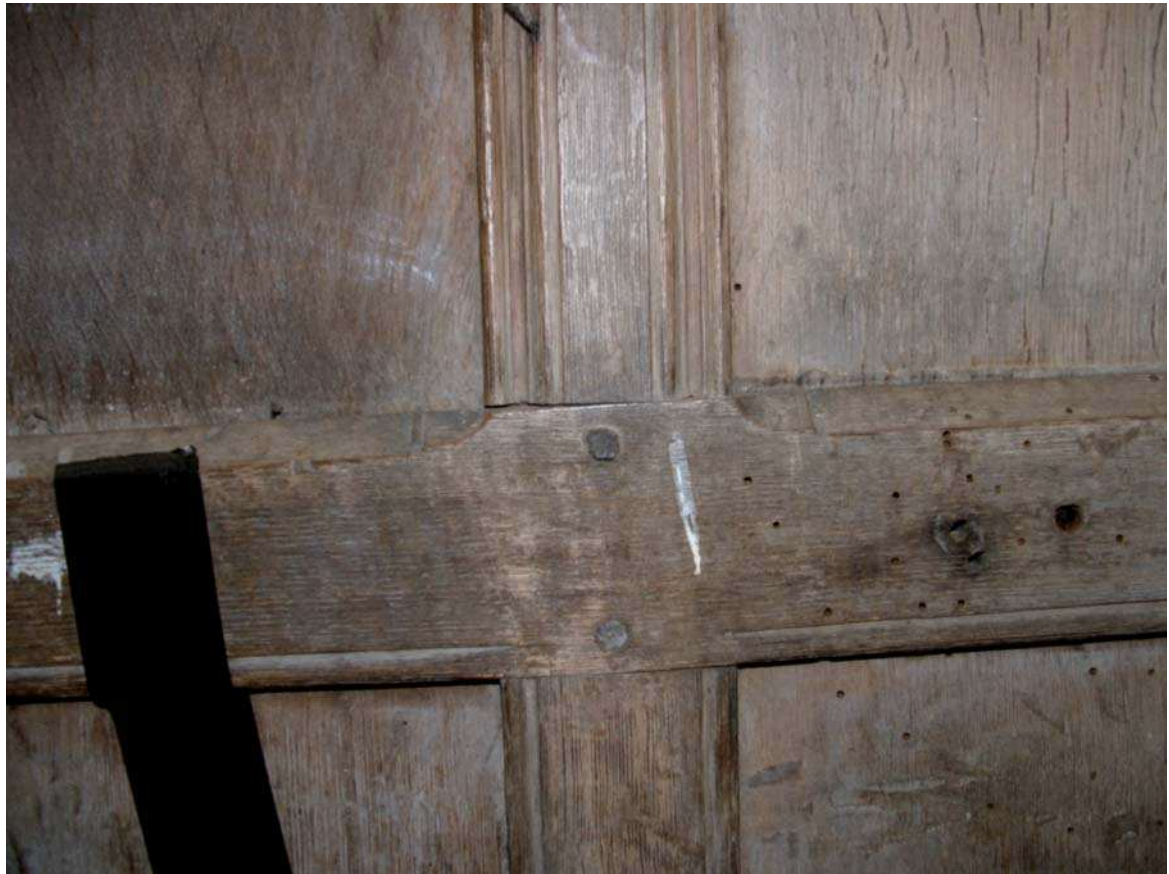
Plate 4: Detail of mouldings and bar stops on panel 5

- 3.4.1 Sections of panelling of various sizes and dates were *in situ* against the north and east walls on the north side of the nave. Section 1 against the east wall was relatively modern of dark stained oak with flat panels in two rows; the upper row of smaller square panels and the lower of vertical rectangular panels with plain rails and mullions, Section 2 against the east end of the north wall was of the same type and date as 1. Section 3 to the west was of two rows of four equal sized panels this was older and of unstained oak. Part of the lower row was missing. The upper mullions and upper rail were moulded; the central rail had a simple chamfer on its upper edge, its lower edge and the lower mullions were plain.

- 5.1.17 Sections of pew panelling seen in situ on the north Nave wall seemed to range in date from examples with bar stops on the rail chamfering, which might indicate a 17th century date, to relatively modern panels.
- 5.1.18 The discovery of the medieval roof timbers in the pew bases indicates the bases were constructed, or repaired, after the roof was replaced which was probably around 1827; the date on the current Nave roof. The box pews, as mentioned, contain earlier panels so there were either some box pews in existence before that date or they contain elements imported from elsewhere.

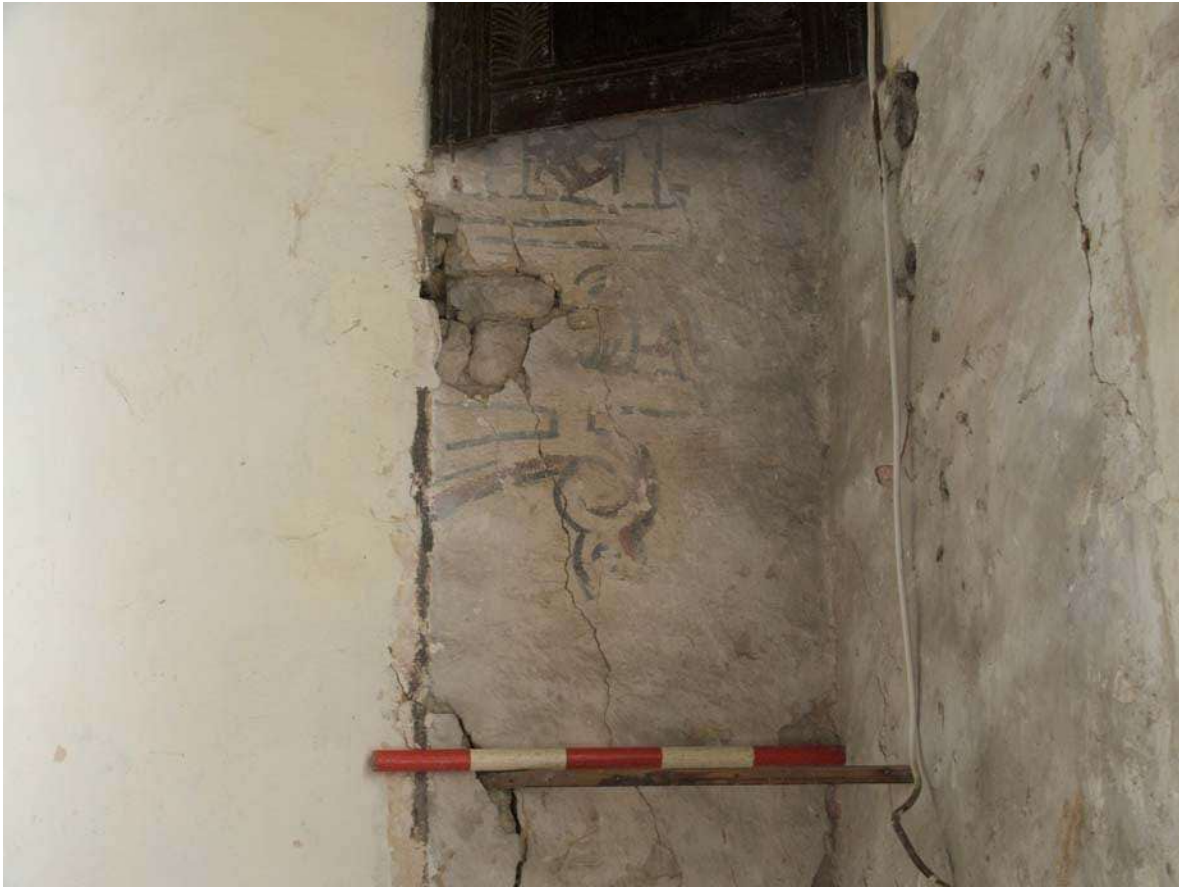
Plate 5: Wall painting beneath pulpit backboard (0.5m scale)

Part of a post-medieval wall painting of framed texts was revealed on the south part of the east Nave wall behind the pulpit and was probably part of a scheme including a similar painting seen in 1986 on the north part of the east Nave wall.

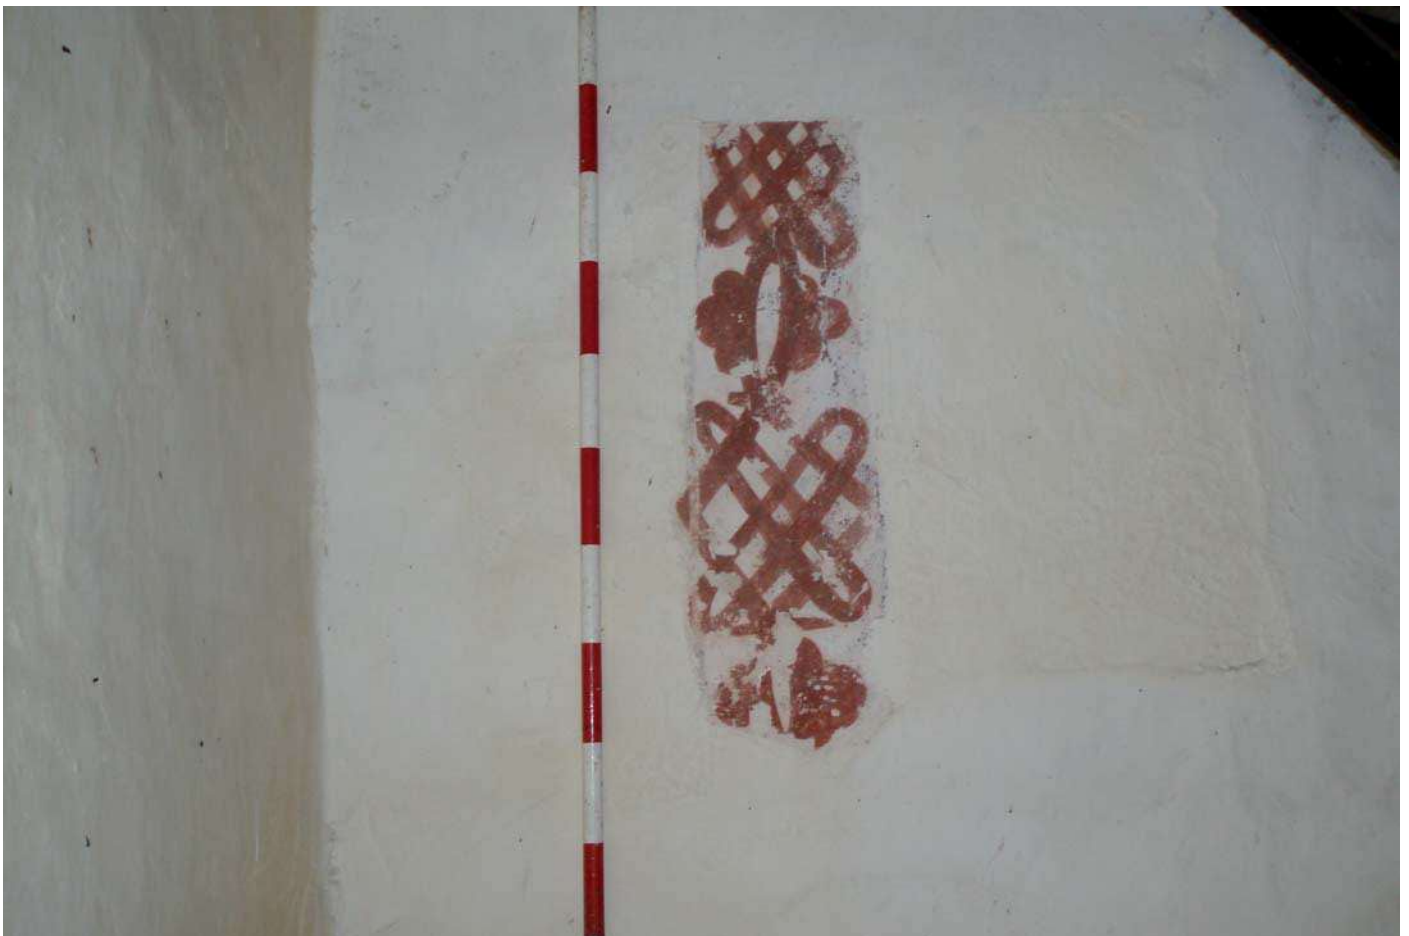
Plate 6: Wall painting at west end of nave (1m scale)

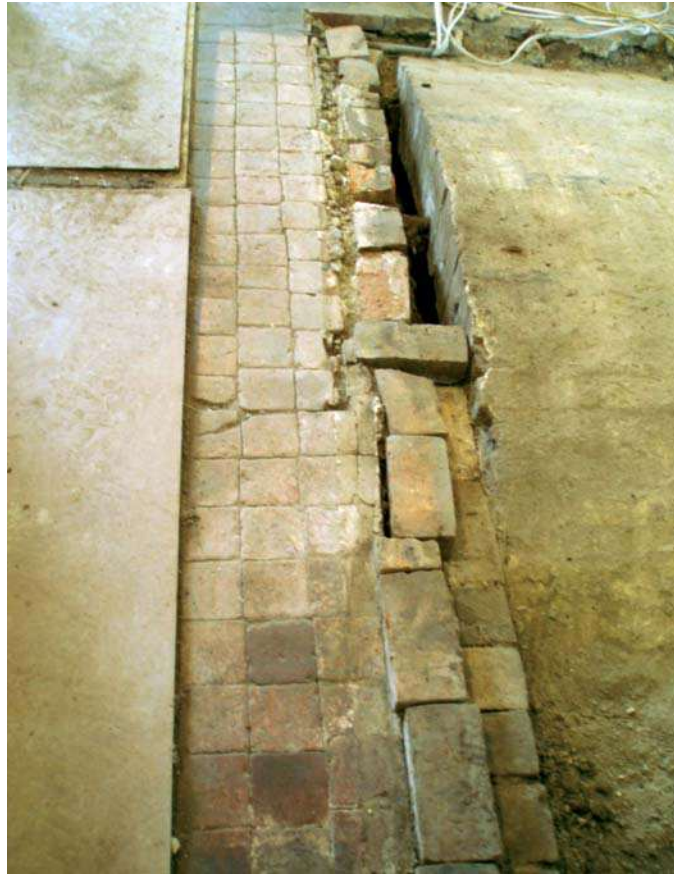
Plate 7: Part of floor of worn medieval tiles leading from south door with west end of burial vault on right (looking north)

- 3.7.1 The central passage in the nave and the passage leading from this to the south door are tiled with what appear to be largely decorated medieval tiles of local Penn type. However these floors were covered to protect them during the works and only tiles at the edges were visible. These tiles were much worn and in places covered in layers of floor wax and the designs could not be recognised except in one instance (plate 7).

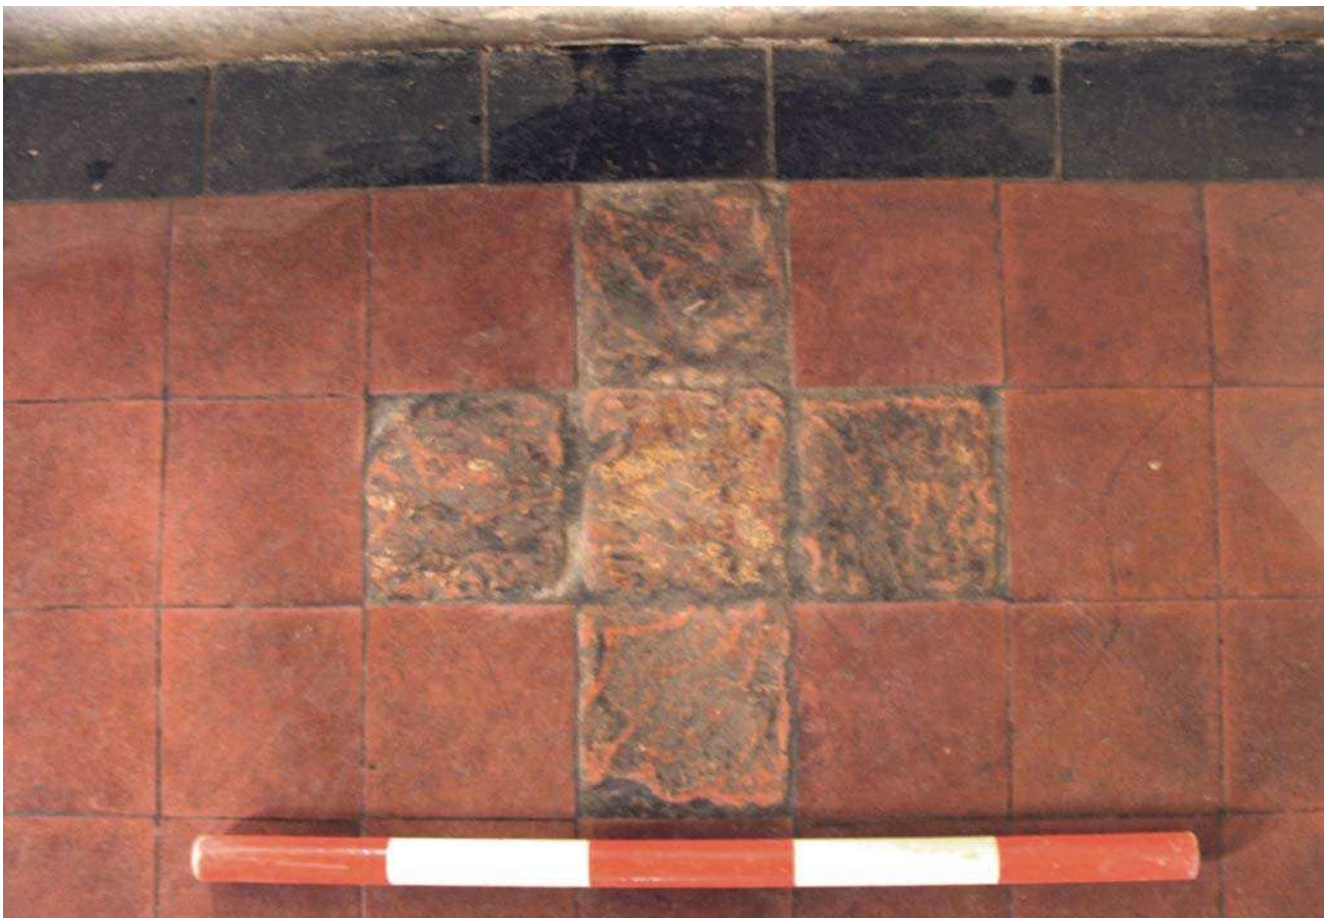
Plate 8: Cross of five medieval tiles set in chancel floor (0.5m scale)

- 3.7.2 A cross of 5 medieval Penn types was set into the Victorian tiles in the chancel. These were worn but two could be identified as type 1 as described below (section 4) (plate 8).

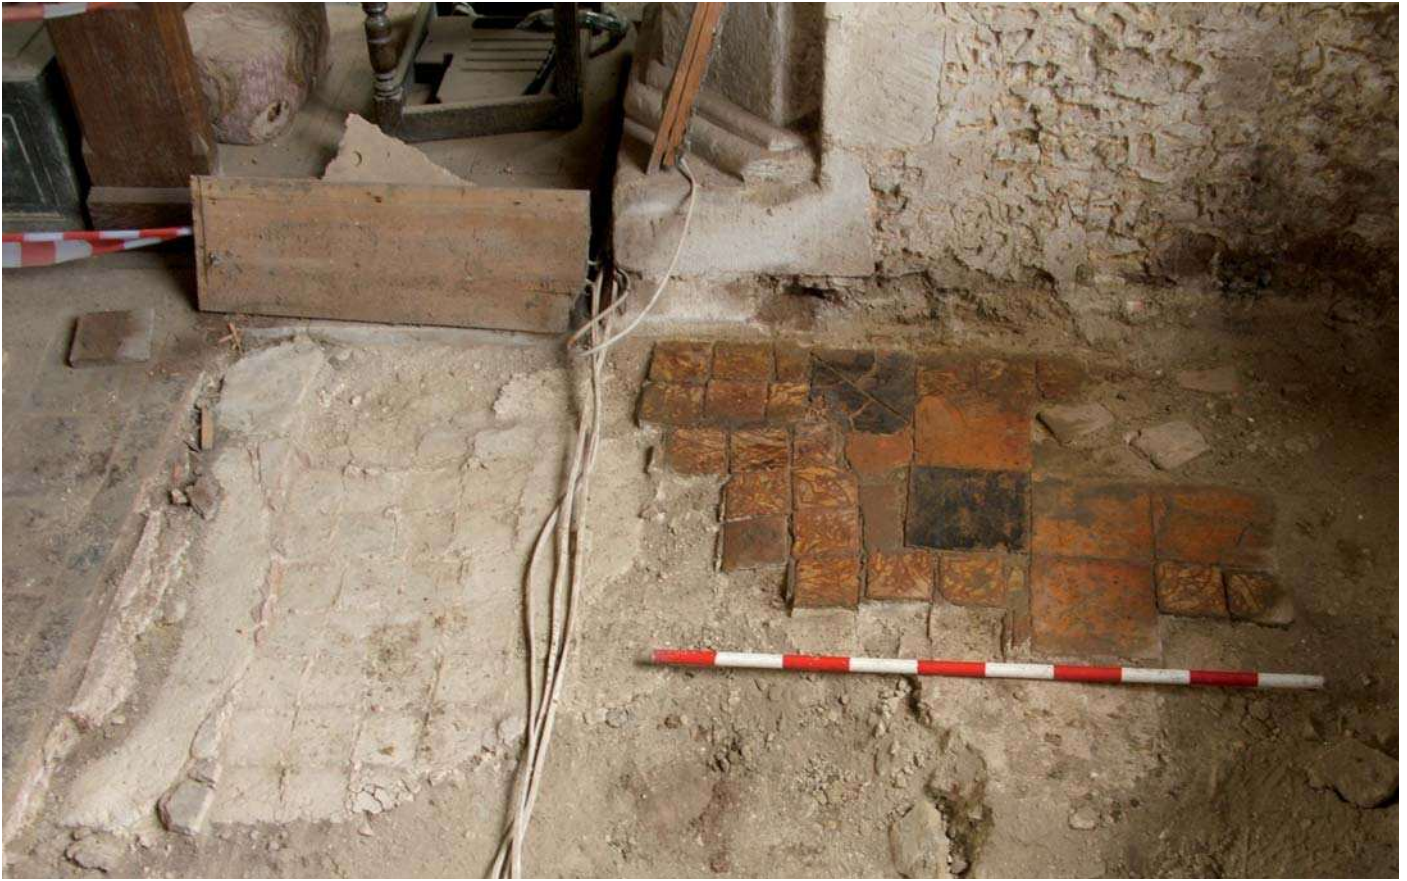
Plate 9: Remnant of tiled floor and tile impressions at east end of south side of nave (looking east, 1m scale)

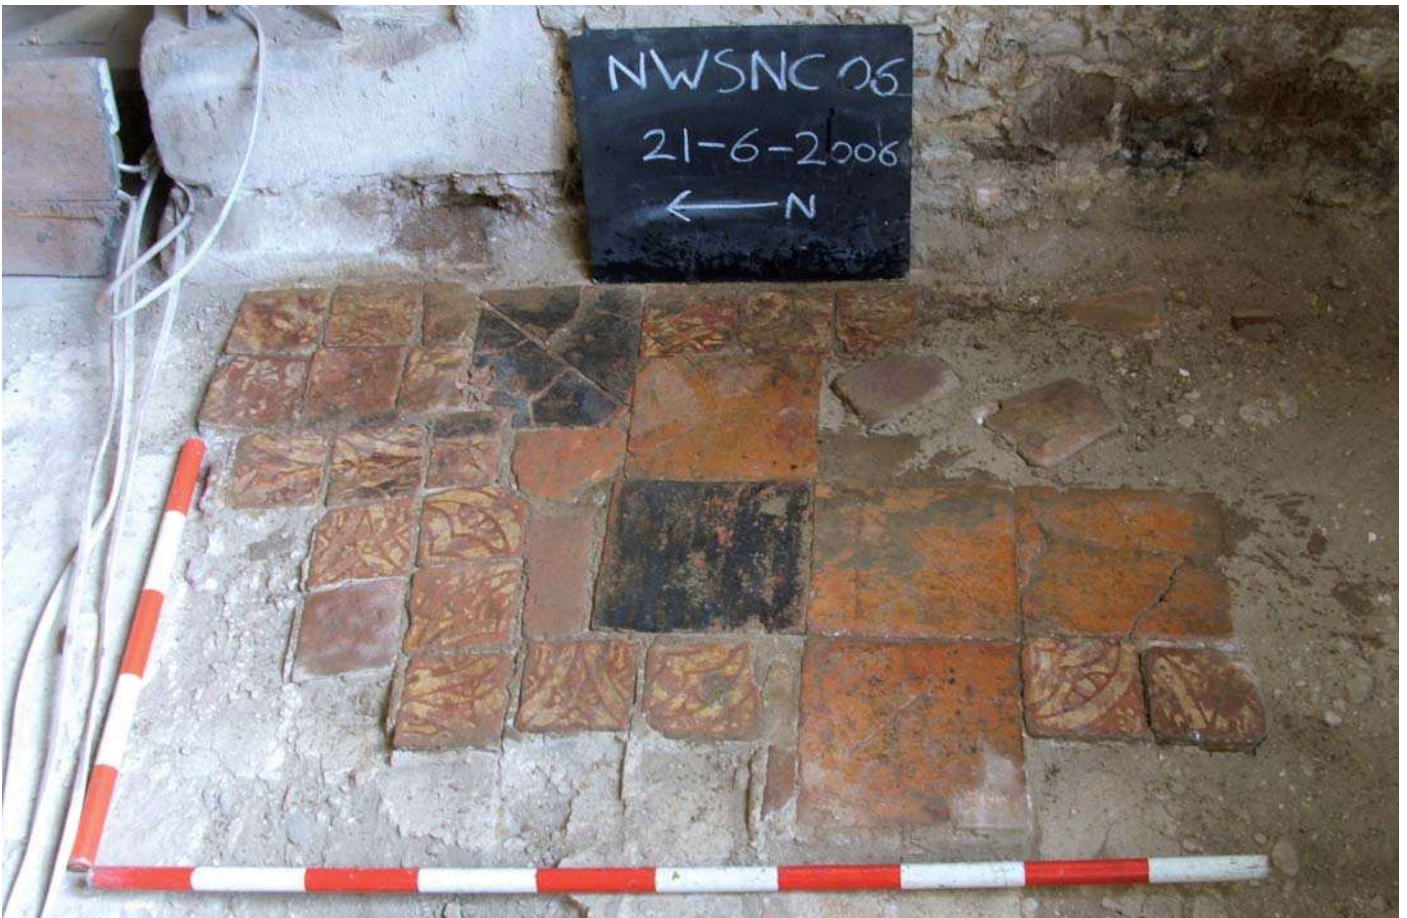
Plate 10: Remnant of tiled floor at east end of south side of nave (looking east, 1m and 0.5m scale)

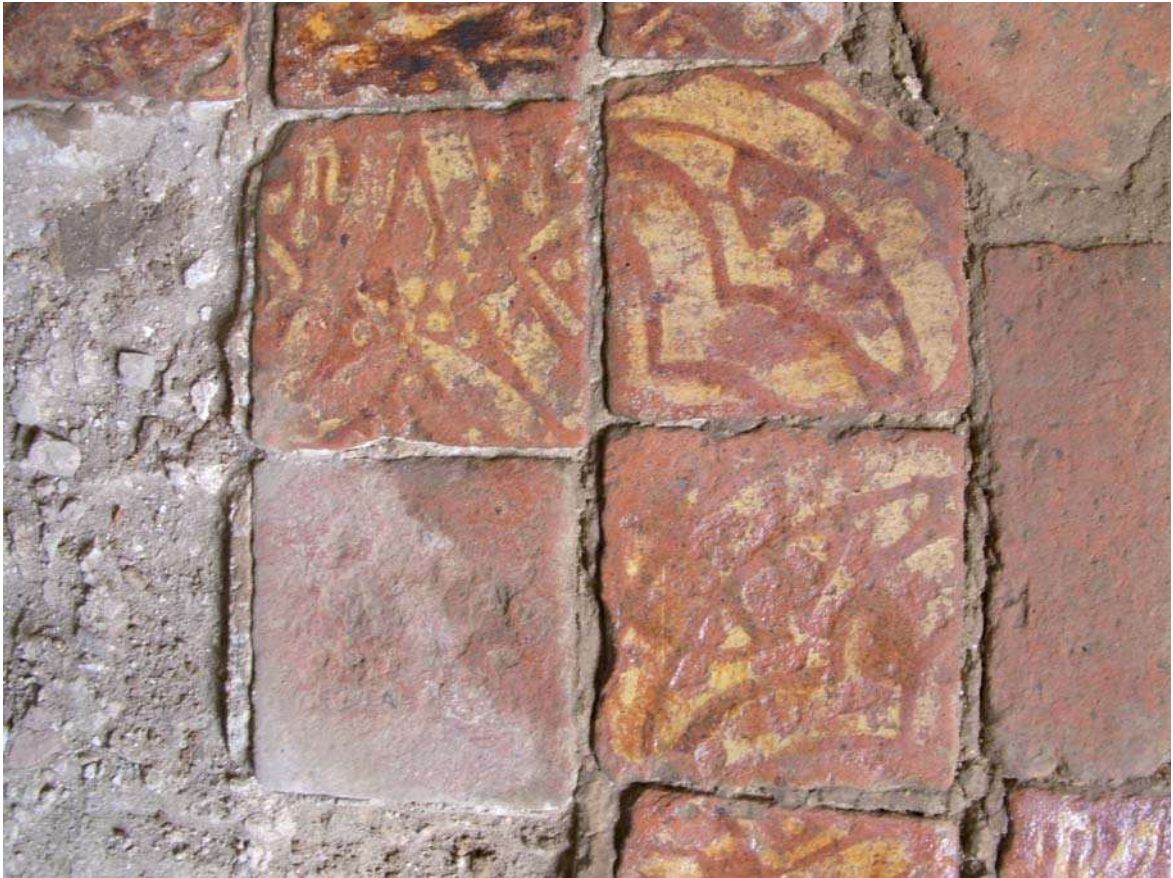
Plate 11: Part of tiled floor showing pattern type 1 on right and type 2 on left

- 4.1.6 Of type 2 there were 9 examples reused in the old floor, 2 relaid in the chancel, 3 loose from the south nave and 1 from the north nave. This is illustrated by Haberley on page 224 (fig CLXXXIII) and recorded as from Lower Winchendon. Hohler illustrates this design as D2 on page 42 and describes it on page 125 'A crude fleur-de-lis and a triangle with a dot in it, on either side of a triangle formed of parts of circles and enclosing a trefoil' he also records it only from Nether Winchendon. This design is a repeat pattern, four tiles create a mandorla design or eight tiles in pairs could create a large circle with space for a four tile pattern in the centre and single design tiles in the corners.

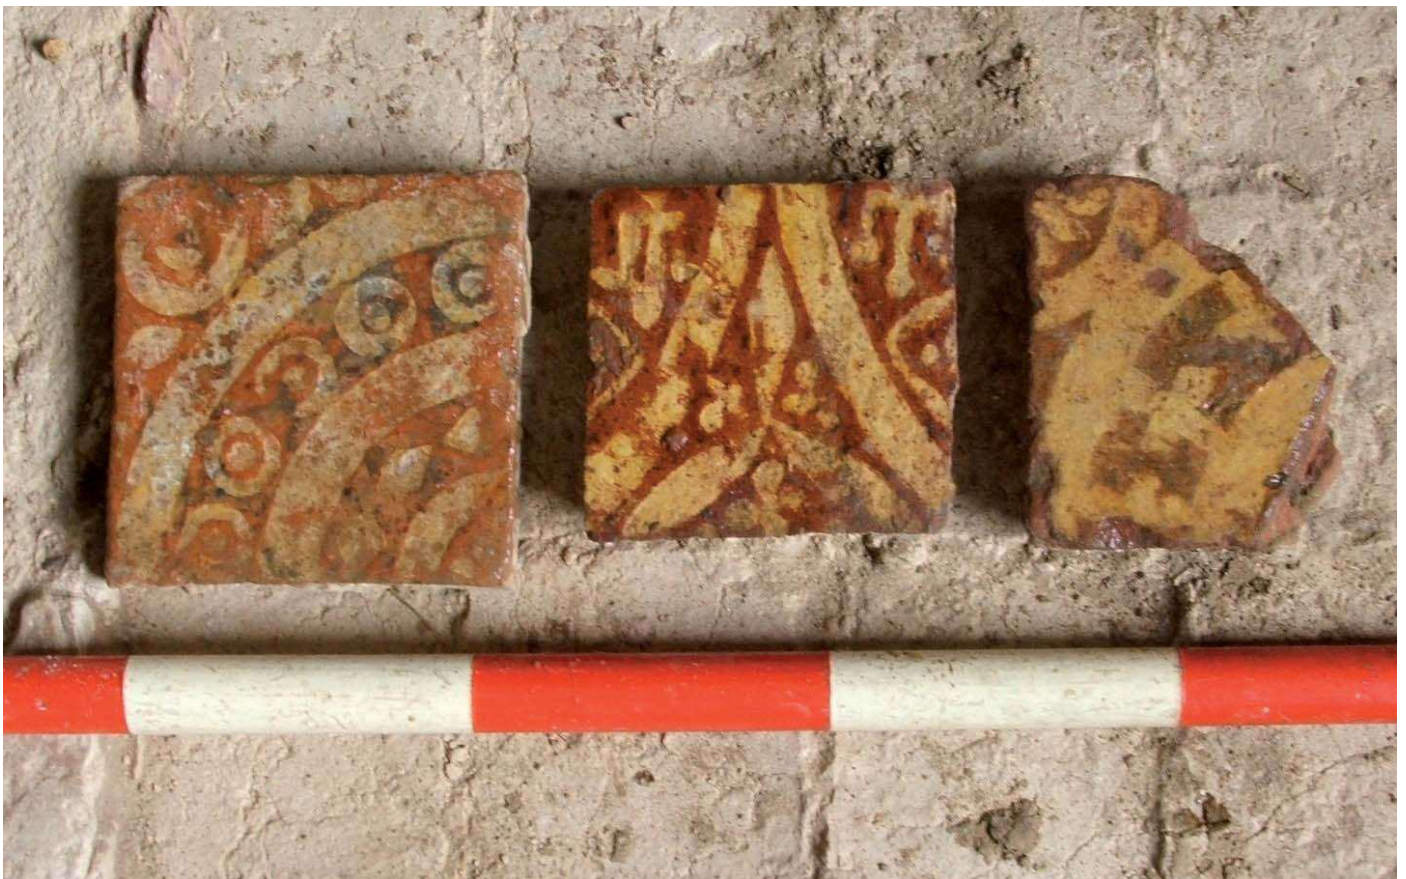
Plate 12: Loose tiles; type 3 on right, type 2 in centre and type 5 on left (scale in 10cm divisions)

- 4.1.9 Type 5 is a 4 tile pattern scheme and was represented by one loose example from the north side of the nave. This type is published in Haberley p 161 fig. CV and was recorded from Notley Abbey and Chilton and Long Crendon Churches all these three sites are in Buckinghamshire within close proximity of each other and are within 4km west of Nether Winchendon. Habereley notes that the churches were probably paved with tiles taken from Notley after its dissolution. This type was published by Hohler as P170 on page 41 and is described as 'Three concentric quadrants separated by bands of dots in rings and lozenges; in the outer angle a dot in a ring between two halved trefoils' he records it in the locations mentioned plus Wyardisbury, Bucks. Hurley Priory,

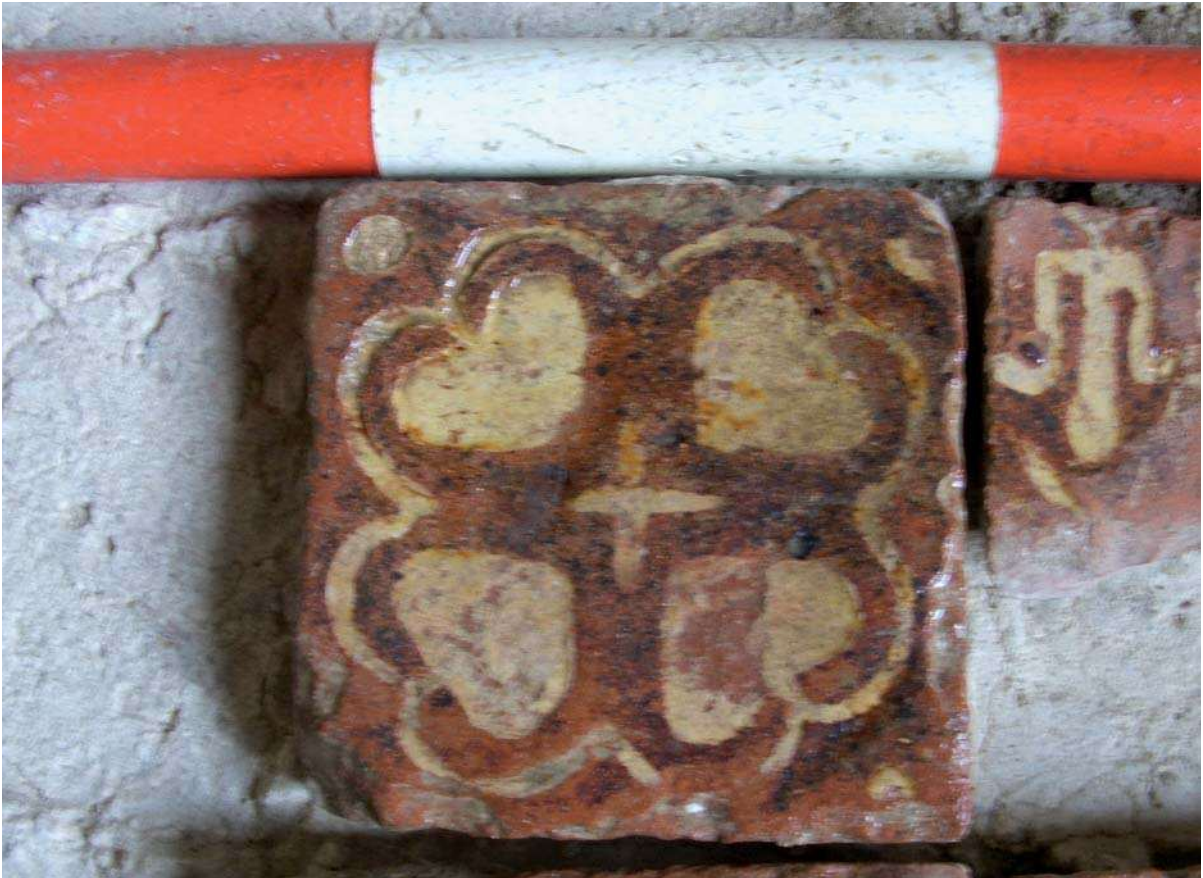
Plate 13: Loose tile; type 4 (scale in 10cm divisions)

- 4.1.8 Type 4 was the only single pattern example found; this was loose from the south side of the nave. This was also the only pattern not recorded in Hohler or Haberley. The design consisted of a diagonally set cruciform figure with lobed arms and a heart shaped leaf motif connected by a short stalk within each arm. There was a dot in each corner and a small cross in the centre. This pattern may exist elsewhere but it was beyond the scope of this project to exhaustively search the literature.

- 5.1.7 Two tiles found loose under the pews were unknown from Nether Winchendon; one of them is not recorded by Hohler or Haberley. This piece of floor clearly represents reuse of these tiles. One of the tiles types has been recorded at Oseney Abbey which was the first Oxford cathedral after the dissolution for a few years and then passed to Christ Church Oxford when the see was transferred there; Nether Winchendon belonged to Christ Church from 1542-1545.

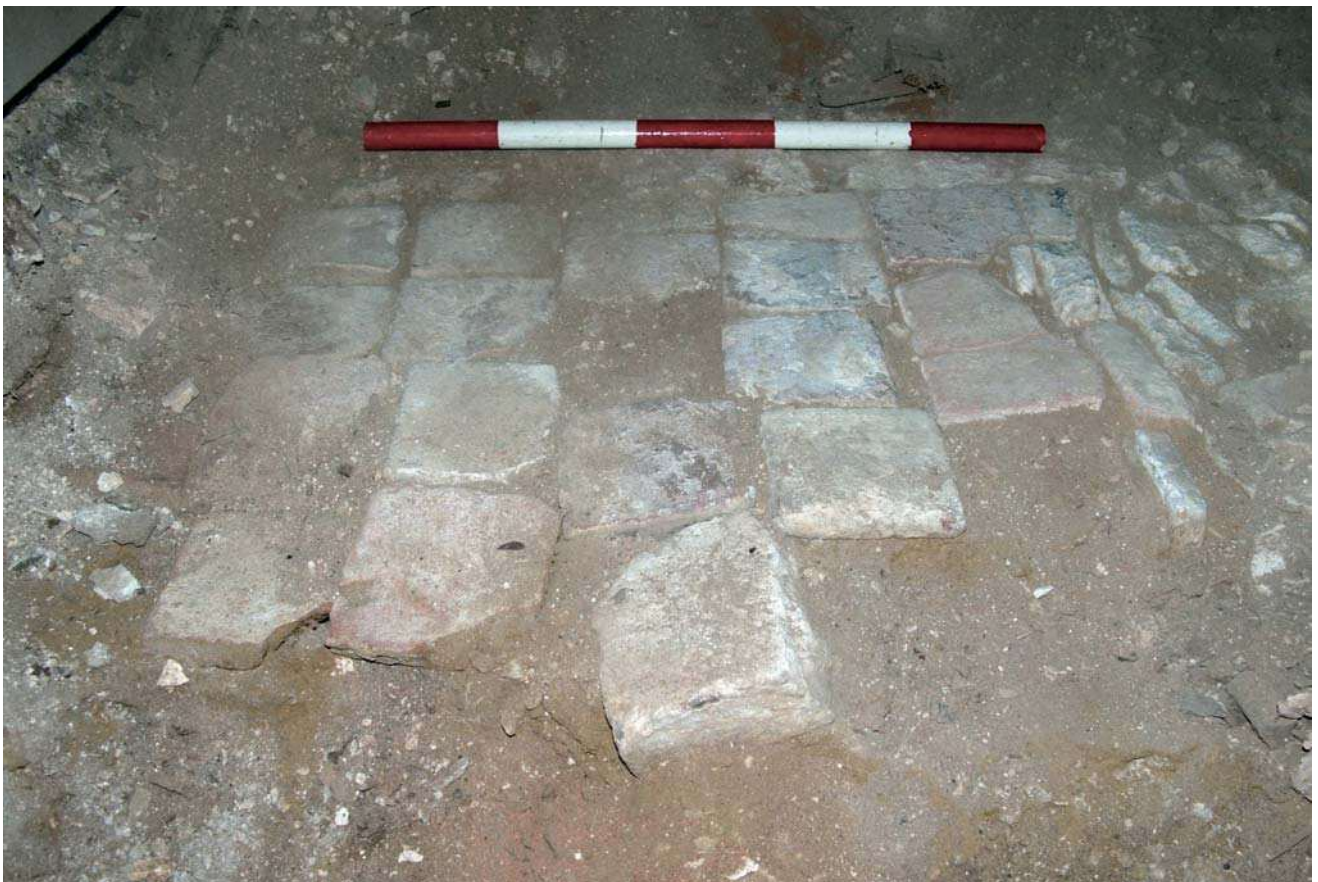
Plate 14: Tiles in recess at west end of south side of Nave (looking west, 0.5m scale)

- 3.7.7 A further small area of tiled floor was seen in a recess below a bench in the base of the west wall on the south side of the nave. This consisted of an area of about 5 x 4 small Penn type tiles that were very dirty and worn with an area of rubble stone flooring north of them. One tile was recognisable as a type 3 as described below (section 4) (plate 14).

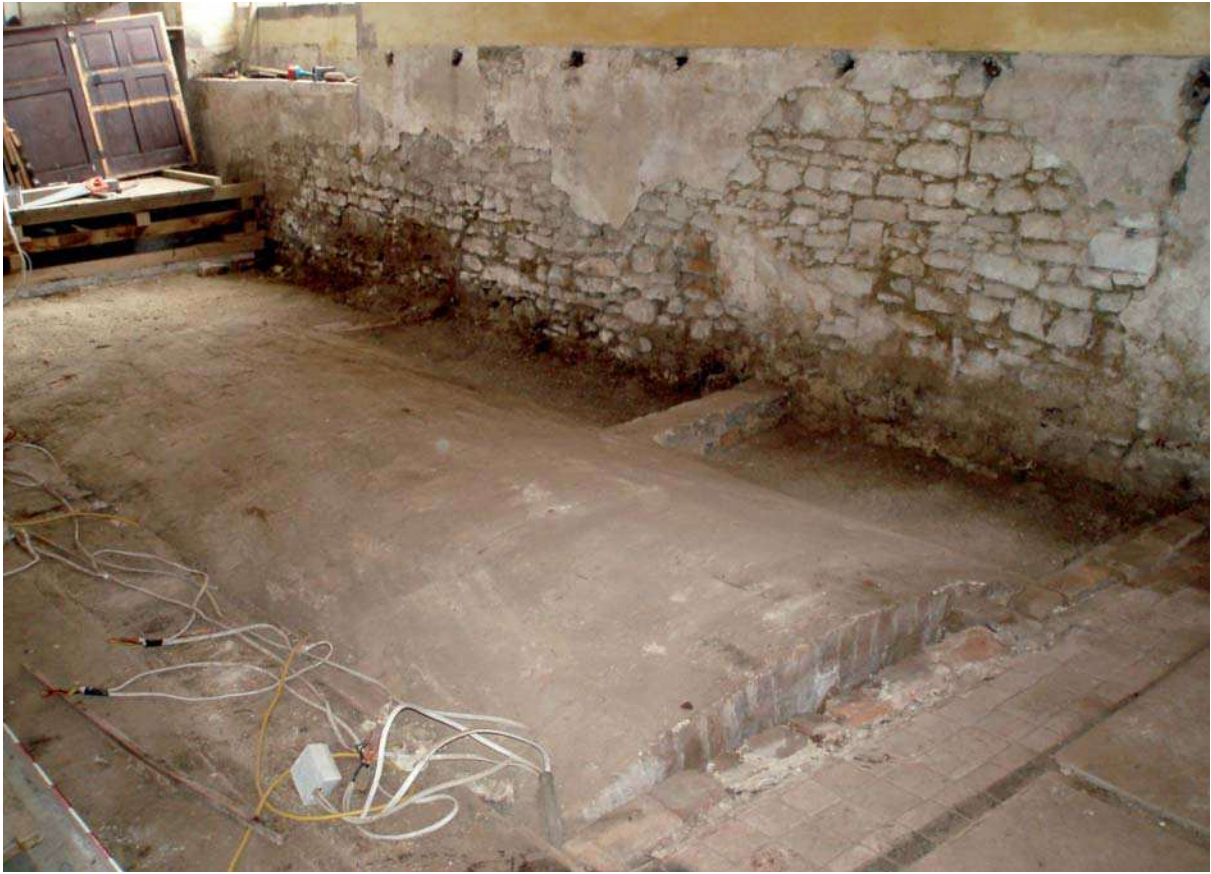
Plate 15: South wall of Nave after pews removed with burial vault to north (looking south-east)

- 3.9.1 Removal of the pews exposed the underlying deposits on the south side of the Nave. At the east end west of the remnant of tiled floor was 3-4 m long area of loose soil deposits and debris. West of this was a shallow segmental brick vault 4 m long east to west and 2m wide north to south stretching from the tiled floor at the centre of the Nave to 0.5 m north of the south wall (see plate 15). The vault projected slightly above the surrounding deposits and had slightly lower north-south brick masonry courses at the east and west ends which were the tops of the end walls. On the south a short brick wall ran from the vault to the south Nave wall and this was probably a dwarf wall for supporting part of the pew base framing.

- 5.1.21 The earth floor and underlying deposits in the central part of the south side of the Nave had been truncated by the construction of a brick burial vault with a segmental brick arched top. This was probably of late 18th or 19th century date. A digital camera held through a small gap in the west end of the vault revealed at least six lead coffins inside. Some were partially collapsed and all appeared to have the decayed remains of timber or other coverings laying on them.

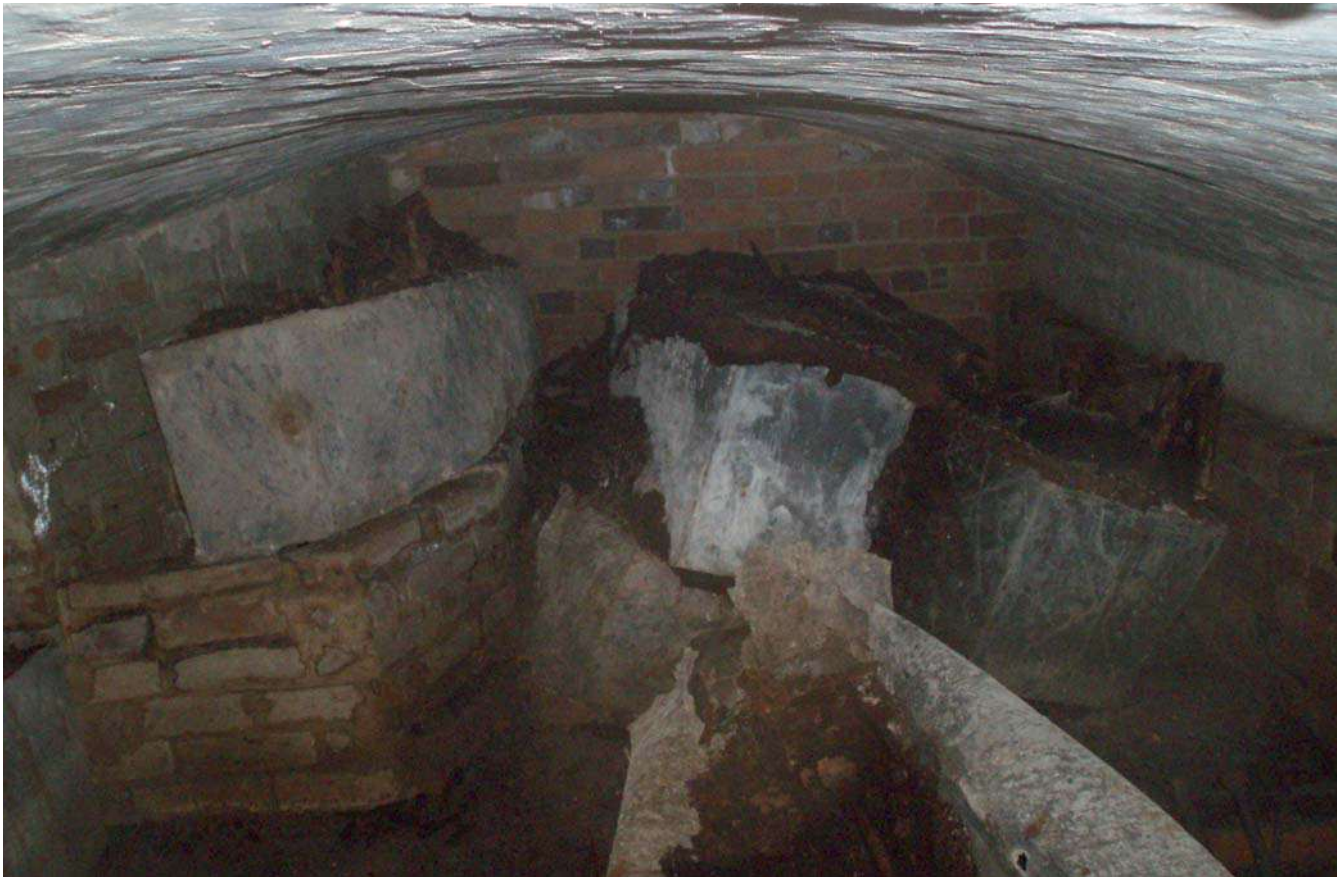
Plate 16: Interior of burial vault looking east

- 3.9.4 At the west end there appeared to be only two more coffins one on the north side of the vault and one in the centre. The coffins were all aligned east-west. Some of the coffins could be seen to be tapered with the head end at the west. Some of them could be seen to have lead tops but all had decayed material on their tops and there was some similar material on the floor and this may represent the remnants of casings of timber and /or other material.
