St Nicholas Church Nether Winchendon Buckinghamshire

Historic Building and Archaeological Recording and Investigation

Document Title: St Nicholas Church, Nether Winchendon, Buckinghamshire,
Historic Building and Archaeological Recording and Investigation

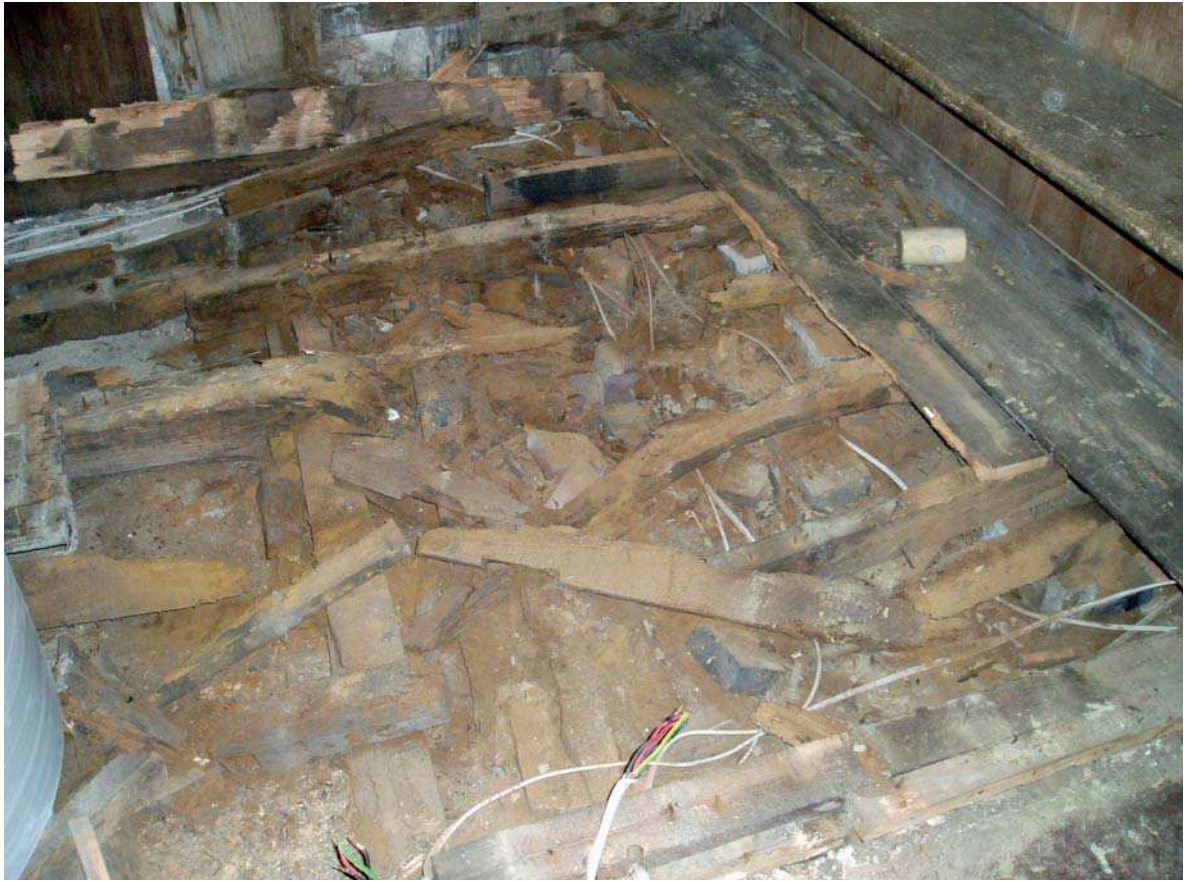
Plate 19: Pew base members before removal showing reused timbers (photo courtesy of Ward and Co.)

- 3.11.1 When the Nave pews were dismantled by the contractors the framework of joists supporting the base platforms were found to contain a substantial number of reused historic timbers (plate 19). These timbers were removed by the contractors so were not examined *in situ*.

- 3.11.2 Many of the timbers were clearly re-used medieval roof components. As both the chancel and the nave roof have been replaced in the 19th century these timbers could come from either of the earlier roofs. However the nave roof is dated 1827 and the chancel roof was replaced in the 1890s therefore it seems more likely that the date of reuse would coincide with the nave roof removal rather than that of the chancel.

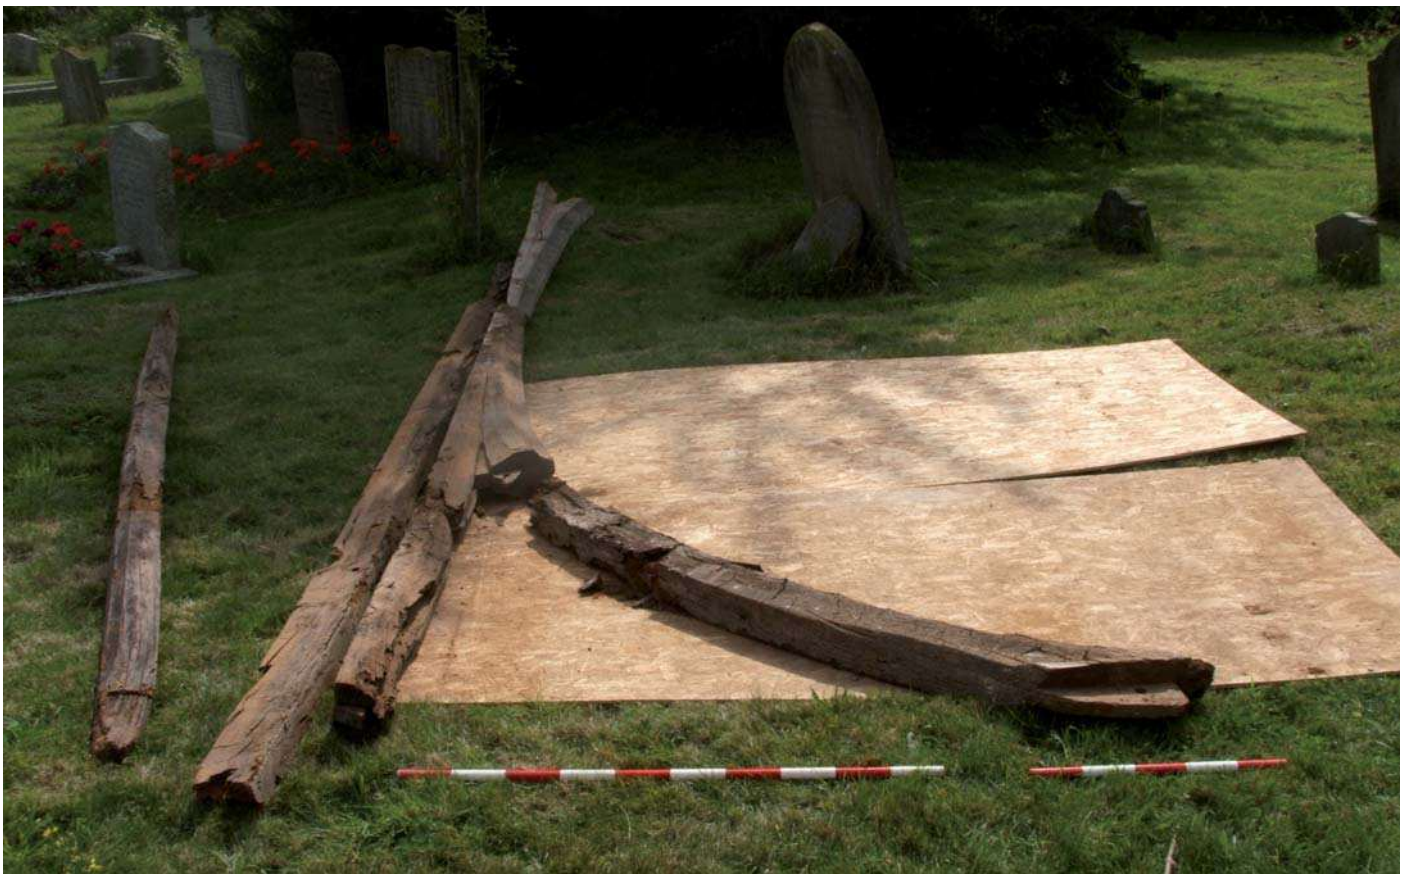
Plate 20: Reconstruction of roof truss from reused members from pew bases (1m and 0.5m scales)

- 3.11.4 Recognisable timbers found in the pew bases included examples of all the different pieces required to make up an arched braced truss, save for the wall posts, of the right size to fit the width of the nave (plate 20, figure 5). The arch brace consisted of two lower curved members and two upper shallower curved members with straight upper faces and with a Y junction at their outer ends where they were connected to the lower brace with a pegged tenon (plate 21) and simply abutted to a short straight member which continued the straight top of the spandrels across to a wall post. The lower curved braces had a large pegged tenon at their lower outer ends which would have mated with mortices in the wall posts (see plate 20 and figure 5). All members of the arch bracing were hollow chamfered. The Y pieces also had plain chamfering on the upper surface of the curved section and although the hollow chamfering was continuous on the lower and upper parts of the arch brace the hollow chamfering did not continue on the lower brace which seemed narrower than the upper piece and this problem with the reconstruction as the tenons at the ends of the Y pieces would seem to extend beyond the upper edge of the lower brace. Possibly the chamfer was continued on a spandrel panel (see below) which was pegged to the same tenon or the design was resolved in some other manner.

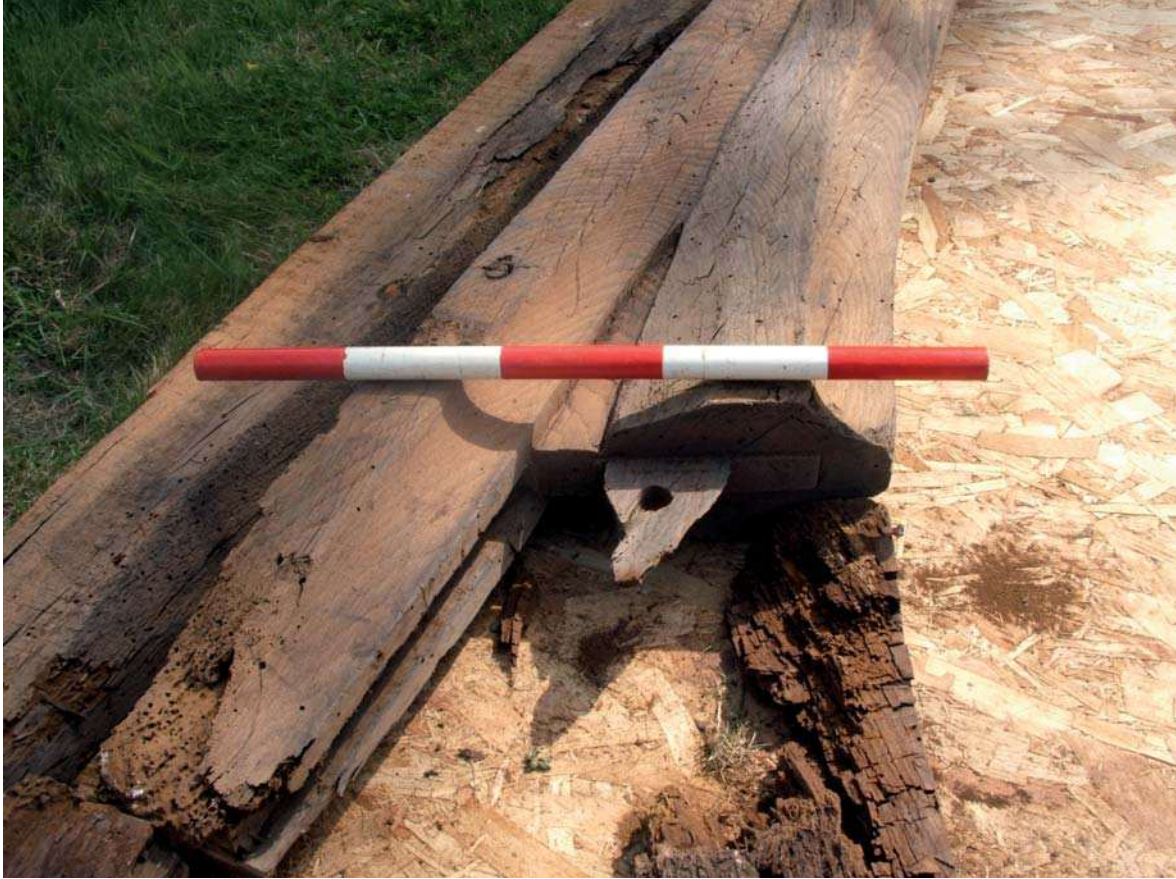
Plate 21: End of upper arch brace segment showing tenon and rebate at top of spandrel (0.5m scale)

- 3.11.5 The upper members seem to have been connected to a tie beam by free tenons; part of a beam with mortices matching those in the Y members of the brace was found. The short Y pieces of the brace had two mortices for free tenons whilst the short upper spandrel pieces had a single mortice for a free tenon and a short triangular tenon at the outer end where it would have engaged with a mortise in the wall post.

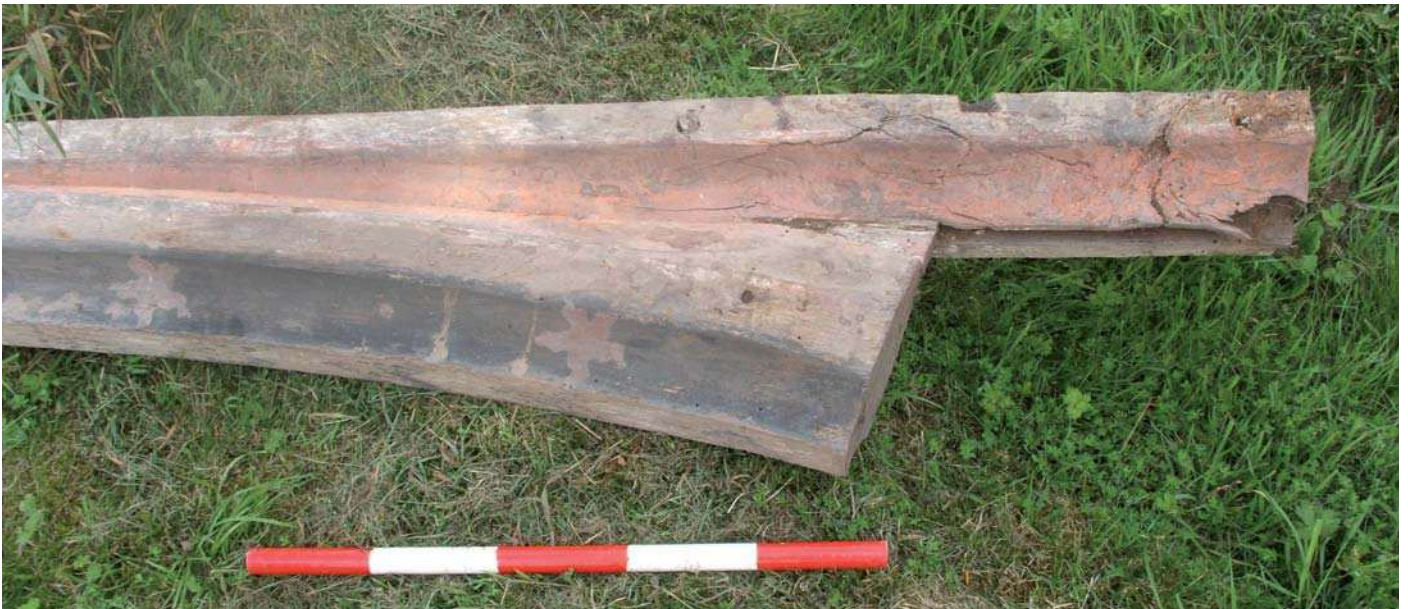
Plate 22: Upper arch brace segment with surviving decoration (0.5m scale)

Some reused timbers retained early painted decoration which included star and chevron motifs on the arch-bracing. Rebates in the spandrels show they formerly contained decorative panels probably consisting of tracery.

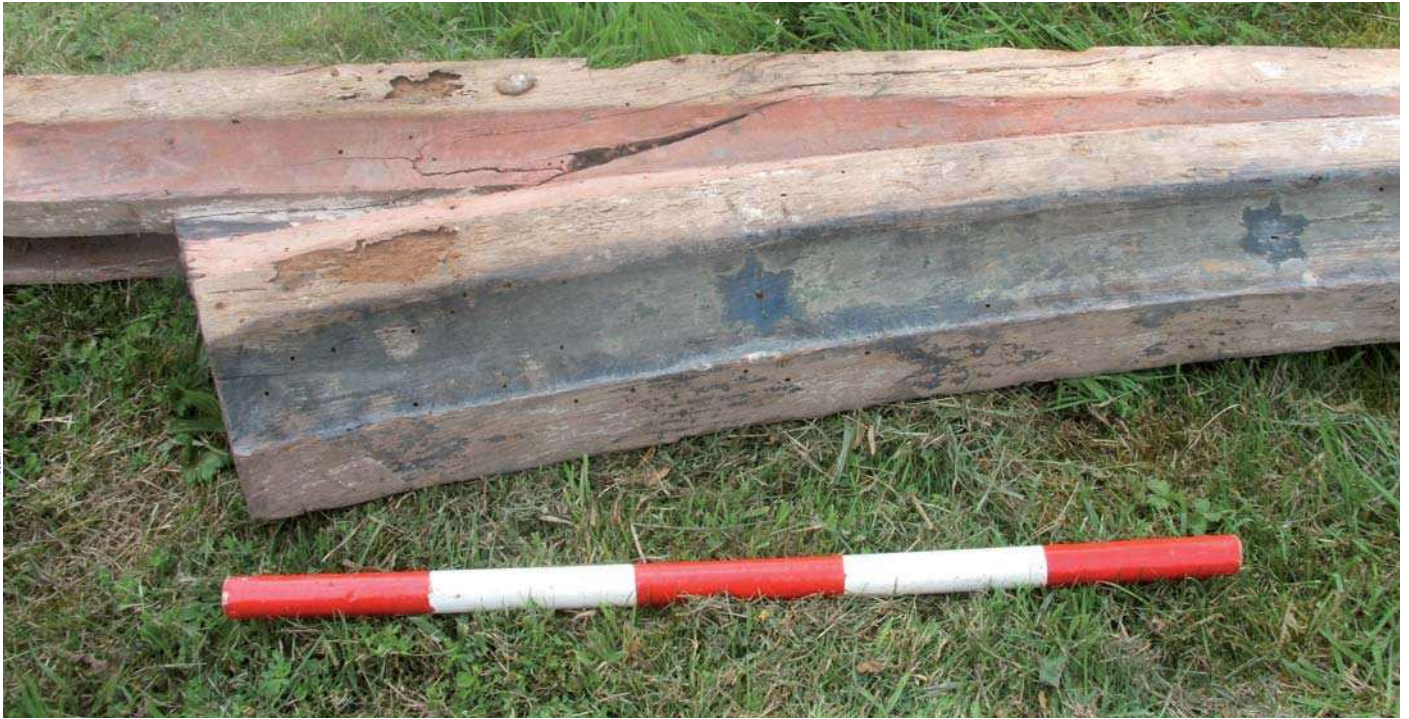
Plate 23: Decoration on opposite face of upper arch brace segment (0.5m scale)
