Marcham Park

Marcham, Oxfordshire

Archaeological Evaluation Report

August 2023

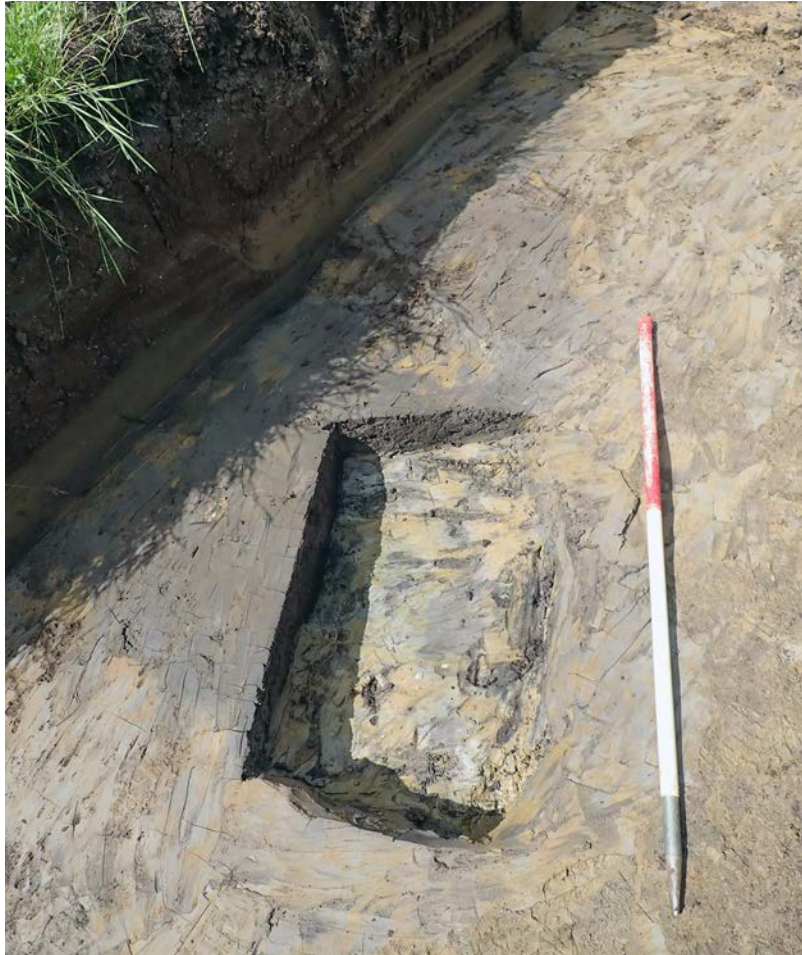
- 3.4.1 At the south-west end of Trench 1, an irregular feature (104) with near vertical sides and an undulating base was revealed (Plate 1). It contained a mixed fill of dark greyish-brown, humic, silty clay material (105). No finds were recovered from the feature and it appears to be a tree hole which was deliberately removed and then backfilled.

Plate 1: Feature 104, view to north-east

- 4.3.2 The irregular and deliberately backfilled feature in Trench 1 almost certainly derives from the removal of a tree or large shrub and then backfilling of the resulting hole. Although the pit in Trench 4 was not evidently backfilled in the same way as pit 104, it is likely to be post-medieval in date and the result of similar activity.

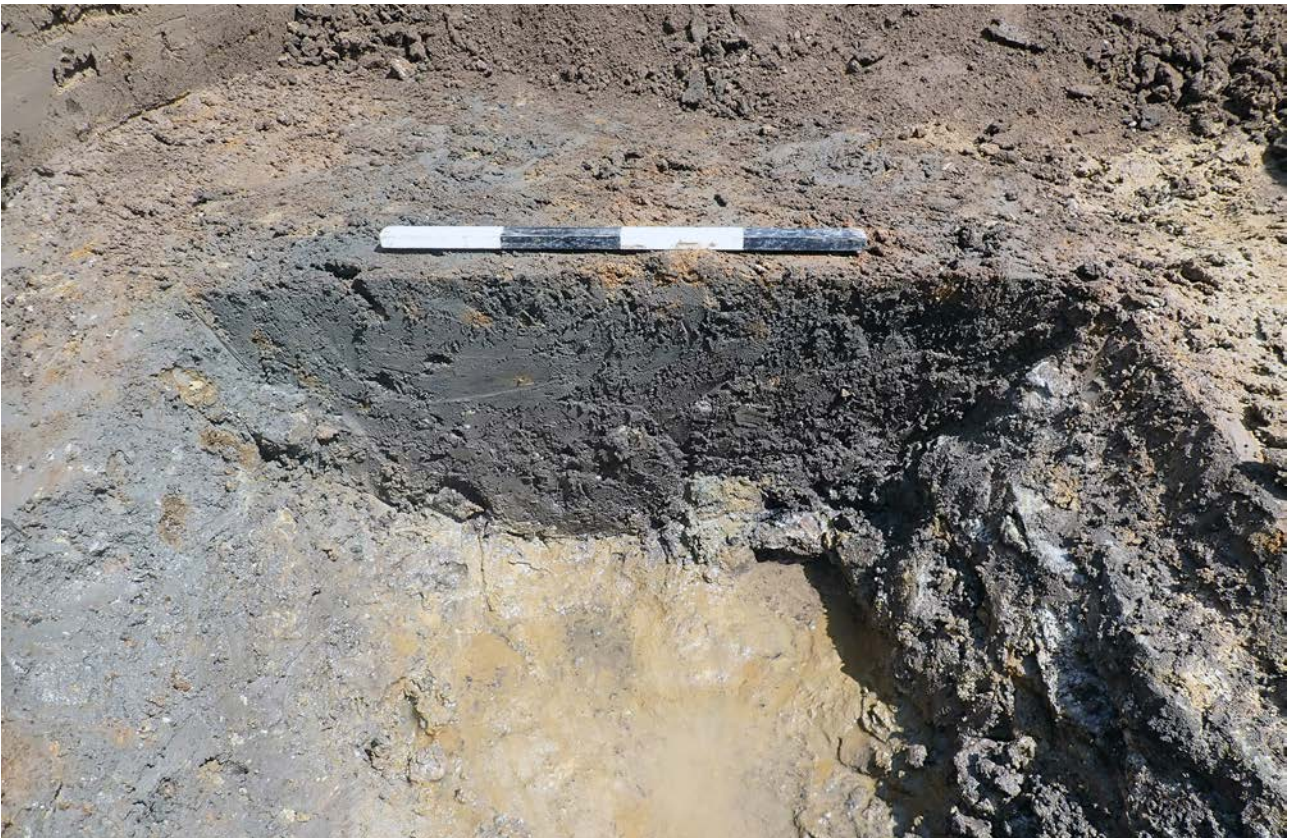
- 3.5.1 Trench 2 revealed an E-W aligned ditch (205; Plate 2). It had moderately steep sides and a broad undulating base (Fig. 4, section 201). Filling the ditch was a dark brownish-grey, silty clay (206). This appeared to be waterlogged at the time of excavation and an environmental sample was recovered. This produced a combination of anaerobically preserved organics and a mix of both freshwater and terrestrial molluscs. A single animal bone fragment was also recovered from sample.
- 3.5.2 The ditch was sealed beneath a layer of buried soil (203) which had been overlain by a deposit of made ground (202) and then the current subsoil and topsoil.

Plate 2: Ditch 205, view to east

- 4.3.1 Although undated, the ditch recorded in Trench 2 extends parallel to the field boundary to the north and it may reasonably be asserted that they were broadly contemporary, if only for a brief period. However, it does not correlate with any boundary features recorded on historic mapping, whilst the extant ditch to the north can be traced back to at least the middle to late 19th century. It is therefore likely to have originated prior to this point and then gone out of use. Based on the nature of the deposit filling the ditch and the ground conditions, it would evidently have performed a water-management function possibly relating to the fishponds that were present in 1761 when they were recorded Rocque's map of Berkshire. The ditch could have originated in the medieval period.

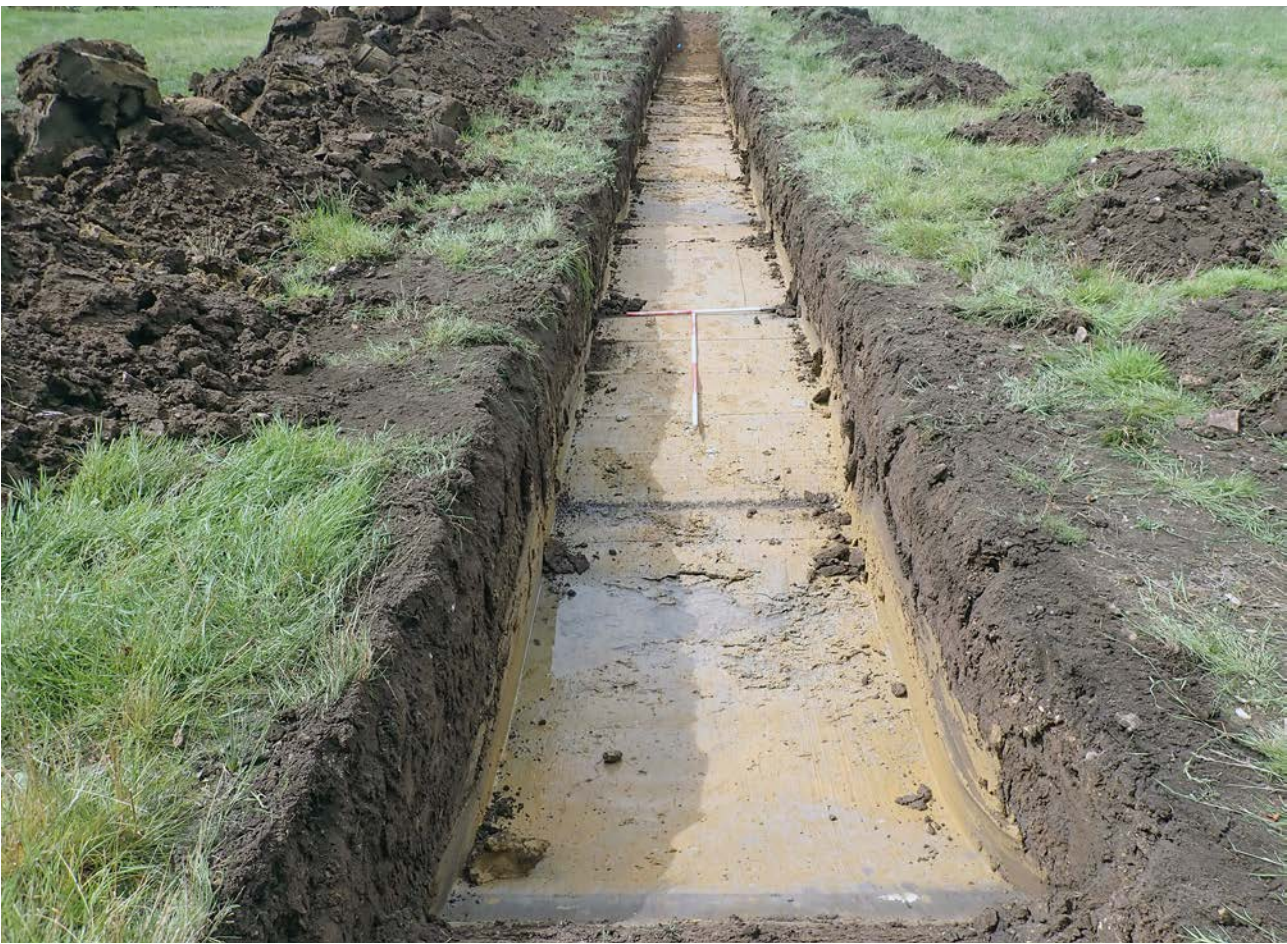
- 3.6.1 Pit 405 was recorded at the north-west end of the trench (Plate 4). It was sub-circular in plan with gently sloping sides and a concave base (Fig. 4, section 400). Filling the pit was a yellow-grey, silty clay deposit (406). A post-medieval iron nail was recovered from this deposit. The pit was sealed beneath a buried soil horizon (403) and later made-ground deposits (402 and 401; Plate 3).

Plate 3: Trench 4, looking north

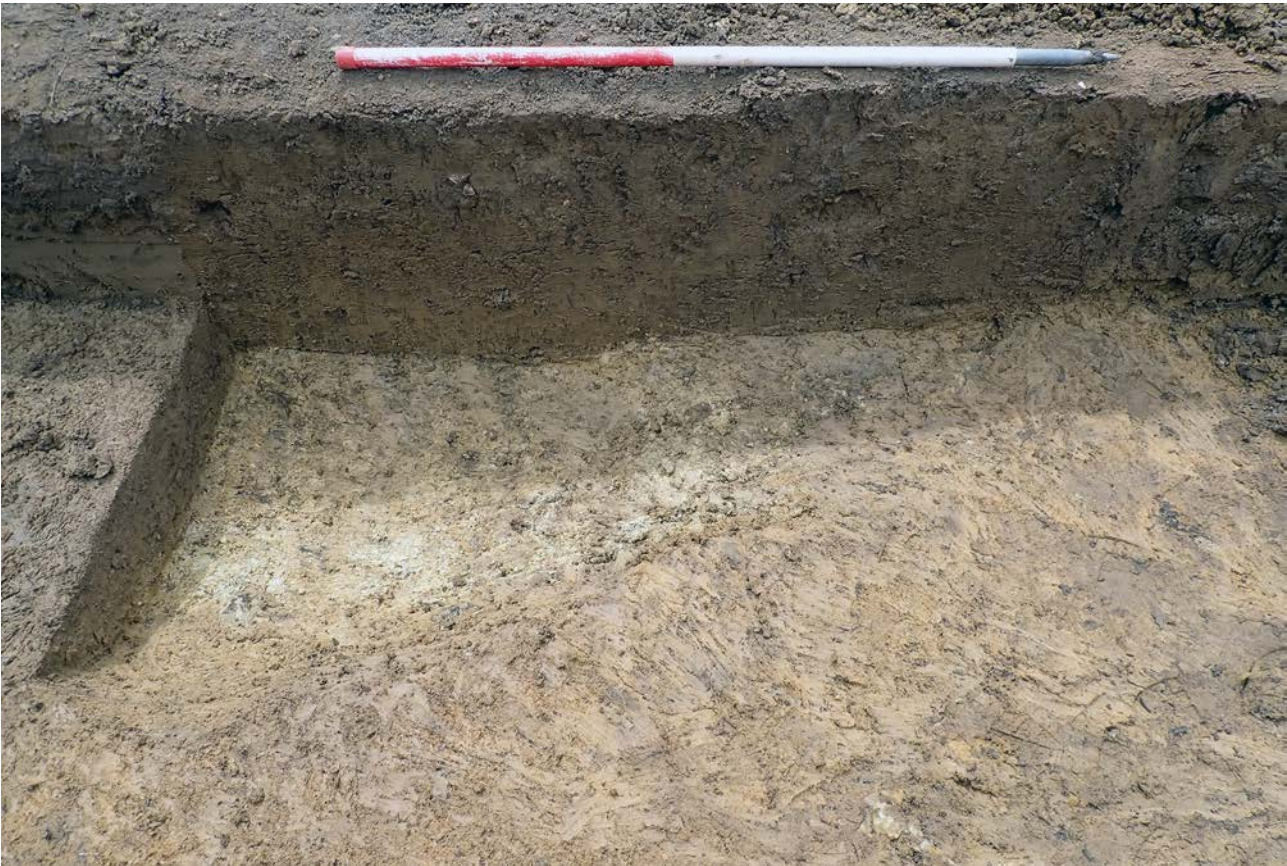
Plate 4: Pit 405, looking west

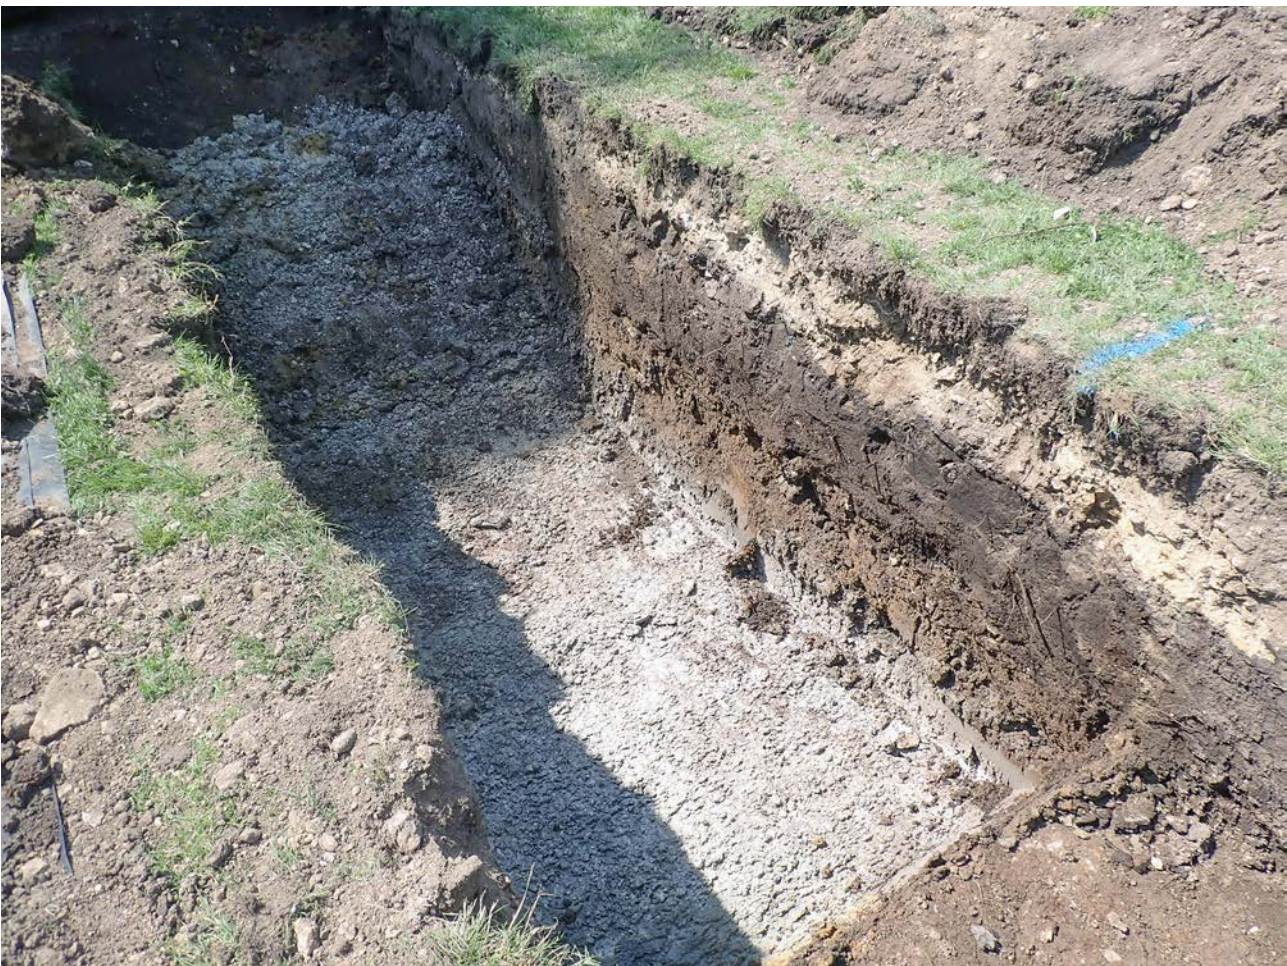
- 3.7.1 Both trenches were devoid of archaeological features, with the natural geology buried beneath deep sequences of overburden (Fig. 4, sections 300 and 500). In both trenches, these layers comprised buried soil horizons, sealed beneath redeposited natural and deposits of made ground. In Trench 5, there was a distinctive layer of stone fragments and CBM (501), sitting directly beneath the topsoil and turf (500; Plate 5). Fragments of drainpipe and a sherd of a white earthenware cup were recovered from deposit 501 and are probably mid-20th century in date.

Plate 5: Deposit sequence revealed in Trench 5, view to north-west

- 4.3.3 The deep sequences of overburden recorded in Trenches 2–5 are all likely to have formed from upcast created during the excavation of the adjacent lake. The layer of stone and CBM recorded in Trench 5 dates from the middle of the 20th century. This corresponds well with cartographic evidence that demonstrates that the lake, in its current form, was established between 1914 and 1959.
