# UNDER THE ORACLE

Excavations at the Oracle Shopping Centre site 1996-8:  
the medieval and post-medieval urban development  
of the Kennet floodplain in Reading

Thames Valley Landscapes Monograph No 36

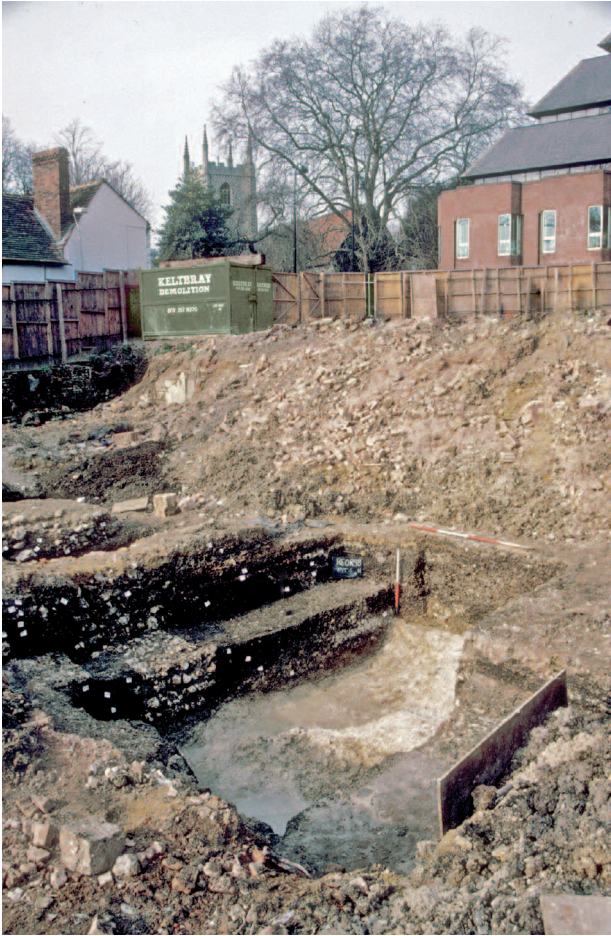
Plate 2.1 Site 29: view looking W of quarry pits at the base of the medieval sequence with St Mary's Church in the background (Project Phase 1)

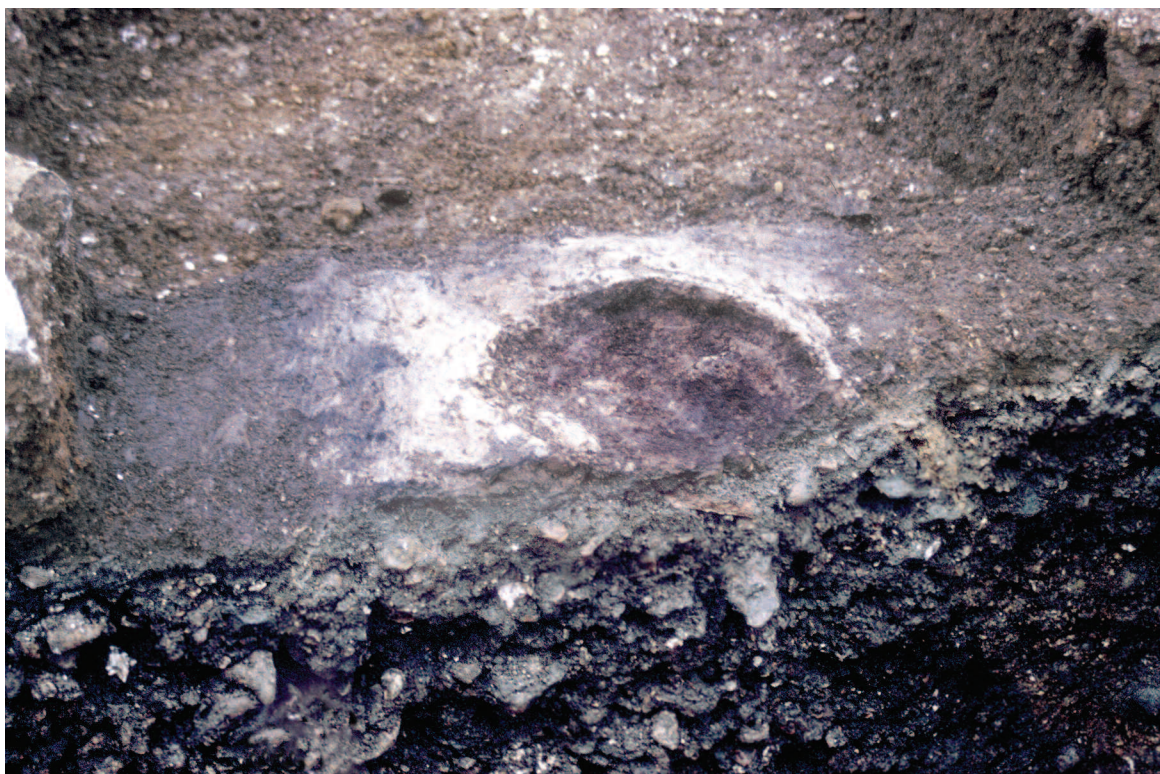
*Plate 2.2 Site 29: circular indentation in hearth 6882 where a large cooking vessel had stood (Project Phase 2)*

ceramic vessel (Plate 2.2). A large quantity of pottery was recovered from the occupation layer that surrounded the hearth (6883=6806=6992). Many pieces fitted together to form the rim and upper body and the base and lower body of two large jars. Both were made in the local fine sandy ware tradition (F1) and had deposits of soot on their outer surfaces, and either of them could have been the vessel that occupied the void in the hearth. A short distance from the hearth was a further scorched area, in the centre of which was part of a stone lamp (ST. 815; Fig. 2.4). This type of lamp is considered rare and is a relatively high status object (Shaffrey, Chapter 9). Two fragments of re-used Roman tegula (roofing tile) were also recovered from the occupation layers.

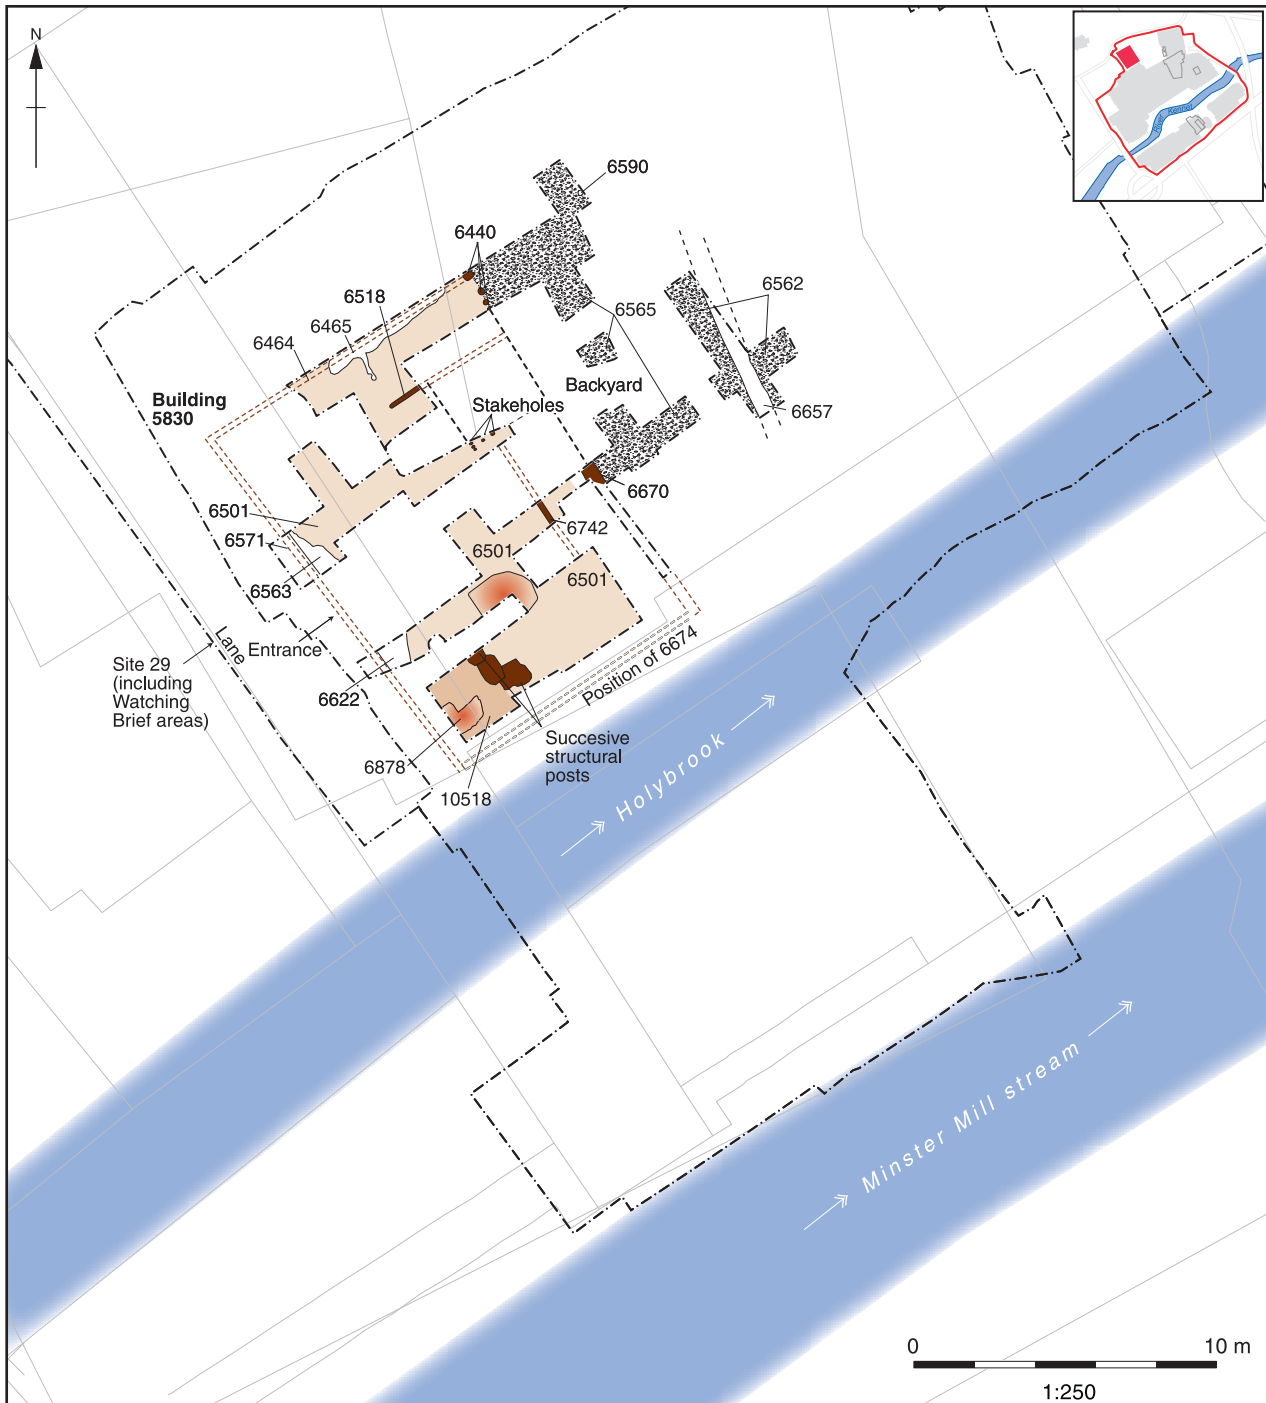
Fig. 2.5 Site 29: plan of Building 5830 (Project Phase 2)

Stakeholes and beamslot alignments (6518 and 6742) within the floor surface suggest that the eastern side of the structure had been divided into three small rooms or bays. From north to south, these measured 2.0 by 4.5 m; 2.5 by 3 m; and 2.5 by over 4.0 m respectively. It is possible that the western side of the structure was a single space, although the area excavated was limited and any internal divisions could easily have been missed. Compacted chalk and mortar surfaces 6501 = 6770 measuring

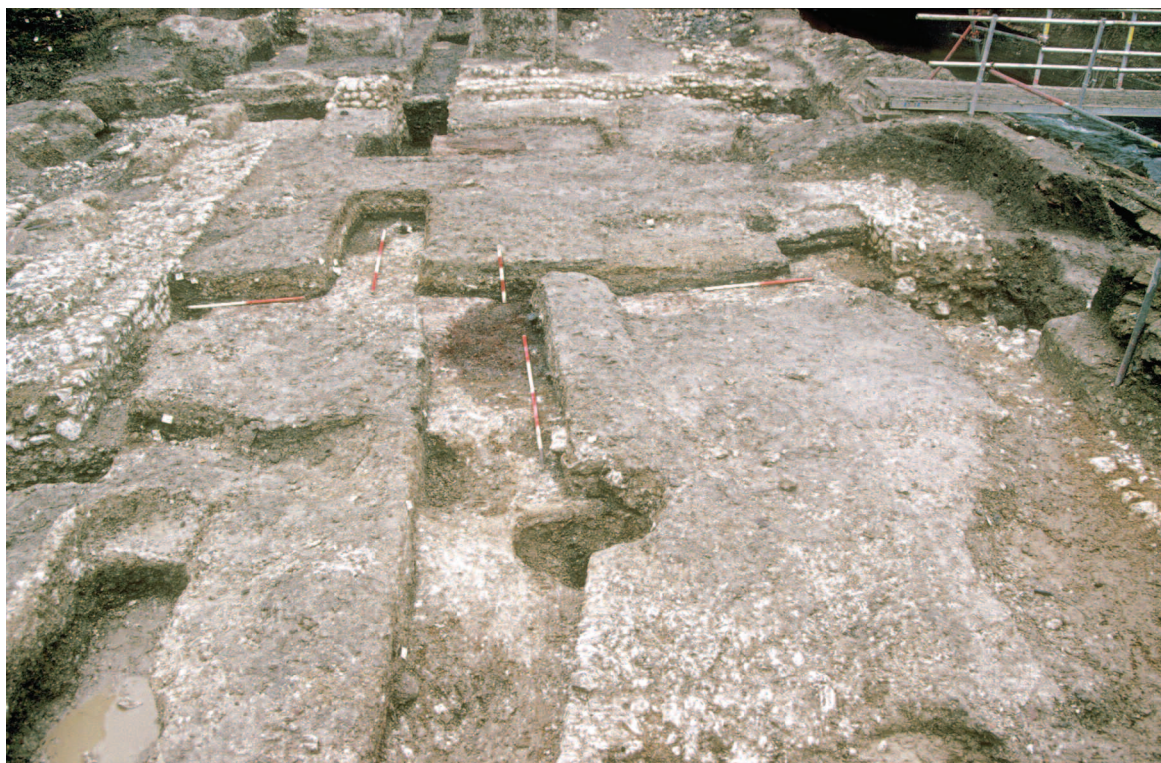
Plate 2.3 Site 29: view looking NE of partially revealed internal floor 6501 with hearth within Building 5830 (Project Phase 2)

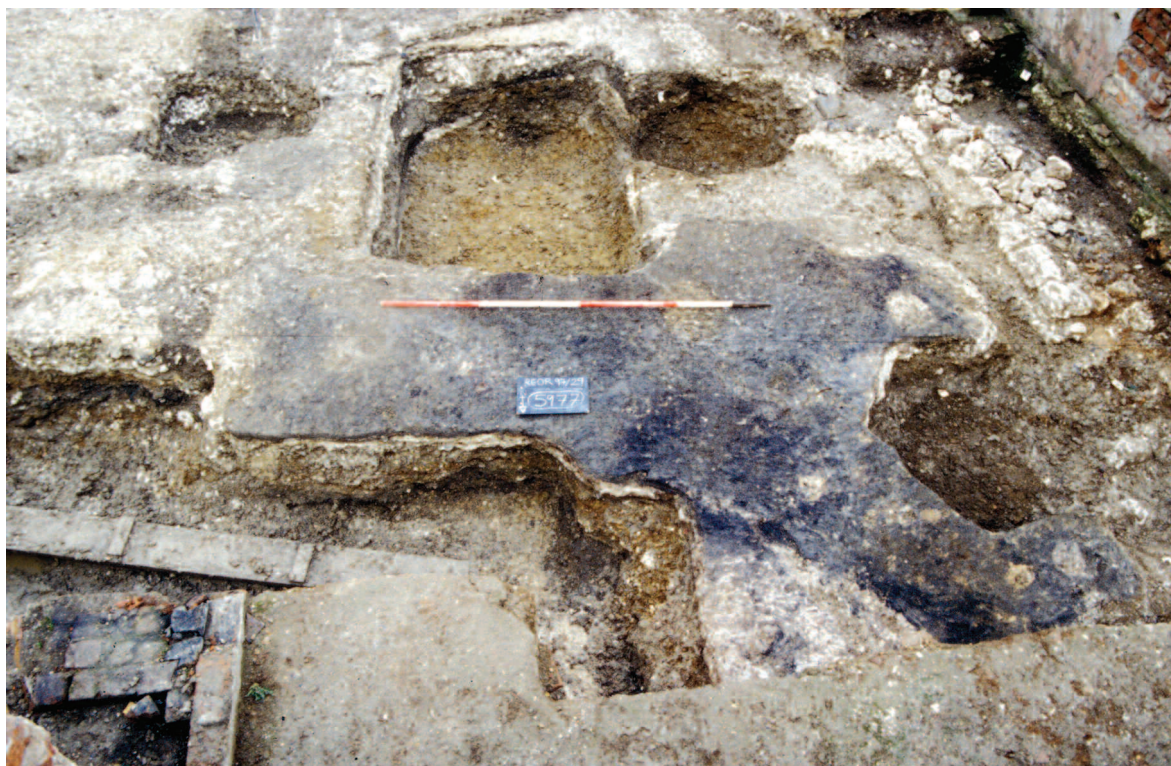
Plate 2.4 Site 29: view looking SW of the heavily fire-scorched hearth area within Building 5820 (Project Phase 2)

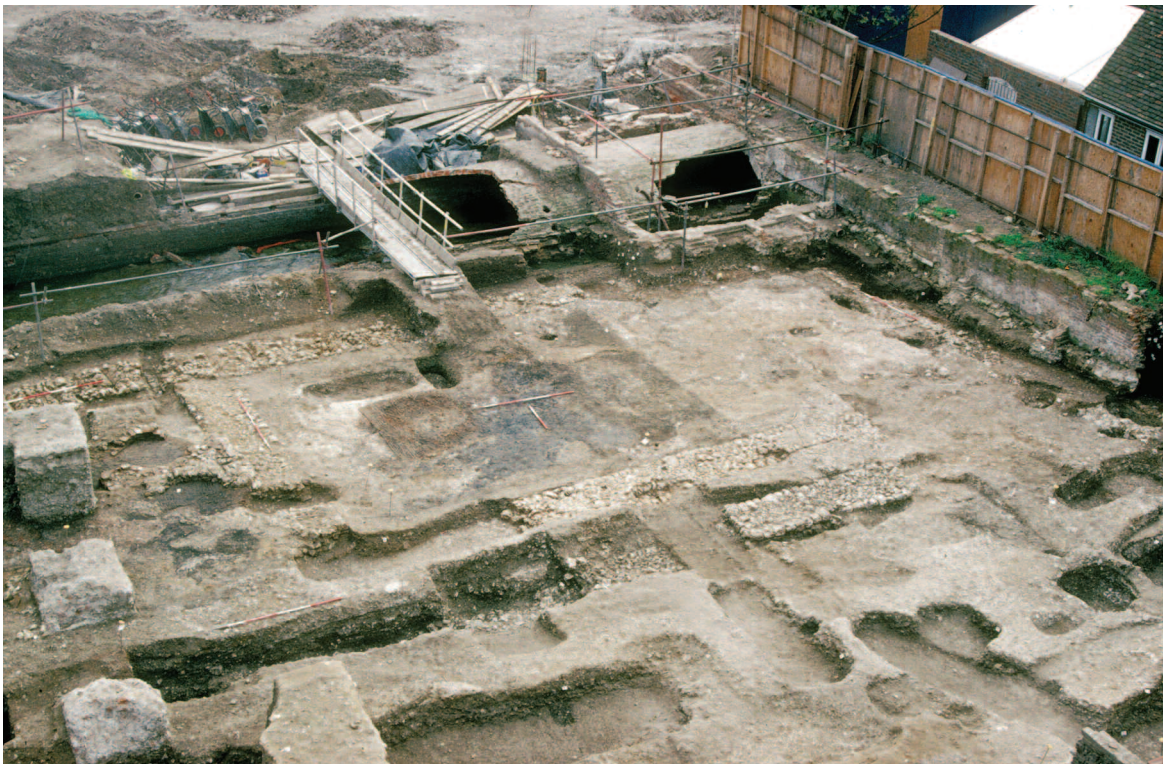
Plate 2.5 Site 29: view looking S with Building 5840 in the mid-ground and the Holy Brook in the background

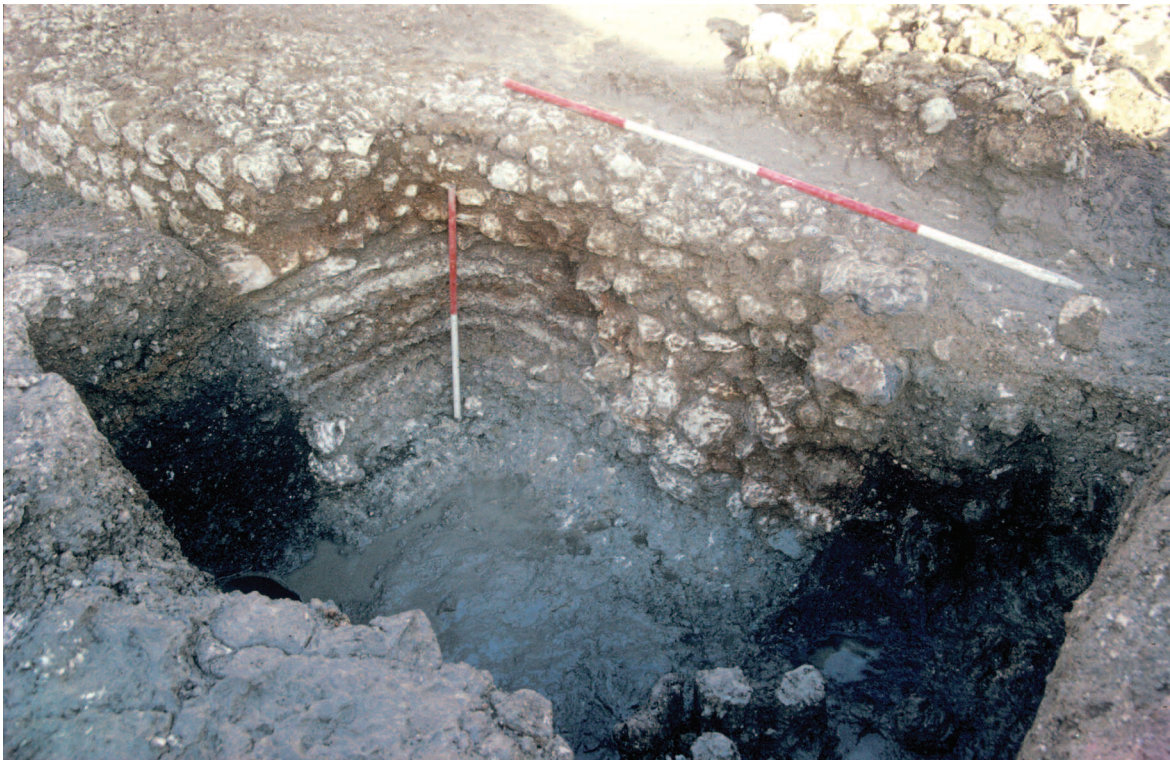
Plate 2.6 Site 29: view looking N showing detail of the foundations and footings at the south-east corner of Building 5840 (Project Phase 3)

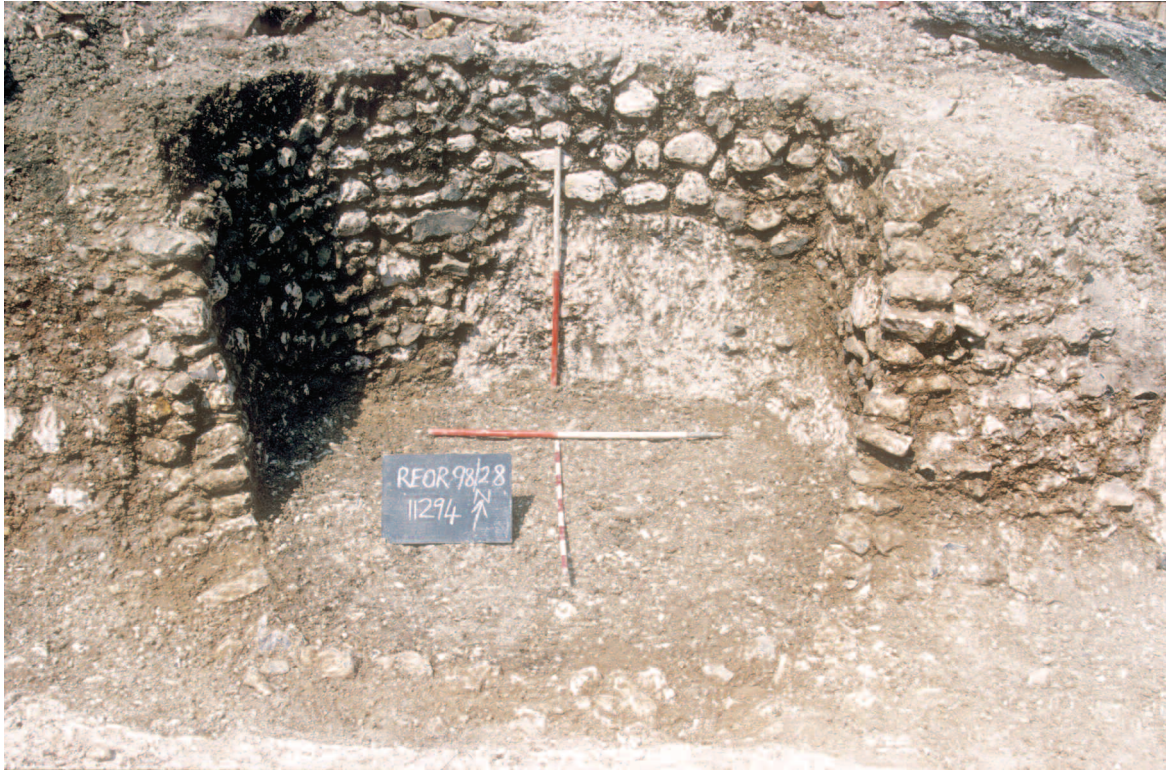
Plate 2.7 Site 29: view looking N of partially excavated stone-lined cess pit 11294 located on Fig. 2.7 (Project Phase 3)

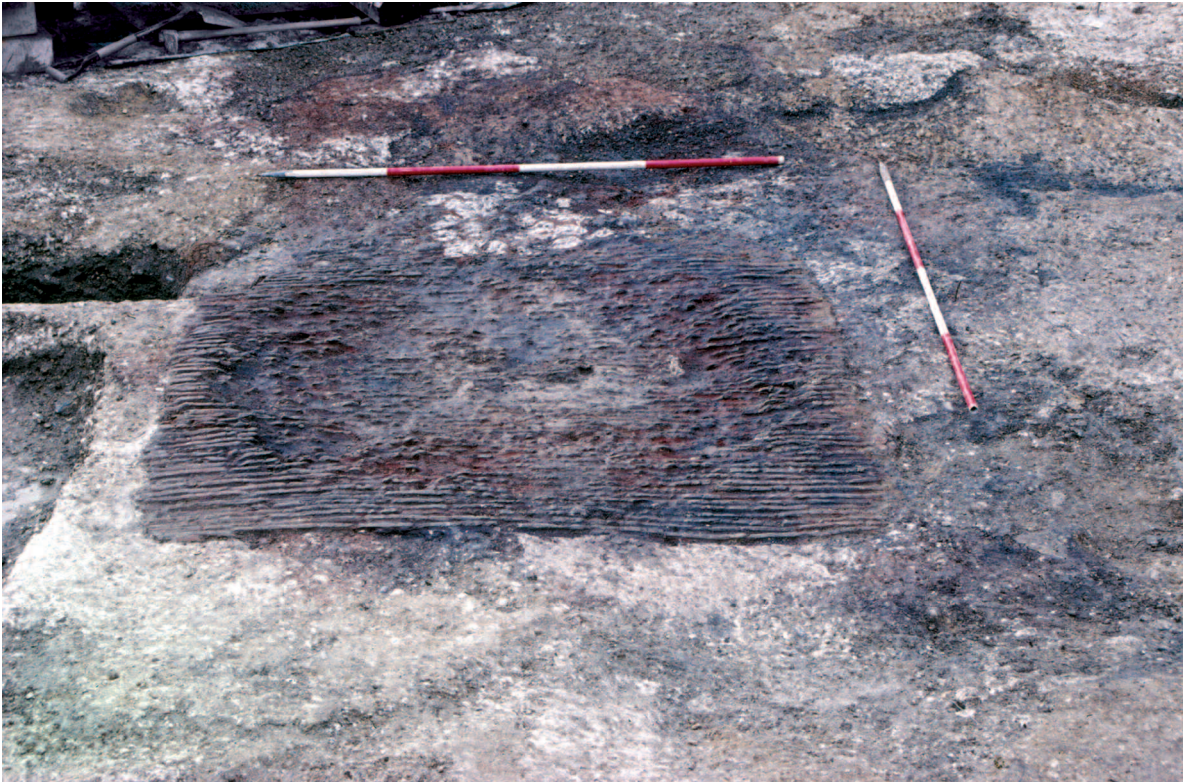
Plate 2.8 Site 29: detail of central hearth 6117 from Building 5840: (above) looking SW before excavation and (below) looking NW after partial excavation (Project Phase 3)

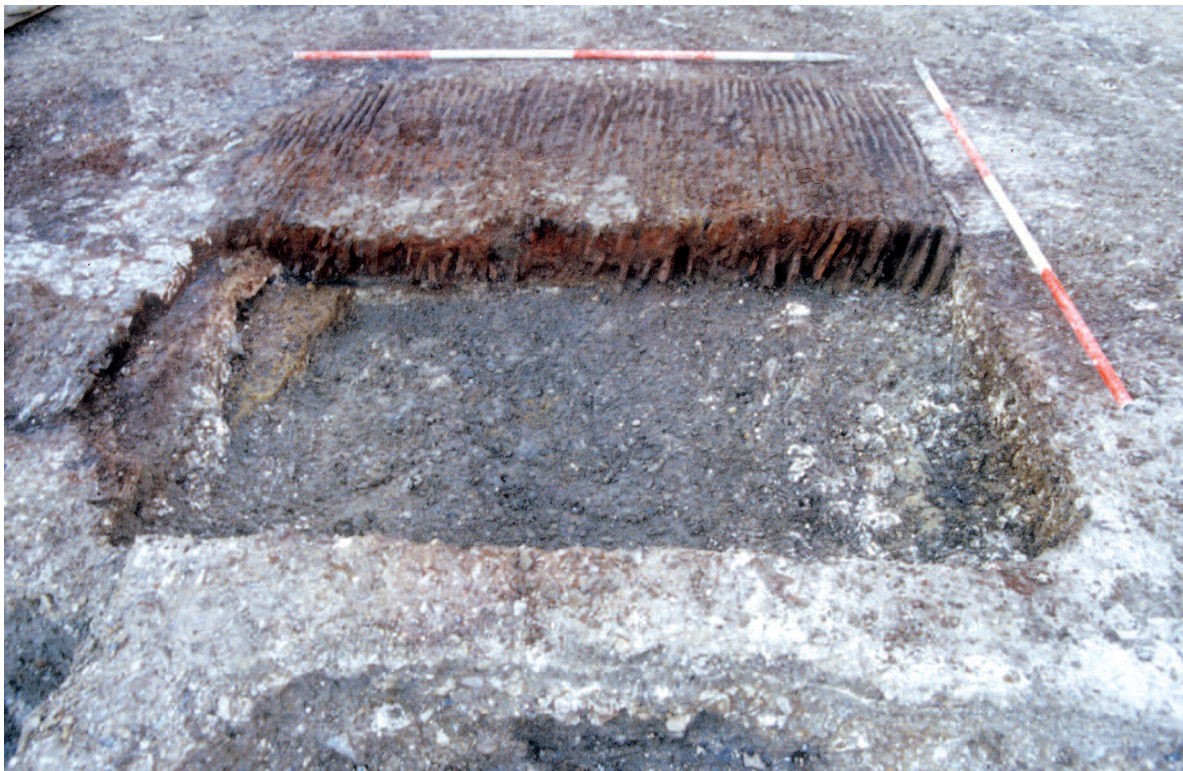
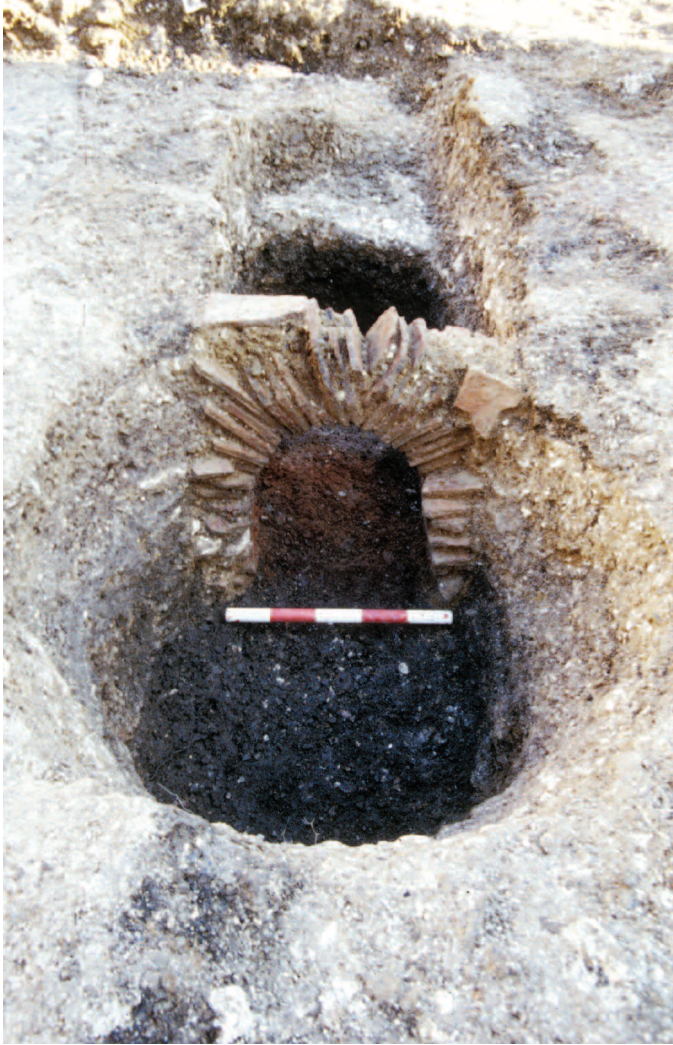
*Plate 2.9 Site 29: details of oven construction: (left) looking NE showing oven 6004 in Building 5840 and (below) looking N showing oven 5953 in Building 5820 (Project*

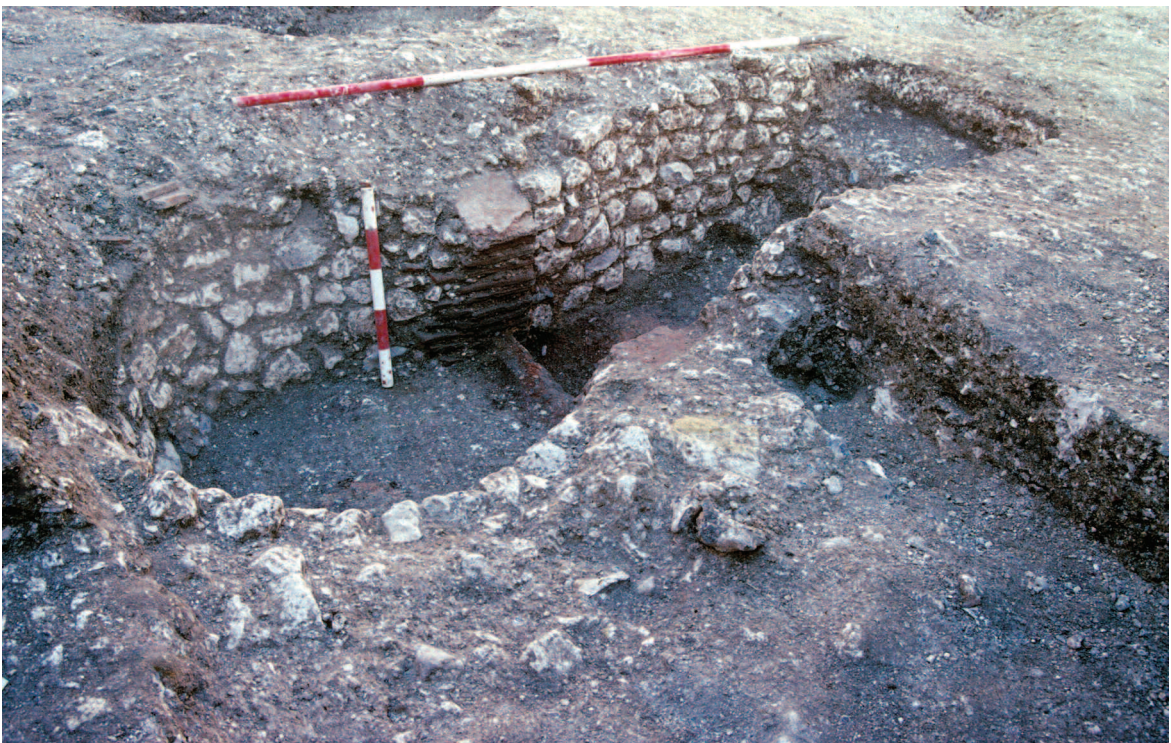
structures. The two structures (Plate 2.9), 6004 within Building 5840 and 5953 within Building 5820, were very similar in size, form, orientation, and construction technique and materials. Their position within each building was also similar, both neatly positioned within the corners. Only the structural elements that were below the contemporary ground level survived. The initial construction cuts were keyhole shaped and *c.* 0.60 m deep. At the south-western end of each were sub-circular firing chambers that measured *c.* 1.1 m in diameter at ground level narrowing to *c.* 0.70 m at the base. These were joined to rectilinear intake flues, both *c.* 1.2 m long and 0.75 m wide, which ran to the north-east. Spanning the entrance to both fire chambers from their respective intake flues were arches constructed solely of ceramic roofing pegtiles (see Vince, Chapter 8). The sides or lining of both the firing chamber and intake flue for each structure were built from different materials. In Structure 5953 they were completely lined with roughly hewn chalk lumps and flint nodules bonded with sandy lime mortar, forming a wall. In Structure 6004 only a layer of sandy lime mortar remained, with a single re-used Roman brick adhering to the east of the arch, suggesting the flue and fire chamber had originally been completely lined with this material. Although much of the original lining in structure 6004 had been removed, evidence remained for heat scorching on the tile arch, floor and sides of the sub-circular fire chamber, although this was limited probably due to the original presence of a brick lining. In Structure 5953 flints within the walling of the fire chamber, the lower courses of the tile arch, and the flooring all showed signs of the effects of heat. Overlying the floors of the intake flues were charcoal-rich deposits that probably derived from *in situ* fires (6004 = 6193).

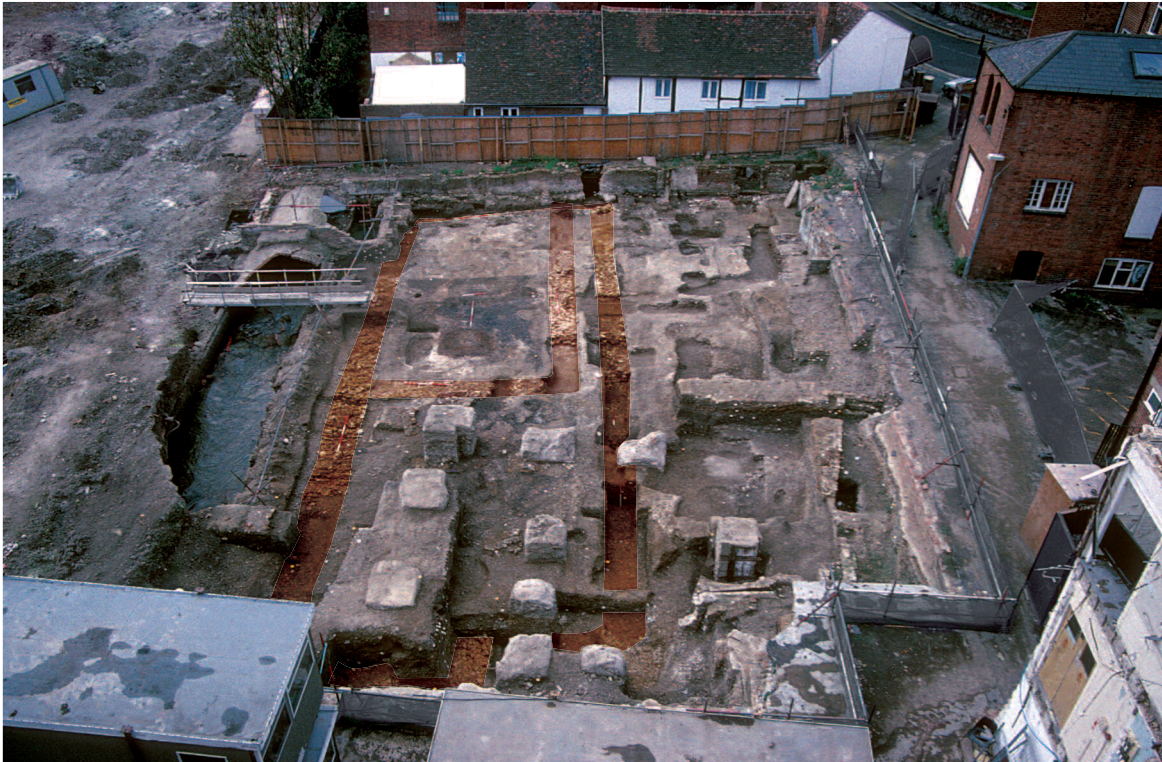
Plate 2.10 Site 29: view looking SW showing Building 5860 (highlighted, along with Building 5840) (Project Phase 4). It is interesting to note that the northern wall of this building (partially robbed) is on the same alignment as the boundary between the two standing buildings immediately beyond the site

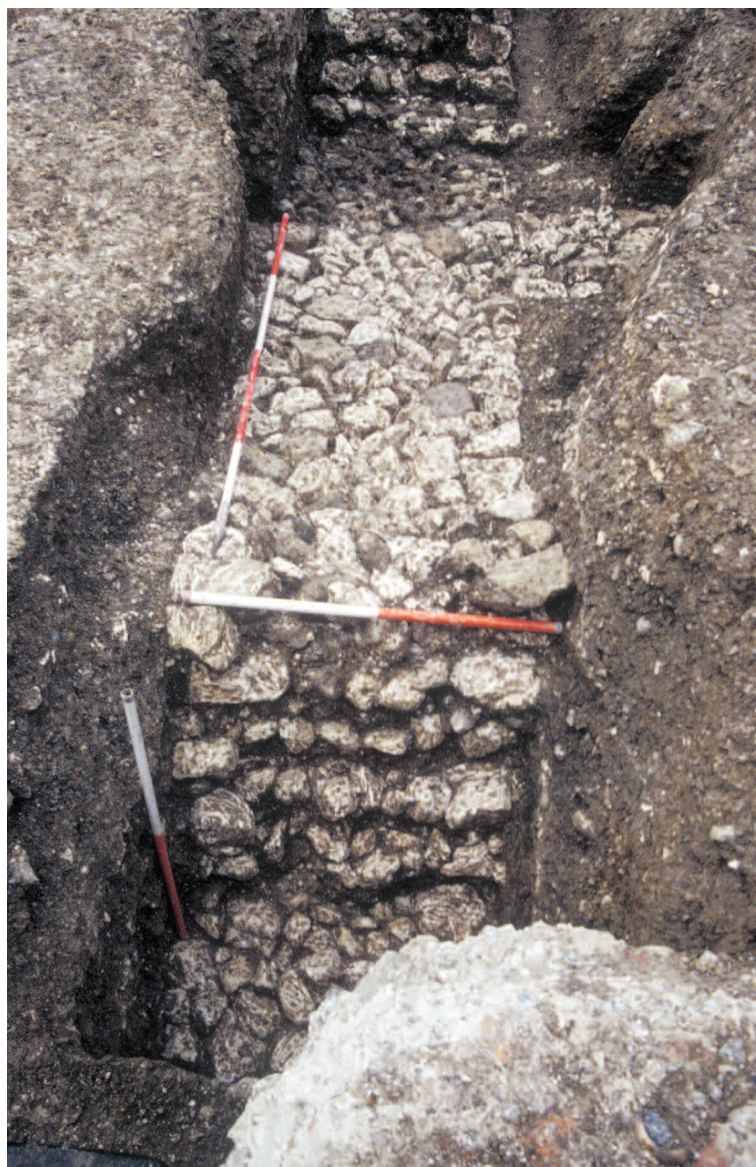
*Plate 2.12 Site 29: Building 5860: view looking NW showing the substantial and partially robbed foundations of the buttressed north wall 5778 (Project Phase 4)*

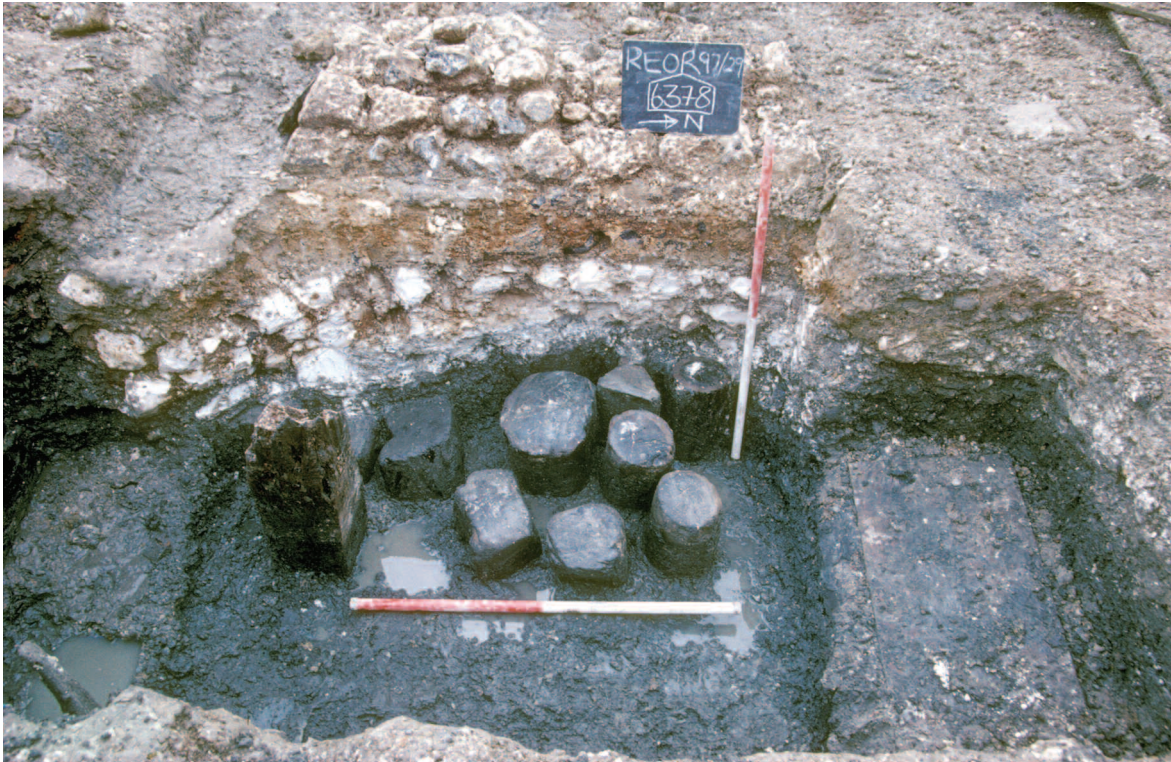
Plate 2.13 Site 29: view looking SE showing timber foundation piles underlying the footings of the southern wall of Building 5860 (Project Phase 4). The piles were tree-ring dated to the period AD 1267-71

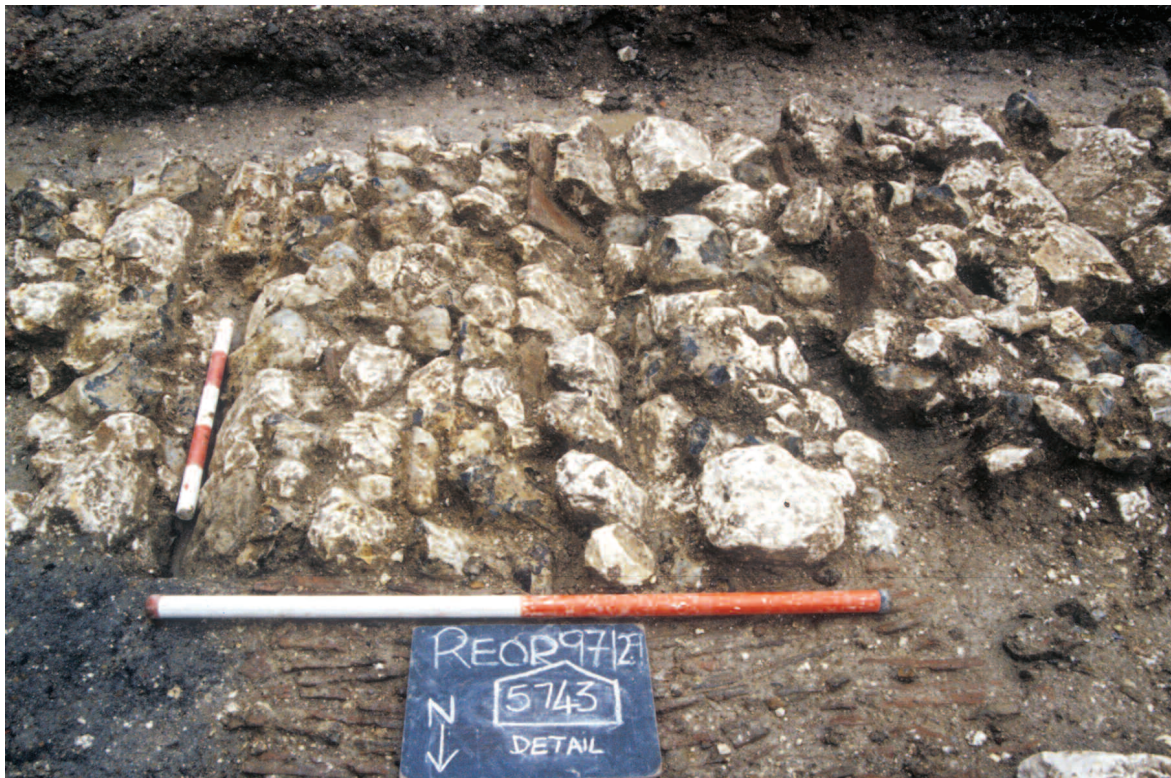
Plate 2.14 Site 29: view looking SW showing the unusual method of setting stones and tiles on the diagonal in the footings of the southern wall of Building 5860 (Project Phase 4)

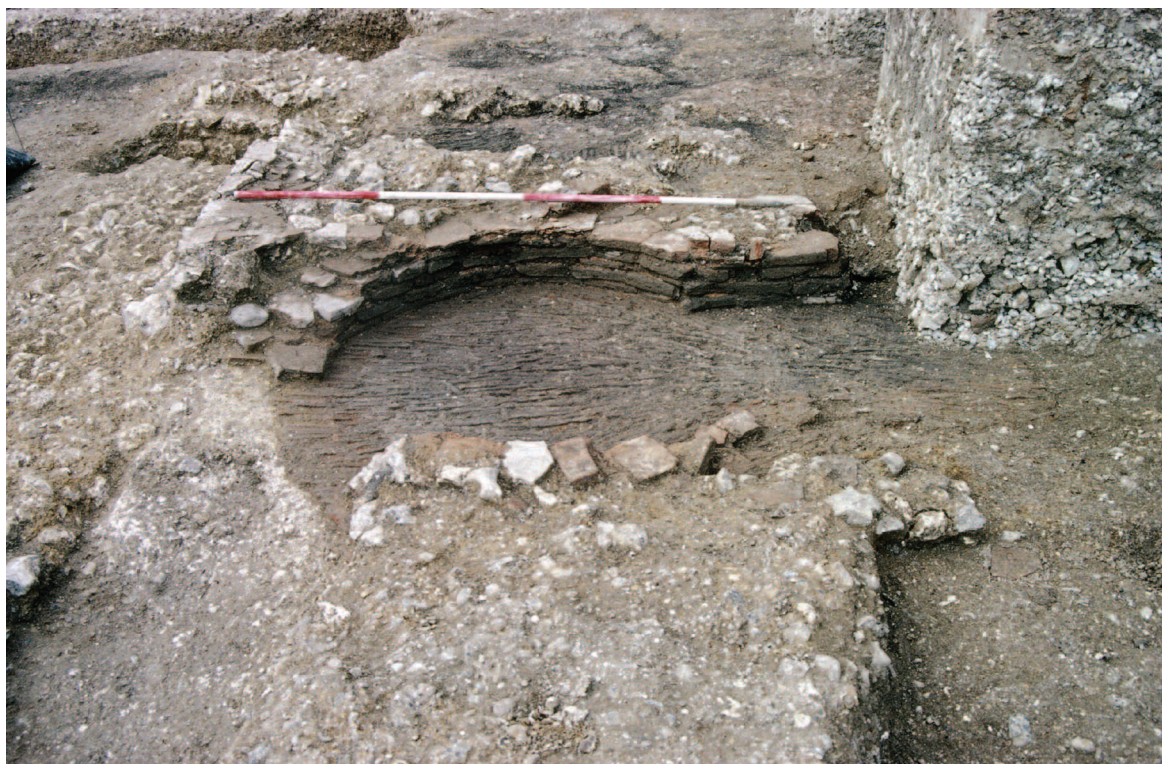
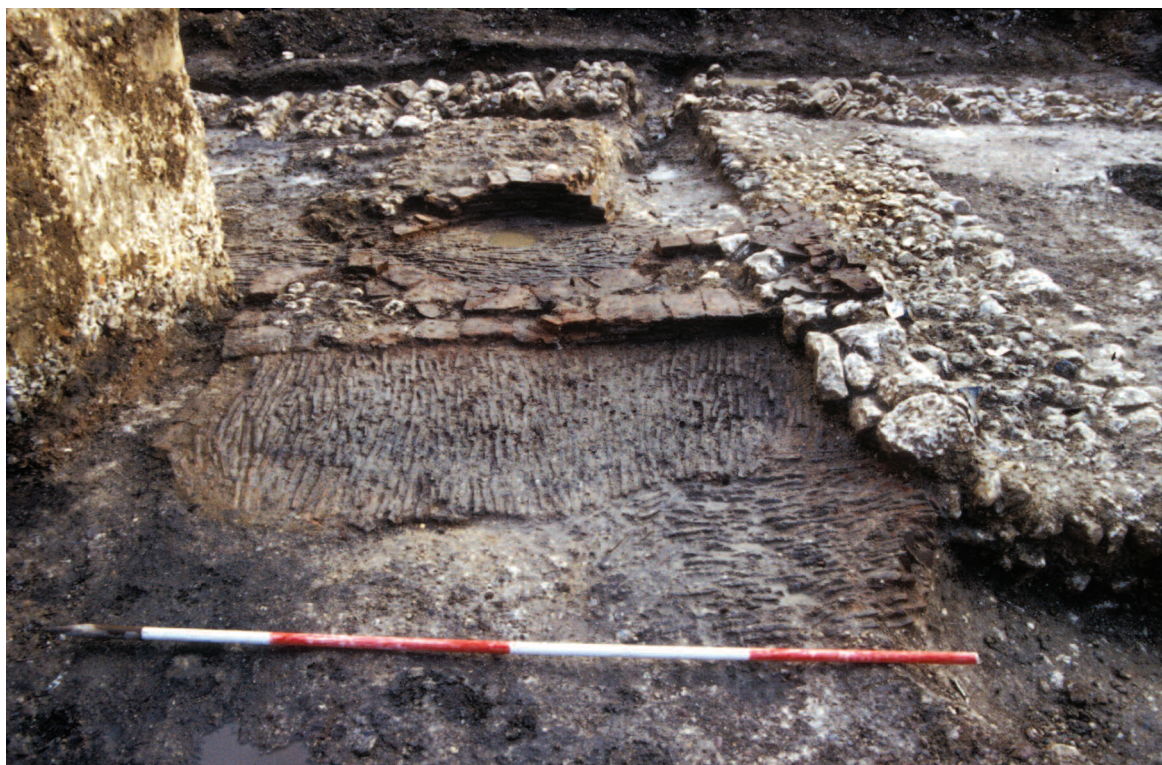
Plate 2.15 Site 29: details of hearths in the eastern end of Building 5860: (above) view looking SW showing large 'key-hole' hearth 6053 and (below) view looking SE showing rectangular hearth 6066 with earlier hearth 6134 in the immediate foreground (Project Phase 4)

A sub-rectangular pitched tile hearth (6066), also defined by low walls, was subsequently added to the northern side of the circular walled hearth structure (6052; site sub-phase 2905d). This hearth appeared to have been open to the north and incorporated an earlier small tile surface 6134. Deposits 6124 (SS 1062), 6111, and 6096 and 6058 (SS 1051) which derived from the use of this hearth were rich in charcoal. Deposit 6124 was rich in animal and fish bones, which included plaice and flounder, woodcock, domestic fowl and other unidentifiable bird bones, as well as pig, sheep/goat and cattle. Overlying this was a further deposit, 6096, within which there was a significant amount of charred grain including free threshing wheat, oats, barley and rye chaff. Other plant remains included broad beans and fig (the only likely import). The sample was dominated by weeds, some of which are typical of medieval cornfields and show that the grain was brought in from a number of different locations including areas on heavy soils as well as lighter well drained soils (Pelling Chapter 11, below).

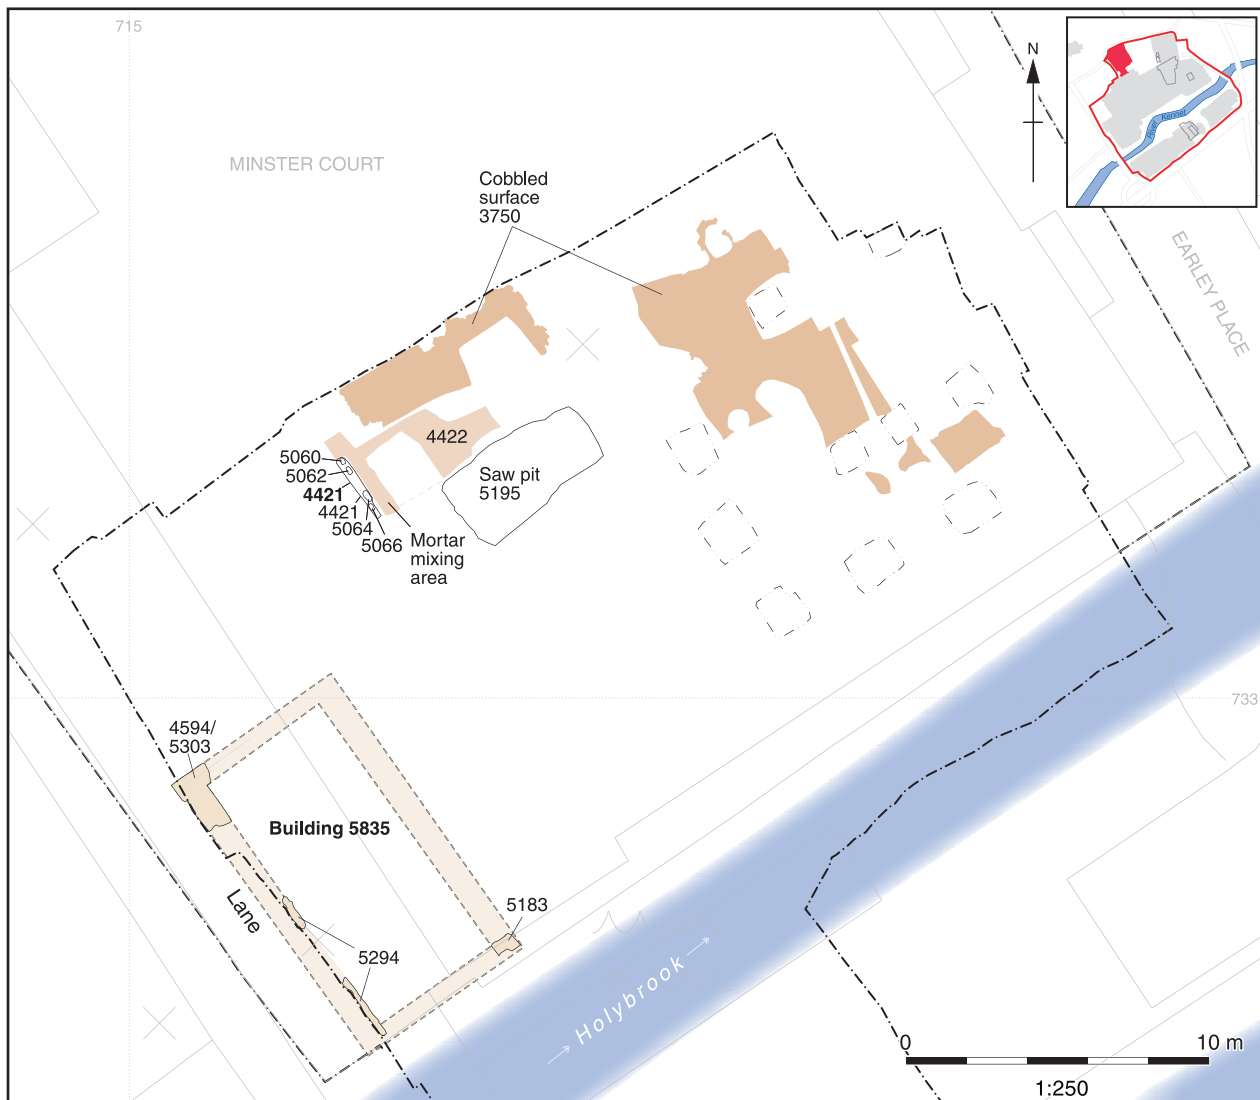
Fig. 2.9 Site 29: plan of Building 5835, re-building in the 16th century (Project Phase 6)

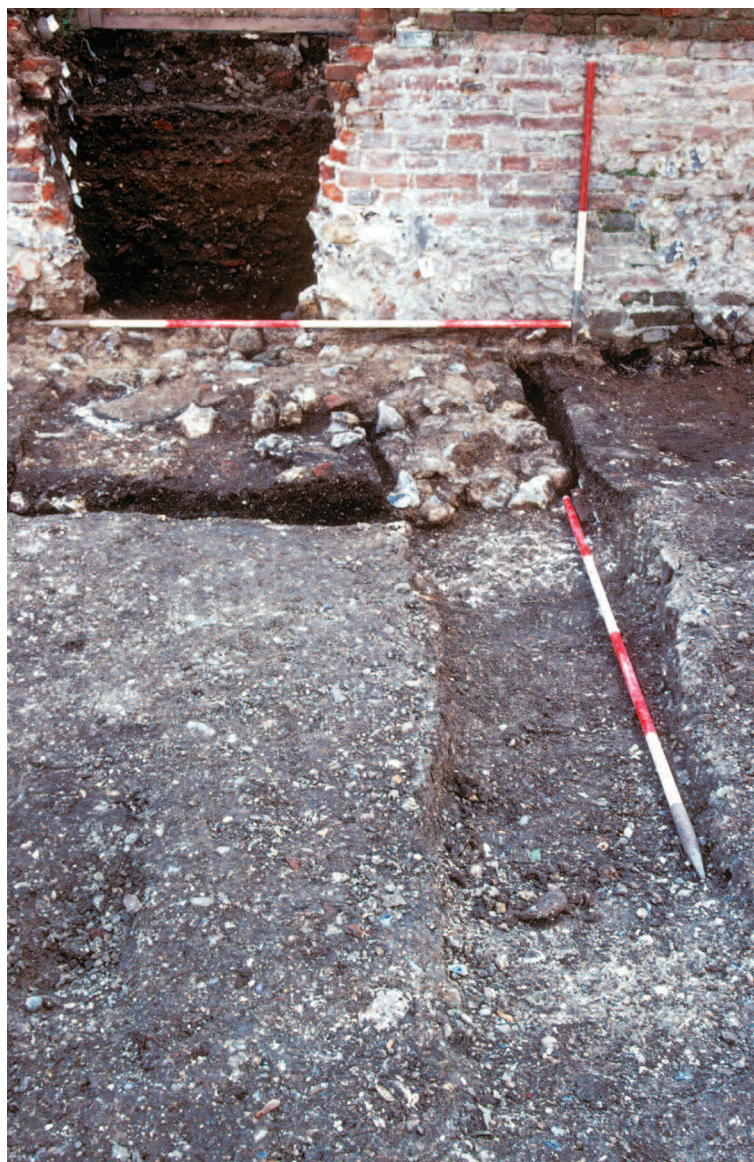
*Plate 2.16 Site 29: view looking SW showing the heavily truncated remains (4594/5303) of early 16th-century Building 5835 (Project Phase 6)*

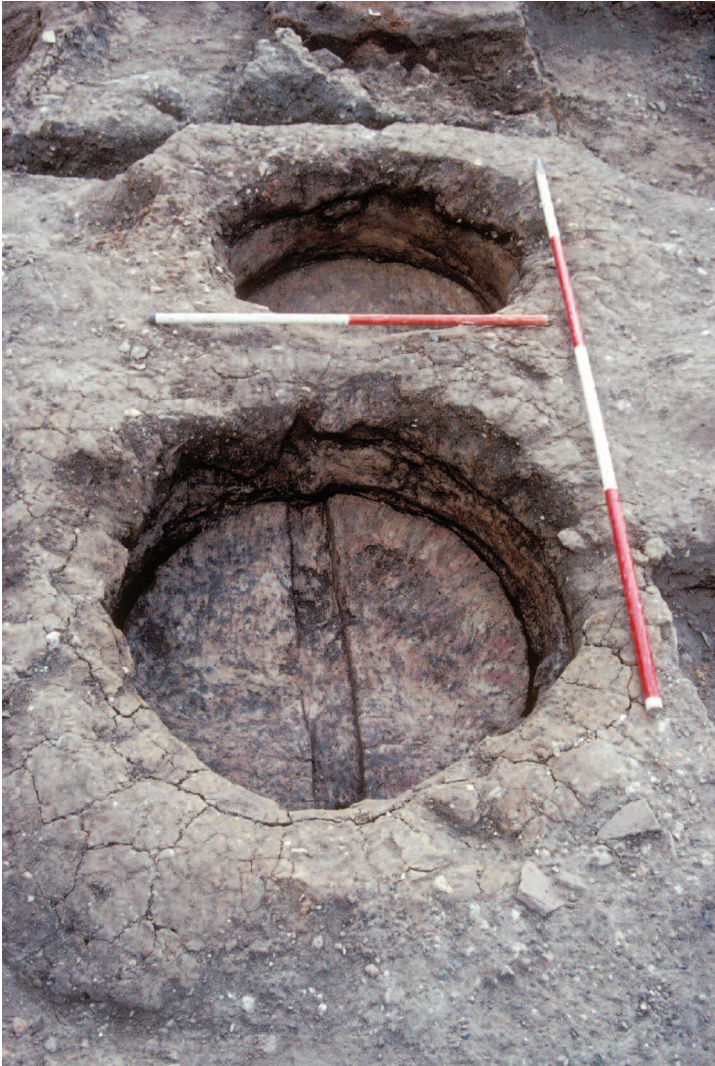
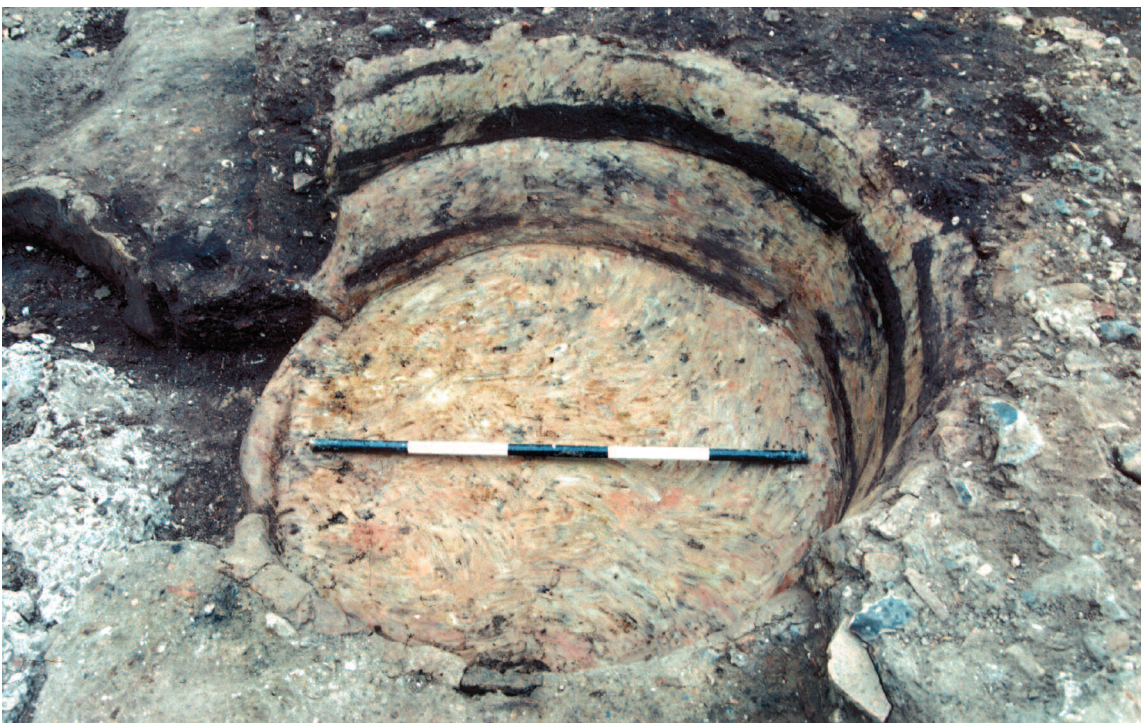
*Plate 2.17 Site 29: the dyeing/ tanning complex (Project Phase 6): (left) view looking S of the clay lining to pit 4741 with the impression of the batten that held the base together, and (below) view looking S showing the clay lining for 4735, with impressions of the wooden barrel and binding hoops that sat inside it.*

The principal features that survived from the complex were the pits that held the wooden vessels that were set into the ground (Plate 2.17). The process of construction for these features was similar throughout all phases. Firstly, a flat-bottomed pit was dug; the base of the pit was then covered in a layer of clay upon which was set a wooden vessel, either a barrel/cask or trough. The entire outside of the vessel was then ‘puddled’ in a thick layer of the same clay, before the void between the outside of the clay proofed vessel and the construction pit was backfilled. The clay functioned as a waterproofing layer, which prevented leakage of the liquids contained within the vessels. A rough working surface of stones and broken ceramic tiles was laid around the top of each pit. It is possible that the barrels protruded, but to an unknown height, above this level.

Although initially the barrels were set one to a pit, later expansion of the complex saw more than one barrel placed in each pit (Plate 2.17i). In addition to the barrels there were a number of shallower rectangular troughs, which appear to have been set into the ground in a similar way.

In almost four centuries since this complex was in operation, the wooden barrels and troughs had decayed, and all that remained upon excavation in the majority of cases was the clay-proofing layer. This preserved the negative shape of the vessels with impressions of the ‘round-wood’ hoops that had bound the staves together, and the batten which joined the boards of the base or headpiece together, (Plate 2.17ii). In a few cases the wood had not decayed completely and elements of the boards and the batten that formed the base were well enough preserved to show the grain of the wood.
