# UNDER THE ORACLE

Excavations at the Oracle Shopping Centre site 1996-8:  
the medieval and post-medieval urban development  
of the Kennet floodplain in Reading

Thames Valley Landscapes Monograph No 36

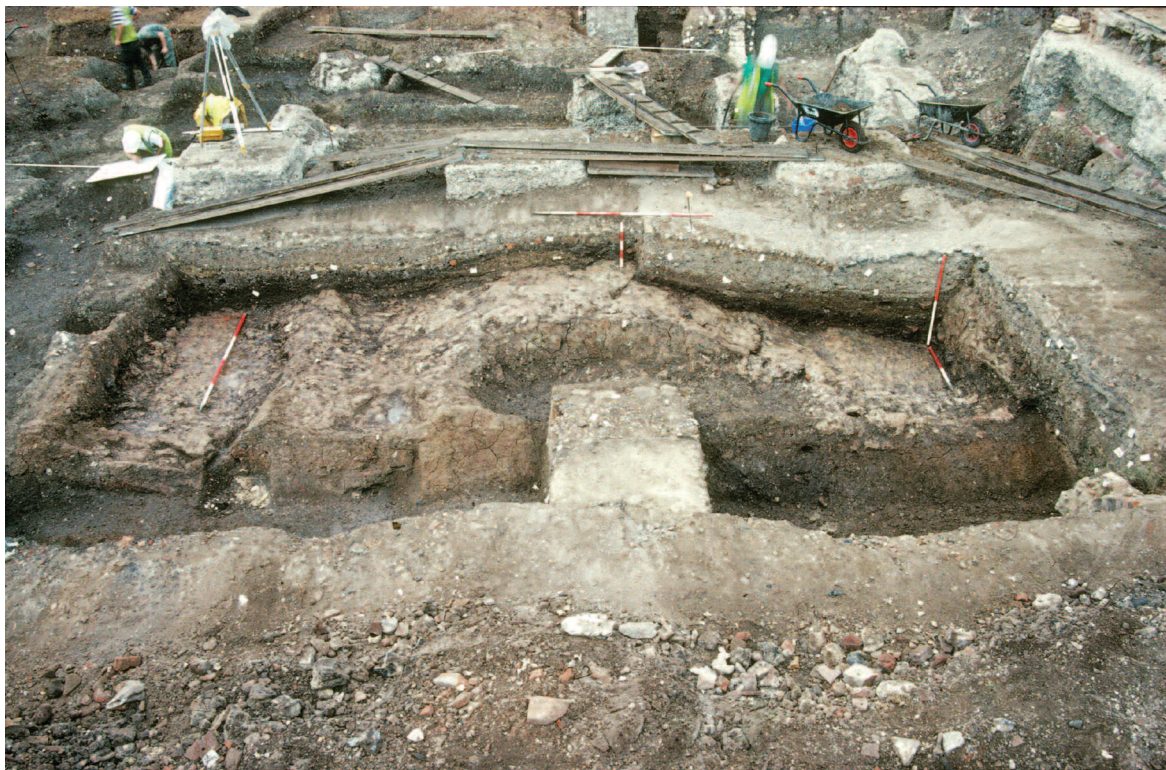
Plate 2.18 Site 29: view looking NW of clay-lined tank 4817 (Project Phase 6)

Immediately to the south, and contemporary with the main sunken vessel complex, a very large pit (4817) was excavated (Plate 2.18). The pit measured 9 m long (SW–NE) by 4.8 m wide (SE–NW). Its base was lined with clay, but no trace of individual vessels was seen, suggesting that this feature remained as one large purpose-built tank. The clay sealed an isolated timber (5466), thought to be related to the modification of the Holy Brook (see below). This was submitted for dendrochronological dating, and gave a felling date range of 1526-?58 (see Chapter 11; Table 11.7).

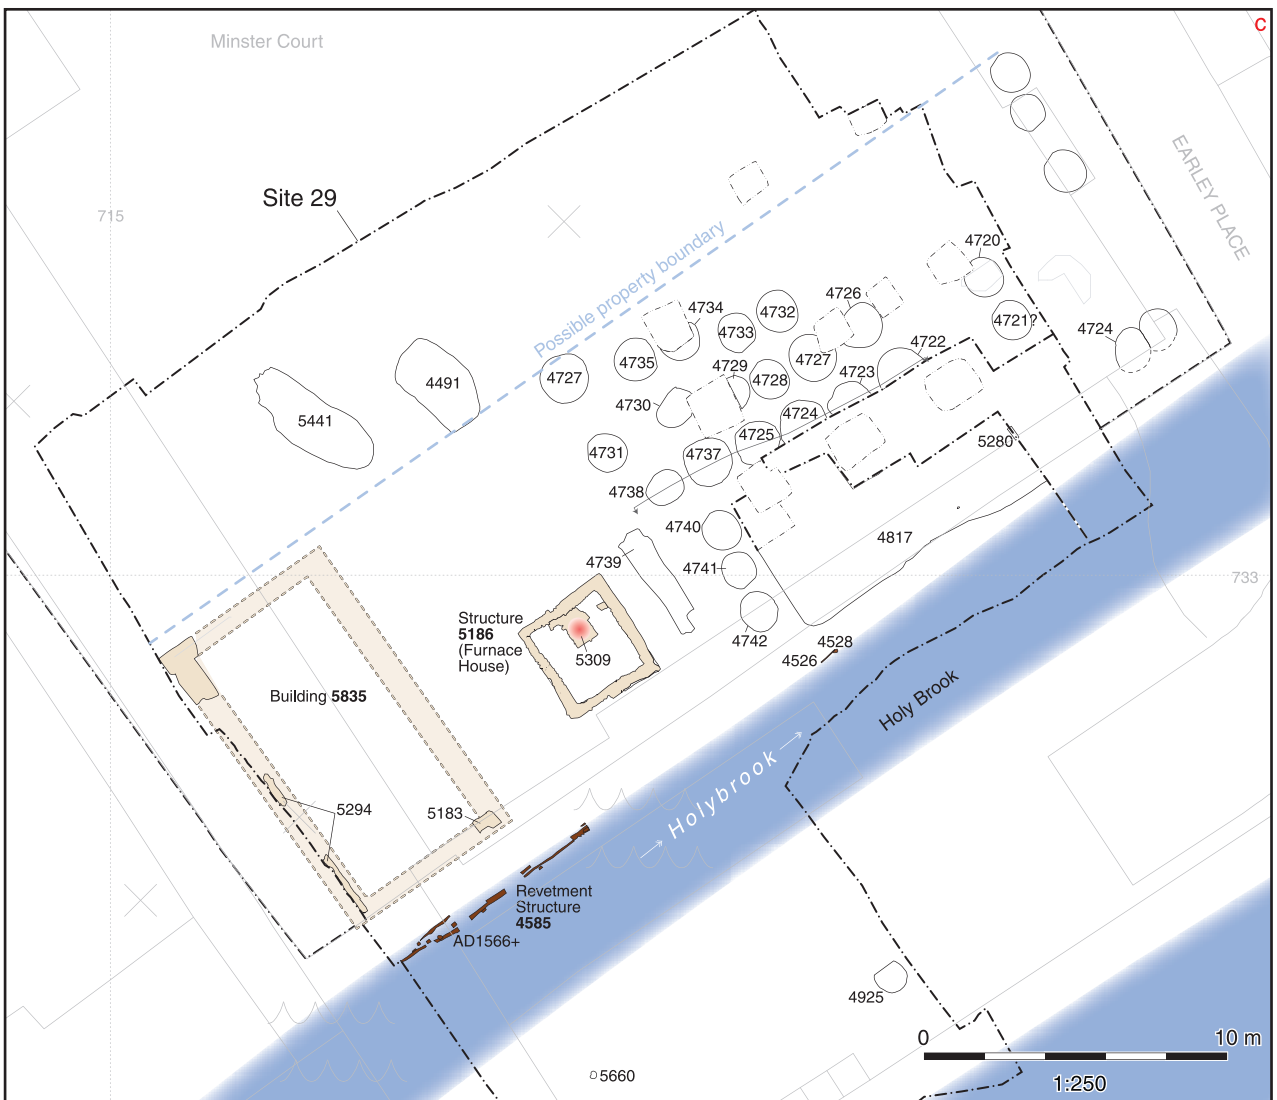
Fig. 2.10 (opposite) Site 29: plan showing the development of the tannery/clothiers' works during the 16th and early 17th century (Project Phase 6)

Evidence suggests that the operation started on a small scale (Fig. 2.10a and c; site sub-phase 2908b), with the construction of four sunken circular wooden vessels (4720, 4721, 4722, and 4726). These were set within four individual and separate pits (5128, 5115, 5055 and 5037 respectively). These vessels were in use simultaneously and were located to the north of the Holy Brook on the east side of the site, a location which allowed later expansion westwards (see below). The dating evidence indicates only that this initial activity occurred after AD 1500. The next phase of development saw a significant increase in the scale of the complex (Fig 2.10b and c; site sub-phase 2908c), which expanded westwards of the initial four vessels. These are considered to have remained operational. A large pit (5040) was excavated, within which were set eight circular vessels (4723, 4724, 4725, 4727, 4728, 4729, 5123, 4743, 4737), laid out in two rows of four on an SW–NE alignment. Vessel 5123/4743 seems subsequently to have been replaced by vessel 4730 in pit 4996. Further vessels were added immediately to the north and south of the western end of pit 5040. To the north, pit 5111 received two circular vessels (4734 and 4735), and to the south pit 5133 housed a further two (4740 and

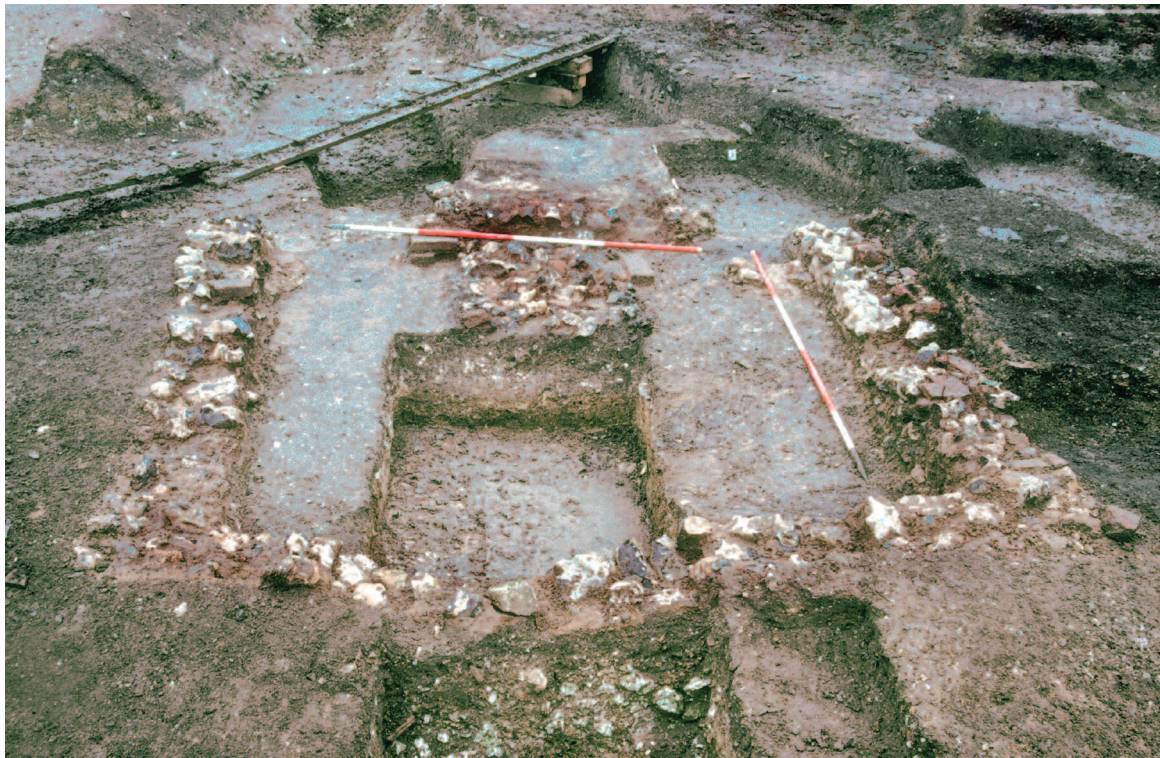
Plate 2.19 Site 29: view looking NW showing the remains of the square furnace house or drying room, structure 5186 (Project Phase 6)

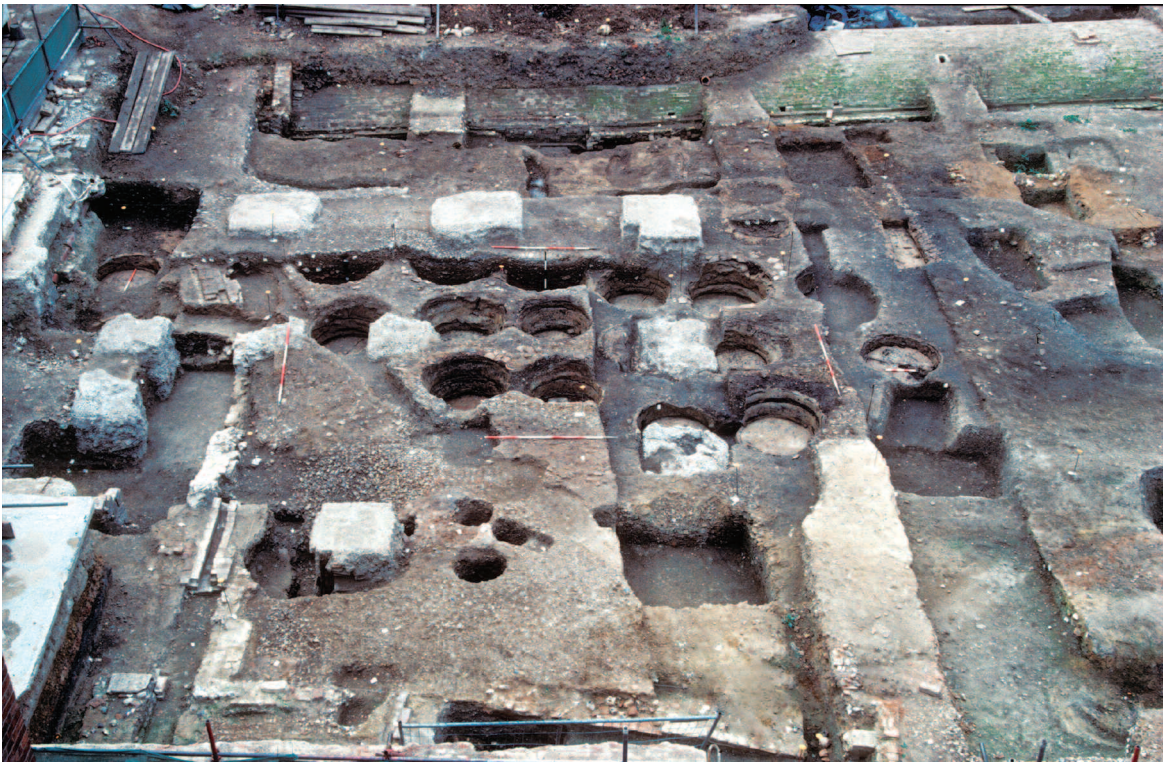
Plate 2.20 Site 29: general view looking SW of the dyeing/tanning complex under excavation (Project Phase 6)

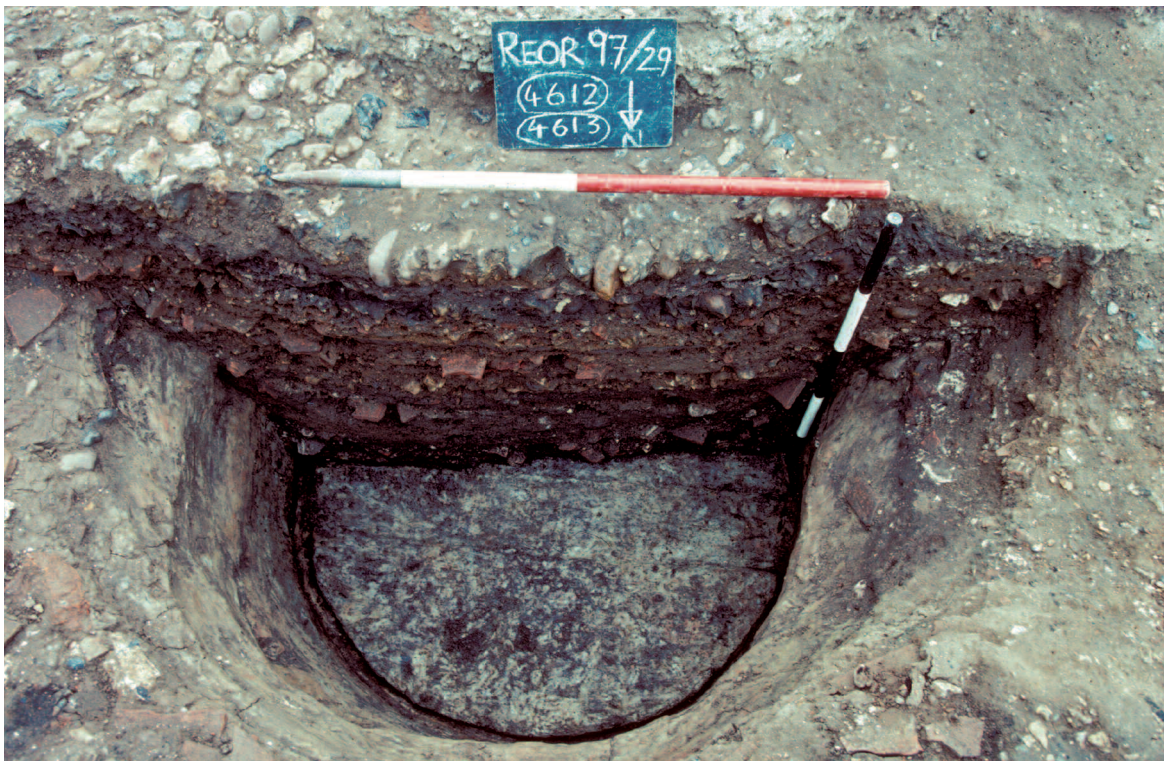
Plate 2.21 Site 29: view looking S of the 17th-century cobbled courtyard surface of the Oracle workhouse slumping into the compressed fills of a decommissioned and backfilled barrel from the tannery/dyeing complex

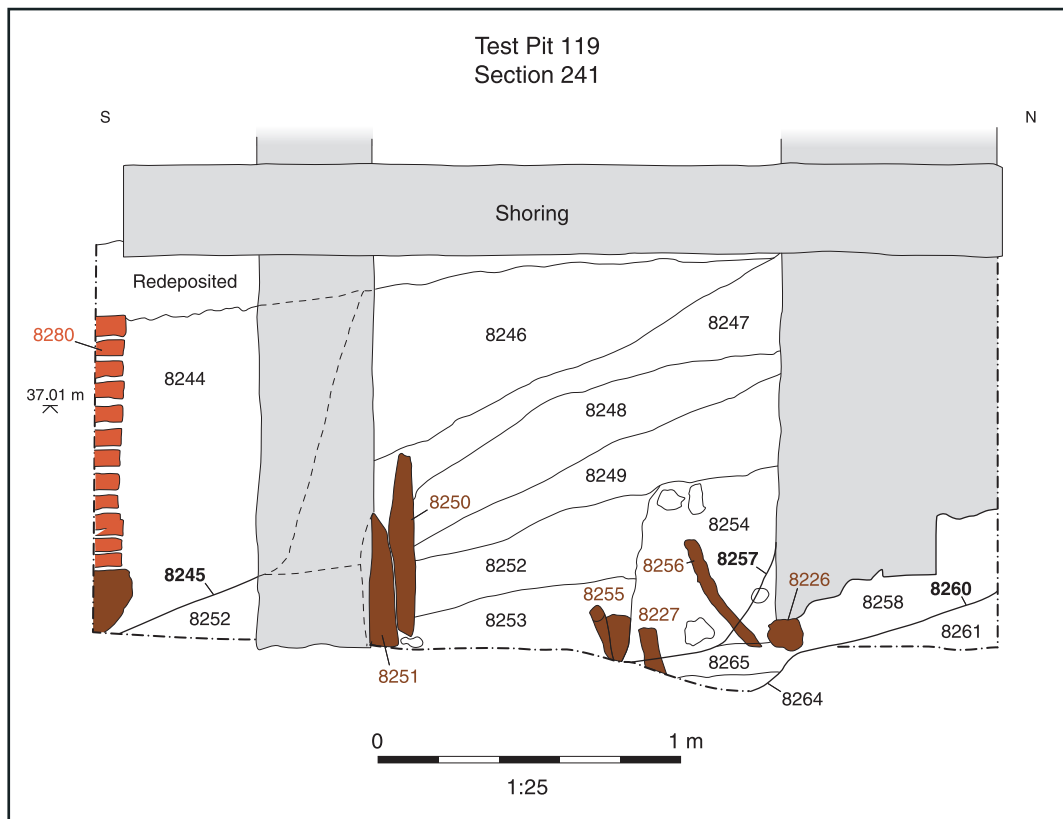
Fig. 2.12 Test Pit 119: NE facing section 241, showing the full sequence of development of the north bank of the Minster Mill Stream

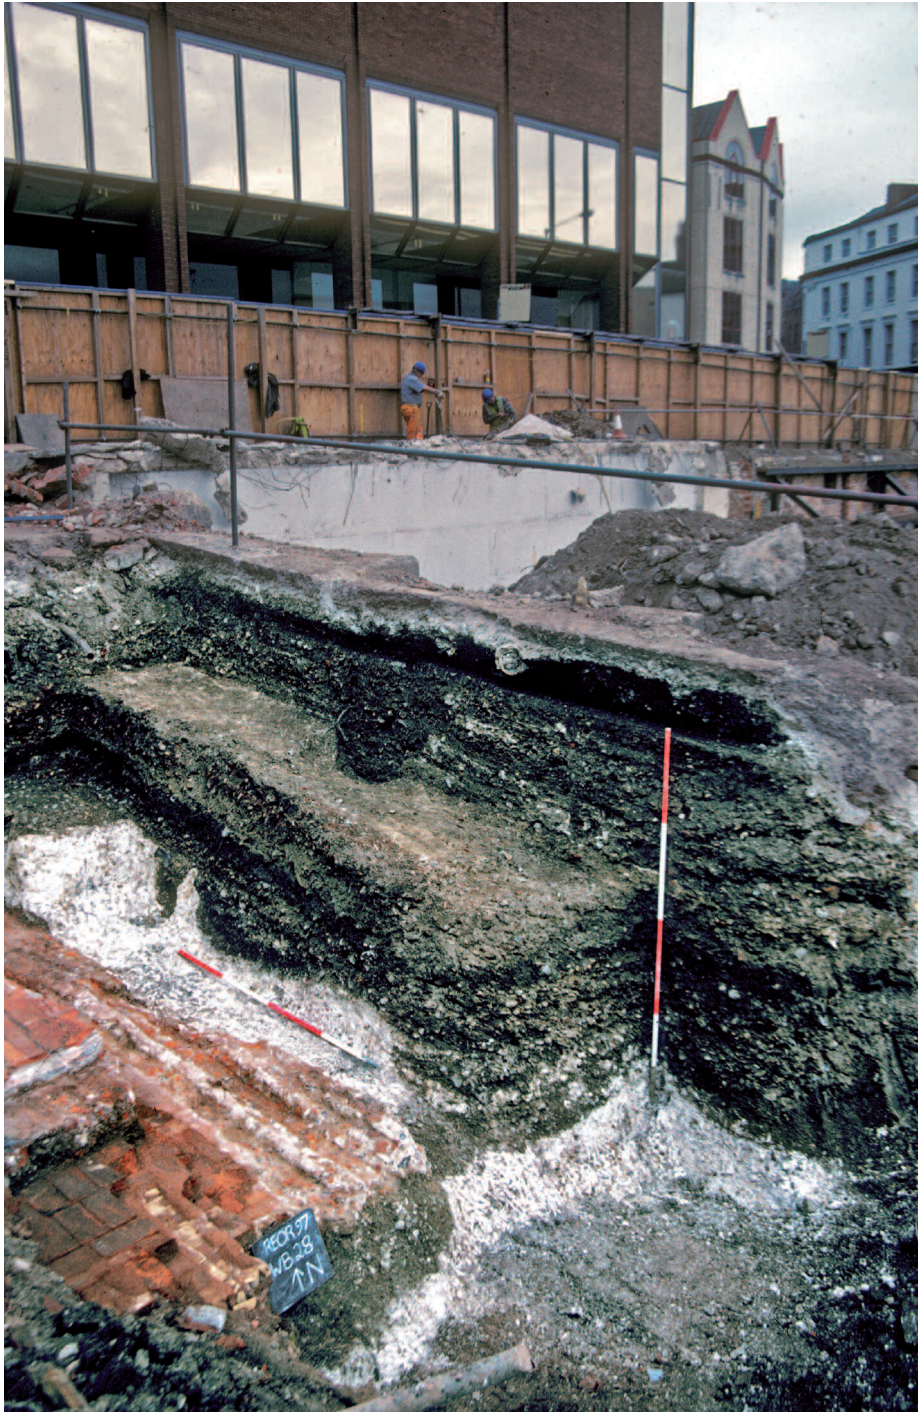
Plate 2.22 Site 150 Test Pit 167: general view looking NE showing multiple resurfacing of the lane leading from Minster Street (left) to the Minster Mill (right) (Project Phases 2–8)

Associated with the increased millstream management was the introduction of a formalised access point to the land. At the north edge of the site, just south of Minster St (TP 167), a lane was established, leading southwards from Minster Street to provide access to the Minster Mill. The lane consisted of a compacted surface (10228) of sand, gravel and very small pieces of fired clay (possibly broken up Roman tile), that overlay the earlier possible quarry pits in this area (see description of Phase 2 for site 29) (Plate 2.22). This lane continued to be maintained and resurfaced during the 12th century. The earlier surface was replaced (site sub-phase 15002c) with one comprising compacted chalk and gravel in a sand matrix. No dating evidence was associated with this surface, but the surfaces were overlain by a layer that contained pottery of mid 13th-century or later date.

Towards the end of the 15th century the lack in maintenance of the lane leading to the site of the Minster Mill that was identified in TP 167 came to an end, and a new road surface of gravel and broken ceramic building material (8486) was laid. No activity dating to Project Phase 6 was identified.

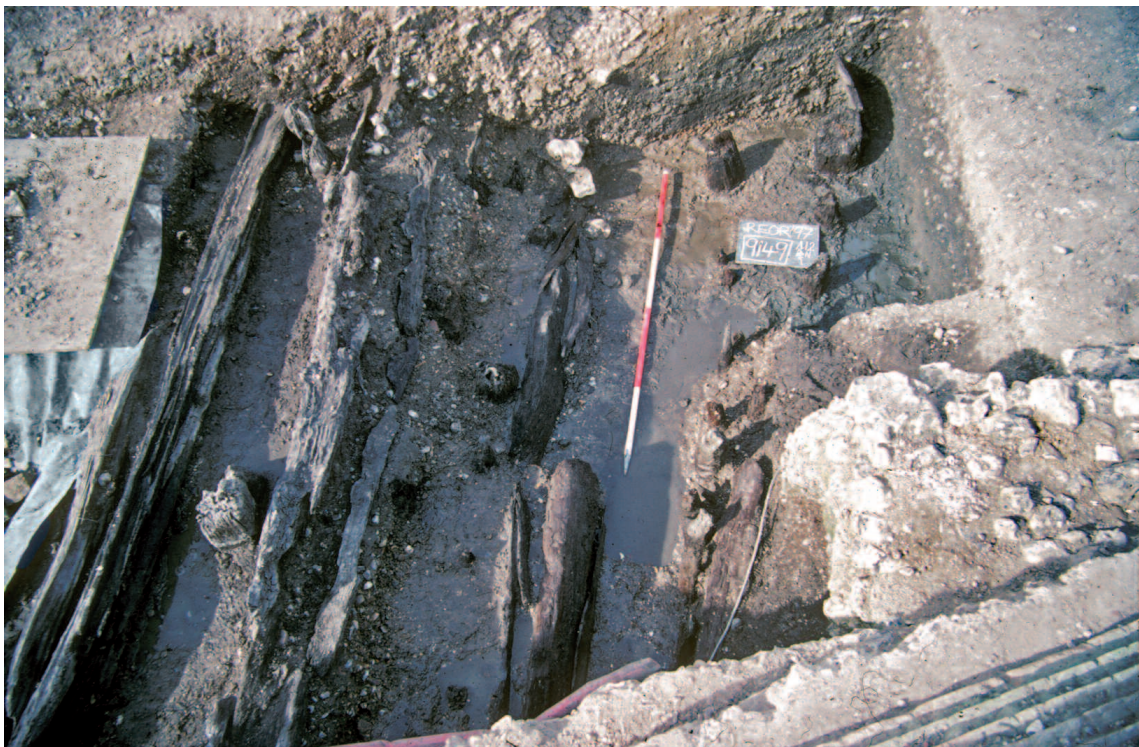
Plate 2.23 Site 12: view looking SE of successive revetments on the eastern bank of channel 9549/9149 (Project Phase 3)

Channel 9549 was re-cut, possibly during the late 12th or early 13th century, approximately 0.50 m to the west, as channel 9149 (Figs 2.14-2.15; Plate 2.23) (site sub-phase 1203a). Channel 9149 was 1 m wide and in excess of 0.60 m deep, and was revetted on both sides with post and plank structures. Most of the timbers that survived were vertical roundwood posts or horizontal planks of 1-1.5 m in length. At least one timber appeared to have been re-used from an earlier structure, bearing the remains of a tenon joint at one end. No dating evidence was recovered from the new channel cut or the revetments, but their relationship to the preceding structures suggests a date in the late 12th or early 13th century.

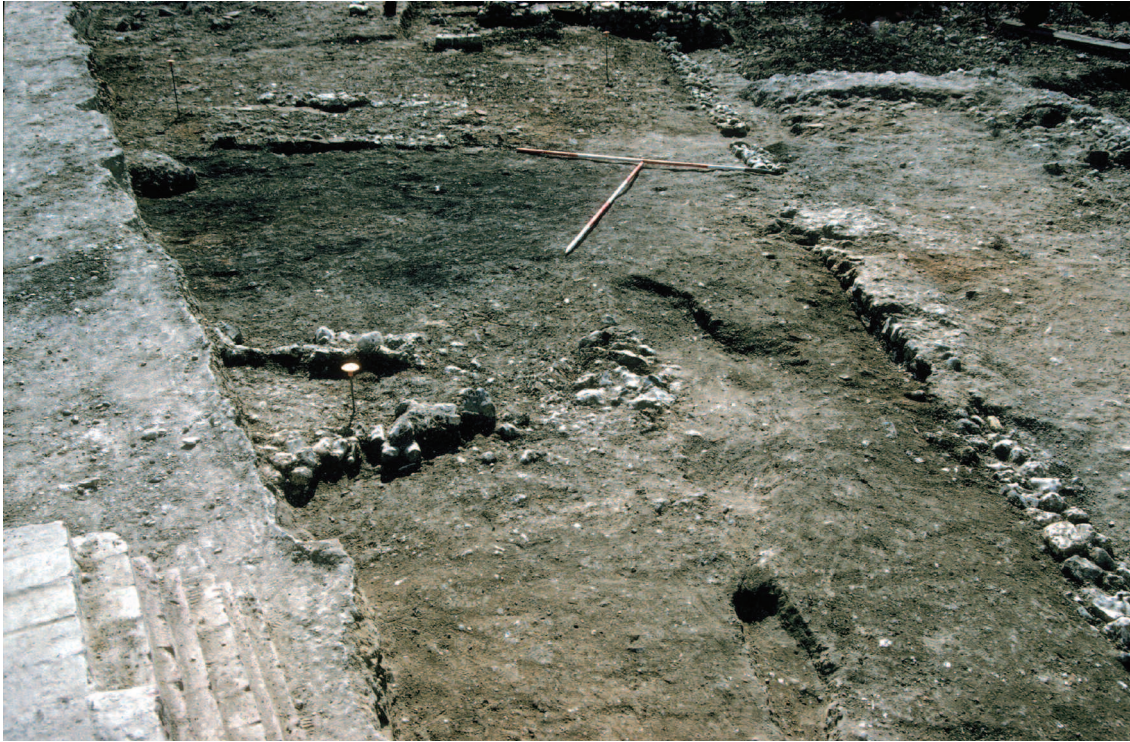
*Plate 2.24 Site 12:  
view looking S across  
Building 7410 with  
tank or vat bases 7401  
(foreground) and 7402  
(background), charcoal-  
rich deposit 9675 in  
between them and wall  
9666 to the right  
(Project Phase 3)*

At the same time, the earlier retaining wall (9824) was demolished and dumps of gravel were laid in its place. A new retaining wall of large chalk blocks and orientated north-south (9834) was constructed approximately 0.40 m to the west. This was observed for over 10 m and probably extended further to the north and south. To the south was a short section of east-west wall 9680, which may have been the eastern return of this wall defining the southern limit of the reclaimed land. A second wall (9666), of flint and chalk, was constructed 2 m east of the new retaining wall 9834 (Plate 2.24). Its

Wall 9666 is interpreted as the west wall of a building or working area, Building 7410, constructed on the reclaimed land between the channel and Yield Hall Lane. Within Building 7410 were two small, probably industrial, open rectangular structures formed by the remains of stone walls enclosing hard surfaces (Structures 7401-2). The better preserved of these, Structure 7402 (Plate 2.25), measured at least 2 x 1.5 m and comprised walls constructed of chalk and flint (9676 and 9677). Between these walls lay two probable surfaces, one

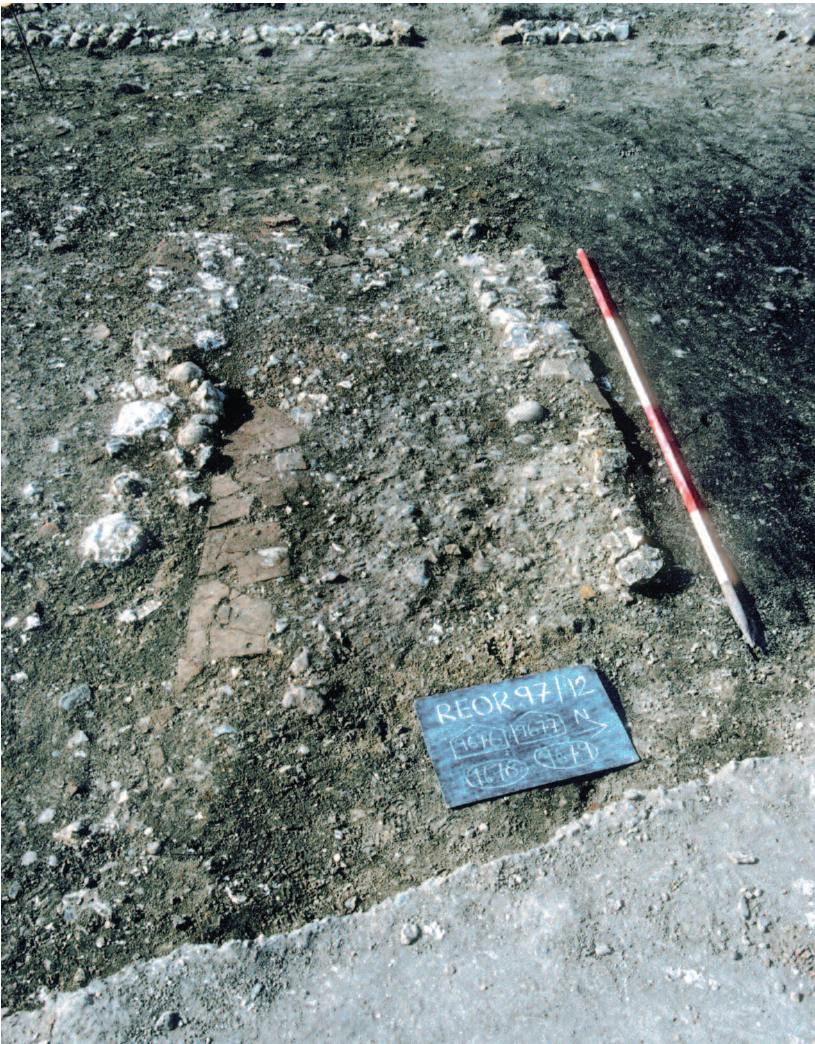
*Plate 2.25 Site 12,  
Building 7410: view looking  
SW of detail of tank or vat  
base 7402 (Project Phase 3)*

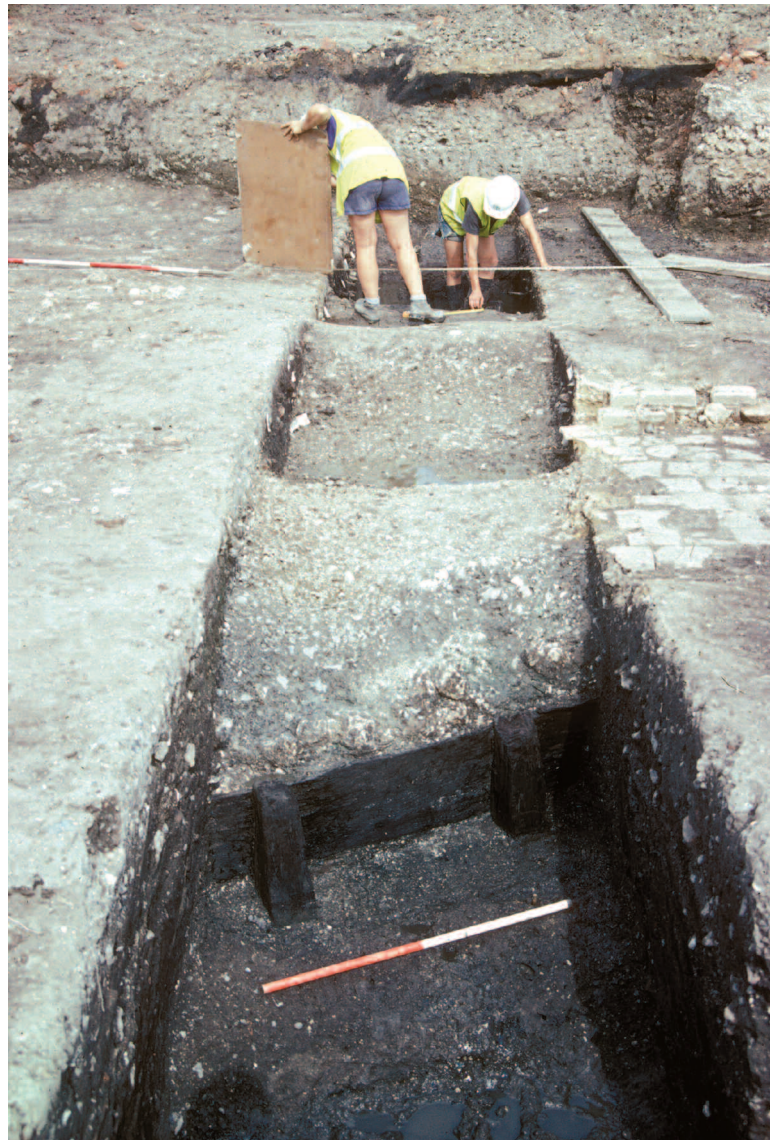
*Plate 2.26 Site 12: view looking NE showing sondage through tanning pit 8742 (foreground) revealing post and plank revetment 8957 (Project Phase 4). The tile floor of the Yield Hall cellar in Room 2 from Project Phase 7 is visible to the right*

None of the pits was fully excavated, but there was evidence for structures that revetted and thus strengthened their sides. Pit 8742 for example, which measured at least 12 m long x 4 m wide, had a wattle revetment (9023) on its west side, and a post and plank/board revetment (8957) on its east side (Plate 2.26). The wattle revetment consisted of 60 mm-wide stakes with large branches of 40-50 mm diameter woven between them. The post and plank/board revetment was represented in the excavated section by two large vertical posts and horizontal planking, which supported a deposit of chalk rubble. The floor of the pit was puddled with clay, which would have made it waterproof. Towards the end of the 15th century, the final recut of the central pit, 8721, showed limited evidence in the form of posts (8780-8783; 8678), at its northern terminus, that its sides had been revetted.

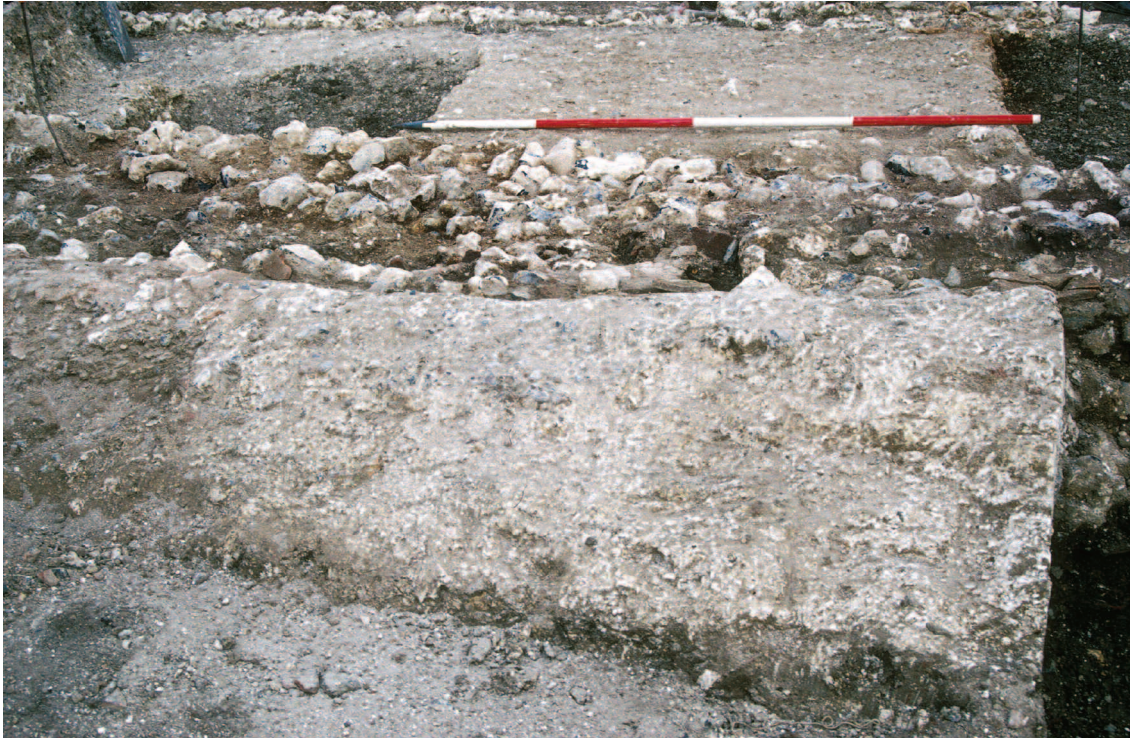
Plate 2.27 Site 12: view looking E with chalk bank 9497 in the foreground abutting wall 9665 behind (Project Phase 4)

proved difficult to interpret. A new channel revetment wall, 9665 (= 9219) of flint nodule construction was built on the west of the reclaimed land (Fig. 2.16; Plate 2.27). It is not clear how long this wall was in place (see below). Wall 9665 may have formed the west wall of a new building, and two short sections of a second flint wall (9617) which lay to the south and at right-angles to wall 9665 may have been associated with an eastern return; however, the remains were too insubstantial for this to be certain.

and an extensive chalk hardcore deposit (Plate 2.27) (9497, 9552, 9626, 9530), which overlay these dumps and the walls of Project Phase 3, and underlay most of the succeeding structures. This suggests activity in preparation for a new phase of building. The only datable material within this deposit was a fragment of used decorated floor tile of a late 14th- or 15th-century type, suggesting that the dump may date towards the end of Project Phase 4 or the start of Project Phase 5.

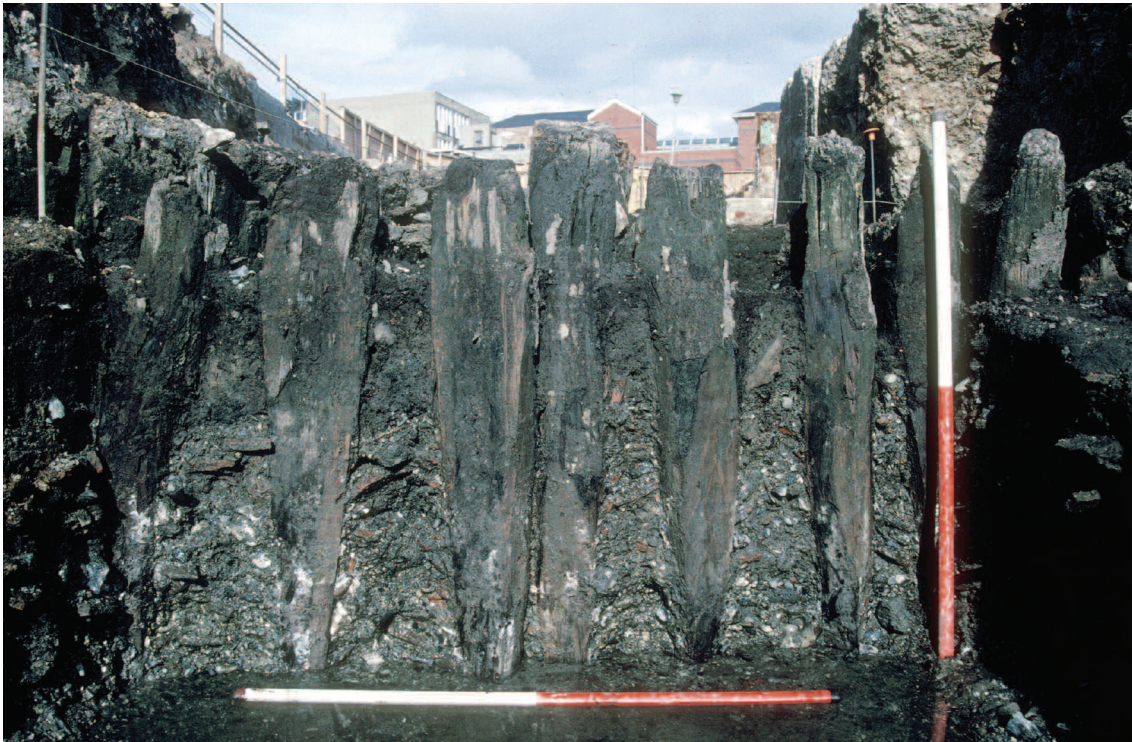
Plate 2.28 Site 12: view looking E showing fish trap 8988 built across channel 8633 (Project Phase 5)

Adjacent to the probable holding tank were two well-consolidated surfaces consisting of brick, tile, sandstone and flint nodule fragments in a matrix of silt, sand and mortar (9682 and 9508). These surfaces measured 0.89 x 0.93 m and 1.6 x 0.7 m respectively and formed an approach to the holding tank. One of these was dated to 1500+ and was therefore slightly later than, but probably contemporary with the later use of, the holding tank. At the western end of the investigated section of channel 8633 was a line of 17 timbers (8988; Plate 2.28) orientated across the channel. The gaps between the posts measured between 0.07 m and 0.14 m suggesting it may have served as some sort of fish trap or water control.

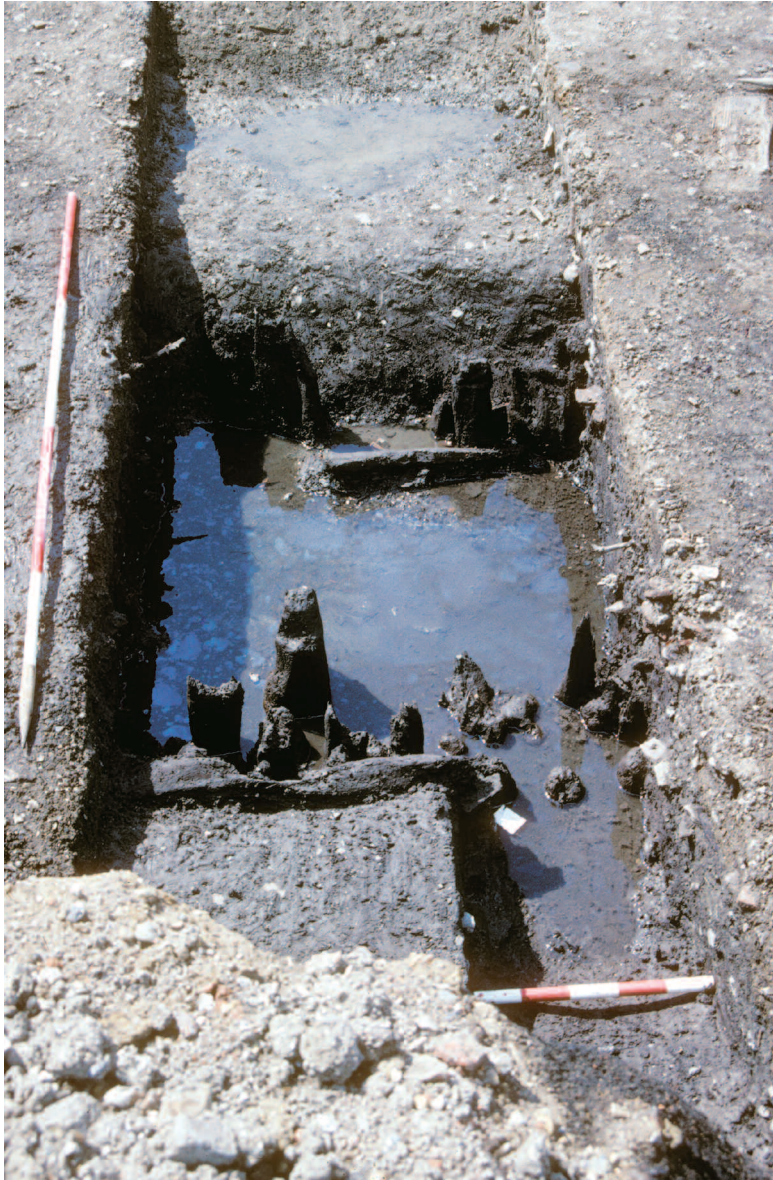
Plate 2.29 Site 12: view looking W showing revetment 9864 marking the banks of channel 8825 near its confluence with the Back Brook

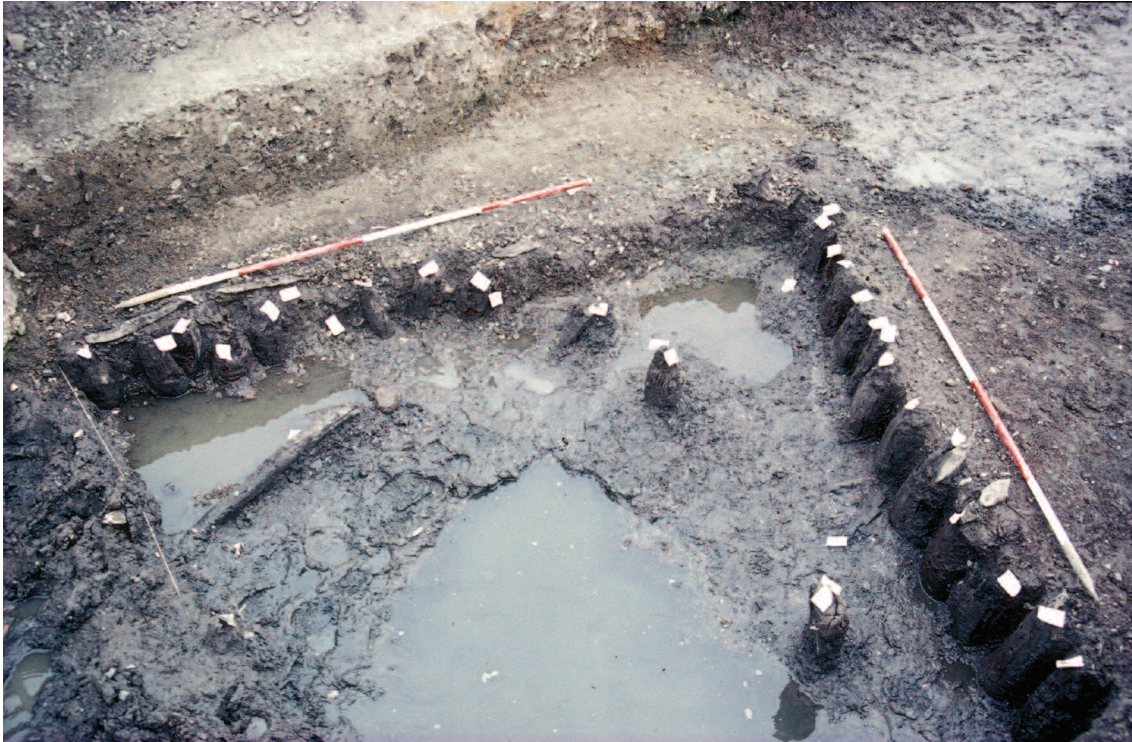
*Plate 2.30 Site 12: view looking NE of revetment 9103 marking the eastern bank of channel 8634 (Project Phase 6)*

These changes resulted in the creation of a new western channel (also called channel 8634), some 20 m to the west of the medieval alignment. Its banks were supported with a post and plank structure (revetment 9103 (Plate 2.30)) comprising at least 12 vertical timbers and at least one horizontal plank. A further revetment was also identified at the confluence of the new channel with the Back Brook, where a series of posts and planks (8757) were found; these were not directly dated, but their position suggests they were contemporary with the channel cut.

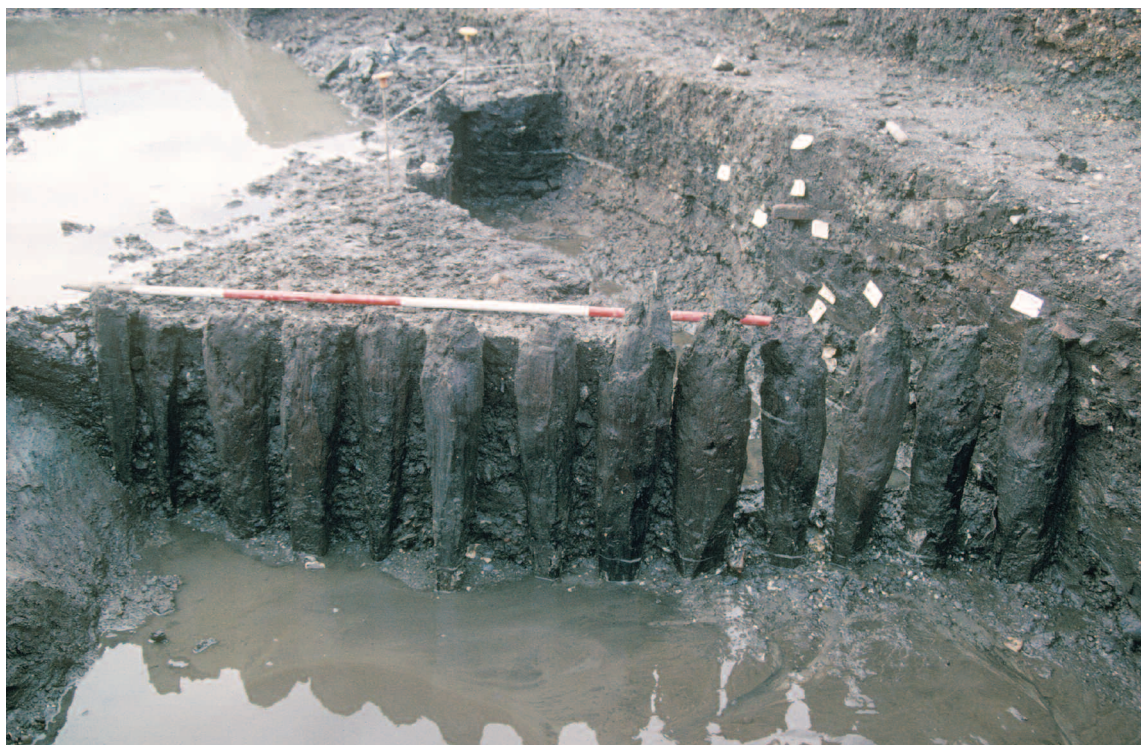
Plate 2.31 Site 12: view looking S of a timber fish trap built across the new channel (8634) (Project Phase 6)

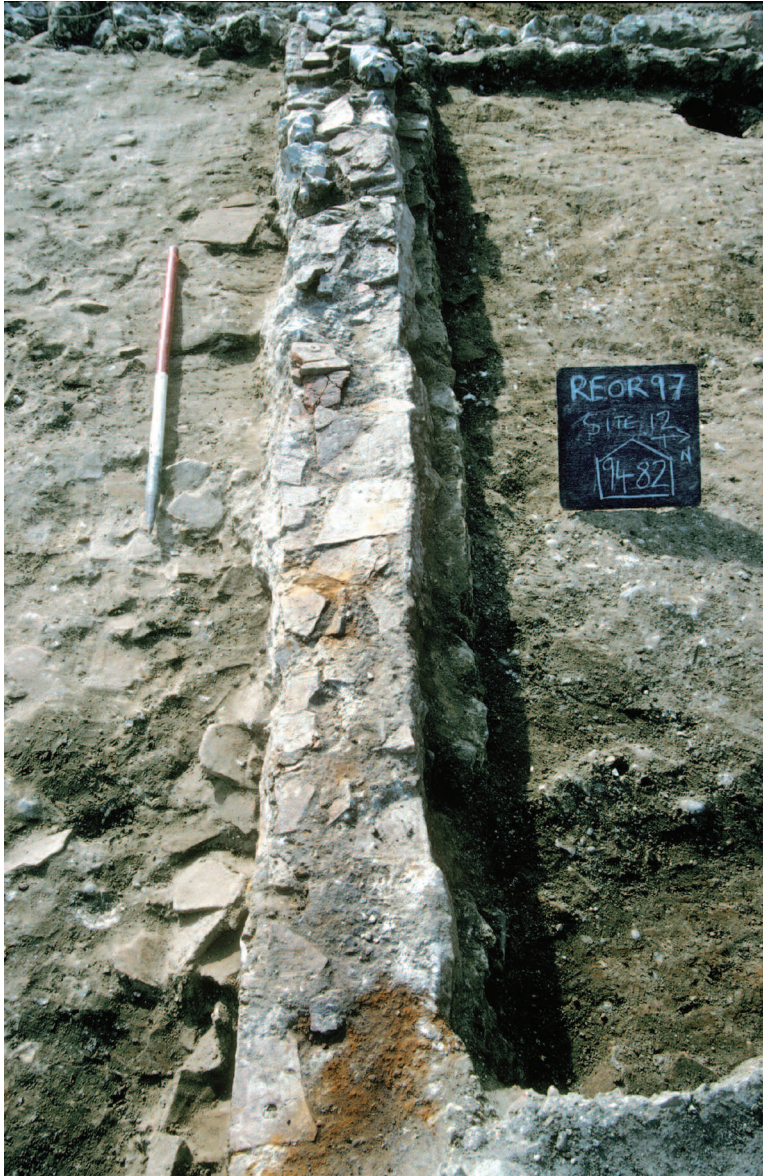
Plate 2.32 Site 12, Building 7411: view looking W of wall 9482 showing the mixture of building materials used (Project Phase 6)

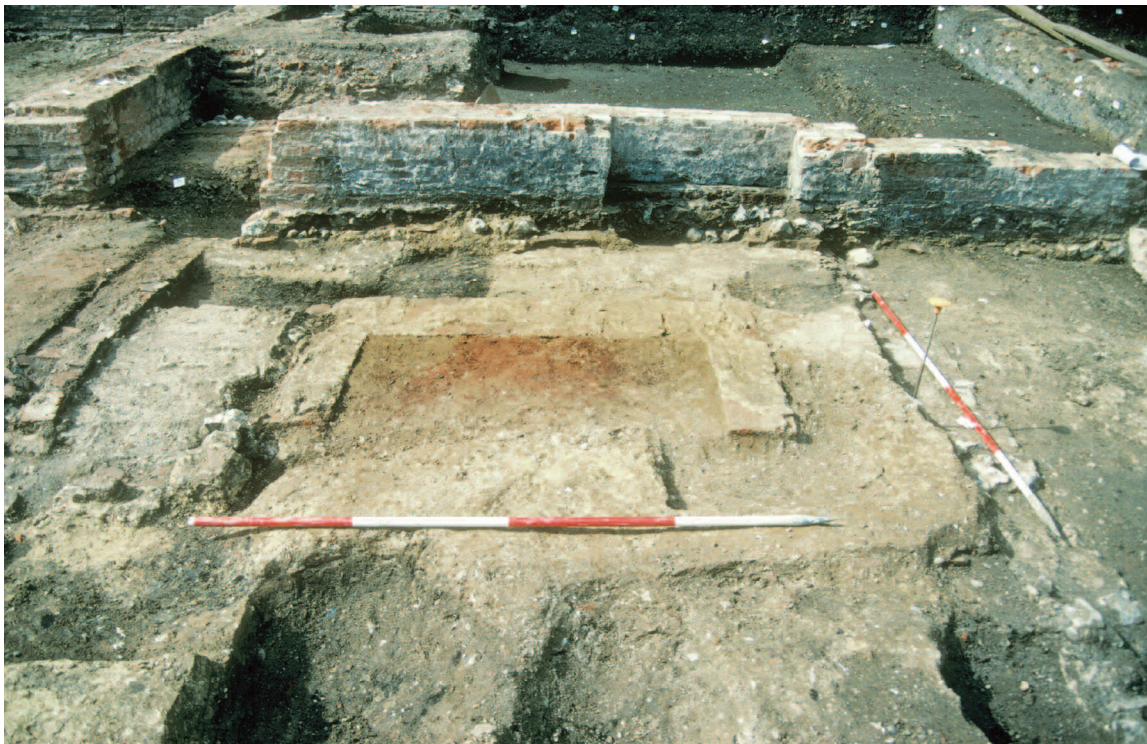
*Plate 2.33 Site 12: view looking NW showing the remains of fireplace 2821 added to Room 3 of the Yield Hall (Project Phase 6)*

At the same time as the extension to the building, a large U-shaped brick fireplace measuring 2 m x 1.1 m was inserted into Room 3 (2821, 2820) (Plate 2.33). The foundations of this hearth (695) comprised flint nodules set in mortar above which a layer of tile and mortar supported a brick fireplace (of which one course survived). The fireplace is not directly dated but the presence of an occupation deposit and possible early floor surface underlying it suggests that the fireplace was not an original feature of the room. A compact mortar floor surface (2743) was laid in and around the fireplace and replaced the earlier compacted earthen floor.

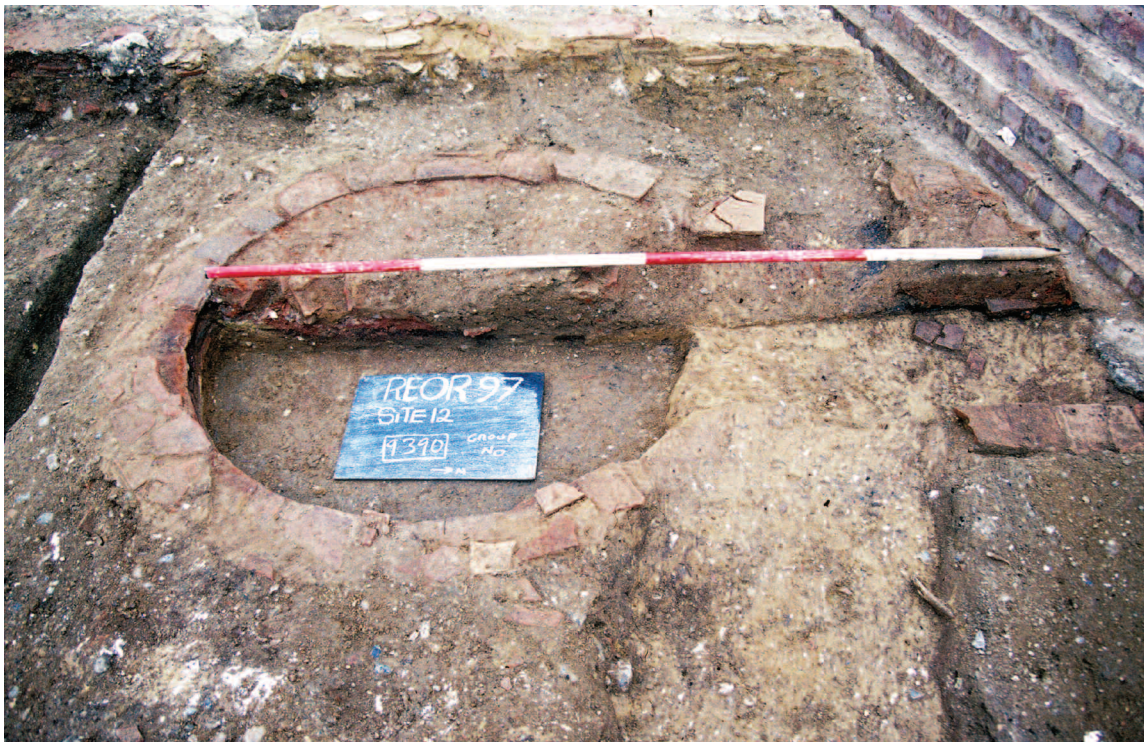
Plate 2.34 Site 12: view looking W showing partially excavated hearth/vat base 9391 in Building 7410 (Project Phase 6)

The timber structure was associated with two hearths, one just to the north and one to the south. Hearth 9391 was a large circular tile feature (9021) consisting of four surviving courses set in brick earth and measuring 1.35 m diameter (Plate 2.34). A possible working surface of tiles, 3 tiles wide and 17 tiles long, was positioned across the northern edge of the hearth (9019). This floor was of the same build as wall 8812. A further smaller hearth (9404) was positioned immediately to the south of the timber structure and the very close proximity of the three features suggests their function was linked. The presence of large circular hearths for heating and an associated platform may indicate that these structures were part of a dyehouse with

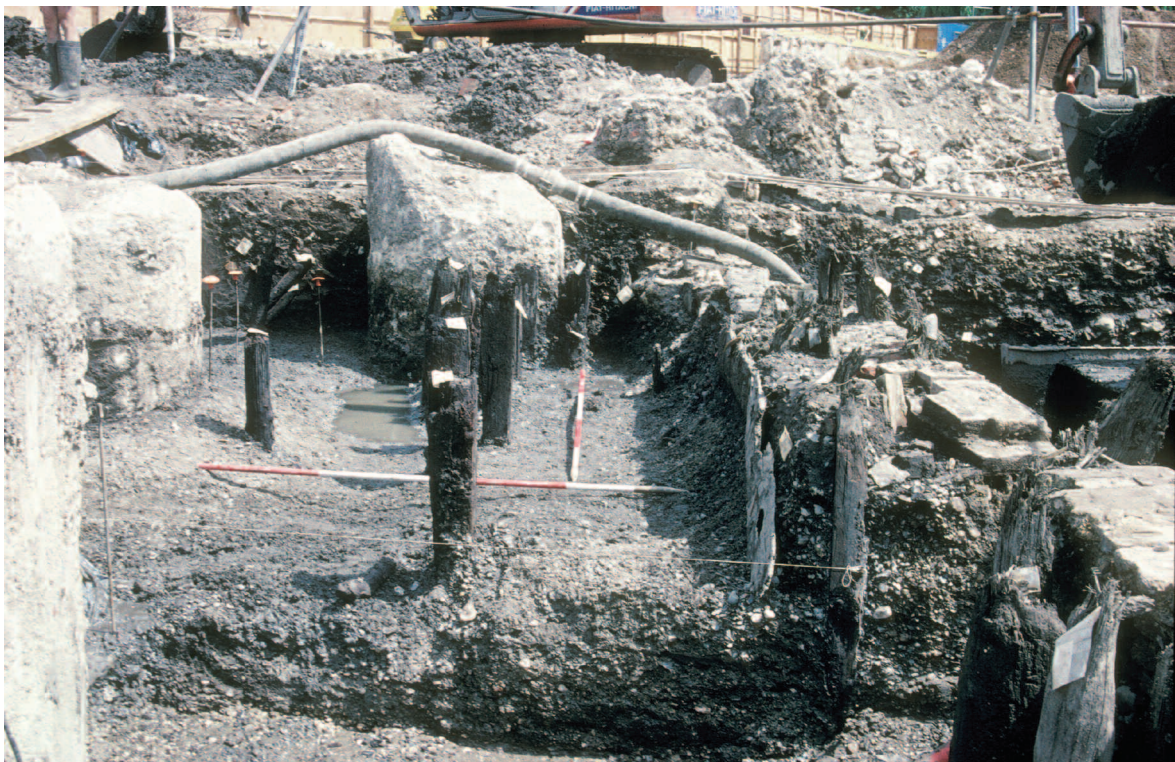
Plate 2.35 Site 101: view looking NE of 16th-century revetments of the northern bank of the Back Brook (Project Phase 6)

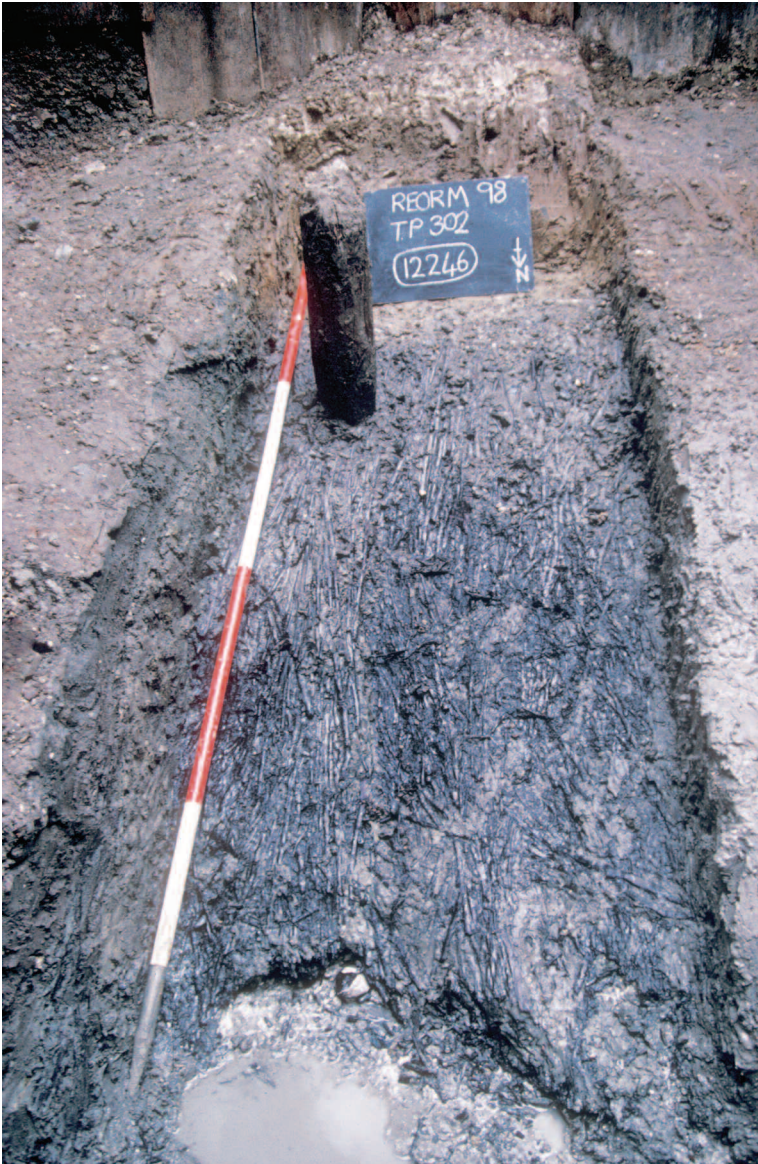
Plate 2.37 Site 300, Test Pit 302: view looking SE of the plant matting placed to consolidate the south bank of the mill tail (Project Phase 2)

In TP 302 to the south of site 300 a man-made clay bank orientated south-west to north-east was consolidated with layers of deliberately laid plant matting (Plate 2.37). This probably represents the southern bank of a man-made channel, which, from its location, seems likely to have been the tailrace channel of the mill, taking water away once it had turned the waterwheel.
