# UNDER THE ORACLE

Excavations at the Oracle Shopping Centre site 1996-8:  
the medieval and post-medieval urban development  
of the Kennet floodplain in Reading

Thames Valley Landscapes Monograph No 36

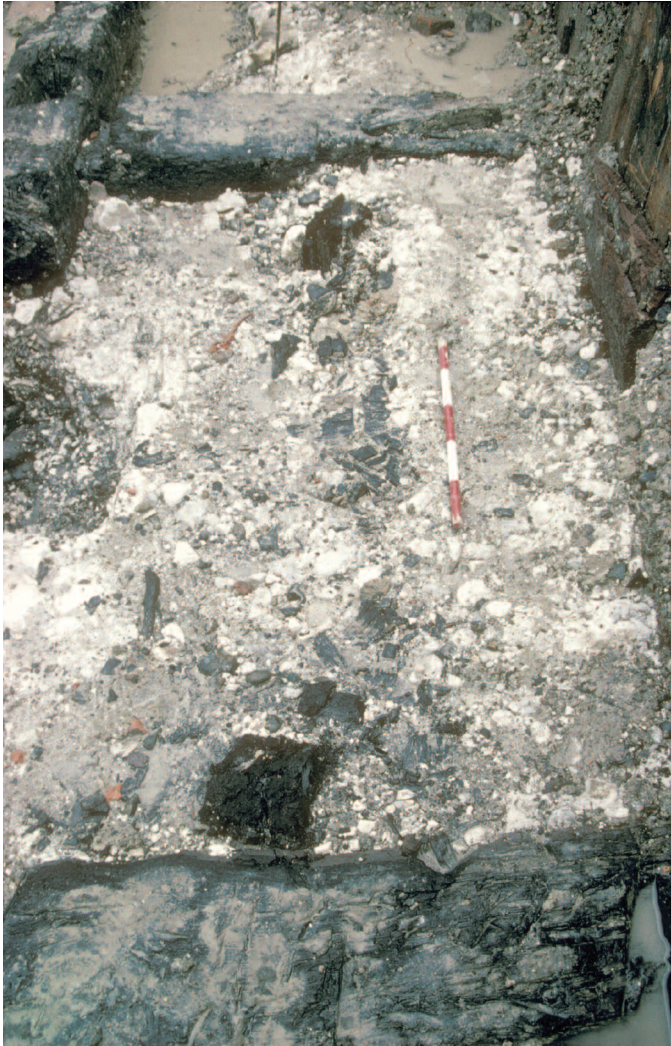
*Plate 2.39 Site 300: view looking NE showing oak chip waste lying on the chalk foundation deposit, as a result of the on-site trimming of the oak frame by carpenters during construction of the early 14th-century mill (Project Phase 4)*

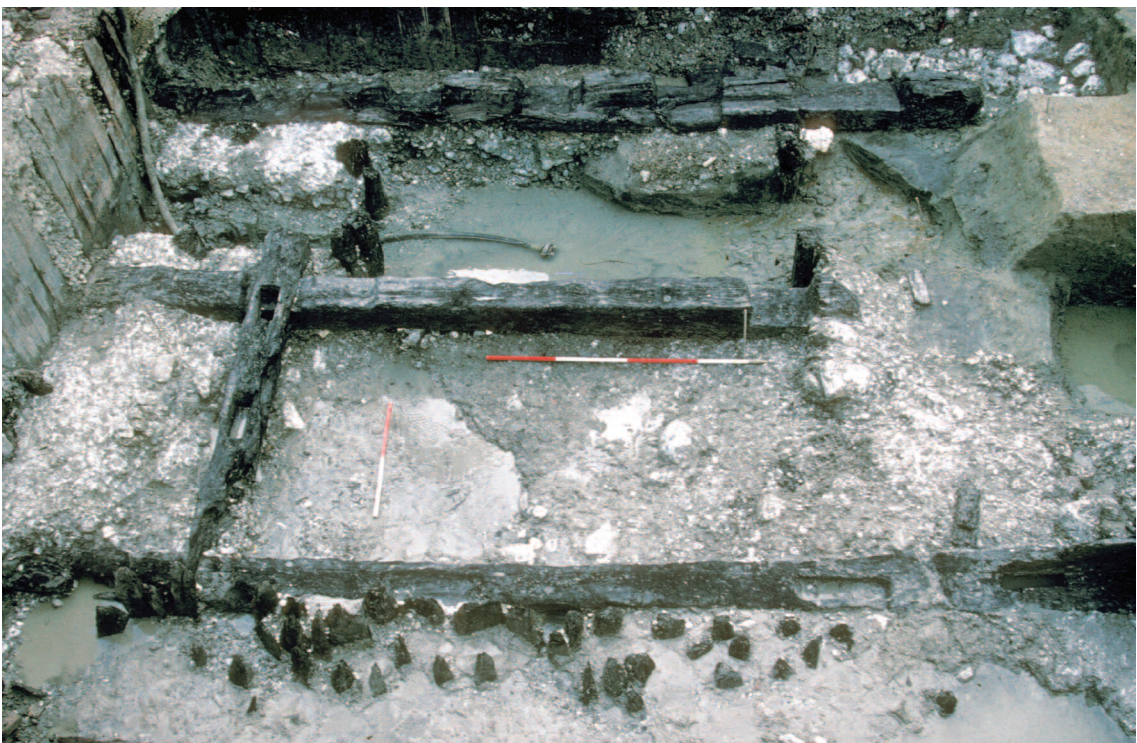
*Plate 2.40 Site 300: general view looking SW of the foundation frame of the early 14th-century St. Giles Mill (Project Phase 4)*

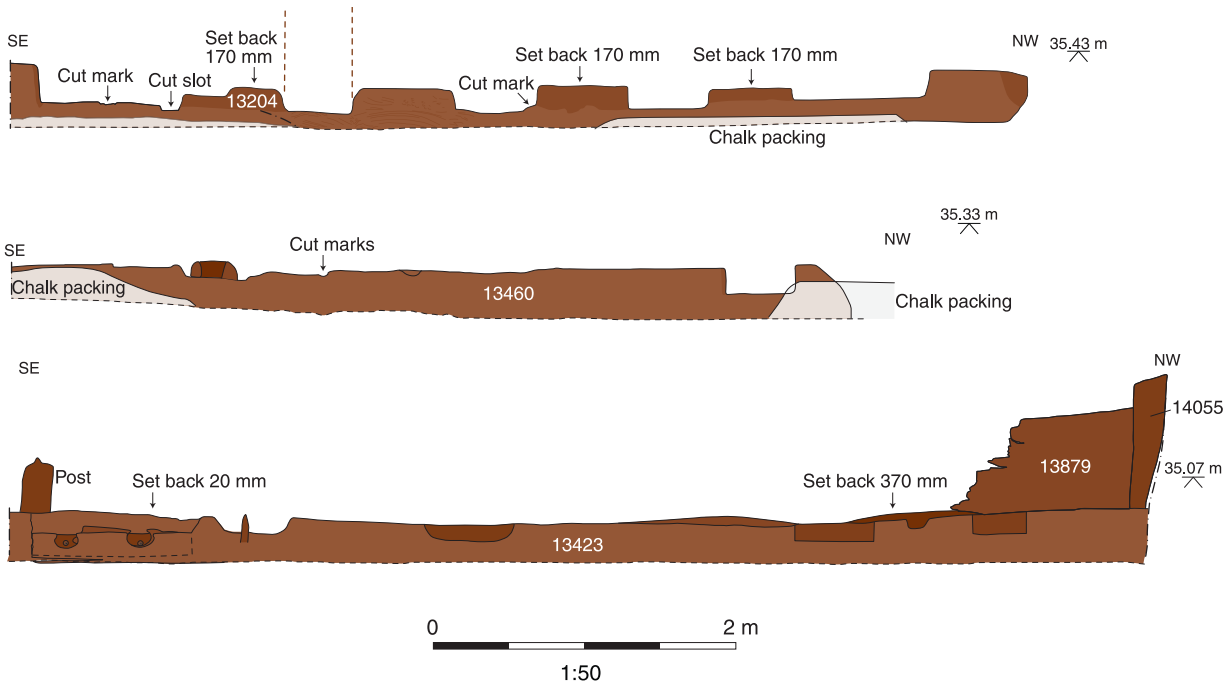
Fig. 2.24 Site 300, St Giles Mill: details of timber joints in the foundation timbers of the 14th-century mill (Project Phase 4)

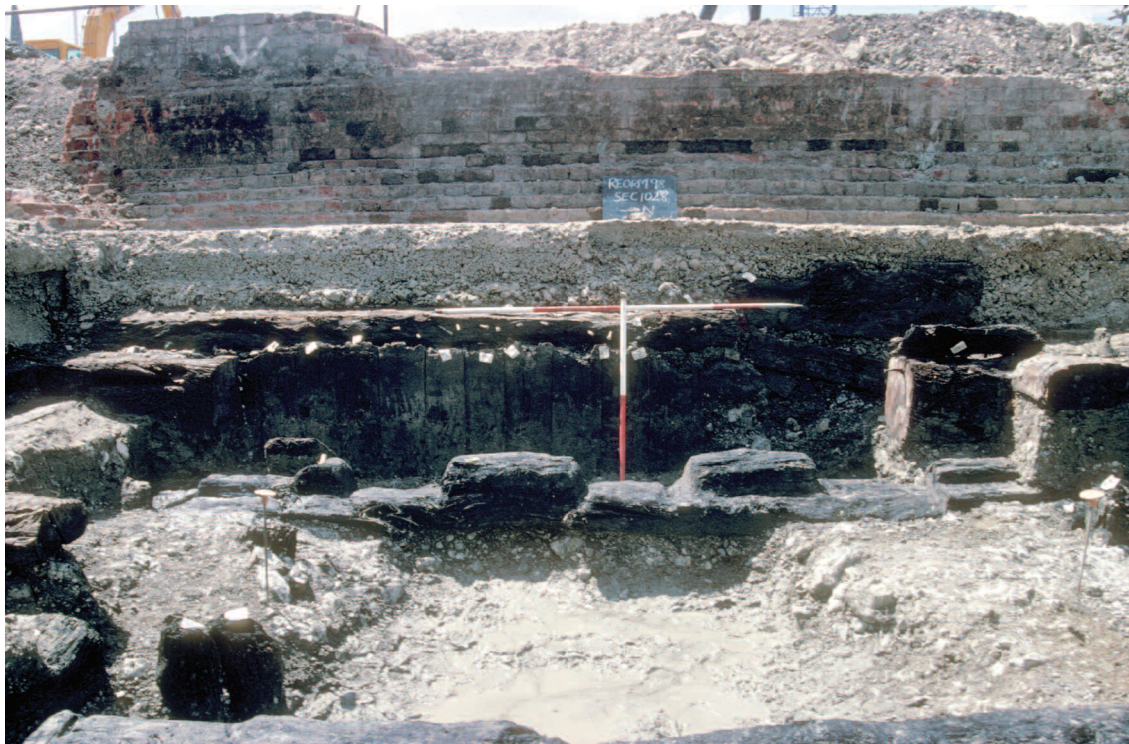
Plate 2.41 Site 300: view looking SW showing the slots and jointing in beam 13204 which gave a dendrochronological date of AD 1302-?34 (Project Phase 4)

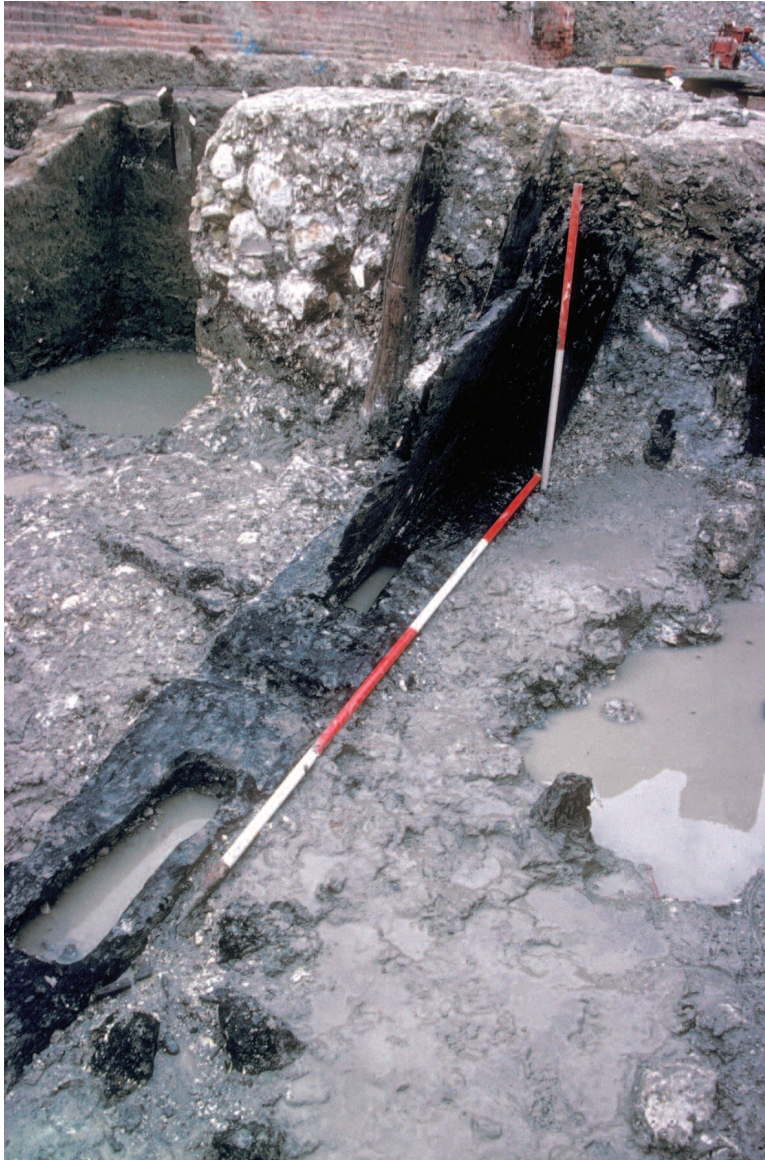
Plate 2.42 Site 300: view looking NW of beam 13423 showing vacant mortises for vertical posts and in-situ planking. The beam was tree-ring dated to after AD 1267 (Project Phase 4)

The ground beams allow us to reconstruct the probable form of this part of the mill, starting with beam 13204 at the upstream end. The three large trenches in the upper face of this timber probably each held timber plank-built trough-like chutes or channels, known as races. The upstream end of the races probably sat in these vacant trenches, directing the water into the races to drive one or possibly two waterwheels, which rotated within them (the third race possibly acted as a spillway or bypass channel or a fish/eel trap). The wheels may have rotated on the same axle (equally it is possible that another wheel sat in the central race upstream of the wheel in the southern race). This axle would have been supported on a Hurst Frame, the remains of which are probably represented by the two groups of opposing posts, 14086 and 14060, situated between the western and central ground beams. The trapezoidal arrangement of the southern group 14086 suggests that this would have been the location of the pitwheel.

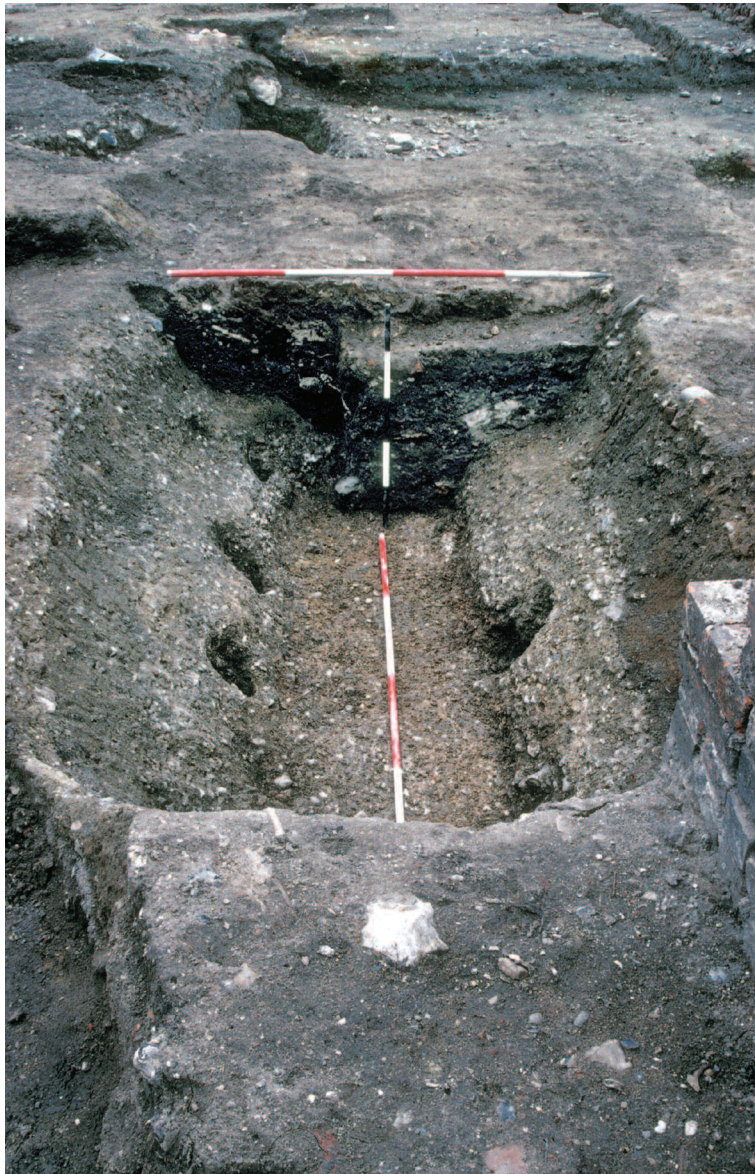
*Plate 3.5 Site 29 the Oracle:  
view looking SE of the saw  
pits (Project Phase 7)*

Two adjacent pits (4326 and 4410), probably saw-pits (Plate 3.5), show that the area that had first been used as a builder's yard in the 16th century (see Chapter 2 Project Phase 7) was probably used again in this way during the construction of the workhouse in 1627 and 1628. The primary courtyard surfaces 3755=3743, 4207 and 4621 sloped gently down to the south and consisted of rubble fragments and small stone cobbles. They survived only in patches, some of which had slumped into the softer infills of the

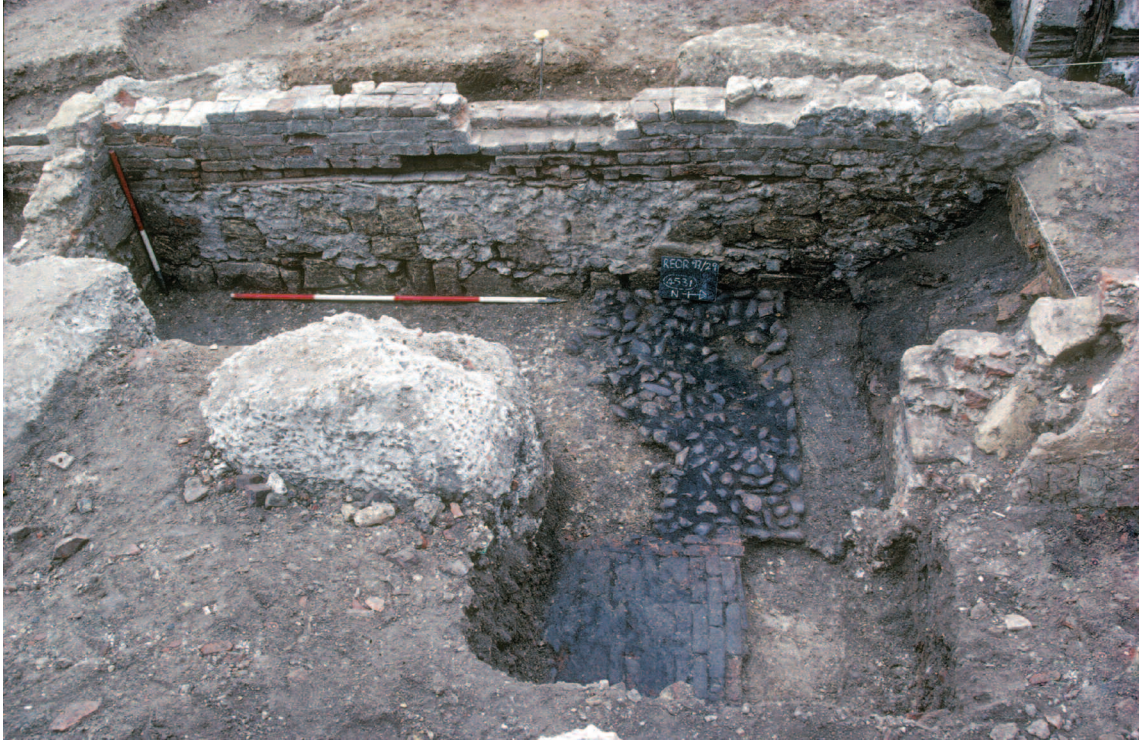
*Plate 3.6 Site 29: view looking NW of cellar 4575 in the east range of the workhouse (Project Phase 7)*

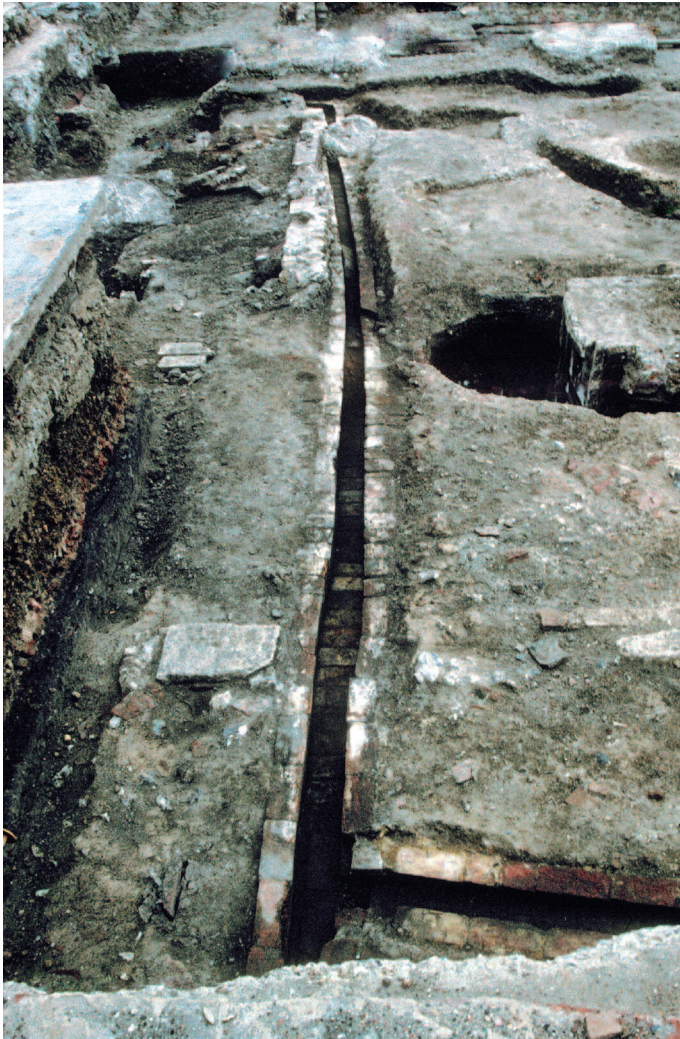
*Plate 3.7 Site 29 the Oracle: view looking SE along drain 3852 (Project Phase 7)*

towards the Holy Brook (Plate 3.7). Access via a set of steps (that did not survive) was provided from the north end. The cellar floor consisted of large well-laid cobbles, 4604, around a brick hearth setting, 4605, in the northern half of the room. The hearth and to some extent the surrounding floor was overlain by charcoal-rich occupation deposits 4790 and 4510, although there were no finds. It is unclear whether this hearth was purely for heat, or whether it had some function in a production process.

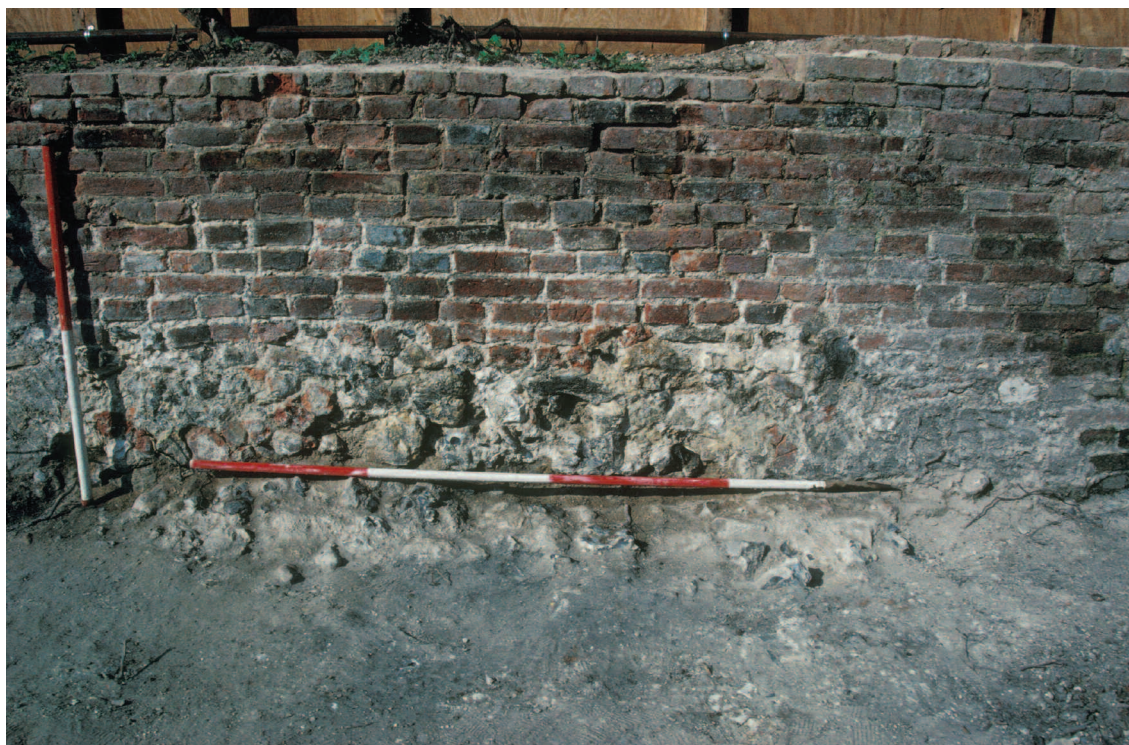
Plate 3.9 Site 29: view looking SW at the west wall (3967) of the west range of the workhouse (Project Phase 7)

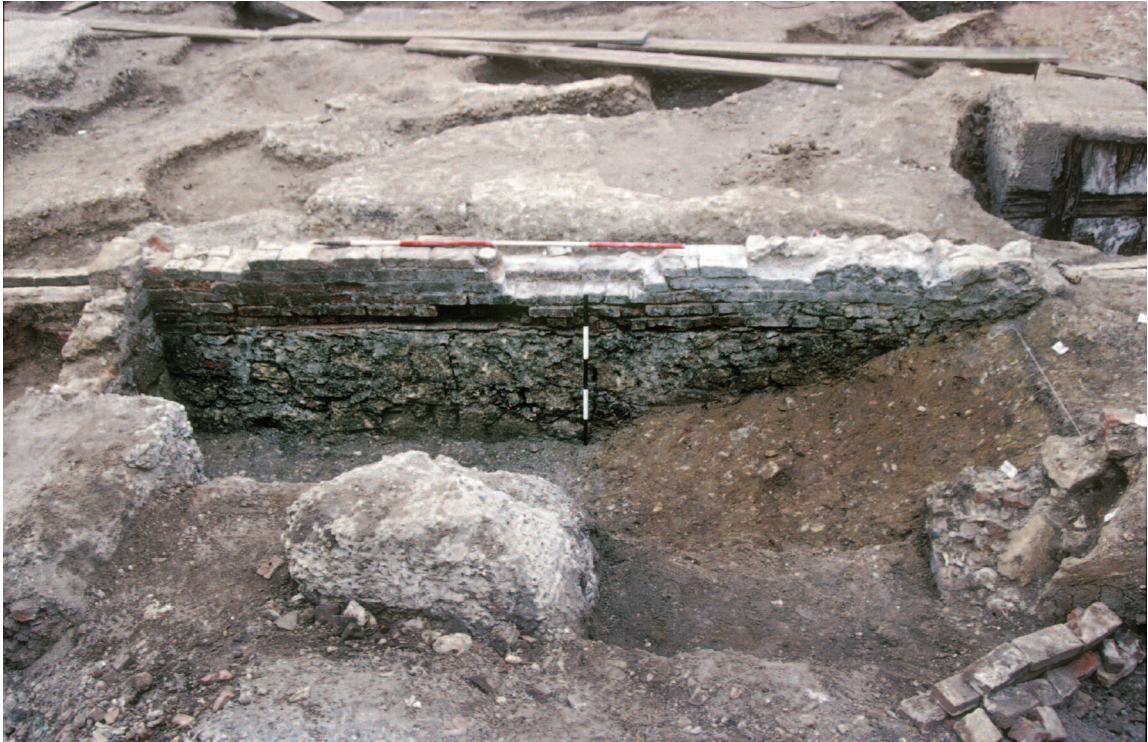
*Plate 3.11 Site 29 the Oracle: view looking SW showing the back-filling in the cellar in the east range of the workhouse (Project Phase 8)*

The 17th-century cellar towards the south end of the east range (4575) and its hearth went out of use, and the cellar was backfilled (Plate 3.11). The initial dumps of sand and brickearth-rich mortar suggest they were the product of demolition activity, probably within the Oracle, and they included broken medieval tiles and post-medieval brick with occasional metal fittings such as hinges and metal straps. Later infilling included material indicative of more domestic activity, such as pottery, animal bones, shell, clay pipes (including locally-made examples, see Higgins, Chapter 9, below), pins and two fragments from an attractive maiolica tile (Plate 3.12). Some of these finds probably derived from the

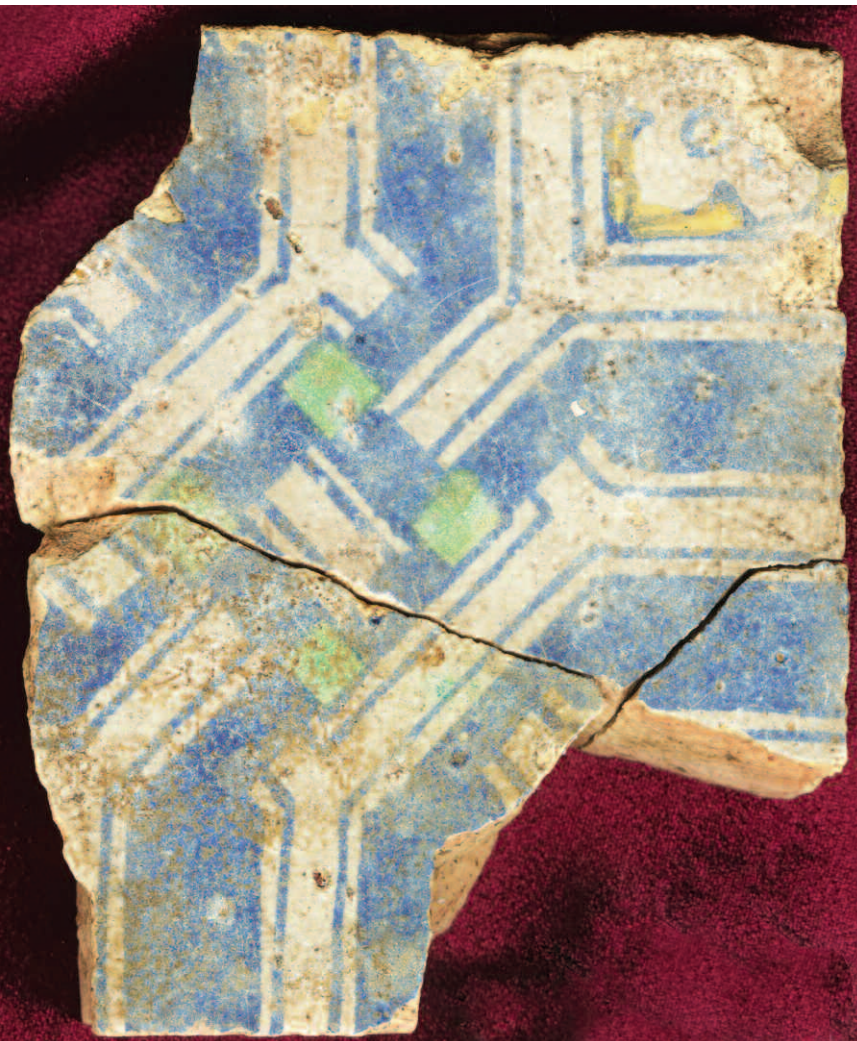
*Plate 3.12 Site 29 the Oracle: a maiolica tile from the backfill to the eastern cellar, perhaps from an original wall of the workhouse*

domestic quarters in the Oracle; the maiolica tile might have been used in a tiled floor, wall or fire-surround, and demonstrates the quality of internal decoration in the better-appointed rooms. The pottery is typical of the period and includes standard English wares such as Surrey borderwares, and locally produced post-medieval redwares. Imports included Frechen and Westerwald stoneware from the Rhineland in Germany, and small quantities of decorative tinglazed wares. The pottery from these traditions was used for the consumption and storage of food and drink. Animal bones included domestic fowl, sheep, and cow and indicate a varied meat diet. One of the tips (4463) was rich in ash and charcoal, which suggests that the building (and perhaps more specifically the domestic quarters) were cleared of rubbish which was first burnt before disposal. The significant numbers of pins present in these later fills suggest that activities involving some form of fabric processing took place at the Oracle, or indeed that pin manufacture had taken place prior to 1720. The former access doorway to the cellar, in the north wall, was blocked (4390) and access from the courtyard was moved to the west wall. Once the cellar had been filled up, a new floor of rammed chalk (4394) was laid. Within the new floor a brick-built sub-circular structure (internal diameter 0.7 m) was constructed adjacent to the southern wall, with a brick-built trough measuring *c* 1.1 m square to its north (Plate 3.13). These structures were probably a small-scale furnace and quenching pit and represent small-scale industry, possibly for the manufacture of metal items, such as pins.

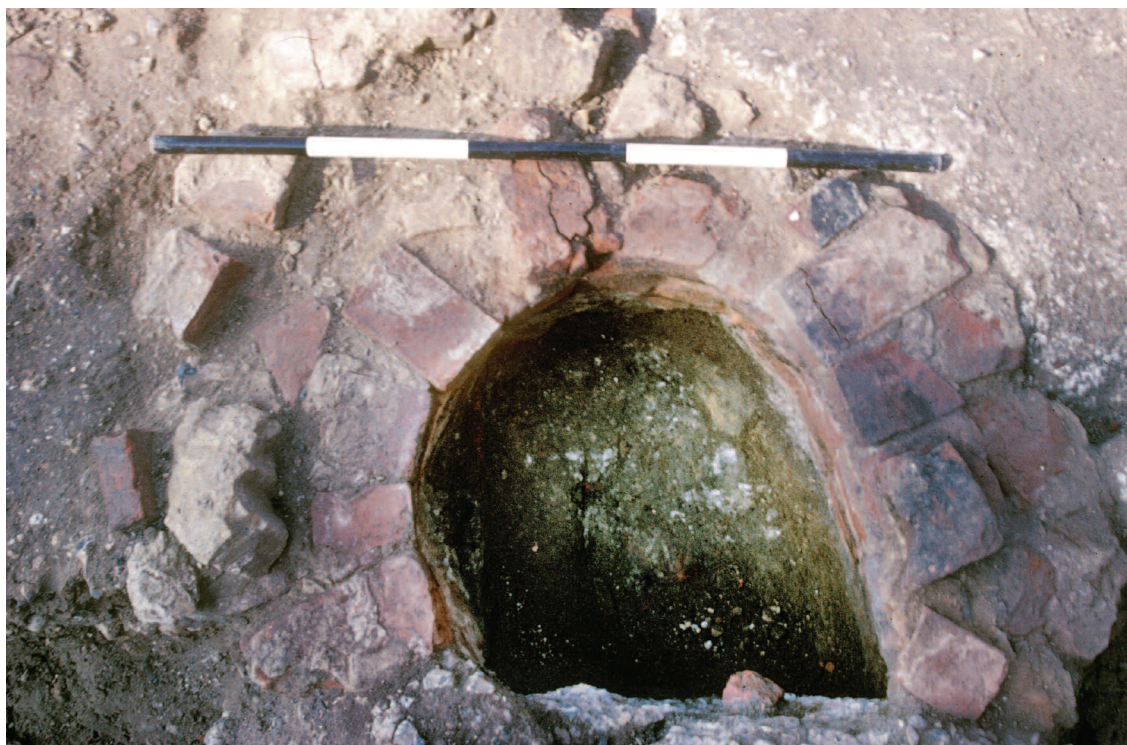
*Plate 3.13 Site 29 the Oracle: vertical view of the furnace (Project Phase 8)*

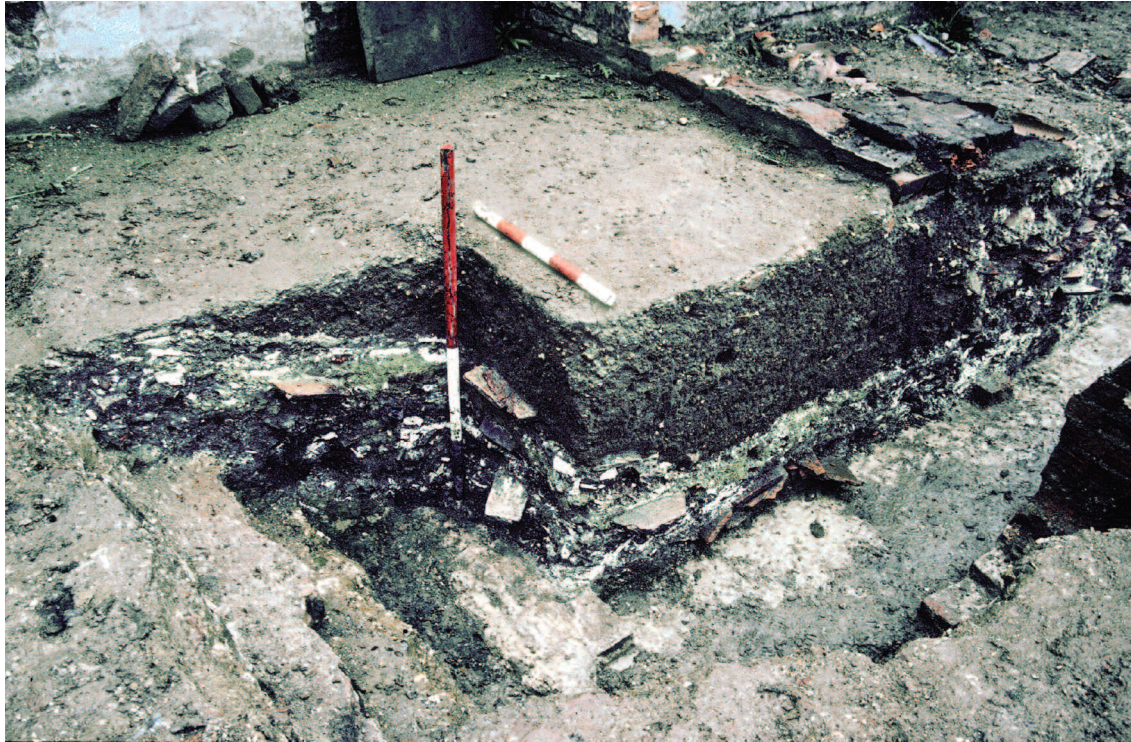
*Plate 3.14 Site 29 the Oracle: view looking E showing material dumped into the cellar (3967) in the west range of the workhouse (Project Phase 8)*

This sub-phase saw major remodelling of the north end of the western range. Echoing changes seen in the east range, the brick-built cellar described in the previous phase in the west range went out of use. Its brick walls were almost totally dismantled, and the resulting hole infilled with material derived from demolition activity (Plate 3.14). The fills contained significantly fewer finds than the backfilled cellar in

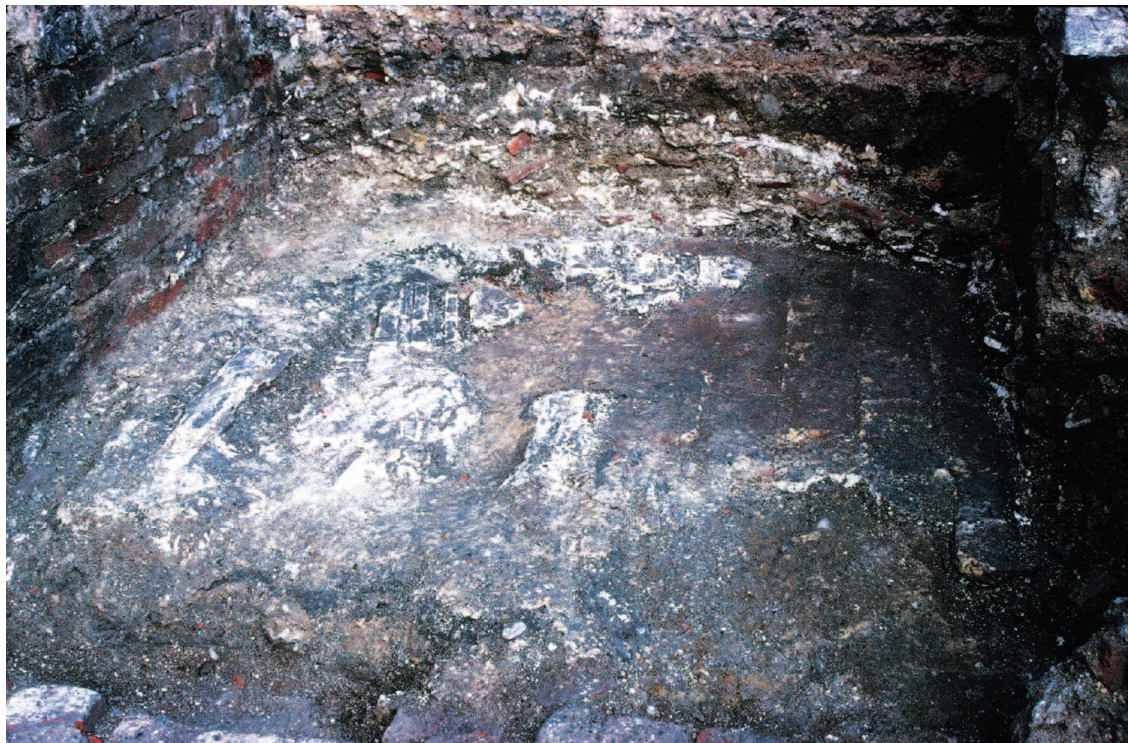
*Plate 3.15 Site 29 the Oracle: view looking NW at a detail of demolished or collapsed workhouse wall and ceiling plaster showing the impressions of laths in the untruncated northern part of the west range (Project Phase 8)*

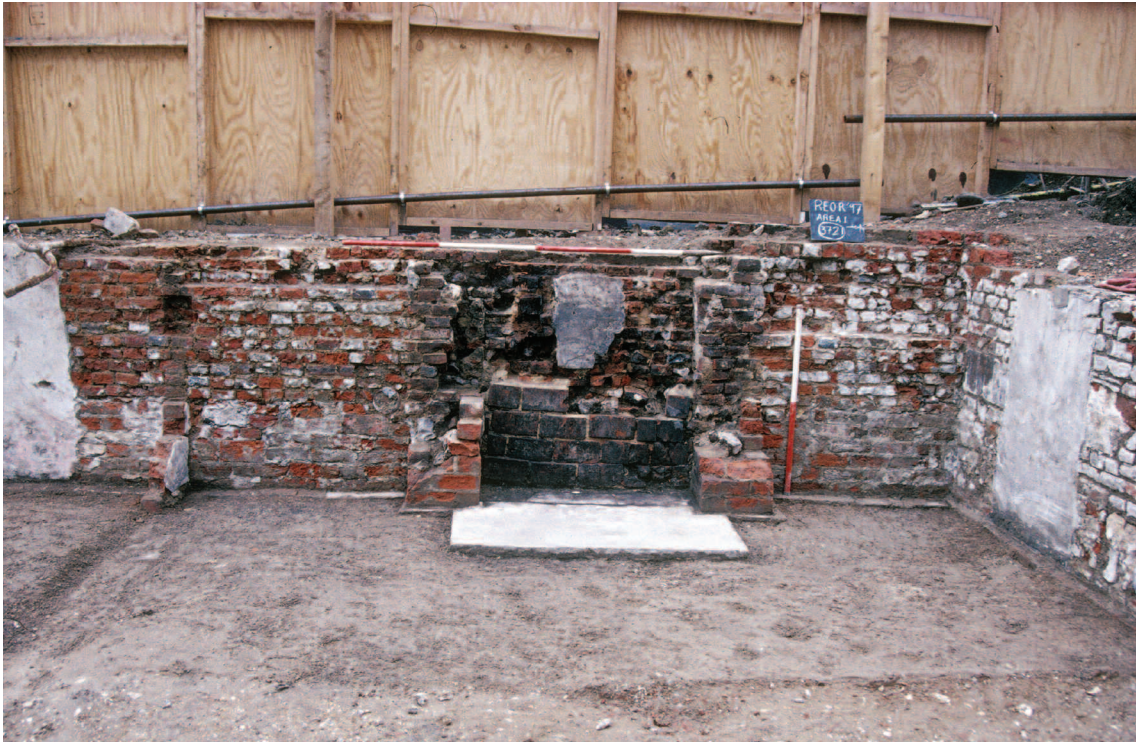
*Plate 3.16 Site 29 the Oracle: fire places: (above) view looking SW at the western fireplace 3721 and (below) looking NE at the eastern fireplace 3775 (Project Phase 10)*

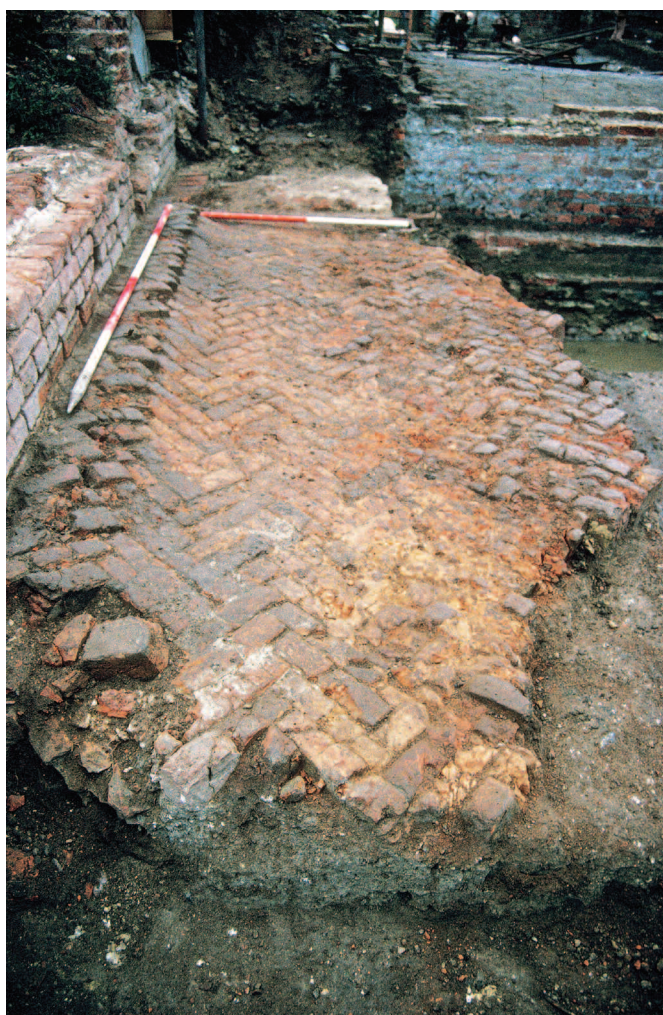
*Plate 3.17 Site 29 the Oracle: view looking NW of herringbone brick floor 3812 (Project Phase 10)*

The far western corner of the south range of the Oracle was also maintained and it is likely that the latest brick herringbone flooring (3812; Plate 3.17) inside this part of the building served as the floor until it was demolished in the mid 20th century. The brick culverts covering the Holy Brook and Minster Mill Stream were recorded. The south-east quadrant did not have basements in the initial or later redevelopment, although foundations for the structures built there comprised large and deep square concrete bases, which removed the archaeology from all the previous phases. The culvert enabled the building north of the Holy Brook to be extended southwards over the watercourse to meet the building in the south-west corner. To the west of this, the bridge that had been constructed in 1628 was retained to provide access over the stream.

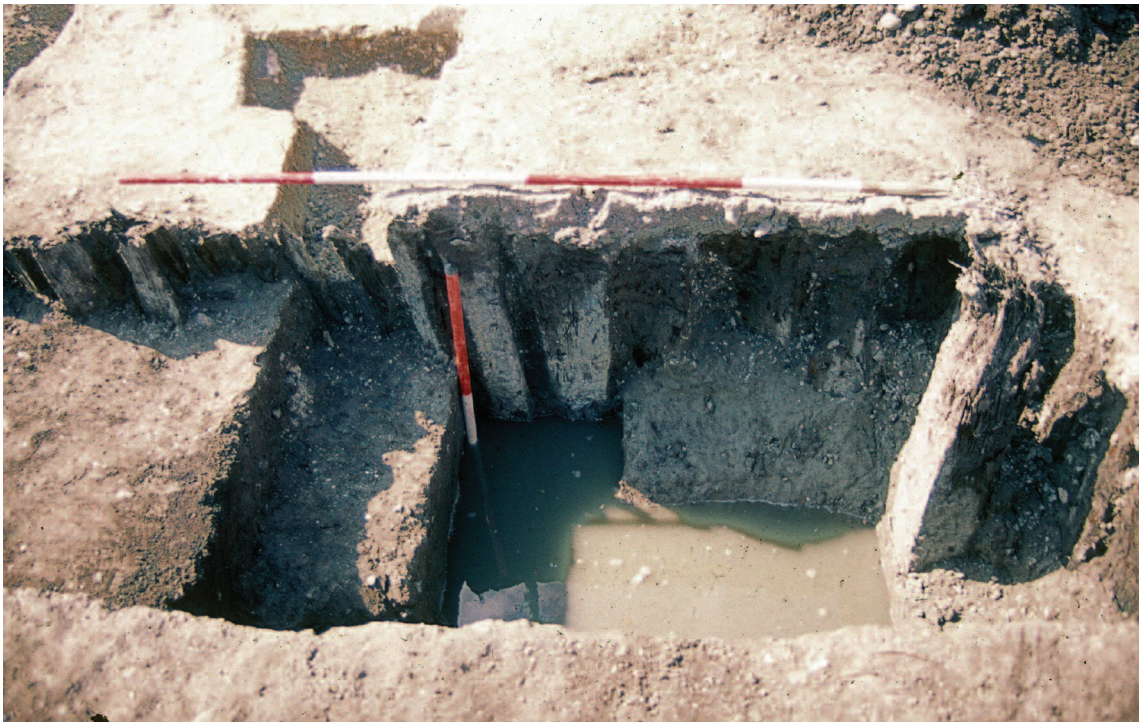
Plate 3.18 Site 78: view looking SE showing the construction detail of the eastern dyeing vat pit 8053 (Project Phase 7)

The eastern pit (8053) was lined with a timber revetment (8052) comprising vertical planks measuring 0.15 m wide x 0.04 m thick x 1.1 m long (Plate 3.18). They were positioned flush with the vertical section of the pit but went through the lower angled part and into the underlying deposits so that the lower part of the pit was not lined. It is likely that the pit would have held a large vessel to contain the liquid and that only the upper part of the pit needed to be protected and lined. Two silty clay fills were deliberately packed around the timbers to keep them in place (8076, 8078) and in each of the two visible corners was a pair of more substantial posts. The function of these posts is not clear but they are most likely to have supported the vessel in the pit. The structure of the pit at Reading is highly reminiscent of Structure 791 at Beverley where a wooden vat was set into a pit in the ground and fed by a wooden pipe. Around the top part of the square pit at Beverley was wooden shuttering, similar to that identified here, and posts to support the vat (Evans and Tomlinson 1992, 29-30). This pit may have been used for cooling liquid, with the coolness of the surrounding earth helping to bring the temperature down (Evans and Tomlinson 1992, 284).

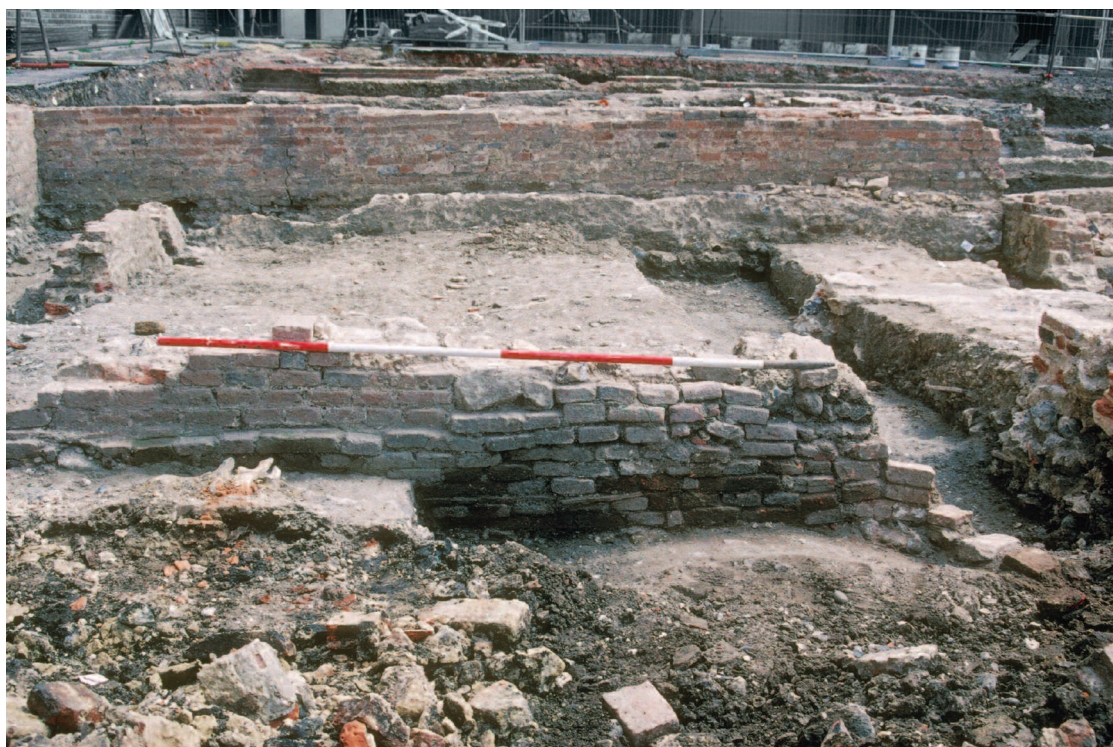
Plate 3.24 Site 12: the Yield Hall view looking NE of brick wall 705 forming west wall of Room 5 (Project Phase 7)

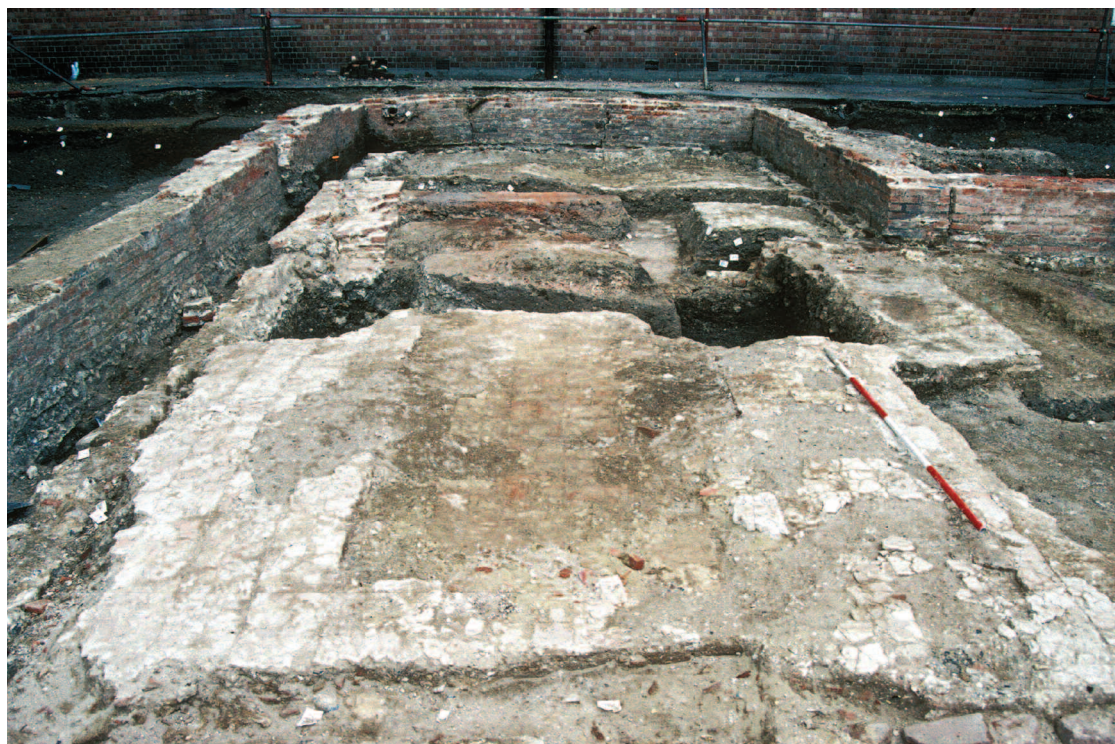
Plate 3.25 Site 12: the Yield Hall, view looking NW showing mortar bedding layer with the impressions of ceramic tiles or bricks for floor 716 in Room 4 (Project Phase 7)

Inside Room 5, the floor was surfaced with tile or brick (the mortar bedding 794 survived) probably at the same time as a similar floor was laid in Room 4 to the south of wall 715 before the insertion of a fireplace and subsequent floors (Plate 3.25). Interestingly, not all the rooms were given tiled floors at this time; a brick floor surface (955) was laid in Room 2 in the early part of the 17th century

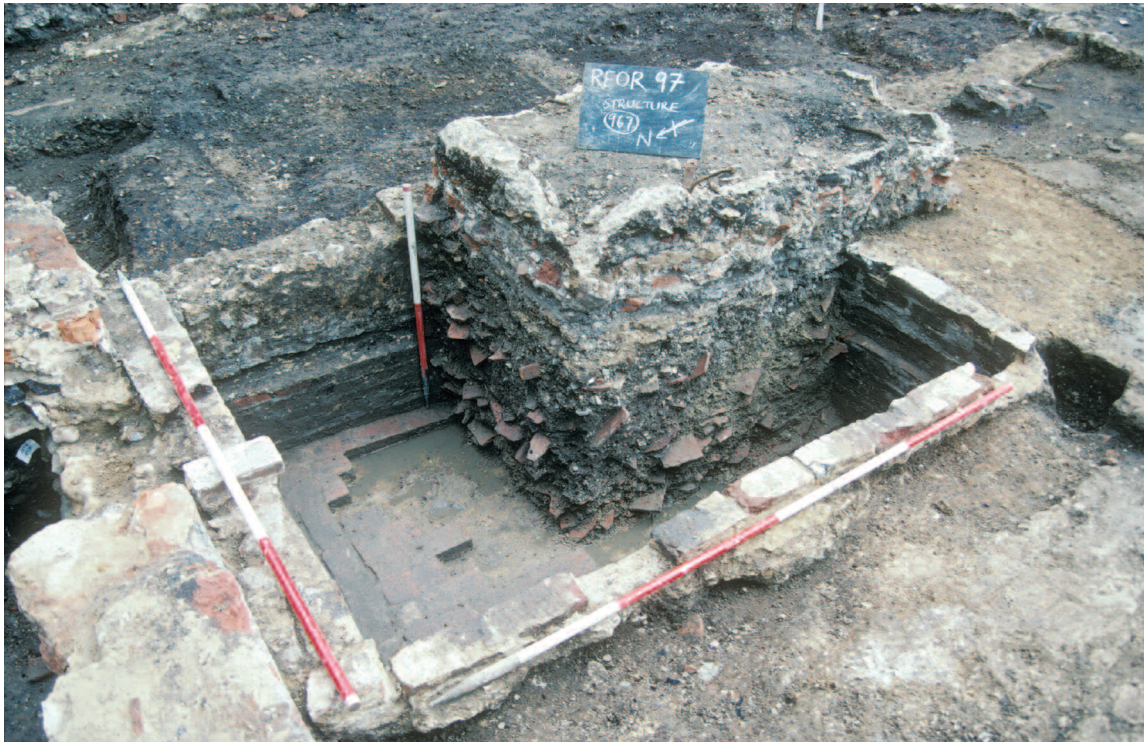
Plate 3.26 Site 12: the Yield Hall (above) view looking NE showing cellar 967 with a later brick reflooring, and (below) with original flooring of reused ceramic rooftiles (Project Phase 7)

(1610+) but there is no evidence that the floor surfaces in Rooms 1 and 3 were changed. At the same time as the brick floor was laid in Room 2, a half cellar (967) was installed in the north-eastern corner of the room. This cut through the foundation deposit 709, forming a cellar 0.7 m deep, with a floor constructed from roof tiles laid in a random pattern. Plate 3.26(i) shows the cellar with a later floor; Plate 3.26(ii) is a detail of the original cellar floor, revealed at a later stage of excavation. In the south-east corner of the cellar and embedded in the floor up to rim height was a complete ceramic vessel measuring 0.32 m diameter x 0.51 m deep. It had been broken and stapled together before being deposited with a weight inside it and capped with brick fragments. A large number of early wine bottles were found in this cellar (see GL 19-35, Chapter 9; for illustrated examples see Chapter 5 and Plate 3.27). These date to the late 17th or early 18th century, and both the type of bottle and the period during which the cellar was used predate the general practice of the ageing of wine (Willmott, Chapter 9) making it unlikely that wine was stored for long periods of time in the cellar.

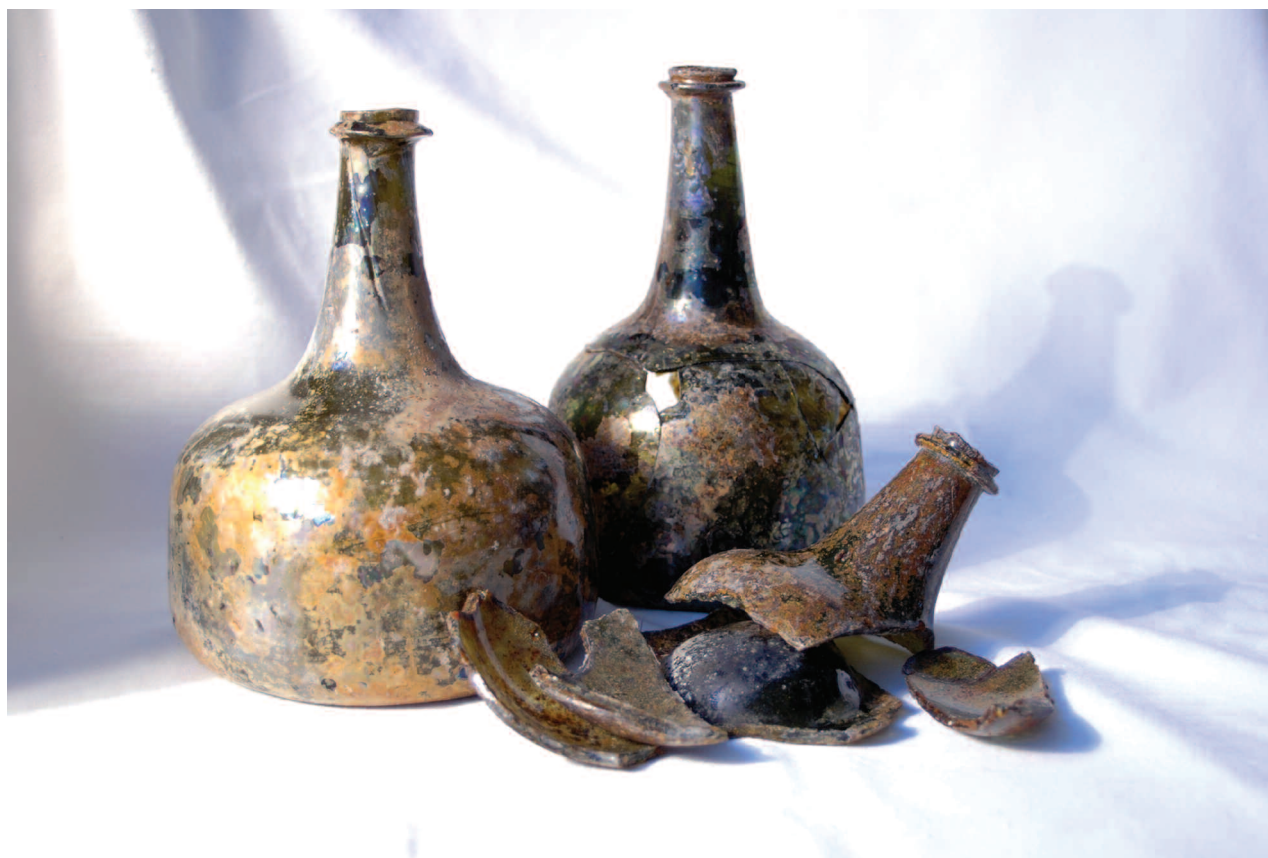
Plate 3.27 Site 12: the Yield Hall, some of the bottles from cellar 967 (Project Phase 7)

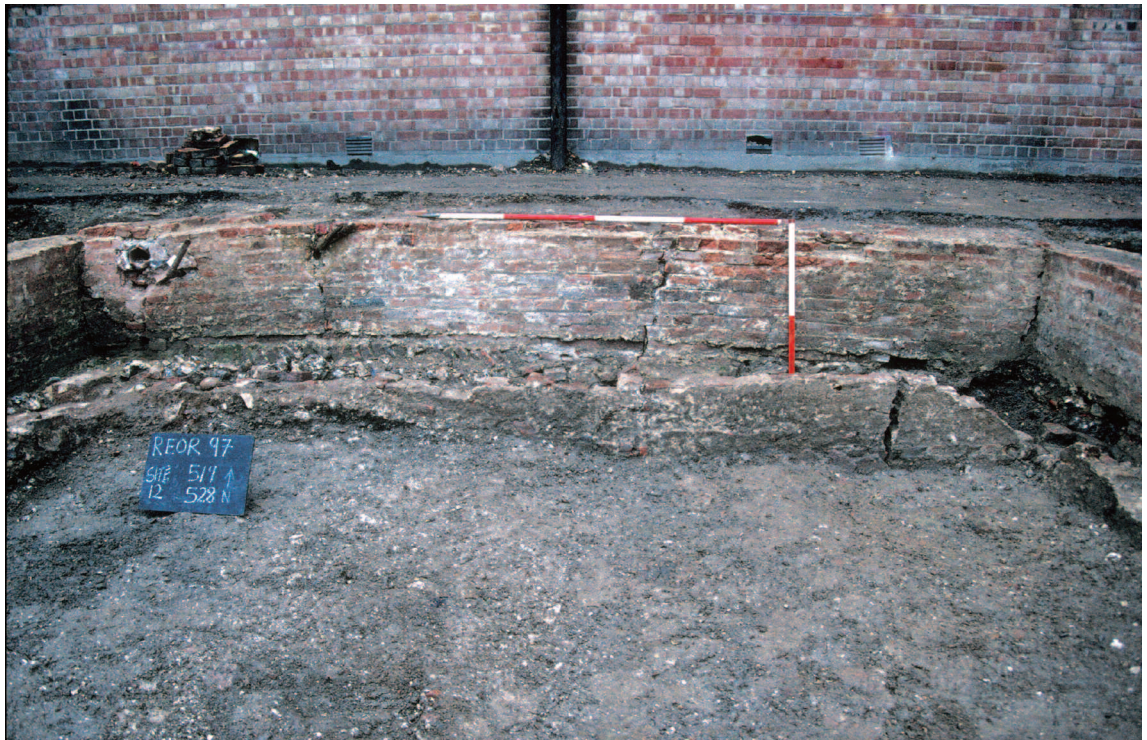
*Plate 3.29 Site 12: the Yield Hall: view looking NW showing the problems of subsidence affecting two phases of walls (Project Phase 8)*

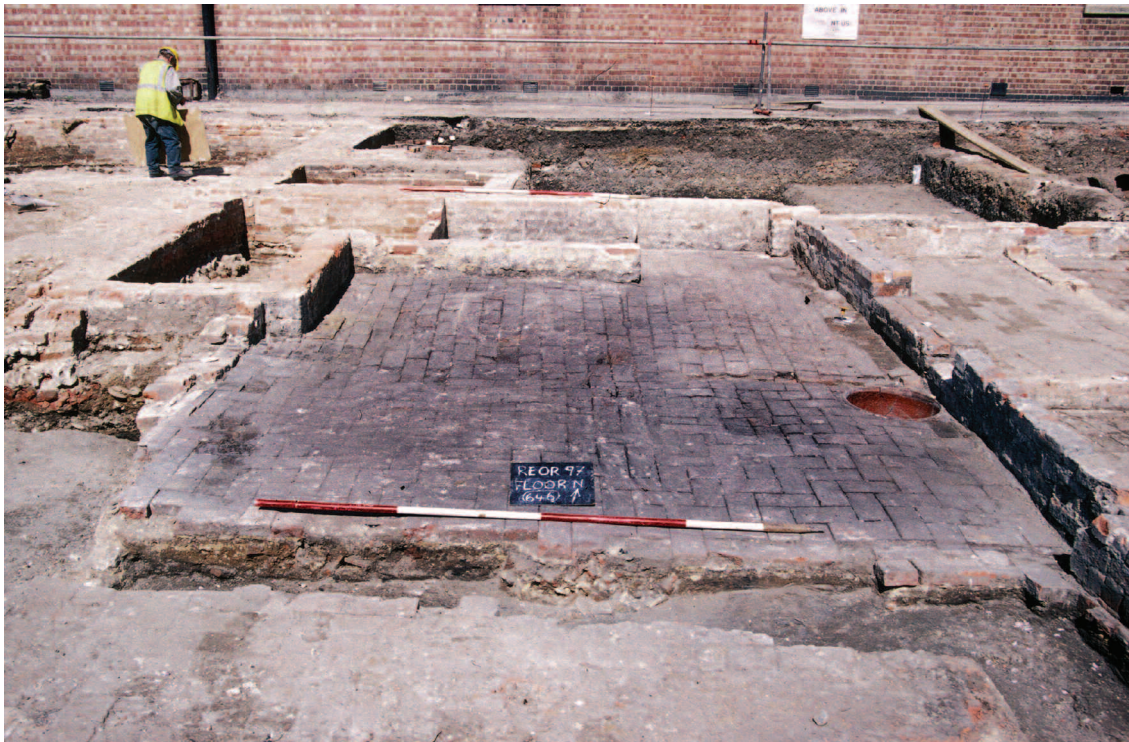
Plate 3.31 Site 12: the Yield Hall, view looking NW showing a ceramic vessel set into surface 646 (Project Phase 10)
