# UNDER THE ORACLE

Excavations at the Oracle Shopping Centre site 1996-8:  
the medieval and post-medieval urban development  
of the Kennet floodplain in Reading

Thames Valley Landscapes Monograph No 36

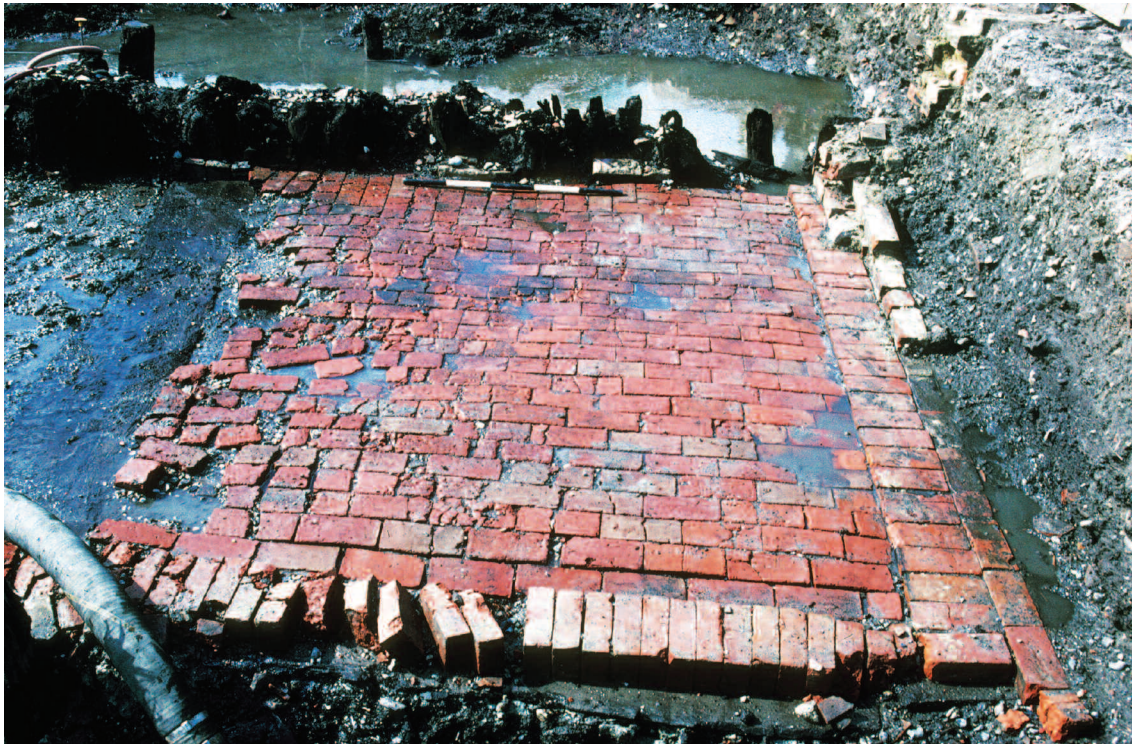
Plate 3.33 Site 101: the Back Brook, view looking NW showing the well-built brick surface 7122 constructed on the southern bank of the Back Brook (Project Phase 7); the Back Brook and its substantial revetment can be seen in the background

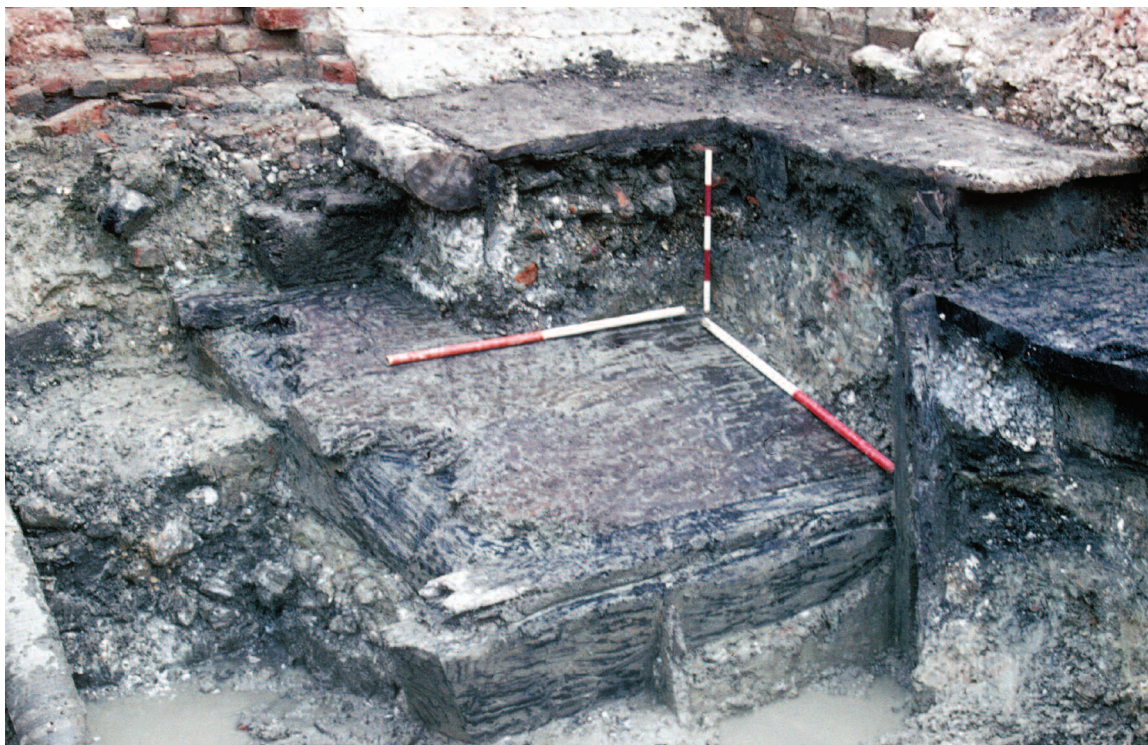
Plate 3.34 Site 300 St Giles Mill: view looking SE showing the exposed 17th-century elm plank deck of the head race (13713) (Project Phase 7)

Plate 3.45 Site 300 St Giles Mill: view looking SE showing a section through multiple phases of head-race structure the latest of which formed a silt trap (Project Phase 9 – also see Plate 3.34)

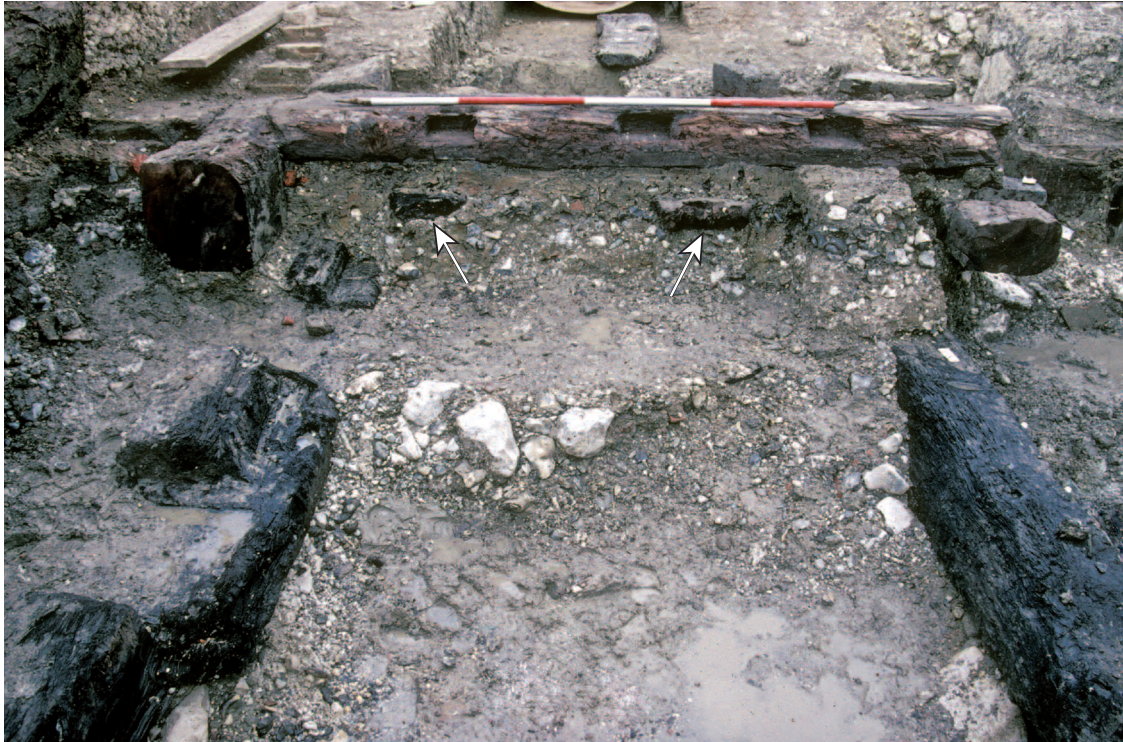
Plate 3.35 Site 300 St Giles Mill: view looking NW showing ground beams 13467, 12057, 13476 overlying the early 14th-century mill timbers (Project Phase 7)

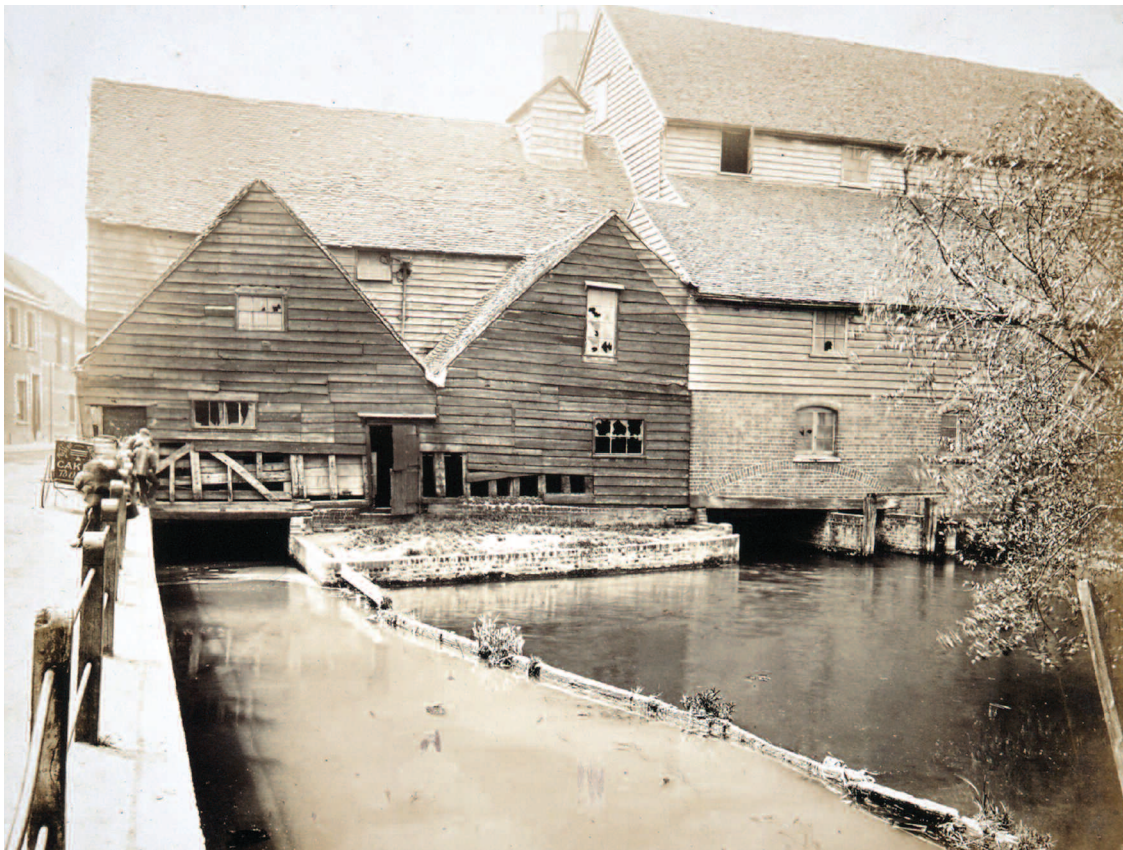
Plate 3.36 Site 300 St Giles Mill: photograph looking SW of the east elevation of the mill taken c 1900; on the left is the 17th-century mill, with the more substantial buildings of the 18th-century rebuild to the right (Project Phase 7)

Early 20th-century photographs of the mill complex immediately prior to demolition show a structure consisting of two principal elements (Plate 3.36) with the larger 18th century mill (see Project Phase 9, below) abutting an older structure to the south (on the left of the plate). The southern element is entirely clad in weather-boarding, some elements of which have fallen away to reveal the timber frame beneath. Architecturally this element

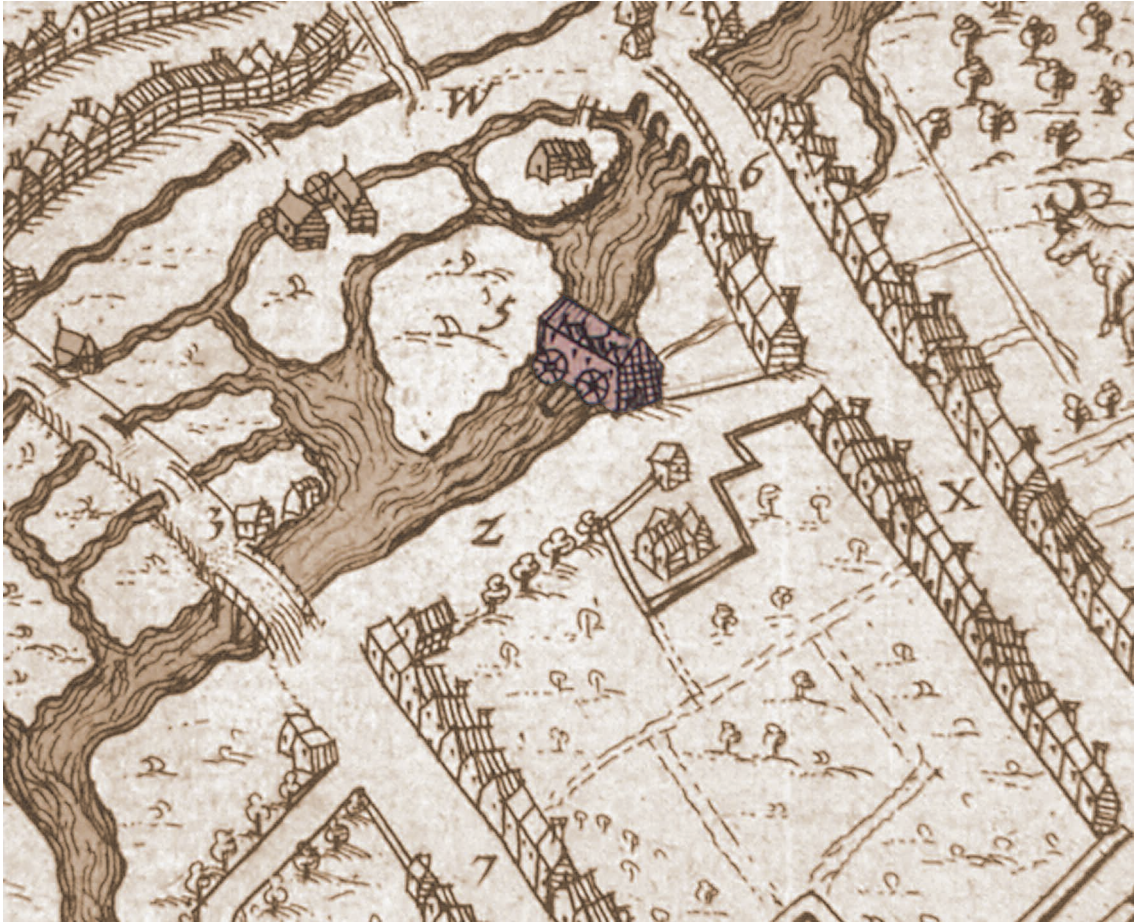
Plate 3.37 Site 300 St Giles Mill: detail of Speed's map (Plate 1.3) showing the 17th-century St Giles Mill (Project Phase 7)

is probably of early 17th-century construction (J Munby pers. comm.), and is likely to be the mill represented on Speed's map of 1611 (Plate 3.37). It is considered that this map and the photograph show the newly constructed mill from this phase.

It is clear that Speed presents a schematic view of the mill as the wheels are positioned on its upstream face; however, it is probably accurate in that the mill is likely to have had at least two water-wheels. The question remains as to where the water-wheels were located. Using a combination of the map and photographic evidence, it is possible to place the footprint of the latest mill complex as shown on the late 19th-century maps (for example the Goad Insurance map of 1895, Plate 1.8), including its 17th-century southern element, over the plan of the excavated remains. This clearly indicates that the northern end of the earlier southern element was located immediately south of the race to which the partial remains of the timber deck described above belonged, therefore strongly suggesting this to be the position of one of the external wheels.

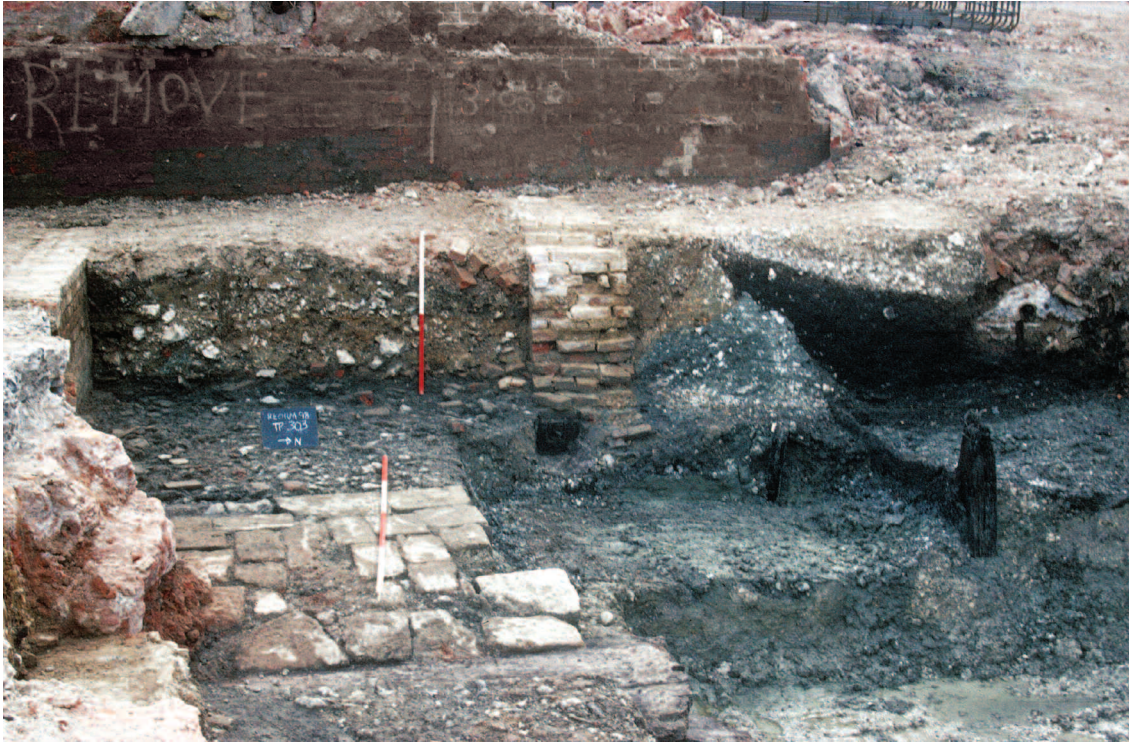
Plate 3.41 Site 300 St Giles Mill: view looking SW showing a section through the central mill channel and retaining wall upstream from the mill (Project Phase 9)

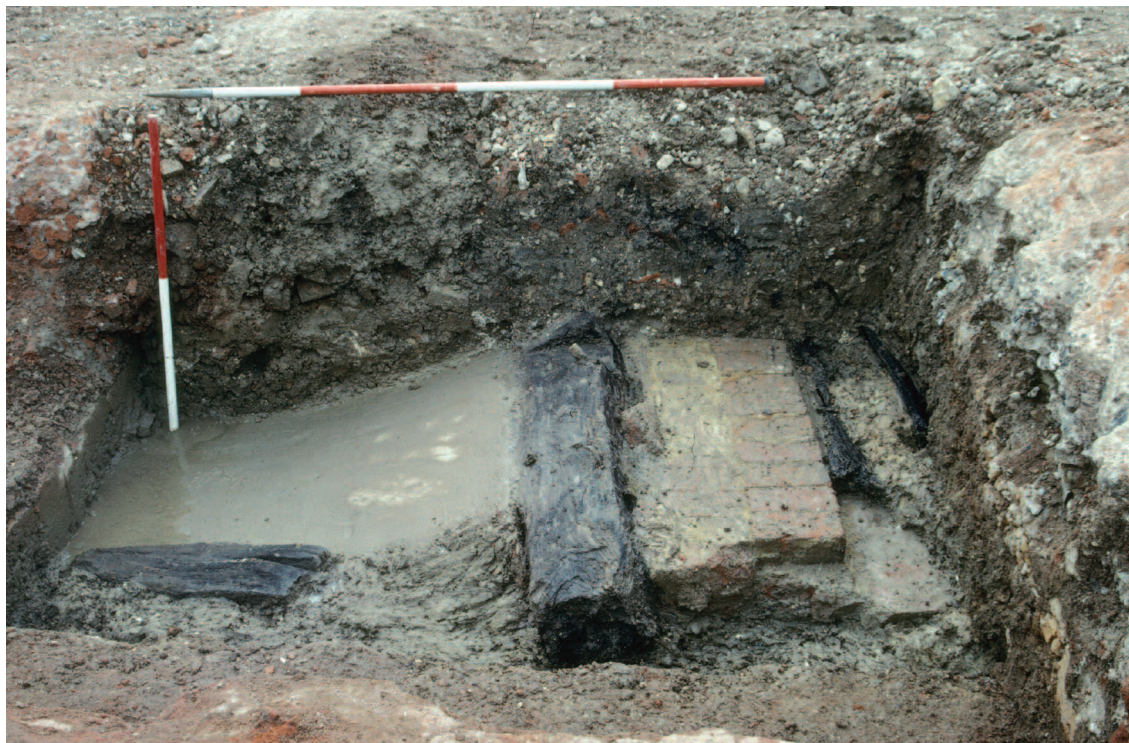
Plate 3.42 Site 300 St Giles Mill: view looking SE showing the curved floor of the wheel race in the northern channel (Project Phase 9)

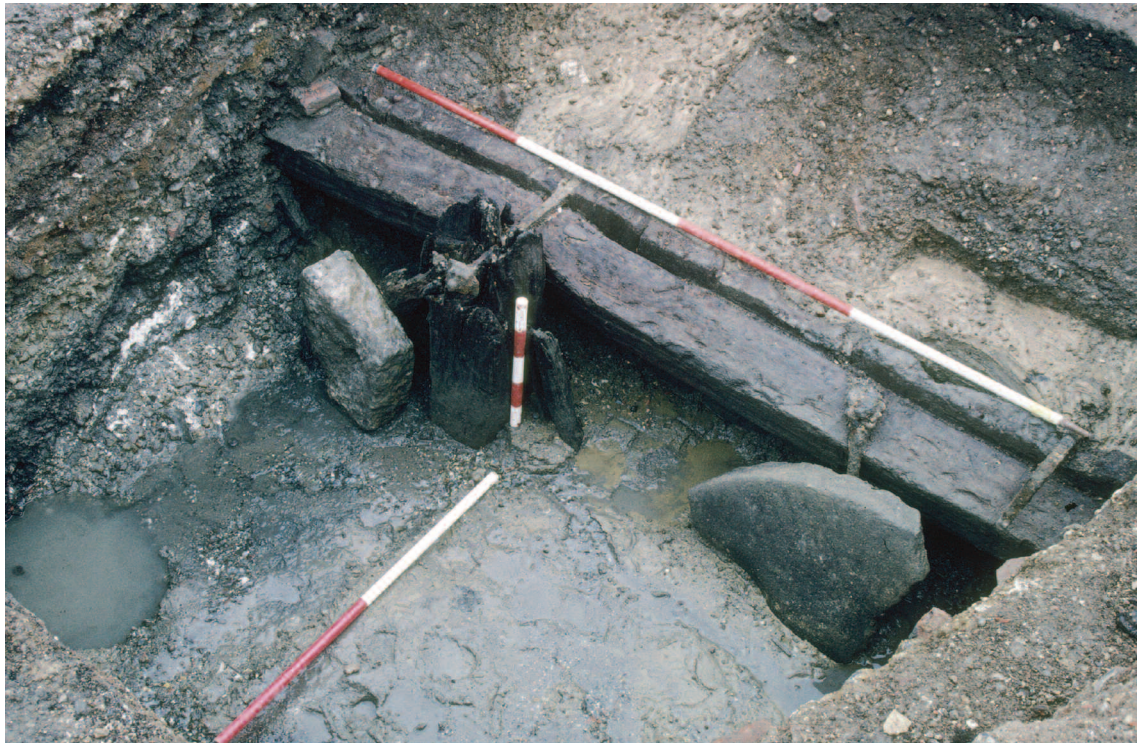
*Plate 3.44 Site 300 St Giles Mill: view looking NW showing the mill tail revetment structure as seen in Test Pit 362 (Project Phase 9)*

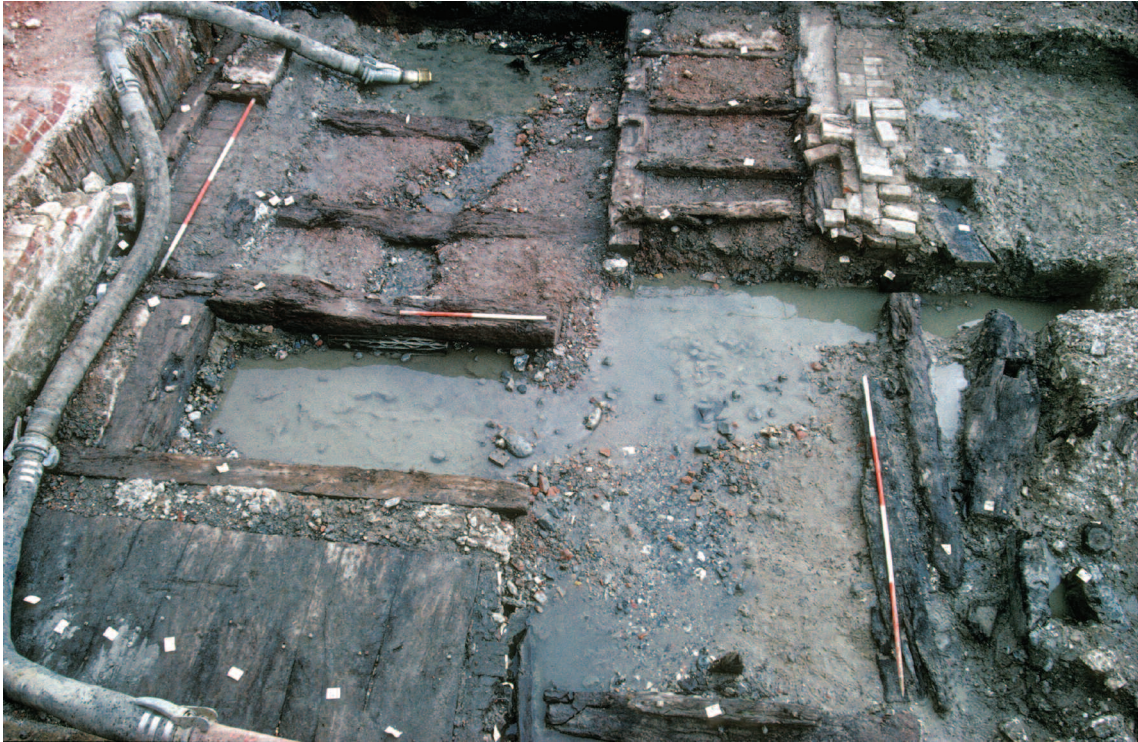
Plate 3.47 Site 300 St Giles Mill view looking SW showing the southern race (Project Phase 9)

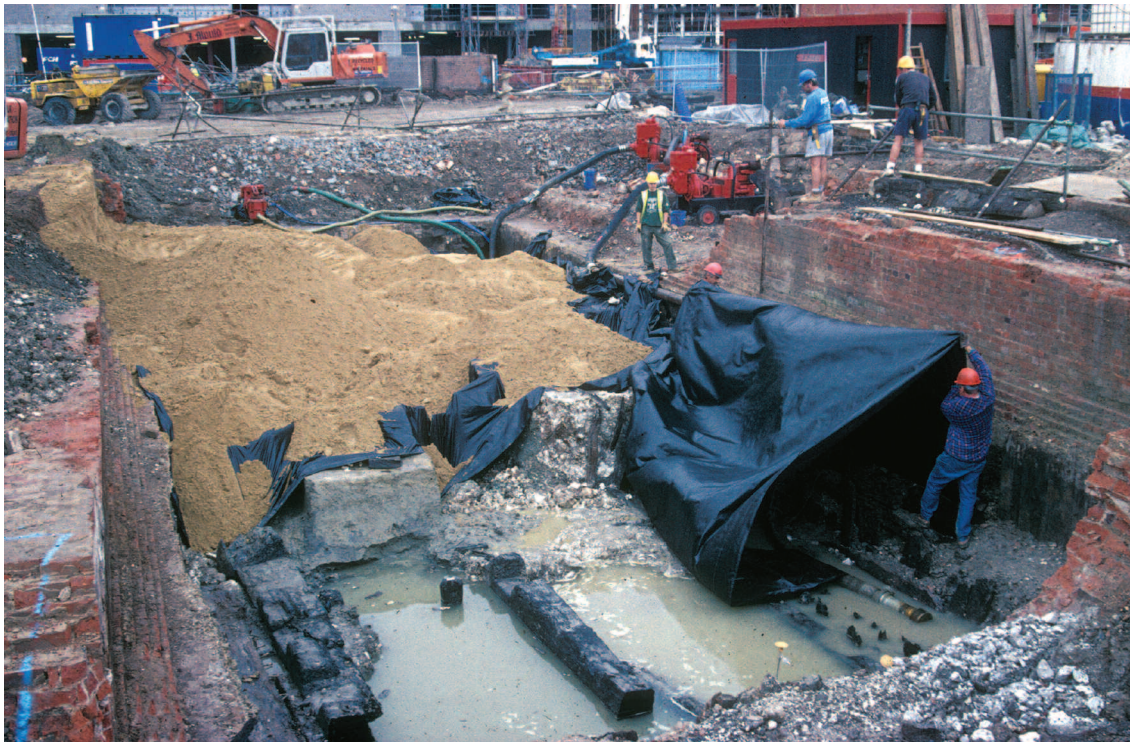
Plate 3.51 Site 300 view looking N, the remaining unexcavated mill timbers of St Giles Mill are preserved in situ

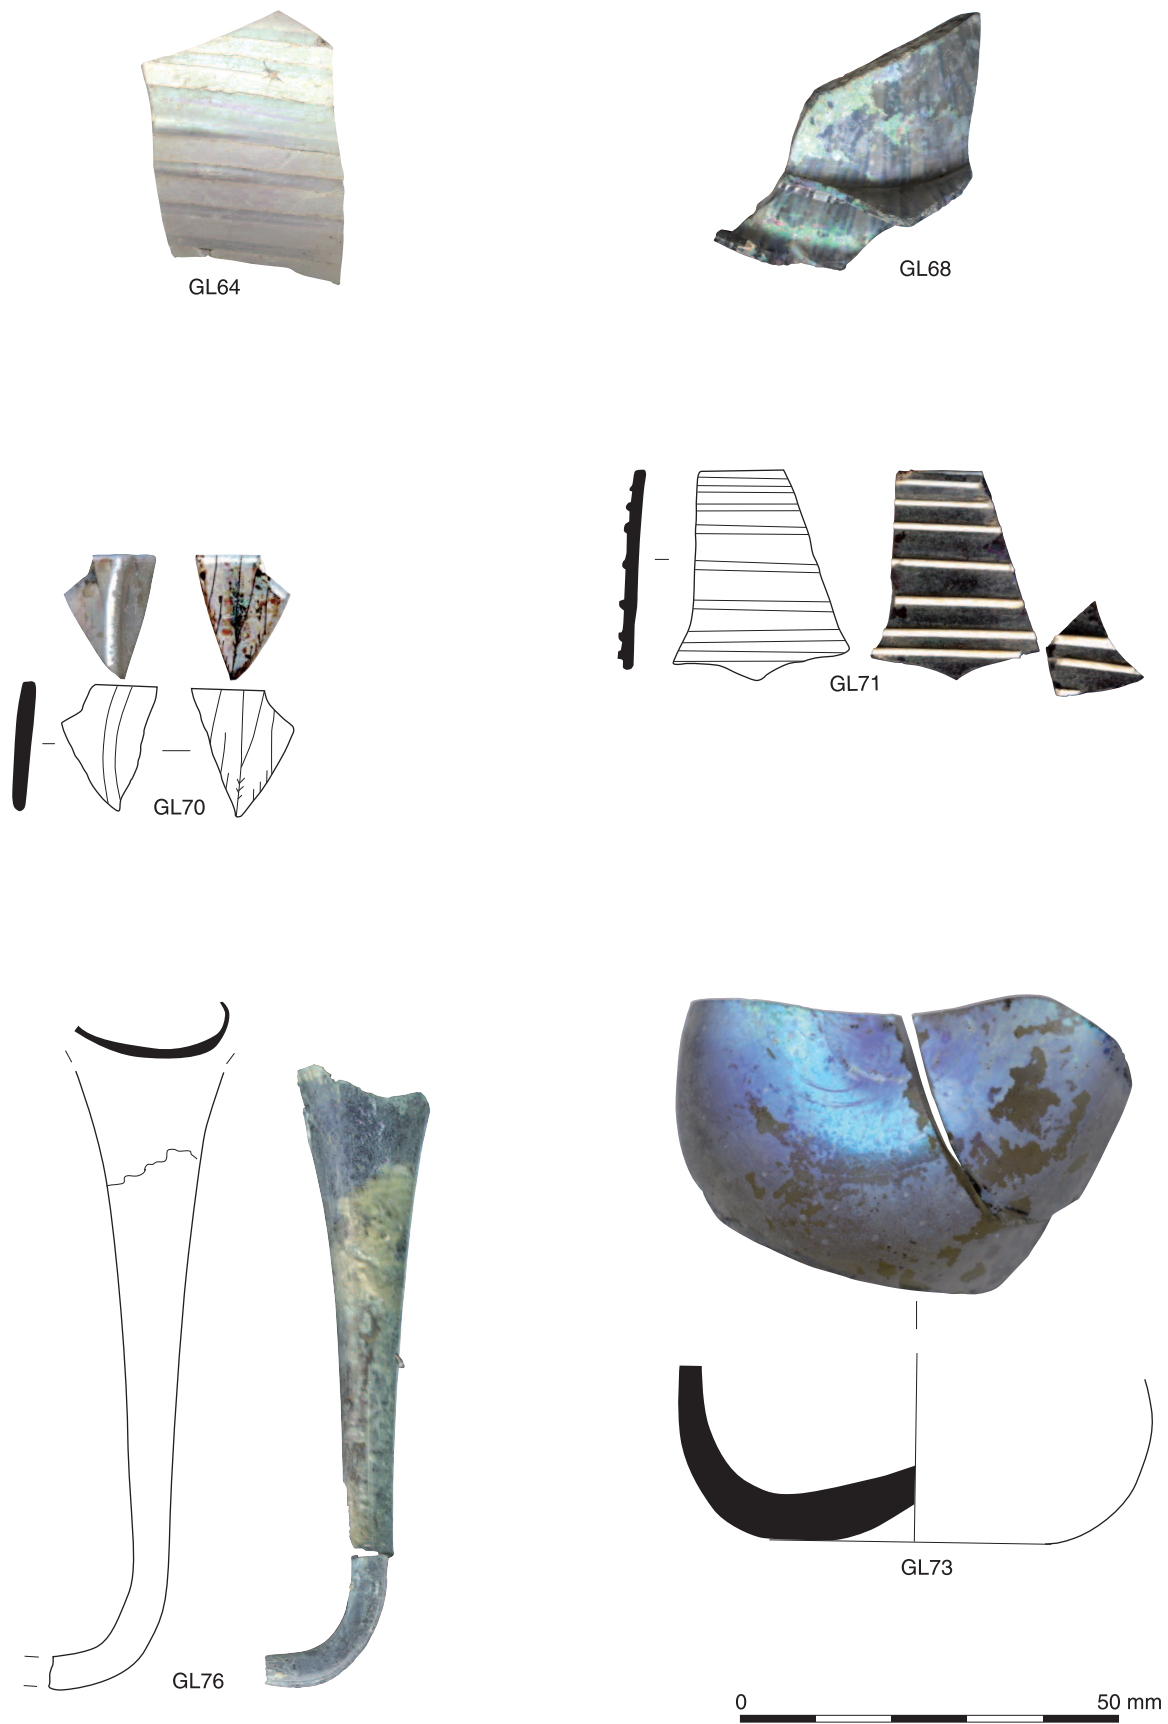
Fig. 5.13 Vessel glass from site 29 (Nos GL64-GL76)

- GL64 **Cylindrical beaker.** 1 fragment of vertical body possibly from a cylindrical beaker. Decorated with vertical bands of opaque white vetro a fili.

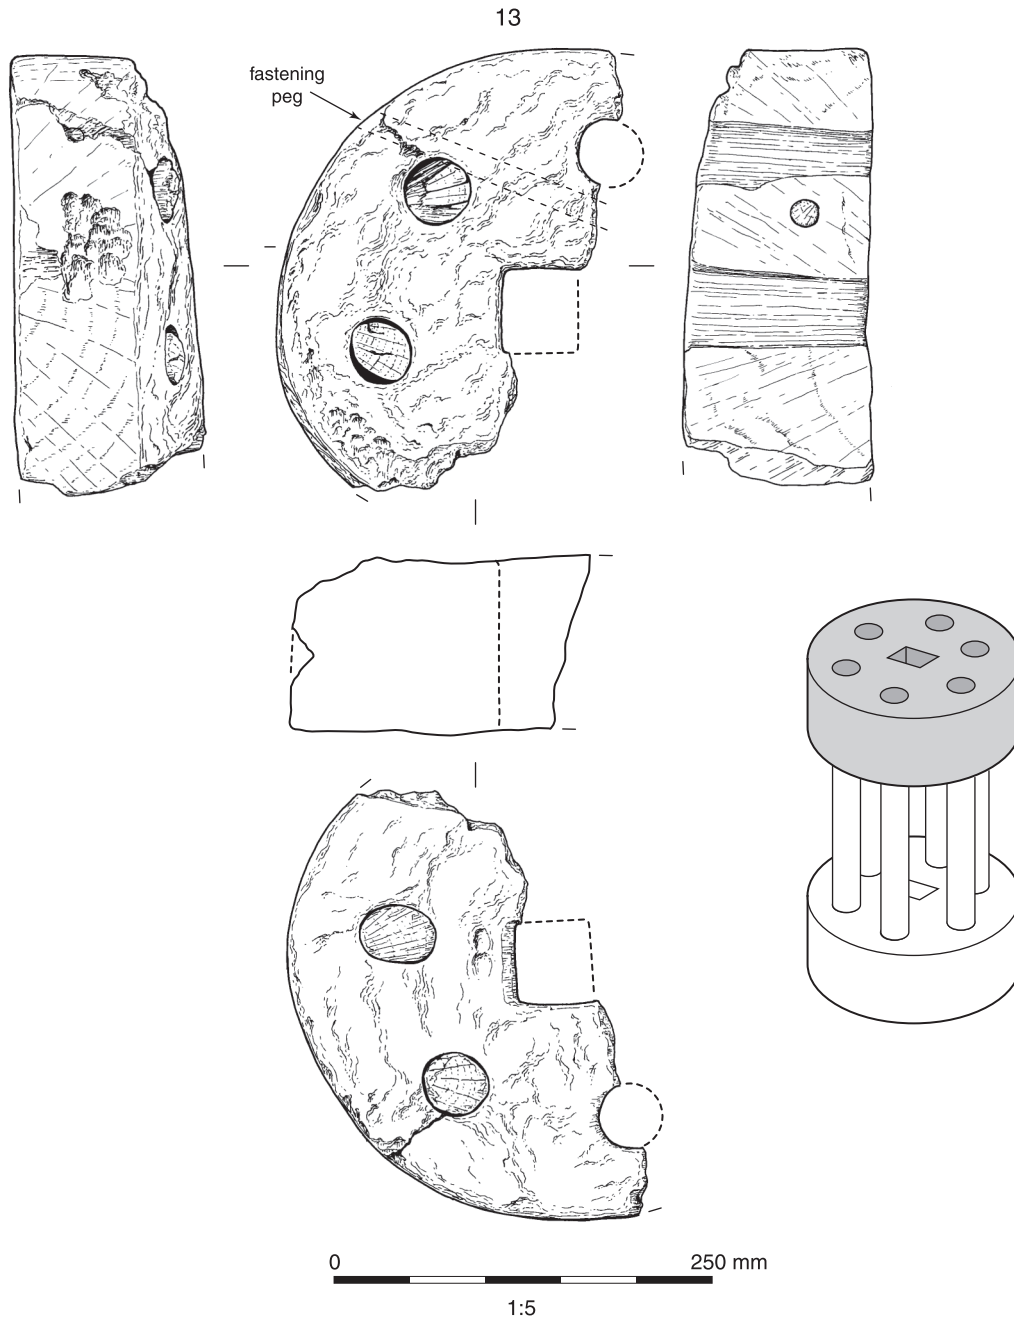
Fig. 5.52 Structural timber, watermill machinery and fittings: Part of the disc or roundel from a lantern pinion (No. 13)
