Langcliffe Quarry Sidings, Stainforth Road, Langcliffe, North Yorkshire

Archaeological Building Recording, Evaluation and Watching Brief Report

May 2022

Client: Craven District Council

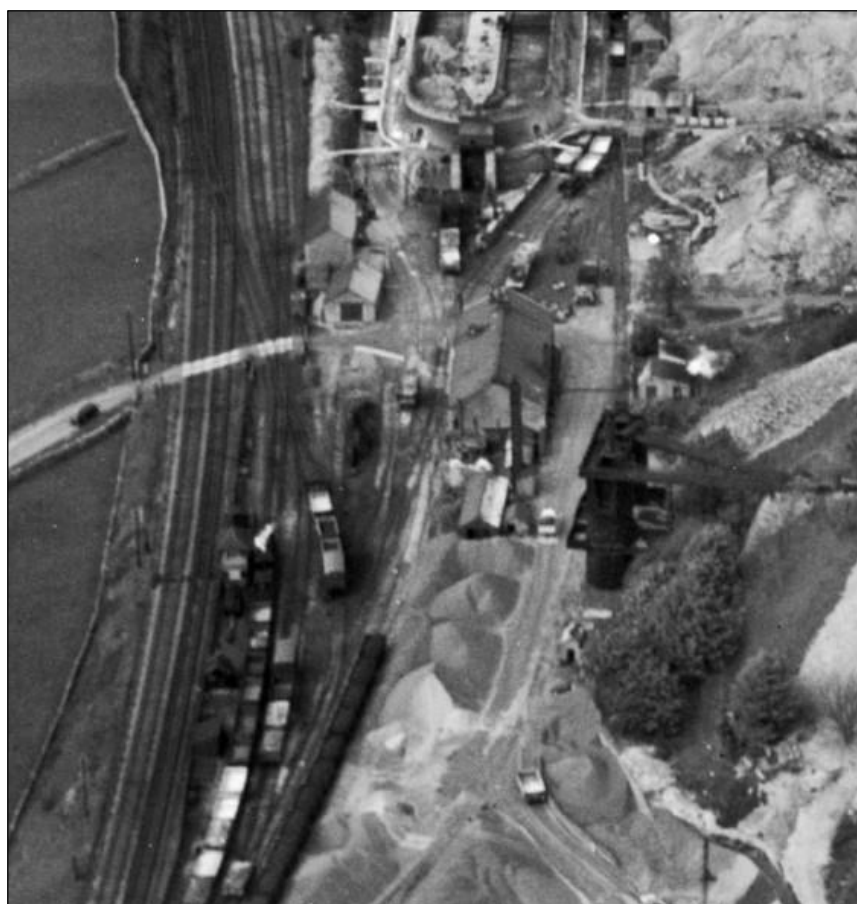
Plate 1: Aerial Photo of the site in 1938 (*Britain From Above, 2021*)

- 1.3.1 The archaeological and historical background of the site have been covered in some detail in the Heritage Impact Assessment and Historic Building Survey (OA North 2020a). The historic background of the site will not be discussed in detail here suffice to say that the proposed development area largely took in the railway sidings to the south of the Hoffmann kiln, which provided access to the Settle to Carlisle line. The sidings and associated works and buildings are most clearly illustrated on the Ordnance Survey (OS) 25" map of 1909 (Fig 3) and aerial photographs of final years of the site dating to 1938 (Plate 1).

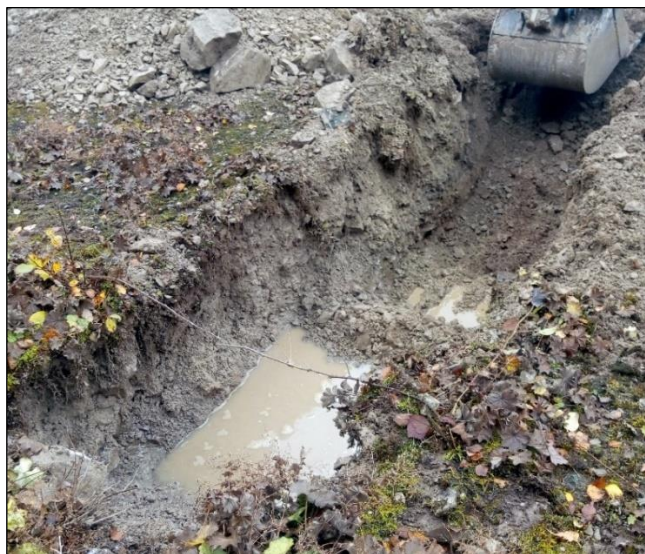
Plate 2: TP 11, facing south-east

3.3.1 **November 2020 watching brief:** 14 test-pits were excavated across the proposed development site (Fig 2). The majority of the test-pits identified similar sequences of made ground deposits, with natural geology only potentially being identified in Test-Pits (TP) 11 and 12, as the former quarry face (Plate 2). The deeper test-pits, up to 3.5m in depth, identified the earliest layers of the made ground, generally as quarry waste of limestone boulders or gravel. Some of the test-pits contained evidence for railway sleepers in the upper deposits, potentially relating to the railway sidings.

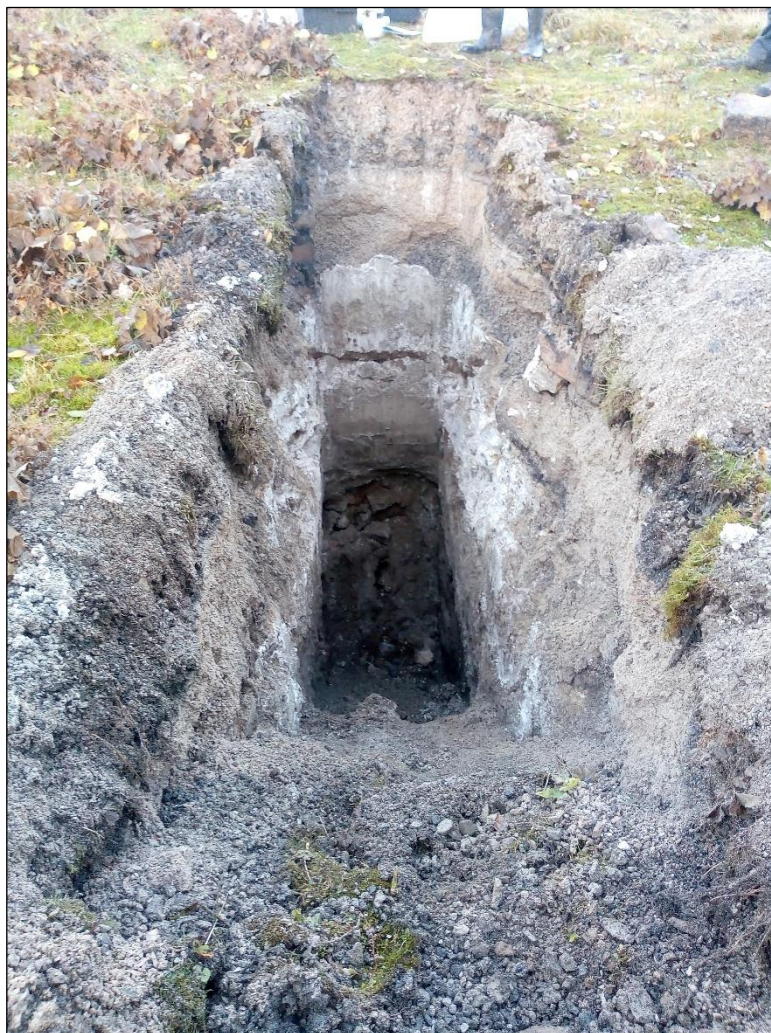
Plate 3: TP 08 showing brickwork at the base, and in the top right-hand side

- 3.3.2 The only test-pit containing archaeological remains was TP 08, in the southern part of the site, which tentatively identified, close to the base of the trench, at approximately 3.5m deep, the west/east-aligned wall retaining the tipped deposits forming the loading bay platform (Plate 3). However, due to the depth the structure was identified, no further investigation could be undertaken.

- 3.5.3 As detailed above, excavation of Trench 7 revealed a single course of a firebrick wall *c* 0.4m below the ground level and sealed by modern overburden (*Section 3.4.11*). Three courses of a firebrick wall were identified in TP 8, *c* 25m to the north, also sealed by *c* 0.3m of modern overburden, with the remains of a possible second wall observed at a depth of *c* 3m (*Section 3.3.2*). Whilst the wall in Trench 7 corresponds with a boundary depicted on the 1909 OS map, those in TP08 do not (Fig 3). TP08 is, however, on approximately the same alignment as the extant element of the loading bay wall to the south, which may have continued further north than is shown on the historic mapping.

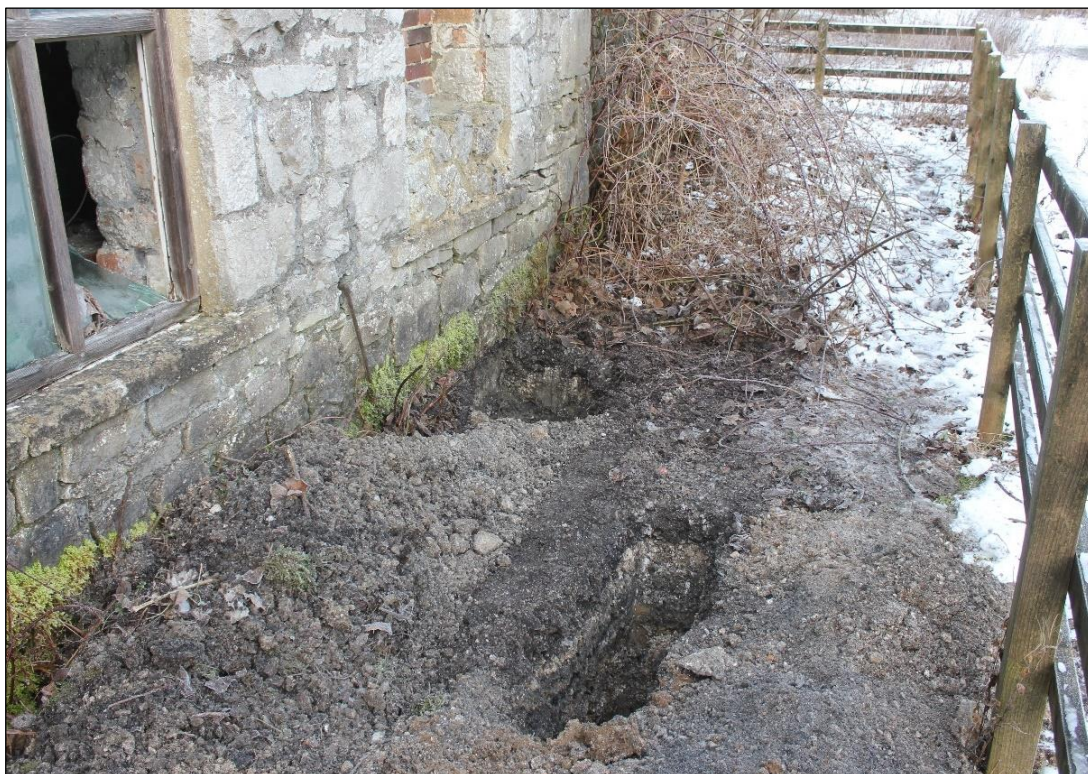
Plate 4: Test-pits against the eastern elevation of the single-storey shed (OA3)

- 3.3.3 **January 2021 watching brief:** three small test-pits were excavated adjacent to the single-storey stone-built shed (OA3; Fig 2) to the immediate south of the former barn (OA1; Fig 2) adjacent to the entrance to the Hoffmann kiln. The shed is to be retained by the development and the pits were excavated to inform its structural investigation. Two pits were excavated (one c 0.5m deep and another c 1.0m deep) against the eastern elevation of the building. The lowest deposit identified was an orange redeposited natural silty gravelly clay, which was sealed by a layer of dark grey kiln waste with traces of hydrocarbon contamination, above which, at a depth of c 0.3m, was a modern levelling layer of limestone chippings and topsoil (Plate 4). Against the southern elevation a single test-pit excavated to a depth of c 0.4m identified orange redeposited natural silty gravelly clay overlain by modern makeup (Plate 5).

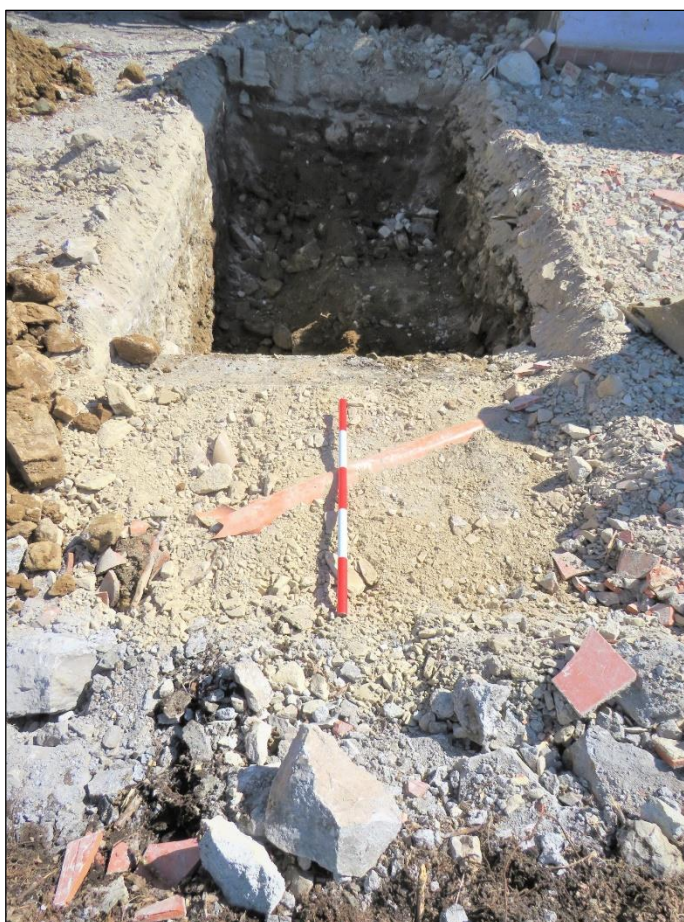
Plate 6: Trench 1, facing east

3.4.1 **Trench 1**: took in the demolished footprint of the former barn/stables (OA1; Fig 2). Although it was originally designed to take in the older, northern part of the old stables building (OA North 2020a), site conditions meant the trench was moved a few metres to the south and took in the early twentieth-century southern extension. Orientated west/east, the trench was 7m long, 2m wide and was excavated to a maximum depth of 1.8m, including a sondage along its northern extent (Fig 4). The trench was not fully excavated on its western edge due to the presence of a plastic service pipe, probably associated with the toilets formerly occupying this part of the building (Plate 6; OA North 2020a).

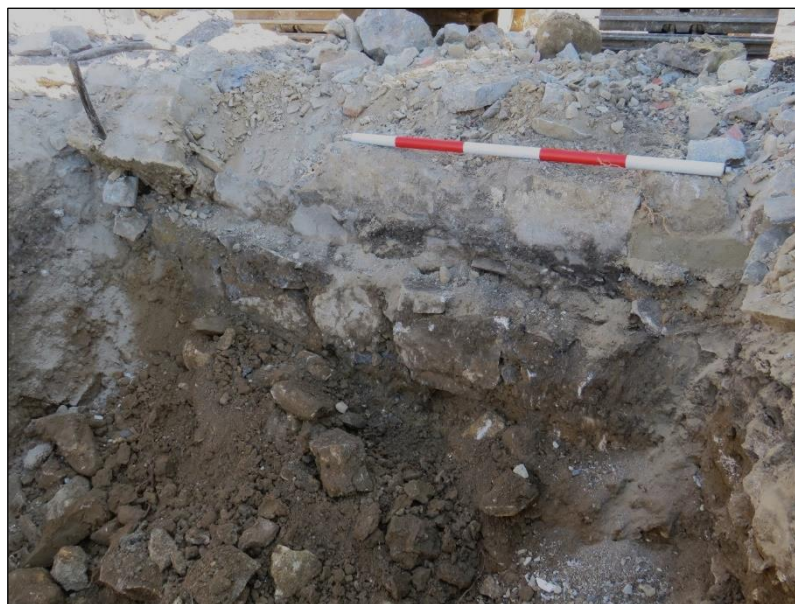
Plate 7: Trench 1, stepped wall footings 103

3.4.2 The earliest deposit identified within the trench was quarry waste **101**, encountered at approximately a depth of 1.5m and extended beyond the maximum extent of the trench, at 1.8m deep. Two walls of the former building were identified cutting quarry waste **101**, the eastern wall, **103**, was 0.46m wide and constructed from undressed coursed limestone (Plate 7). Wall **103** had a wider foundation step, approximately 0.14m wider than the wall at a depth of 0.3m, the foundation then continued for a further 0.3m deeper. Perpendicular to the wall **103** (but not stratigraphically connected) was **102**, a stone wall aligned approximately west/east and 0.9m wide. The footings were 1.5m deep and capped with light blue grey cementitious mortar

containing infrequent inclusions of lime. These structures were sealed by demolition overburden **100**.

| Trench 1 | | | | | | |
|---|---|---|---|---|---|---|
| 103 | Structure | 0.46 | - | North/south oriented lime rubblestone footings perpendicular to 102 , but unknown stratigraphic relationship. Overlies 101 . East wall of building. Foundation step below, an additional 0.14m wide | - | - |
| 104 | Structure | 0.46 | 1.8 | North/south oriented lime rubblestone footings perpendicular to 102 , but unknown stratigraphic relationship. Overlies 101 . West wall of building. Foundation step below, an additional 0.14m wide | - | - |

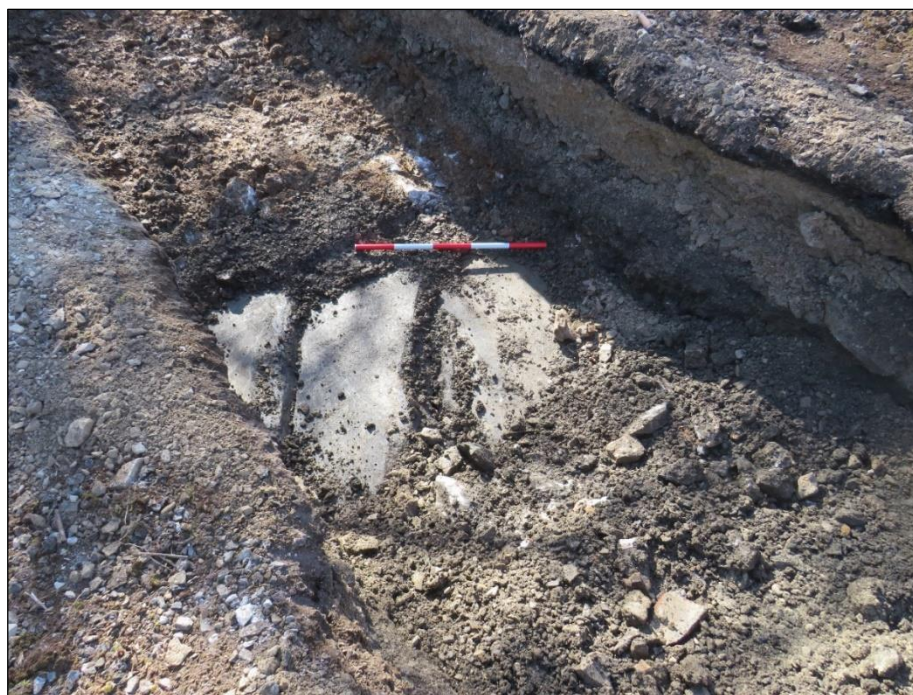
Plate 8: Trench 2 showing stone culvert, 1m scale

3.4.3 **Trench 2:** took in part of the footprint of a proposed new building to the south-east of the Hoffmann kiln, where tramways/railways are shown on the historic mapping (Fig 3). The narrow cuttings for these railways remain extant adjacent to and outside the development area. Aligned north-west/south-east, Trench 2 was 10m long and 1.9m wide and was excavated to a depth of between 0.8m and 1.1m (Fig 5; Plate 8).

3.4.4 The earliest deposit identified within the trench was a layer of made ground, formed of silty clay with abundant yellow brown limestone quarry waste, **203**. This was

excavated to a depth of 0.4m. In the eastern half of the trench, quarry waste **203** was cut by a culvert, **204**, which was 2.1m wide and aligned north/south (Plate 8). It was constructed from large stone slabs **205**, at 0.6m below ground level, and was backfilled with dark grey limestone gravel **206**. Both the yellow brown quarry waste **203** and the backfill of the culvert **206** were sealed by a layer of dark grey ashy clay kiln waste **202**, approximately 0.10m thick. This was overlain by a 0.35m-thick hardcore levelling layer formed of crushed limestone quarry waste, **201**, which was, in turn, overlain by the present tarmac surface **200**. There was no evidence for the former railway track, depicted on historic mapping (Fig 3).

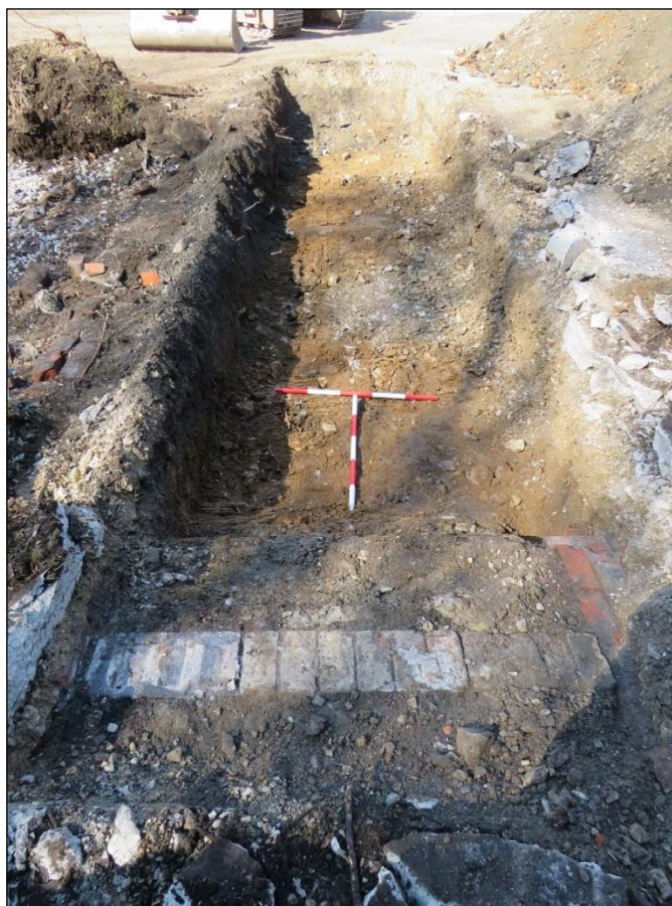
Plate 9: Trench 4, facing west

- 3.4.5 **Trench 4**: positioned to investigate the presence of a former chimney stack depicted on historic mapping and a mid-twentieth century aerial photograph (OA North 2020a; Fig 3; Plate 1). Although the chimneys precise function is unknown it may have been connected to an engine in the Craven Cottage workshop and associated with the nearby Spencer kilns.

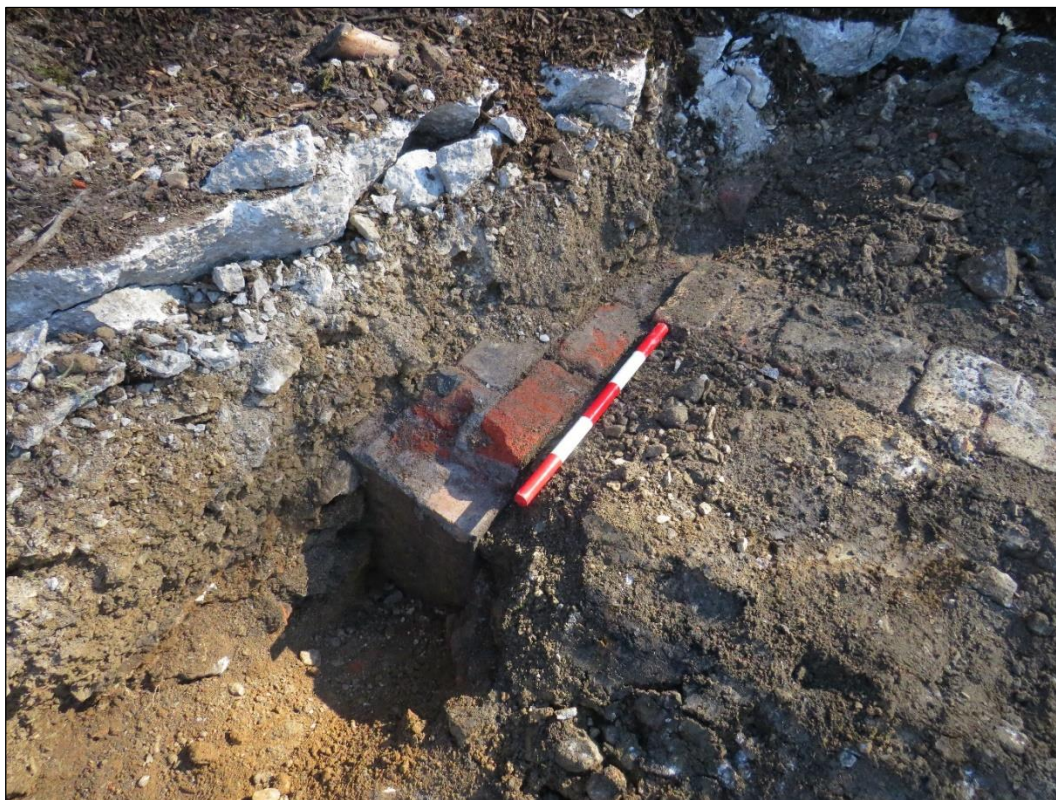
*Plate 10: Red-brick structure **404** and firebrick structure **403***

- 3.4.6 The earliest deposit identified was a layer of limestone quarry waste **405**, into which double-skinned firebrick wall **402** was cut (Fig 6). Aligned north/south, wall **402** crossed the width of the trench and terminated against structure **404**, a double-skinned brick wall constructed from red machine-made brick. The part of the wall observed within the trench edge was 1.2m long and aligned west/east, with a northern return continuing through the baulk (Plates 9 and 10). Structure **404** possibly represents the chimney, with structure **402** being the remains of a possible flue. Both

structures were mortared with light blue grey Portland cement. A west/east-aligned wooden sleeper with iron fittings for track shoes (**403**) was identified 2.5m west of structure **402**, 0.25m below the modern surface. The modern surface was formed of 0.1m deep gravelly hardcore **401**, which was, in turn, overlain by a thick layer of concrete (**400**).

| 402 | Structure | - | 0.3 | Firebrick wall of two skins, 0.3m BGL, 0.22 x 0.11 x 0.06m. Observed for 2m crossing the trench on a north/south alignment running into/up to 403 . Blue/grey cementitious mortar. Possible flue. Not removed. | - | - |
| 404 | Structure | | 0.78+ | Red brick wall, partially extant, observed at 0.4m and down to 0.78 (excavated depth). Base not identified. Structure is aligned east/west with a north return continuing through western baulk. Bricks are machine made. Blue/grey cementitious mortar. | - | - |

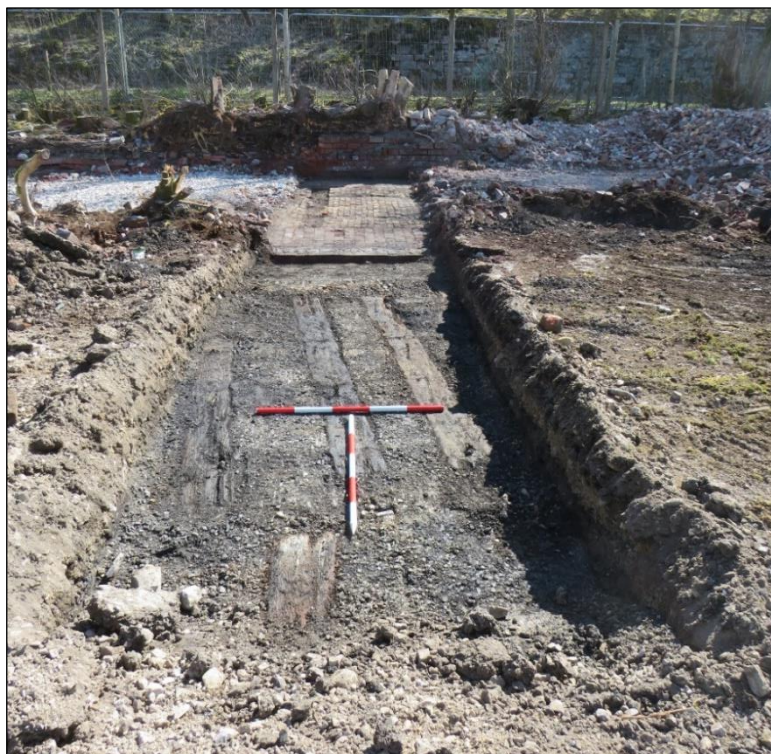
Plate 11: Trench 5, facing west

3.4.7 **Trench 5**: was located to investigate the below-ground remains of the demolished red-brick building (OA 5; Fig 2) to the south of the Craven Cottage workshop. The function of this building is not known, although it may have been related to the former chimney or railway sidings associated with the Spencer kilns. Trench 5 was aligned west/east and was 10m long, 2m wide and had a maximum depth of 0.35m (Plate 11; Fig 7). It was 10.3m to the south of Trench 4.

- 3.4.8 In the western part of the trench, three railway sleepers, **504**, overlay a deposit of white, oil-stained railway ballast, **506**. Railway sleepers **504** measured 2.76m long, 0.24m wide and were separated by c 0.5m. Their orientation was slightly different to that of the former workshop building to the east, but consistent with that shown on the OS map of 1909 (Fig 3). Also consistent with the historic OS map, the edge of another railway line was evidenced by another railway sleeper set upon stained railway ballast at the western extent of the trench (Plate 11). The sleepers were sealed by a 0.1m deep layer of dark grey overburden **507**, which was overlain by a 0.10m layer of yellow brown limestone chippings **508**, which was, in turn, overlain by modern hardcore **502**. One of the 2008 evaluation trenches (OA North 2009, Trench 2), immediately to the north of Trench 5, also revealed evidence of rail tracks visible on the 1909 OS map (Fig 3).

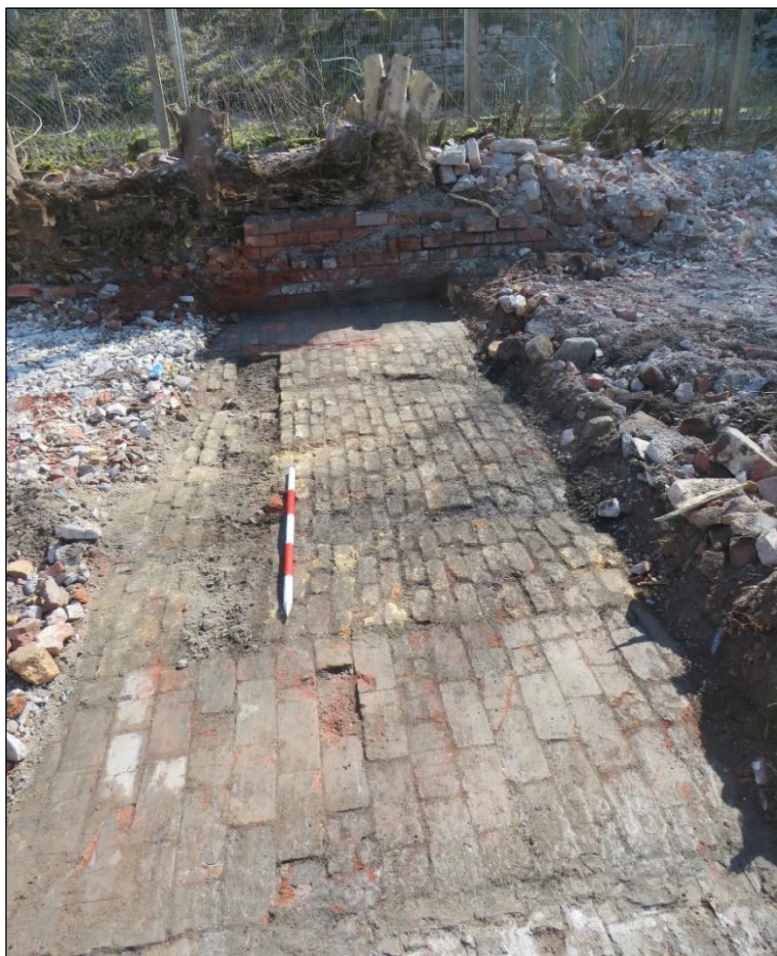
*Plate 12: Detail of floor surfaces **503** and **508**, facing west*

- 3.4.9 In the eastern part of the trench, structures associated with the demolished red brick building were identified. Firebrick floor surface, **503**, was delineated to the west and east by red-brick floor surface **508**, which appeared to be contemporary. The floor surfaces abutted brick wall **505** at the eastern extent of the trench and the western workshop wall, **507**, at the western edge of the floor surfaces (Plate 12 and Fig 7). Walls **505** and **507** were formed of frogged-red-brick, 0.34m wide. The internal floor surfaces **503** and **508** were bonded with light blue-grey Portland cement. Red bricks were laid as stretchers to form surface **508**, were 1m wide to the east, 0.8m wide to the west and were laid either side of a central, firebrick-constructed element of the floor (**503**). Floor surface **503** was 2.7m wide, with the firebricks laid as soldiers. There was evidence of a recess in the shape and depth of a railway sleeper; with grooves in the surface perpendicular to the recess and separated by 1.35m, suggesting the former presence of railway lines within the building (Fig 7). Hardcore **502** overlay the

brick floor surfaces, which were sealed by the former concrete floor of the workshop (**501**). This was overlain by demolition rubble (**500**), 0.1m deep, derived from the recent destruction of the building.

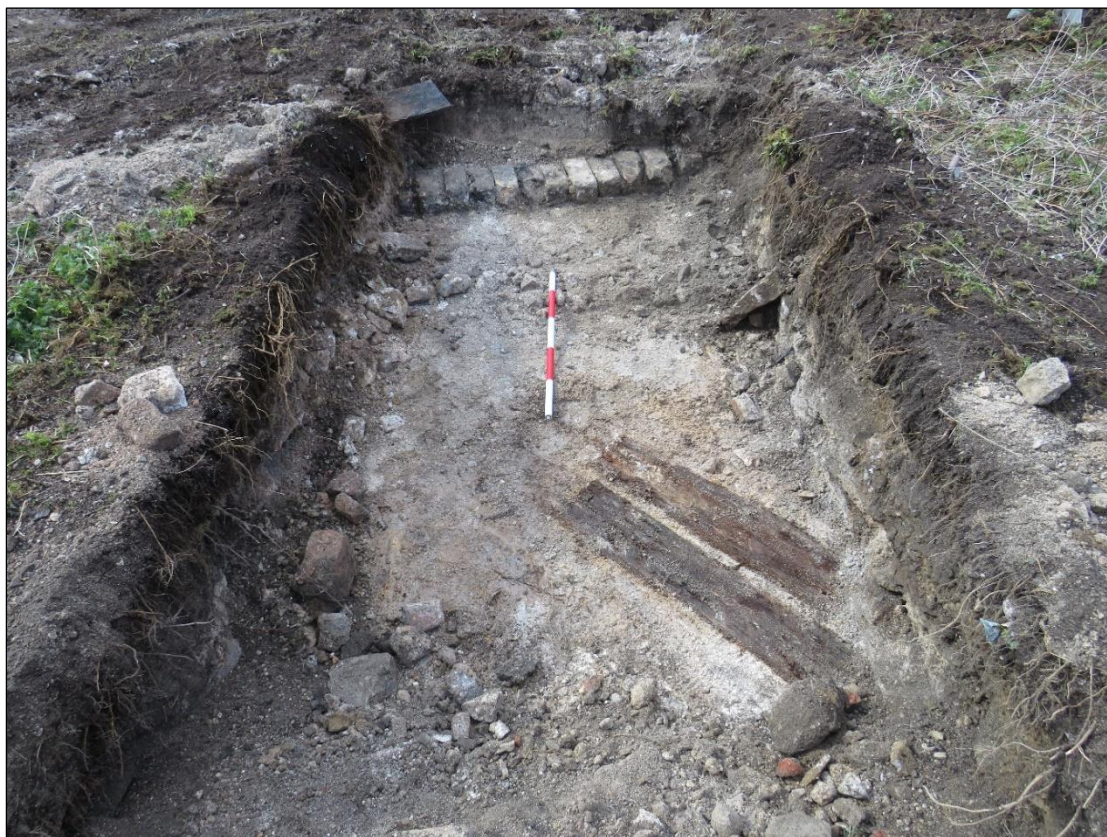
Plate 13: Trench 7, illustrating sleepers and wall footings

3.4.10 **Trench 7**: was positioned to take in the site of a proposed new building at the south end of the site, in the location of a loading platform formed of made ground at the south-eastern extent of Stainforth Sidings. The platform is contained by a wall which remains partially extant (*Section 3.5*). The trench was aligned south-east/north-west, was 9.5m long, 2m wide and had a maximum depth (including a 0.3m sondage) of 1.5m (Plate 13; Fig 8).

3.4.11 The earliest deposit identified within the trench was a coherent deposit of crushed and burnt lime with coal inclusions (**702**), at 0.7m below the modern surface, two railway sleepers, not obviously *in situ*, were found within this deposit at the eastern end of the trench. Cutting the lime deposit, was the truncated foundation of firebrick wall **703**, running the full width of the trench and extending beyond the excavated area. The line of this footing, which was visible as only one stretcher course, appeared to correspond with a dog-leg in the loading bay retaining wall illustrated on the OS map of 1909 (Fig 3). Overlying lime deposit **702** in the eastern part of the trench was a layer of yellowish brown crushed limestone **704**, c 0.1m deep. Overlying crushed limestone **704** was mixed demolition deposit **701**, which comprised of dumps and spreads of crushed concrete, limestone quarry waste, clay, burnt lime, fire brick and charcoal, 0.5m deep. This was, in turn, overlain by topsoil **700**, with a maximum depth of 0.20m.

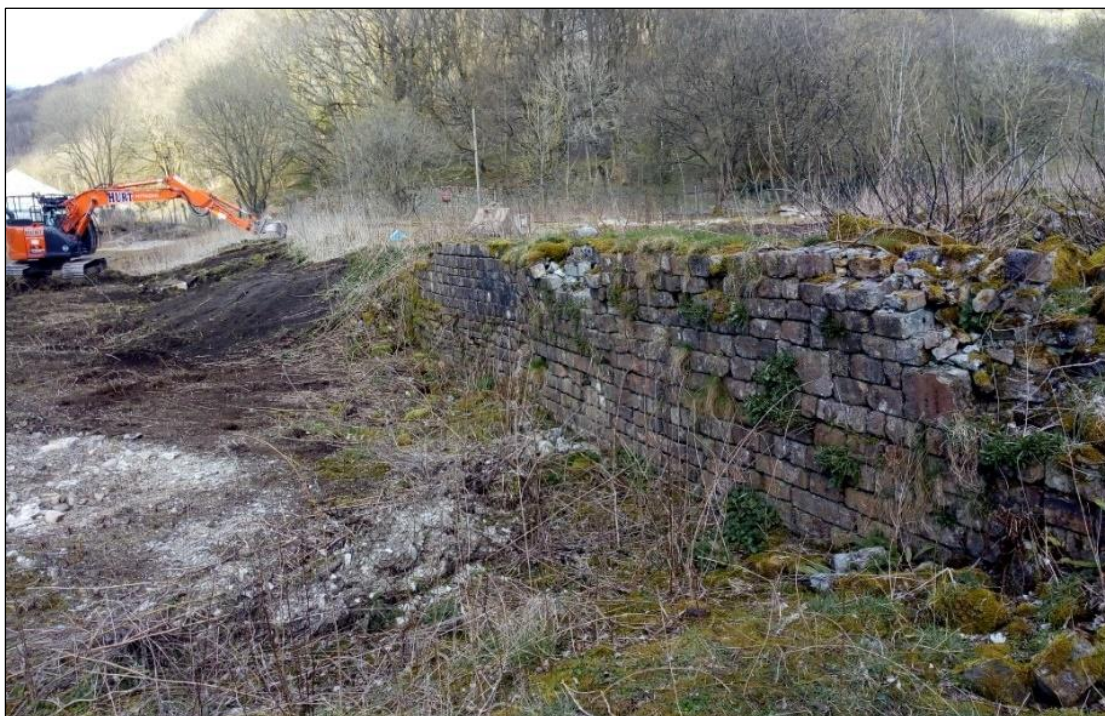
Plate 14: The extant element of the loading bay wall, showing removal of overburden

3.5.1 At the southern extent of the site, a firebrick wall, c 2m high, retains an area of made ground to its west (Plate 14). The top layer of bricks corresponds with the present ground level to the west, which is thought to have been used as a loading bay, used to unload coal and fill wagons with lime from the Spencer kilns. A wall on the same line, seemingly on the line of a former field wall, is illustrated on the historic mapping, apparently associated with a steep downward slope to the east of the railway line (Fig 3). The line of the wall, partially in the form of a rubble bank and corresponding with

the break of slope between the loading bay and the sidings, was recorded during the 1989 LUAU survey (Fig 2).

- 3.5.4 Both firebrick walls identified in Trench 7 and TP08 sat upon made ground layers formed predominately of burnt lime, which seems likely to have derived from the Spencer kilns. In the 2008 evaluation, Trench 3 revealed that these layers had a depth of at least 3.6m and had been tipped into the area defined by the loading bay wall,

making up the platform by levelling up the natural slope (OA North 2009). It seems likely that the extant structure, and the fragments of wall revealed by excavation, defined areas into which waste material was tipped and these were replaced or added to over time, as the area of made ground expanded.

- 3.5.5 The firebricks themselves were waste from the lime burning process. Firebricks were recorded in use at the site where they lined the Spencer kilns, operational from c 1900-1927, and were periodically replaced (Johnson 2002). Vitrified fire bricks are visible in many of the buildings across the site and make up much of the Spencer kiln's retaining wall (OA 8) close to the present site entrance.

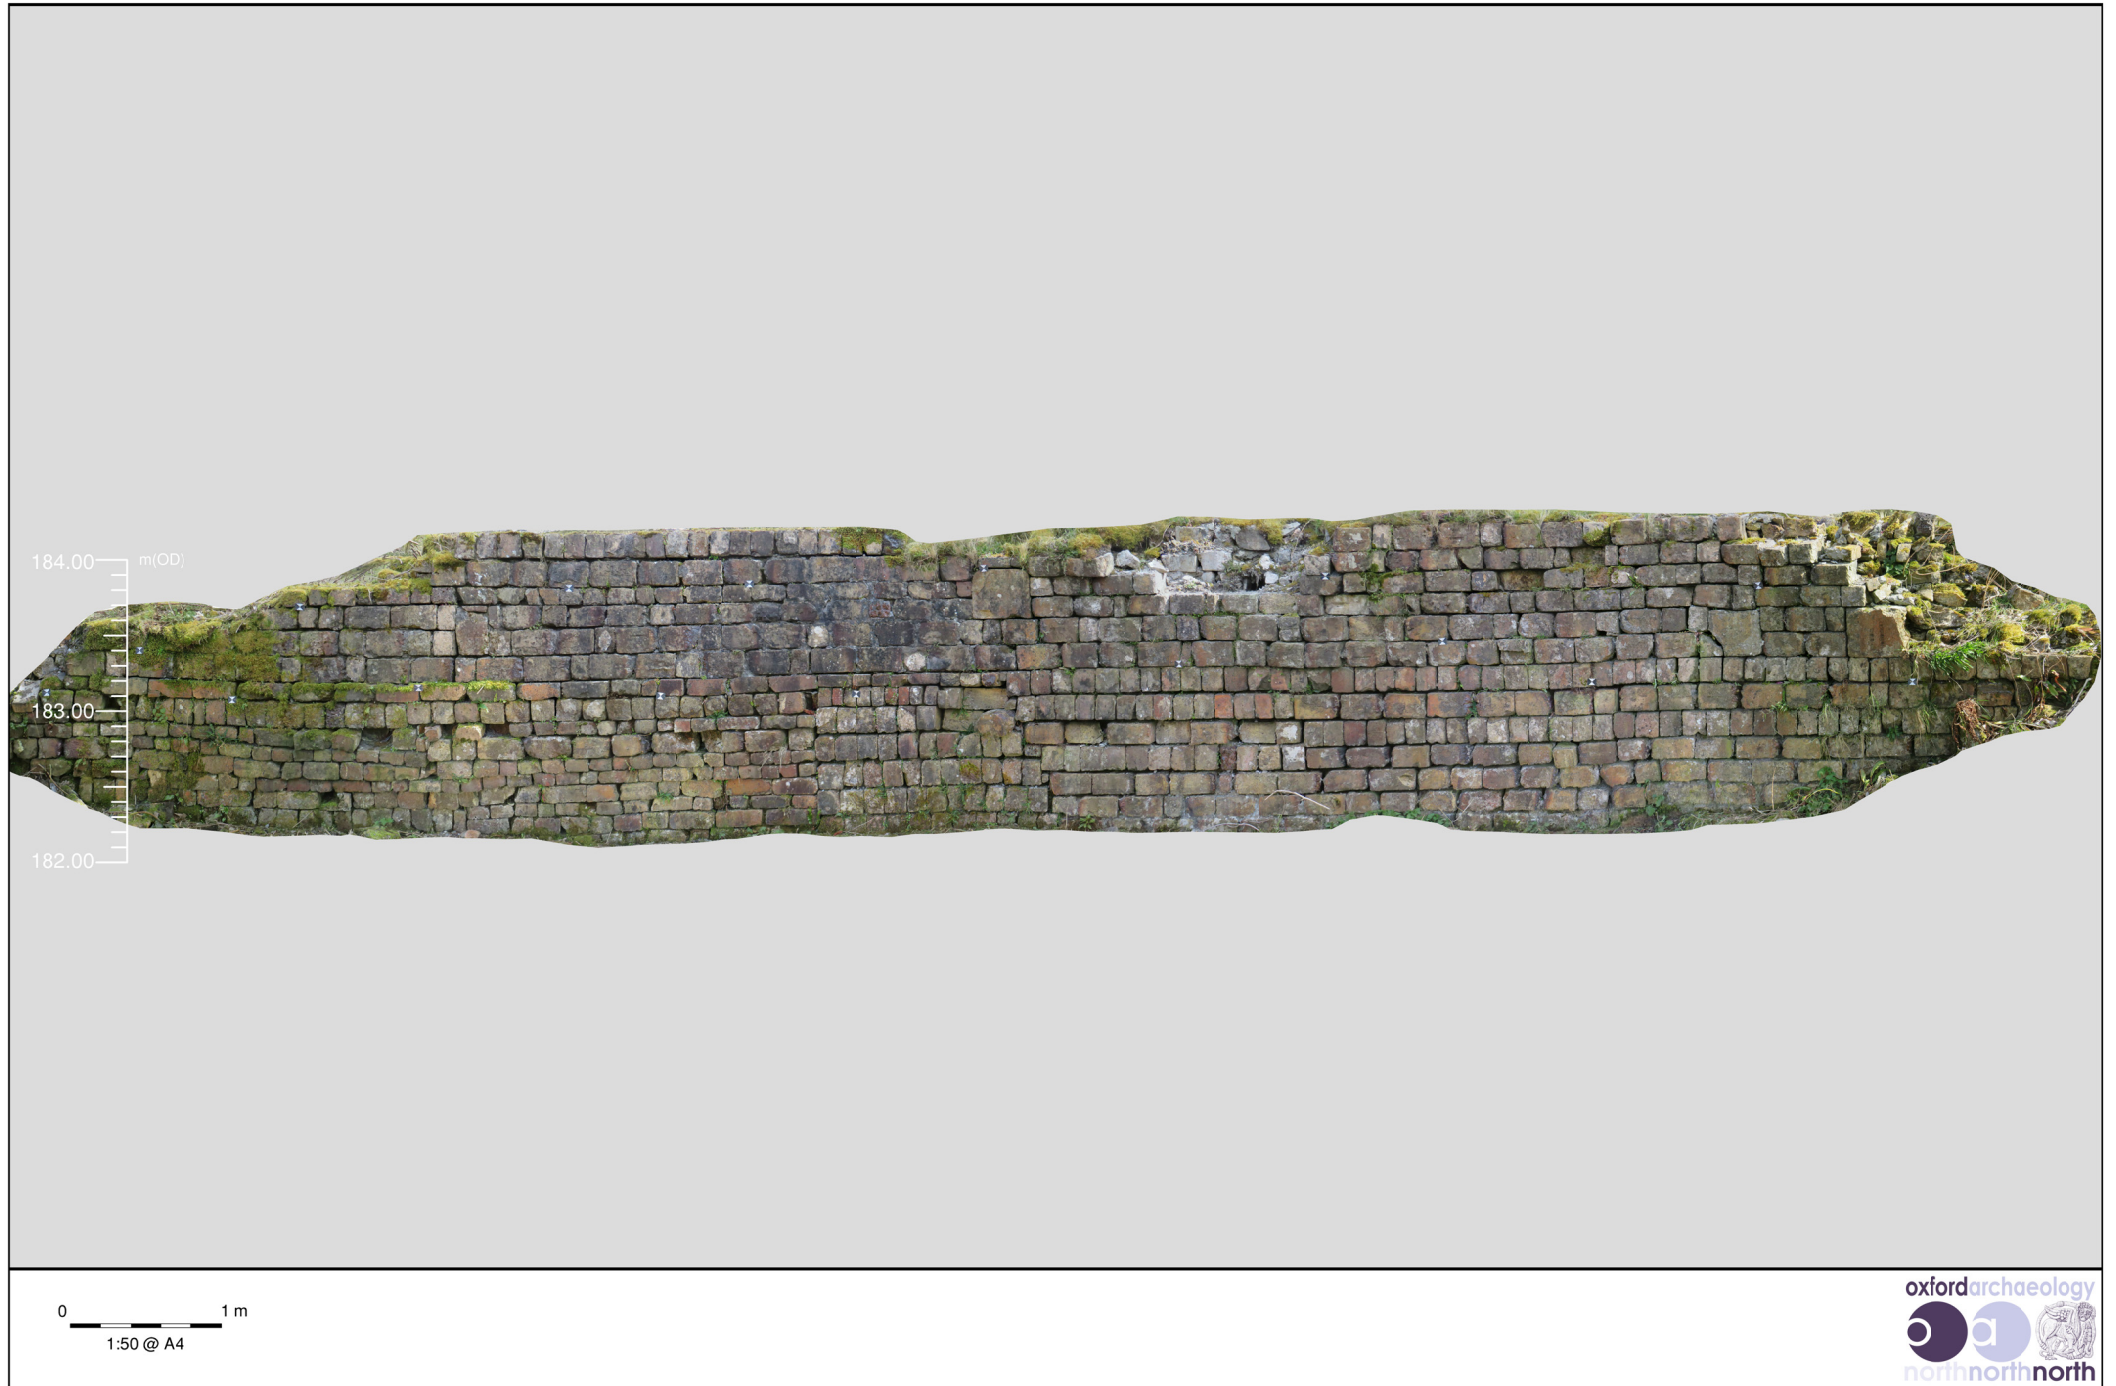
Figure 9: Photogrammetric model of the extant remains of the loading bay wall

- 3.5.2 The condition and full extents of the loading bay wall were not fully established during earlier phases of work. In April 2021, the wall was badly overgrown and its northern extent appeared to be sealed by overburden dating to the use of the site as a council depot. Removal of the overburden and plant growth along the embankment thought to represent the northern continuation of the extant wall was undertaken by machine and revealed that the visibly extant remains of the wall were all that survived (Plate 20). The remains were subject to photogrammetric survey, the results clearly illustrating the wall was not of a single phase. There are elements of infill and differential coursing indicating several construction phases along both its length and height (Fig 9).
