# Former Gasworks Walton Avenue, Felixstowe

## Phases 1 and 2 Historic Building Investigation and Recording

## Former Gasworks, Walton Avenue, Felixstowe: Phases 1 and 2

### *Historic Building Investigation and Recording*

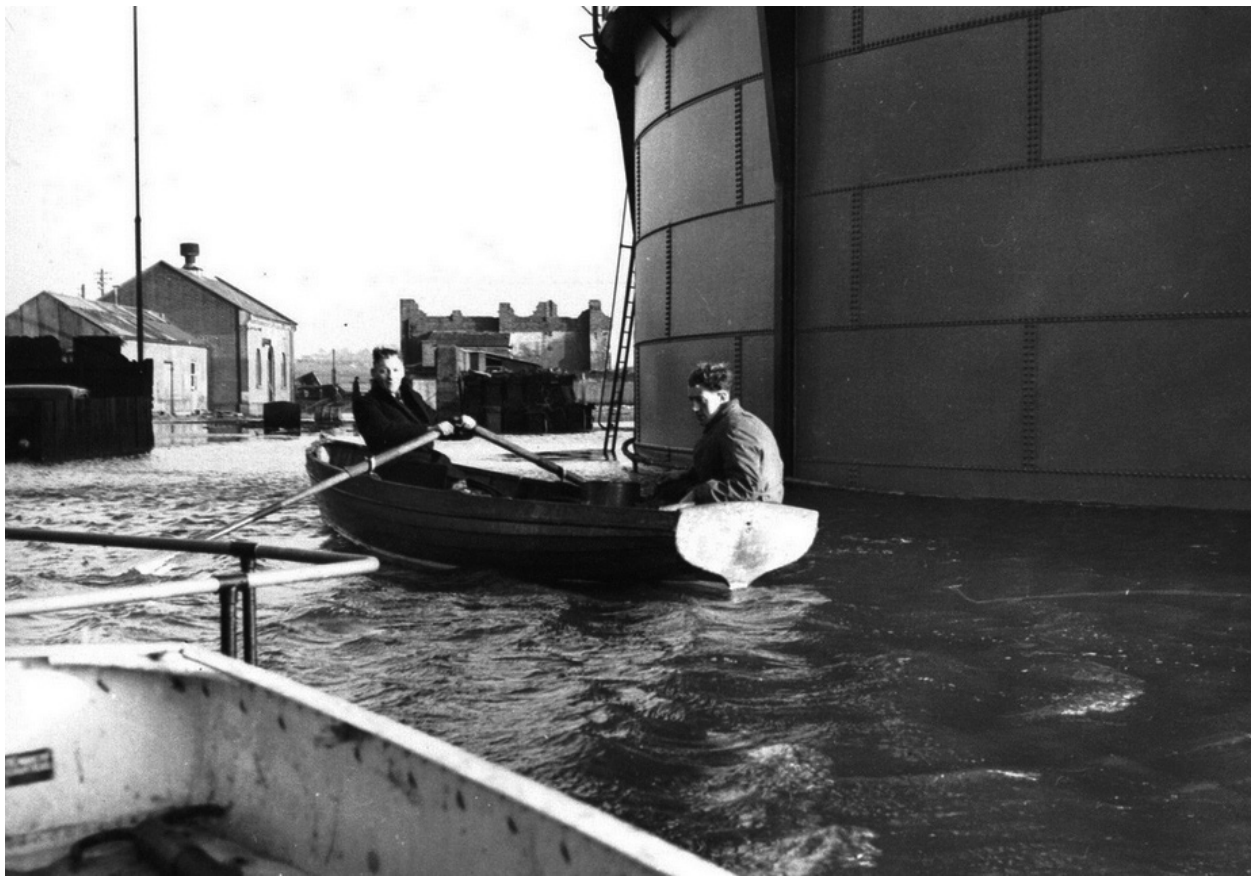
Plate 1: Looking north across site the morning after the flood. 1st February 1953. ©Environment Agency

- 2.2.5 On the 31st January 1953, a flood caused destruction along the east coast of England. Felixstowe suffered much damage and the gasholder station and the surrounding buildings were also flooded. Photographs taken the following day have been made available by the Environment Agency show the flooding. Plate 1 shows the tank of the original gasholder with the already-ruined retorts in the distance and the Governor House to the north-west. The column-guided gasholder tank has steel plates riveted together with one row of rivets top and bottom and two rows of rivets between sheets, the joints being staggered. Thin columns are at regular intervals around the tank, supporting the walkway which is accessed via a ladder and in turn the columns which supported the lifts.

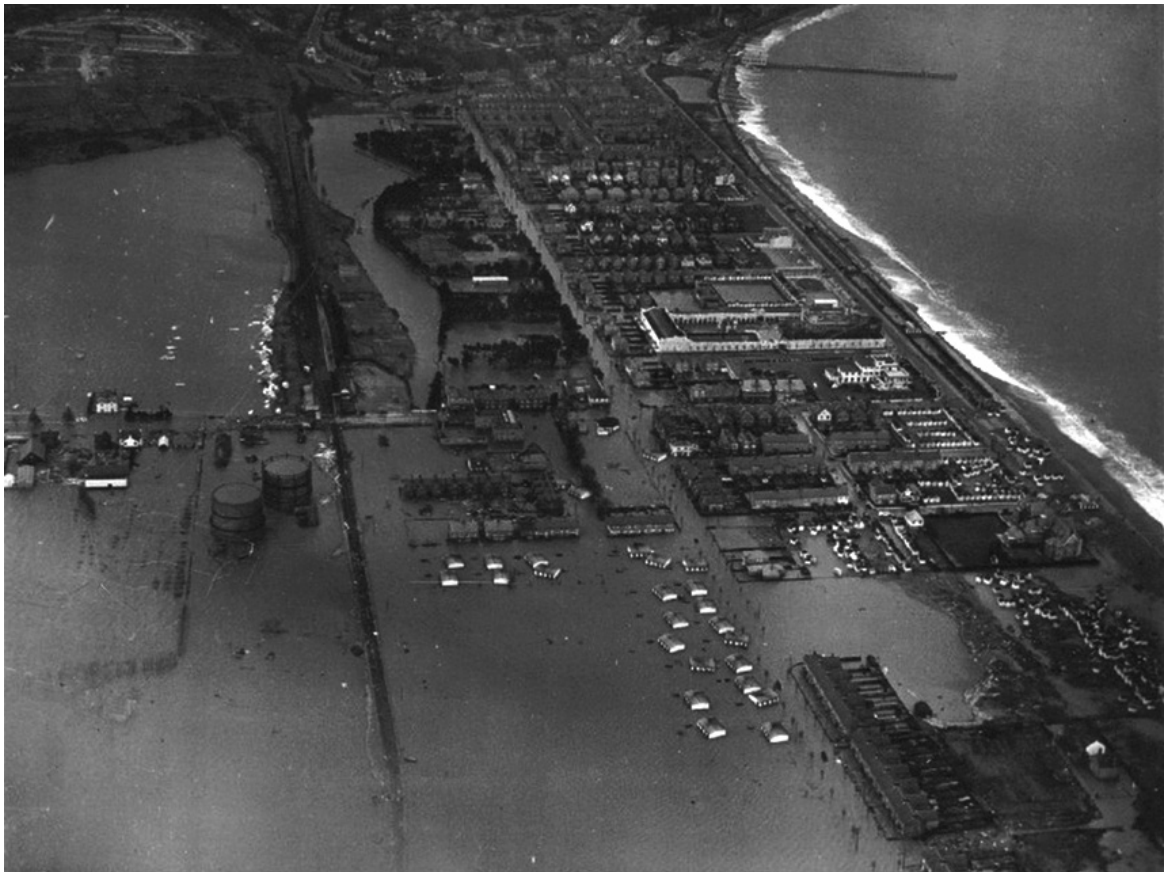
Plate 3: Looking north across site the morning after the flood. 1st February 1953. ©Environment Agency

- 2.2.7 An aerial photograph (Plate 3) of the flooded area shows the two gasholders: the later spiral-guided gasholder to the west and the original column-guided gasholder to the east and in the location of the current gasholder. The other buildings cannot be seen clearly on the image and the houses and the single storey building to the north of the gasholders are hidden from view behind the gasholders, however, the floating prefabs to the east of the railway line, where most of the fatalities occurred, indicate that the photograph is definitely of the 1953 flood.

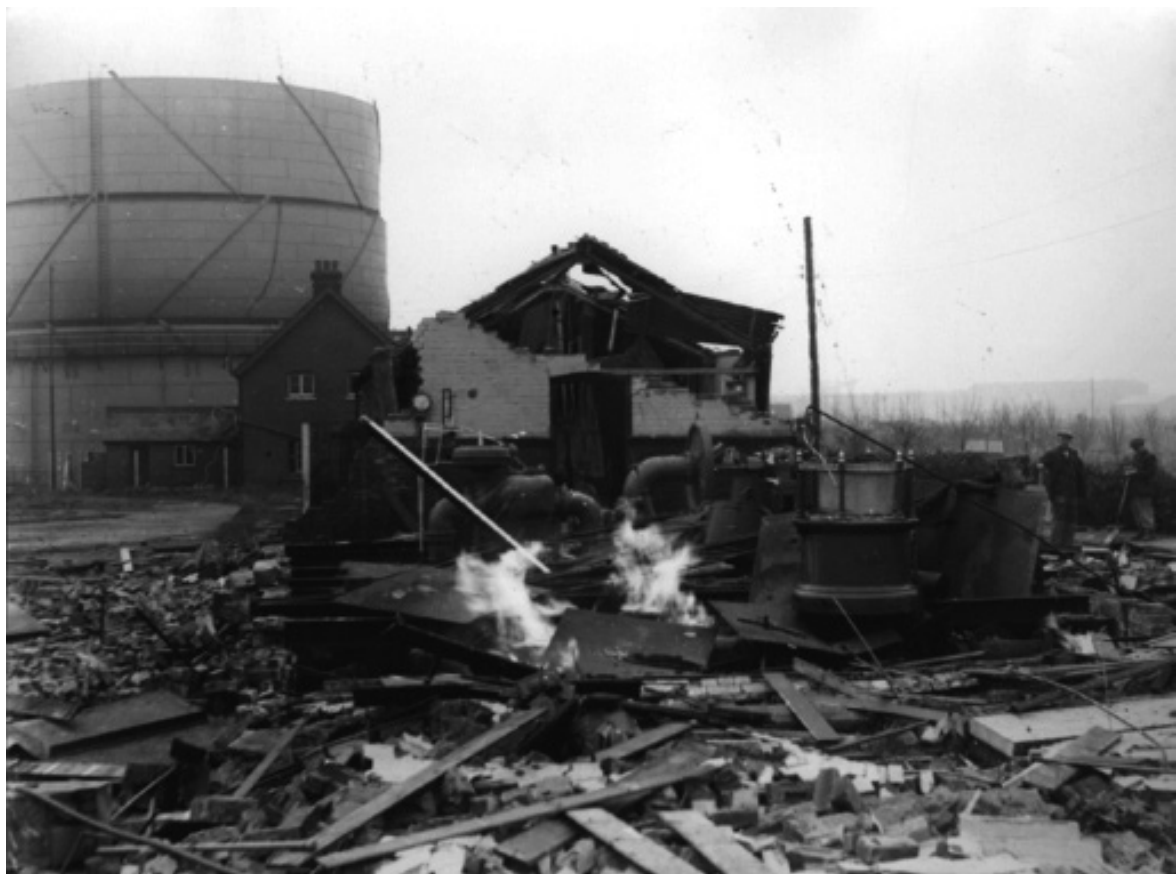
Plate 4: The Governor House following the explosion of 6th January 1956, looking south. National Gas Archive Document Reference: EA/FEG/E/F/1/xg02662

- 2.2.8 On the 6th January 1956, an explosion destroyed the Governor House and two men were killed. Eric Sparrow, whose family were caught in the flood which destroyed the Gasworks Cottages, was also hospitalised. A photograph (Plate 4) in the National Gas Archive's collection shows the remains of the building at the northern end of the western boundary, with the houses, still to be demolished, and the spiral-guided gasholder in the background. Another photo available on the Ipswich Star's website, but not of sufficient quality for reproduction in this report, shows both of the gasholders in the background which appear to have escaped damage and no damage to the gasholders was reported in the newspaper (Ipswich Star, 2018).

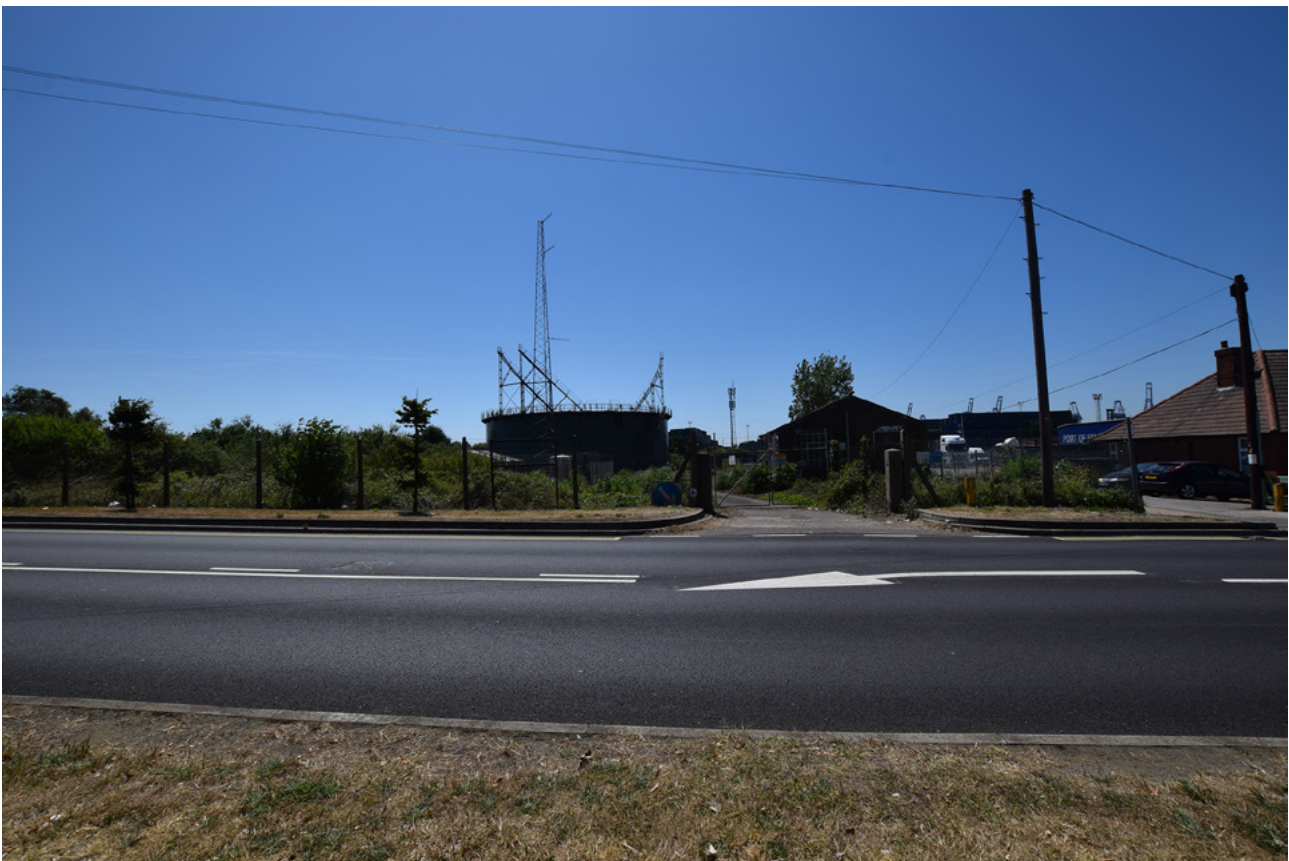
Plate 6: The view of the site from Walton Avenue, looking south

- 3.1.1 The site is located to the south of Walton Avenue (Plate 6) and is bounded to the east by the railway and to the west by a service road called Outfall Road in reports of the 1953 flood, but not named on available maps and plans of the area (Plate 7). To the north between the site and Walton Avenue is a distribution site controlled by the gas distribution company, Cadent, and was formerly part of the gasworks site. To the south is wasteland, also formerly part of the gasworks. The site boundary is marked by chain link fencing and concrete posts.

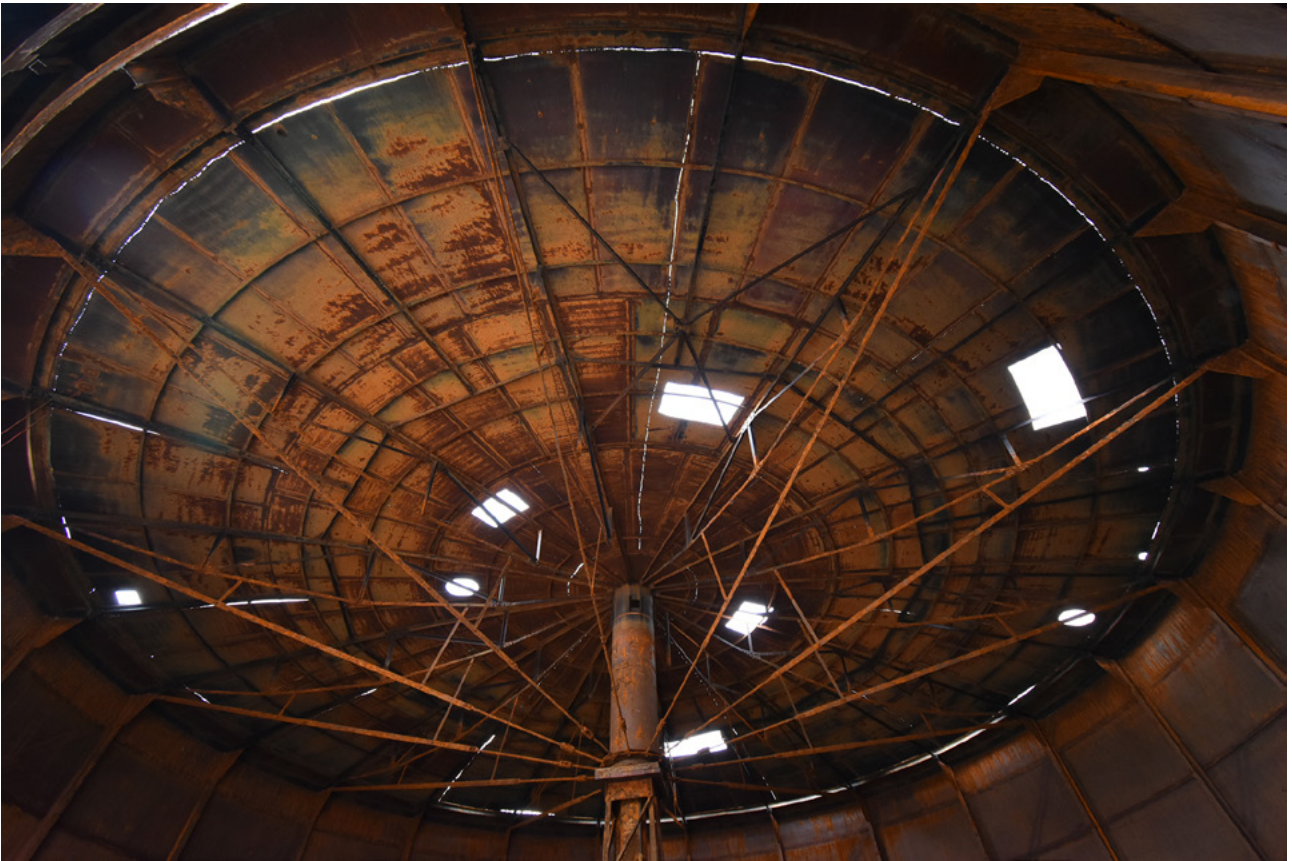
3.2.9 The welded plates of the domed crown were supported on a frame of concentric steel rings supported in turn on trusses spanning between the central post and the inner lift (Plates 26 & 27). An additional brace was located at the north-west of the crown, although it was not evident if this was a later repair or part of the original design. The trusses were formed from a bar and rod spanning between the post and inner lift with further bars spanning between the inner lift and the centre of the crown cover. The braces were formed from angles and all joints were bolted.

Plate 26: The crown structure

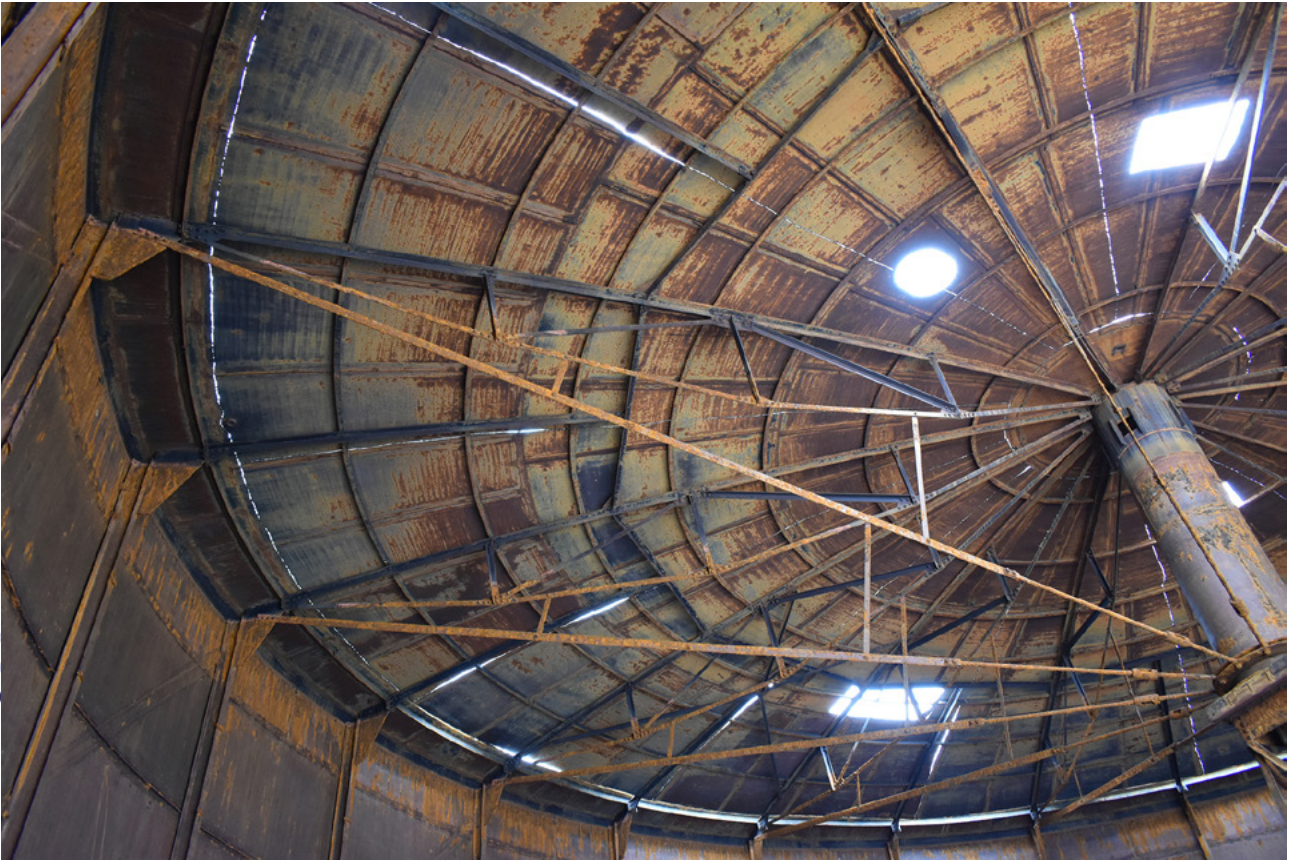
Plate 27: The trusses

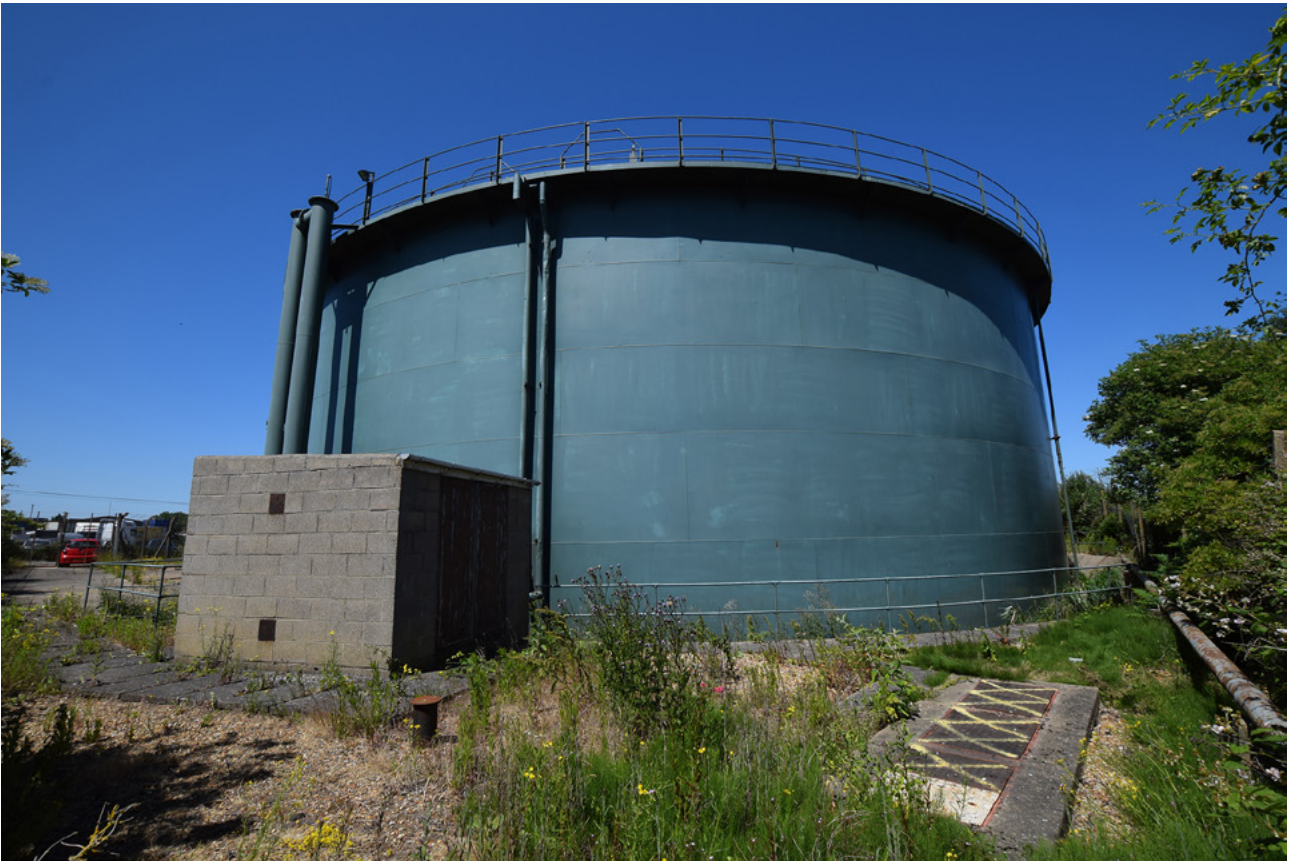
3.4.1 To the south of the gasholder was a dilapidated, flat-roofed, concrete block building (Plates 36 - 38). Timber plank double doors were to the east and west walls and vents were in the north and south walls. The roof covering was missing but was evidently a corrugated sheet as the fillet survived to the west wall; the joists survived. The roof sloped slightly to the east to the grey plastic gutter, although the downpipe had gone by the time of survey.

Plate 36: The concrete block building in relation to the gas holder, looking north

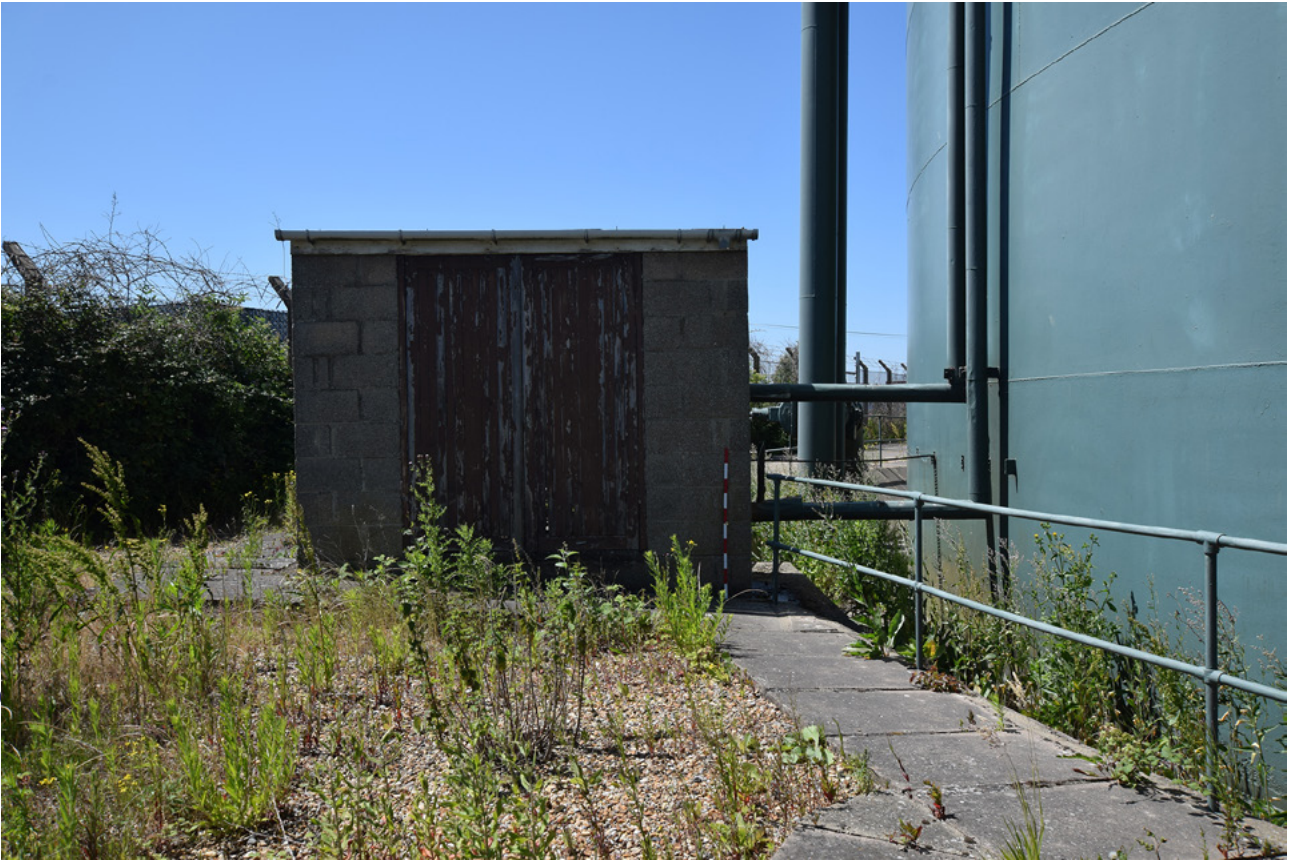
Plate 37: The east elevation of the concrete block building

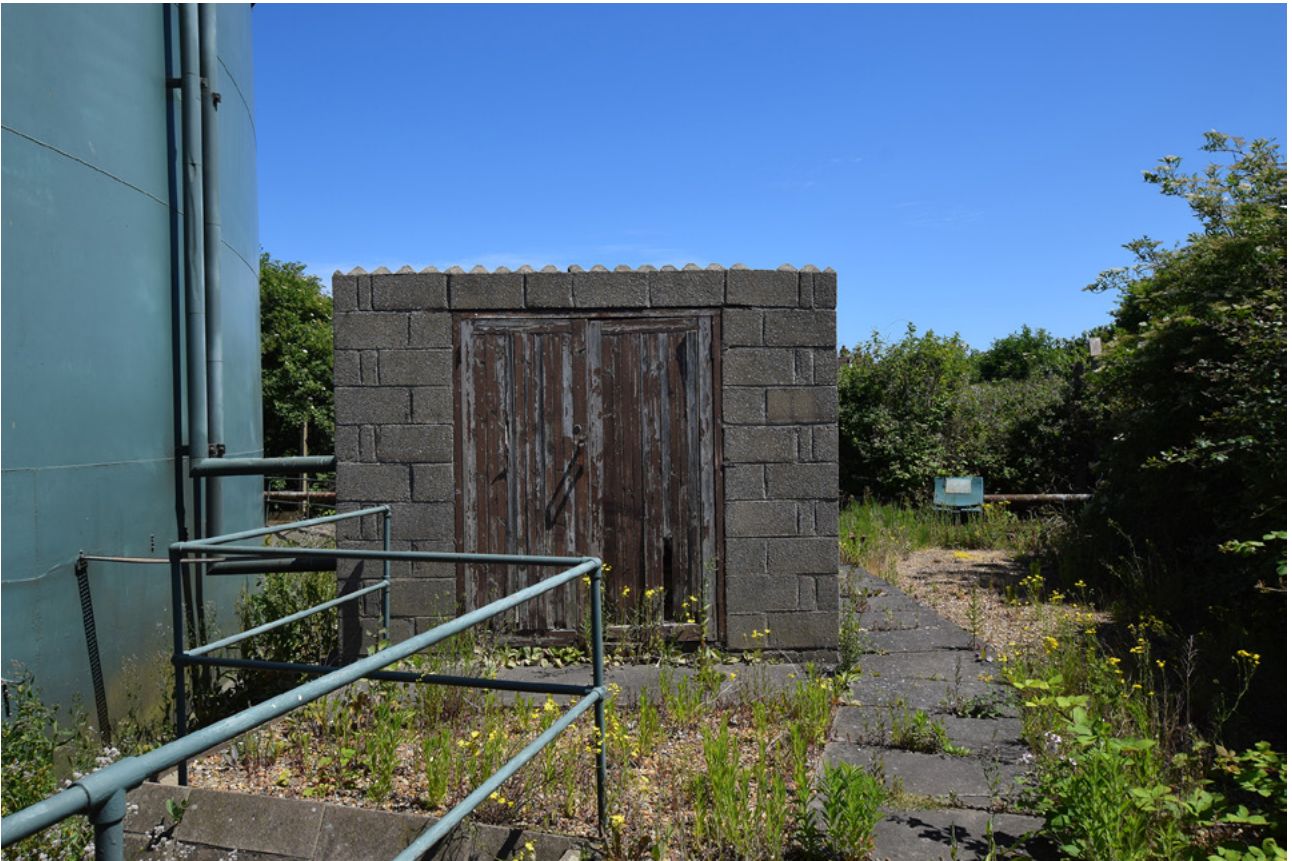
Plate 38: The west elevation of the concrete block building
