Chapter 2: Archaeological Description

The phasing and chronology of the archaeology (Figs 2.1–2.5)

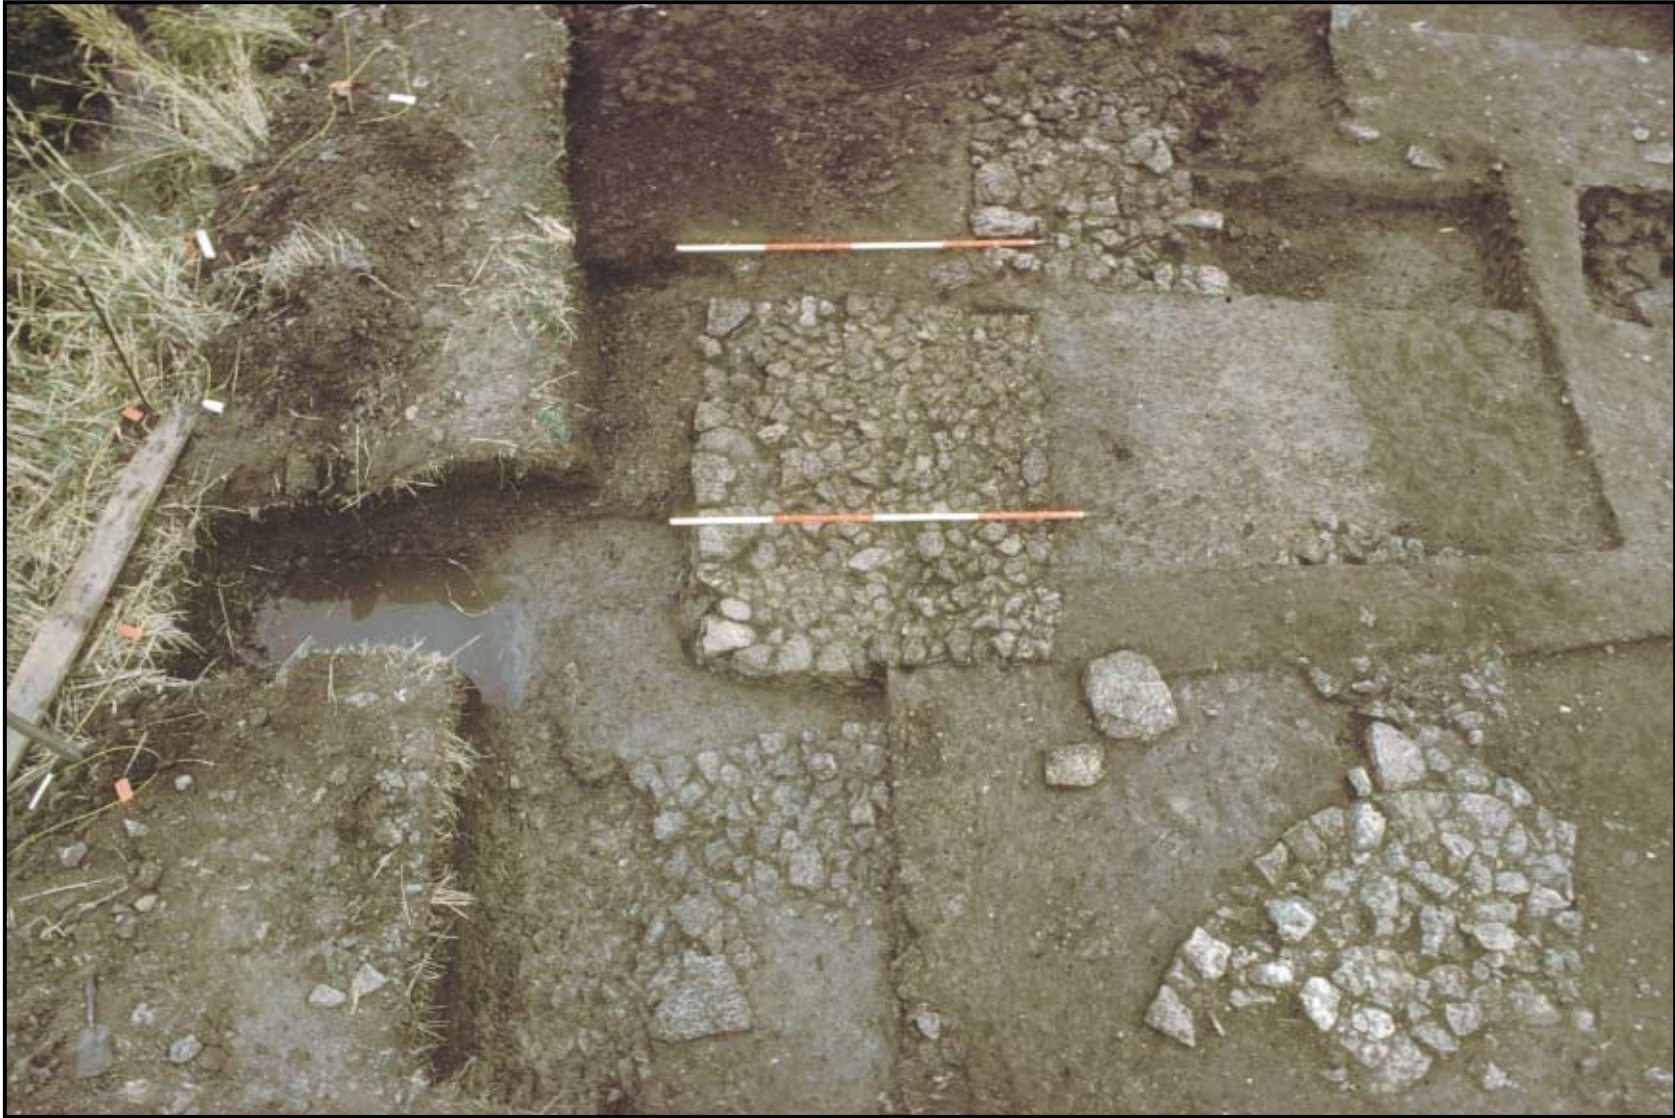
Plate 2.1 The northern moat, showing bridge abutment 730 and the edge of Building E.

On the northern edge of the large island a length of substantial rubble limestone footing (736) with a width of c 0.80 m was partially exposed. Its stratigraphic relationship with the moat and the Phase 1 features to the south was unclear; it could represent a pre-moat structure truncated by the moat construction or equally possibly, an early bridge abutment, later rebuilt as 730 (Fig. 2.9 and Pl. 2.1).

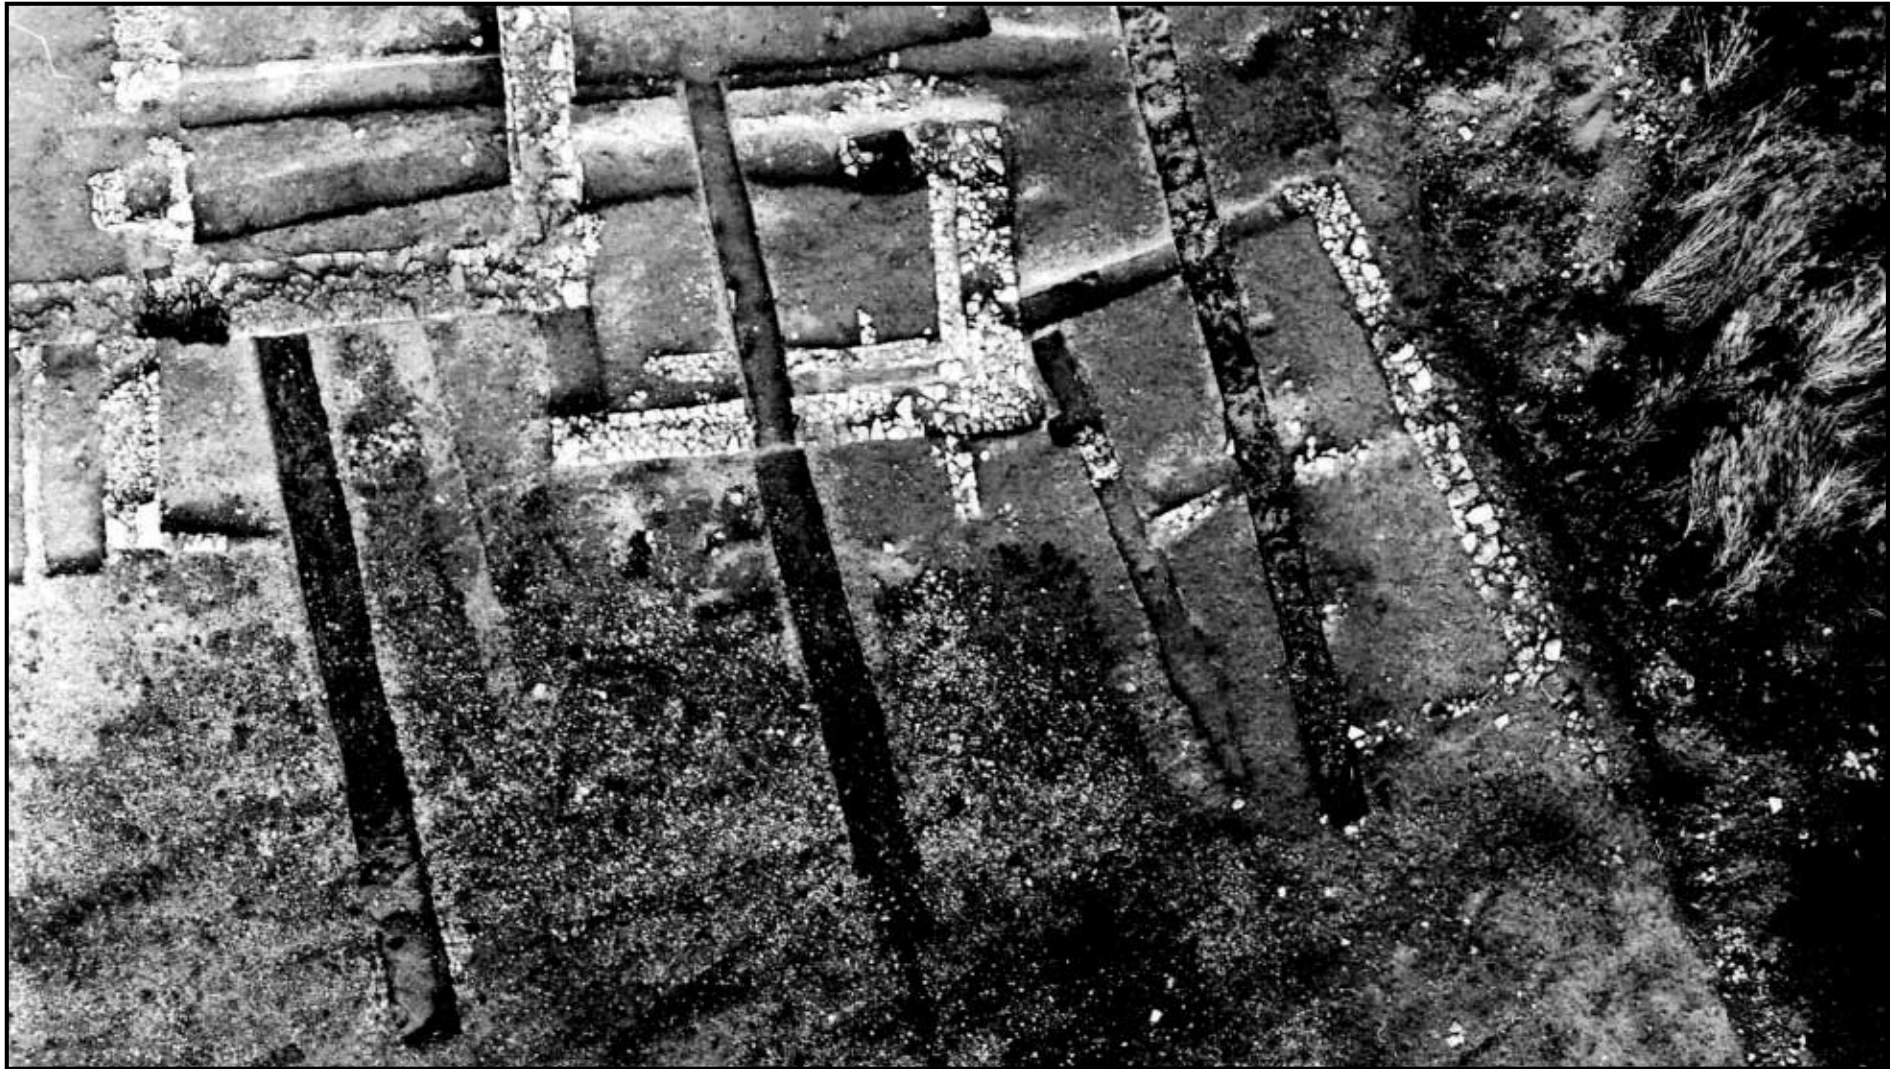
Plate 2.3 The eastern edge of the main island, showing Buildings A7, A11, B, and edge of eastern moat. Note evaluation trenches.

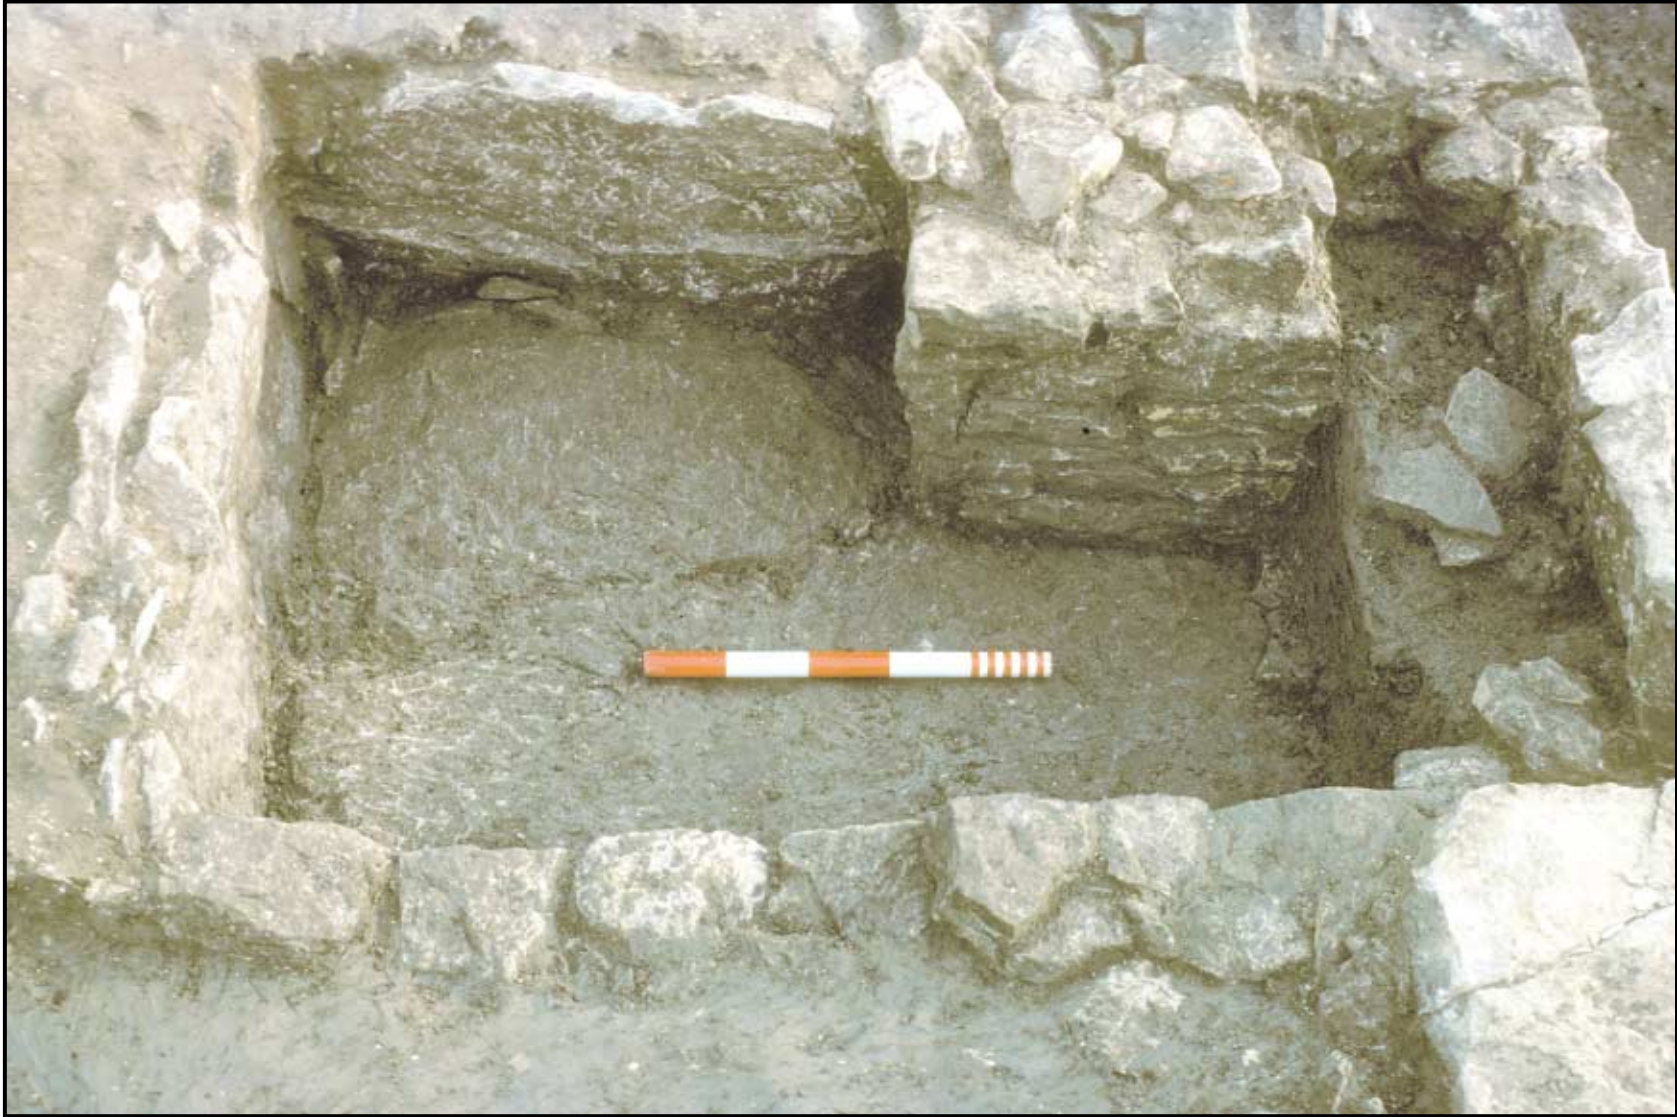
Plate 2.4 The storage pit in Building I. (Phase 3 – early 14th century.)

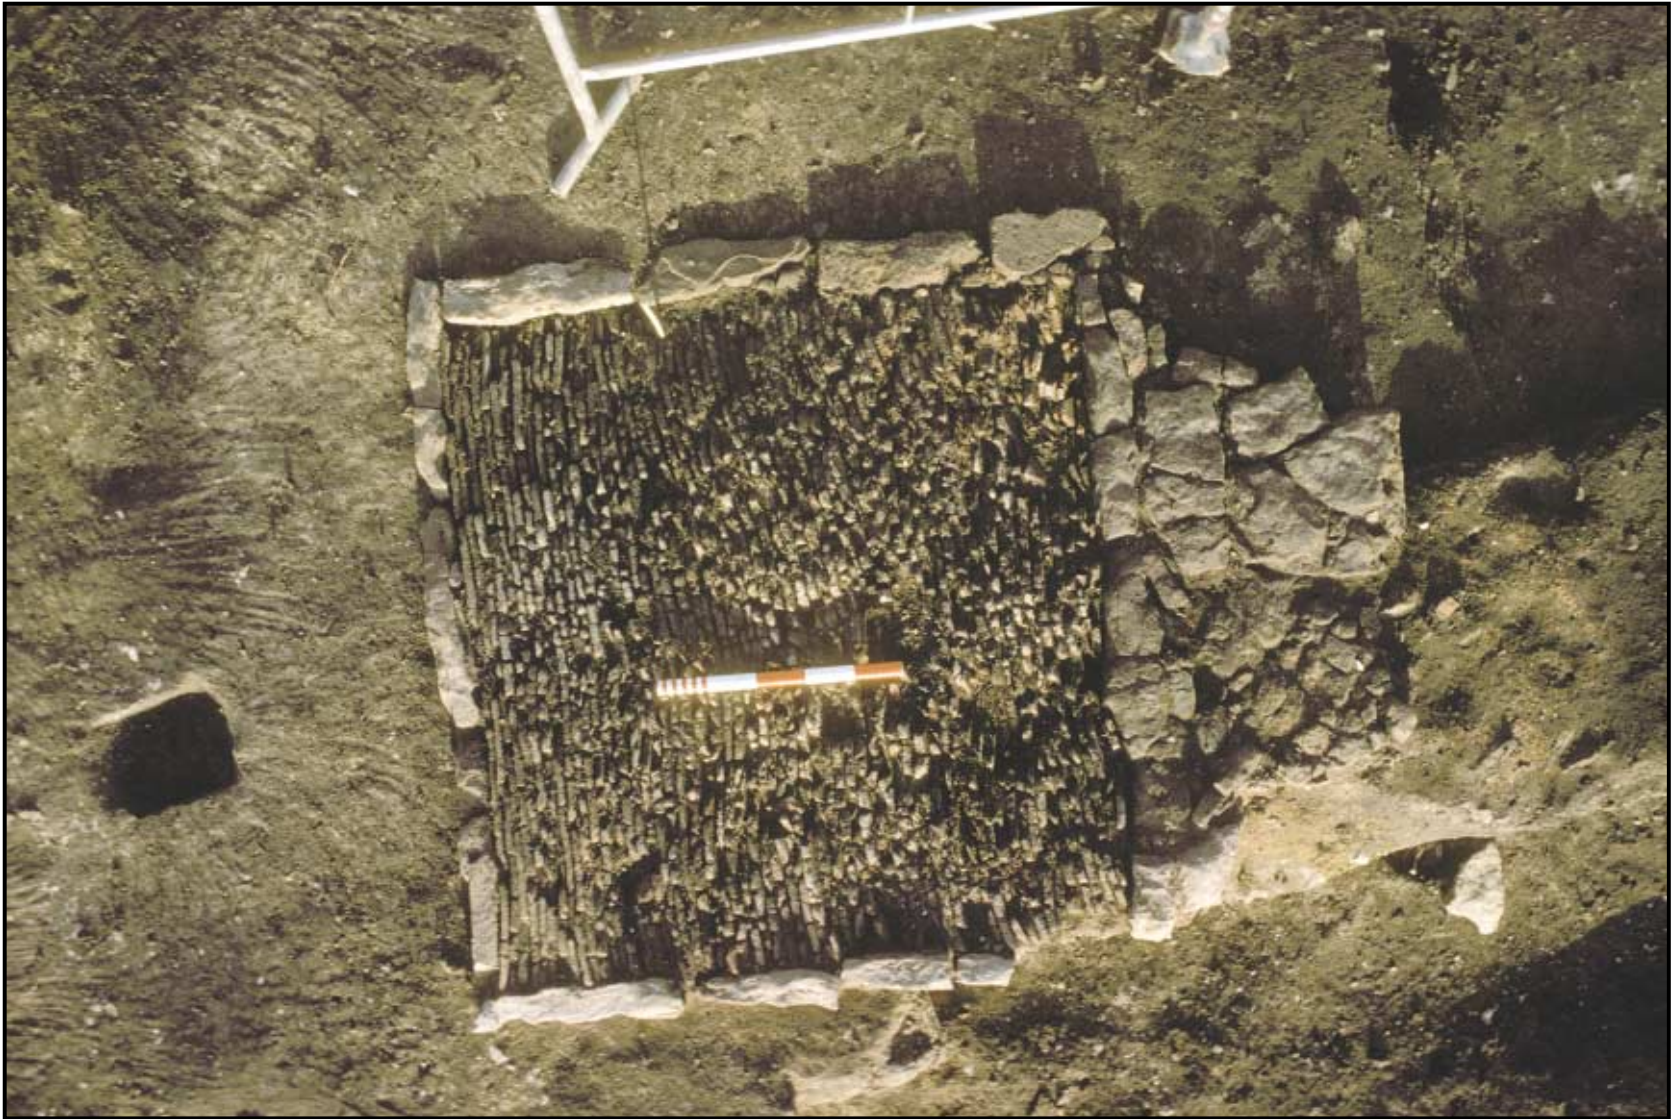
Plate 2.5 Central hearth 563 in Building A1. (Phase 4 – late 14th century.)
