Chapter 6: Discussion

INTRODUCTION

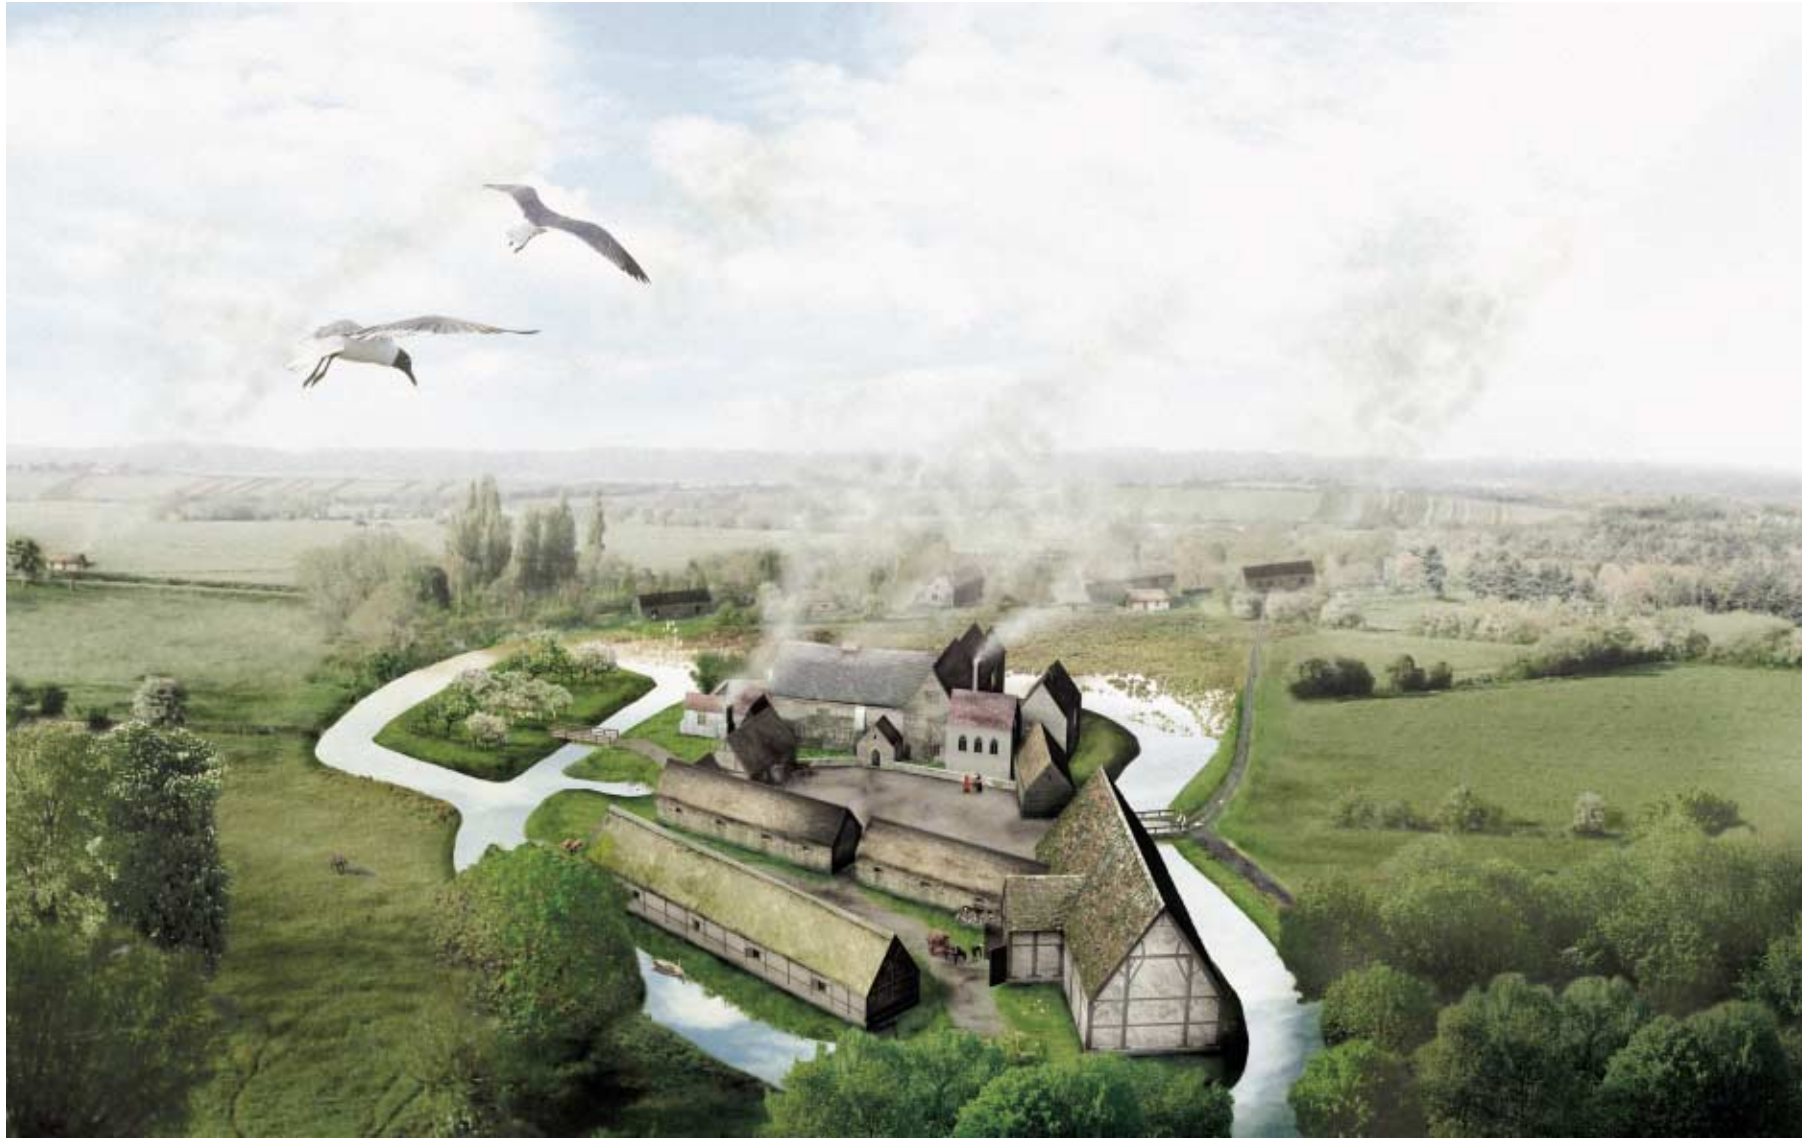
Plate 6.1 Artist's reconstruction of Barentin's manor in the late 14th century.
