1 Northgate Street, Warwick, Warwickshire

Archaeological Watching Brief Report

September 2017

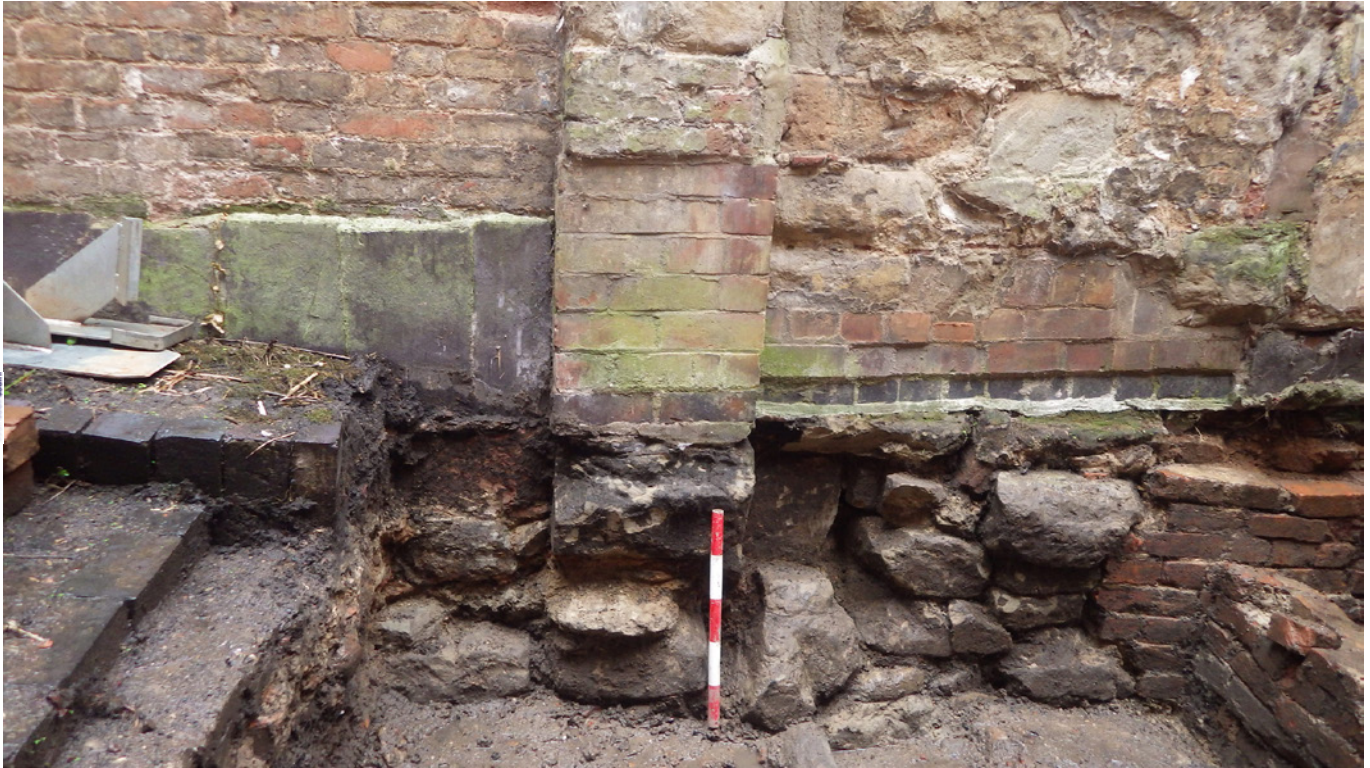
- 3.2.1 The earliest structure found on site was a wall or foundation (numbered 5), built of large roughly dressed blocks of greyish-green sandstone (Plate 1). Some of these were more carefully finished, and were mostly square, but others appeared to have been shaped

Plate 1: Sandstone wall/foundation 5 with wall 11 above , looking west

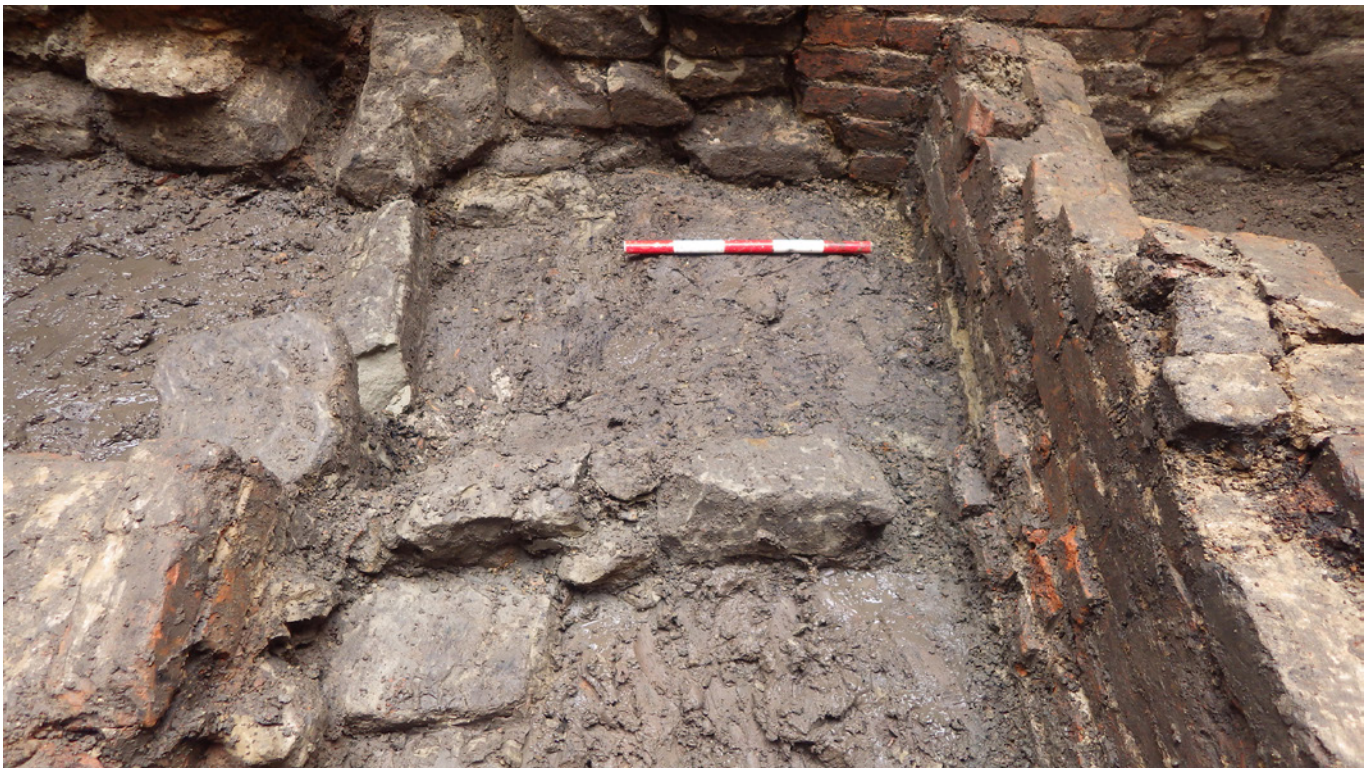
- 3.2.3 On the west side of the excavation, and abutting structure 5, layer 13 was cut into for the construction of stone structure (9), which was built of sandstones similar to those of structure 5. It was constructed of blocks and slabs lying up against the edge of the cut to form a rectangle 1.1m × 0.8m (Fig. 2; Plate 2). This was filled with a soft reddish-brown clay (8), which was only exposed to a shallow depth, and did not produce any finds.

Plate 2: Detail of structure 9 looking west

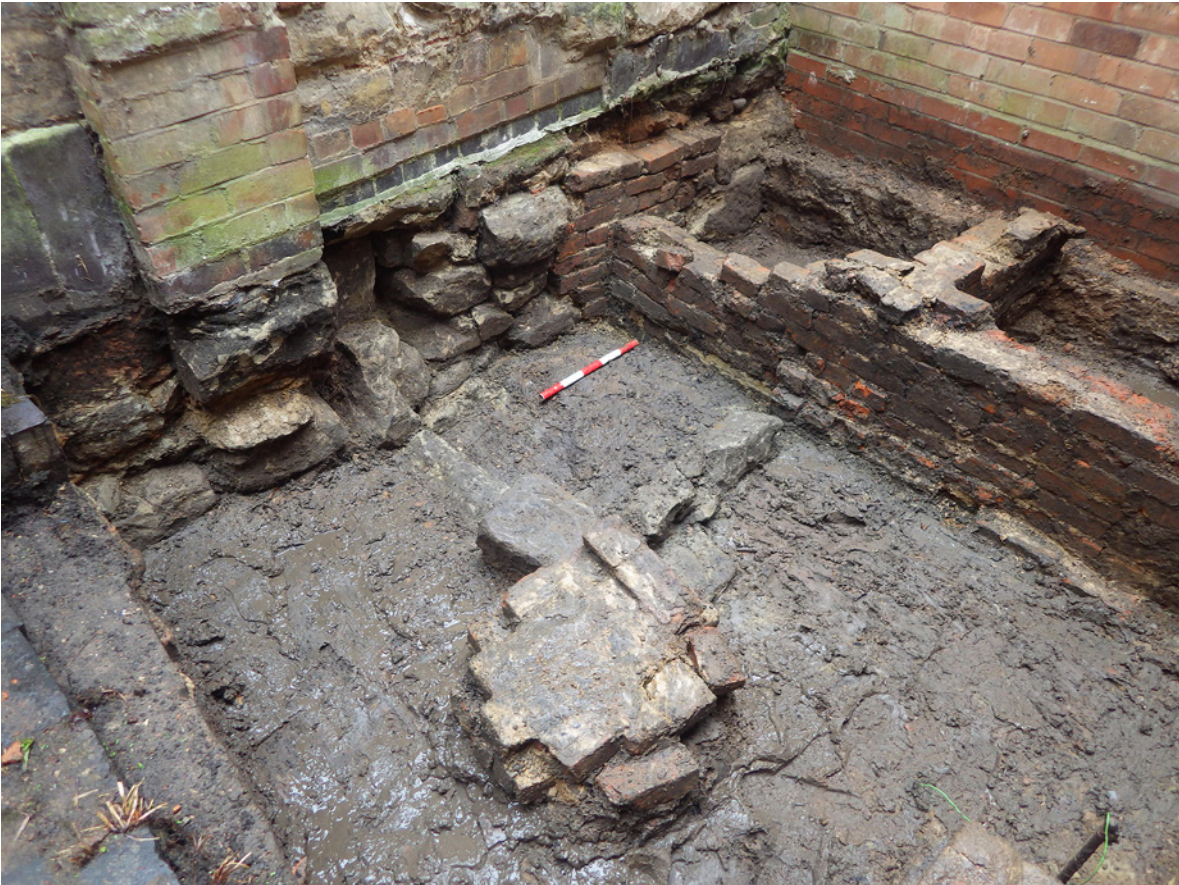
Plate 3: Sandstone structure 9 with brick plinth 7 and walls 6 and 12 behind, looking north-west

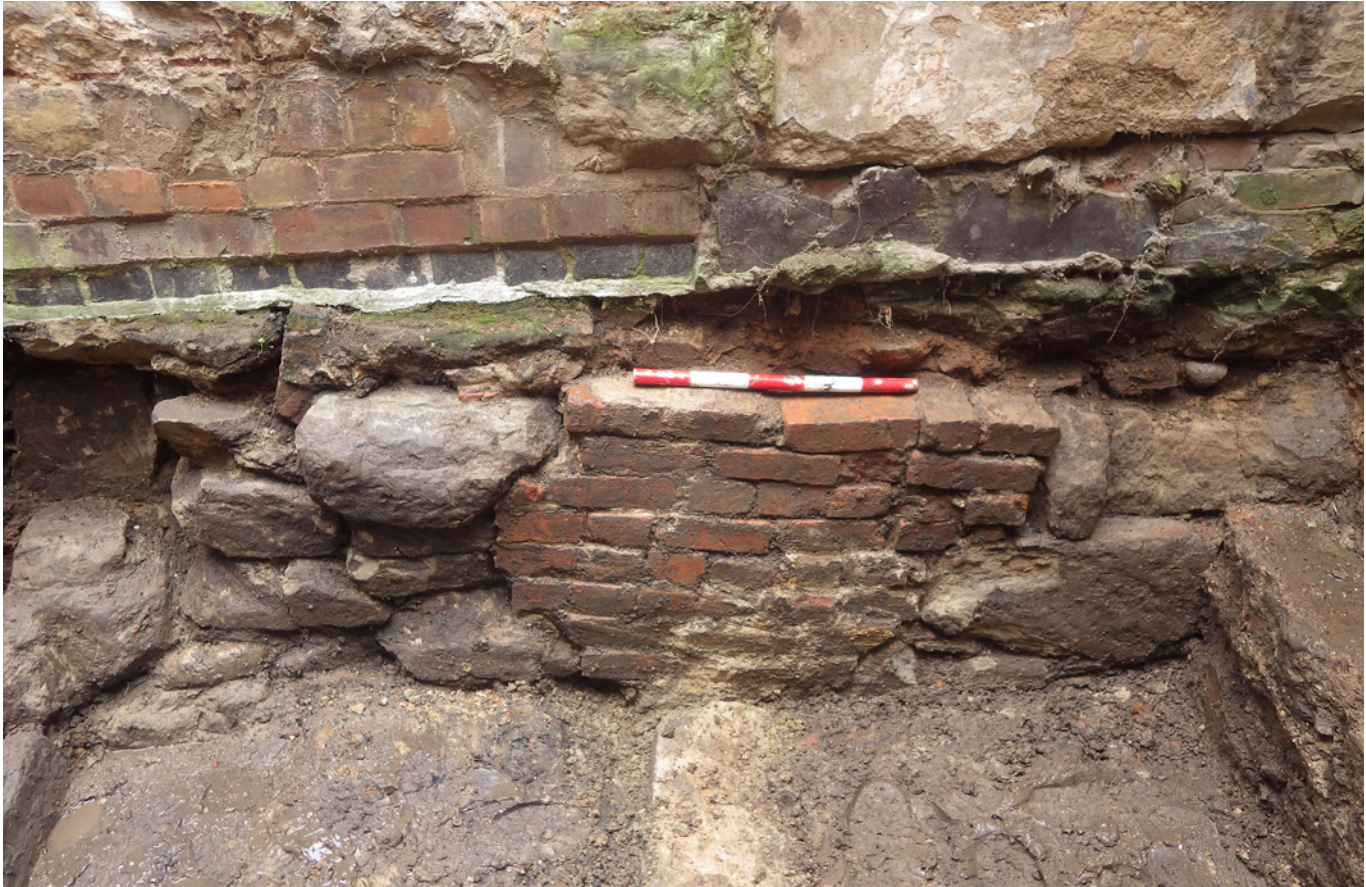
Plate 4: Brick infill 12 in sandstone wall/foundations 5 after removal of wall 6, looking west

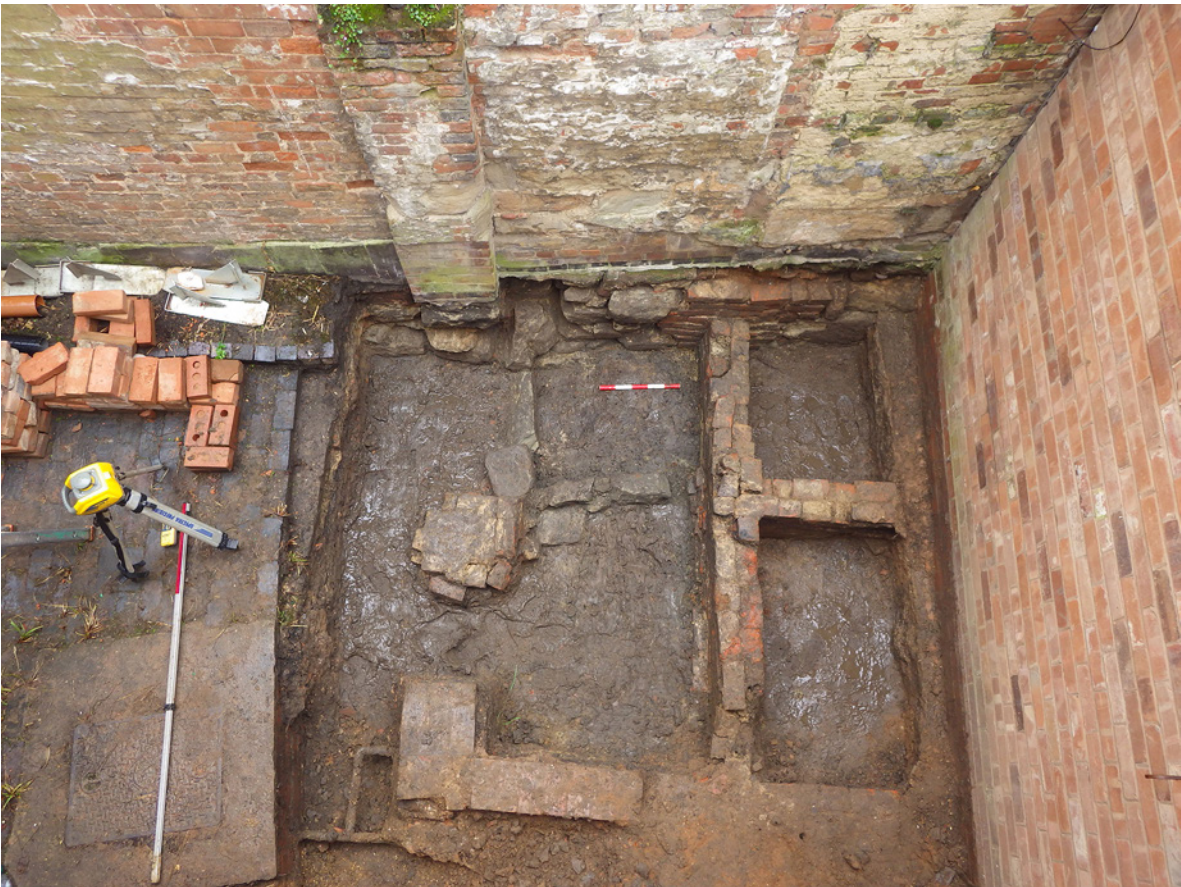
- 3.2.4 Structure 9 and its fill, and layer 13 beyond it, were covered by a loose grey coarse sandy clay (3), which contained fragments of roof tile of 16th-18th century manufacture and sherds of pottery dated to between c.1550-1750 (See below 4.14 and 4.15). This probable levelling deposit was in turn cut and overlain by an east-west aligned brick-built rectangular structure (6) (Plates 5 and 6).

Plate 5: Overhead view of site showing structures 9, 7, 6, brick pier in wall 11 and modern wall 10

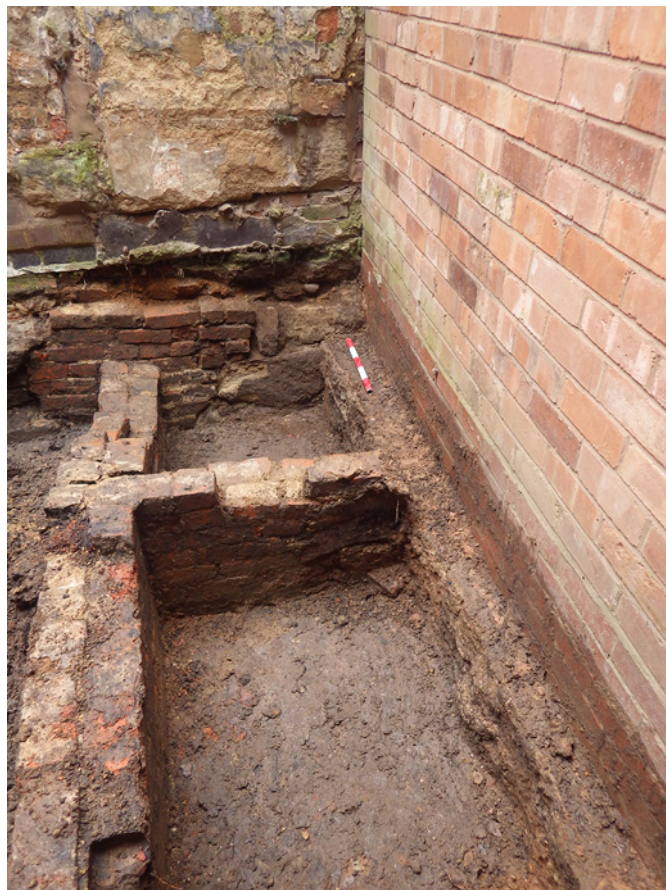
- 3.2.7 The southern wall of structure 6 could clearly be seen as a scar on the western wall of the property marking its former position and continuation upwards (Plate 6), and the line of the roof of the outbuilding which stood in the northern edge of the site. This was clearly the outbuilding marked on historic maps along the northern edge of the site. No floors or surfaces were found within this structure.

Plate 6: Structure 6 and wall 12, looking west

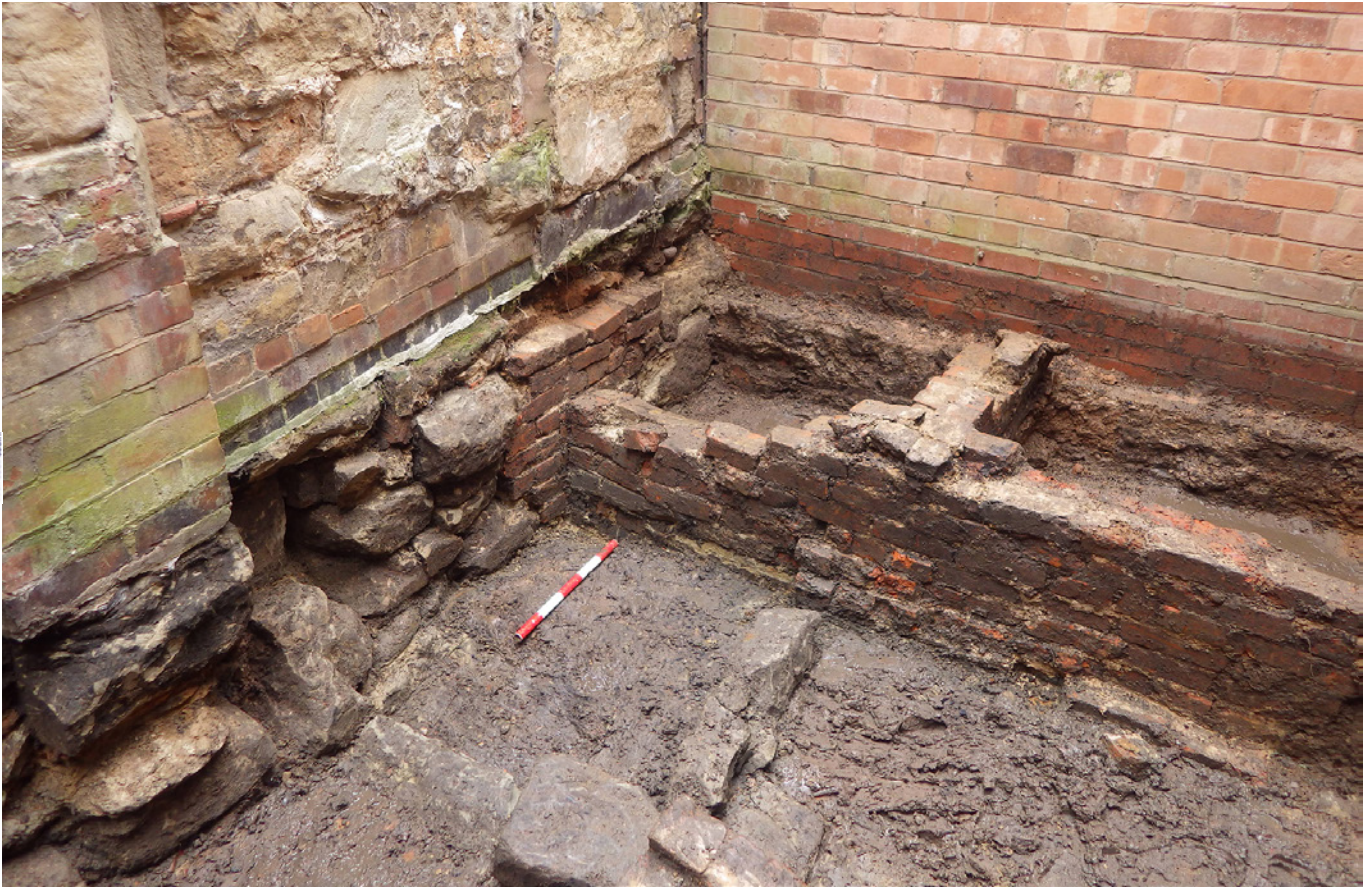
Plate 7: Structures 6 and 9, looking north-west

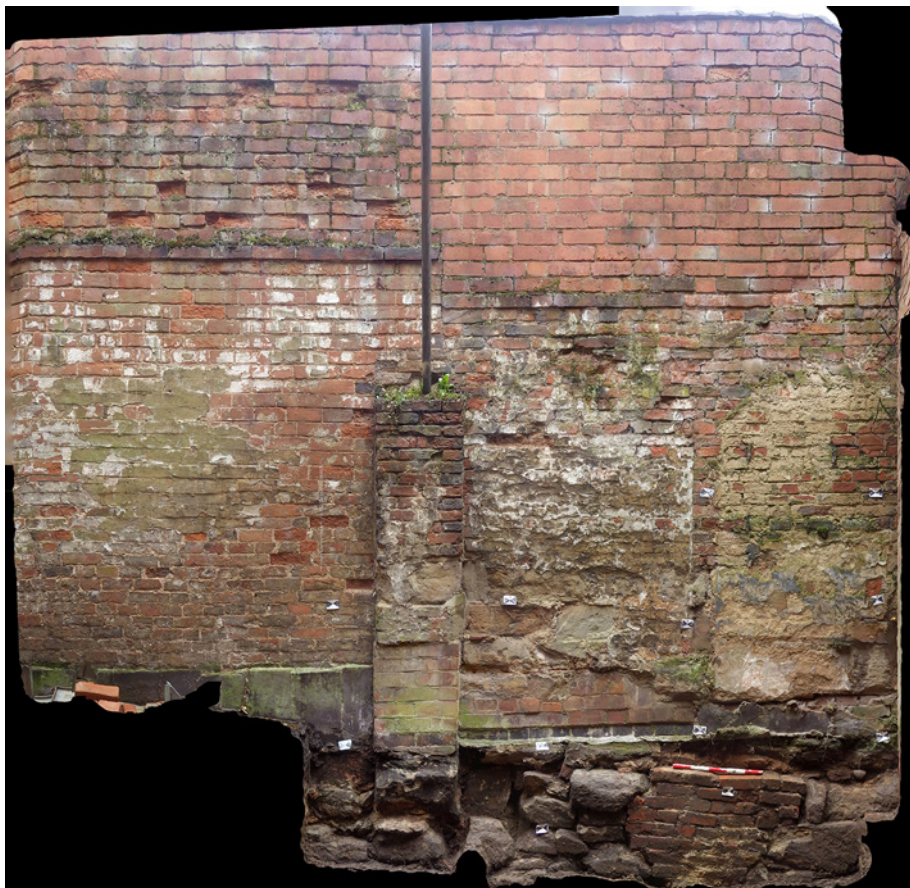
Plate 8: Walls 5, 9, 12 and 11 showing scar of lean-to and multiple phasing on wall 11
