Archaeological Watching Brief Report

November 2023

**Client: Martin Ashley
Architects**

Clarence House, 2 The Vineyard, Richmond, London

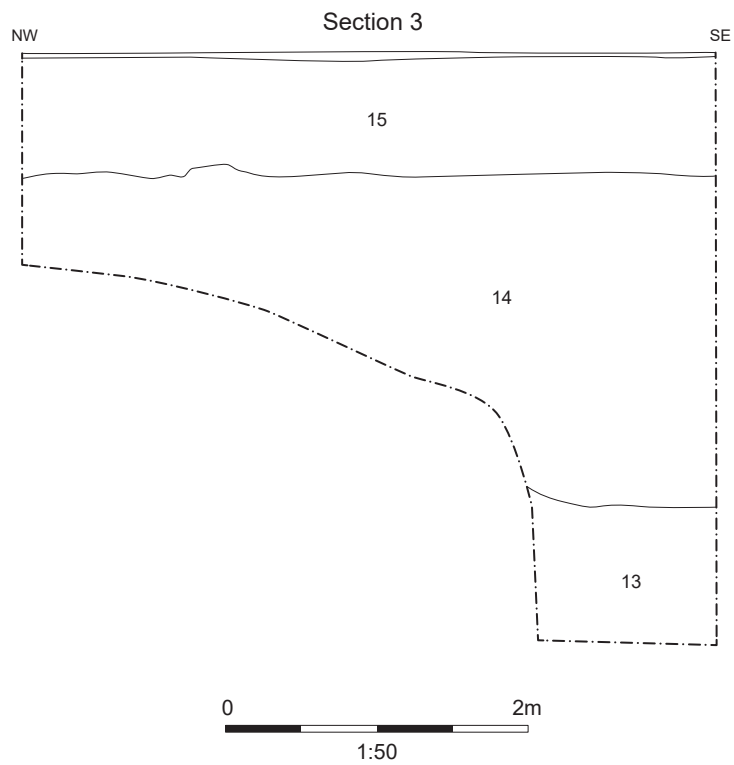
Figure 4: Section 3

3.2.2 The stratigraphic sequence exposed was similar in both pits (Fig. 4). A layer of undisturbed natural orange clay sand (13) was encountered at a depth of 3.1m below ground level. Overlying this was a 2.2m deep layer of orange-brown clay (14), likely natural. This deposit exhibited banding within its structure suggestive of waterborne deposition. This deposit was sealed by a 0.8m deep layer of reddish grey sandy silt (15). This layer contained numerous fragments of brick and concrete together with mortar flecking throughout its depth, which may indicate a layer of made ground. Overlying this made ground was a 0.1m deep layer of dark-brown silt loam (16), a landscaping layer of topsoil and turf.

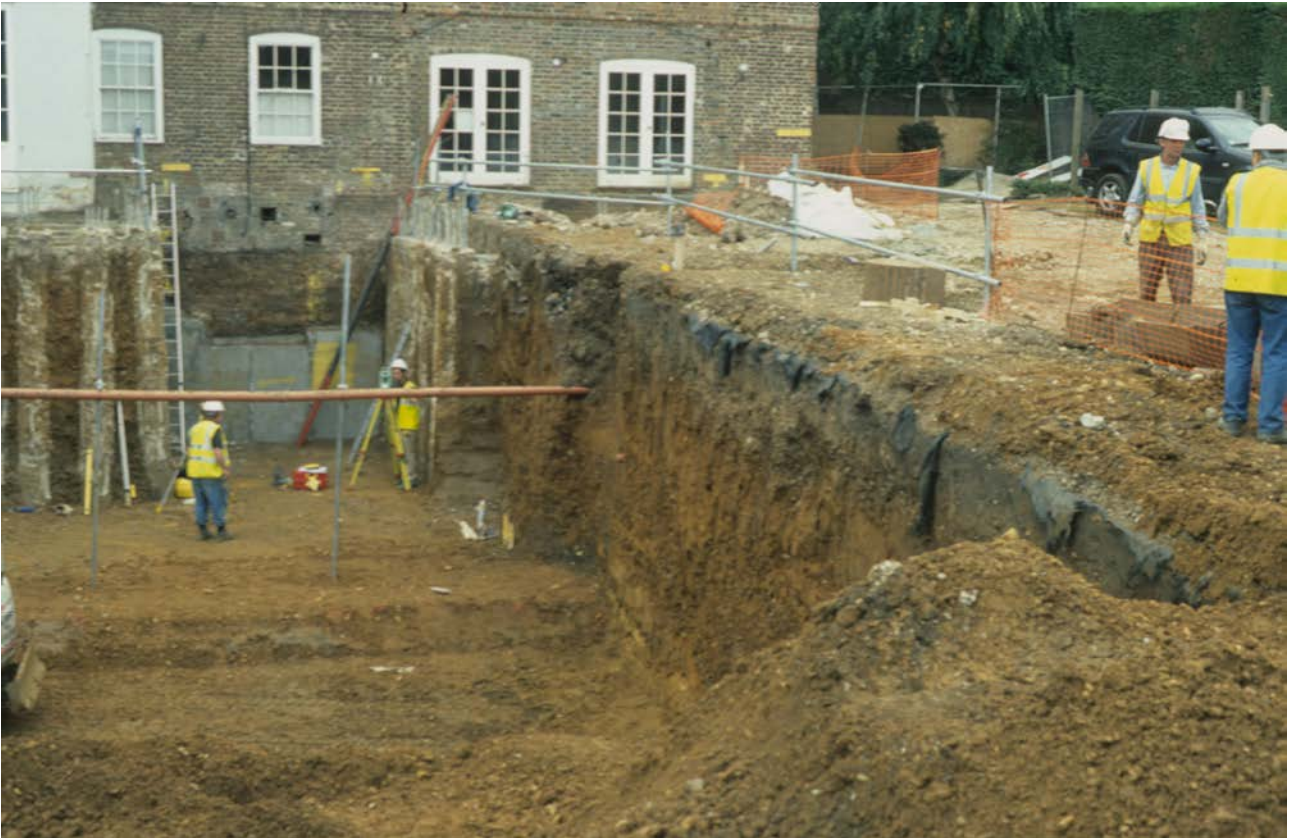
Plate 1: Basement construction to the rear of Clarence House, view to the south

3.3.1 An area measuring approximately 12 x 32m was excavated to a maximum depth of 4m. This area was excavated within a box of previously inserted concrete piles (Fig. 2).

3.3.2 A continuation of the orange clay sand (13) was encountered at a level of 3m below the original garden level. This was overlaid by a 2.15m deep layer of banded orange-brown silt clay (14). This banded is indicative of waterborne deposition and this layer is therefore a probable continuation of layer 14.

3.3.3 Sealing this was a 0.78m deep layer of reddish grey silty sand. This deposit contained numerous fragments of brick and occasional fragments of concrete and was a continuation of layer 15. The landscaping layer of topsoil (16) overlay made ground layer 15.

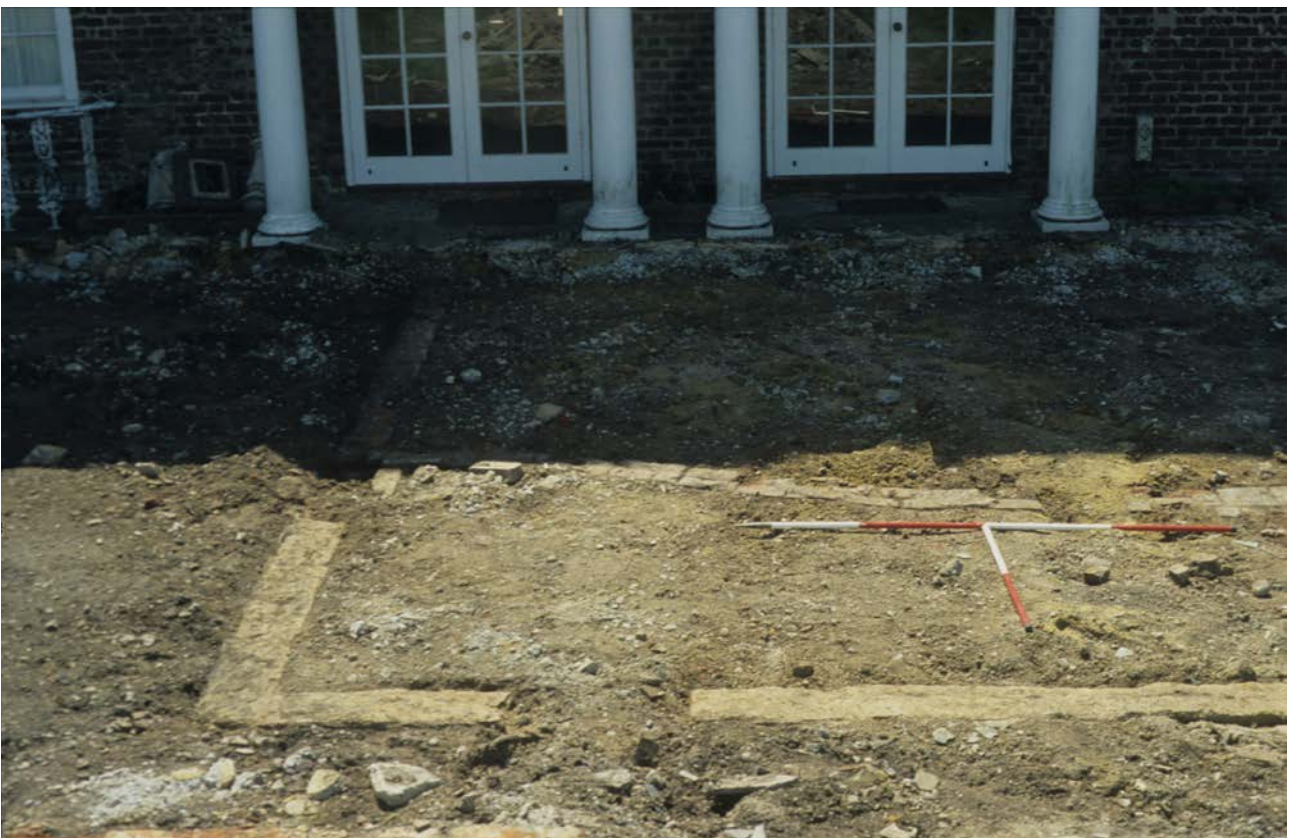
Plate 2: Ground reduction showing the foundations of the orangery, view to the south

3.4.1 An area measuring approximately 10 x 7m was reduced by roughly 0.5m to level the area prior to deposition of the piling mat (Fig. 5). This work included the removal of a modern patio.

3.4.3 Butting up to the north-western corner of wall 2 was the second foundation trench (4). This ran to the north-west for 4m before turning to the north-east and also running parallel to the north wall of Clarence House. This trench measured 0.8m deep and 0.8m wide and ran across well 6, exposing it in the base of the trench.

3.4.4 Cast in the base of the trench was a 0.3m deep concrete footing (3). Built upon this was a brick wall (1) using machine-moulded frogged bricks bonded with a cement mortar. Backfilling the trench was a dark brown silt sand (11). Butting up to the inside faces of both walls was a 0.2m deep layer of yellow-brown sandy silt containing gravel and brick fragments (10). This was a layer of made ground supporting the modern patio.
