Chapter 7

An outline of the technology used and the underground landscape at Combe Down

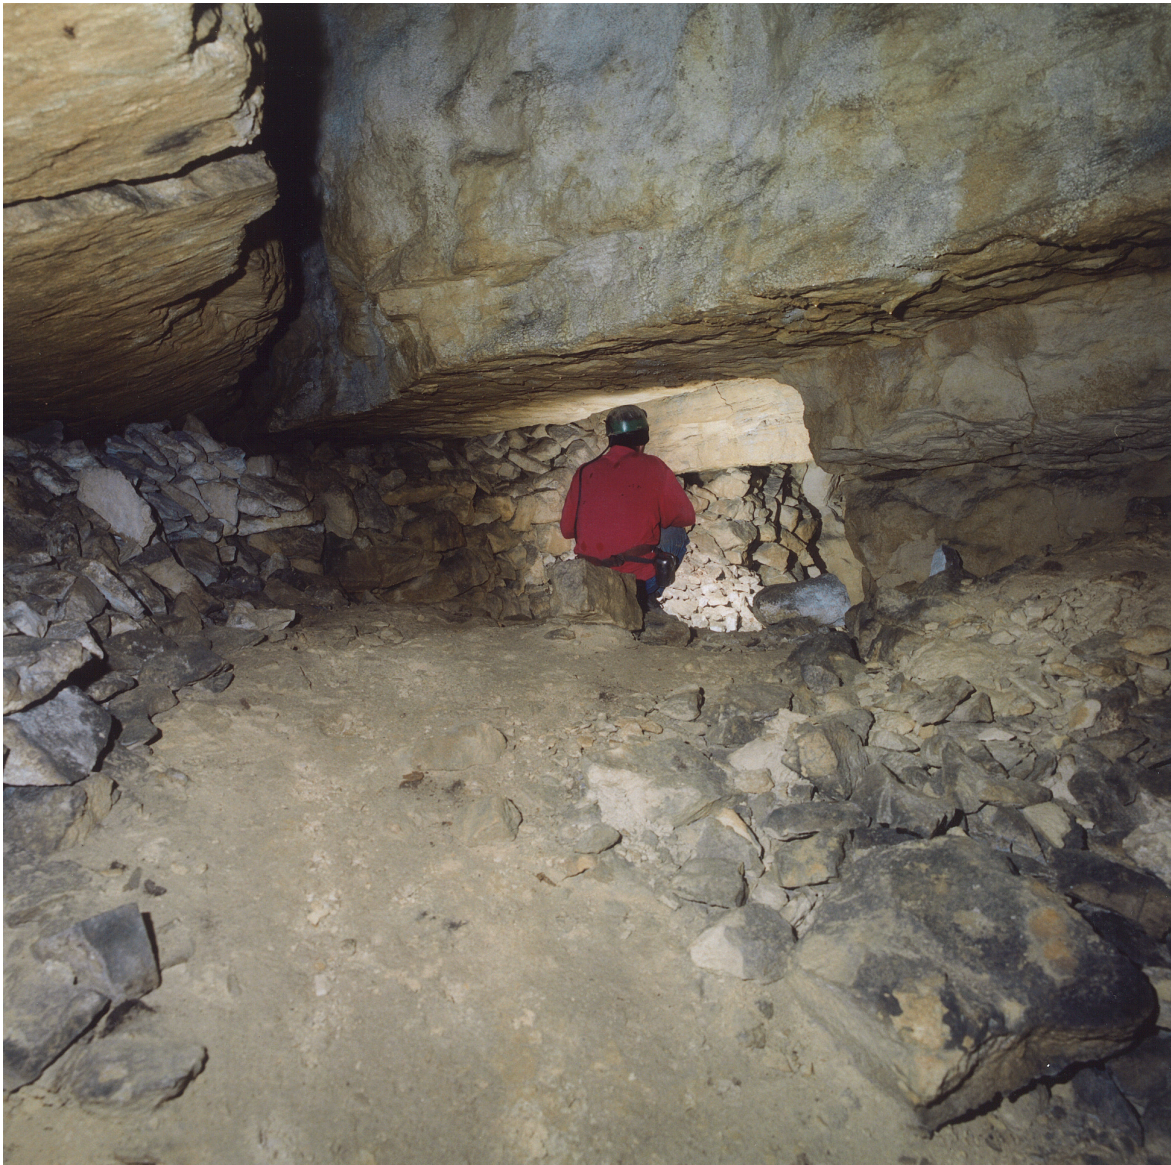
Fig. 7.3 Horsecombe Quarry, showing a large open joint or 'gull' which is parallel to the side of the escarpment resulting from cambering or land-slipping of the strata

One of the earliest and easily visible examples of an undermining quarry was located on the southern escarpment at Horsecombe Vale (Quarry 2376) to the south of Bradford Road and the Brow, close to and just below a footpath on the cliff top known as 'Shepherds Walk'. The surviving outcrop consists mainly of vertical quarry faces extending for about 70-80 m (Fig. 7.3). Small openings were made into

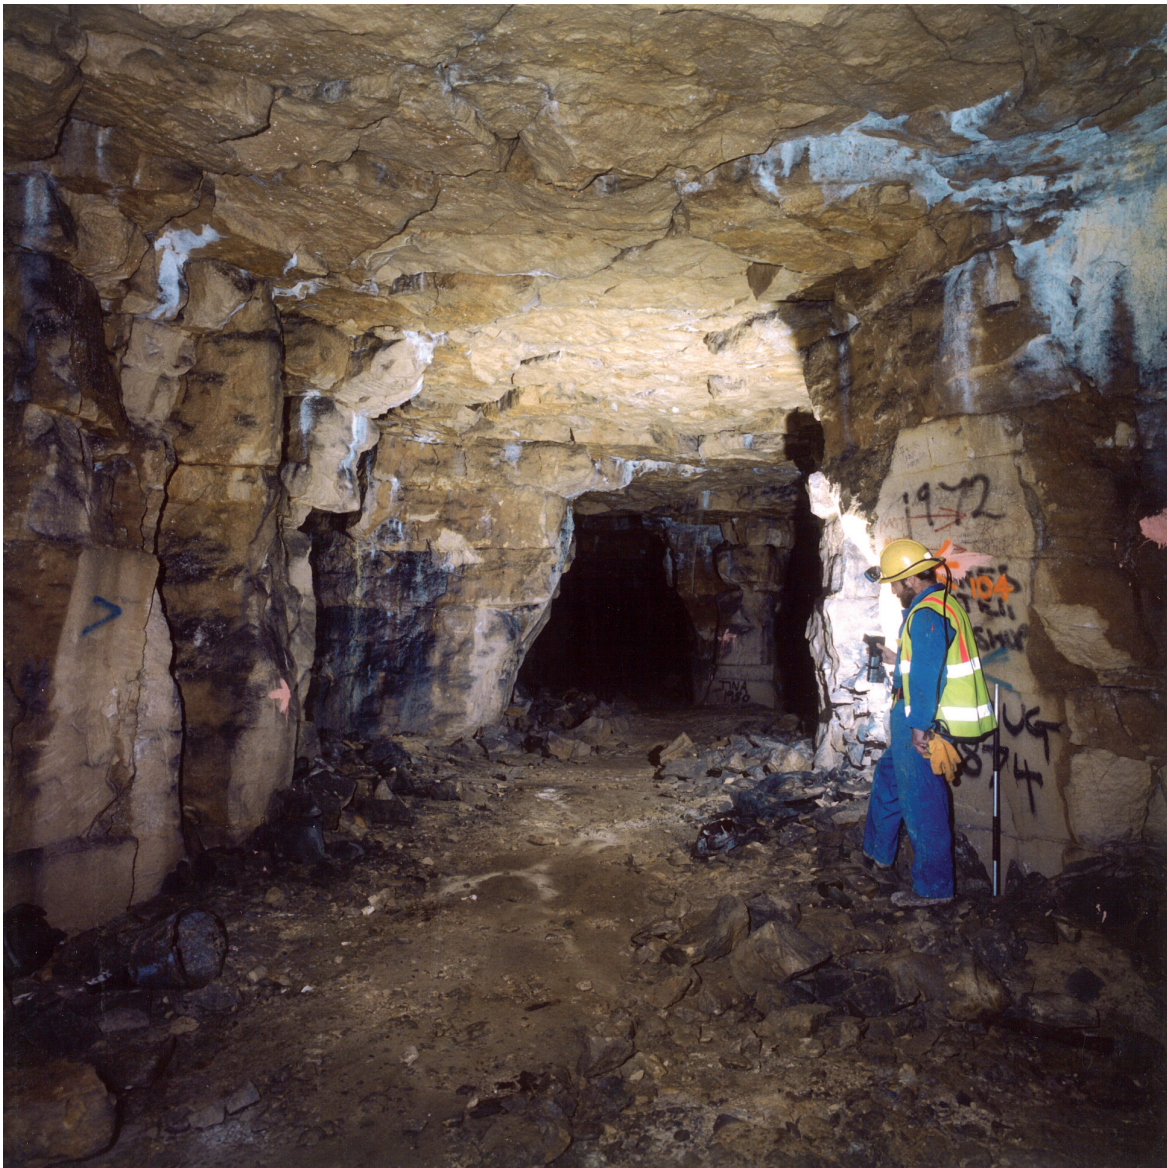
Fig. 7.4 Cartway within an adit or level entry (Allen's east cartway, central Firs) before stabilisation (Photo, Paul Deakin)

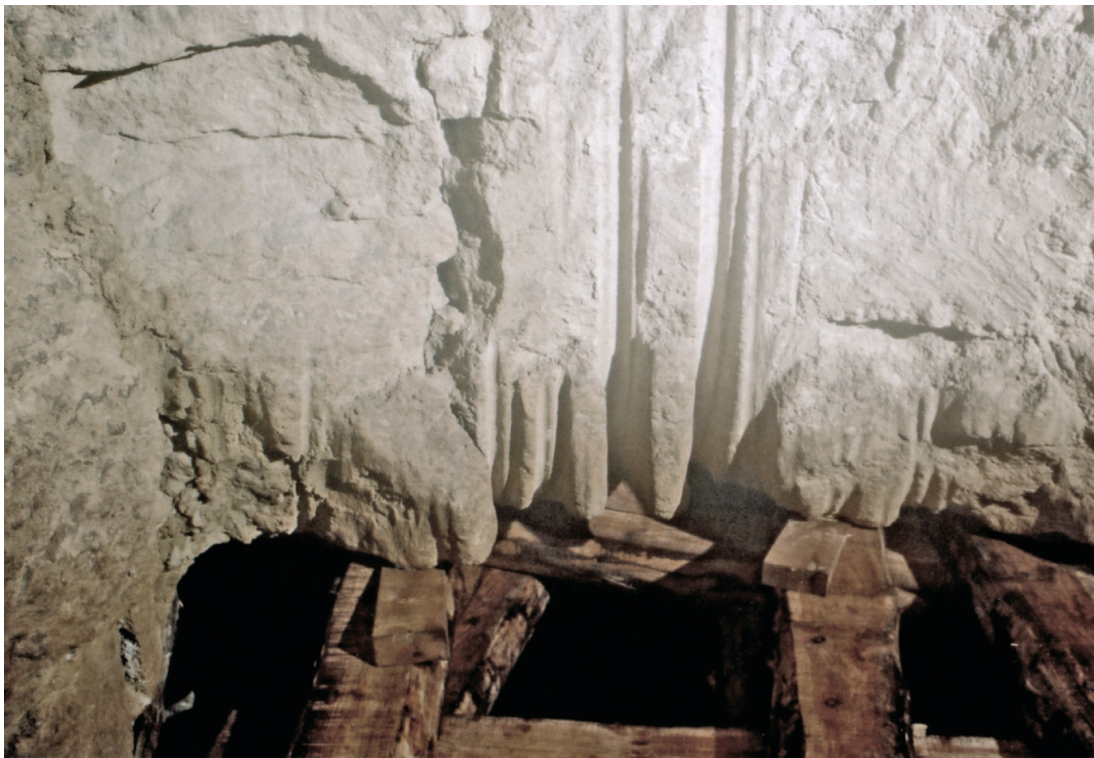
Fig. 7.6 Vertical cable grooves in the side of a shaft, East Firs

Quarries worked by vertical shafts alone were not common at Combe Down, though Coxes Vertical Shaft Mine and Tankfield Quarry, dating from around 1900 and situated under what is now the MOD Establishment at Foxhill were fully worked in this way (Chapter 12, Case Study 13). A number of smaller quarries in Far East Firs, near Gladstone Road were also worked from shafts, though most of these also had underground levels linking them to adjacent quarries and ultimately the surface. However, vertical shafts, designed to wind extracted stone directly to the surface from close to the underground working faces, were used in the 18th century onwards at Combe Down during and after the latter part of the Allen period. Though also linked by cartways, it is probable that the principle mode of working became vertical shaft in the workings as they approached North Road. This use of shafts can be recognized by cable grooves in the side of the shaft caused by dragging blocks to the shaft before hauling out (Fig 7.6).

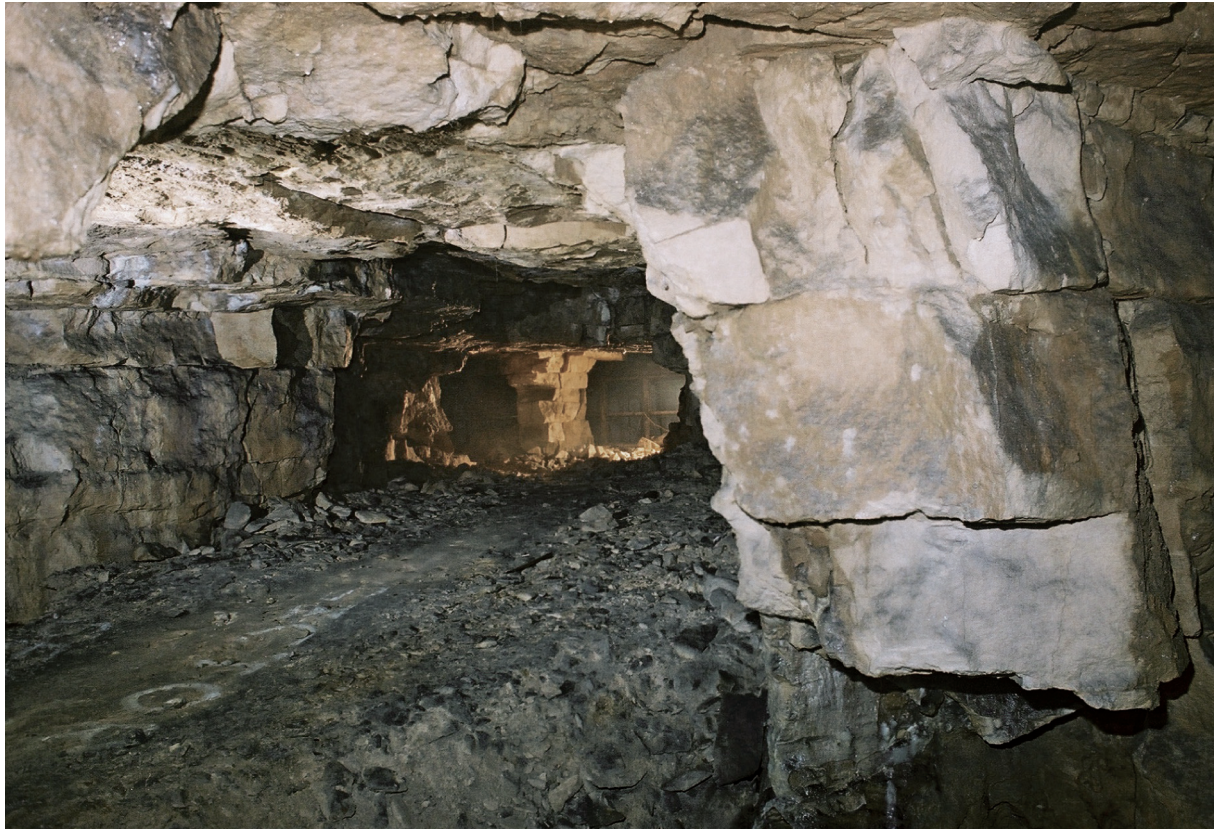
Fig. 7.7 Inclined barrow-way over dumped rubble, eastern end of the Grand Canyon, Central Firs

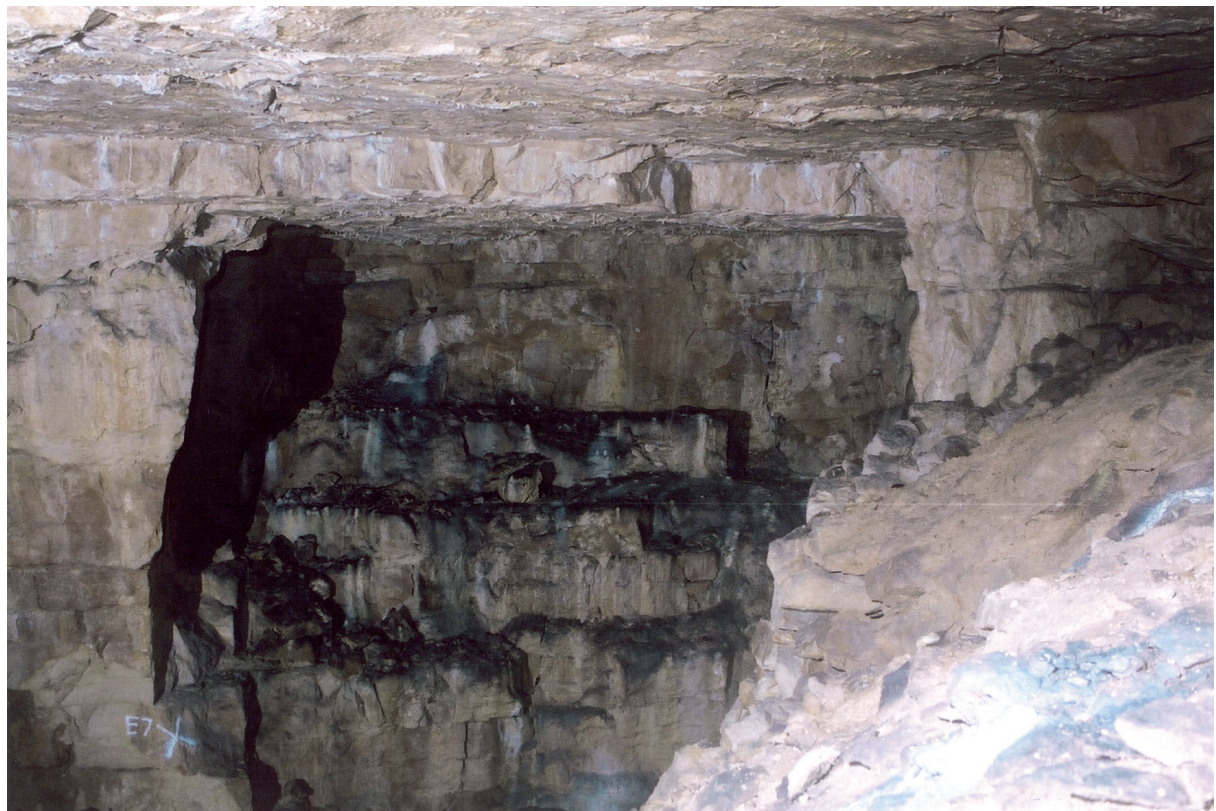
Fig. 7.8 Stepped working face, south-west Firs. This was the only full example found, as usually faces were left vertical or the area backfilled with spoil

The working face itself was formed in large steps (Fig. 7.8), and it would there be apparent in the pools of light shed by the candles that the cartway was formed on spoil some two or more metres deep, leaving a trench at the front of the face to work the beds at the bottom of the face. The face might end just in front of the cartway, or the cartway could extend either side into a trench or gullet to allow a number of rooms to be worked in a line, with pillars left to support the roof between them. The face and gullet advanced as the stone was extracted. At the top of the face, pickmen worked at opening a gap below the roof to free the beds below. This was in the picking bed, and before the middle of the 18th century an opening was made a yard or so (0.9 m) high and a few yards deep and wide, the men forming the rather rounded and flaring-out pillar tops with their picks and hacks as they proceeded, between rooms of up to 10 m width. Later they cut out only a narrow jad slot at the top a metre or so deep and 10-15 cm high so as to free the beds below, leaving the pillars roughly squared. By using a weakness such as a wide joint, or by breaking into the face at each step or bed, the remainder of the bed-blocks at the lower levels between the pillars were fairly easily barred-out and slid down or raised up to the cartway floor level. The blocks slid fairly easily over rubble or on thick timber planks. Very large blocks, up to several tons in weight, were few but prized and a great deal more care and effort was used to load these straight out of the bed on to a carefully placed two-wheeled cart or four wheeled wagon. Blocks and rubble were roughly squared to send out of the quarry for building, the bulk of it smaller in size and fairly easily handled.

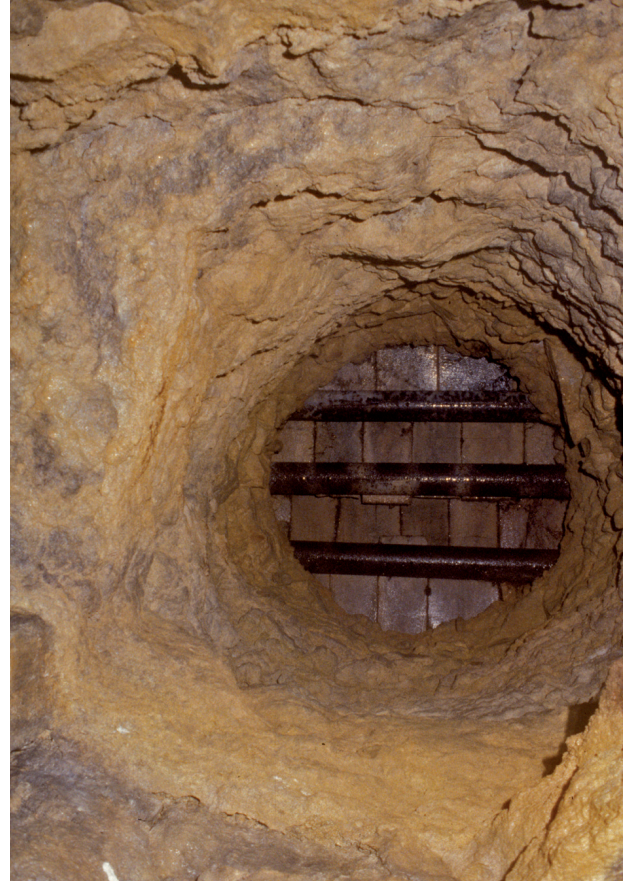
Fig. 7.9 Small ventilation shaft in the roof of the workings, with cap formed of stone slabs over timber supports, Central Firs

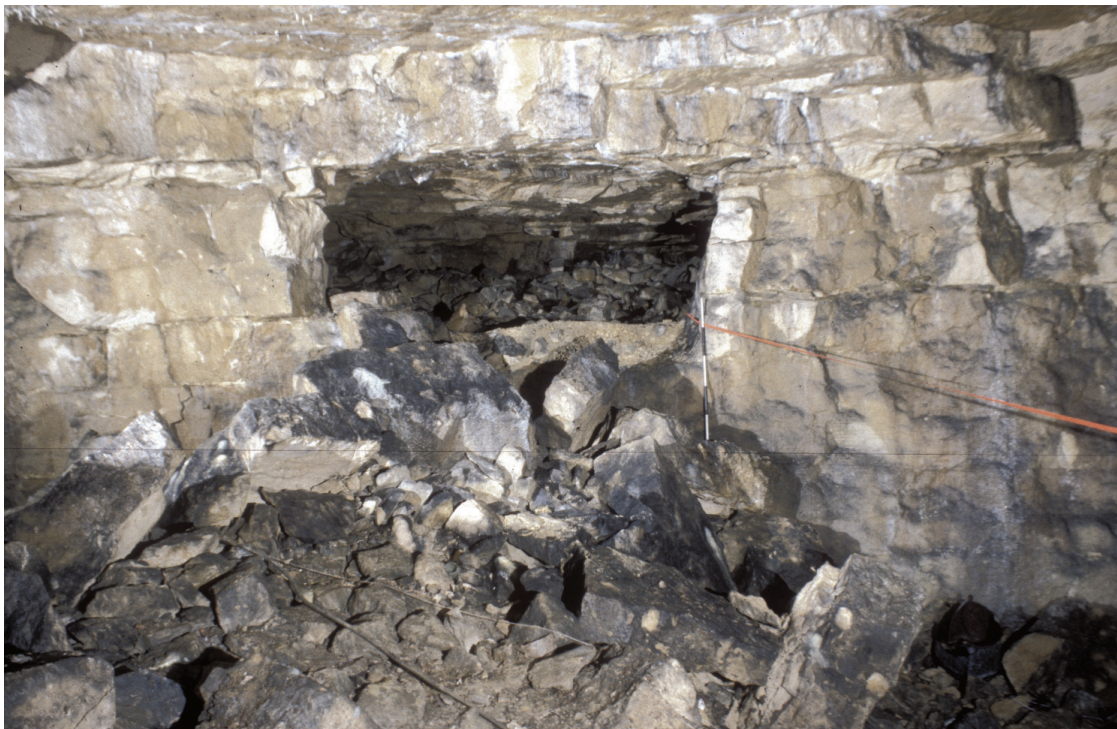
Fig. 7.10 Window used to throw out high-level spoil from Long Room working beyond, just north of Firs Shaft

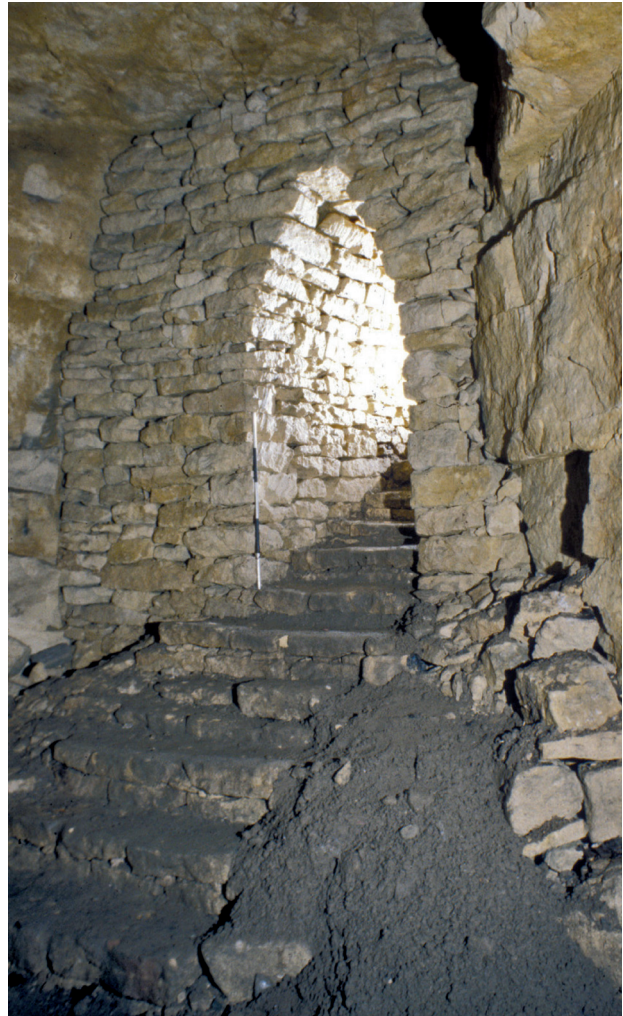
Fig. 7.11 Corbelled stone arch over the Hadley Arms steps. The stone pack was part of that supporting the North Road and the patina suggests it was built later than the steps (Photo by Paul Deakin)

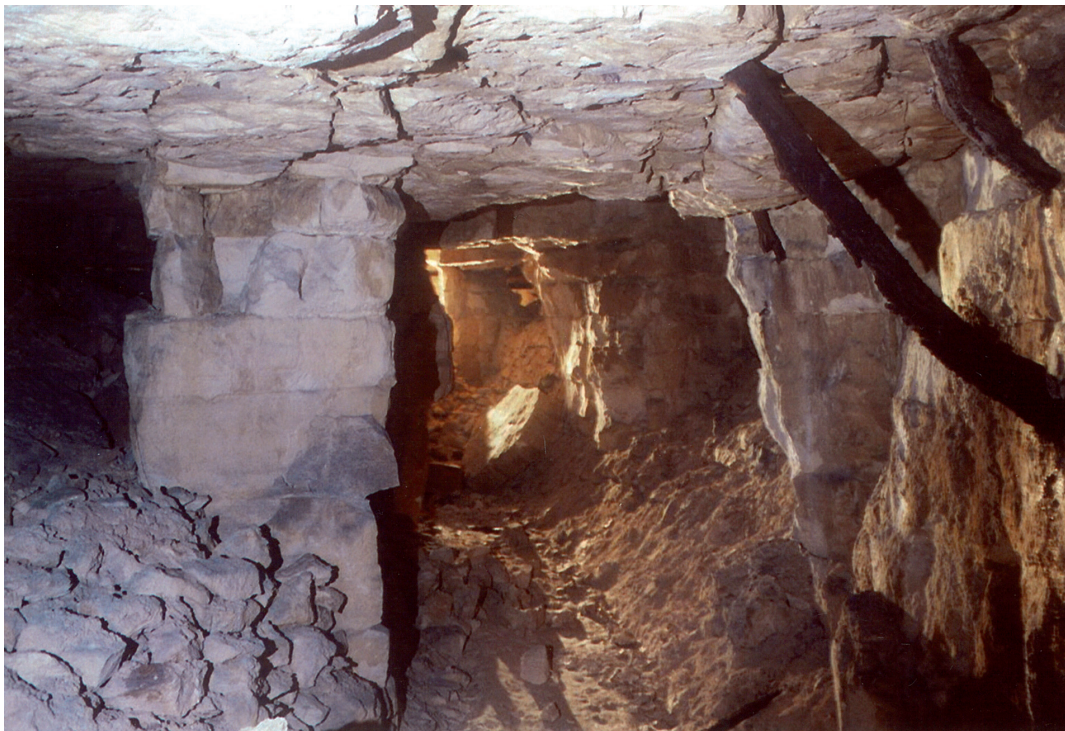
Fig. 7.12 Partially sawn pillar with timber sprag (or scorter) to tighten blocks in the roof (Photo by Paul Deakin)

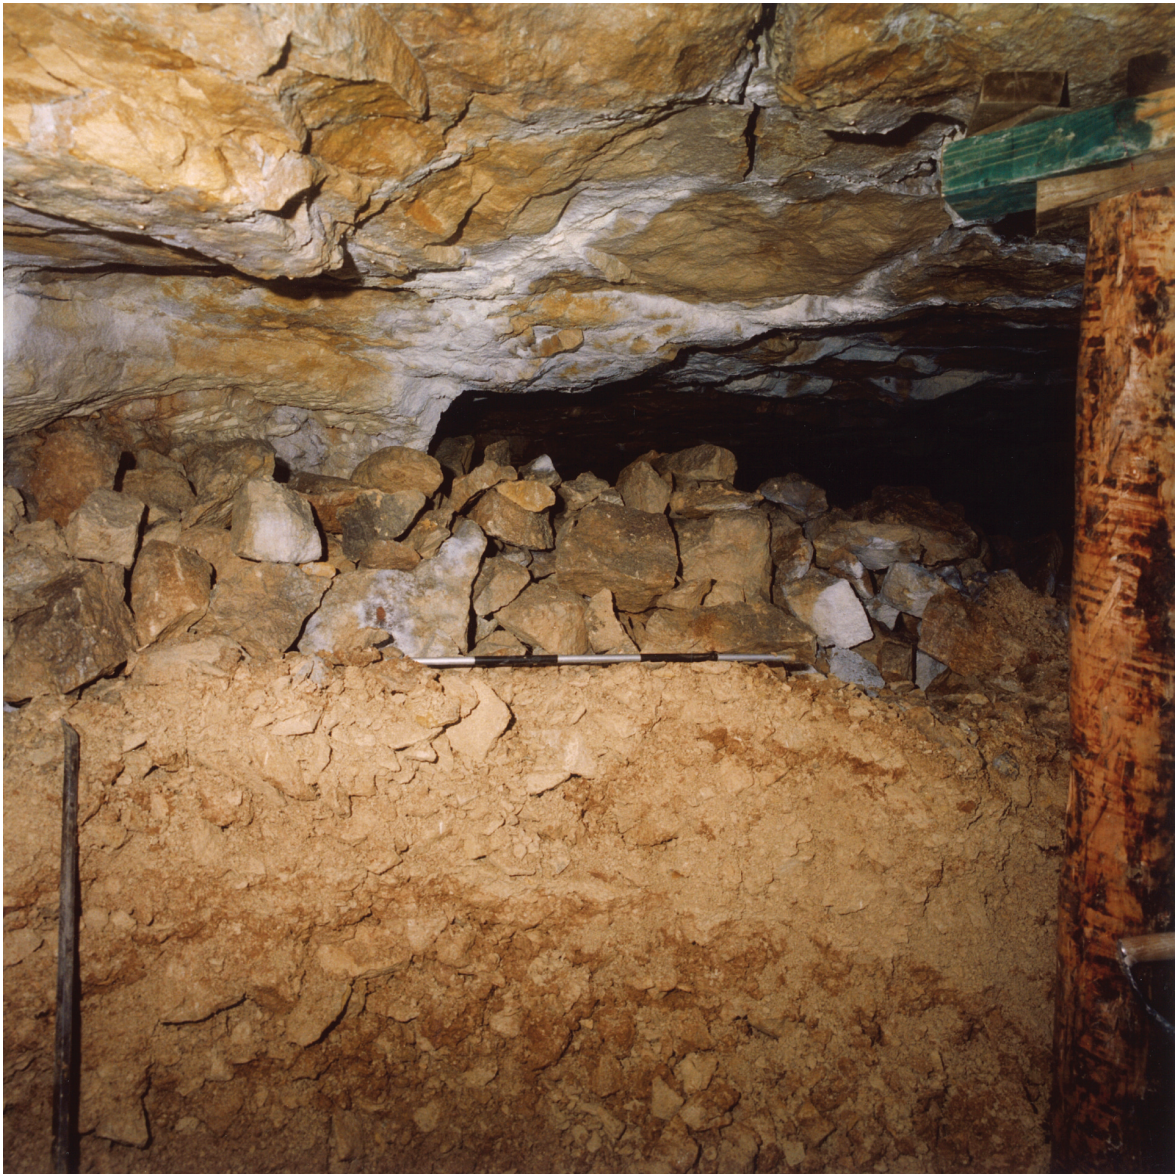
Fig. 7.13 Section through a barrow-way with rubble thrown up onto dumped rubble and fines, West Byfield (Quarry 514) (Photo by Paul Deakin)

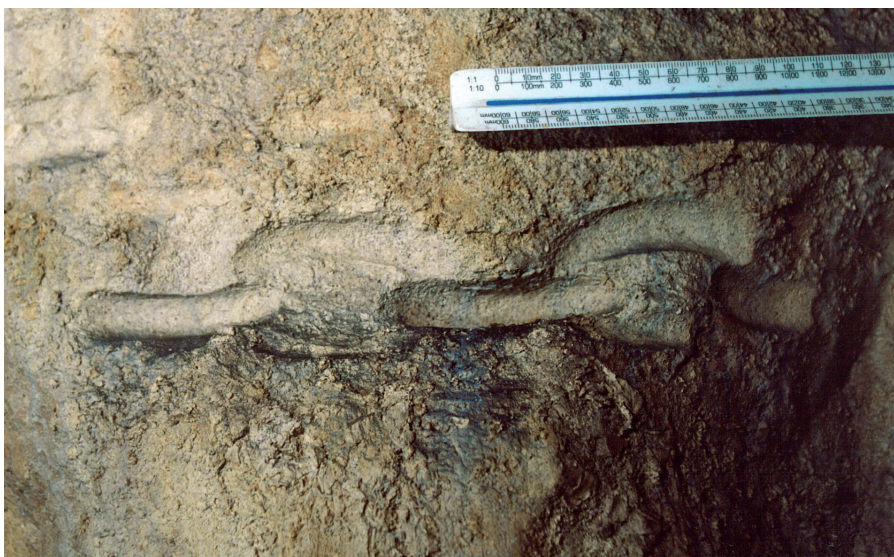
Fig. 7.14 Mould of chain formed by links pressing into the stone. The chain, wrapped around a pillar, was part of a crane anchor, late 19th century, Central Firs (Quarry 2201)
