## Chapter 9

### Techniques of underground quarrying: 2. Transport and materials handling

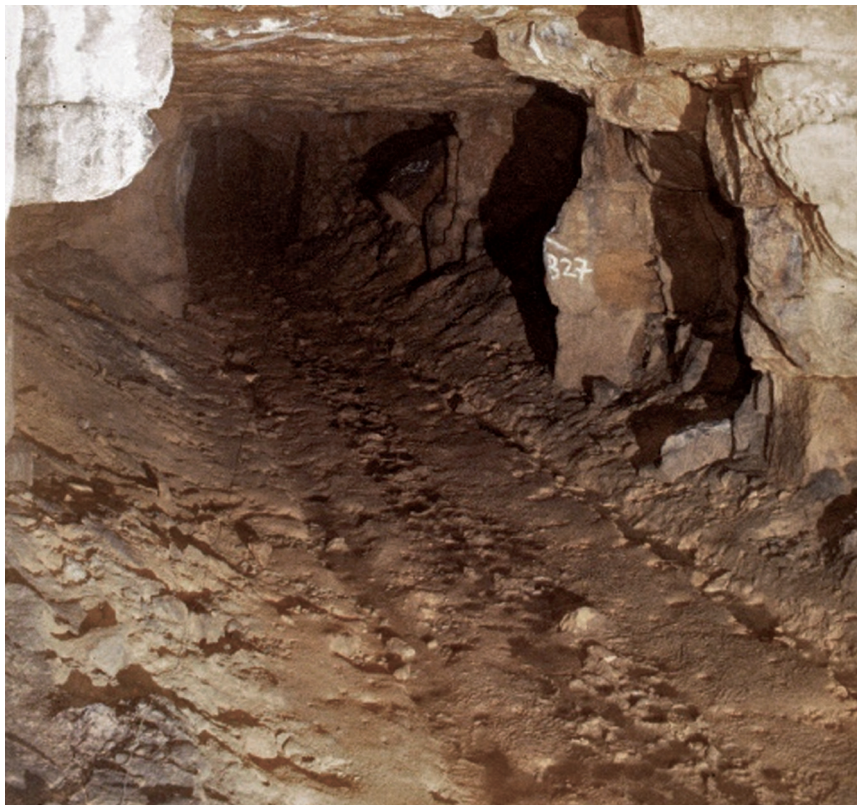
Fig. 9.1 The only example of a cartway where likely traces of horse-hoof impressions were noted, north-east Byfield Quarry (505)

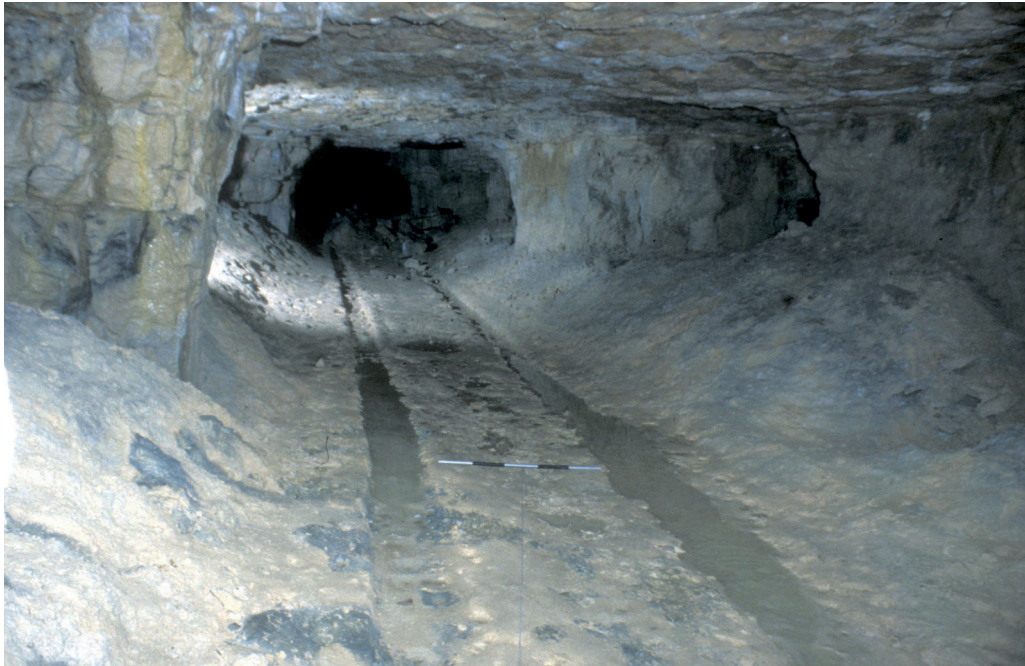
*Fig. 9.3 Allen's western cartway in Central Byfield, near the entry. It appears not to have been used after abandonment in the mid 18th century because of bad roof conditions at its inner end, discovered after work restarted c 1803. The white reflection may be due to stone particles within the re-crystallising mud cleared to the side of the cartway*

The early to mid 18th-century cartways were driven from surface open quarries, and their routes were identified by the contemporary pillar types, generally apophygate with some corbelled elements, through which they had been extended. The Allen cartway routes were of this type and were all driven northwards from his surface quarries in the Byfield and the Firs quarries west of the Long Drung. Nearly all the cartways were re-used by later quarrying enterprises that succeeded Allen's direct management in the later 18th and during the 19th centuries. Consequently any clear early evidence for the use of the Allen cartway routes was buried or obscured by later transport activity. Because its use was abandoned before the end of Phase II and the area at the far end apparently not worked thereafter due to roof instability, the most likely un-modified Allen cartway was the westernmost of the two driven in from Jones Quarry in Central Byfield, which exhibits very prominent cart ruts (Fig. 9.3).

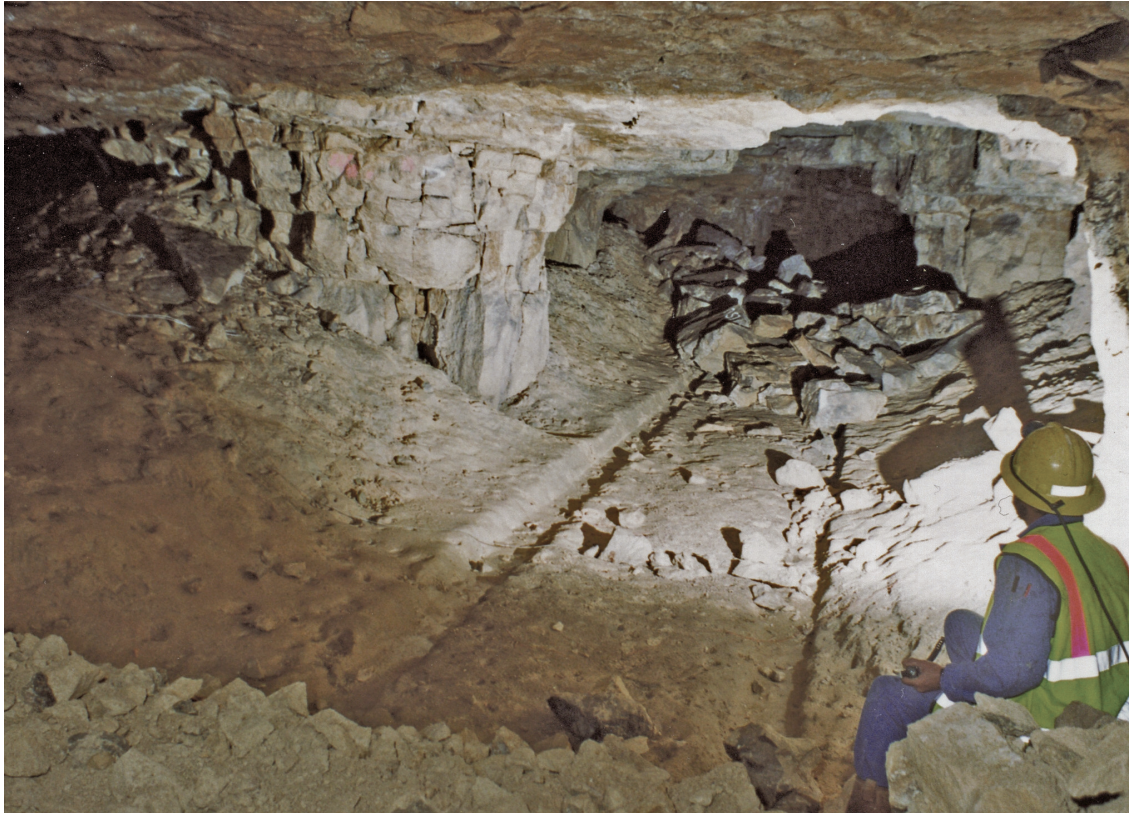
Fig. 9.4 Upper section of Allen's western cartway in central Byfield showing a roof-fall which is below a wide joint or "gull" in the roof. The seated figure is mine manager, John Lister

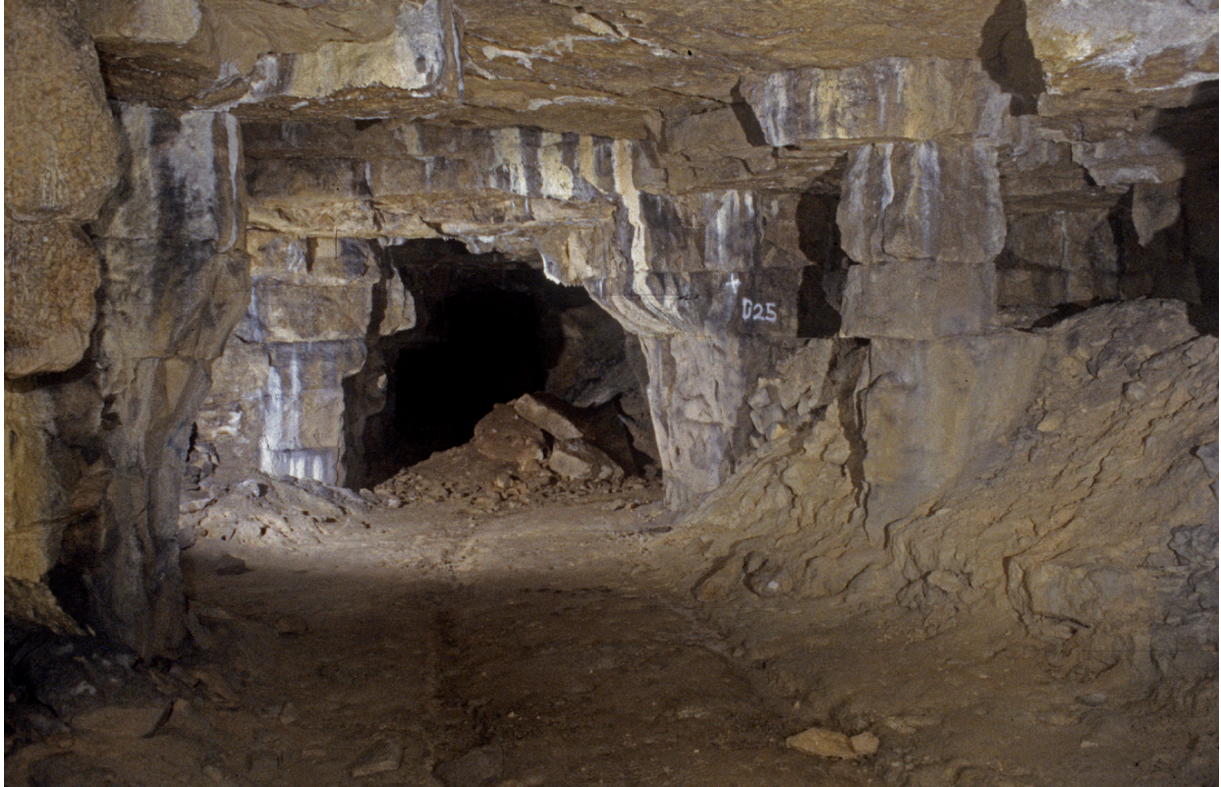
*Fig. 9.5 Allen's east cartway in Central Firs. Note the remains of an apophygate pillar, on the left, the original roof destroyed by a fall. The heap is a cone of debris from the narrow shaft above. The passage with light from the left links to the west cartway*

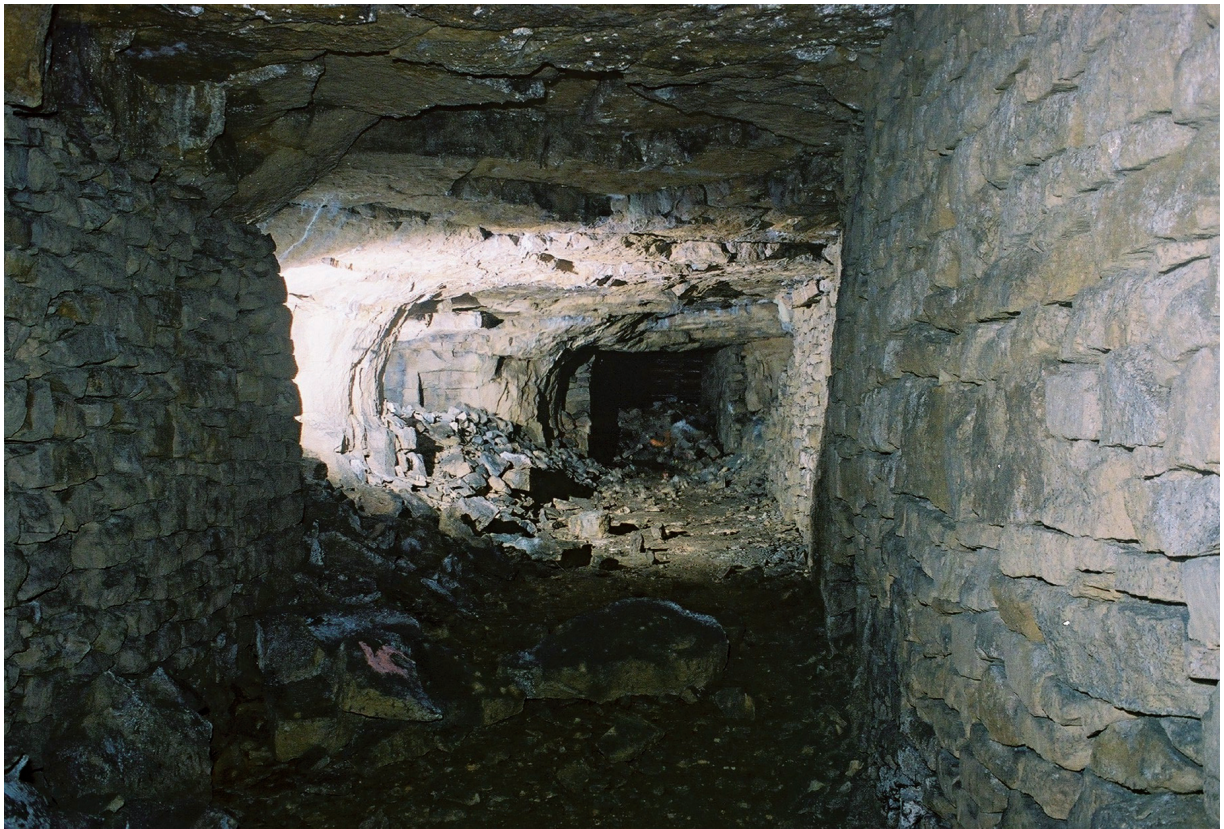
*Fig. 9.6 Allen's west side cartway in Central Firs showing apophygate pillars and support packs alongside*

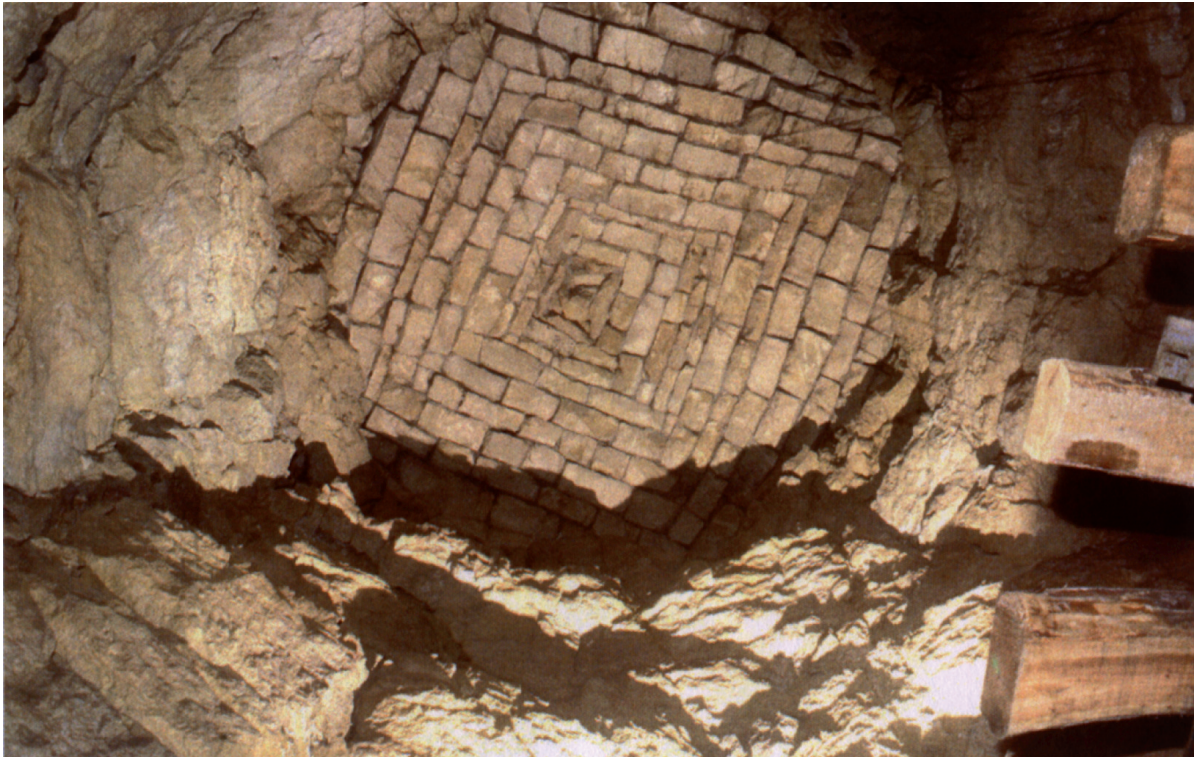
Fig. 9.9 Shaft cap above cartway (2194) viewed from the underside, associated with Allen Phase II workings in East Firs (Quarry 2206)

west of The Avenue, but full details were not recordable due to collapse within much of these workings. The two shafts involved were capped by a particularly fine shallow-arched domes formed of roughly cut blocks (Fig. 9.9).

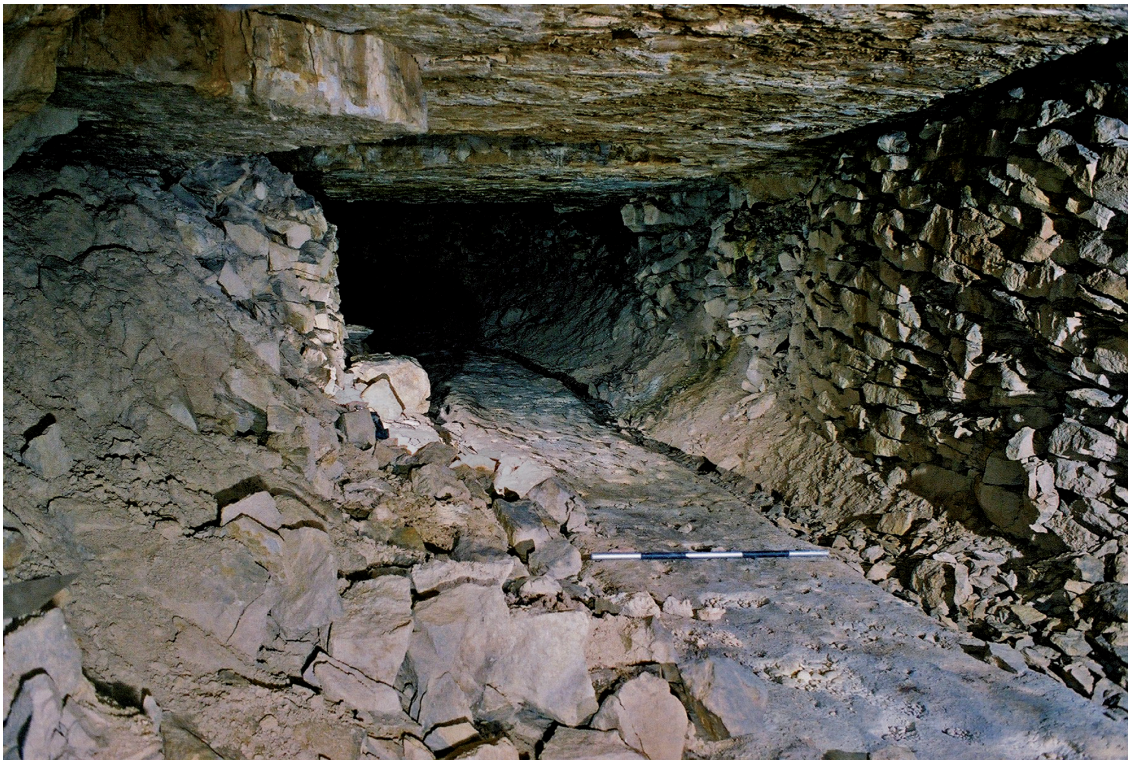
Fig. 9.10 Southern end of the cartway east of the Long Drung

The southern extent (Fig. 9.10) did not appear to have been extensively re-used in the 19th century, possibly because of poor roof conditions. It was open for about 16 m, otherwise sealed by roof collapse and accumulated surface- and roof-derived clay. The northern section was open for approximately 120 m and had been built over by a stone pack to retain waste stone. A masons' working area located 11 m to the south-west of this cartway length on the western limits of Quarry 2369, which is also thought to be roughly contemporary with Quarry 2350, contained a large collection of scapped and sawn blocks contemporary with the cartway, dated by graffiti on a block reading 'June 1730' (Chapter 12, Case Study 1). No cart-ruts were evident, as it had been re-used by later barrow-way routes and access for general spoil tipping. Several large shafts further along the route may have been either sunk or re-used for later quarrying.

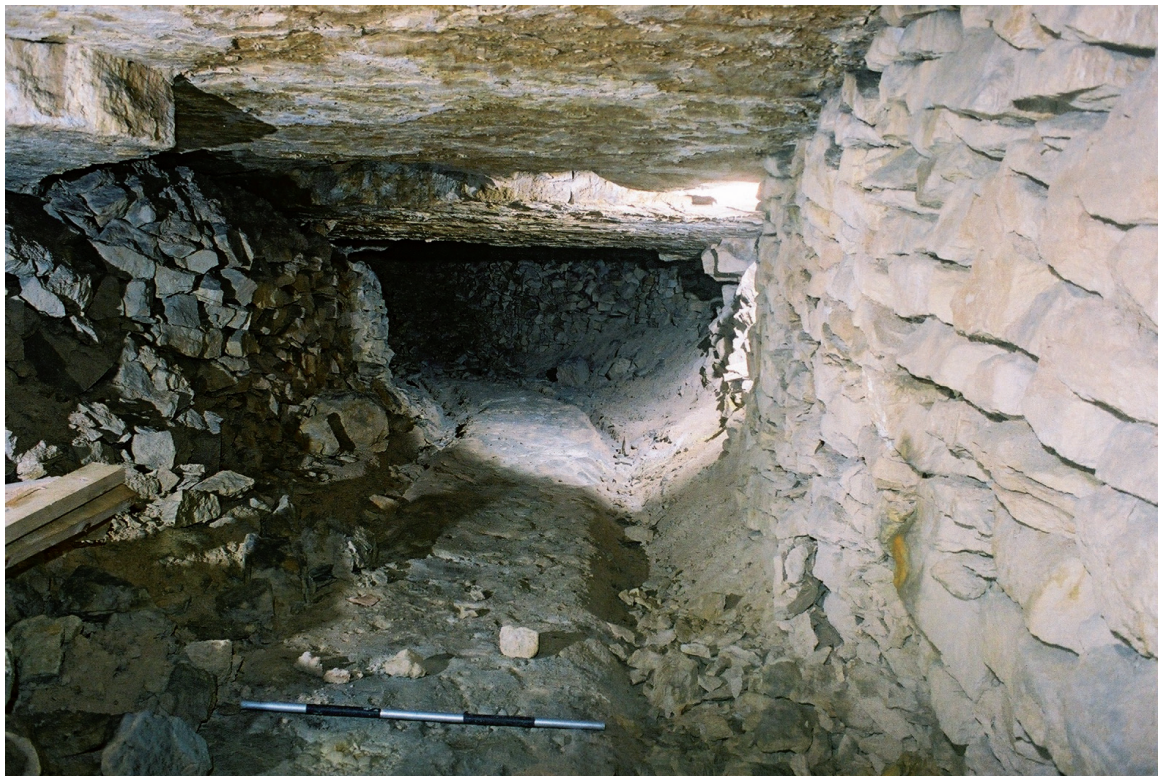
Fig. 9.12 *Curving cart ruts cutting deep into the surface of the westernmost cartway east of the Long Drung*

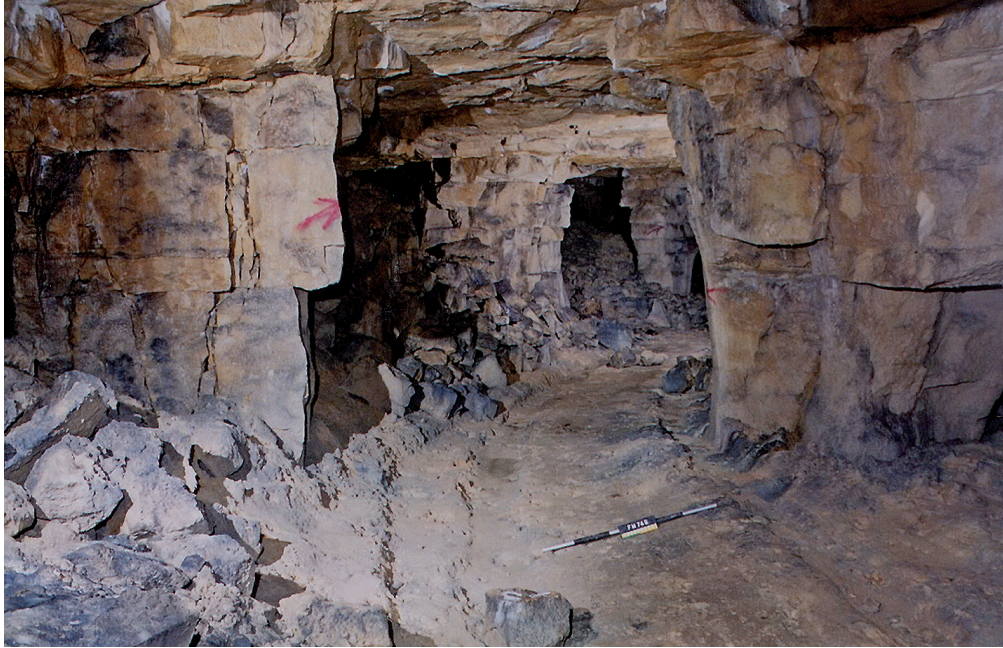
*Fig. 9.13 Nineteenth-century cartway in East Byfield, showing rub marks caused by a cable on the right side pillar, and wheel ruts on the floor*

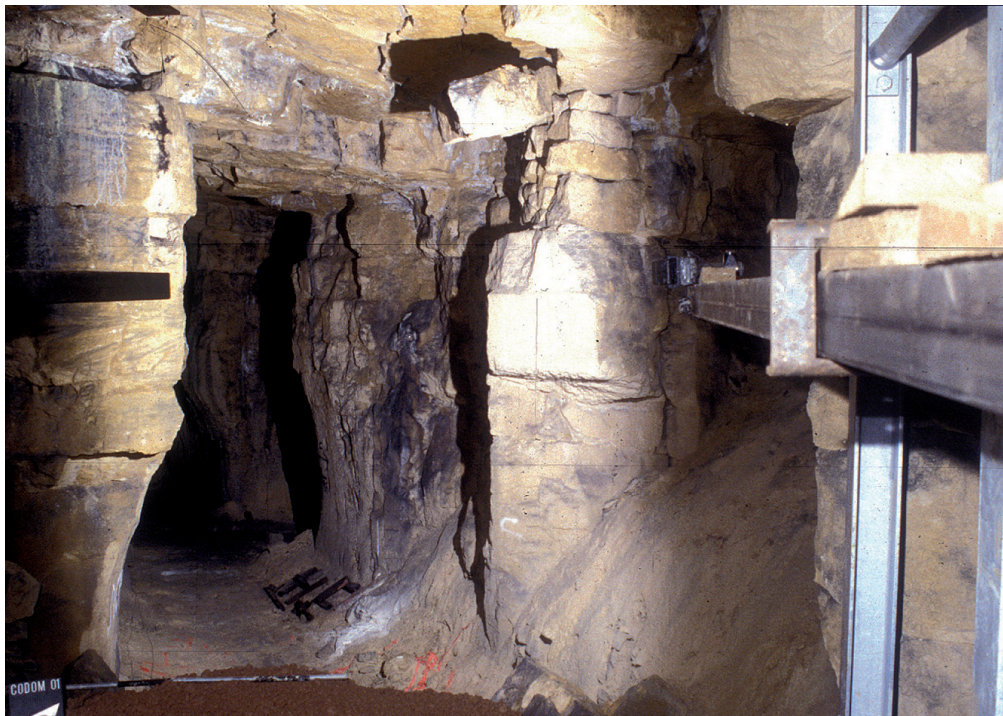
*Fig. 9.14 Cartway near Firs Shaft leading towards the Hadley Arms. Note rub-marks from a cable on the left side-pillar and a corbel with a post-working fracture on the right-side pillar*

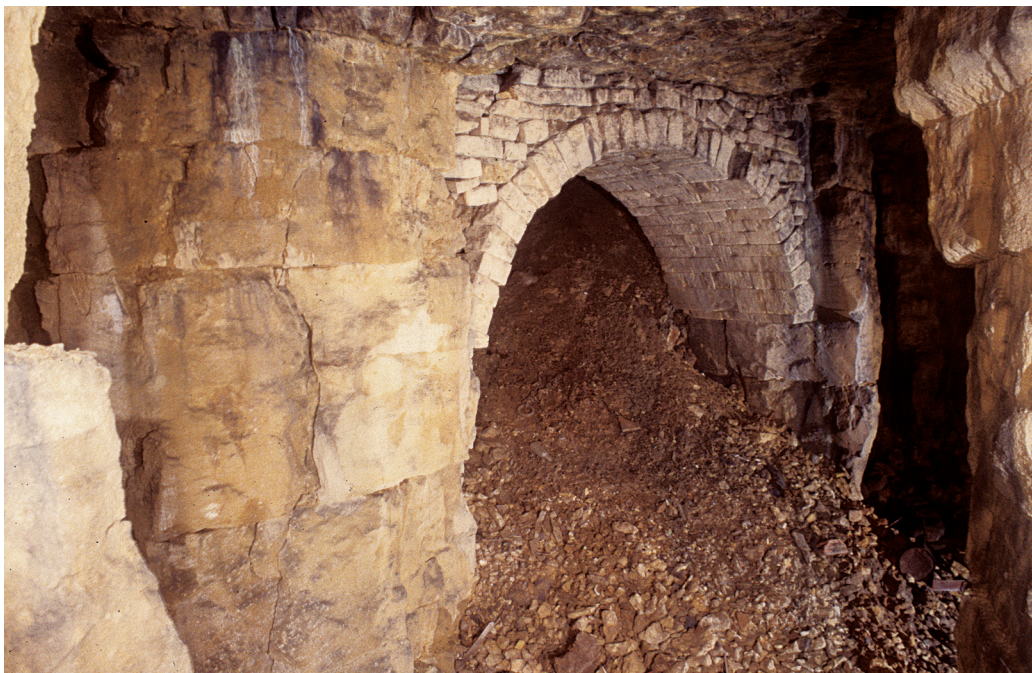
Fig. 9.15 The arch supporting the shaft on the Firs-Hadley Arms cartway

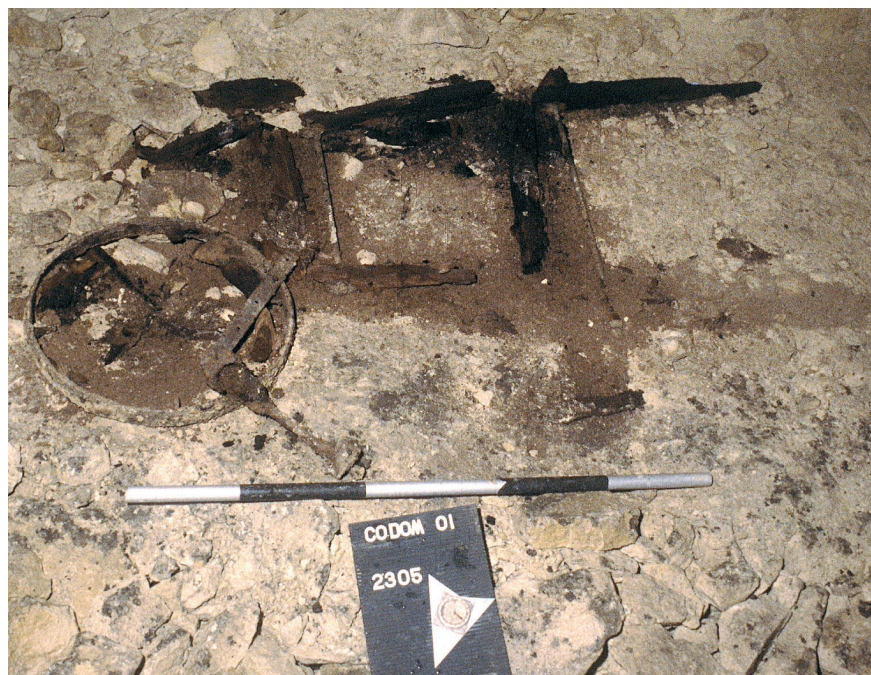
Fig. 9.16 Wheelbarrow 'shadow' in East Firs, close to the Long Drung

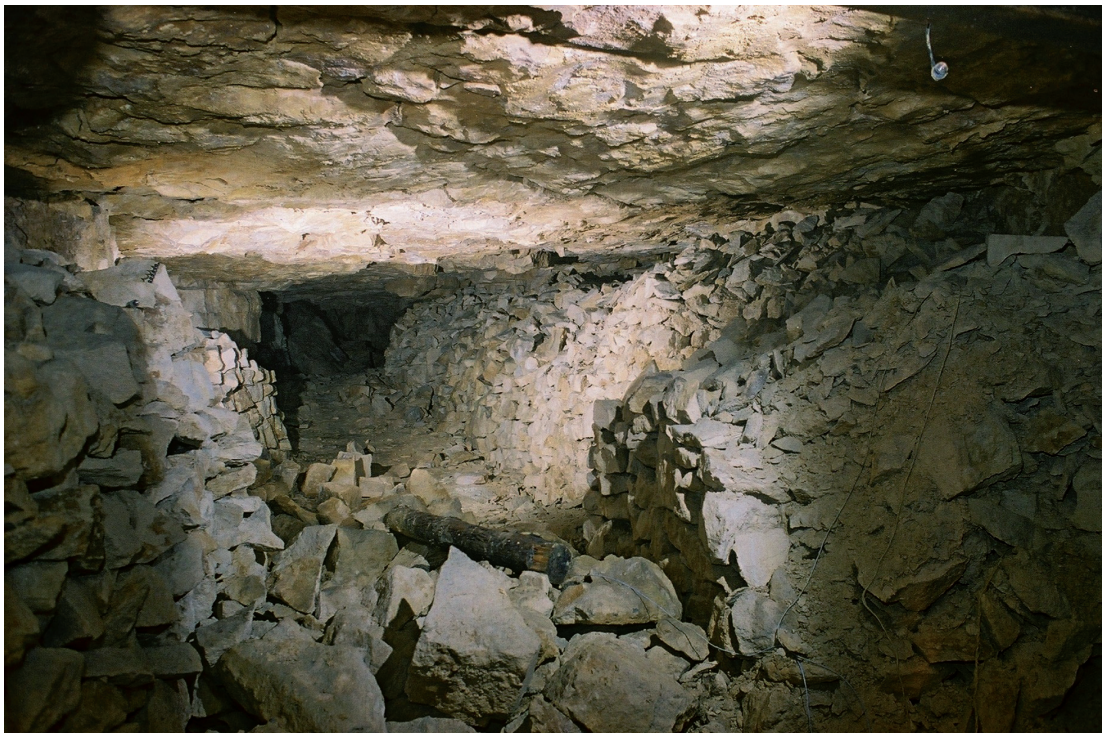
Fig. 9.19 Barrow-way in Far East Firs (Quarry 2356)

A good example of probably the longest of this type was a barrow-way noted in Quarry 2356 (Fig. 9.19). It extended for at least 75 m, with floor to roof flanking packs on either edge. It was between 0.86 m and 1.20 m wide and had well-maintained and compacted floor surfaces. Several phases or sequences of barrow-way were noted, with the heights of the compacted barrow-way surfaces recorded at 1.50 m, 1.90 m and at 2.40 m below the roof level. Often several stone packs had been constructed on either side of the access routes. Sometimes they directly abutted the face of the previously erected pack and sometimes a thin deposit of mixed fines and rubble was stacked between successive builds. This barrow-way route and other examples of longer barrow-ways acted as access routes for the quarrymen and used, as conditions were adequate, to carry the finished stone, but they were also maintained for the lateral disposal of spoil in the flanking packs. This made them semi-permanent routes.

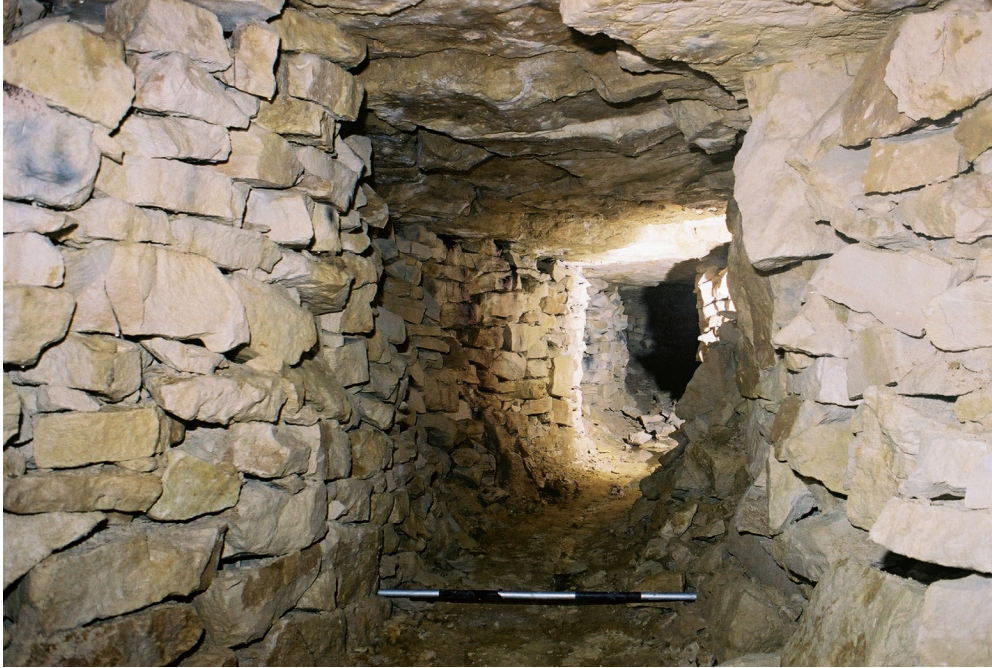
Fig. 9.20 Barrow-way in Far East Firs (Quarry 2365)

A shorter barrow-way of this type was recorded in Far East Firs in Quarry 2365 (Fig. 9.20). The barrow-way was initially 25 m in length and 0.80 m wide and was 1.80 m below the roof level, later developed to a length of over 50 m. Access was good throughout with level and compacted surfaces of fines. It had flanking packs along its length which retained discards on either edge, with adjacent rooms filled with spoil. The route linked the working face on the boundary pillar on the eastern edge of the Firs complex to a shaft in the north of the quarry.

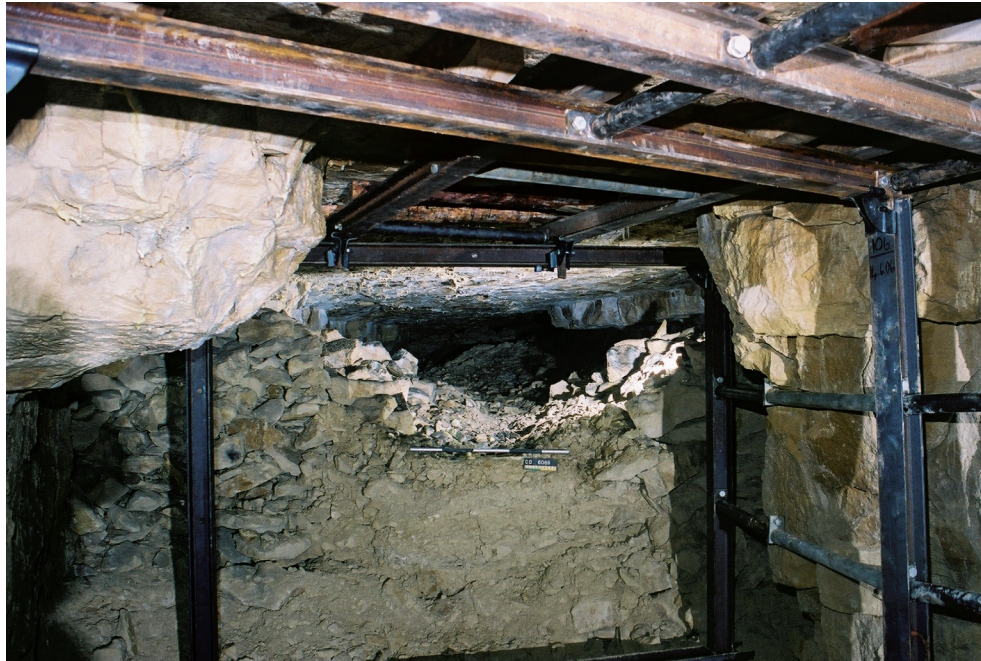
Fig. 9.21 Barrow-way filled in on retreat in Central Firs. The rubble pack rests on the former barrow-way (Quarry Area 2347)

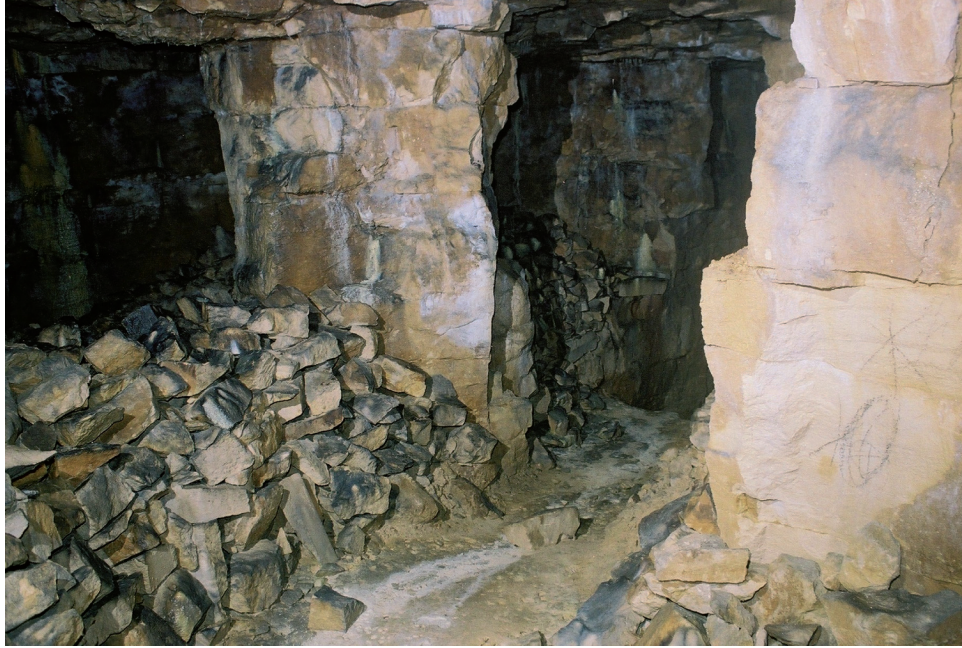
*Fig. 9.24 Barrow rut preserved by calcitic flowstone Eastern Firs (Quarry 2337)*

alongside the barrow-way, preparatory to tipping the barrow over its front corner. The survival of barrow ruts was assisted in some cases by calcitic deposition on the softer surface, noted, for example, in the centre of a barrow-way in the early 19th-century Firs Quarry 2337 (Fig. 9.24).

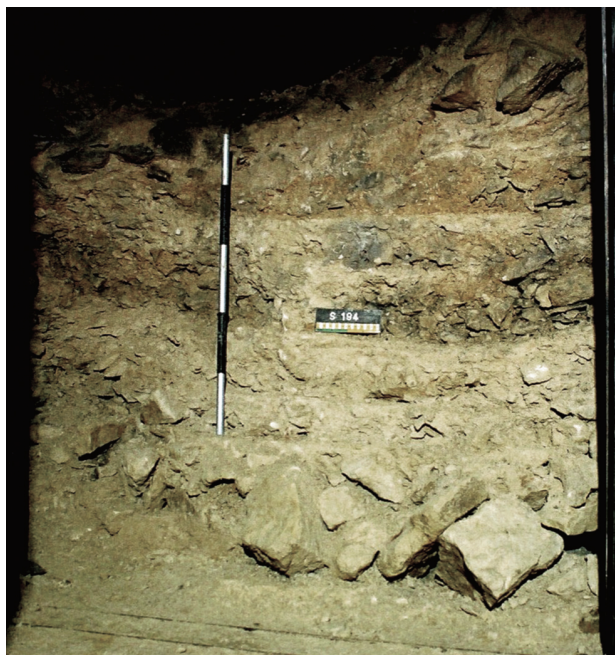
Fig. 9.26 Vertical section in Central Byfield (Quarry 505), showing successive barrow ways

barrow-way was 2.80 m below roof level and the lowest in the sequence was 3.90 m, directly overlaying the uppermost cartway surface. All the barrow-ways in the sequence abutted an earlier stacked rubble or stone pack on the eastern edge of the cartway surface. The surfaces varied in depth from between 0.08 m to 0.28 m and were fairly typical of the barrow-way depths noted elsewhere (see Chapter 12, Case Study 15).

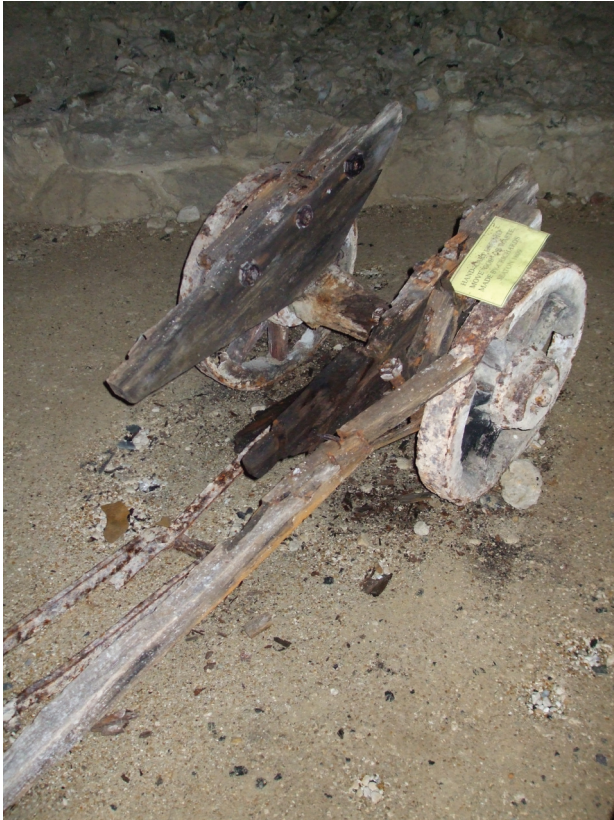
Fig. 9.27 Example of a two-wheeled cart at Beer Stone Quarries, Devon (photograph by David Pollard)

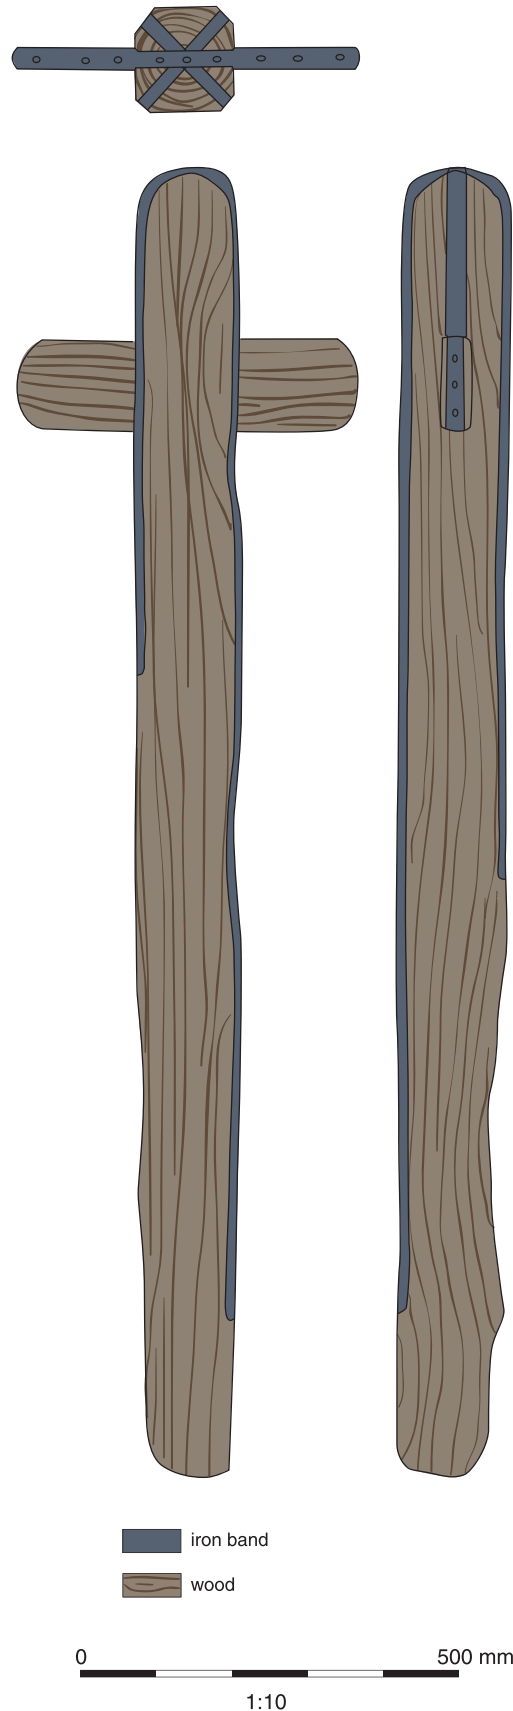
Fig. 9.28 Shaft from a two-wheeled cart, found near Burgess' Arched Shaft in Central Firs

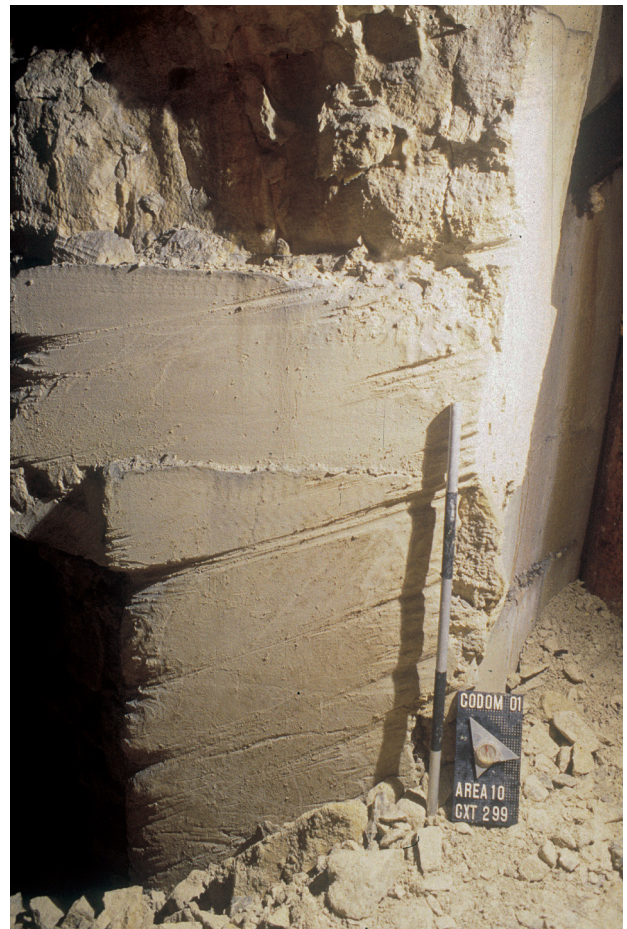
Fig. 9.30 Grooves in the side of a pillar at Allen's east side entry at Jones Quarry (Ralph Allen Yard), the nearly horizontal grooves suggesting the crane cable was diverted up the cartway to draw-out carts or wagons

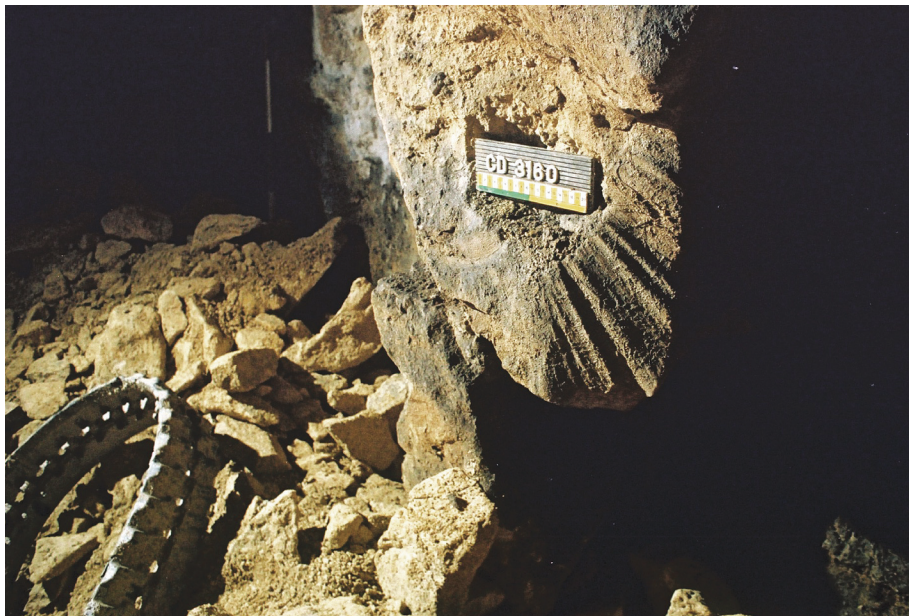
Fig. 9.32 Crane-cable grooves in the branch cartway out of the east Allen Cartway in Central Firs

At least three fastenings and chains for each crane would have been required, but, by analogy with later surface cranes, there may have been more in case one stay broke. Traces were found of Lewis holes from anchors on pillars, grooves from cables wrapped around pillars, and, in one instance, of the chain impressing a negative mould of itself in a pillar face in the Allen Estate Quarry 2201 (Fig. 7.14). The use seems to have been an experiment, used only in one area on the east side of the Allen cartways in Central Firs, where they seem to have lined the cartway. Blocks were probably dragged from nearby Long Rooms and loaded on to carts. Cable grooves at an angle indicating an origin near the roof are characteristic evidence of their use (Fig. 9.32).

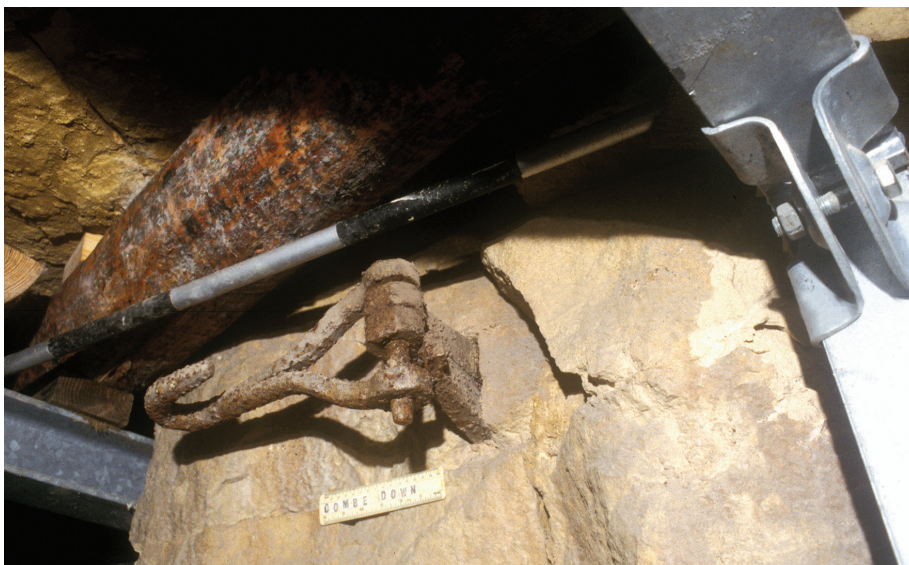
Fig. 9.33 A Lewis in situ in north Central Firs, used to hold a crane stay

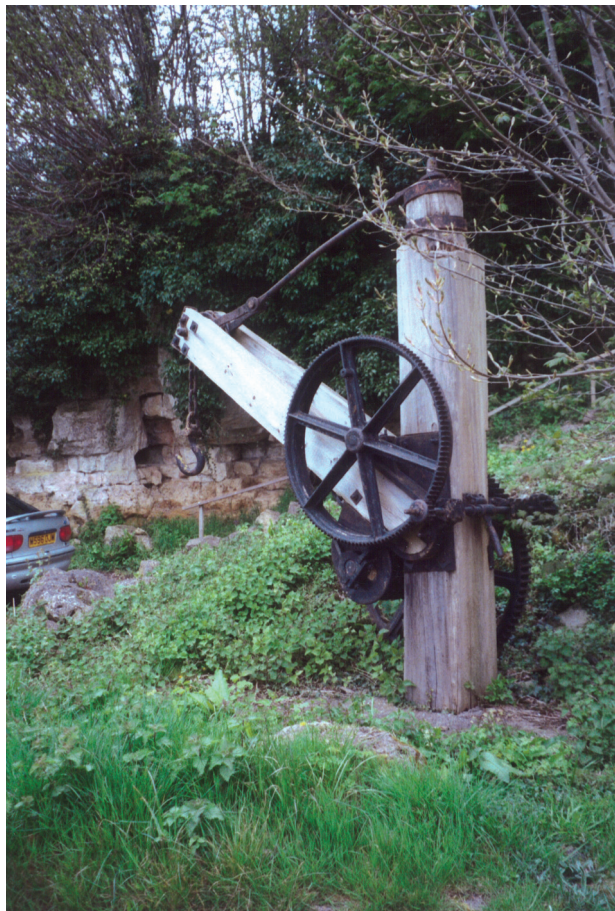
Fig. 9.36 Preserved underground crane at Combe Manor Hotel

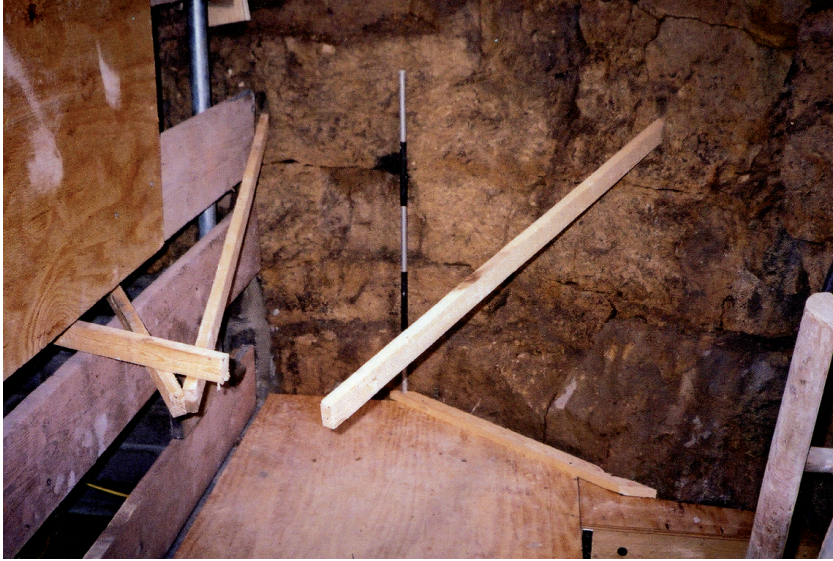
Fig. 9.37 Probable mast crane position inside the Firs Shaft indicated by wooden slats projecting from an arrangement of Lewis slots

The locations of mast cranes were determined from Lewis hole group distributions (Fig. 9.37). Several locations also contained wedge holes for anchorages, but these were less common and represent only a small fraction of the anchorage types. One of the earliest known locations of the mast-type crane was identified alongside cartways in Central Firs, probably associated with the eastern development of Allen Estate Phase III quarrying within Quarries 2201 and 2202. The latter was developed along a

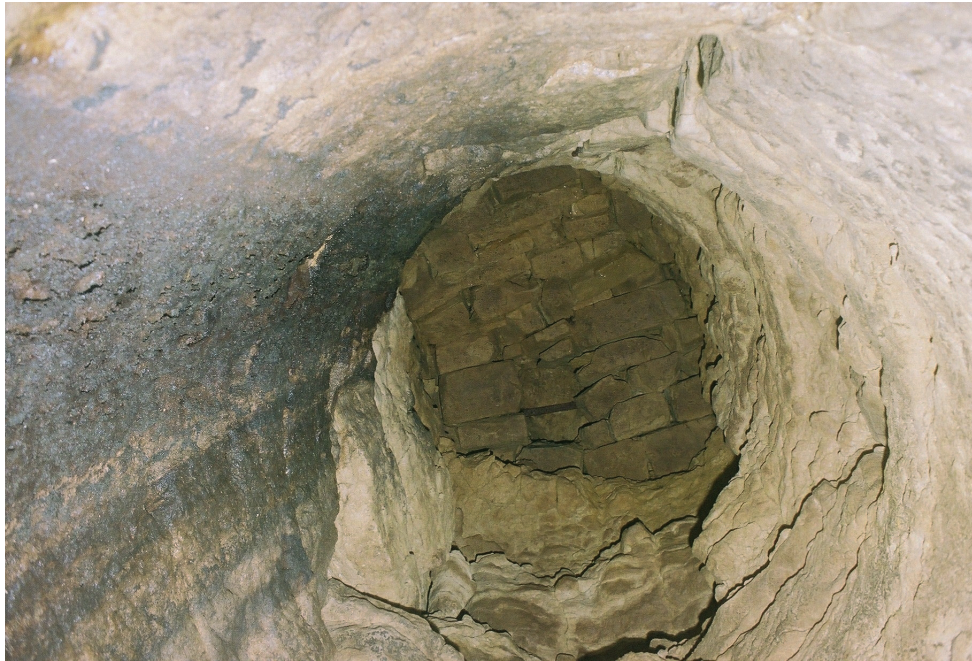
*Fig. 9.39 Shaft (12062) capped with stone blocks*

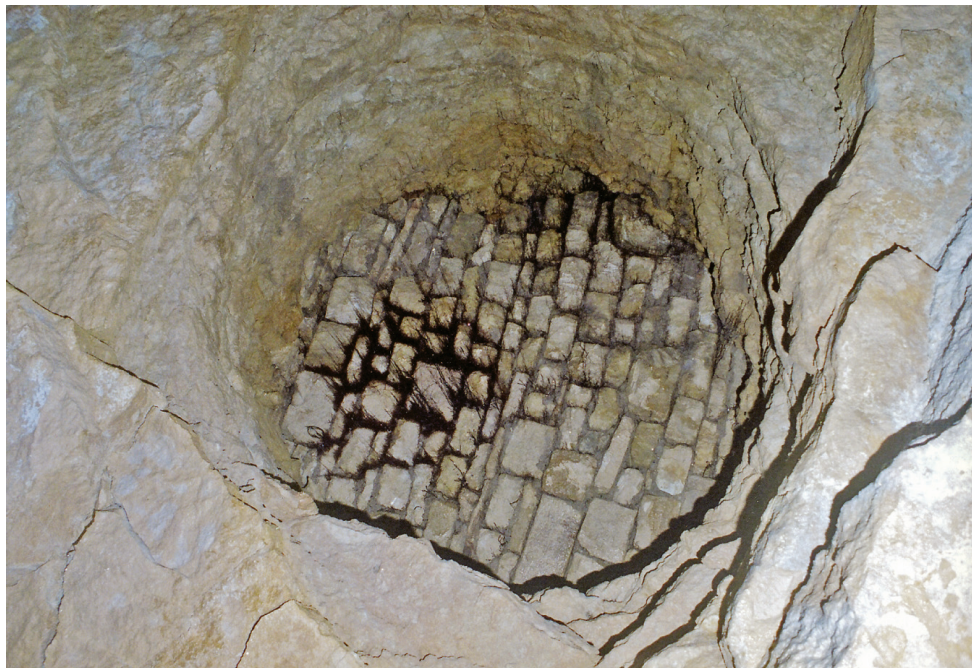
*Fig. 9.40 Underside of barrel-arched shaft-cap in East Firs*
