Chapter 12

The Combe Down complex – chronology, development and case studies

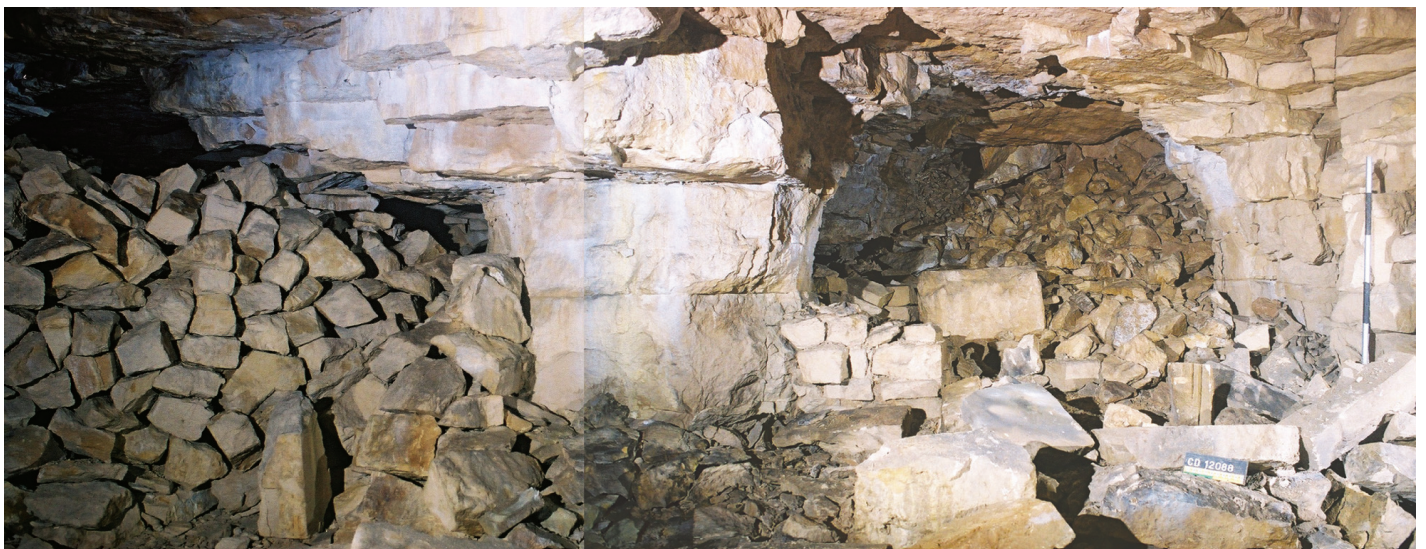
Fig. 12.3 Apophygate arches and supporting packs with masons working area in the foreground

Many of the pillars in the quarry were apophygate, but often were less well formed than in Allen's quarries, the apophygation often almost vestigial and in some cases looking almost like a poorly defined corbelled pillar. Much of the area seen was a substantial way from the entrance, and this may thus be a similar transition in pillar morphology chronologically comparable to that seen in Allen's quarries. Such corbelled pillars probably mark the second sub-stage in Phase II workings which all suggests rapid adoption of new ideas, though which way these flowed is unknown. The corbelled pillar form involved stepping-out underhanging beds under the roof, probably leaving the upper picking bed (s) *in situ* and thus removing less poor-grade rock than the picking bed removal associated with the apophygate pillar.

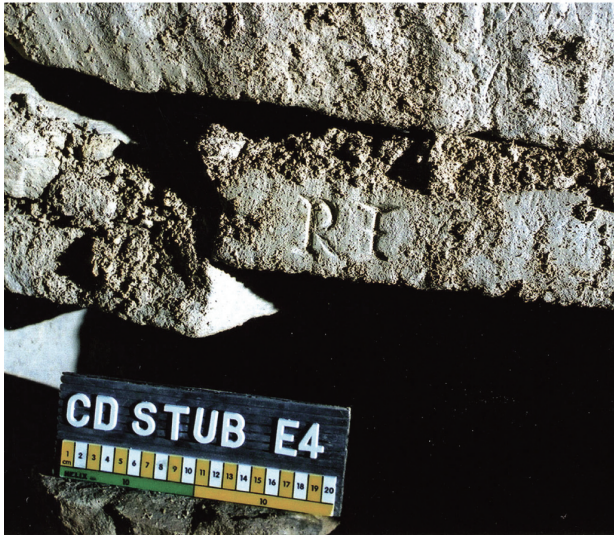
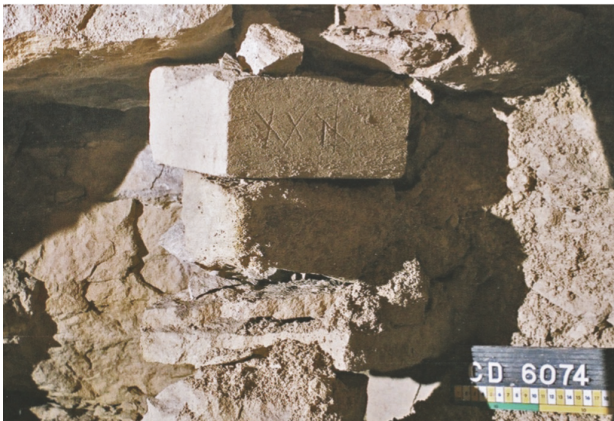
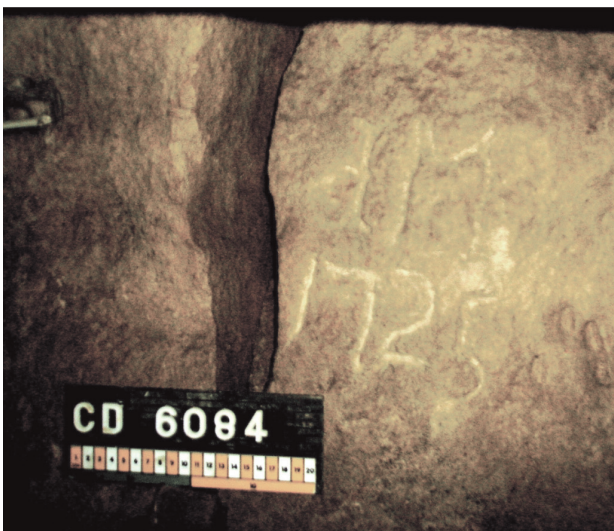
Fig. 12.5 Graffiti from the E4 stub, indicating early 18th-century workings

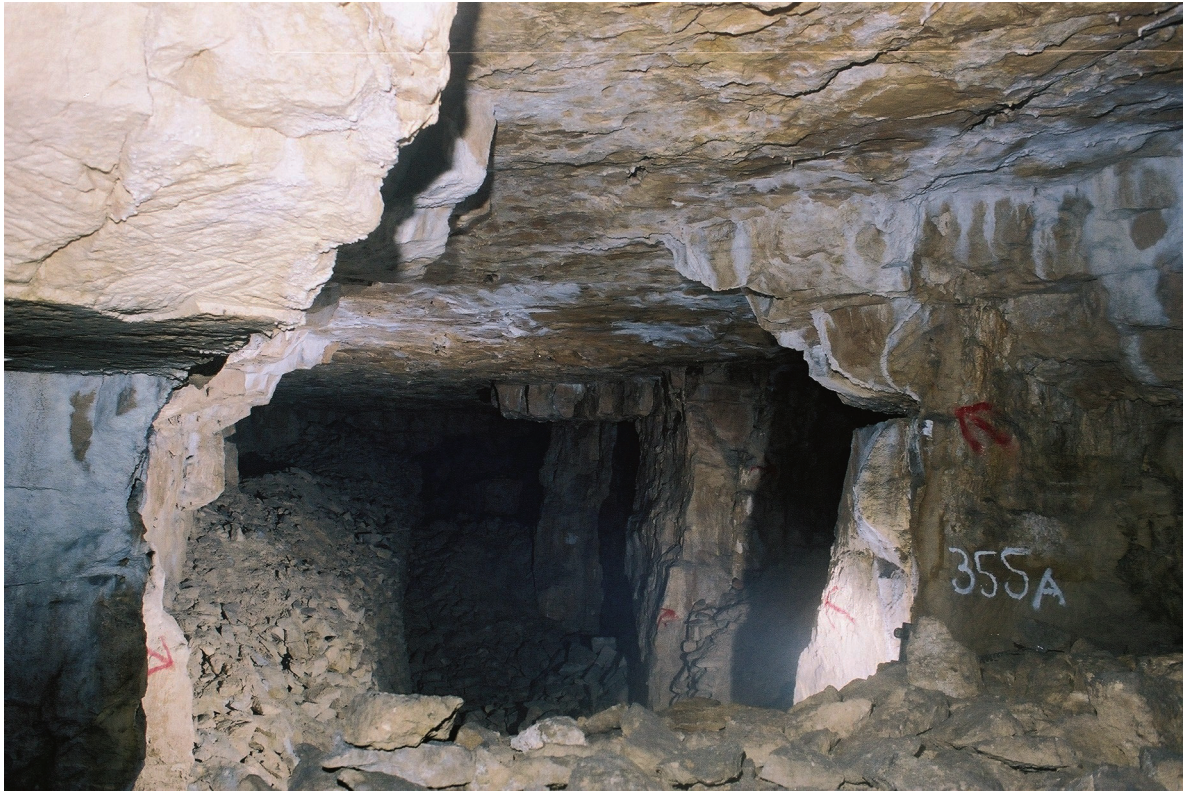
Fig. 12.6 The partially infilled cartway suggesting an entry from the north-west side (in Sheeps House Quarry)

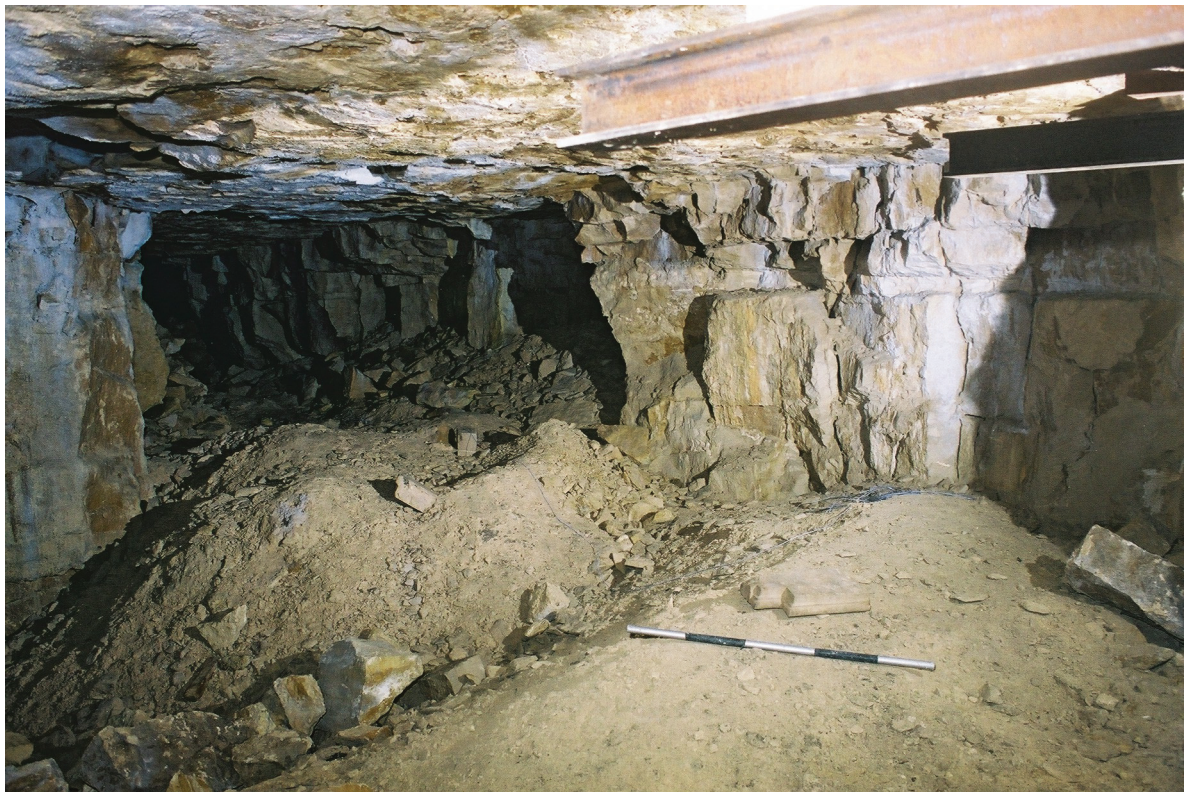
Fig. 12.7 Banker mason's workplace indicated by spoil heaps

masons' workplace (Fig. 12.7). The site had heaps of fine spoil derived from trimming blocks, which form small ridges running perpendicular from the wall. One or two working positions may suggest the masons had been seated next to the wall or along a plank parallel to the ridges. Several small pieces of stonework of good quality were found a few metres

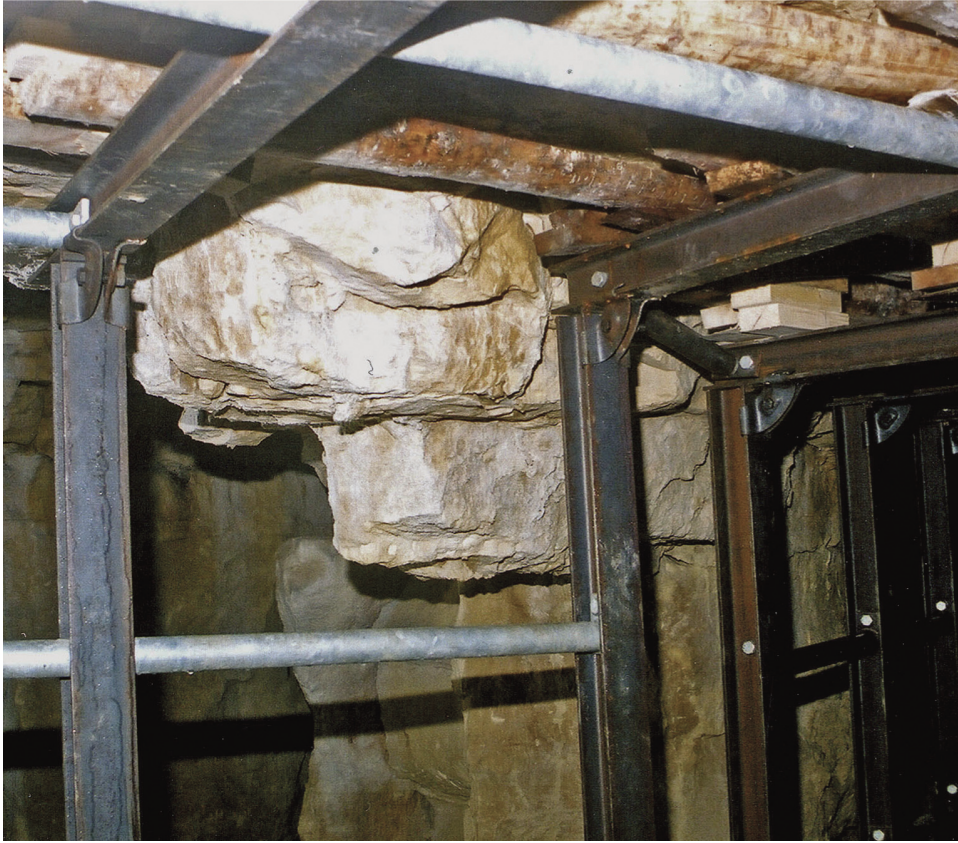
Fig. 12.8 Long corbels on a pillar in the E4 Stub

Near this was probably the northern extent of the quarry, which was indicated by the distribution of jad slots and the outermost of the corbelled pillars. The corbels here and elsewhere in the workings were substantial and long, a metre or so projecting under the roof each side along the length and above the pillars (Fig. 12.8). This is substantially longer than seen anywhere else in the Combe Down workings. They also did not seem to show signs of contemporary or post-working stress in the form of a crack in line with the pillar, so were a successful design for the local geological conditions, unlike very many in other places where they had failed. Most but not all pillars had them, with fewer at the east end.

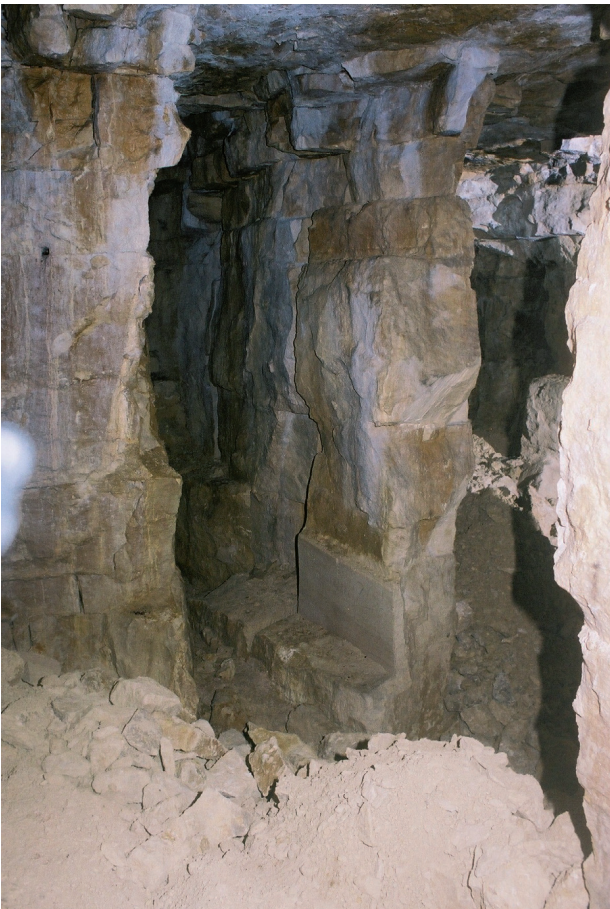
Fig. 12.9 Long but narrow room in the E4 Stub

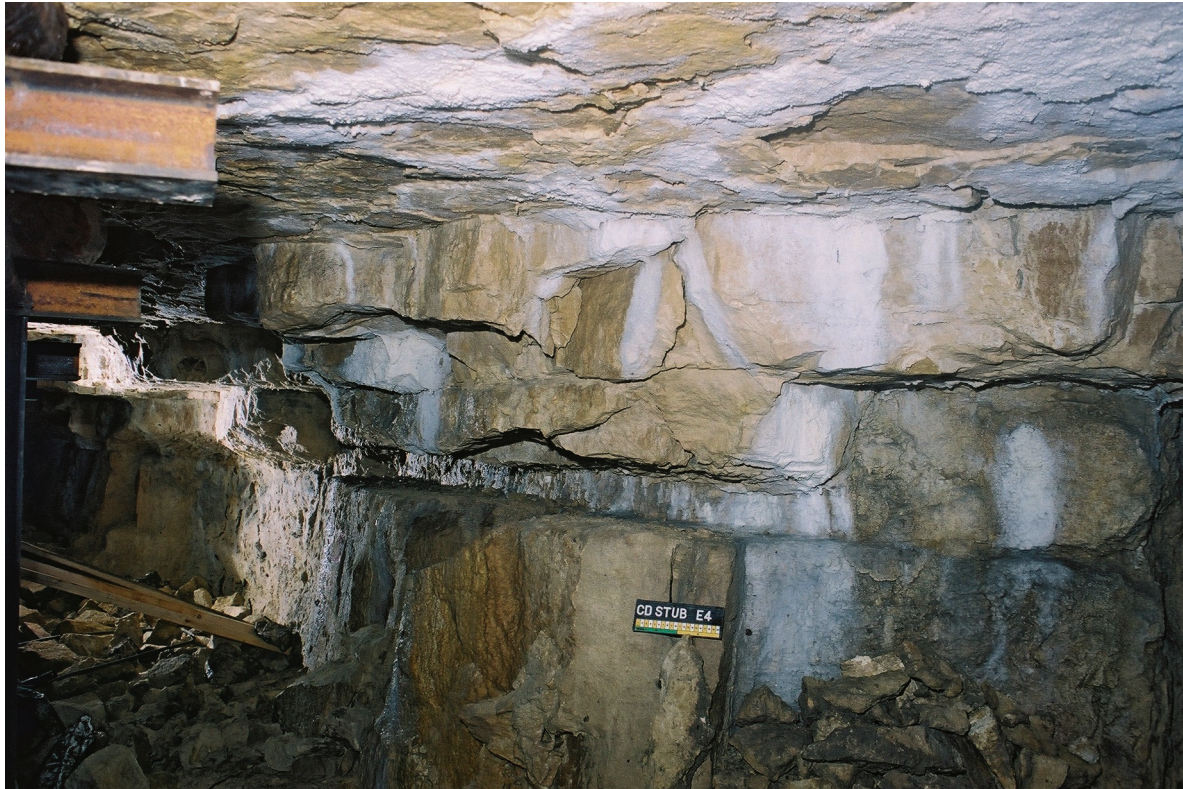
Fig. 12.10 *Development of jads in the E4 Stub*

Long lengths of jads were found on the bounding walls of the quarry (Fig. 12.10). These were used to free the beds being worked below them. Two were up to 3 m long, though others were less. The jad was normally a much later feature in quarrying at Combe Down. Its use in this working was coupled by both a neatness in working, and in the condition of the workings and floors, which we associated with those areas in which banker masons, rather than just freemasons, worked underground. There were a few other such places. The implication is that the pace of work was slower and the care necessary higher, as a characteristic of the banker mason; perhaps only enough stone was taken at a time as was immediately required.

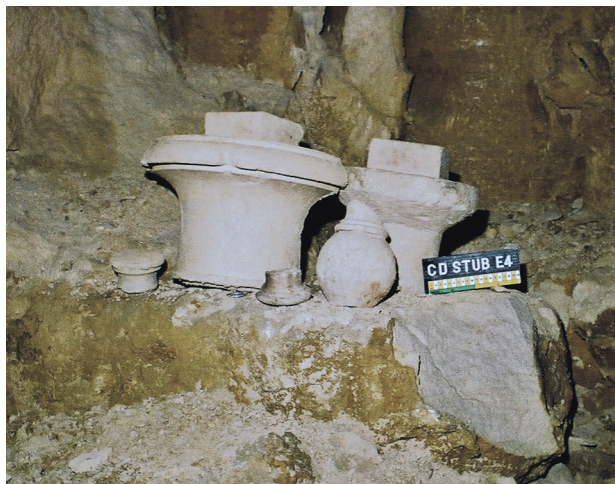
Fig. 12.11 *Capitals for columns. It seems likely these were produced to a pattern, not turned on a lathe (Quarry Area 2348)*

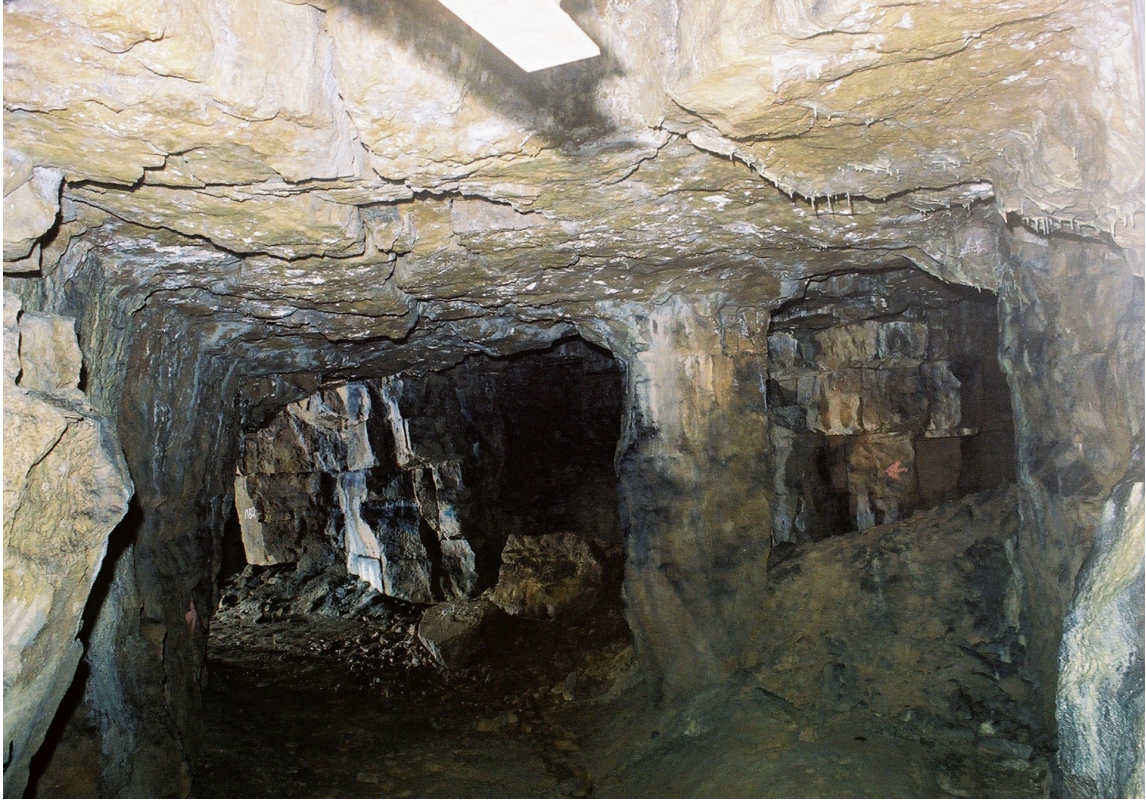
Fig. 12.13 View along the eastern Allen cartway at the junction with the branch cartway

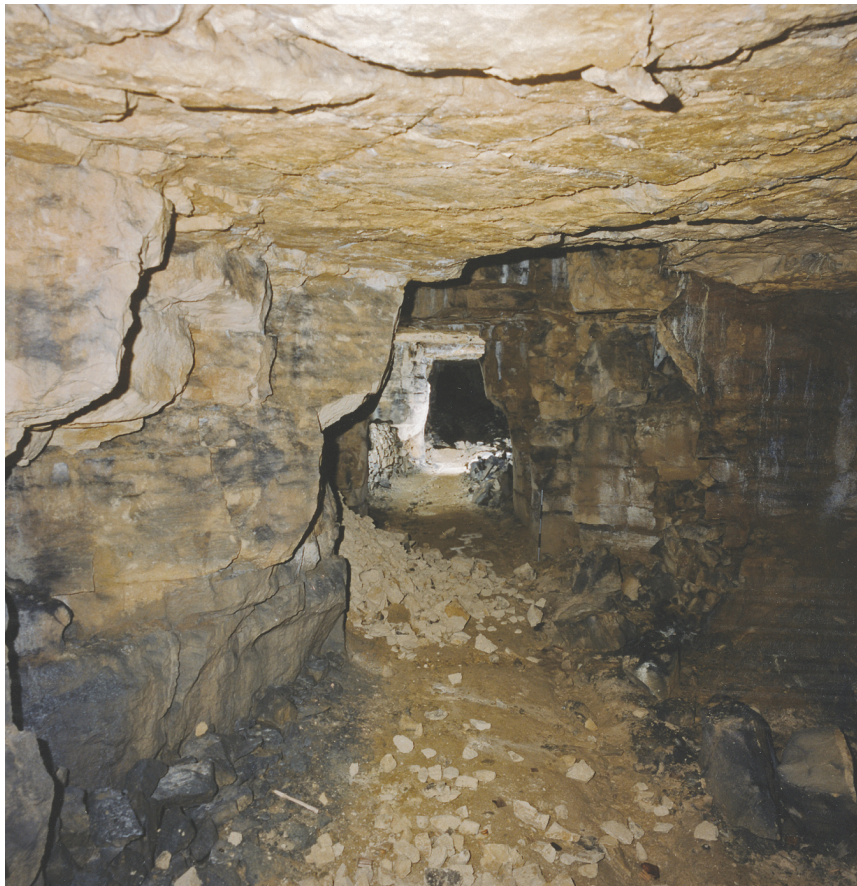
Fig. 12.14 View down the eastern cartway near the Firs Shaft

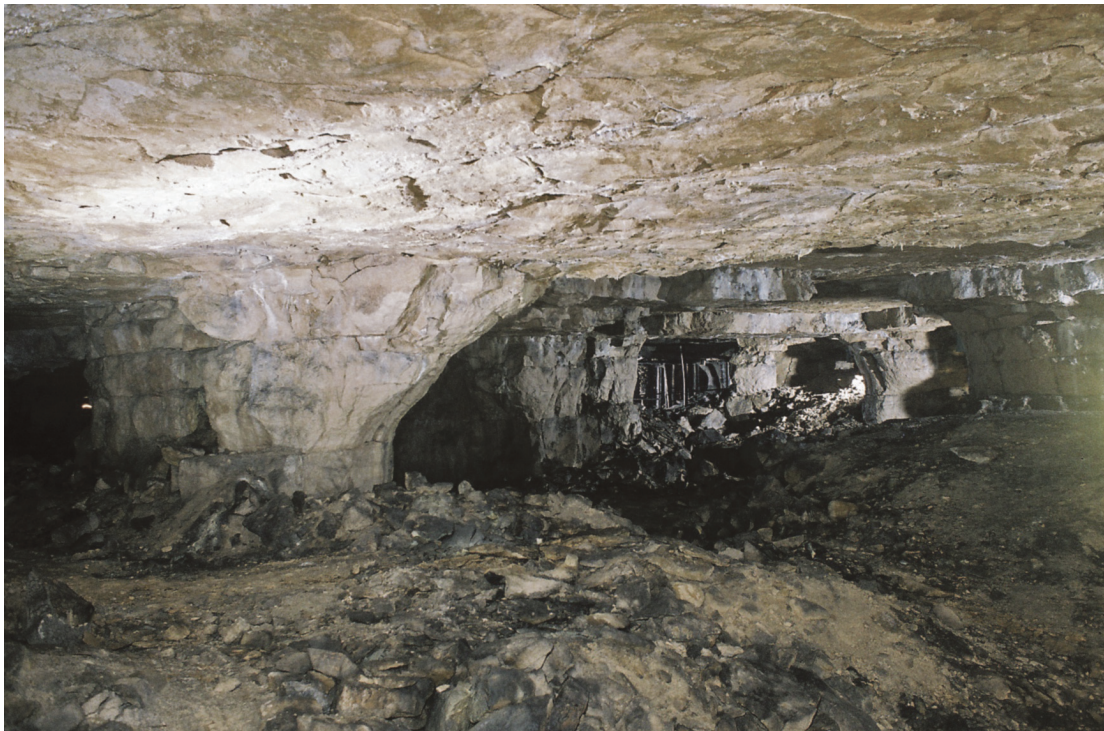
Fig. 12.16 View of the 'Great Quarry' in Central Byfield (505). This was by far the largest area open to view in the Allen workings

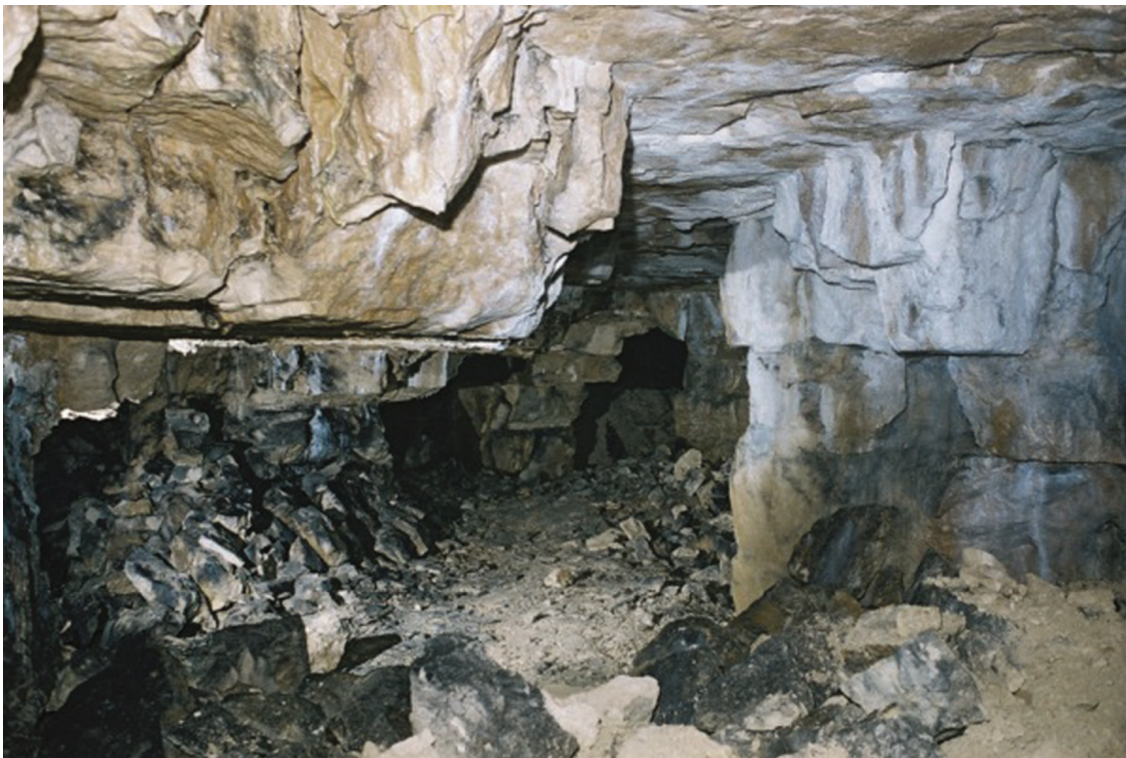
Fig. 12.18 John Davidge's working, to the south of Hills Shaft in East Byfield (Quarry 520)

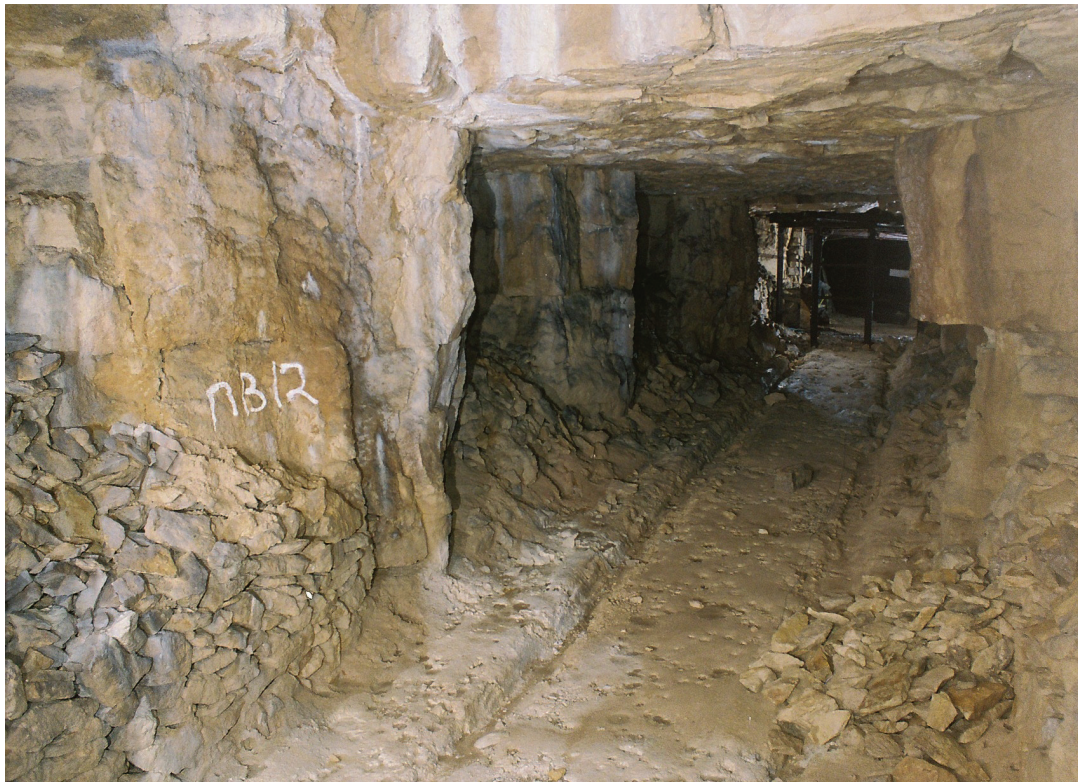
Fig. 12.19 Late 18th- to 19th-century cartway with cart ruts in West Firs (Quarry 2342) which belonged to Samuel and John Pearce

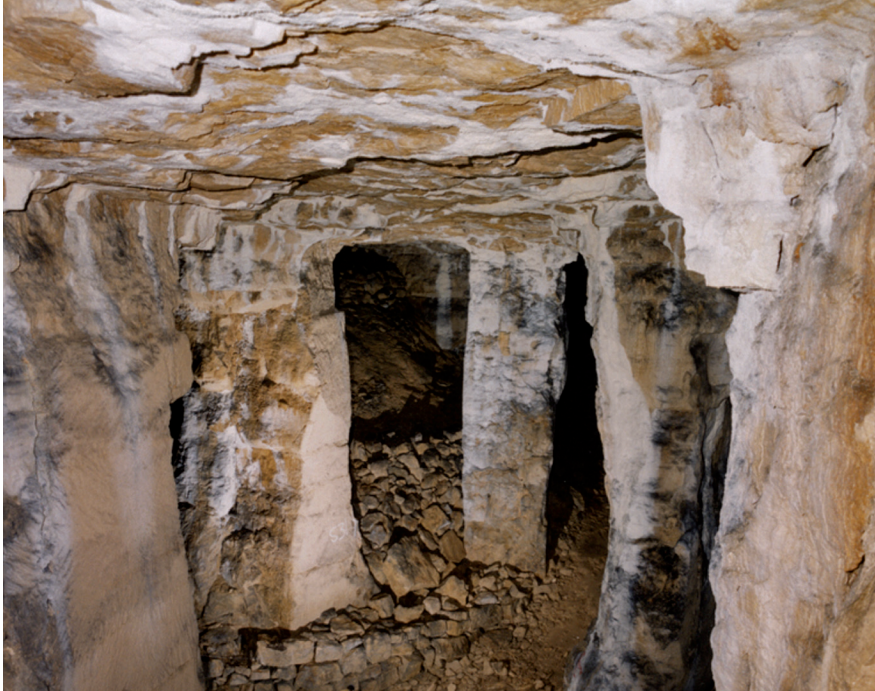
Fig. 12.21 High pillars in William Hulonce's Quarry (West Byfield)

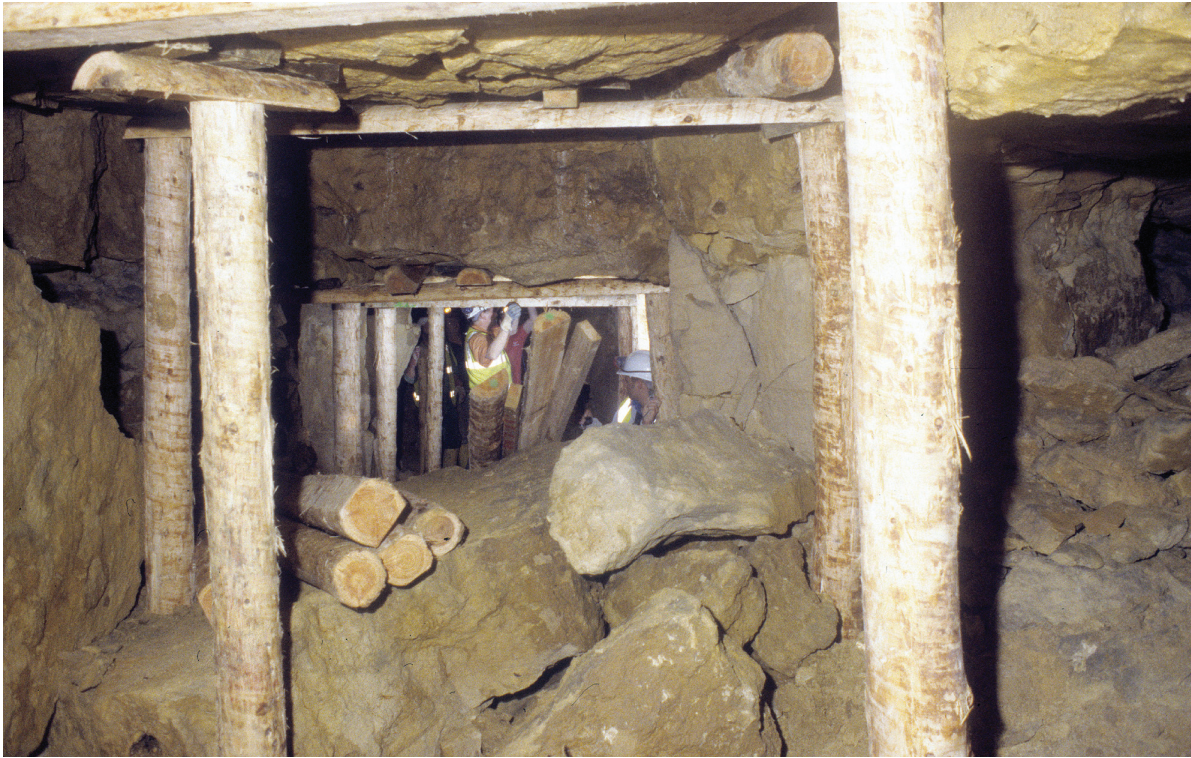
Fig. 12.23 The unstable lower working in Scrace's quarry (Quarry Area 512, Byfield)

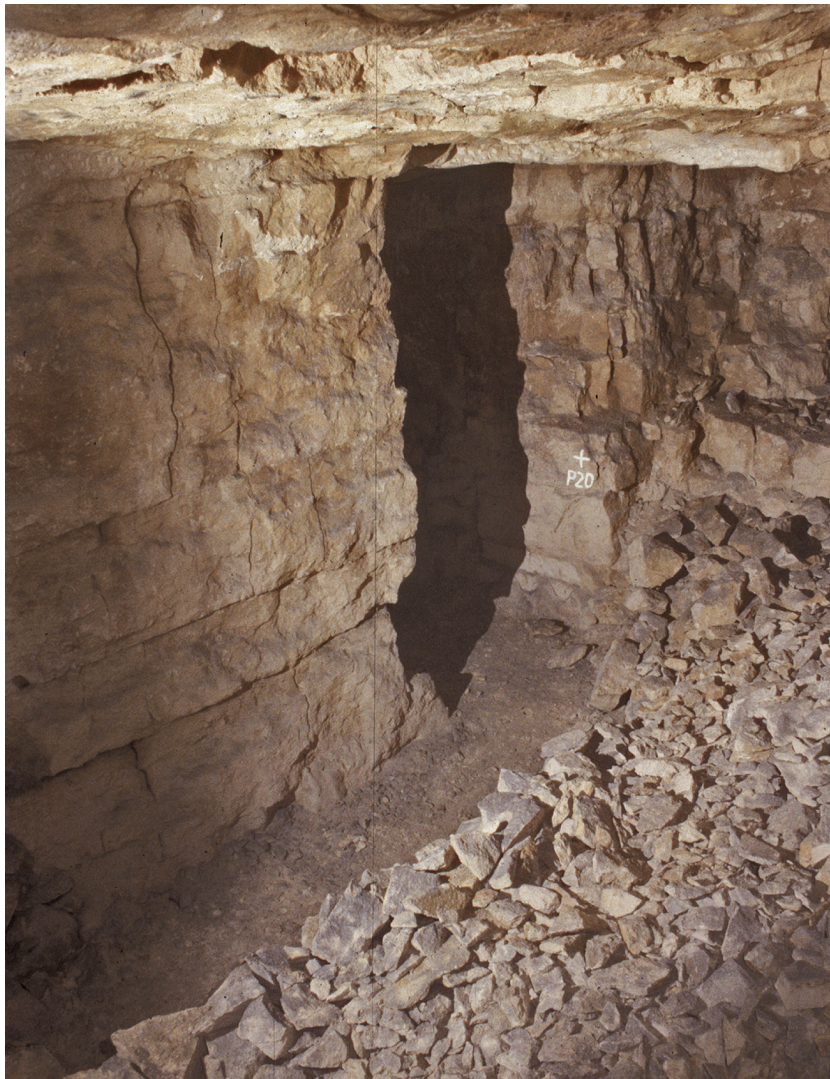
Fig. 12.25 *The masons' quarry: note the clear floor, spoil neatly stacked and the clear-cut faces on the pillar*

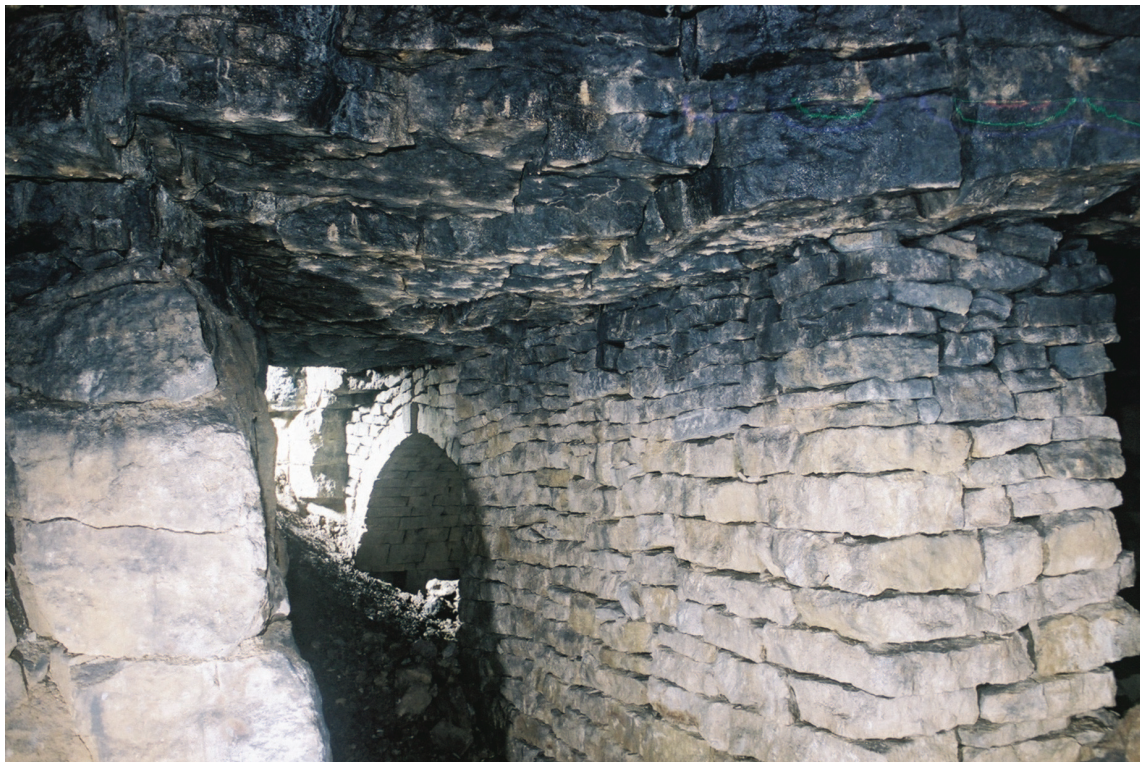
Fig. 12.26 Supporting stone packs at the Arched Shaft

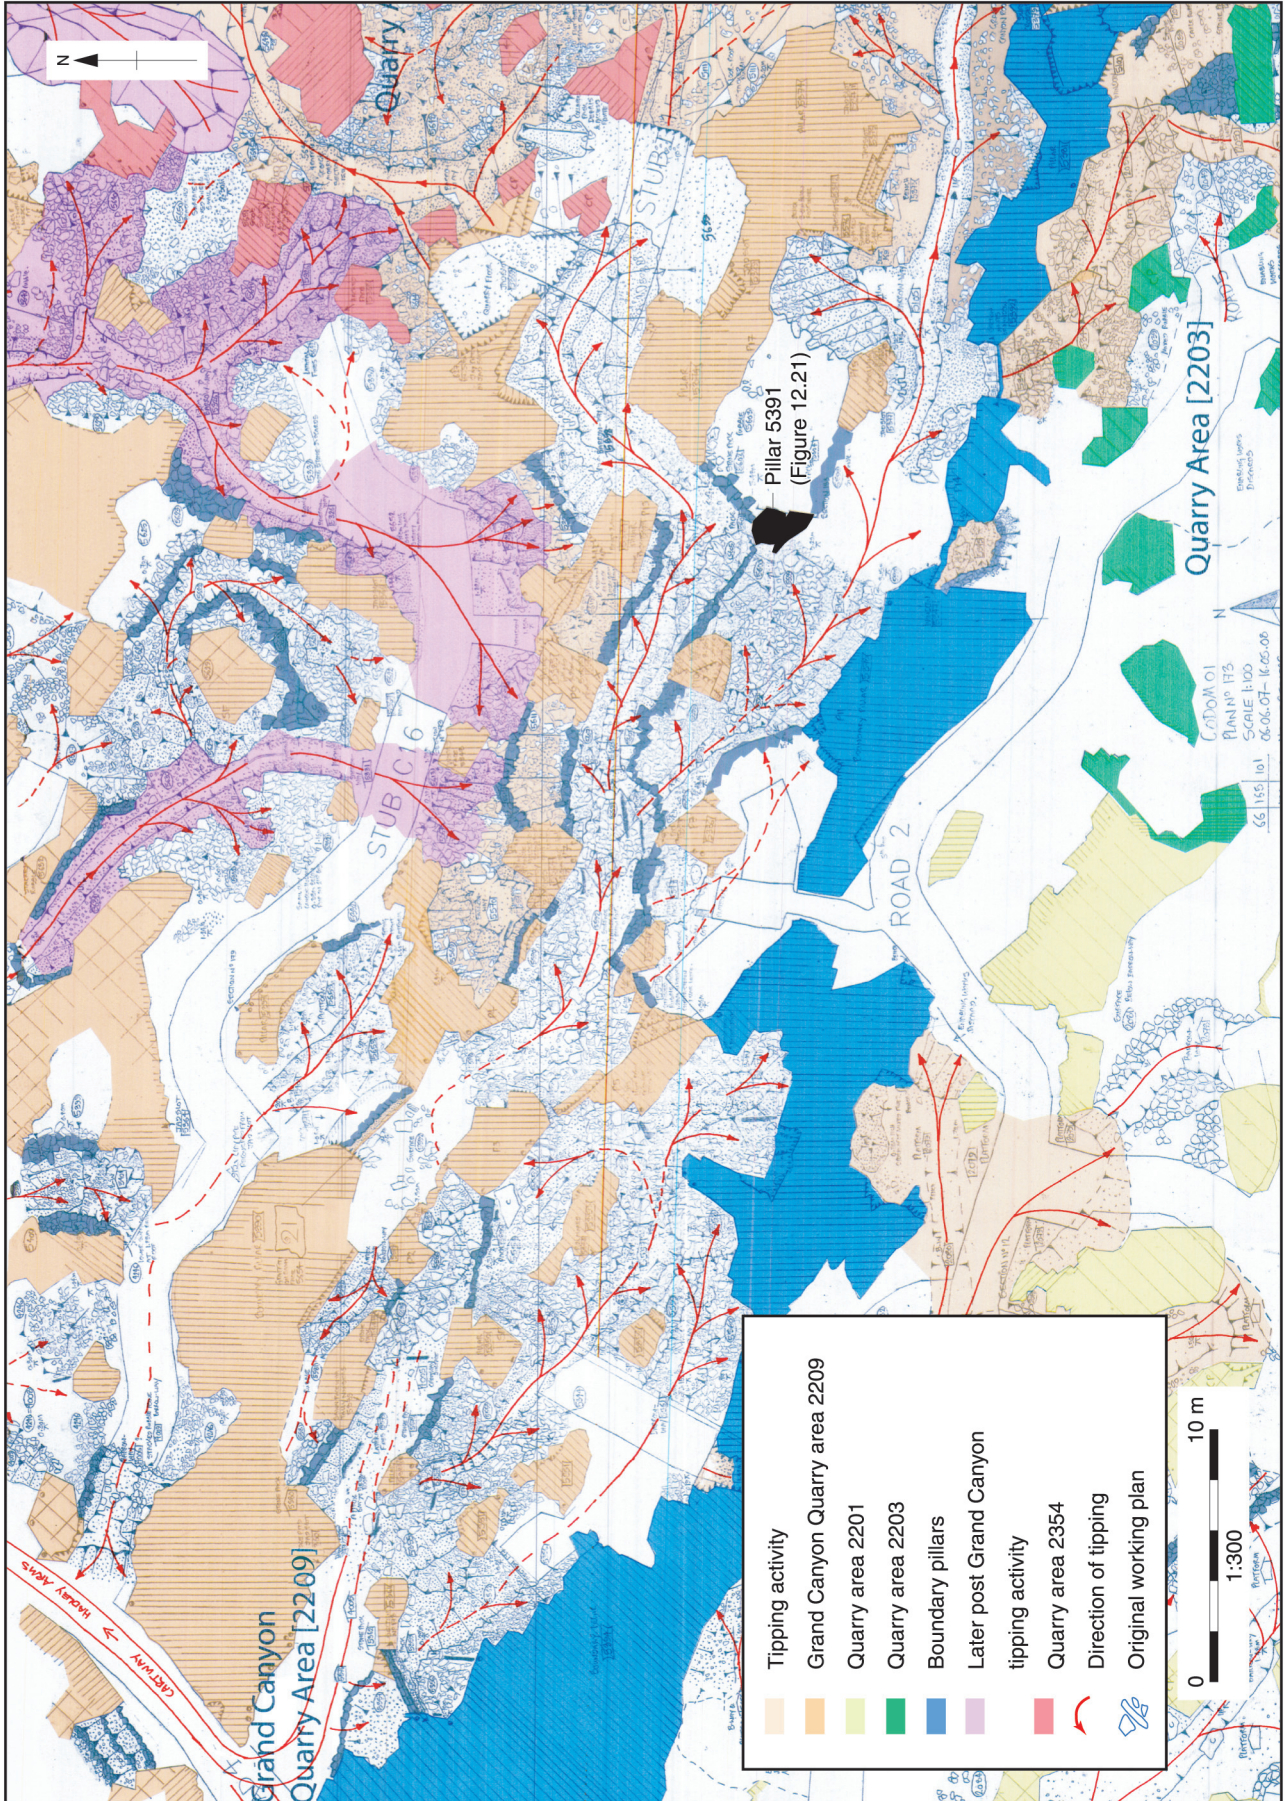
Fig. 12.27 Plan of the Grand Canyon area (2209) of the Three Acre Quarry

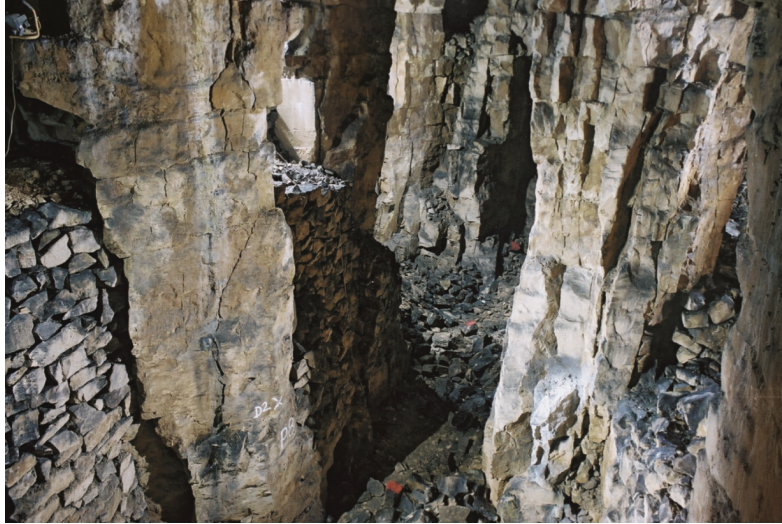
Fig. 12.28 View towards the north-west from just under the roof of the Grand Canyon, directly over the central gullet, showing the full 8.5 m maximum height of the direct pillars and the barrow-way below, with over 5 m-high rubble stone packs at the side

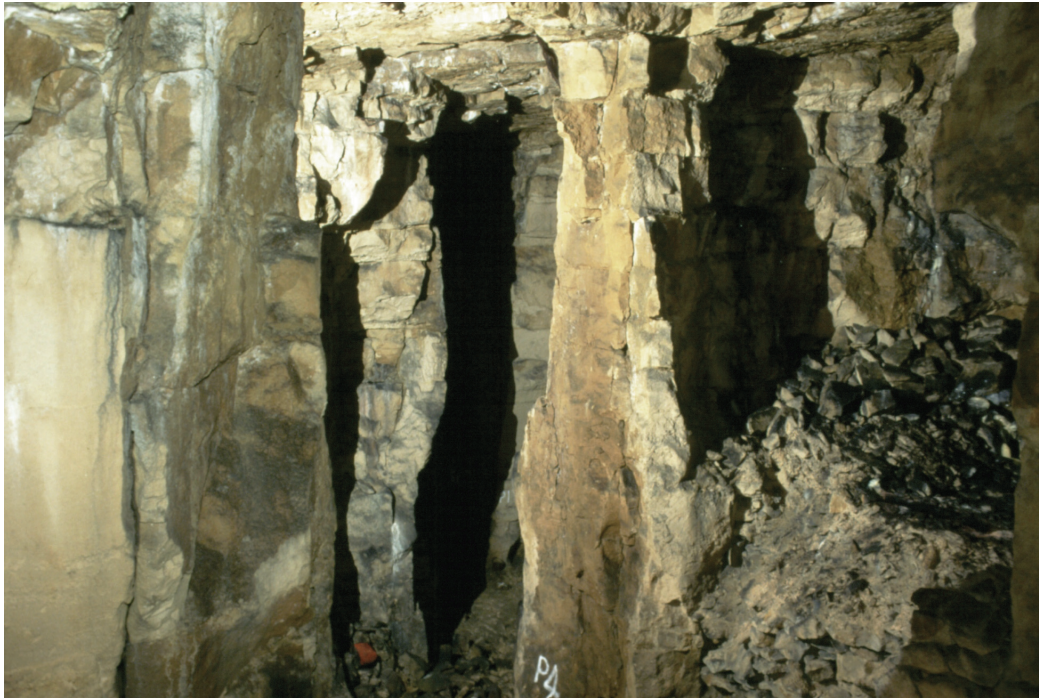
Fig. 12.29 Direct pillars seen from the southern end of the Grand Canyon

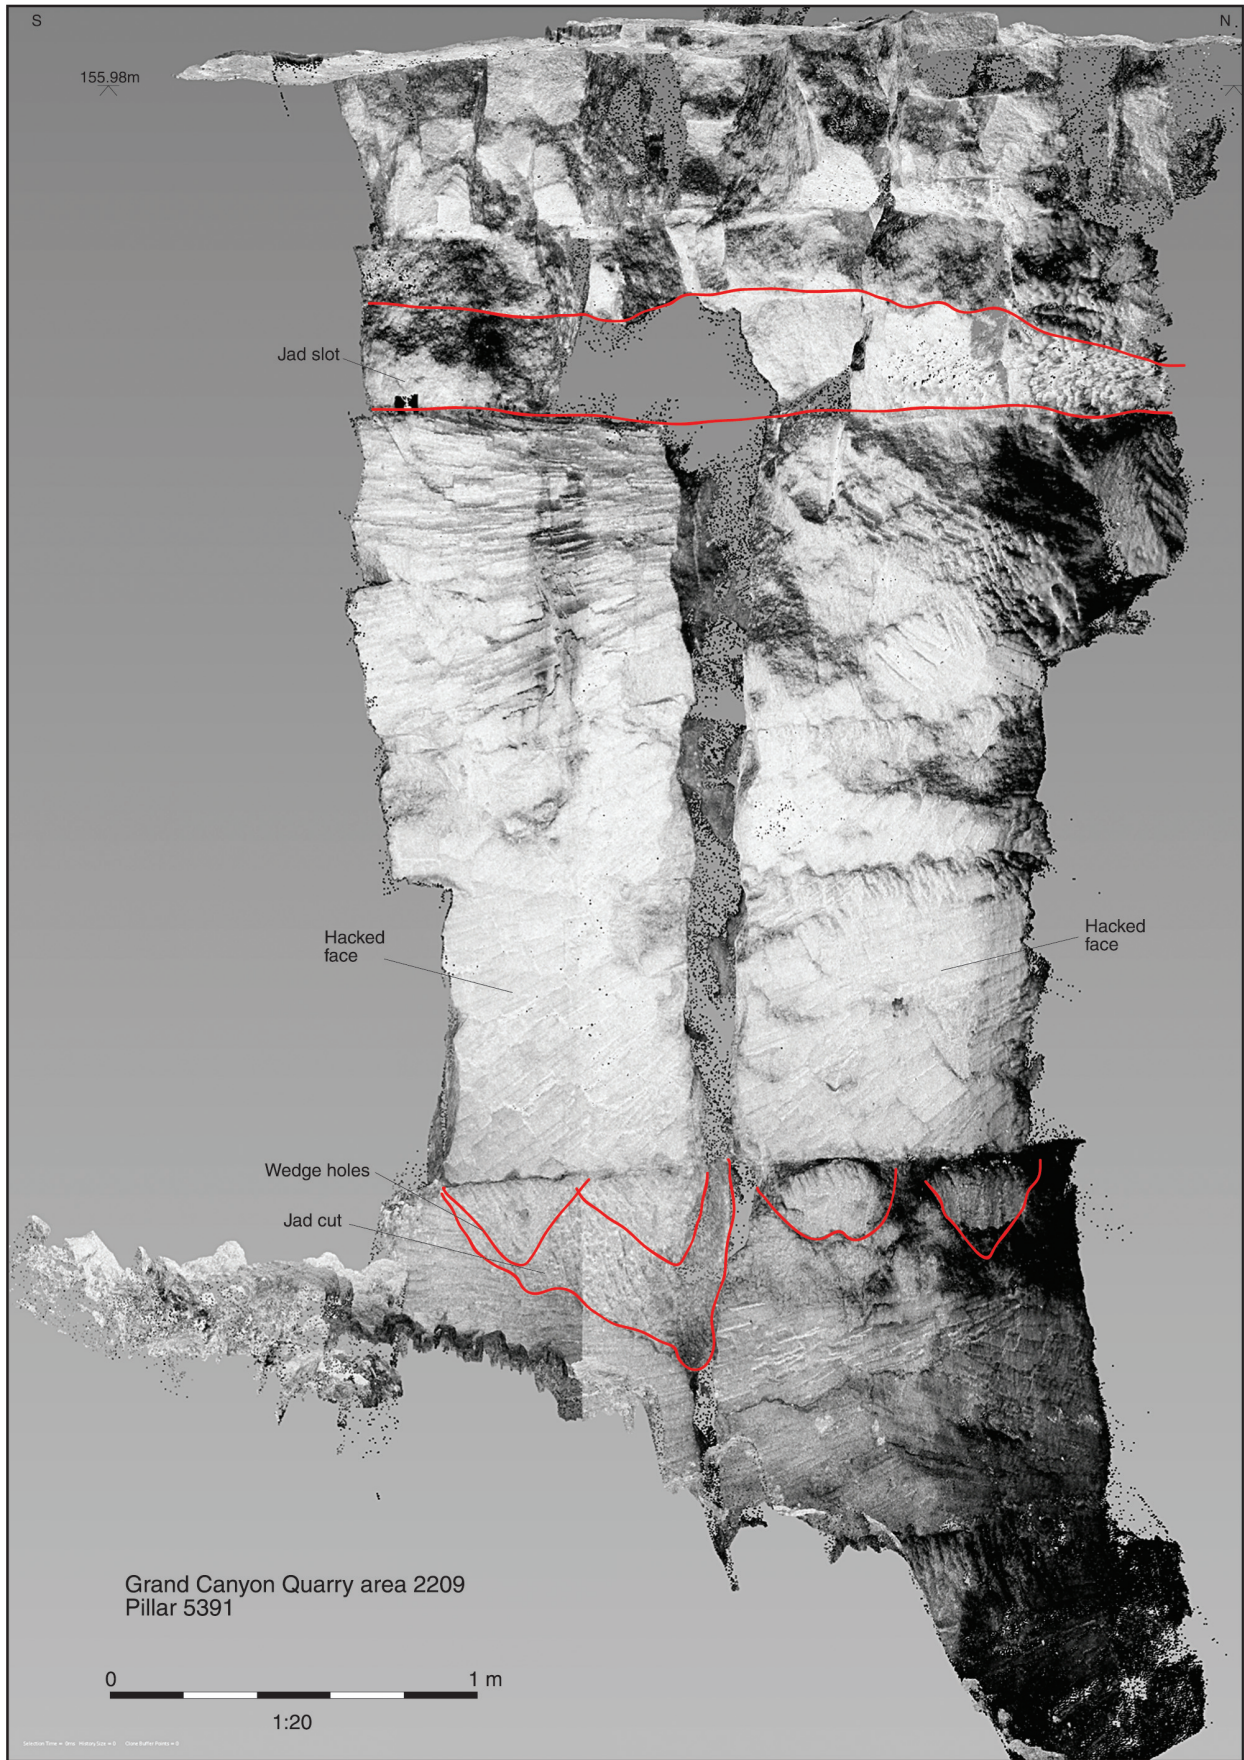
Fig. 12.30 Laser scan image of the east face of pillar 5391 (within the Grand Canyon), showing working features

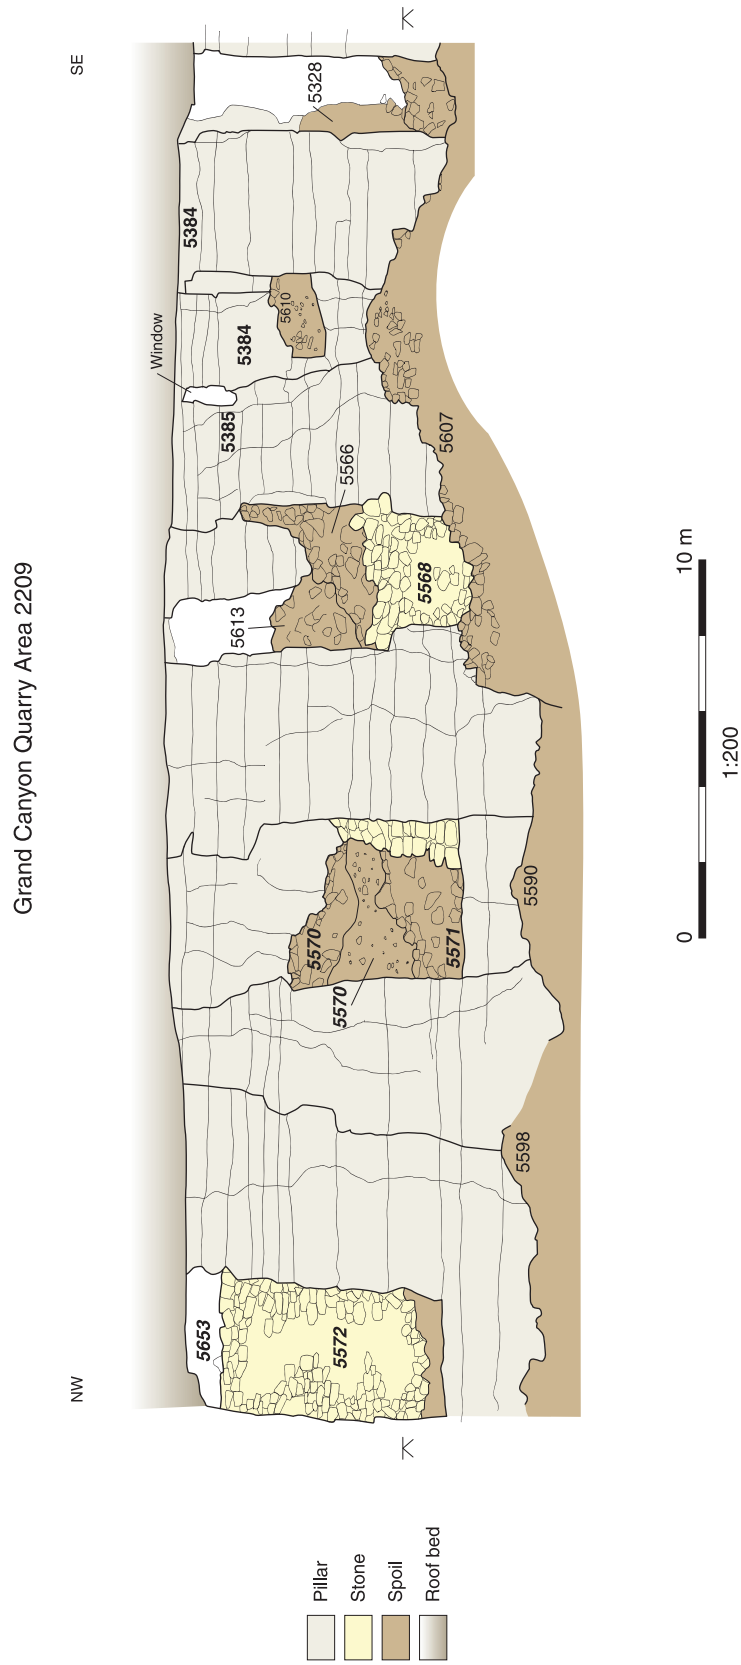
Fig. 12.31 Long elevation of the Grand Canyon produced by laser scanning, viewed to the north east of the central row of pillars, intervening spoil-supporting packs and the north-east wall between. Note the over-deepening of the floor shown by the higher level of the base of the rubble packs

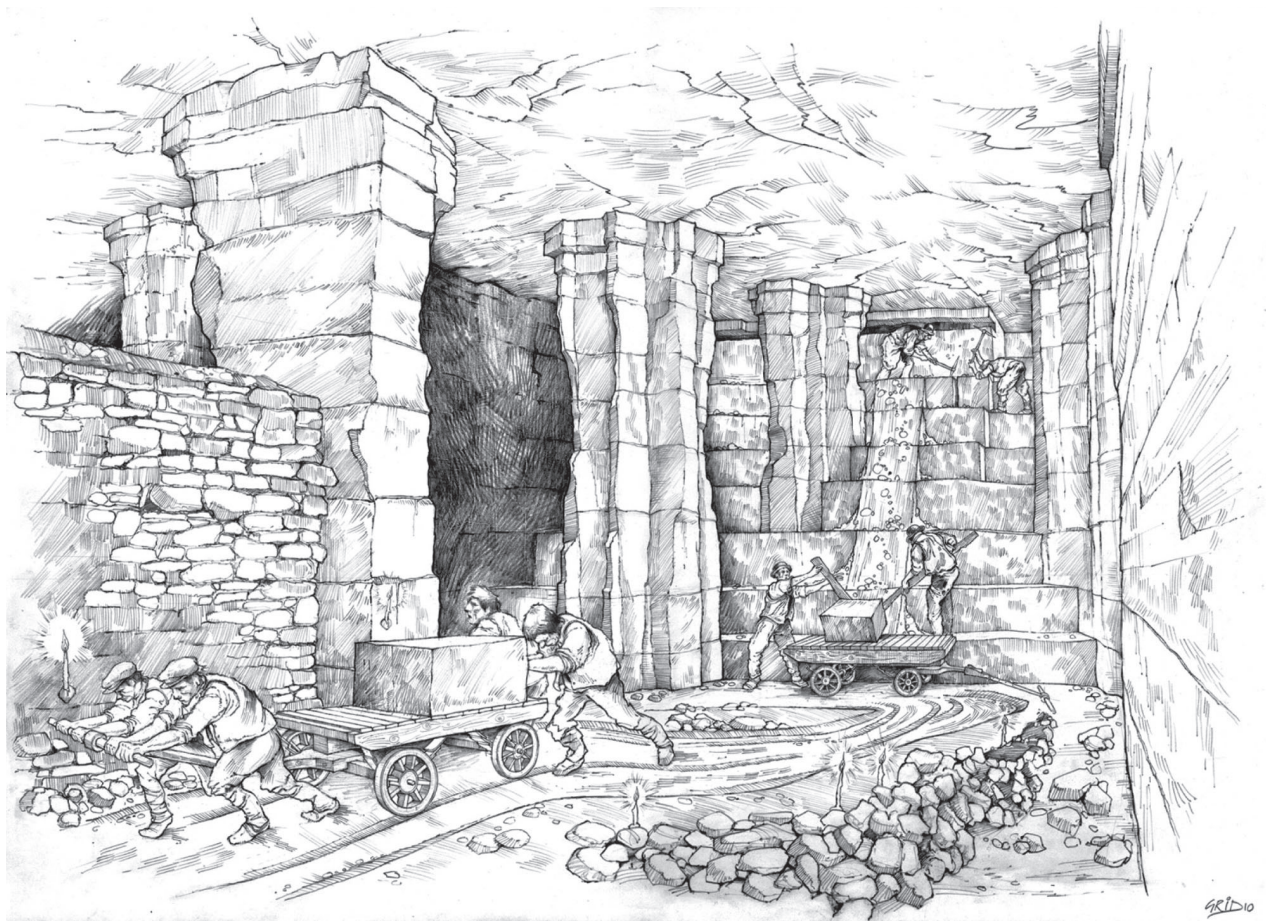
Fig. 12.32 Reconstruction drawing to show how stone may have been worked at the south east end of the Grand Canyon

The south-east corner of the Grand Canyon offered a useful insight into the method of working in these conditions. For approximately 10 m this end appears not to have been initially worked, with only a sufficiently wide opening made to allow spoil to be transported out of the way on a spoil-incline (see below). To work this end a narrow vertical opening was opened on a cross-joint alongside the packs and dumps behind the gullet, through the long joint face forming the east-side
