Chapter 12

The Combe Down complex – chronology, development and case studies

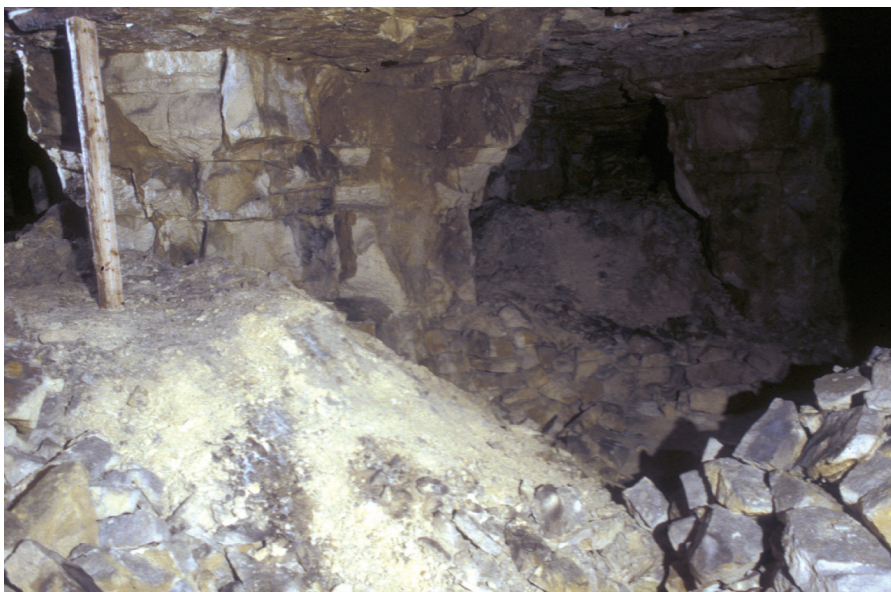
Fig. 12.33 Arcuate tipping front in Quarry 2353 from the Grand Canyon

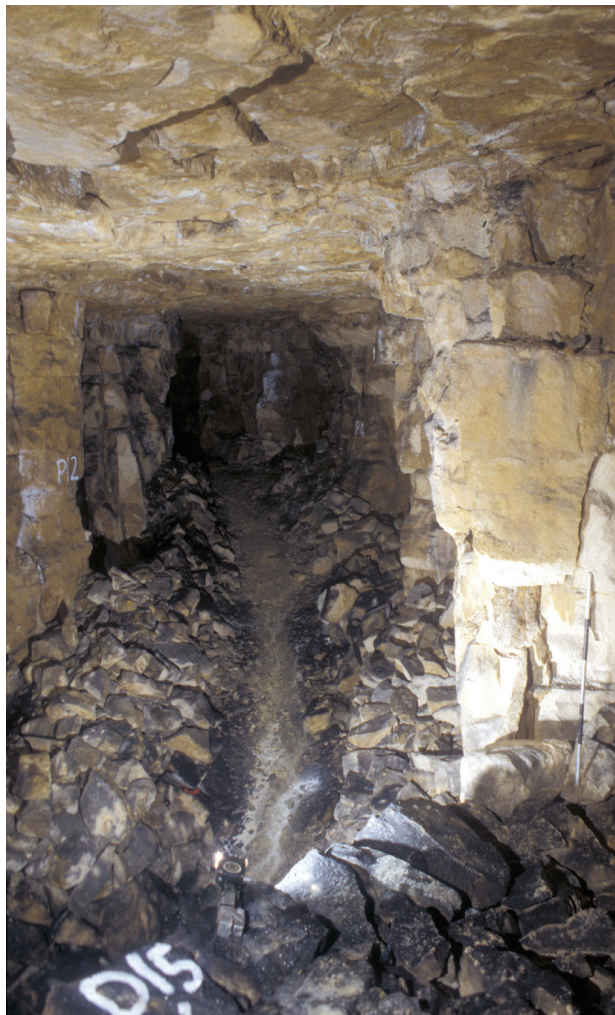
Fig. 12.34 *Inclined barrow-way at the south-east end of the Grand Canyon*

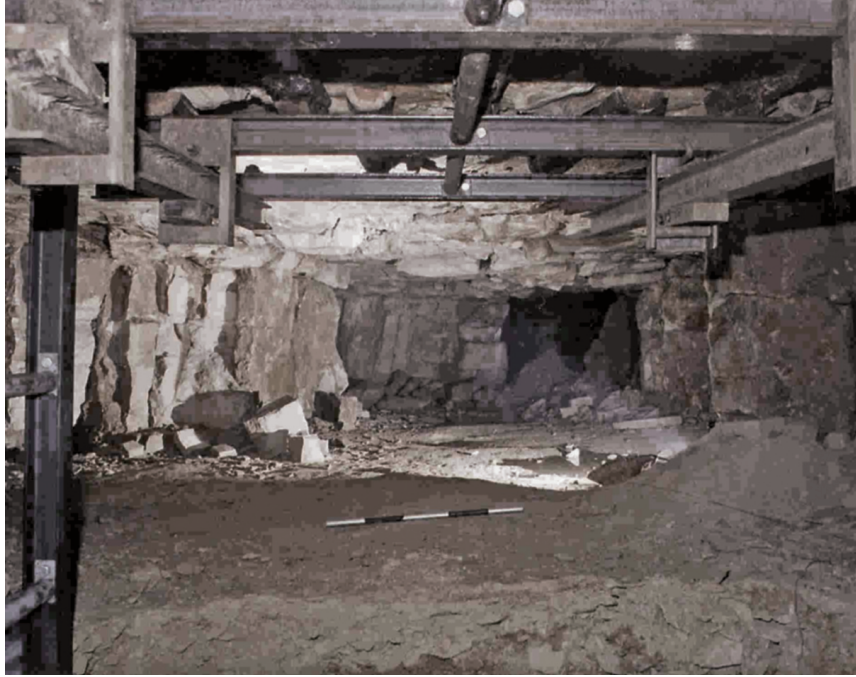
Fig. 12.35 Cleared floor at Stonehouse Lane Quarry, with scapped slabs

Further to the west behind pillars with jad slots and wedge slots, was a clear floor (Fig. 12.35), with nearby scapped blocks or slabs leaning against the wall. More slabs were found north of the pillars along the front of the clear area. The area narrowed as it went north and at the west side were openings walled up with packs or with spoil of a type we had learned to associate with surface quarries. The multiple entries from the surface quarry suggest the underground, after the initial working, was probably used as a convenient shelter, either for working stone (possibly in the winter) or for storing it. As found today the open workings were largely just west of the

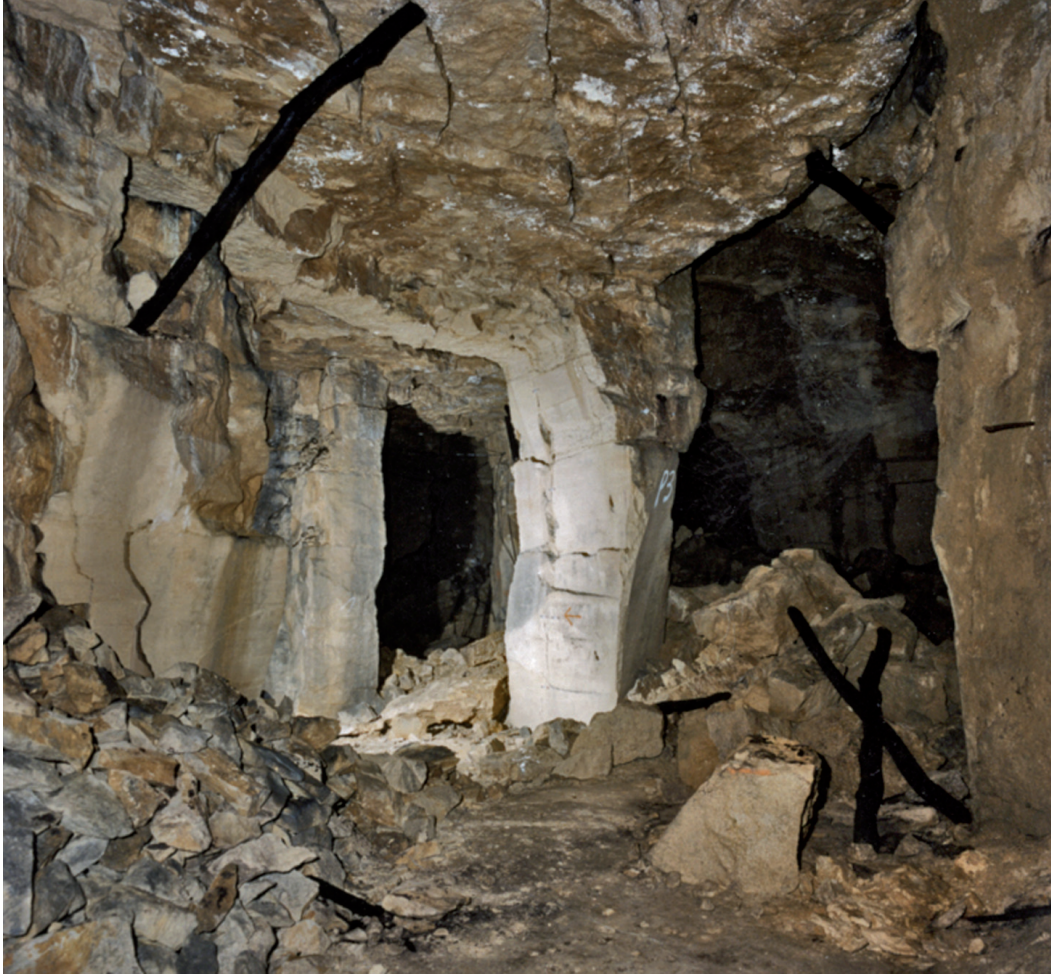
Fig. 12.36 Open room working floors in Quarry 2202

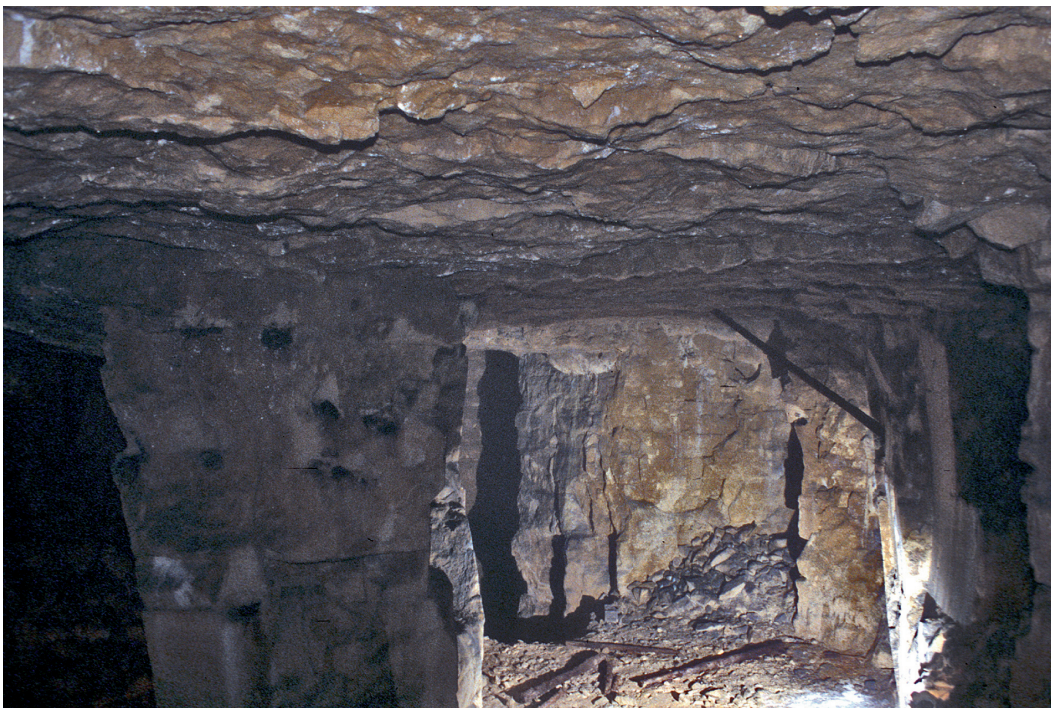
Fig. 12.37 Pillar with scorter recesses

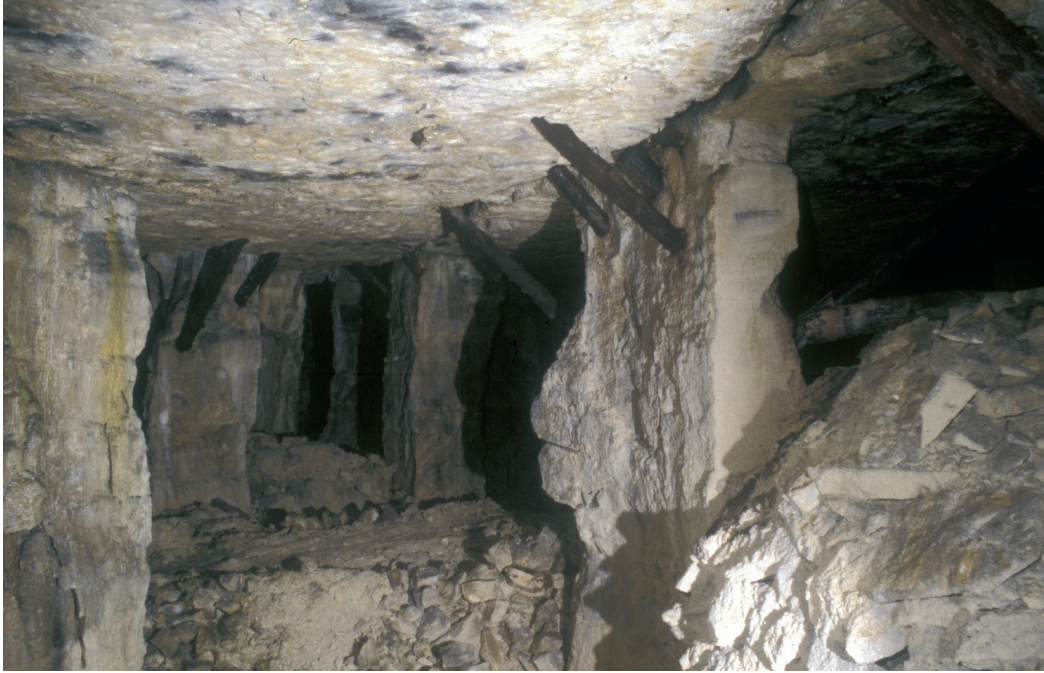
Fig. 12.39 Pillars in James Riddle's Quarry

The first area to be worked seems to have been on the south side where pillars are of two forms, vertical with deep jad slots and sawn, split and natural faces and a northern area where the majority of faces are sawn vertically (see Fig. 8.30). Pillars on the south side also had cable grooves and it is possible a mast crane was also in use at some time, though part of the area had several post crane chog holes too.
