Manor House
Church Lane
Barford St John
Oxfordshire

**Archaeological Watching Brief
Report**

February 2012

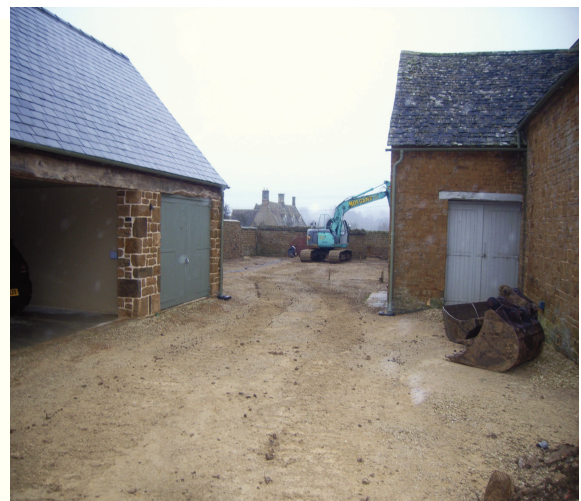
Plate 1: Swimming pool location looking west

- 1.2.1 The village of Barford St John is situated approximately 6.5 km south of Banbury. Manor House is located on the northern edge of the village, immediately west of the Church of St John at National Grid Reference SP 4383 3319. The new swimming pool was positioned to the rear of existing barns south of the house, approximately 35m west of the church (Fig. 2).
- 1.2.2 The underlying geology is Clay and Marlstone (Geological Survey of Great Britain, Sheet no. 218).
- 1.2.3 The proposed development area is currently in residential use and lies at approximately 104 m above Ordnance Datum.

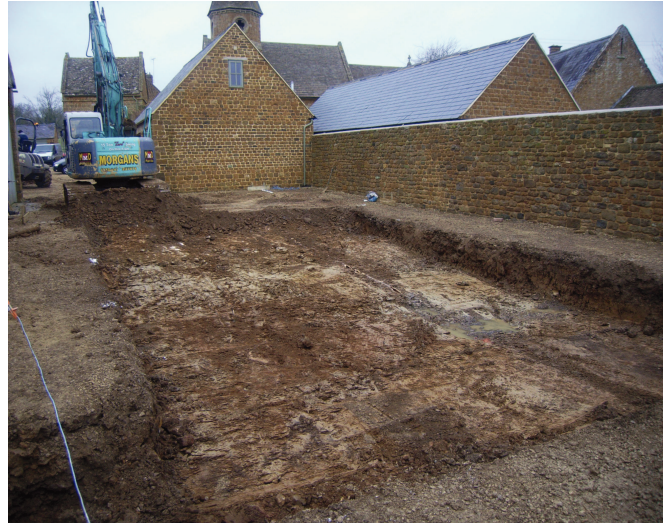
Plate 2: Footprint of swimming pool fully excavated to natural geology

3.1.1 Natural clay (4) was recorded at between 100.97 m OD to the south and 101.24 m OD to the north within the footprint of the excavation, with a seam of ragstone present at the northern end. A 0.3m yellow orange clay subsoil (3) was observed overlying the natural clay in the southern part of the footprint. The subsoil extended 5 m into the excavated area. A levelling deposit 0.3-0.35m thick covered the entire area. This consisted of mid brown grey silt clay containing 20% large ragstone rubble <500mm diameter (2) and was capped with the stone chipped yard surface (1) which was 0.12-0.15m thick.

4.1.1 Layer (4) is a natural deposit and part of the underlying geology of the area and was seen to follow the southward slope of the surrounding terrain outside of the present levelled yard area.

4.1.2 Layer (3) is also likely to be naturally derived but may also possibly represent an in-situ remnant of a past agricultural regime.

4.1.3 Layer (2) appears to be an imported levelling deposit for the overlying surface (1) which provides a level working area to the east of the existing barn.

4.1.4 No archaeological remains were observed during the course of the watching brief.
