St Nicholas Church Chadlington

Archaeological Watching Brief Report

Document Title: St Nicholas' Church, Chadlington, Oxfordshire

ARCHAEOLOGICAL WATCHING BRIEF REPORT

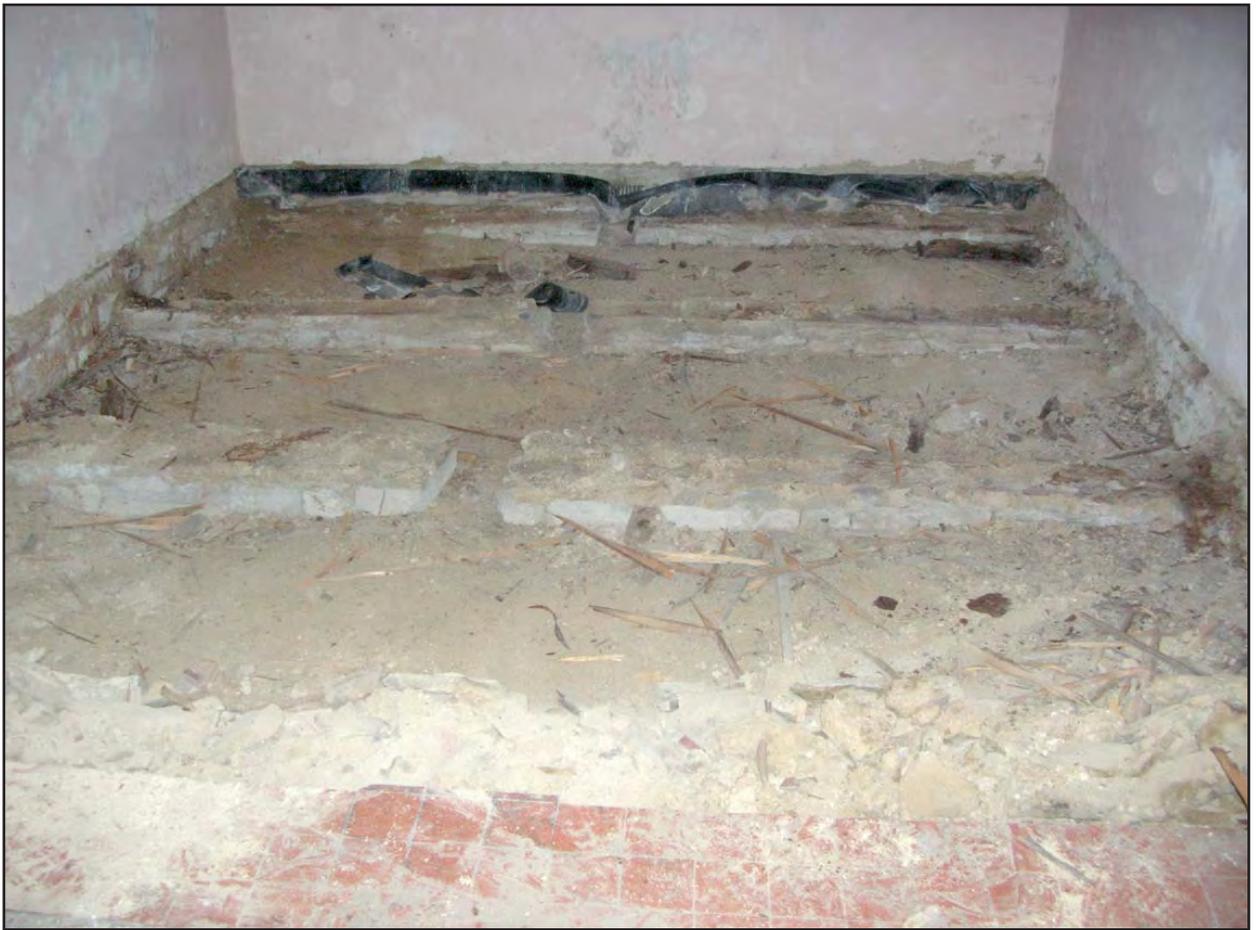
Plate 1: Victorian floor supports, east end of north aisle (looking north)

- 3.1.1 The pews within the church had been removed prior to the watching brief, as had the timber floor boards within each of the pew areas. The walkways within the church – along the central, north and south aisles, and between the north and south entrances – were surfaced by 0.11 by 0.11 m square, red quarry tiles (1), set on to a thin cement bedding (2) and screed layer (15). These were removed by machine. Floor supports, in the form of a series of dwarf walls were revealed below the edges of each of the walkways. The walls were constructed in limestone blocks and had timber beams cemented onto their surfaces. Similar E-W floor support walls were also present below the timber floored areas and tiled walkways in the north and south aisles (Plate 1) and within the nave, either side of the central aisle. Unlike those in the central aisle, occasional red bricks were included within these, and the finish of the limestone blocks was slightly better, suggesting a slightly later date.

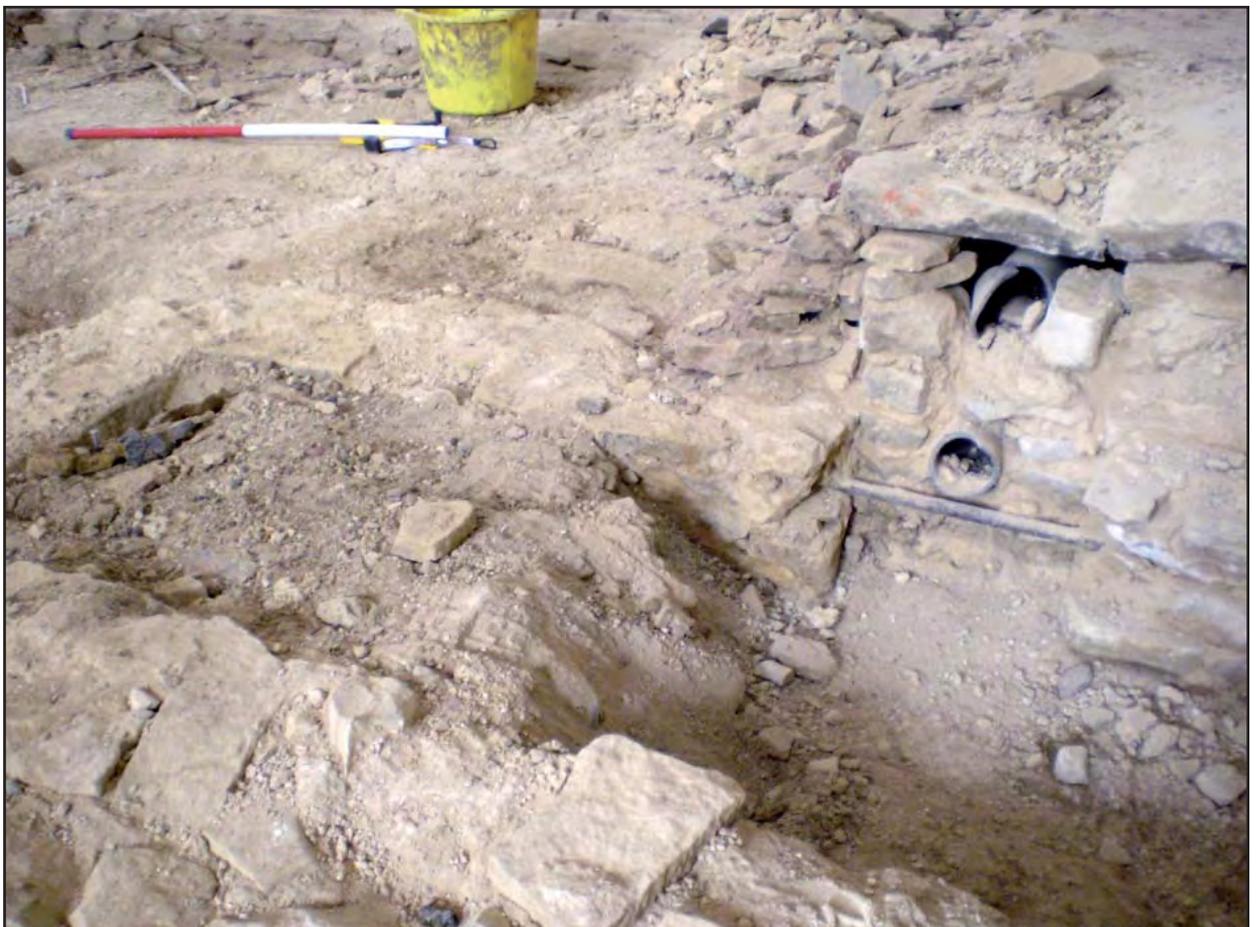
Plate 2: West end of tunnel 20, (looking north-west). Note the truncation of the north wall by the Victorian heating pipes

- 3.1.3 At the very eastern end of the central aisle a tunnel (20), constructed of limestone, was revealed (Plate 2). The walls of the tunnel measured between 0.3 - 0.4 m in width, and were 0.43 m in height. Its very western edge lay approximately 3.3 m from the step up to the chancel and continued eastwards below the chancel, turning southwards in the direction of the crypt (now the boiler room). Within the crypt itself an opening in the west wall, of similar dimensions to the tunnel (20), had been blocked up with bricks.

- 3.1.4 Upon removing the floor within the church, the Victorian heating pipe system, coursed around the outside of the nave area, was also revealed, running N-S in front of the chancel. Truncation of the north wall of the tunnel (20) where the heating pipe course coincided with it indicated that, while the actual pipe was no longer present within the tunnel, the tunnel *had* been used as a continuation for

the later heating pipe course (Plate 2). This was further evidenced by the heat blackened internal surfaces of the tunnel walls and undersides of the large limestone capping slabs (28) that had been placed over the tunnel. Where the north wall of the tunnel was truncated, a thin iron rod, probably a wall reinforcement, was revealed, running lengthways through the wall (Figure 3, Plate 2). A thin layer of cement (21) had been used to secure the capping slabs onto the tunnel walls. The very western end of the tunnel was not capped, and loose, limestone rubble (23) filled this end of the feature.

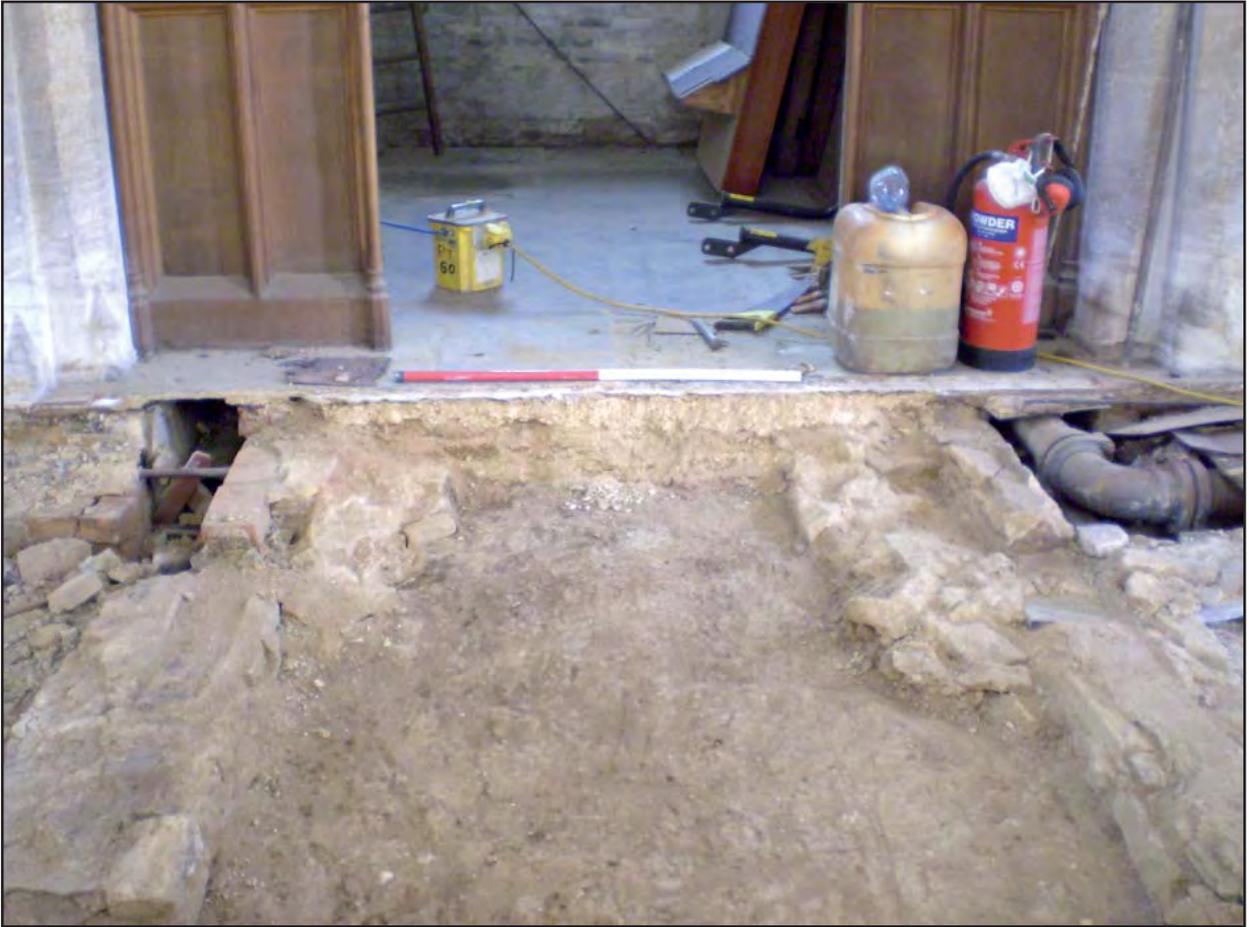
Plate 3: West end of central aisle (looking towards west tower). Note the Victorian heating pipe course either side of the doorway and the two short stretches of masonry (26) and (27) protruding from beneath the tower

- 3.1.6 At the very western end of the central aisle area, two short stretches of W-E limestone wall, (26) and (27), projected from beneath the entrance into the west tower (Plate 3). These walls were roughly constructed of unfinished limestone slabs/fragments, with no real identifiable coursing. The function and date of these structures was unclear, at just 0.8 m (26) and 1.14 m (27) in length, but it is possible that they were associated with the foundations of the tower, or part of an older floor that originally sloped up to the level of the tower floor. Alternatively, they may simply have served as reinforcement for the Victorian heating pipe duct walls that ran alongside the outer edges of (26) and (27).

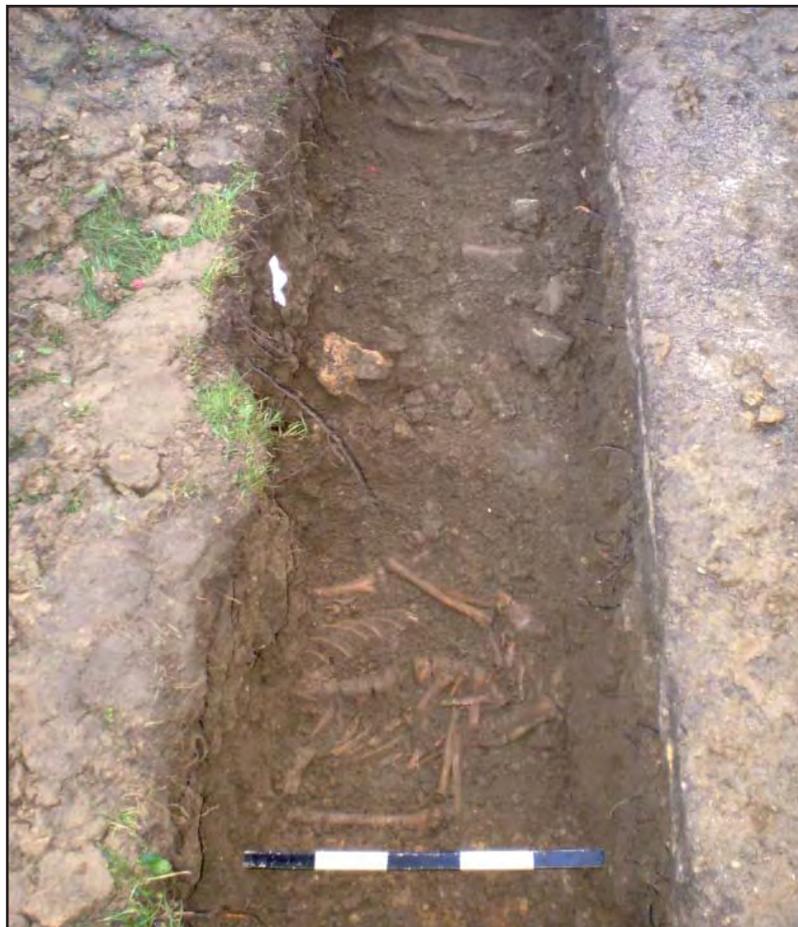
Plate 4: Trench 1, looking north. Skeletons 114 (at bottom of image) and 109a, at top of image

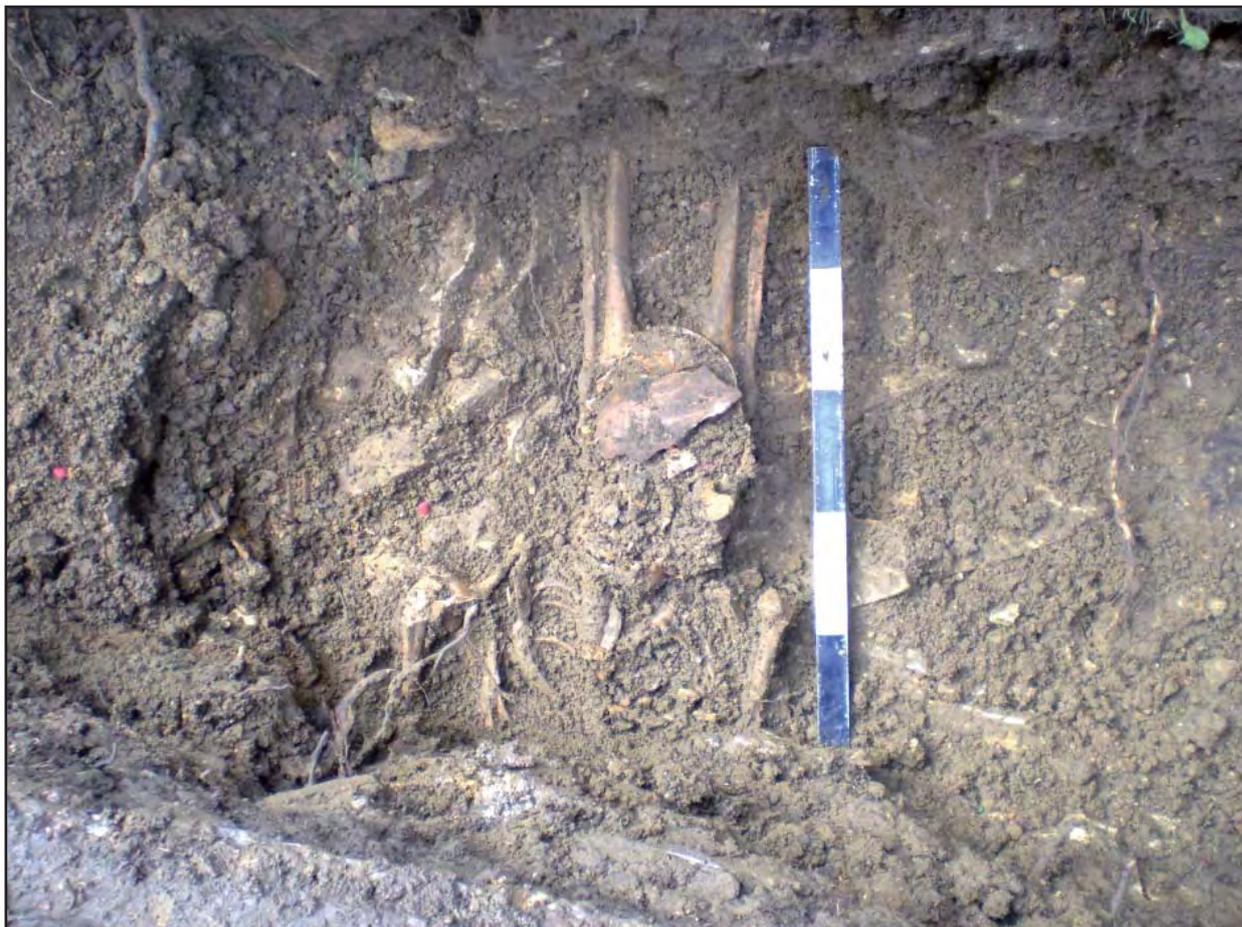
Plate 5: Trench 1, looking west. Feet of skeleton 116, truncated by burial 115

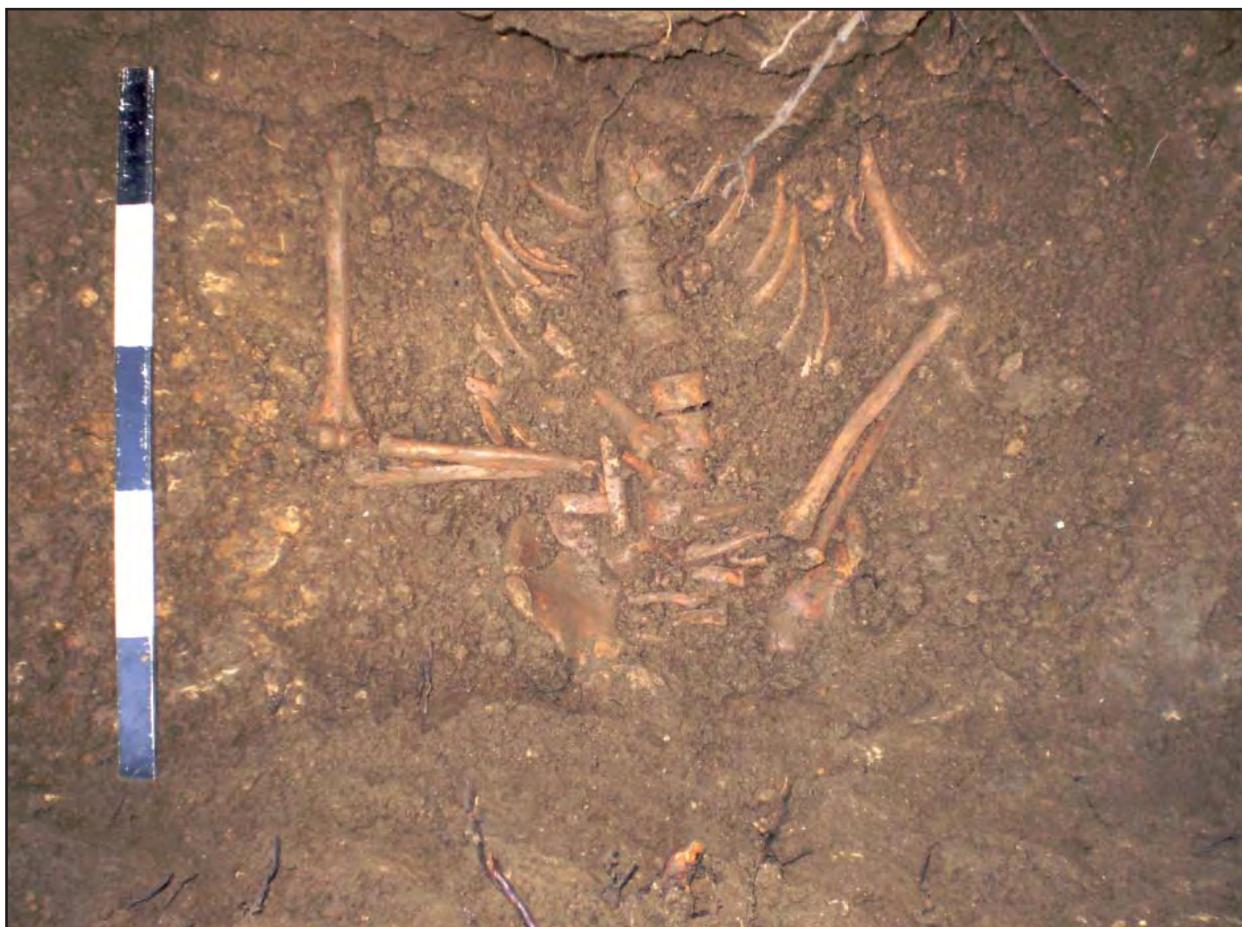
Plate 6: Trench 1, looking west. View of skeleton 114. Note the position of the hands over the pelvis

3.1.17 All skeletons were lying in a supine (on their back) position with their heads at the west end of the graves. Arm positions could be observed in a few instances and were found to be either lying by the sides, or with one or both hands over the pelvis (Figures 5a and 5b, Plate 6). Observations relating to the positions of the skeletons was limited by the fact that none were exposed in their entirety.

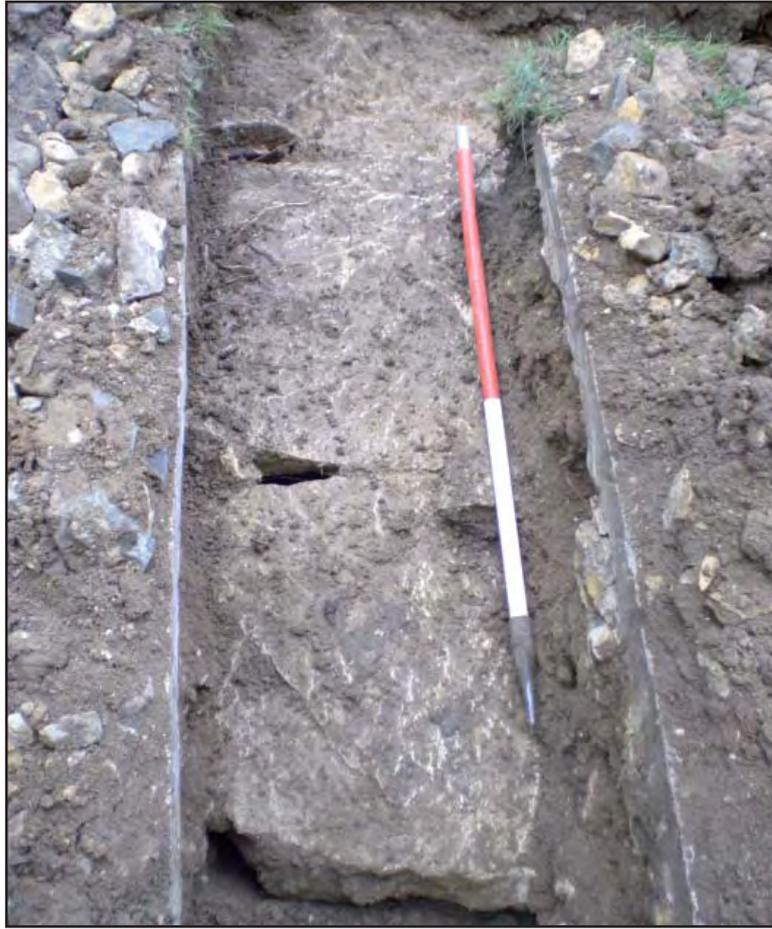
Plate 7: Trench 1, looking west. Shaft grave 102

3.1.18 An 18th or early 19th century shaft grave (102) was revealed within the E-W section of Trench 1. It was located near to grave (103) and was the southernmost grave to be excavated. Aligned E-W, parts of its eastern and northern edges were revealed (Figure 4). Three large limestone ledger stones (0.43 m below the current ground level) capped the grave, with smaller limestone slabs covering the gaps between the main stones (Plate 7). One of the smaller stones from the very eastern edge was removed during machining, and this allowed a somewhat restricted view into the grave (Plate 8). The remains of a probable wooden coffin, with iron fittings (including upholstery studs and a grip) were visible, as well as at least one adult skeleton. The internal walls of the shaft grave appeared to be stone lined, plastered and white-washed in places.

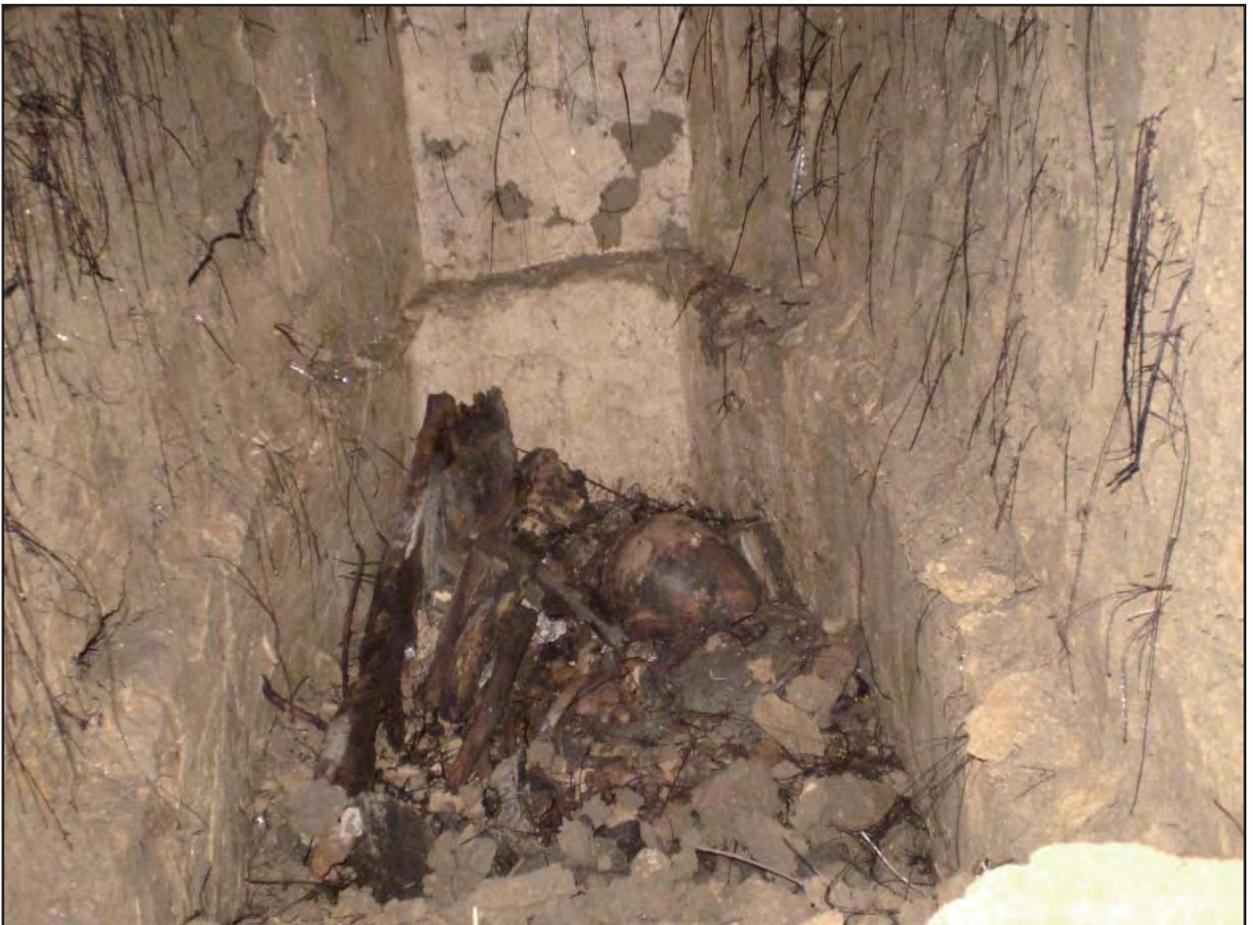
Plate 8: Trench 1, looking west. View inside shaft grave 102 (looking west)

3.1.19 A small continuous stone ledge was present approximately halfway down the walls of the grave. This may have originally supported a rack for supporting coffins above earlier ones. The skeletal remains that were visible appeared to be quite disturbed, so it is possible that these do not represent the first burial within this grave, but a later one that was originally placed, in a coffin, on the supposed rack and has subsequently 'dropped down' onto an earlier burial, following the decay of coffin. The shaft grave was not excavated, nor were the *in situ* capping slabs lifted.

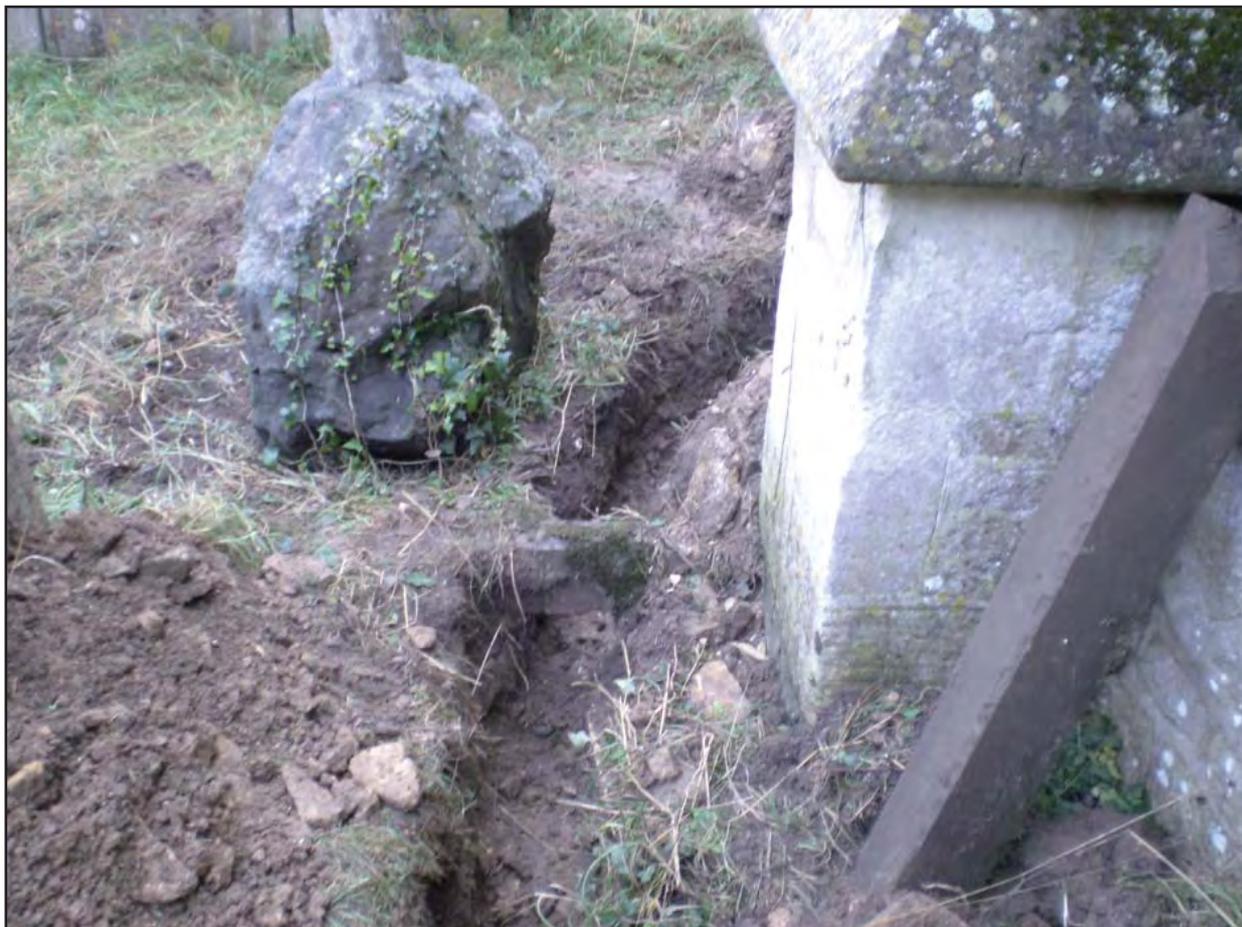
Plate 9: Trench 2, looking south. Note the rear kerbstone of grave monument temporarily removed

3.1.22 Where the trench changed its course from E-W to N-S (at the south west corner of the chancel), it was necessary to temporarily move an existing kerbed burial monument (Plate 9). Upon completion of the works, the monument was reinstated.
