Rover VQ Building, Garsington Way, Oxford

Archaeological Evaluation Report

Site code OXROVQ

Oxford Archaeological Unit
10 November 1995

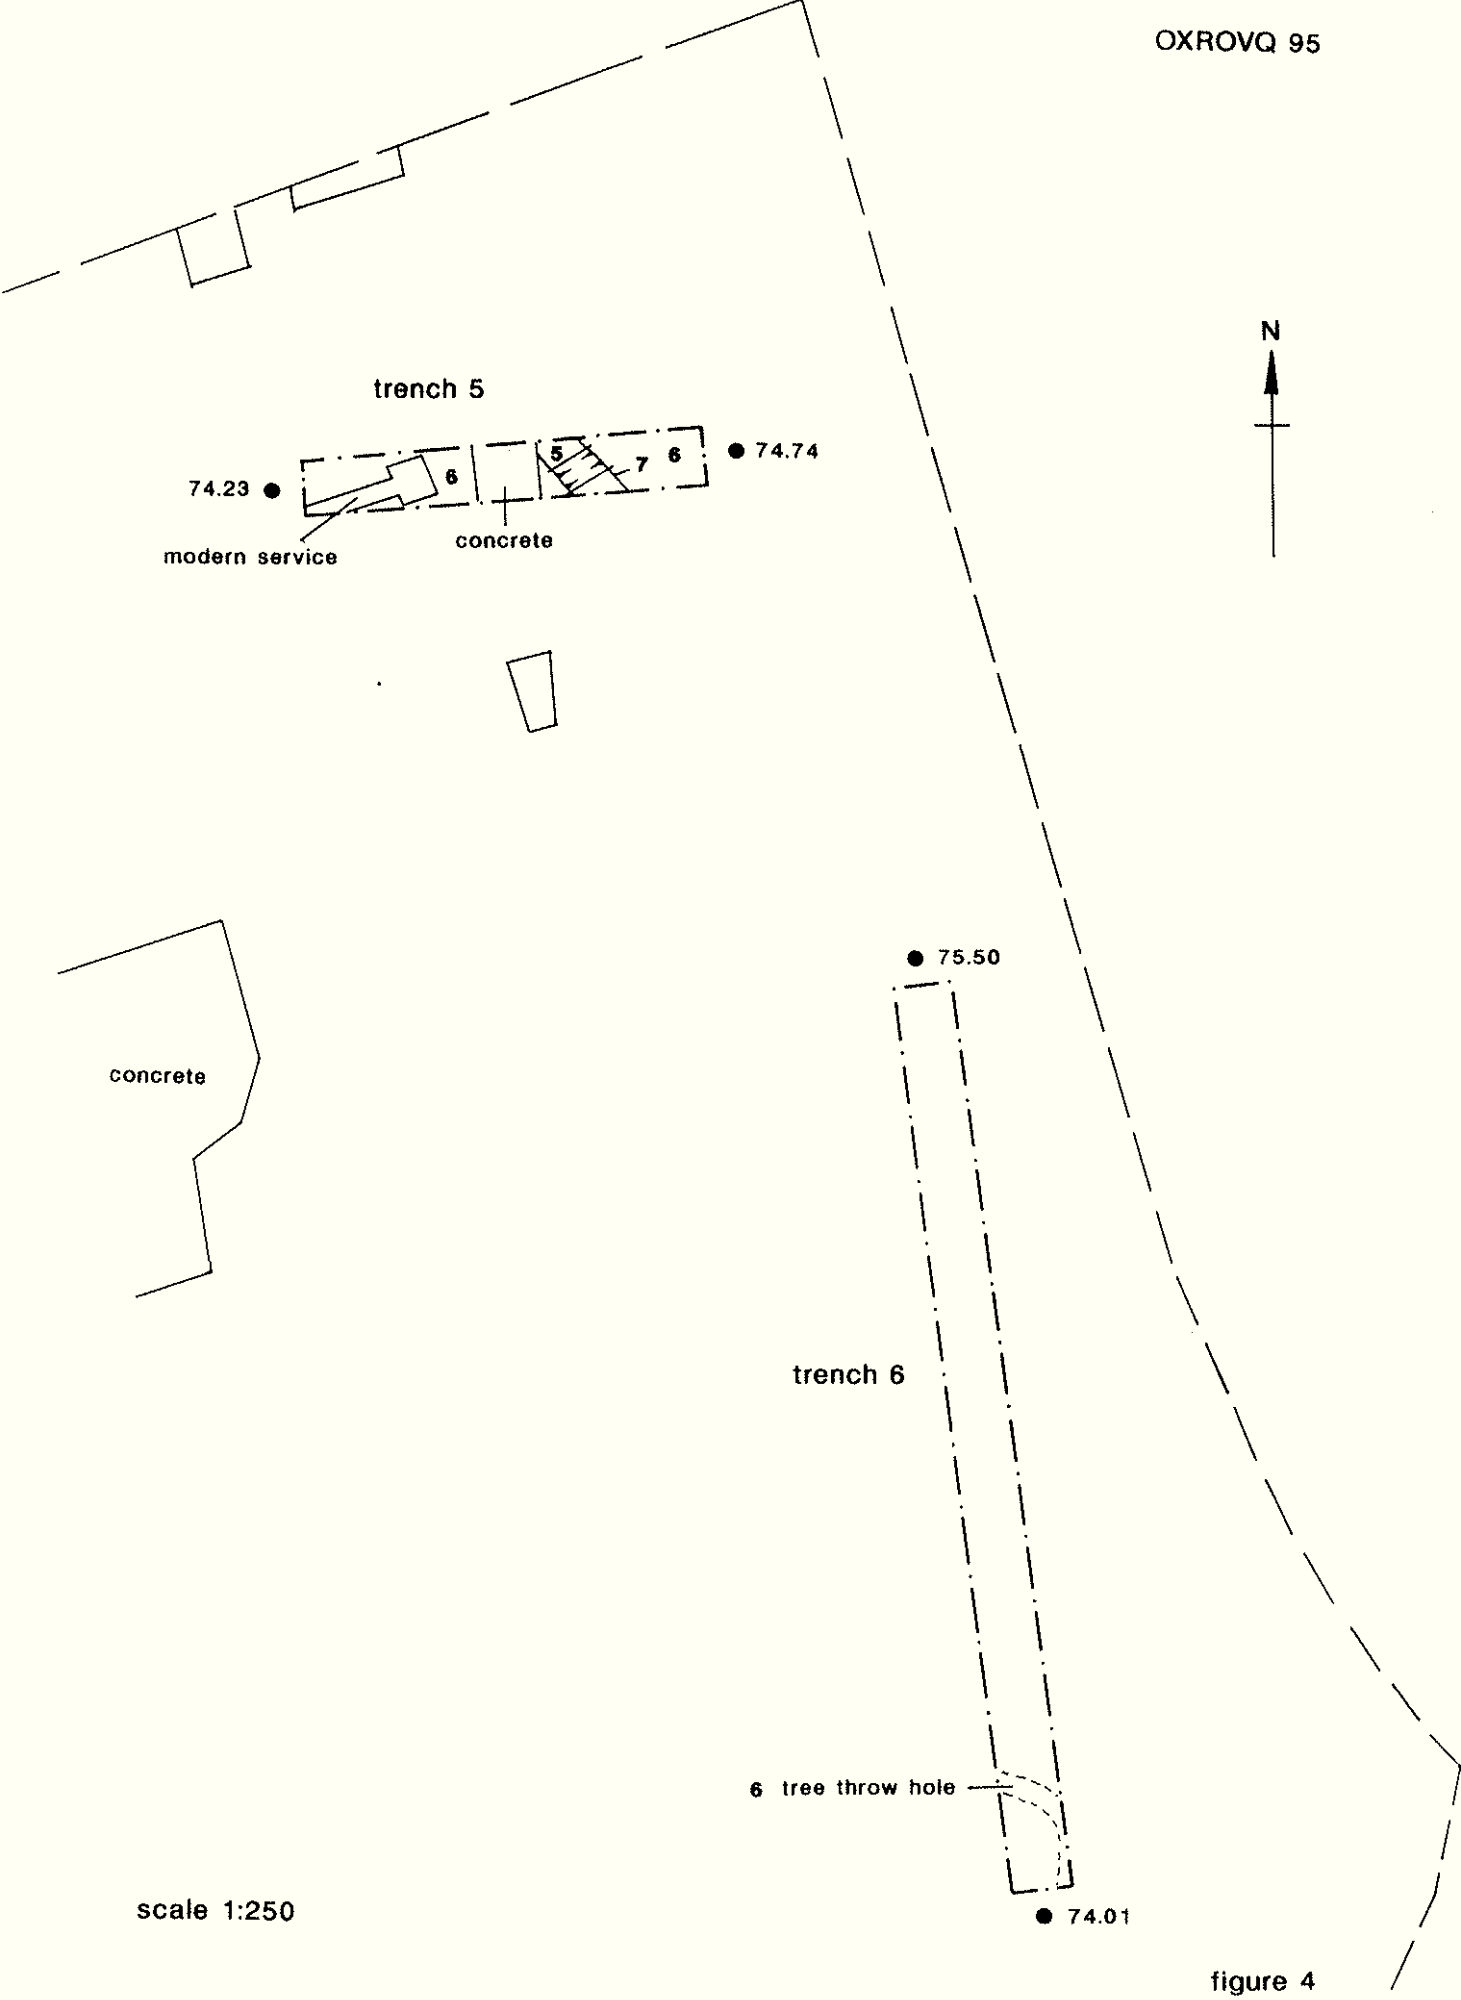
figure 4

Natural features (Fig 4)

Natural features were found in trenches 5 (feature 7) and 6 (feature 6). In both cases the

features were filled by clean sandy fills with no finds or charcoal and few natural inclusions (ie gravel, limestone fragments). Feature 5/7 was fairly regular in plan, while feature 6/6 was irregular. Feature 5/7 probably represents natural disturbance (?animal burrow) and feature 6/6 is interpreted as a tree-throw hole. Neither is archaeologically significant.

Traces of former buildings were found in trenches 1 and 4 at the east end of the site. Two east-west walls were found in trench 1, while an east-west wall in trench 4 defined the north side of a cellar. This had been filled with rubble (layer 4/2). Modern services were also found in trenches 2 (feature 6) and 3. The electricity feeds for the lamp posts in the central and western parts of the car park constricted several of the trenches there (8, 9, 11 and 14).

Natural features were found in trenches 5 and 6. These probably relate to land clearance for agriculture, but there is no direct evidence from the site for when this occurred. A later prehistoric date would seem plausible, especially in the light of the ditch in Trench 9.

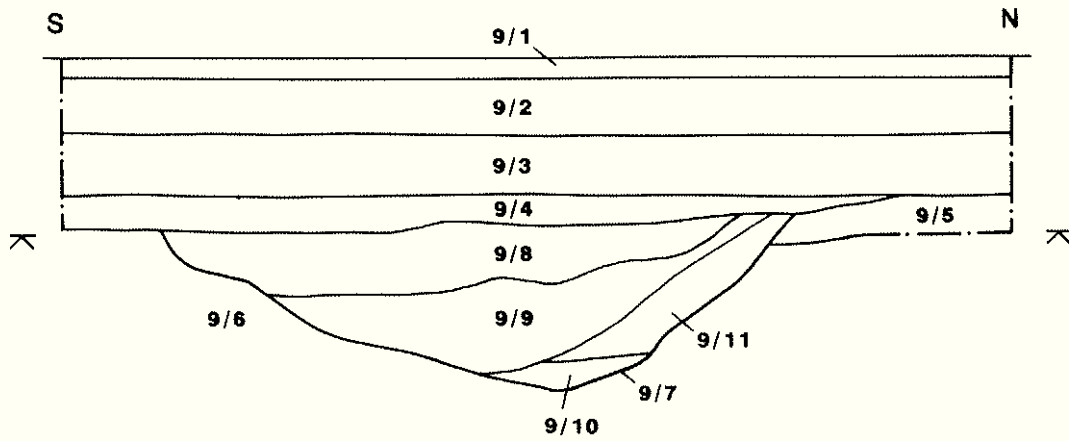
figure 6

An approximately east-west ditch (9/7) in Trench 9 was the only archaeologically-significant feature encountered on the site. The ditch was 2 m wide and 0.46 m deep, with sides sloping fairly evenly to an irregular base. The ditch cut through a layer of orange-brown silty clay subsoil (9/5) with 5 % limestone, which only survived in the northern part of the trench. Virtually identical layers were found in Trenches 3 (layer 5), 5 (layer 5), possibly 14 (layer 4), and 15 (layer 4). The primary fill (9/10) of the ditch contained approximately 50 % limestone, probably representing erosion of the natural geology. The remaining fills (9/8, /9 and /11) were all clay loams. It is possible that layers 8 and 9 form part of a recut (a second ditch on the same line; see Fig 6), but this was not recognised on site.

The upper fill (9/8) of the ditch was sealed by a layer (9/4) of mixed grey silt with 60 % limestone. It is possible that this represented a plough-damaged bank, as the soil was different from the ploughsoils found in other trenches. Layer 4 was sealed by a dark grey clay loam ploughsoil (9/3). This layer was found throughout the trench.

Trench 9 section

Only one archaeologically significant feature was found: the ditch in Trench 9 which contained late Bronze Age/early Iron Age pottery in its upper fills. The ditch would appear to have a restricted extent, and it probably terminated immediately to the west of the trench. Presumably a further ditch carried on the alignment westwards. The assemblage of pottery is very important in the local/regional archaeological context because settlement evidence of this date is relatively rare in and around Oxford. The assemblage is reasonably substantial given the small section of the ditch which was excavated. The dating implications are not absolutely clear, however, because all of the pottery was derived from the upper two fills; these could represent a secondary recut of the feature, in which case the original ditch might be middle Bronze Age or even earlier. In the absence of more positive evidence one can only say that the ditch was in use during the late Bronze Age/early Iron Age but that it may have an earlier origin.

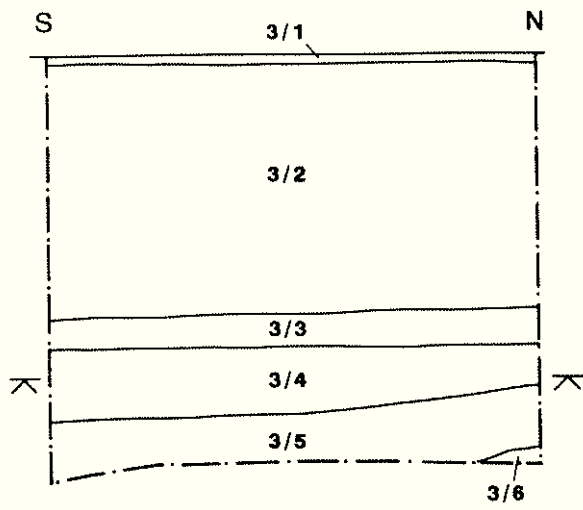
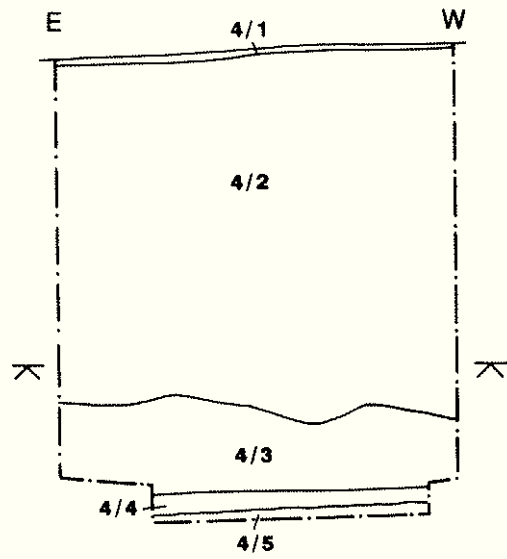
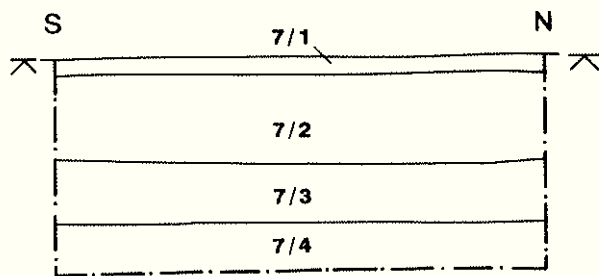
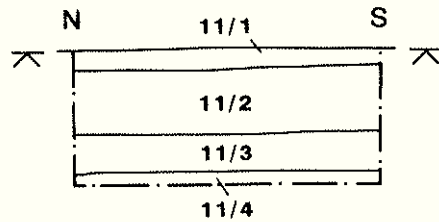
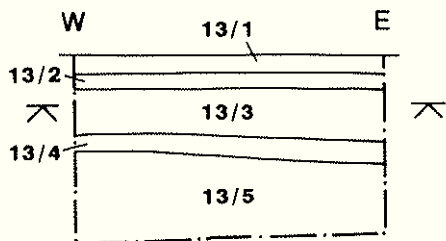
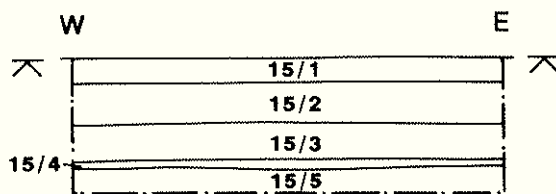
General sequence of deposits (Fig 7)

The natural limestone was exposed in all trenches, but the depth at which it was encountered varied significantly. There was very little soil cover between the modern tarmac and its make-up and the limestone at the east end of the car park, but other soils became more common in the middle of the site. A thin clay subsoil was noted in trenches 14 and 15, for instance, while ploughsoils of medieval or later date were noted in most trenches from the centre of the site westwards (1/3, 2/4, 3/4, 4/4, 5/4, 6/4 and 6/5, 7/3 and 7/4, 8/4, 9/3, 10/3 and 16/4). These were generally mid- or dark brown silty clays or reddish or yellowish brown clay sand. The layers were well-sorted and contained low levels of inclusions (usually less than 10 % limestone or other material such as sand). These were overlain by modern dumped layers in virtually all trenches in the eastern third of the car park, where the ground appears to have been built up slightly during the construction of buildings here before 1956. The sequence of deposits generally culminated in a coarse limestone gravel (hoggin) representing the bedding or make-up (context 2 in every trench) for the tarmac surface of the car park (context 1 in every trench where the tarmac was present). Trench 1 at the east end, however, was wholly cut through the concrete slab of a former building.

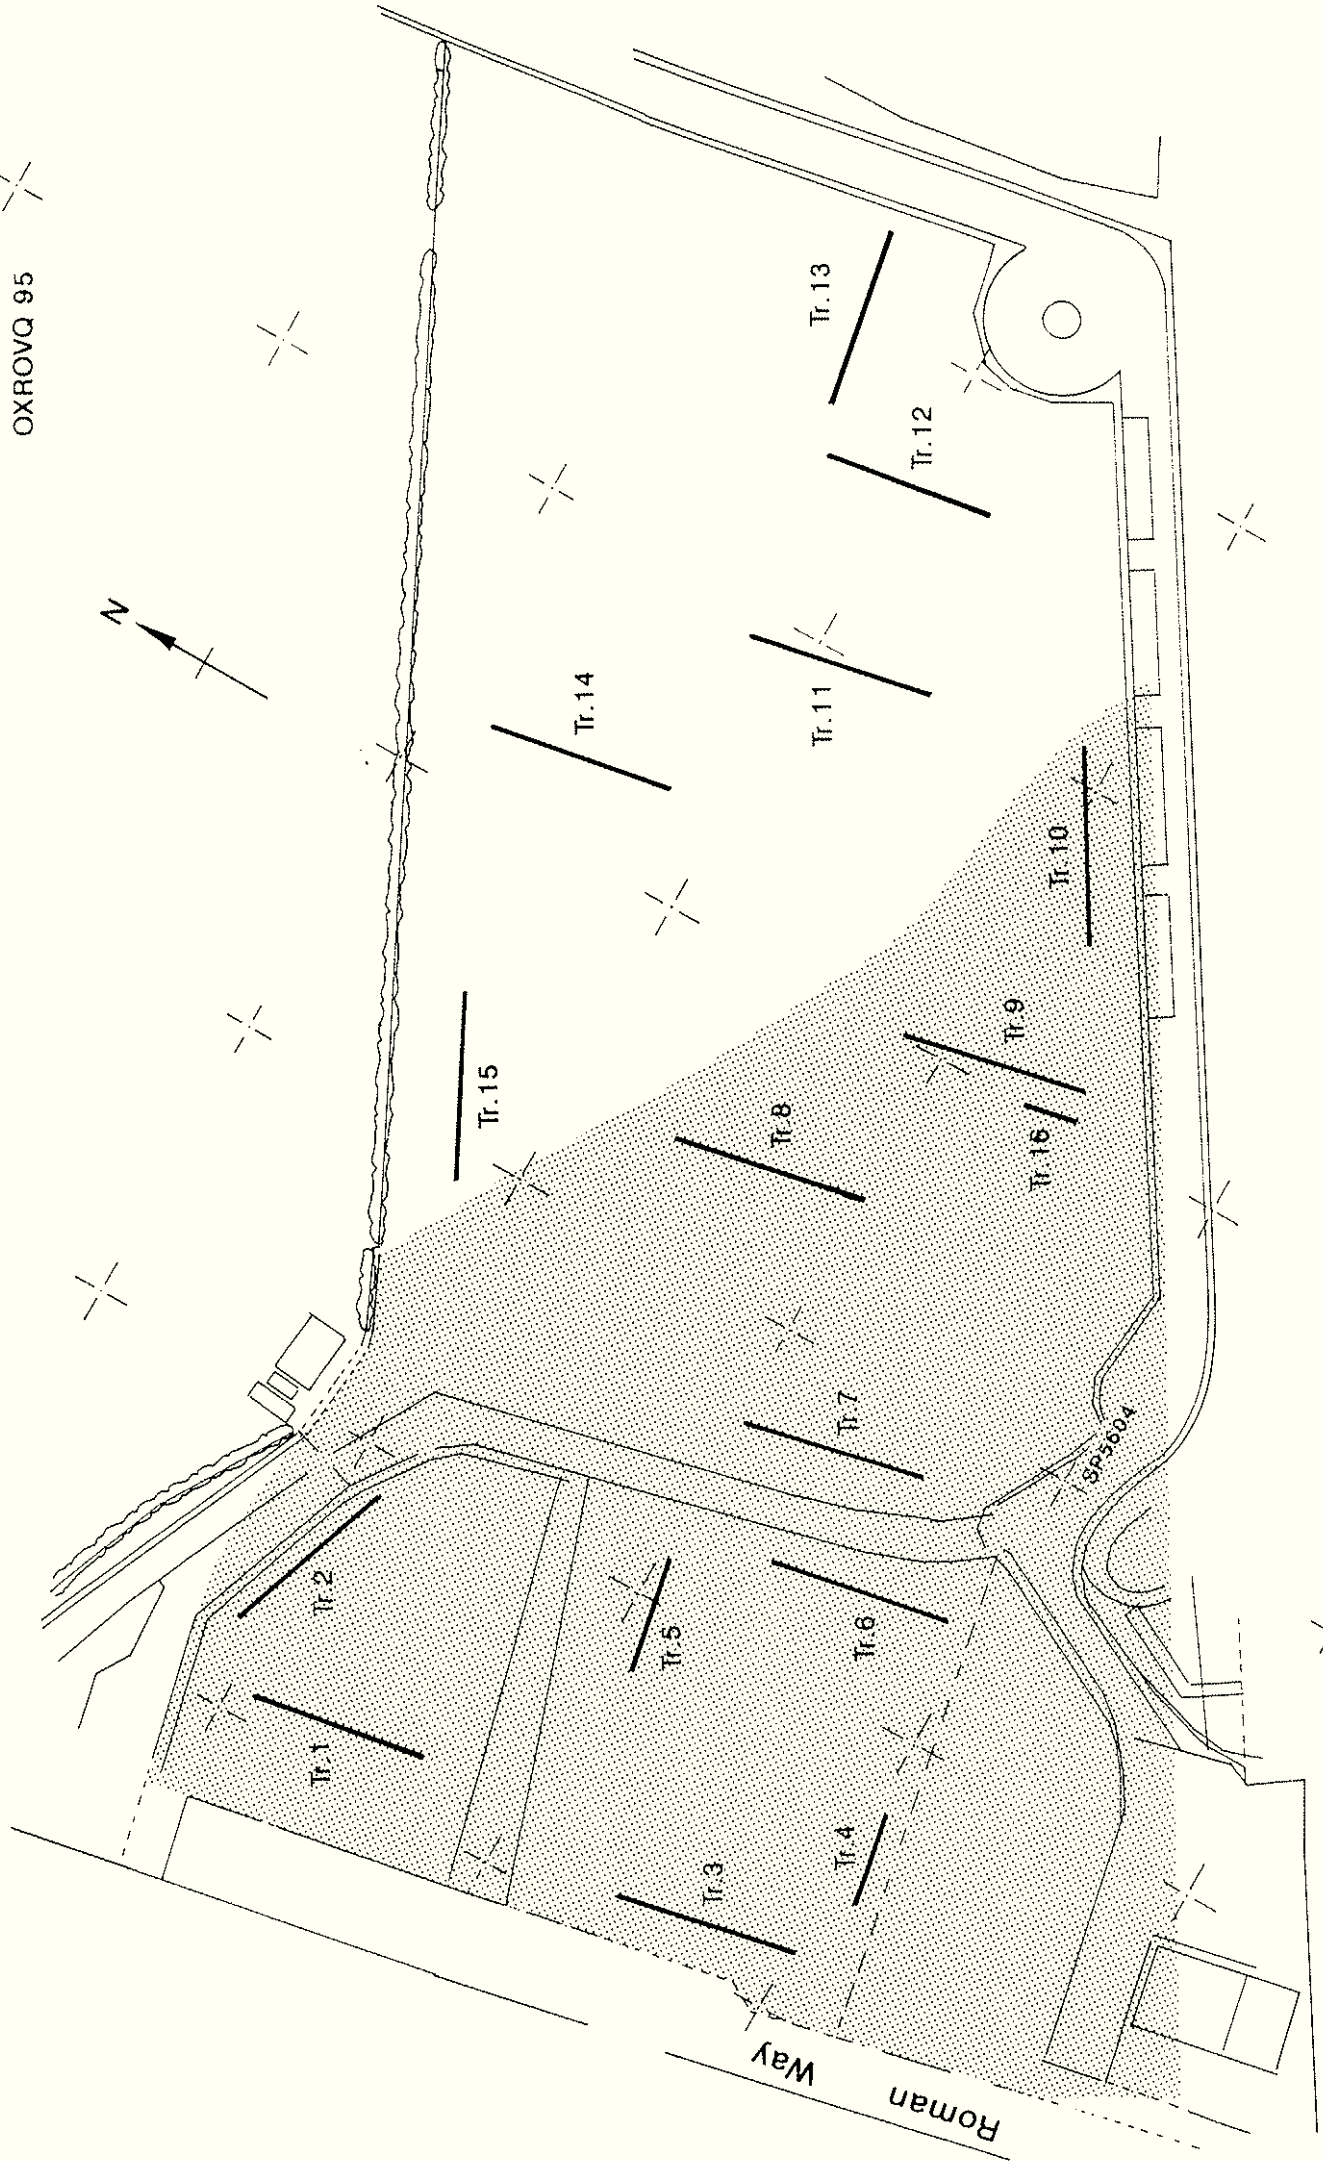
figure 8

natural topography of the site. The eastern third seems to have been stripped down to (and most probably into) the natural bedrock, removing all traces of the topsoil which was found over the central and western areas (Fig 8). Some of the material removed from the east end may have been dumped at the west end, as layers of disturbed soils were found in trenches 3 and 4. The natural topography otherwise comprised limestone, sometimes overlain by a clay subsoil, with ploughsoils over all.

area of ploughsoil

removed at the east end of the site; see Fig 8) suggests that the car park had previously been agricultural land for a very substantial period. The historical evidence (Appendix 1) certainly shows that this was an area of open fields in the late post-medieval and Victorian periods. The pottery evidence would suggest that this use goes back to the medieval period at least.

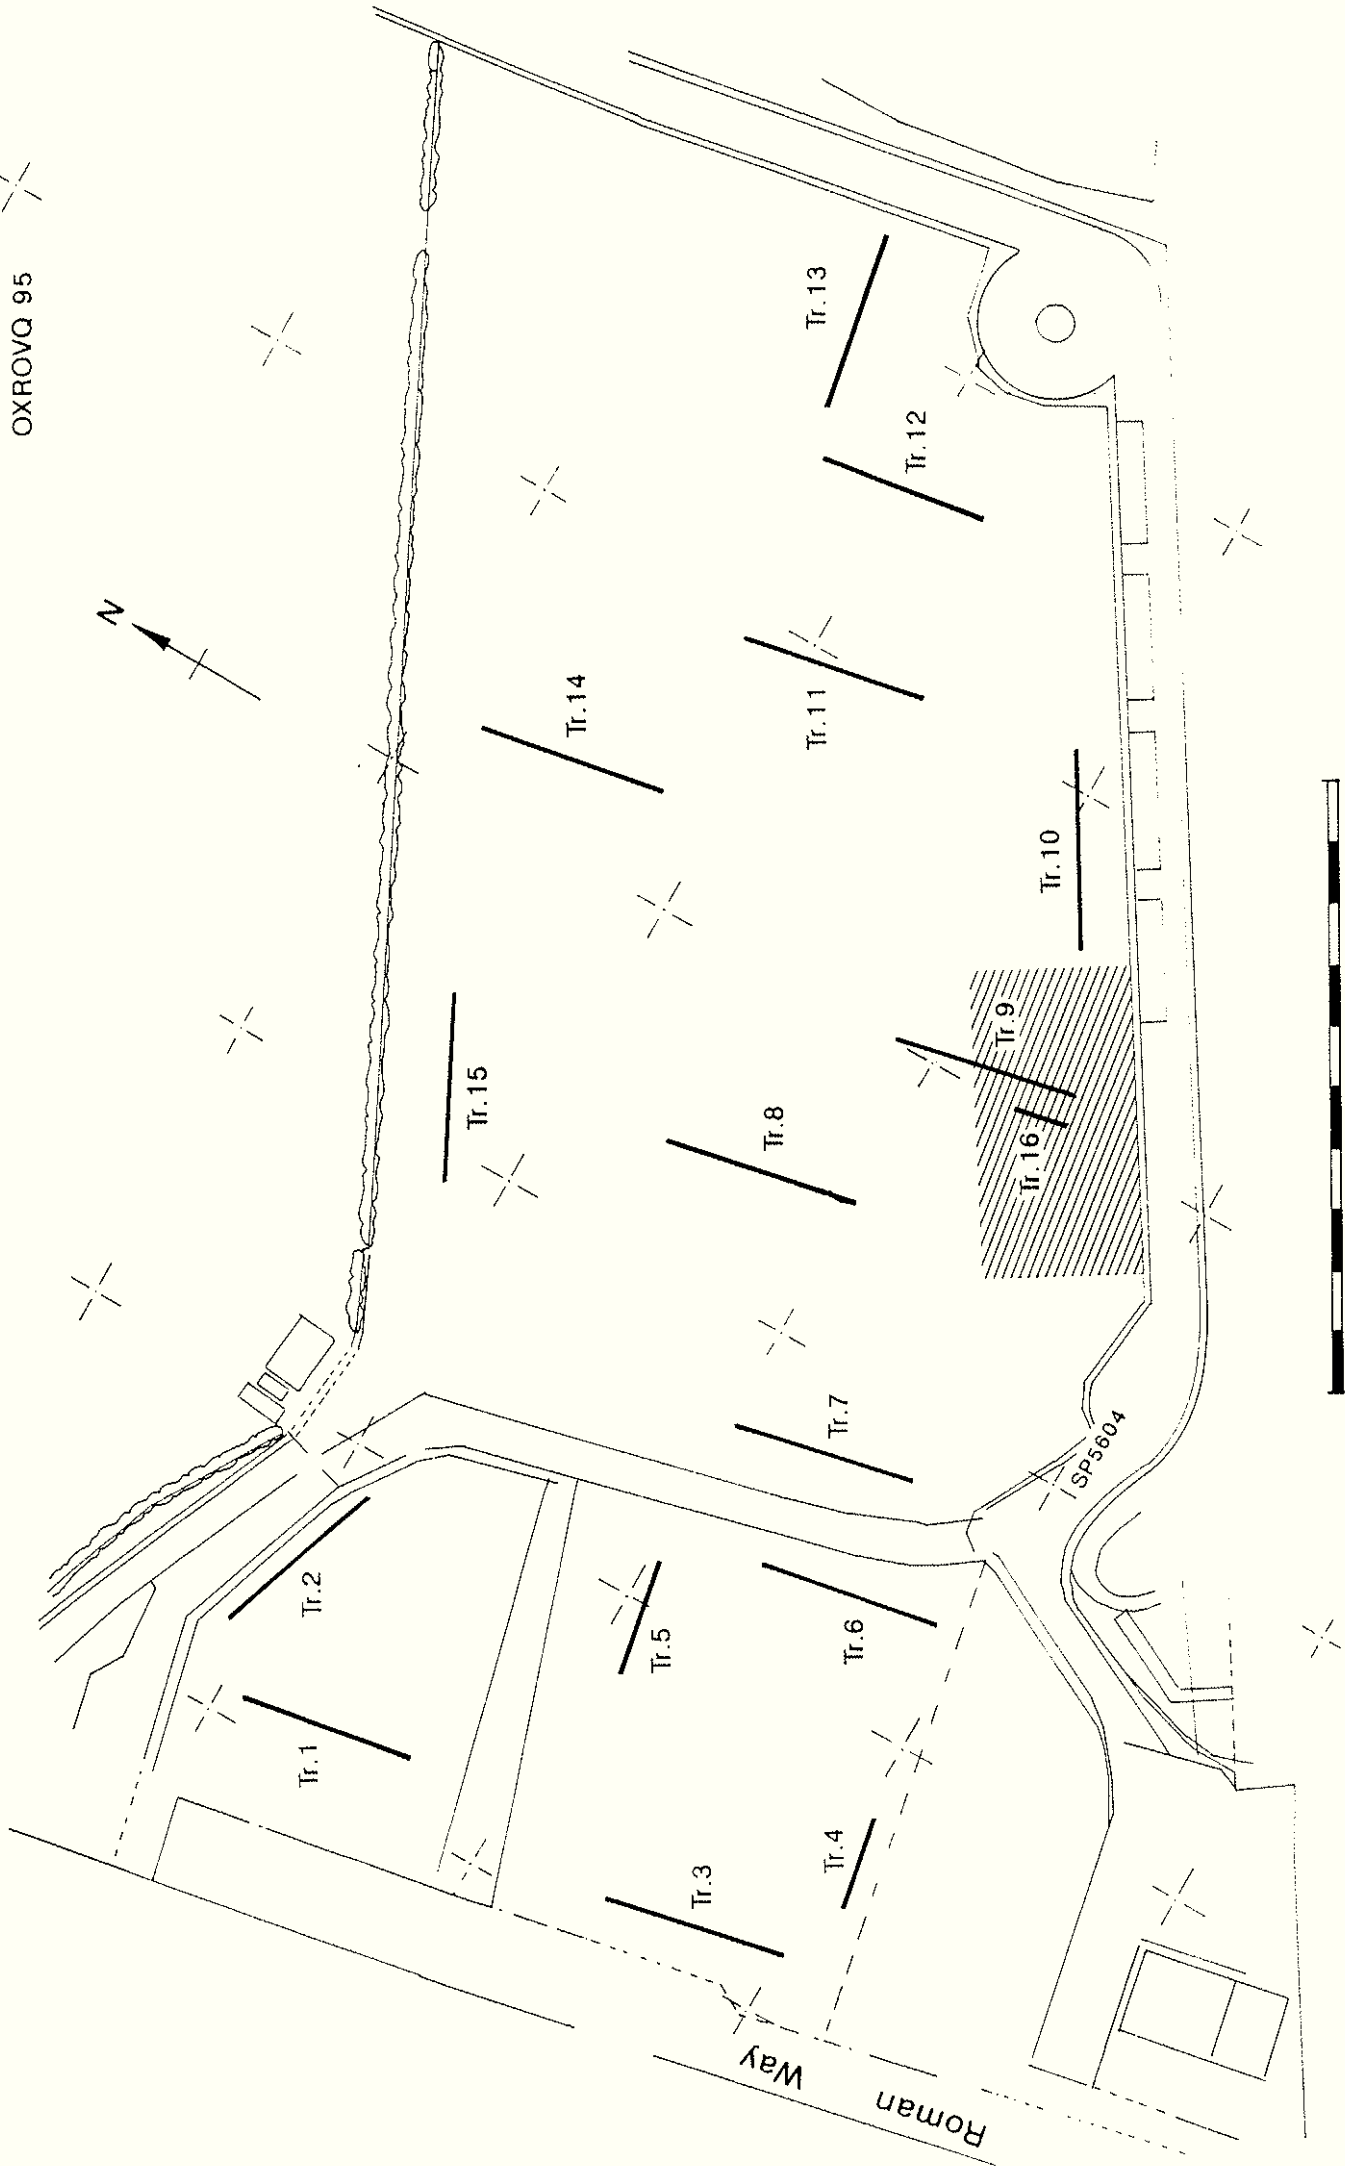
figure 9

The proposed development has been shown to contain one apparently discrete area of archaeological potential. This seems to be restricted to Trench 9/16 and perhaps an area to the south. No archaeology was found in the nearby Trenches 7, 8 and 10. Although the area lies just outside the building footprint, associated groundworks would probably have a significant impact on the archaeology. It is therefore recommended that an area around the south end of Trench 9 should be stripped under archaeological control and then archaeologically excavated prior to the development taking place so that the archaeology can be dealt with in advance. A suggested area for stripping is provided in Figure 9, but it must be stressed that the archaeology may extend beyond this area in any direction. It is possible that a larger area will have to be examined, although this seems unlikely on the available evidence.

suggested location of excavation

The evaluation established that there is a limited amount of archaeological interest within the development site, comprising evidence for late Bronze Age/early Iron Age activity. It is recommended that the relevant area should be excavated before building works commence. Otherwise the evidence from the evaluation was largely negative.
