# Bedfield Unitarian Chapel Bedfield, Suffolk

## Historic Building Recording

**Bedfield Unitarian Chapel, Bedfield, Suffolk**

*Historic Building Survey*

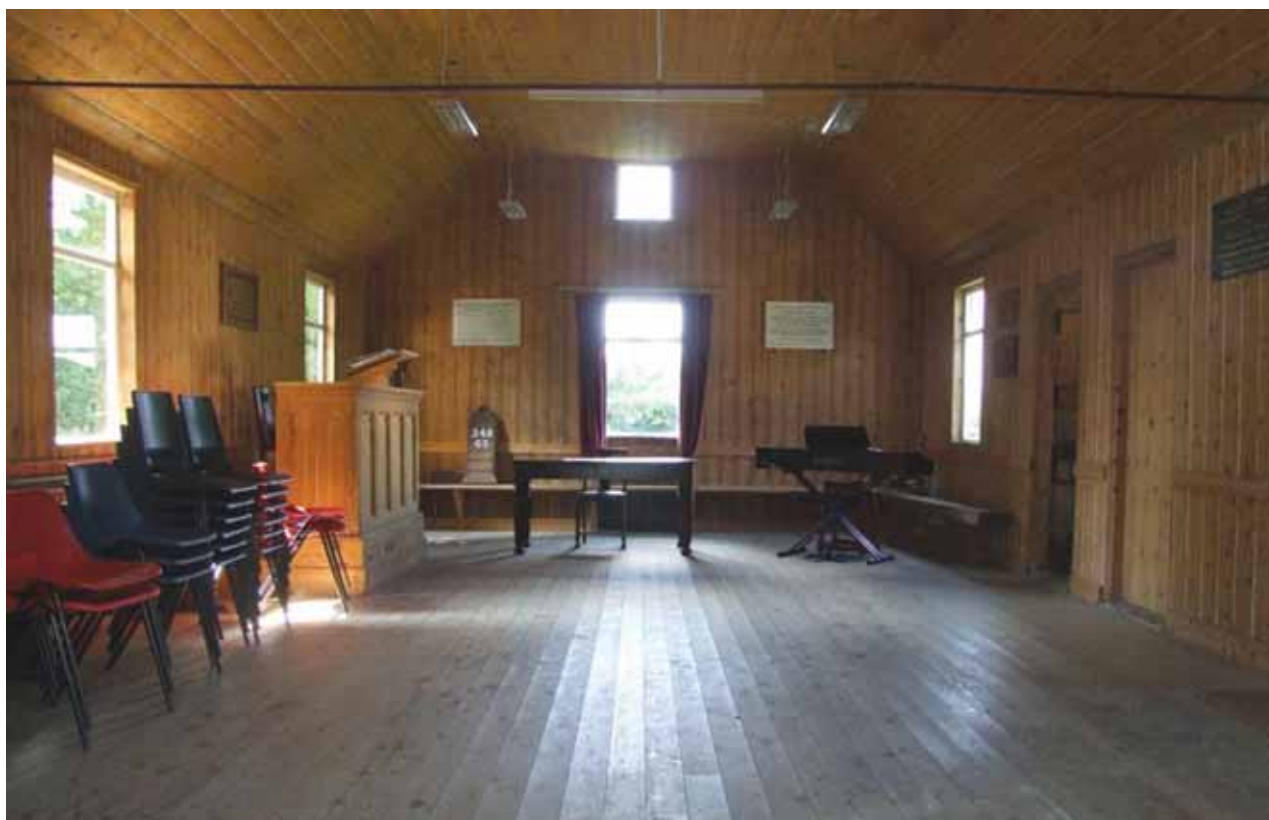
Figure 3: Photograph of chapel interior prior to closure (reproduced with kind permission from Simon Knott)

- 3.2.9 A photograph taken by Simon Knott, who has visited and photographed a number of Suffolk churches and chapels, shows the interior of the chapel taken whilst it was still in use (Figure 4). The plaques on the far wall which commemorate the works of Lucy Tagart and Florence Hill were moved to the Framlingham Unitarian Meeting House after the chapel closed ([www.onesuffolk.co.uk](http://www.onesuffolk.co.uk)).

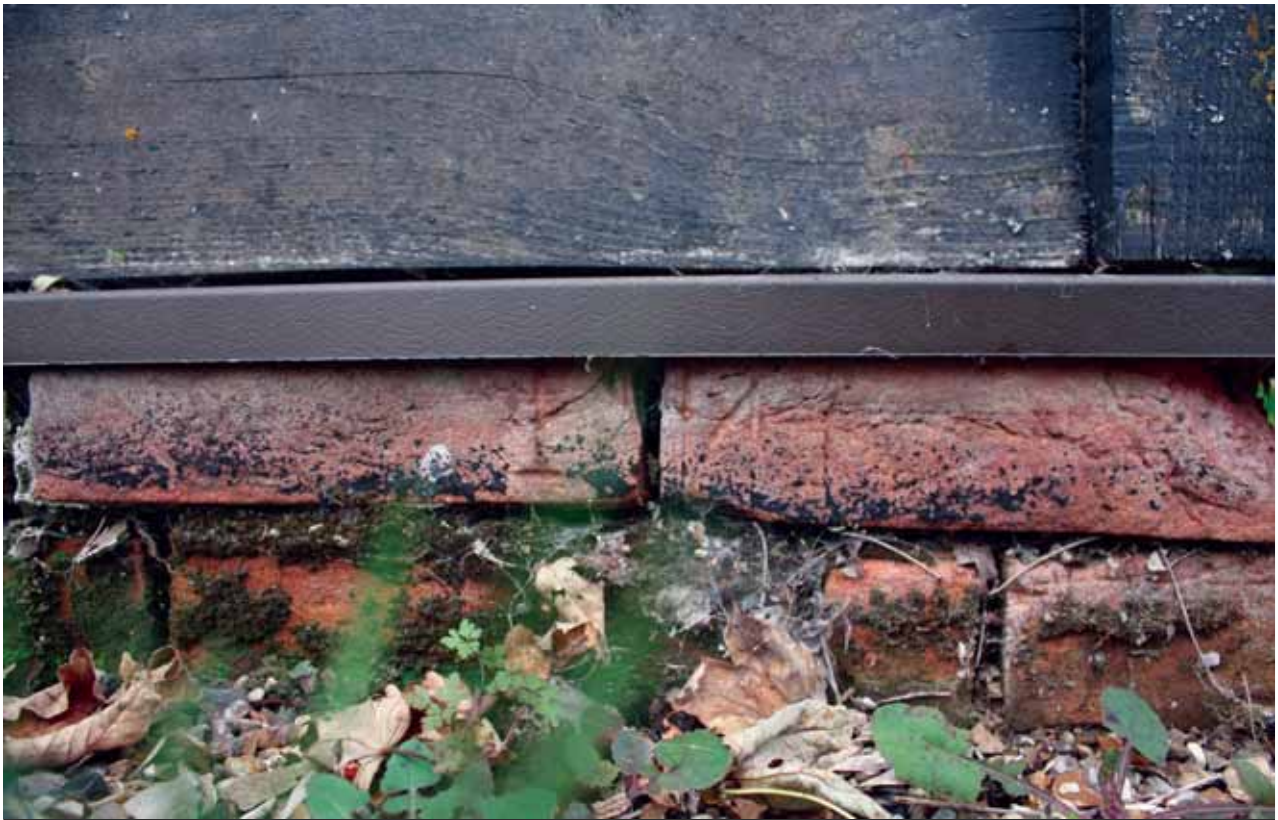
- 4.1.6 At both ends of this elevation are initials inscribed in the brickwork, perhaps of those involved in constructing the chapel (Plates 2 and 3). Although very worn and difficult to read, they appear to be “WW” and “PN”.

Plate 3: Detail of brick plinth on north-east facing elevation

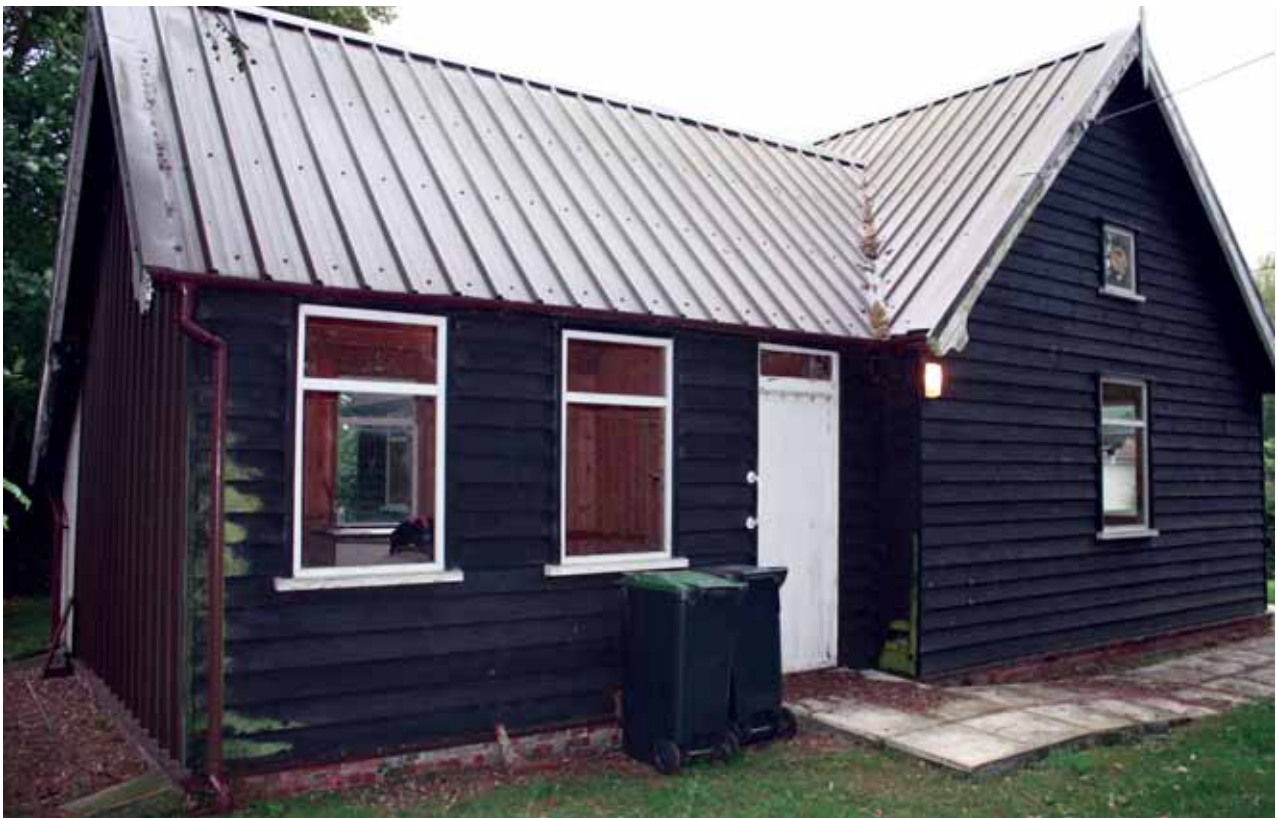
- 4.1.7 This elevation (Plates 4 and 5; Figure 5) reveals a later phase of addition to the rear of the chapel, shown as being present by the 1957 Ordnance Survey map (not illustrated).

Plate 4: South-east facing elevation

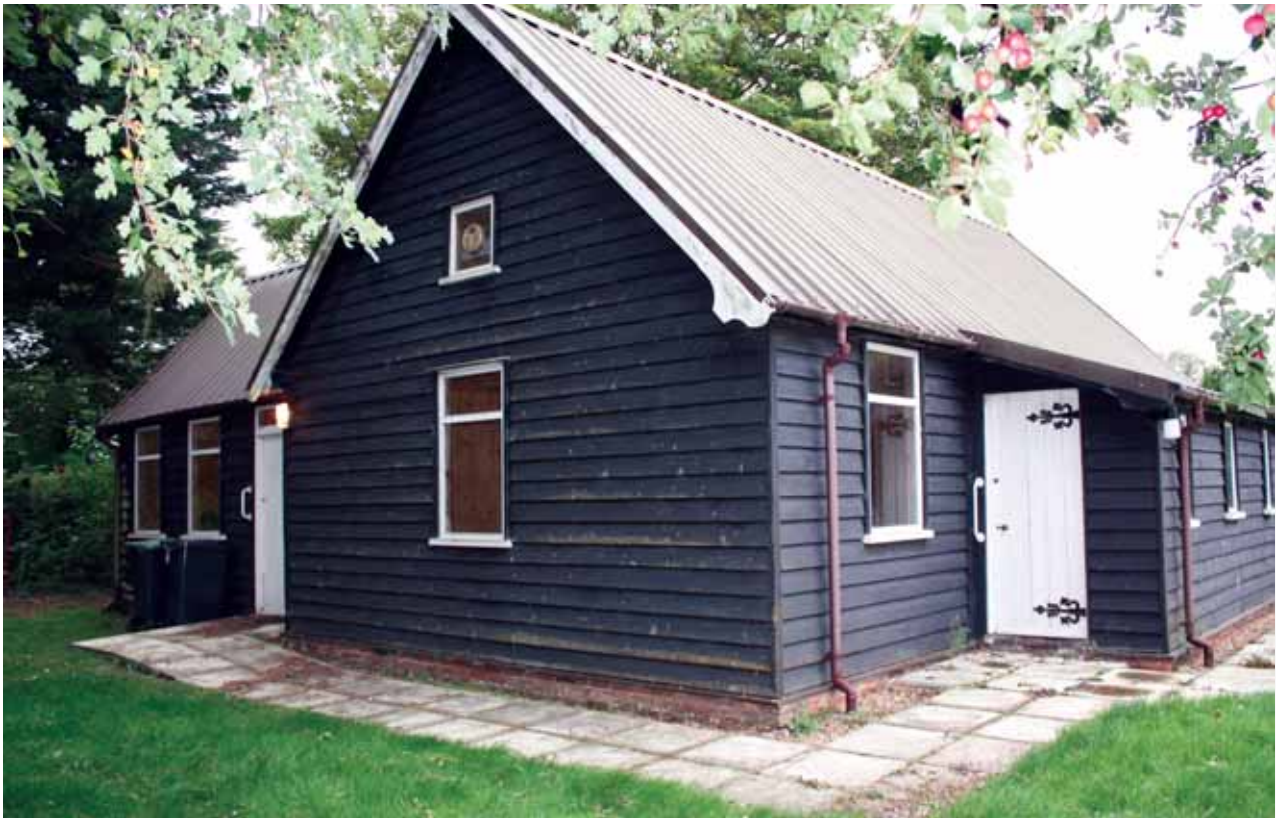
Plate 5: Corner of south-east and north-east facing elevations

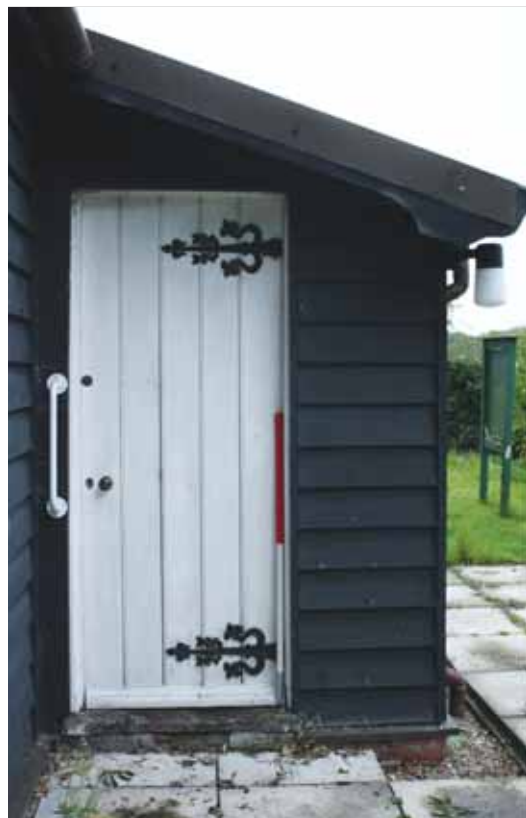
- 4.1.10 On the far right of this elevation is a door which is currently used as the main access to the building. This door is painted white with decorative, heavy iron hinges (Plate 6).

Plate 6: External door on south-east facing elevation

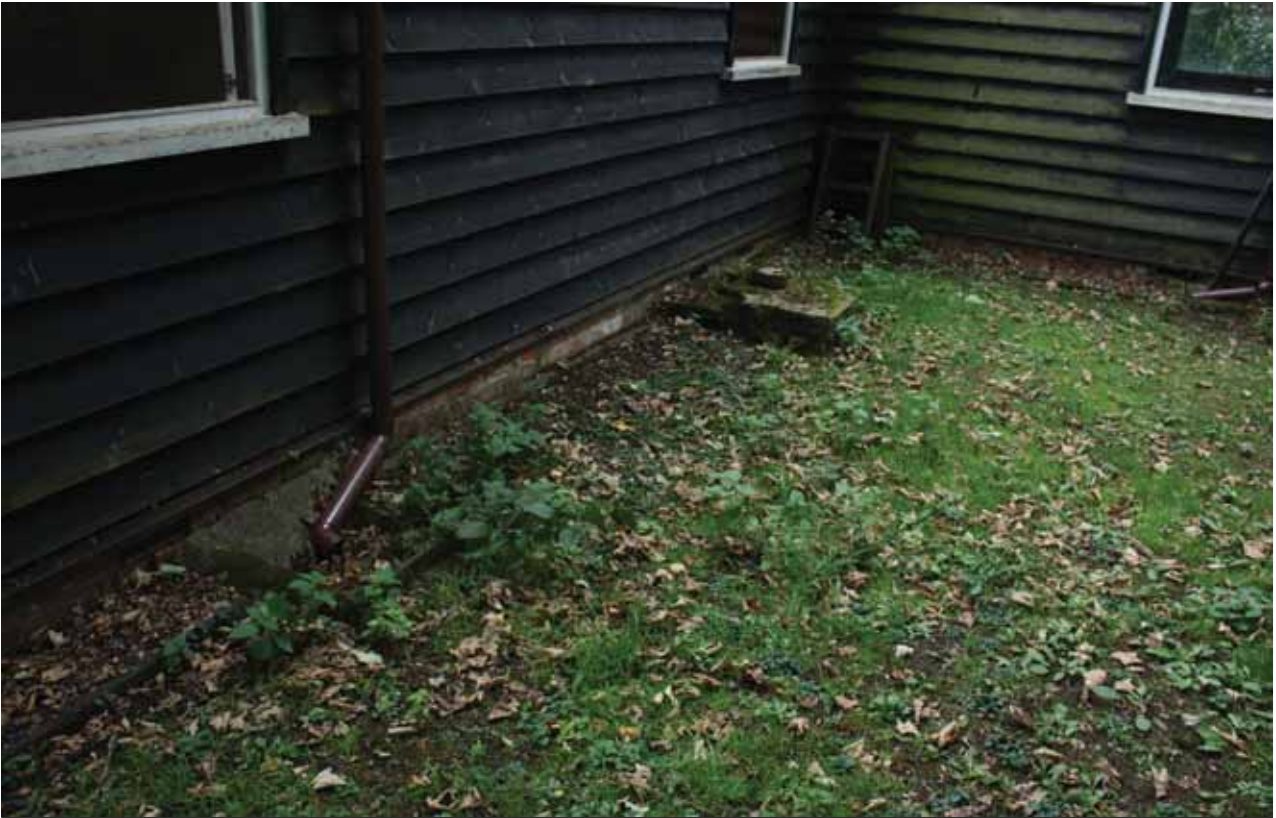
- 4.1.11 The south-west facing elevation incorporates the two principal phases of the structure (Figure 5). On the far left of this elevation is the rear of the original chapel building. There is evidence of the remains of what may be the small rectangular part of the building as recorded on the Second Edition Ordnance Survey map (Figure 3). All that remains is a small brick pillar, some concrete and part of a ceramic water pipe (Plate 7). The location would imply it is part of the original structure, although perhaps an external, separate feature, as there is no break in the brickwork to indicate an entrance into the main building here.

Plate 7: Remains of removed structure on south-west facing elevation

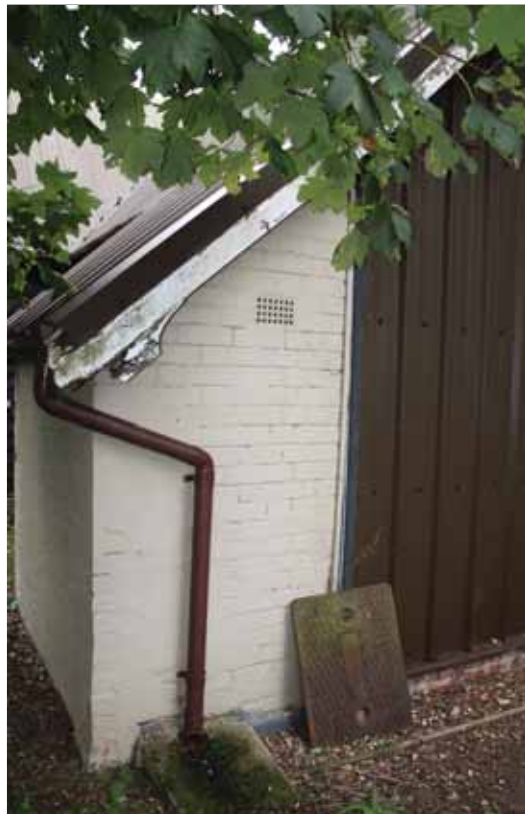
- 4.1.12 The gable end of the east-west extension is viewed from this elevation (Plates 8 and 9). There are two main elements to this: an area of brick wall on the left, with the rest comprising the same coated profiled metal sheeting as used on the roof covering. Both elements are contained beneath a moderately steep pitched roof with a plain wooden barge-board and carved diamond finial as seen on the south-facing elevation.

Plate 8: Detail of brick-built element of south-west facing elevation

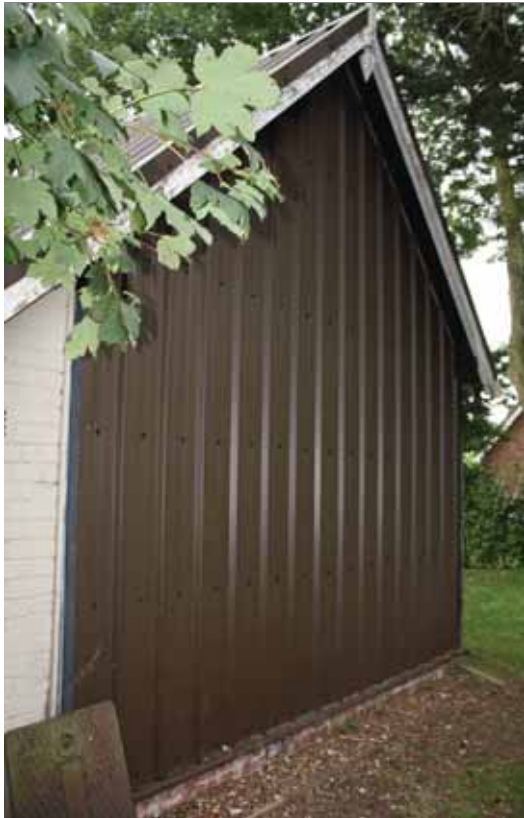
Plate 9: Detail of south-west facing elevation

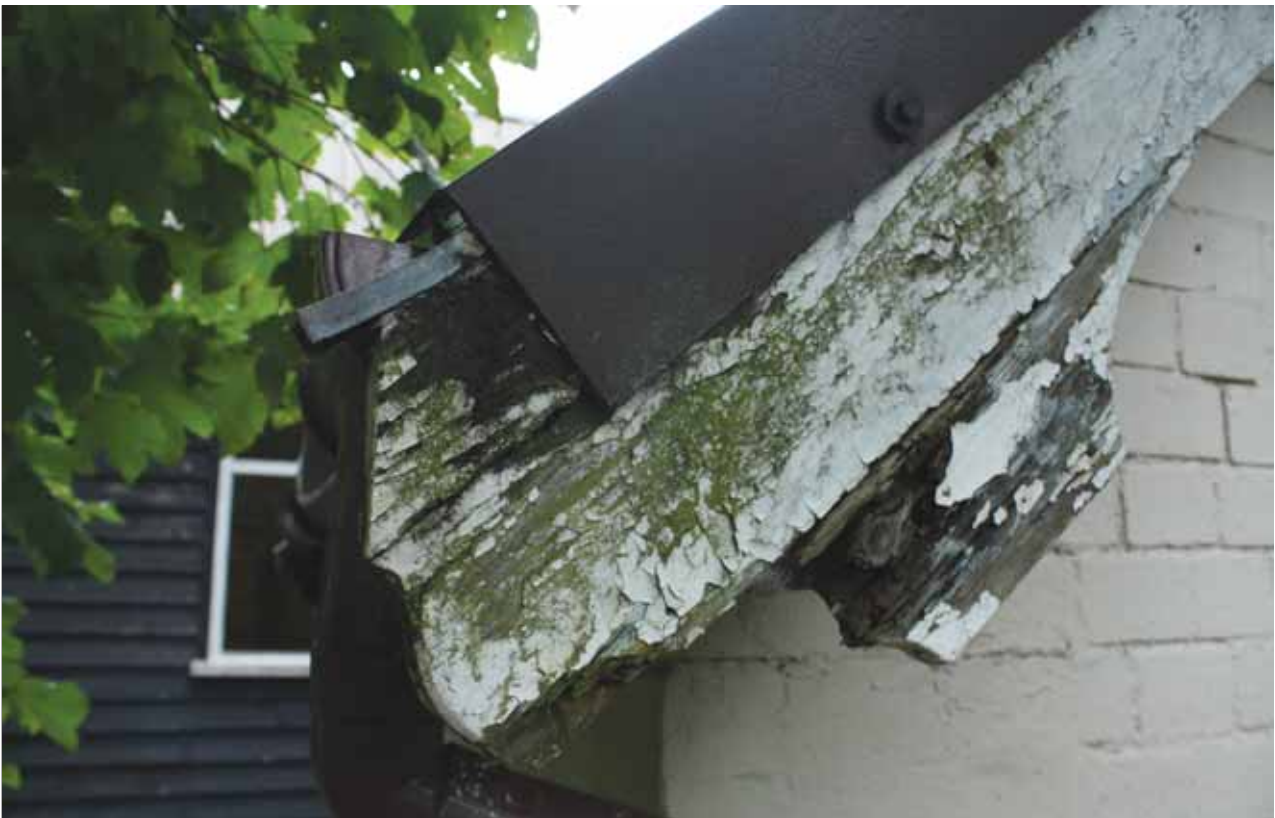
Plate 10: Detail of roof covering on eave of south-west facing elevation

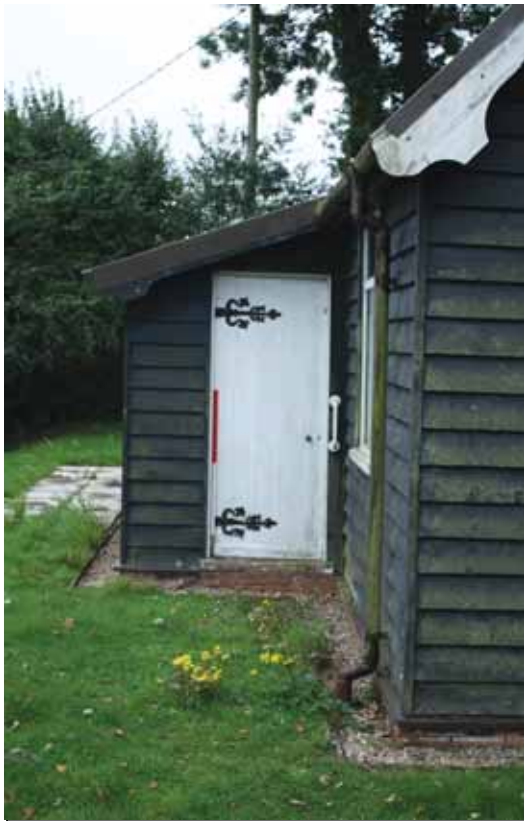
- 4.1.13 This side of the building almost mirrors that on the opposite south-east facing side with entrance door (Plate 11) on the left and gable end in the centre; both parts of the original construction. On the right is the east-west addition (Plate 12) and at the far end the brick-built extension (Plate 13). This brick-built addition is constructed using a Flemish bond with headers and stretchers laid alternatively in each layer of bricks. The roof has the same covering as the rest of the building, under a continuous pitch and there is a small wooden framed window on the east-facing wall (Plate 13).

Plate 11: External entrance door on north-west facing elevation

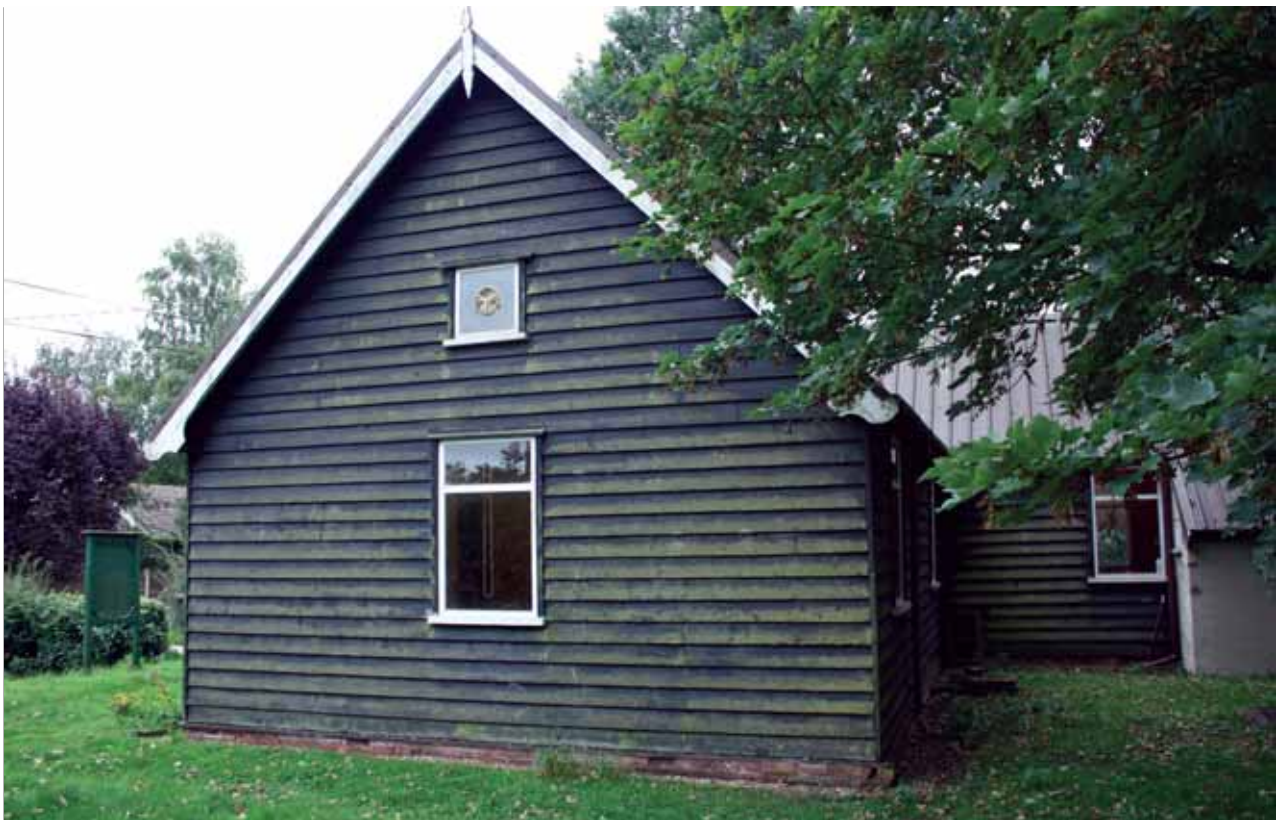
Plate 12: South-west facing elevation

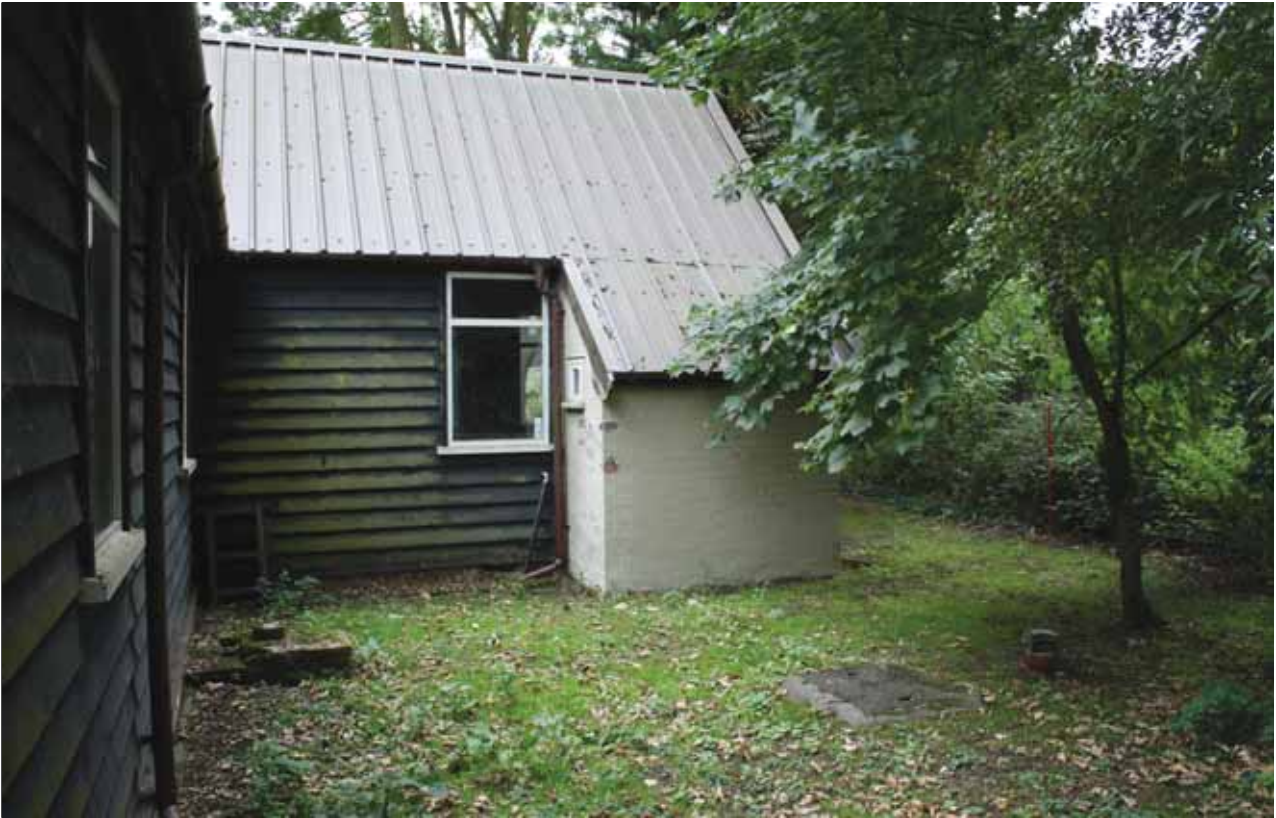
Plate 13: South-west facing elevation

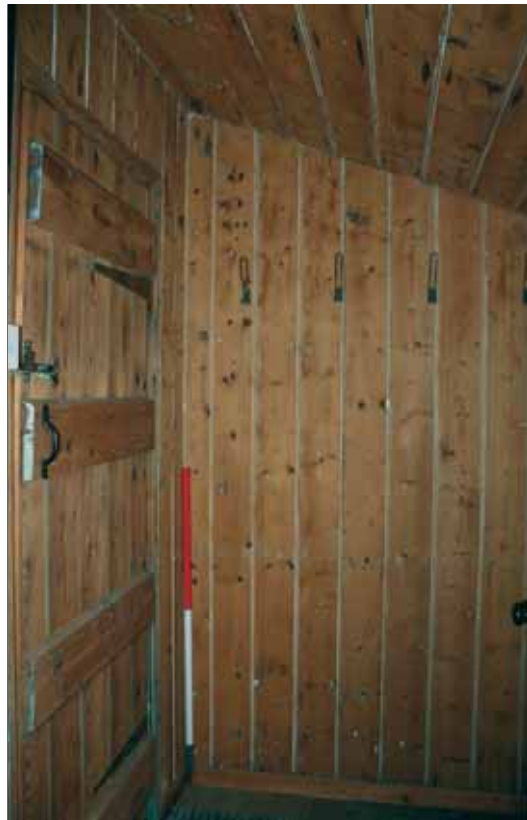
- 4.2.1 This area/room comprises the entrance area accessed from the external door recorded on the south-facing elevation (Plate 6). This small area measures 1.40m by 1.40m and is boarded throughout with a tongue and groove, vertically laid pine board, each board measuring 15cm (6") wide (Plate 14). Remnants of paint on the boards indicate that at some point all of the chapel interior was painted white. Wooden floorboards are exposed and a door on the left on entering provides access into the main hall. The hinges and latch (Plate 15) used on this door are typically late 19th century in date (Hall 2007) and therefore thought to be original.

Plate 14: Internal view of entrance area G1

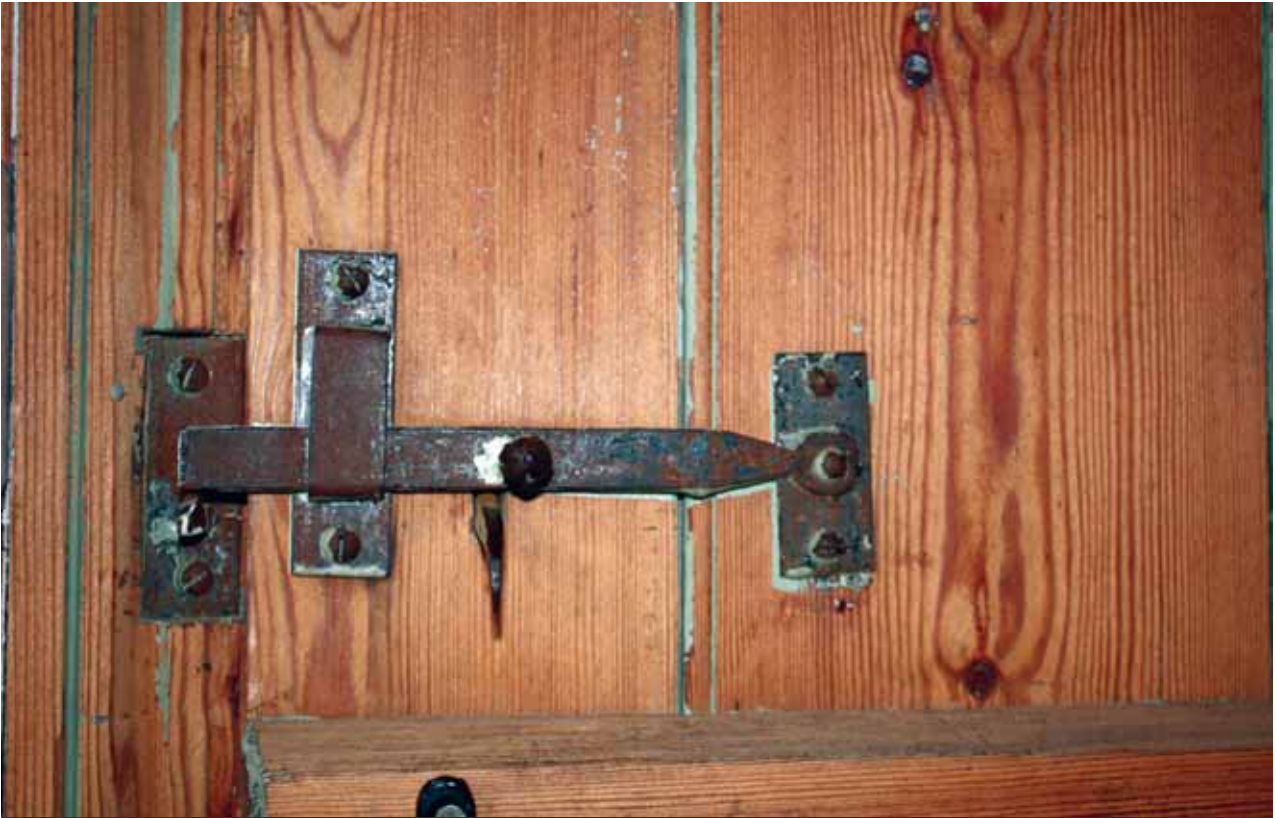
Plate 15: Detail of internal door latch, G1

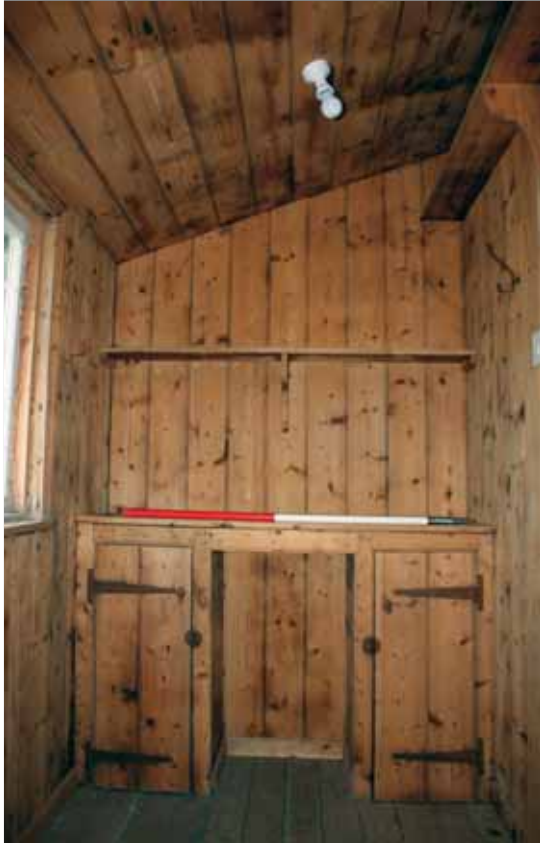
- 4.2.2 This entrance area is accessed via two internal doors from G3 and also externally via the door recorded on the north-facing elevation (Plate 11), which is no longer in use. This room measures 3.36m by 1.39m and, as G1, the walls and ceiling are covered with tongue and groove boards with exposed wooden floorboards.
- 4.2.3 This room has a number of interesting fixtures including a built-in cupboard at one end (Plate 16), a wooden shelf above and a number of iron coat hooks (Plate 17), all thought to be original.

Plate 16: Built-in cupboard, G2

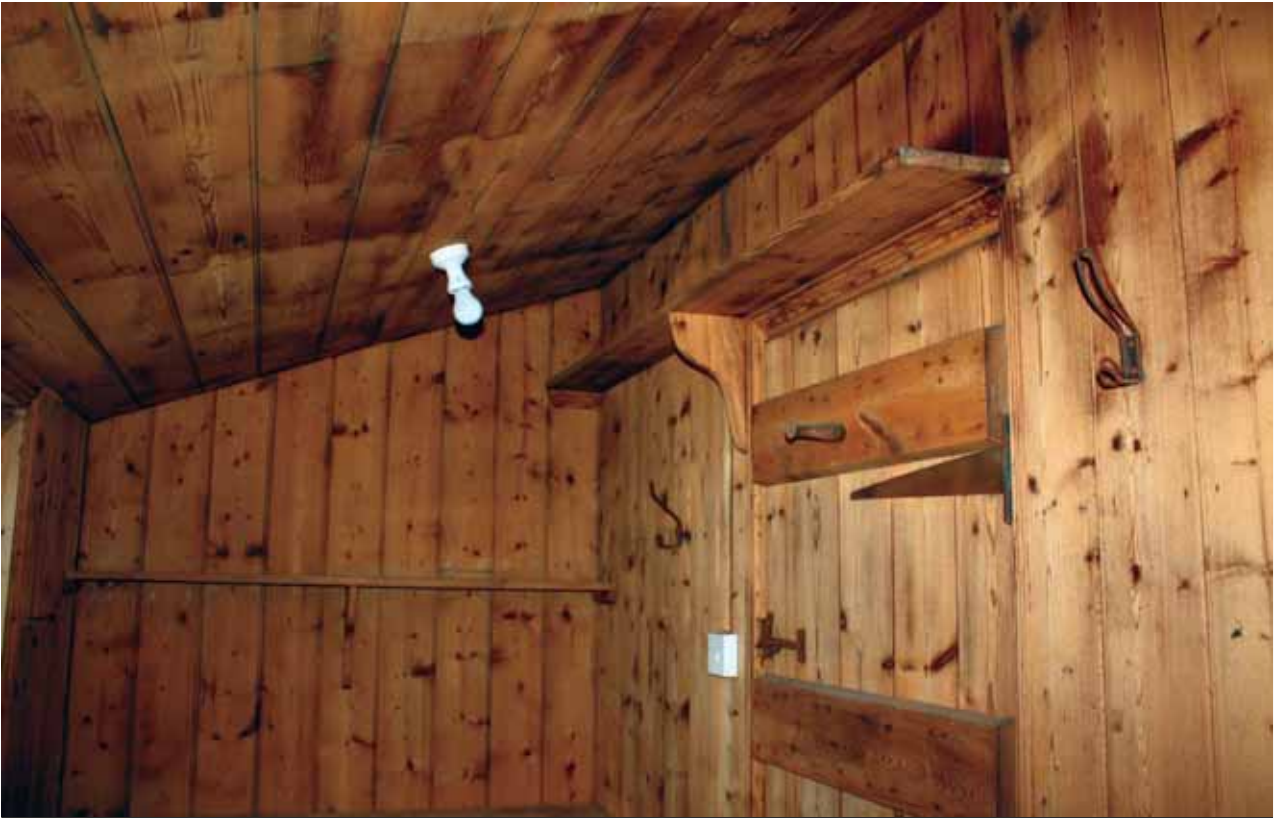
Plate 17: Detail of shelves and hooks, G2

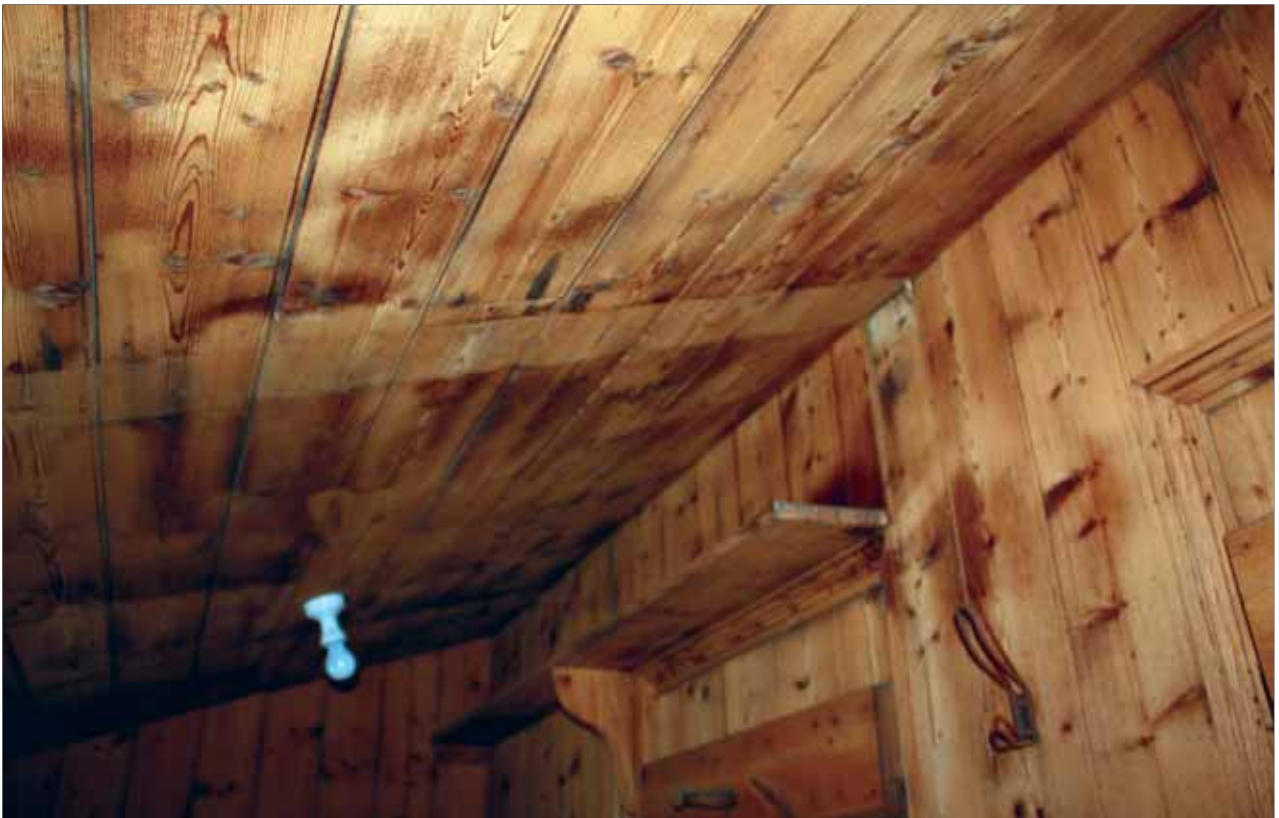
- 4.2.4 There are two doors in this room which provide access into the main hall. There is evidence on the wall and ceiling between these doors that there may once have been a temporary screen or dividing wall between these doors (Plate 18). This sub-division may have been to create a separate storage area (with cupboard), or it may have been used to separate the boy's and girl's entrances at Sunday School, as was common in the 19th and early 20th centuries.

Plate 18: Evidence of removed internal partition, G2

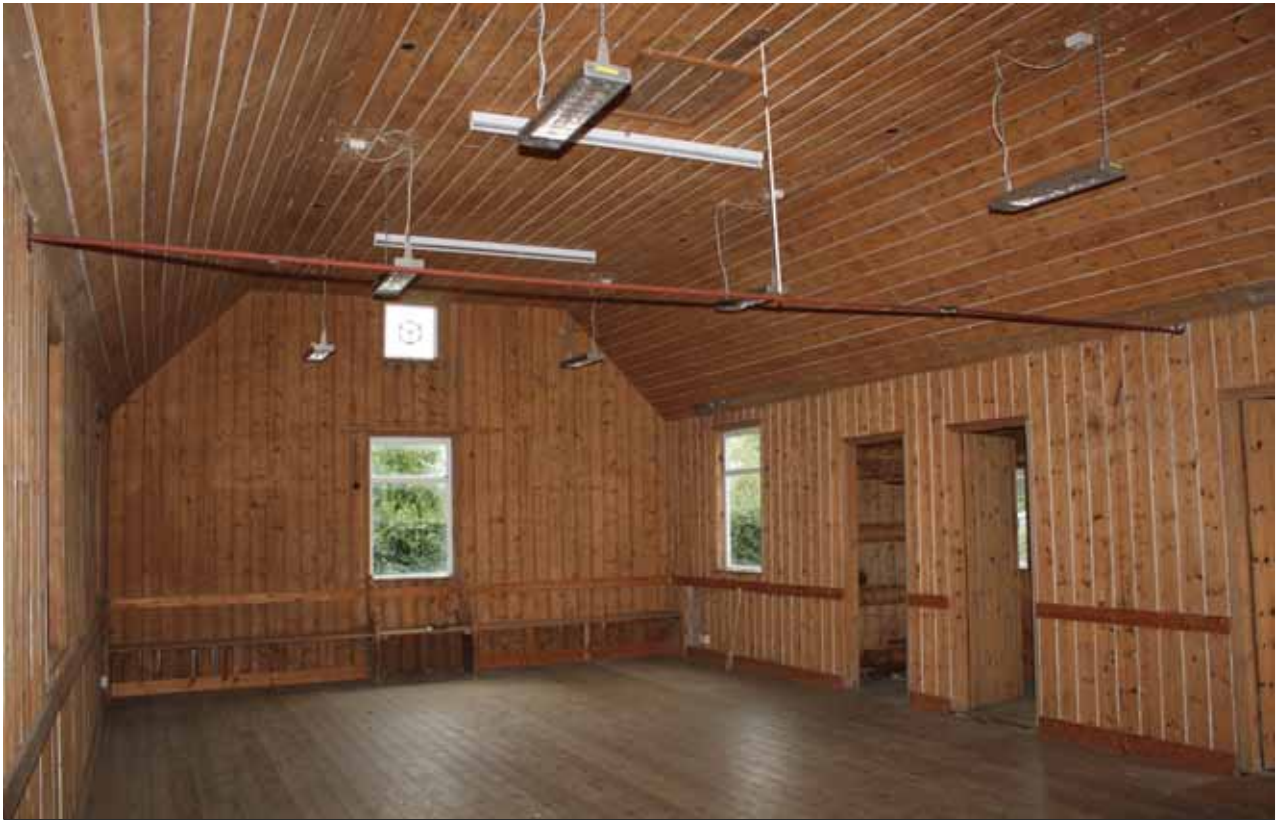
- 4.2.5 This area is the main chapel hall/meeting room, measuring 10.67m by 5.54m. Like the other rooms the ceiling and walls are covered with tongue and groove board and it has an exposed wooden floor (Plate 19).

Plate 19: General room view, facing north, G3

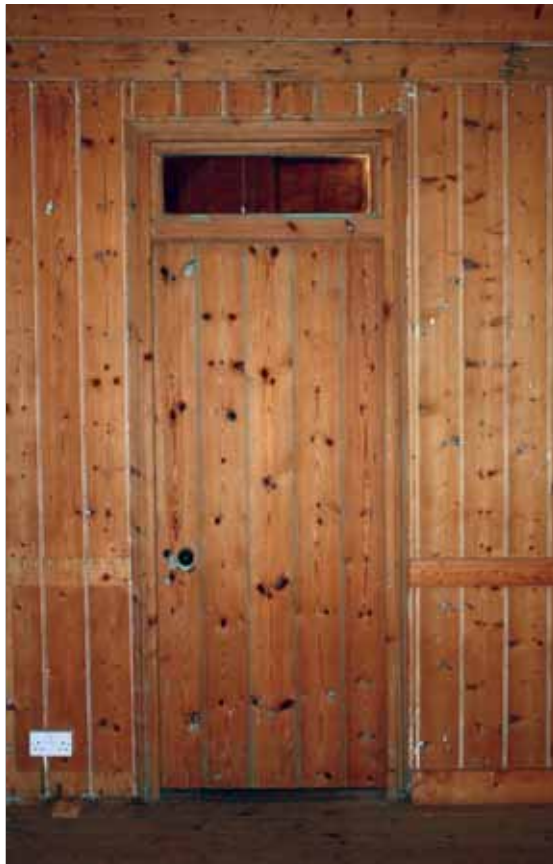
- 4.2.6 Internally there are three doors on the eastern side of the room; two leading into G2 and one into G1 and on the opposite side there is one door leading into the east-west extension (G4); (Plate 20).

Plate 20: Detail of internal door leading from G3 to G4

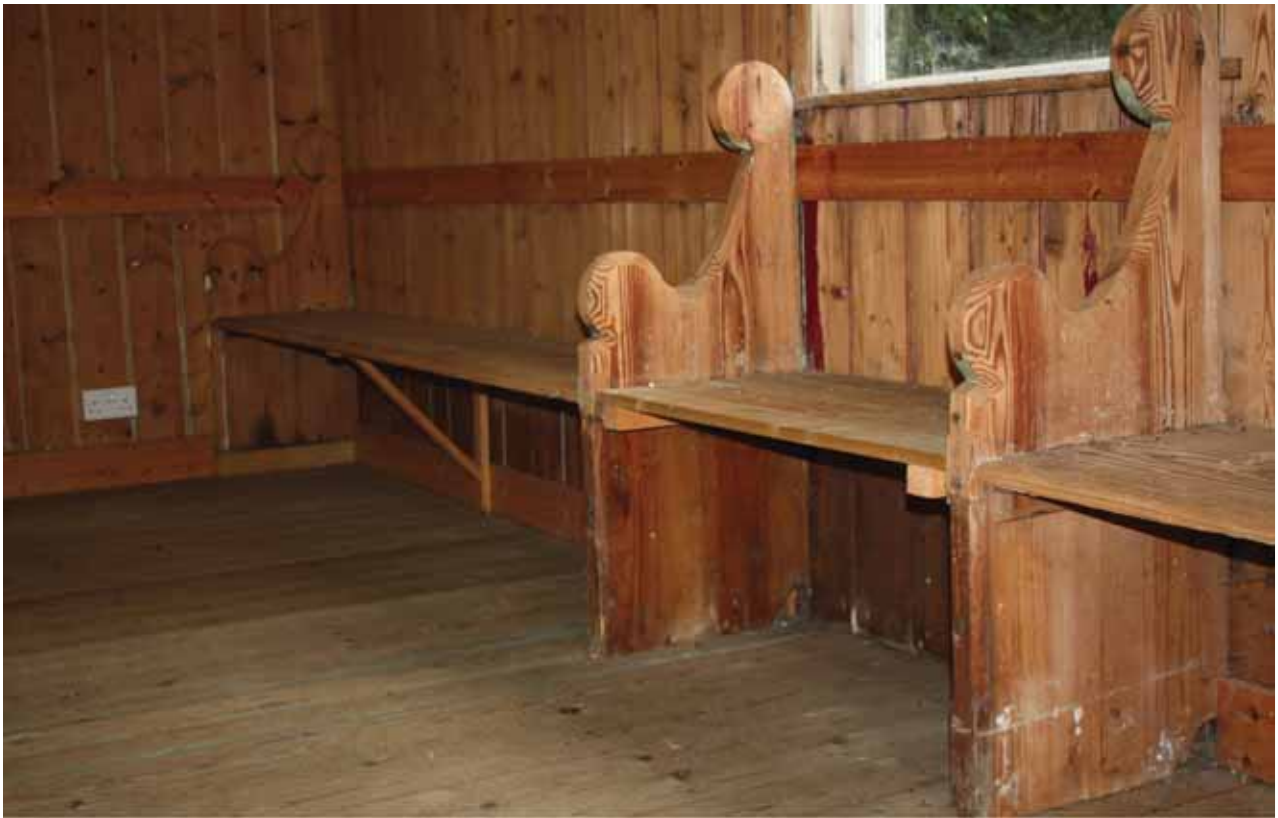
- 4.2.7 At the northern end of G3 there is a fitted wooden bench which spans the width of the room (Plate 21). This bench has a centrally located seat with carved scroll ends and chamfered edges.

Plate 21: Bench at northern end of G3

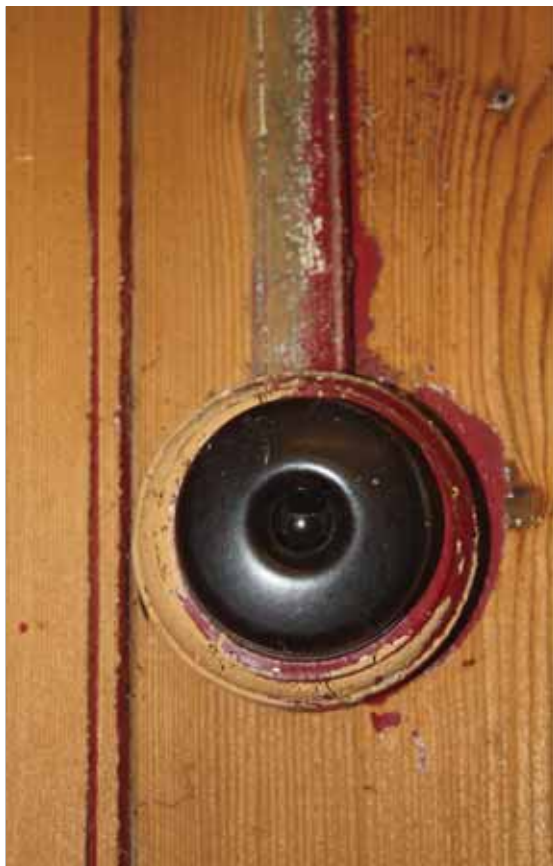
- 4.2.8 A chair rail and skirting board run all the way around the room – these appear to be a later addition. There are also a number of bakelite light fittings as well as evidence on the walls where fittings had previously been (Plate 22).

Plate 22: Detail of Bakelite light switch, G3

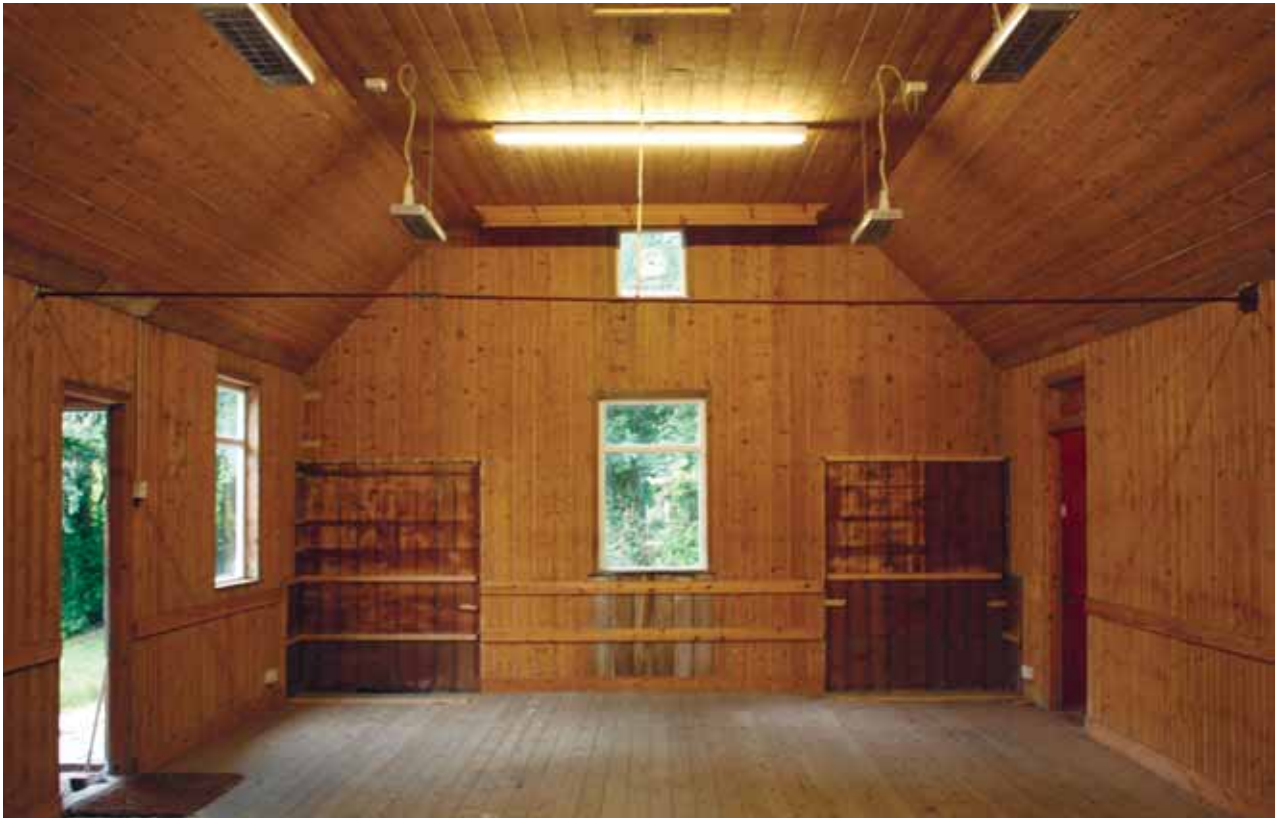
- 4.2.9 On the southern end wall are marks which would indicate the presence of built-in cupboards which have been removed (Plate 23) as well as evidence of pictures and other wall hangings throughout the room which correspond to some of those seen on Simon Knott's photograph (Figure 4) taken whilst the chapel was in use.

- 4.2.10 There is an access to the roofspace, however it was not safe or possible to investigate this during the visit. There is a large iron tie which spans the width of the room and has been added to provide structural support (Plate 23).

Plate 23: General room view, facing south, G3

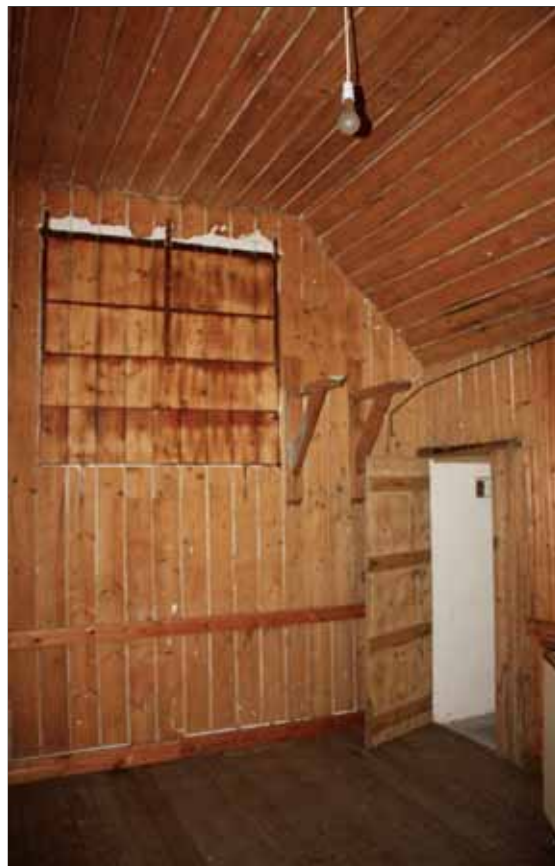
- 4.2.11 This room comprises the roughly east–west orientated extension recorded at the rear of the chapel. As with the other rooms, this is also covered with tongue and groove board, however the boards used are narrower, measuring 14cm (5<sup>1/2</sup>"") wide. This room has a sink and cupboard and was until recently used for welfare/making refreshments.
- 4.2.12 At the far end (west) of the room there are marks on the wall which indicate the location of a cupboard (Plate 24) as well as two large wooden brackets/supports.
- 4.2.13 There is a wooden plank-and-batten door which provides access into G5 (Plate 24), whilst a door on the southern wall which provides access from outside as recorded on the south-east facing elevation (Plate 25). This door appears to be a fairly modern replacement.

Plate 24: Evidence of removed cupboards and internal door, G4

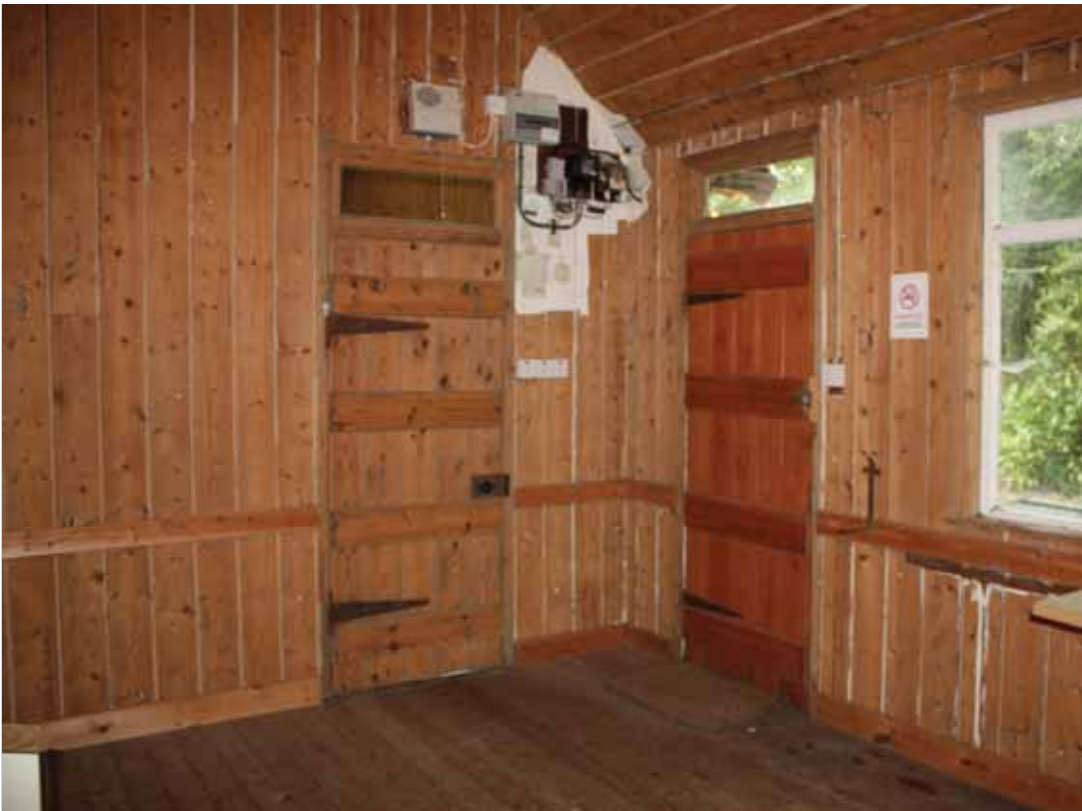
Plate 25: Detail of doors, G4

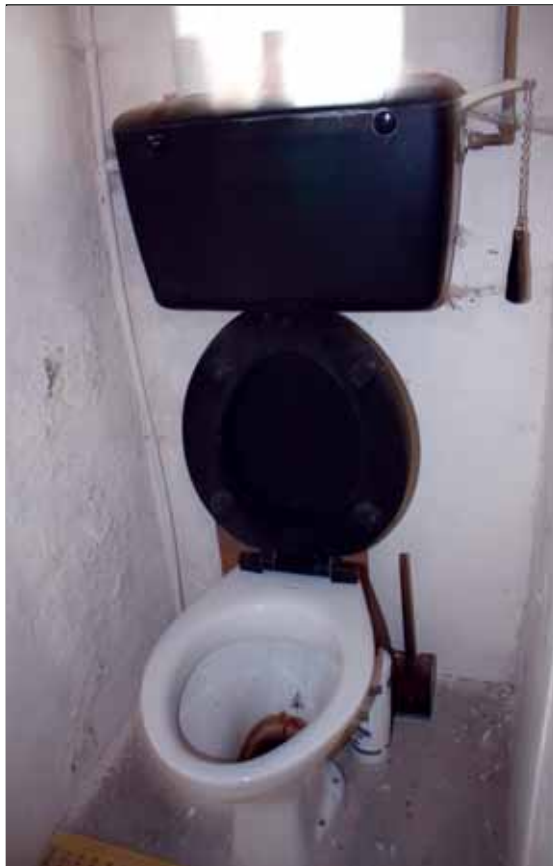
- 4.2.14 This small room is accessed via an internal door from G4 and measures just 1.53m by 0.84m. There is a small casement window on the east-facing wall and a mid-late 20th

century toilet unit below (Plate 26). The brickwork wall is exposed and painted white and the floor is covered with concrete.

Plate 26: General room view, G5
