St GILES CHURCH OXFORD. OXSGC94(SP 512071)ARCHAEOLOGICAL WATCHING BRIEF REPORT.INTRODUCTION.

The Oxford Archaeological Unit undertook a watching brief at St. Giles Church, Oxford, during the renewal of the floor of the South Chapel.

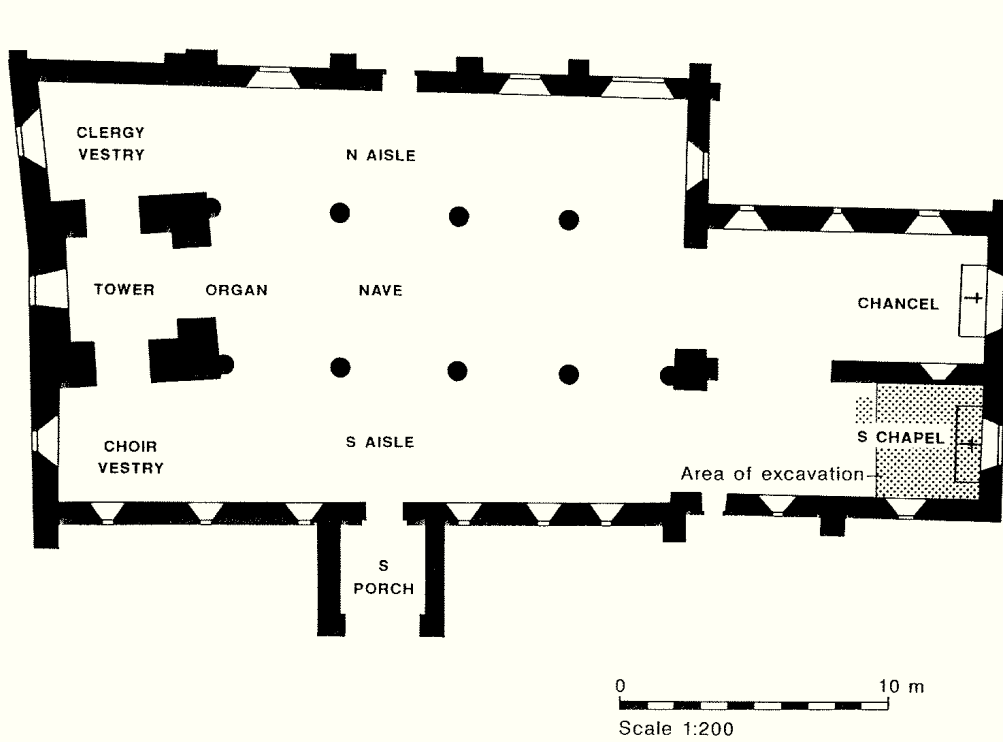
figure 1

Along the S side of the chapel was a 1.0 m deep pipe gully which was not disturbed by the excavation. The remaining area was filled with a very loose dumped deposit (1) of mid brown sandy silt, with considerable quantities of brick fragments, concrete and light gravel.

Layer 1 was removed to a depth of 0.9 m, revealing two partly demolished brick walls (2), oriented W-E and one course thick, extending below the limit of excavation. The walls were 1.35 m apart, and the N wall was revealed sufficiently to indicate a length of 1.8 m, and a return to the S.

The face of the E wall of the chapel showed traces of a plaster rendering between the two brick walls.

The stepped out footings of the N wall of the chapel were revealed; these continued along the E wall to the N brick wall.

To the W of the walls (2) was an area of compact dark brown gravelly silt (4), cut through from W-E and backfilled with material similar to layer 1. No finds were recovered from the excavated part of layer 4.

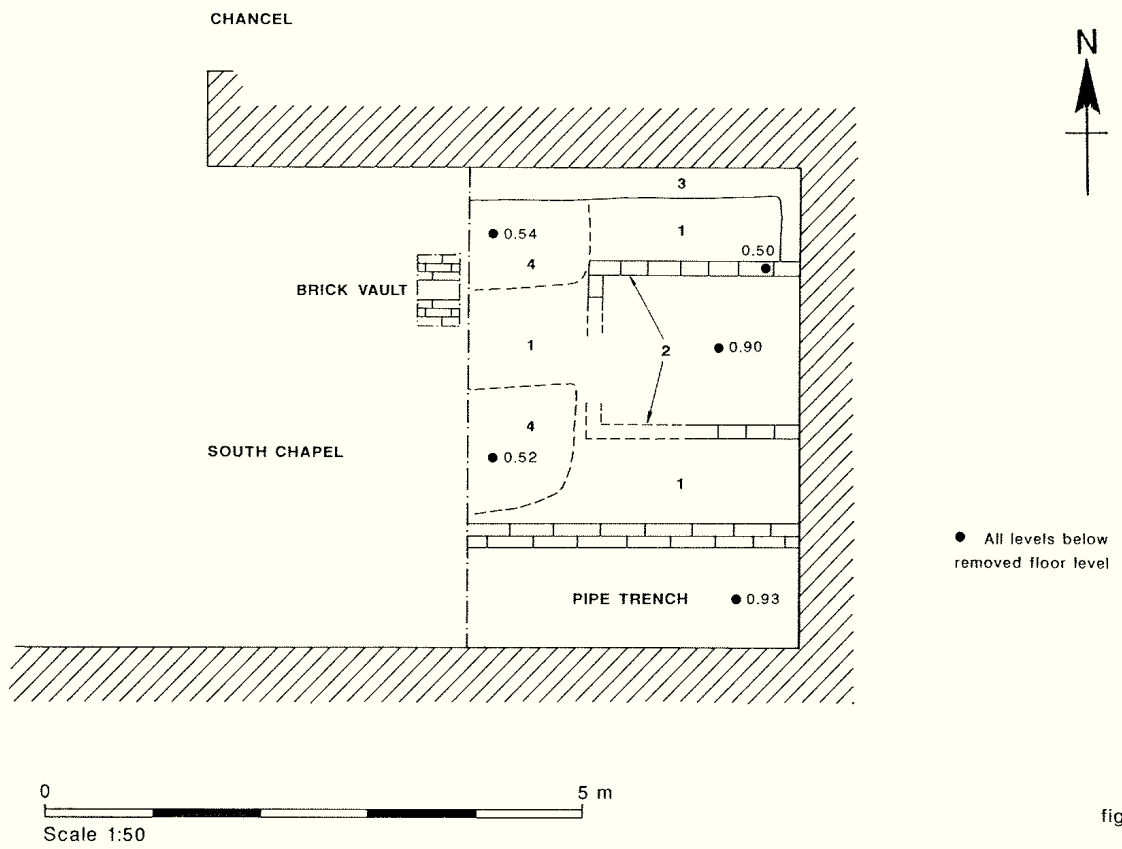
Visible under the floor to the W of the excavated area was the barrel top of a brick vault, extending to the W. It is reasonable to conclude that the brick walls (2) represent the surviving structure of another vault, demolished and backfilled. It would appear that the construction of the vault entailed the cutting back of the E wall footing. The backfilled cut through layer 4 may have been a common entrance to both vaults.
