Post-Medieval Lime Kiln  
at the former Mount Pits  
Thetford Road

Brandon  
Suffolk

**Heritage Asset Recording**

**Post-Medieval Lime Kiln at the former Mount Pits, Thetford Road,  
Brandon, Suffolk**

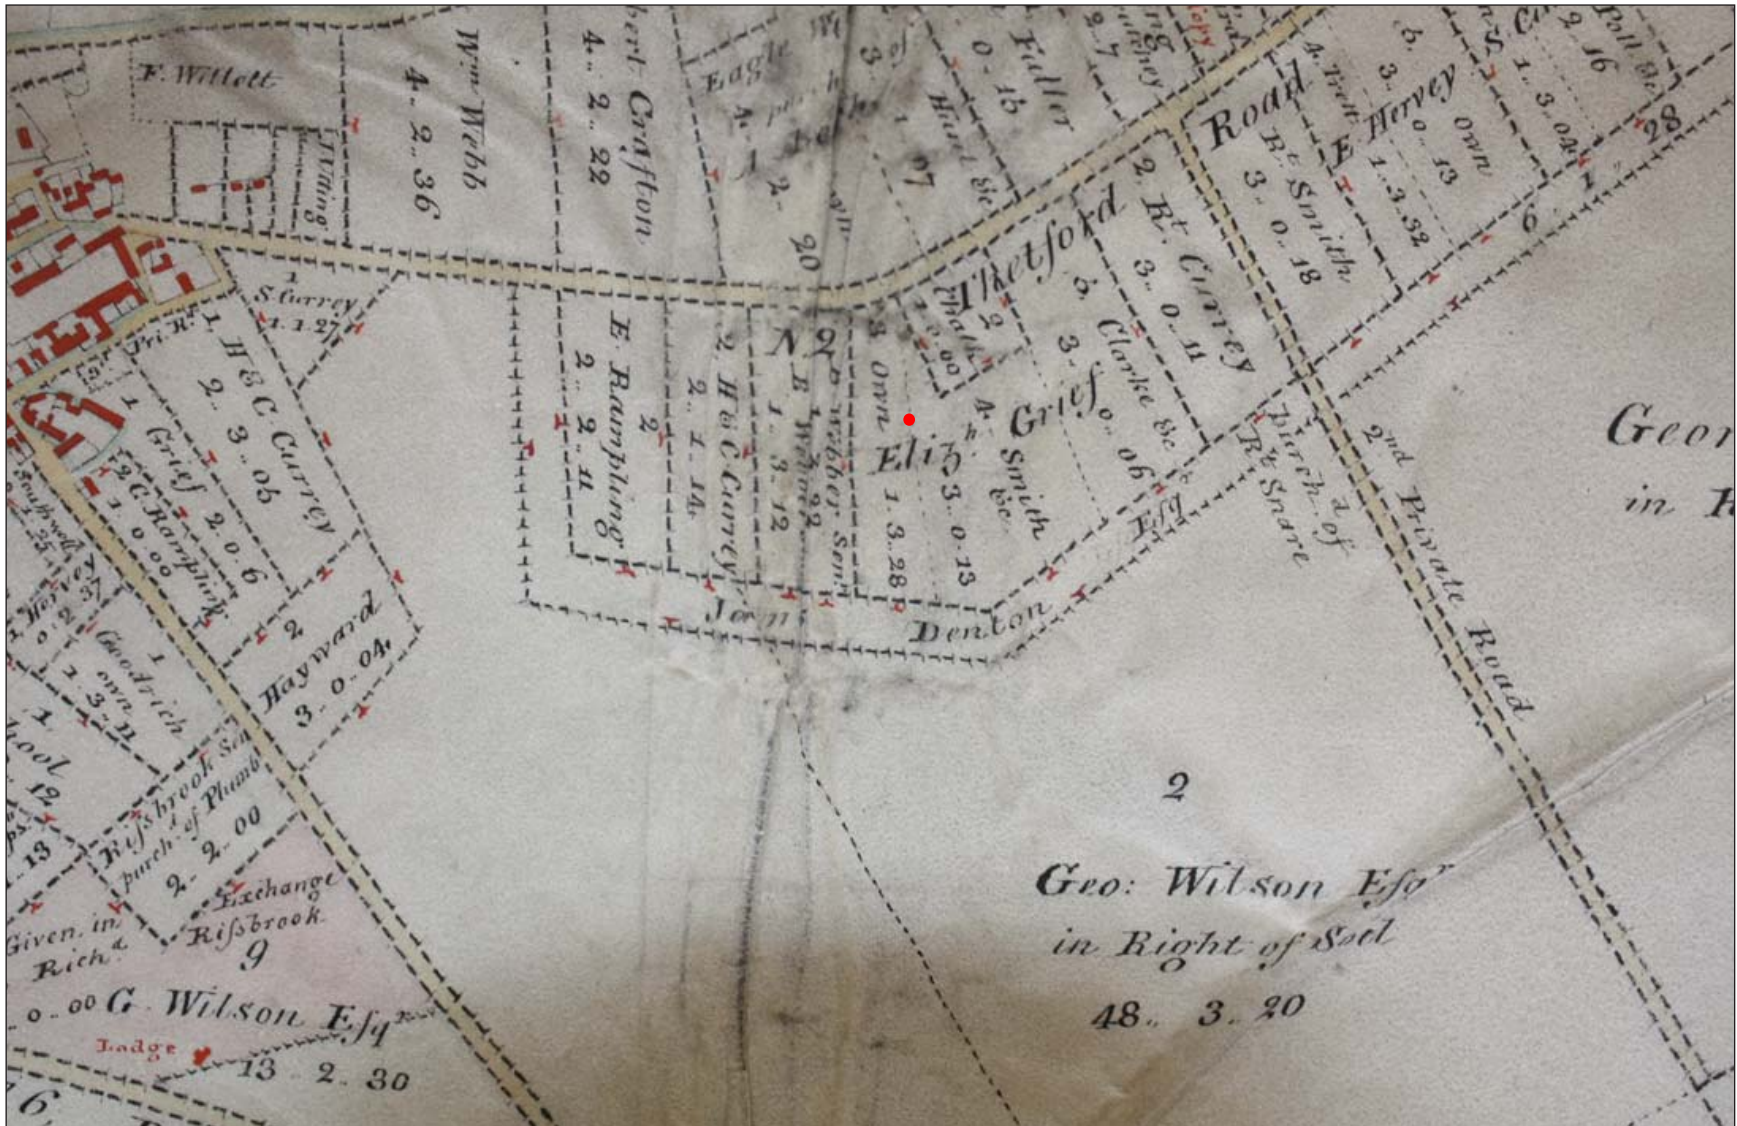
Figure 2: Extract from Brandon Enclosure Map, 1809, showing approximate location of lime kiln (red)

- 5.1.1 The Enclosure Map of 1809 was the earliest cartographic evidence found for the site (Figure 2). The map shows the study site divided into a number of plots leading off Thetford Road and owned/occupied by a number of different individuals.

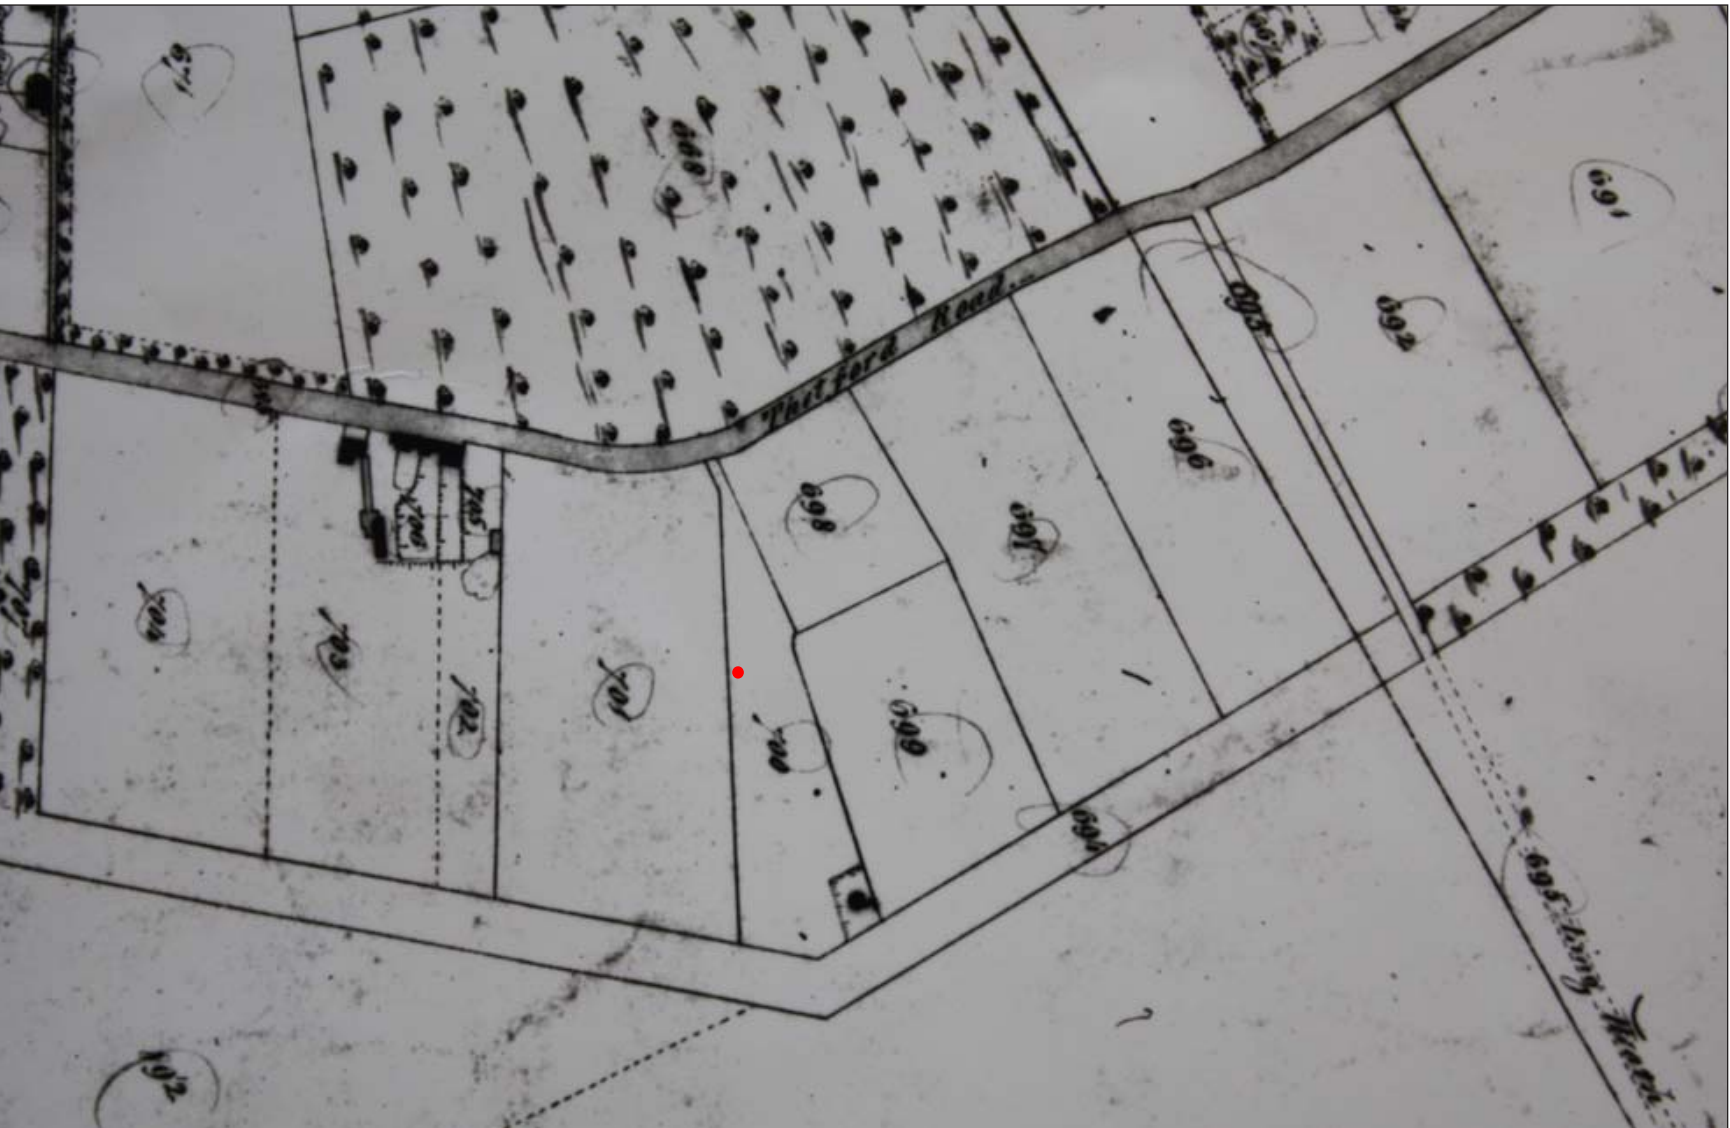
Figure 3: Extract from Brandon Tithe Map, 1838, showing approximate location of lime kiln (red)

- 5.1.5 The 1838 Tithe Map (Figure 3) shows little detail of the site, land use or any buildings/structures which may be present. The accompanying apportionment can be used to find the land use which corresponds to the plot numbers in this case 698-701. Plot 698 (the square-shaped parcel of land fronting onto the Thetford Road) was under the control/ownership of the “Brandon Overseers” and is described as a chalk pit which corresponds to the previous Enclosure Map. Plot 699 is described as an “Allotment of land”, owned and occupied by Robert Goodrich and its status was listed as “arable”. Plot 700 was owned and occupied by James Green and was known as “New Mill Piece”. Corresponding information for plot 701 could not be found.

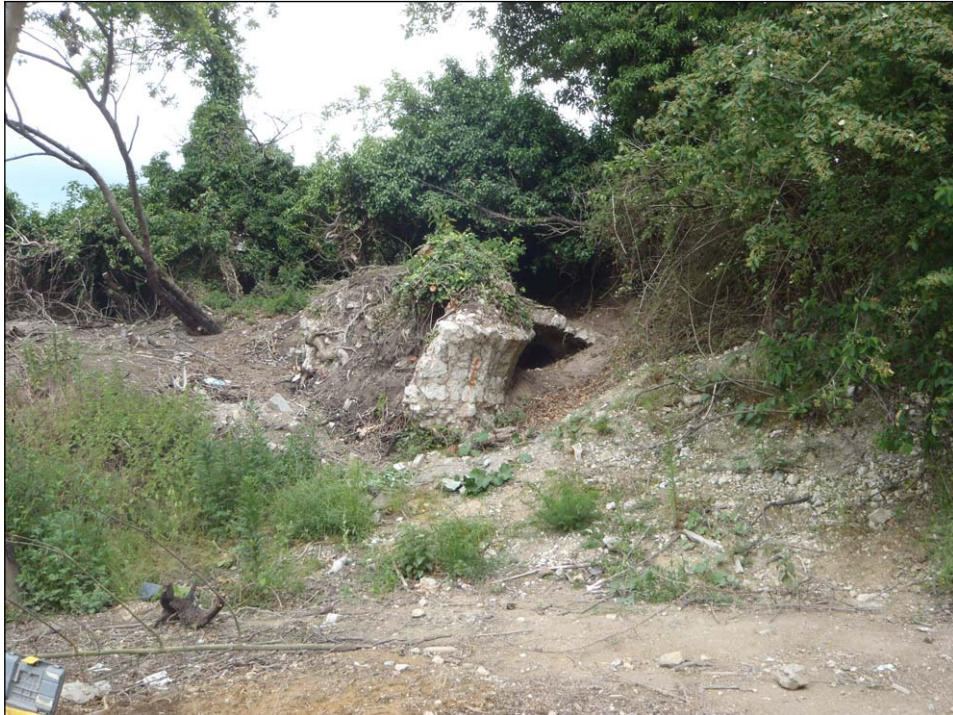
Plate 1: Position of lime kiln on quarry edge (from south)

- 2.2.1 The kiln structure is located on the edge of the former chalk quarry which has been backfilled and developed for housing. The site was accessed through the development site and via the contractor's site office. The area around the kiln was set back from the development and construction, on a raised soil bank surrounded by shrubs and bounded by trees to the north and east (Plate 1).

6.1.1 The kiln is located on the edge of the now in-filled quarry, located in the north east corner of the new housing development area (plate 1). The structure is constructed of chalk blocks with a beige coloured, sandy lime mortar with small crushed flint and brick inclusions.

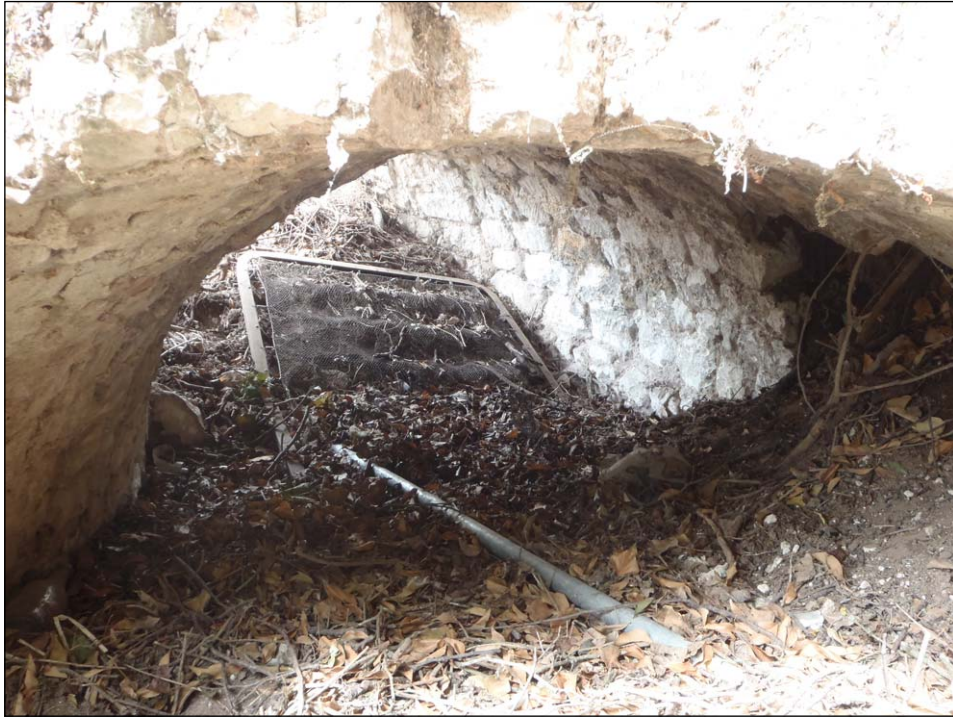
Plate 5: Internal view of kiln structure (from south)

6.2.1 Internally, more detail of the chalk blocks are revealed. The blocks are various sizes, with the largest used at the base and bottom of the walls (plate 5). The largest blocks measure up to 30cm in length and 15cm in thickness. Many show tool marks and have been laid in a random bond.

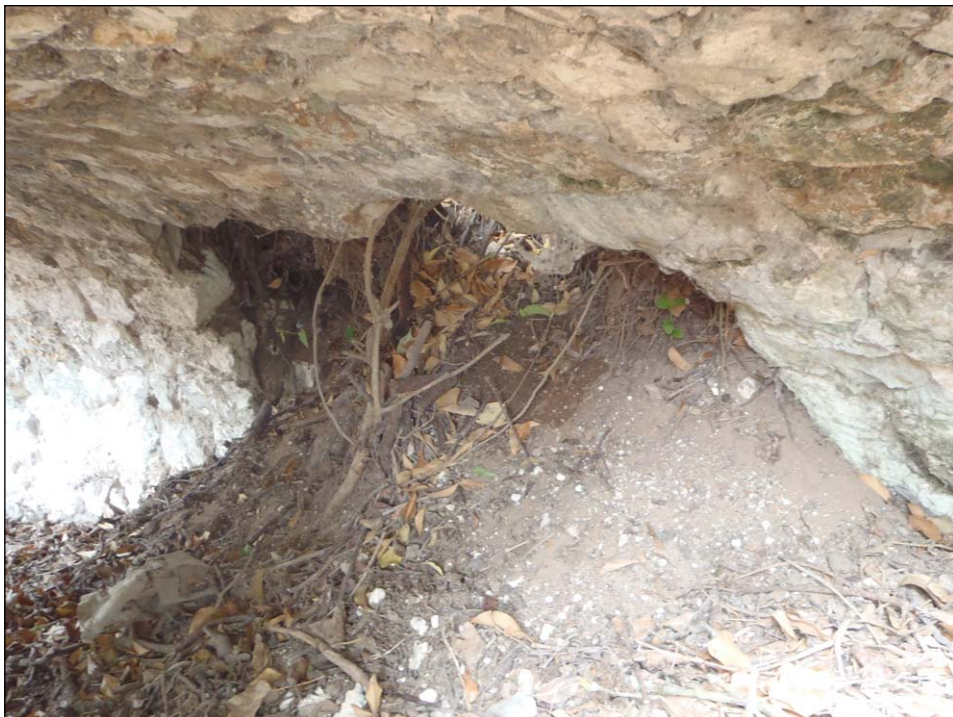
Plate 6: Detail of opening on the east side of kiln structure (from south)

6.2.3 On the eastern side of the chamber, there is an opening which is barely visible from the outside due to soil and vegetation build-up (plate 6). This opening has a square surround and may have provided original access into the structure.

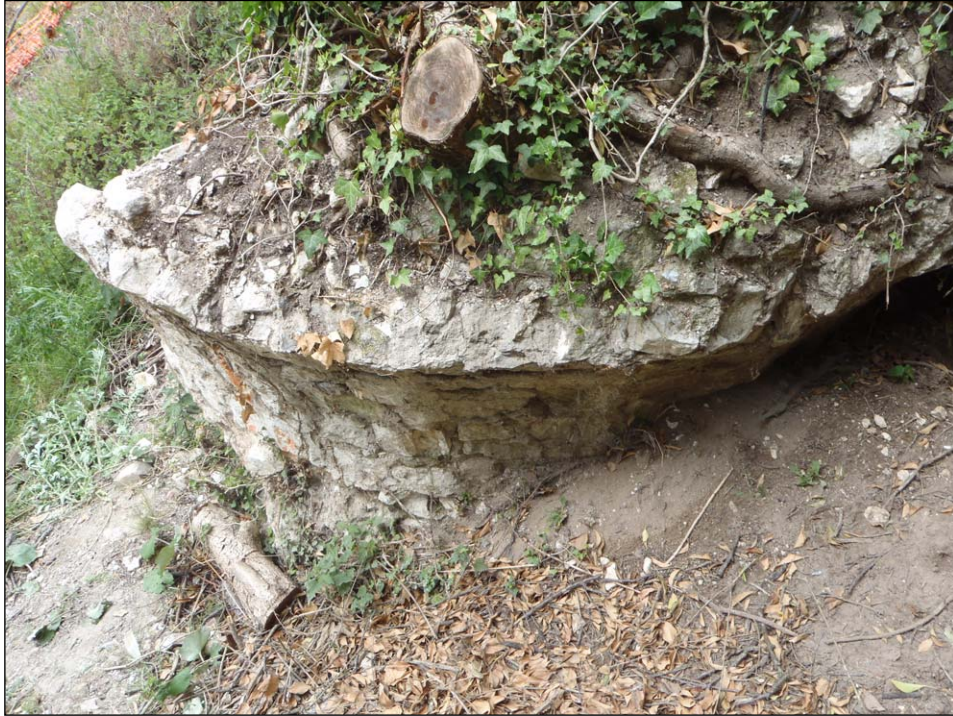
Plate 7: Detail of arch on southern side of kiln structure (from south)

6.1.4 The southern side of the kiln (Figure 7, Elevation 2 and plates 3 and 4) reveals an exposed “curved” wall (left side of plate 3 and plate 7). The curve of this part of the structure would indicate that it may have been a complete chamber and a continuation of that recorded further along on the right side of the section (plate 4). Here, as on the west-facing side, the archway has been truncated, as evidenced by the rough and uneven finish of the chalk blocks around the opening (plate 4). The evidence on this side suggests the archway or “chamber” was once present around this side in an unbroken continuation.

- 7.1.2 The evidence recorded on the two exposed sides of the structure would support the suggestion that a “chamber” continued on both the southern side (plates 7 and 8) and on the western side, which has been removed/demolished. The projected continuation of the chamber would match the circular shape of the kiln as depicted on the 1st Edition Ordnance Survey map of 1885 (Figure 4) with access gained from the eastern side which, at the time would not have been so overgrown. The chamber would have allowed access to a poking hole in the kiln pot to light and stoke the kiln and also to the drawhole at the base of the kiln pot to allow the flow of air and access to rake-out after firing. Although no pokehole or draw hole were recorded, they would most likely be close to the base of the kiln or lower in the chamber wall/kiln pot and therefore may remain buried beneath the soil.
