# South Hill Park Bracknell Berkshire

## Archaeological Watching Brief Report

February 2009

## South Hill Park Bracknell, Berkshire

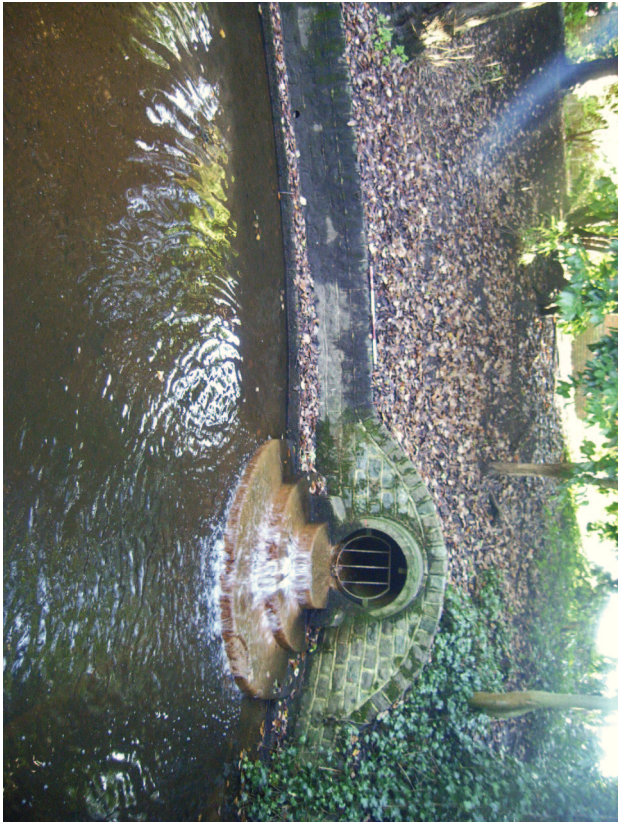
- 3.1.8 The masonry comprising the inlet to the southern lake was composed of a stone wall enclosing the southern end of the lake, with a concrete pipe projecting out of its southern extent (Plate 1).

- 3.1.9 The stone wall was built using dressed sandstone blocks measuring on average 0.25 m x 0.18 m x 0.15 m. The wall consisted of 4 courses. The bottom 3 courses were laid using Flemish bonding, while the upper course was laid using the blocks on edge and running the width of the wall, the total height measuring 0.62 m. This was constructed on a concrete foundation which projected 0.2 m in front of the wall.

Plate 1: Southern lake inlet and wall

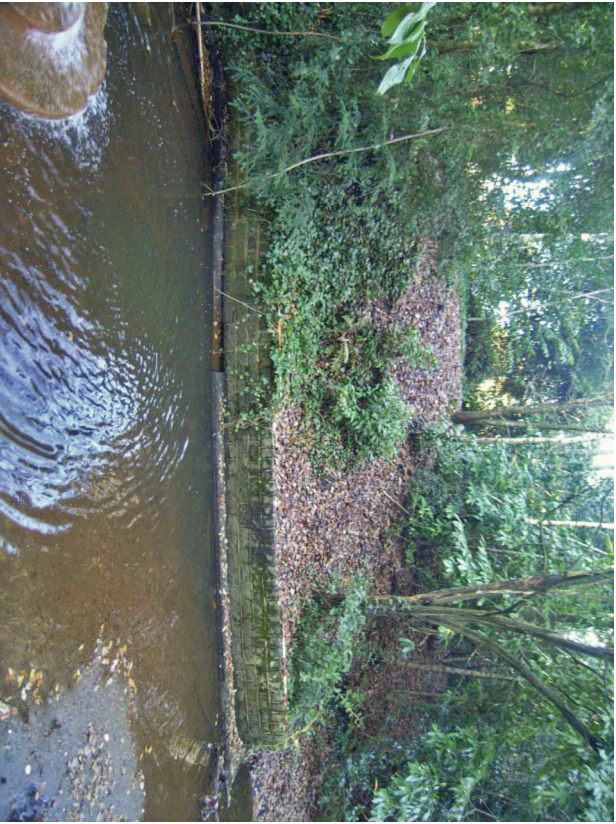
- 3.1.12 The wall is in a generally good state of repair, however within a 3 m long stretch of wall along the western edge of the lake, the concrete footing has partially subsided (possibly in the silts forming the sides of the lake) leaving the stone wall unsupported (Plate 2).

Plate 2: West wall of Southern inlet, showing subsidence
