Site/Project Name: **Easthampstead, Bracknell, South Hill Farm**

Site/Project Type: Watching Brief

**South Hill Park,  
Bracknell,  
Berkshire**

Archaeological  
Watching Brief Report

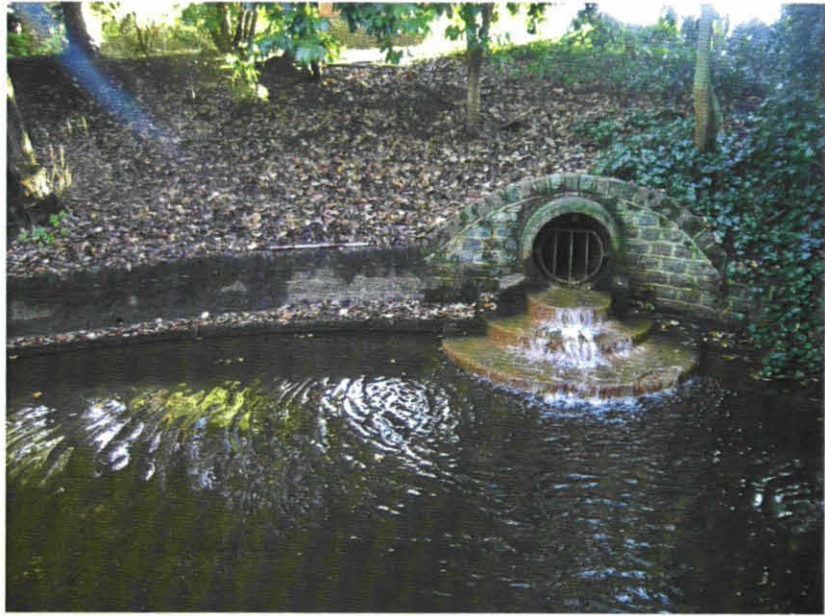
- 3.1.9 The stone wall was built using dressed sandstone blocks measuring on average 0.25 m x 0.18 m x 0.15 m. The wall consisted of 4 courses. The bottom 3 courses were laid using Flemish bonding, while the upper course was laid using the blocks on edge and running the width of the wall, the total height measuring 0.62 m. This was constructed on a concrete foundation which projected 0.2 m in front of the wall.

Plate 1: Southern lake inlet and wall

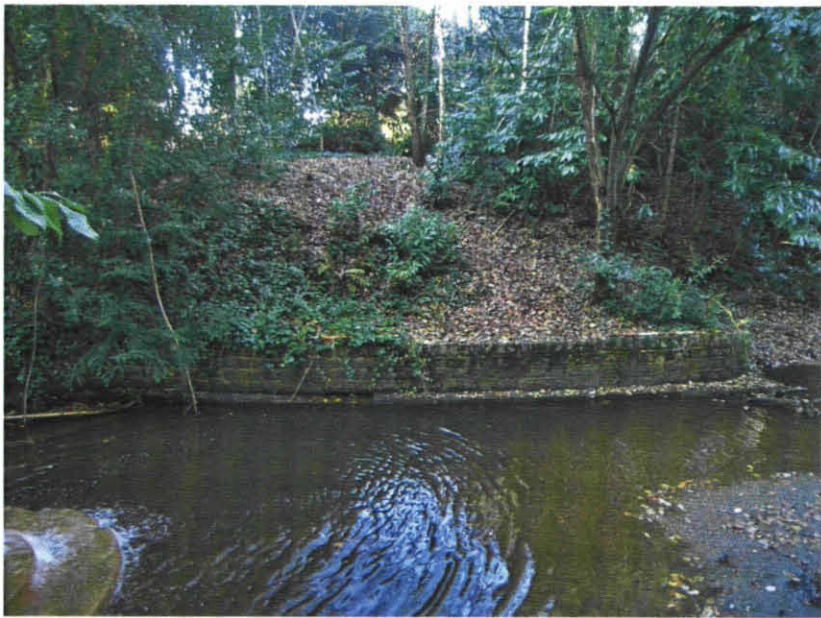
- 3.1.12 The wall is in a generally good state of repair, however within a 3 m long stretch of wall along the western edge of the lake, the concrete footing has partially subsided (possibly in the silts forming the sides of the lake) leaving the stone wall unsupported (Plate 2).

Plate 2: West wall of Southern inlet, showing subsidence
