23-25 High St Marlow Buckinghamshire

Archaeological Evaluation Report

May 2008

Document Title: 23-25 High Street, Marlow, Buckinghamshire

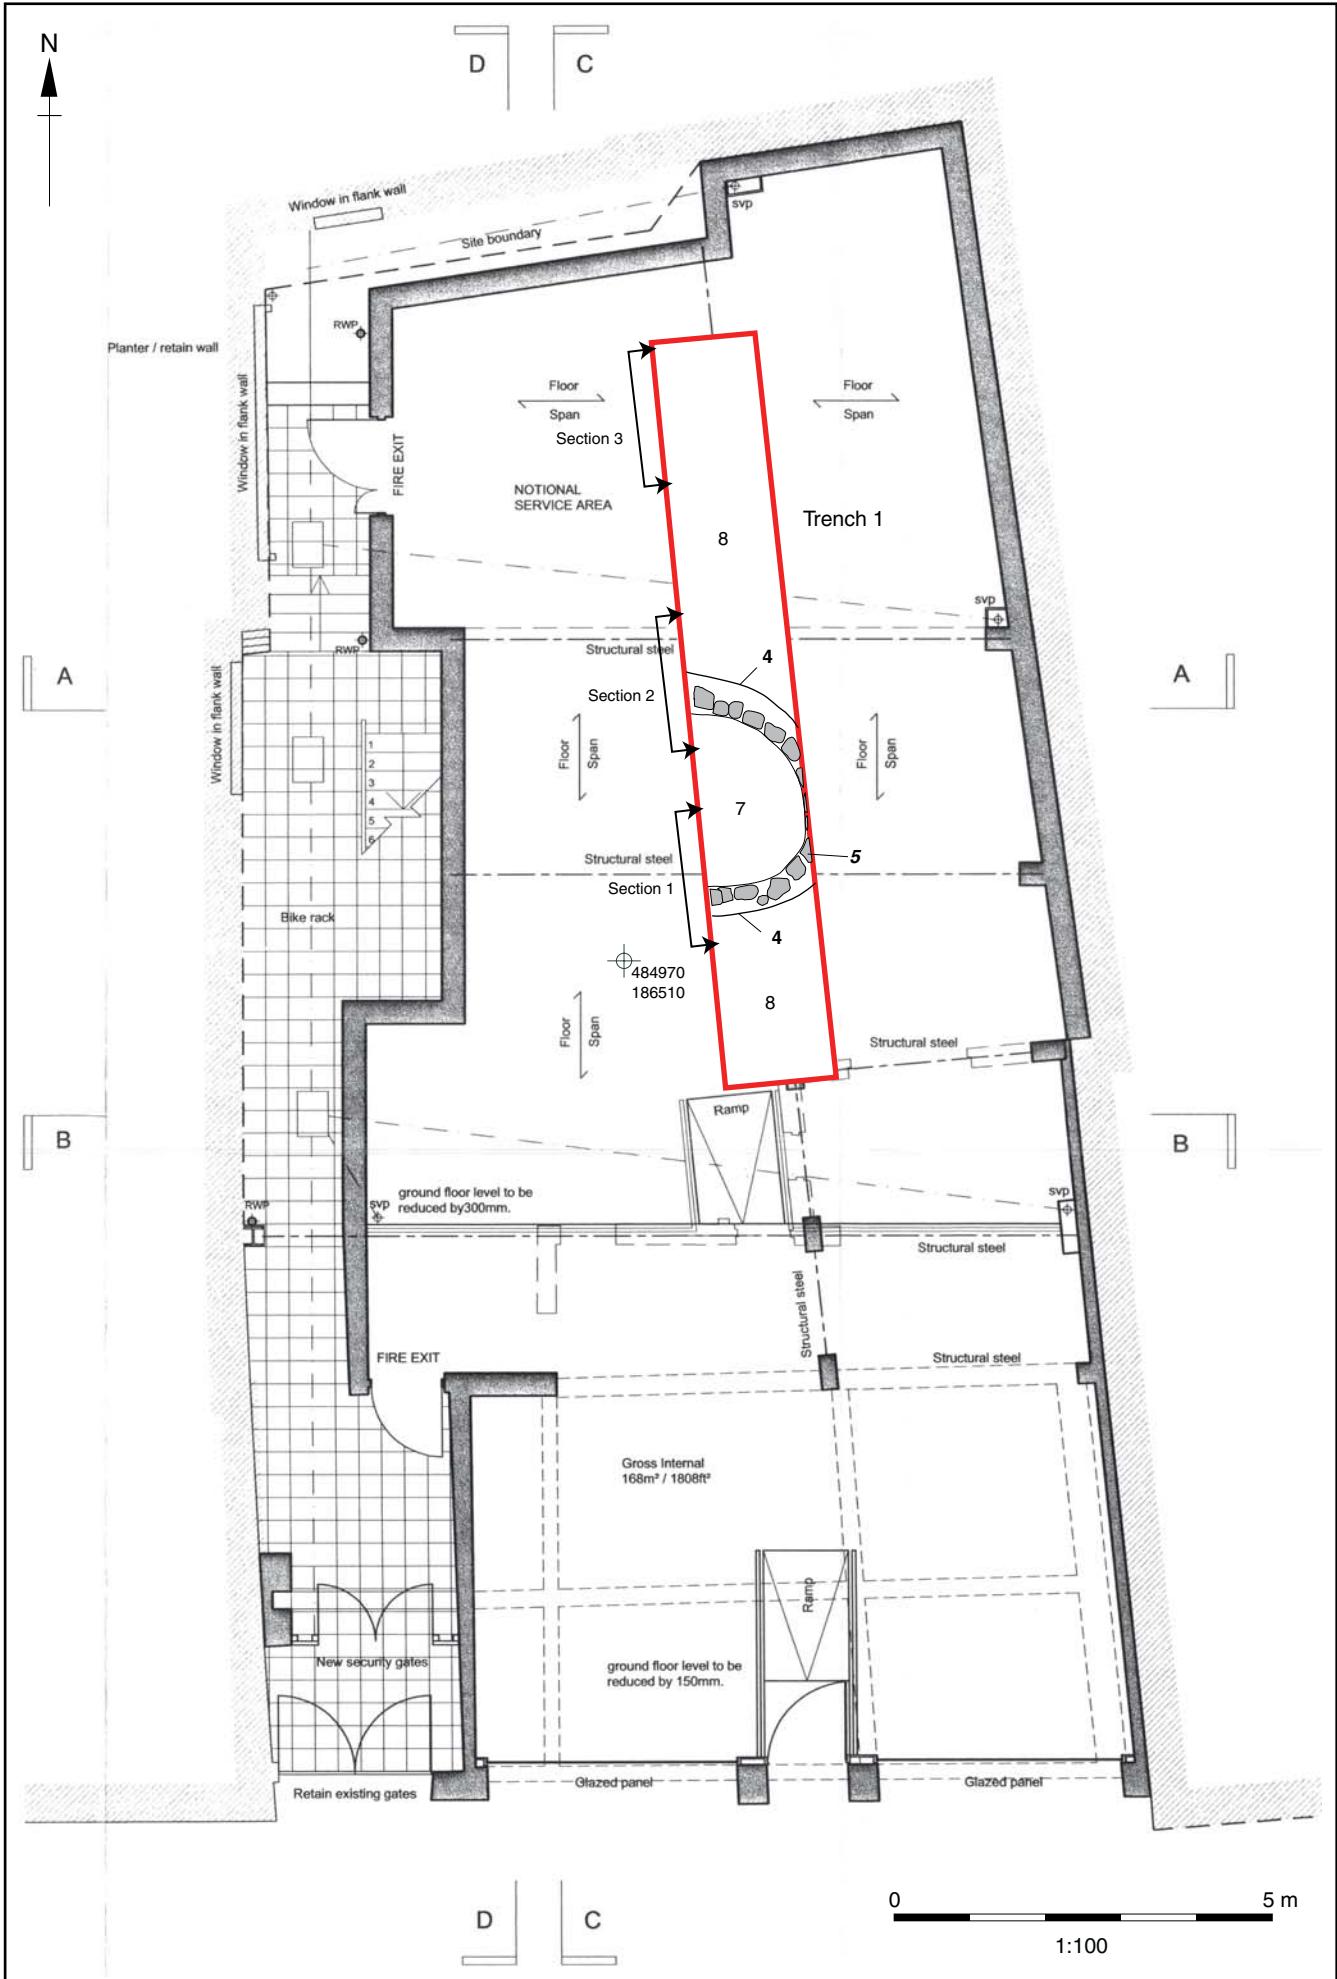
Figure 2: Trench location plan showing archaeology

- 3.1.1 The evaluation consisted of a single trench measuring 10 m long and 1.5 m wide located running the length of the rear yard of the property (Fig. 2). The concrete yard surface had been previously broken out and removed prior to excavation, while the overburden was removed under close archaeological supervision by a 360° mechanical excavator fitted with a 0.8 m wide toothless bucket. Excavation proceeded in spits down to either the top of the underlying natural geology or to the top of the first significant archaeological horizon, whichever was encountered first.

- 5.1.2 Cutting this layer was a roughly circular feature with steeply sloping sides (4) (Fig. 2, Fig. 3, Sections 1 and 2) measuring 3.3 m in diameter. Constructed within this cut was a circular vertical faced wall of roughly dressed chalk blocks, a single block in thickness laid without mortar (5). The space between the back of this circular lining and the edge of the cut was backfilled with a grey-brown clay silt (6) which

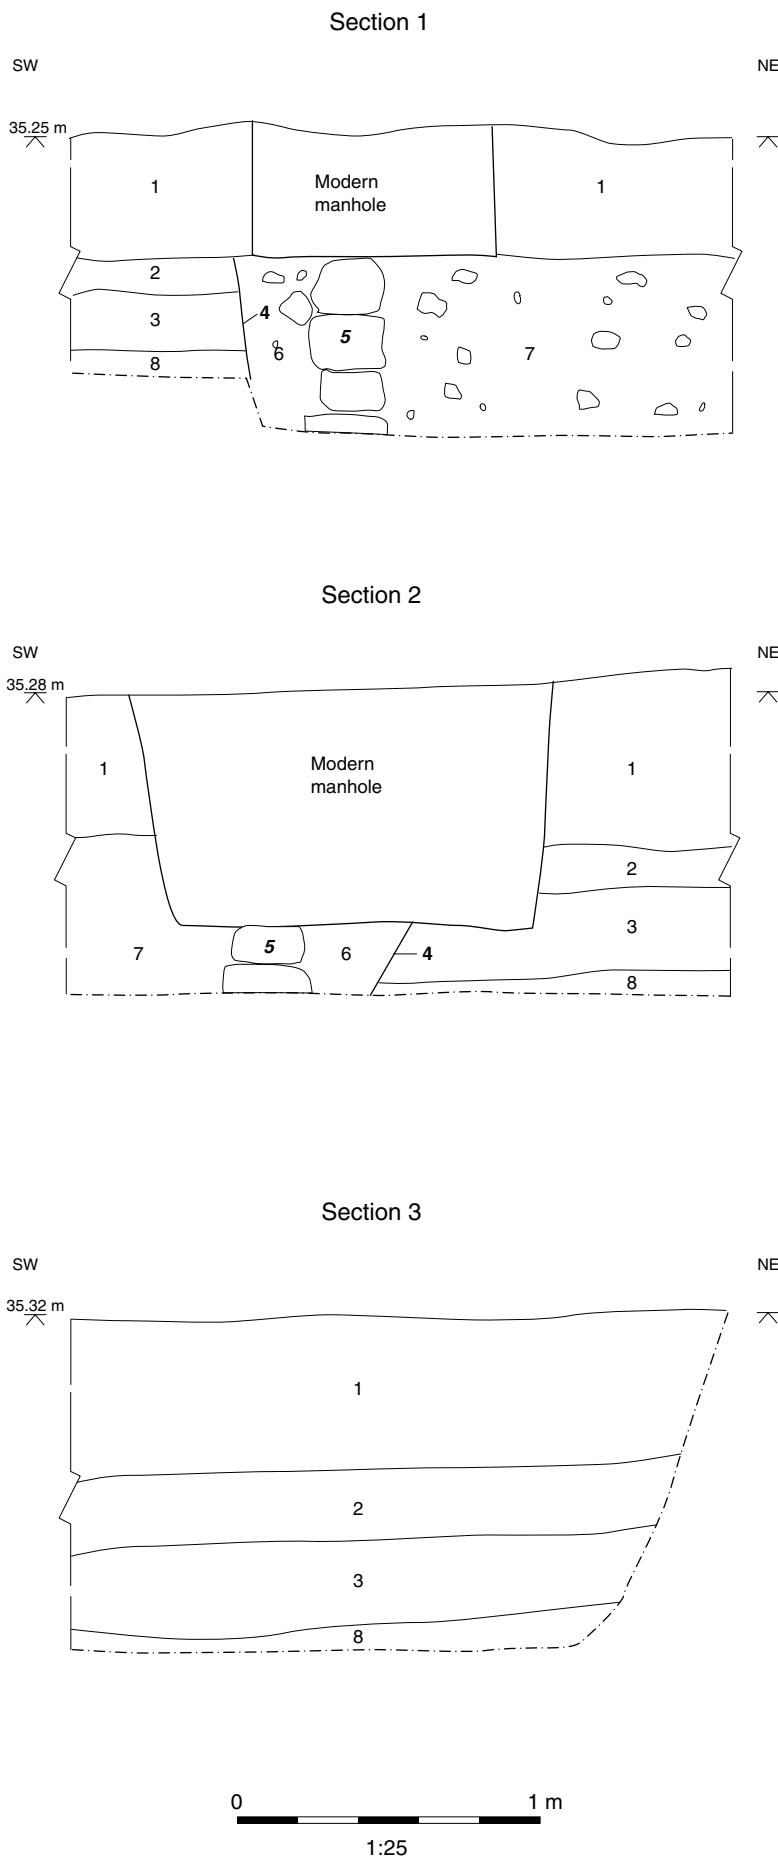
Figure 3: Sections

- 5.1.1 The underlying natural, an orange yellow-brown sandy clay silt (8) was encountered at a depth of between 0.75 m and 1 m below the current yard level (Fig. 3, Sections 1, 2 and 3). This was sealed by a 0.2 m deep layer of dark yellow-brown clay silt (3), which produced fragments of clay roofing tile. Overlying this deposit was a 0.15 m deep layer of grey-brown clay silt (2). This deposit contained some charcoal flecking and fragments of 18th/19th-century pottery suggesting an occupation layer.

- 5.1.3 A sondage dug though this feature prior to backfilling the trench showed that the cut and the chalk lining extended deeper than 2 m below the current ground level, but the base of the cut and the chalk lining was not encountered.
