Betteshanger Colliery Deal Kent

Archaeological Evaluation Report

NGR: TR 337 531

ARCHAEOLOGICAL EVALUATION

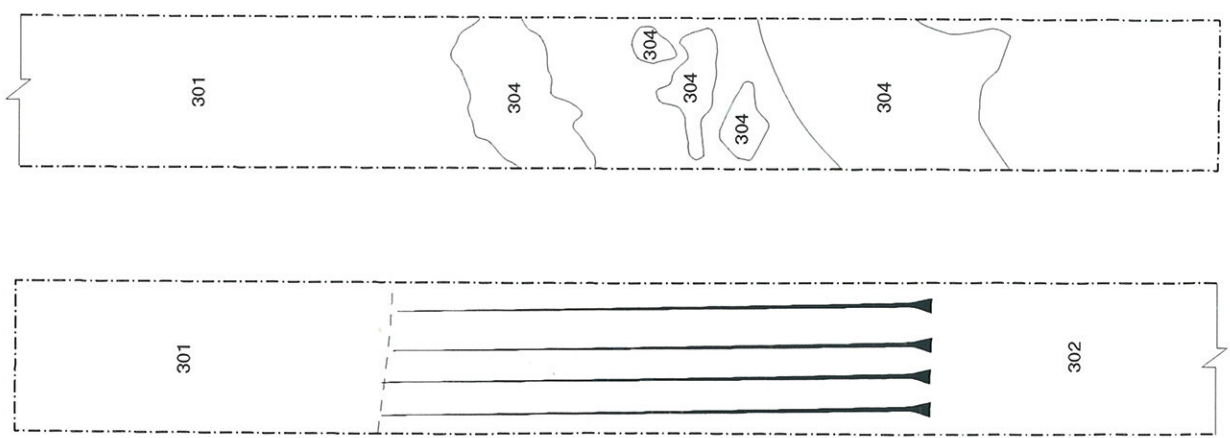
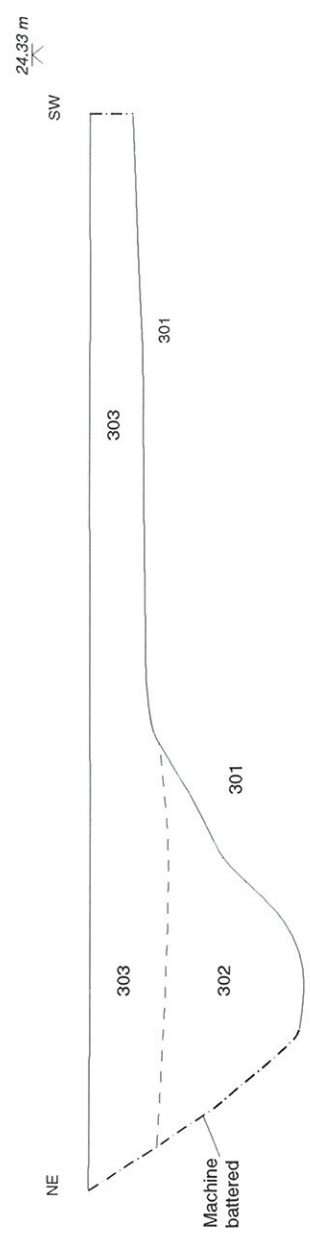
Figure 3: Trench 3, plan and section

- 5.1.5 The proposed location for Trench 3 was in the middle of area Aii, but the presence of a concrete platform occupying this area made it necessary to relocate the trench to the south-east edge of the area under investigation. Excavation revealed natural chalk (301) at the south-west end of the trench at 21.3 m OD, 1.5 m below the current ground level. Undulations in the surface of the chalk were filled by patches of greensand (304). In the north-east half of the trench the chalk dropped away sharply to 17 m OD before starting to level off at the end of the trench. This is probably the original slope of the side of the valley prior to the deposition of the made ground, which now covers the area. The made ground at this point comprised of two distinct layers. The lower part (302) was fairly compact mining waste 3.75 m thick, and exhibiting distinct tip-lines suggestive of the tipping of material down the valley side. The upper part (303) was 1.5 m thick and consisted entirely of large pieces of mudstone up to 0.5 m across.

- 6.1.2 Trench 3 uncovered the original profile of the valley side, which is now submerged beneath dumps of mining waste.
- 6.1.3 The concrete structures recorded in Trench 4 date to the period of use of the mine and clearly relate to the movement of excavated materials around the site using conveyor belts and skips.

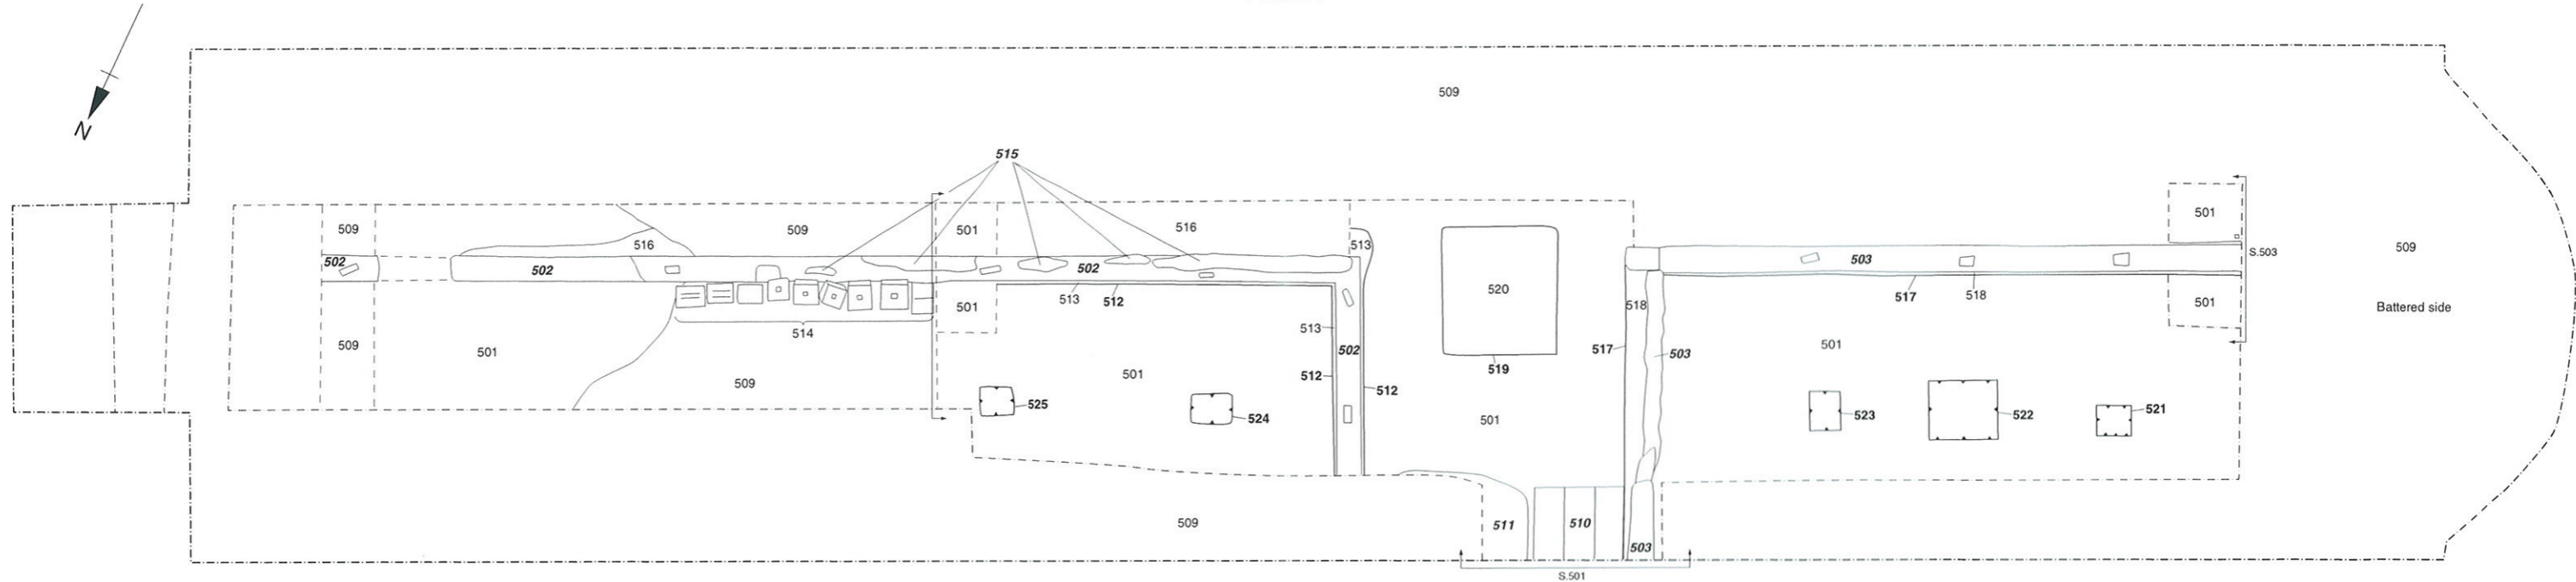
Trench 5 Plan 501

- 5.1.14 Area Aiii was a flat area used as a car park until recently, and currently overgrown with grass. Trench 5, the only trench in this area, this trench measured 15 m long and 1.9 m deep and was oriented north-east to south-west.

- 5.1.15 Undisturbed natural brickearth (501) was encountered at 21.17 m. Along the south-east side of the trench the brickearth was overlain by a layer of greyish brown sandy silt 0.1 m thick interpreted as the remains of a buried topsoil (516). This layer was cut by the footings for two rectilinear buildings (502 and 503). Structure 502 lay on the same north-east to south-west orientation as the trench. The full dimensions of the building were not exposed within the trench. It was represented by concrete foundations extending from north-east to south-west for 10.2 m before returning toward north-west and continuing beyond the limits of the trench. The foundations were 0.25 m wide and 0.24 m deep, made from a dark red concrete containing a high proportion of brick fragments and set in a construction cut (512) 0.4 m wide. The concrete foundation supported a horizontal timber (515), while slots were cut into its upper surface at intervals of 1.5 m to hold timber uprights. A line of pre-formed concrete blocks (514) in the same material as the foundation lay alongside it. The blocks measured 0.25 m x 0.25 m x 0.20 m and through the centre of each was a

square-sectioned hole 50 - 70 mm across. They did not appear to be in situ, but the similarity of their construction indicates that they were part of building 502. Within the structure were two rectangular features (524 and 525) which probably held post-pads or supports for the floor.

- 5.1.16 Building 503 lay on the same alignment as 502 and was made from the same red concrete. Less of this structure was exposed within the trench, its revealed dimensions being 6 m north-east to south-west by 3 m wide. Three rectangular features which originally held internal supports (521, 522 and 523) formed an alignment parallel to the main axis of the building. The building had been accessed by means of a set of three concrete steps (510) on the north-east side, at the foot of which was the remains of a crushed brick path (511).

- 5.1.17 Pit 519 was located between the two buildings. It was square in plan and 1.25 m wide, with a fill containing many broken bricks, and concrete; it may have been a soakaway associated with one or both of the adjacent buildings.

- 6.1.4 The structures uncovered in Trench 5 are believed to be the sinkers' buildings, occupied during the sinking of the mine shafts and then buried beneath made ground after they had become redundant.

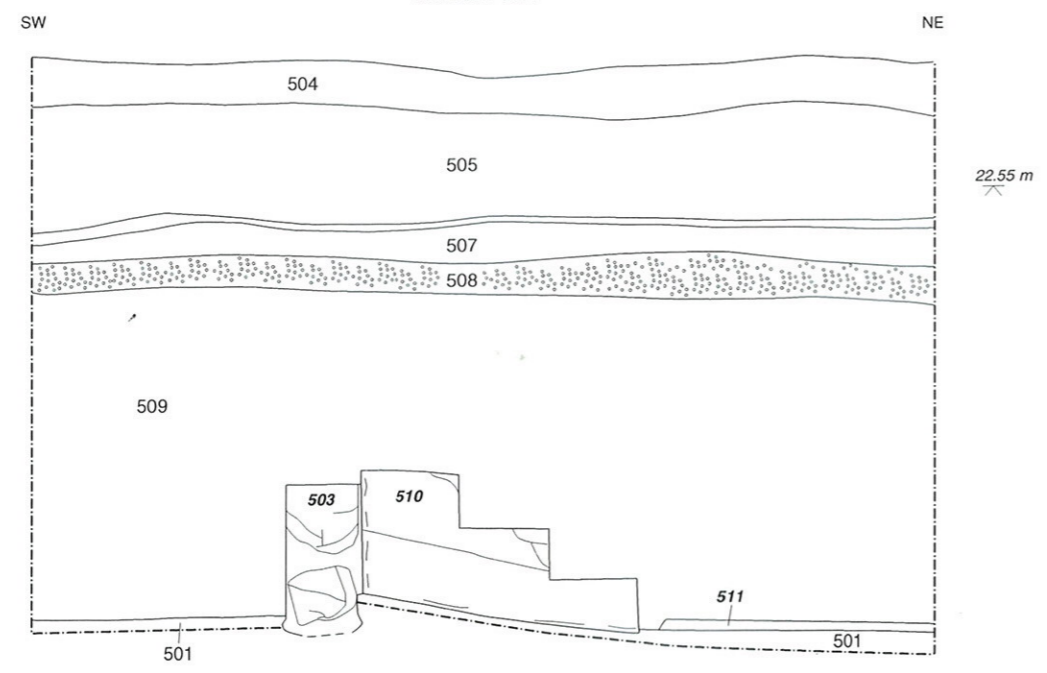
Trench 5 Section 501

- 5.1.18 These structures and features were sealed by a layer of very loose made ground (509) consisting of mining waste and refuse 1.1 m thick, overlain by a possible clinker surface 0.16 m thick. A layer of made ground (507) 0.13 m thick separated this from a gravel surface (506), which was buried beneath another, more compacted layer of made ground (505). Overlying this was the most recent surface, a layer of brick hardcore laid down for use as a car park.

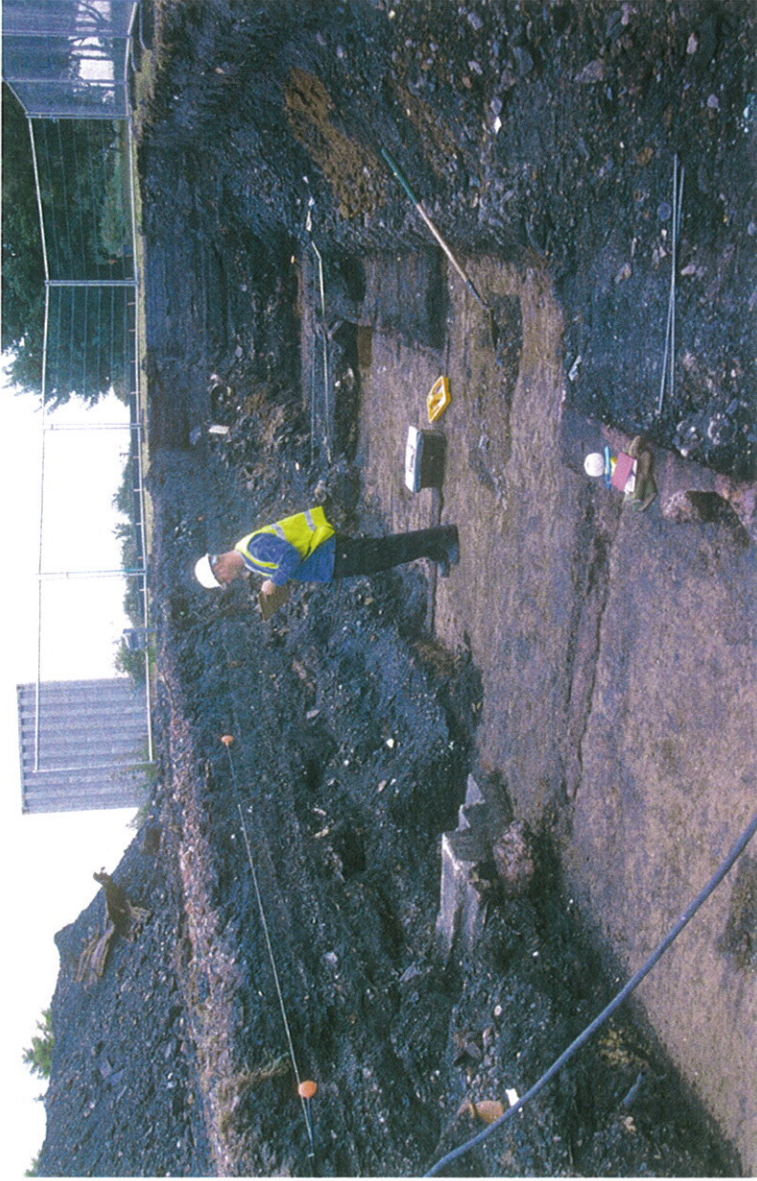
Trench 5: 'Sinkers Buildings,' view to southeast

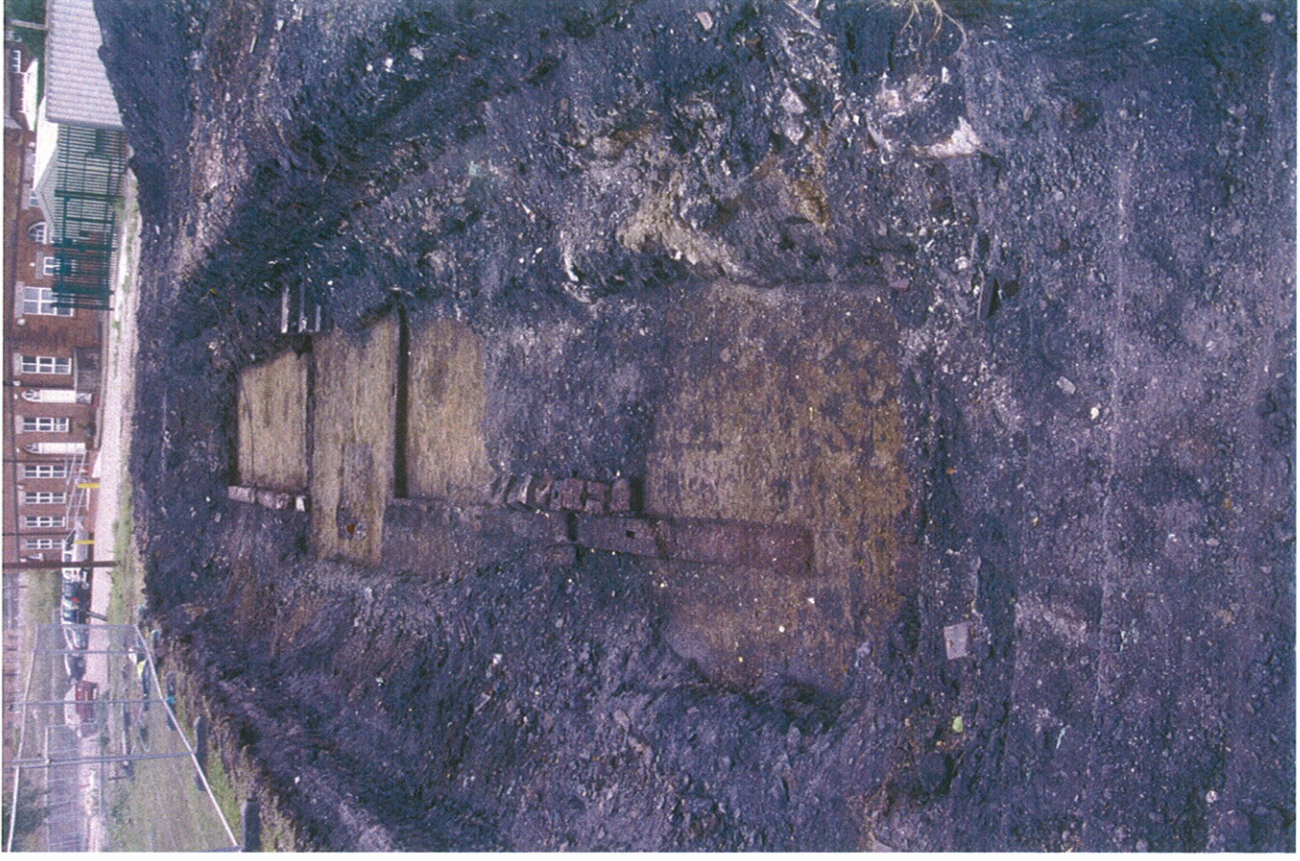
Trench 5: 'Sinkers Buildings,' view to northwest

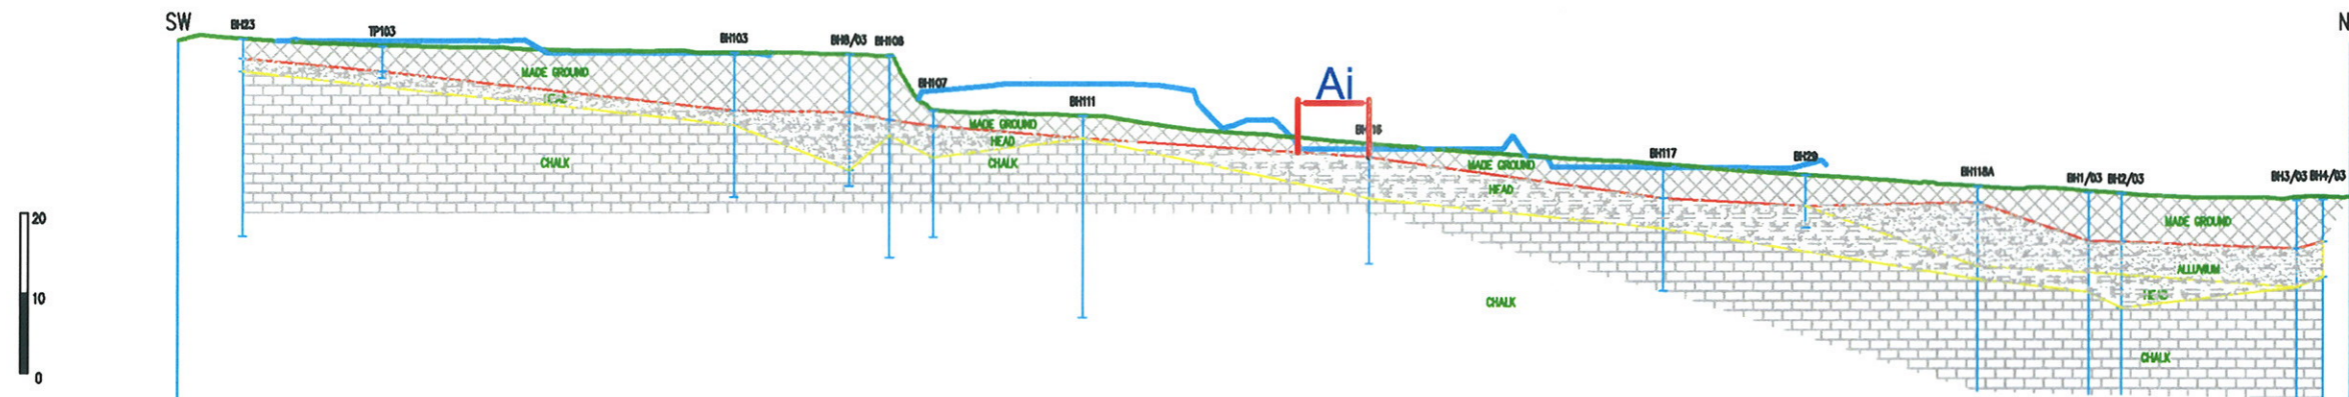
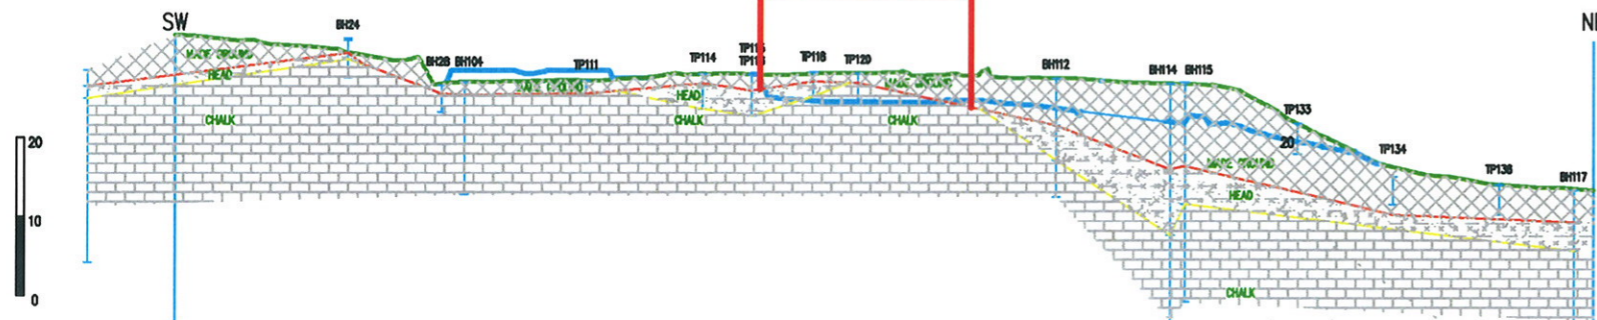
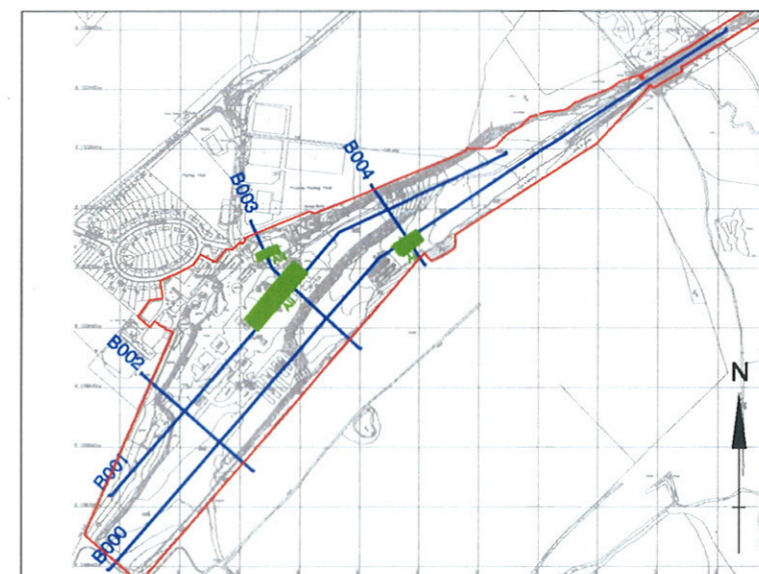
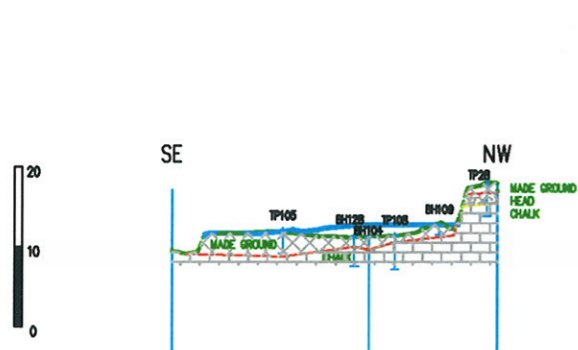
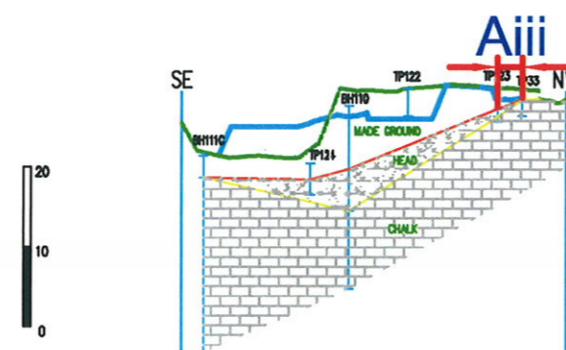
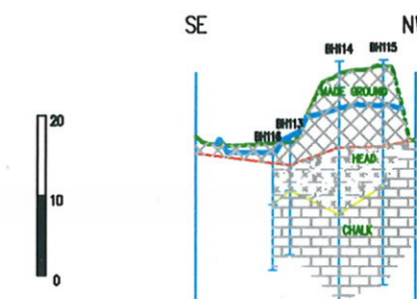
Drawing No. **Fig. 6**

Transect sections showing areas of impact on potential archaeological horizons.

- 3.1.2 The results of the borehole survey indicated that in areas Ai and Aiii the natural geology should be less than 2 m below the current ground level. In these locations Trenches 1 and 5 were excavated measuring 30 m and 15 m long respectively, and 2 m wide.

- 3.1.3 Area Aii, containing Trenches 2, 3 and 4, was shown by the borehole survey to be overlain by made ground approximately 4 m deep. In advance of excavating each of these trenches, a test pit was dug in order to ascertain whether the natural geology had been truncated prior to the deposition of the made ground. Such truncation would be signalled by the absence of a buried topsoil sealed beneath the made ground, and would indicate that further trenching was unnecessary due to the destruction of any archaeology formerly present. In the event, the results from the test pits were inconclusive due to the possibility that any buried topsoil may have been compressed or contaminated by the made ground. Excavation of evaluation trenches 30 m long therefore proceeded in these locations, the initial test pits being incorporated into the trenches. The depth of Trenches 3 and 4 necessitated battering the trench sides for health and safety reasons.
