The Old Auction House Church Street Saxmundham, Suffolk

Historic Building Recording

The Old Auction House, Church Street, Saxmundham, Suffolk

Historic Building Survey

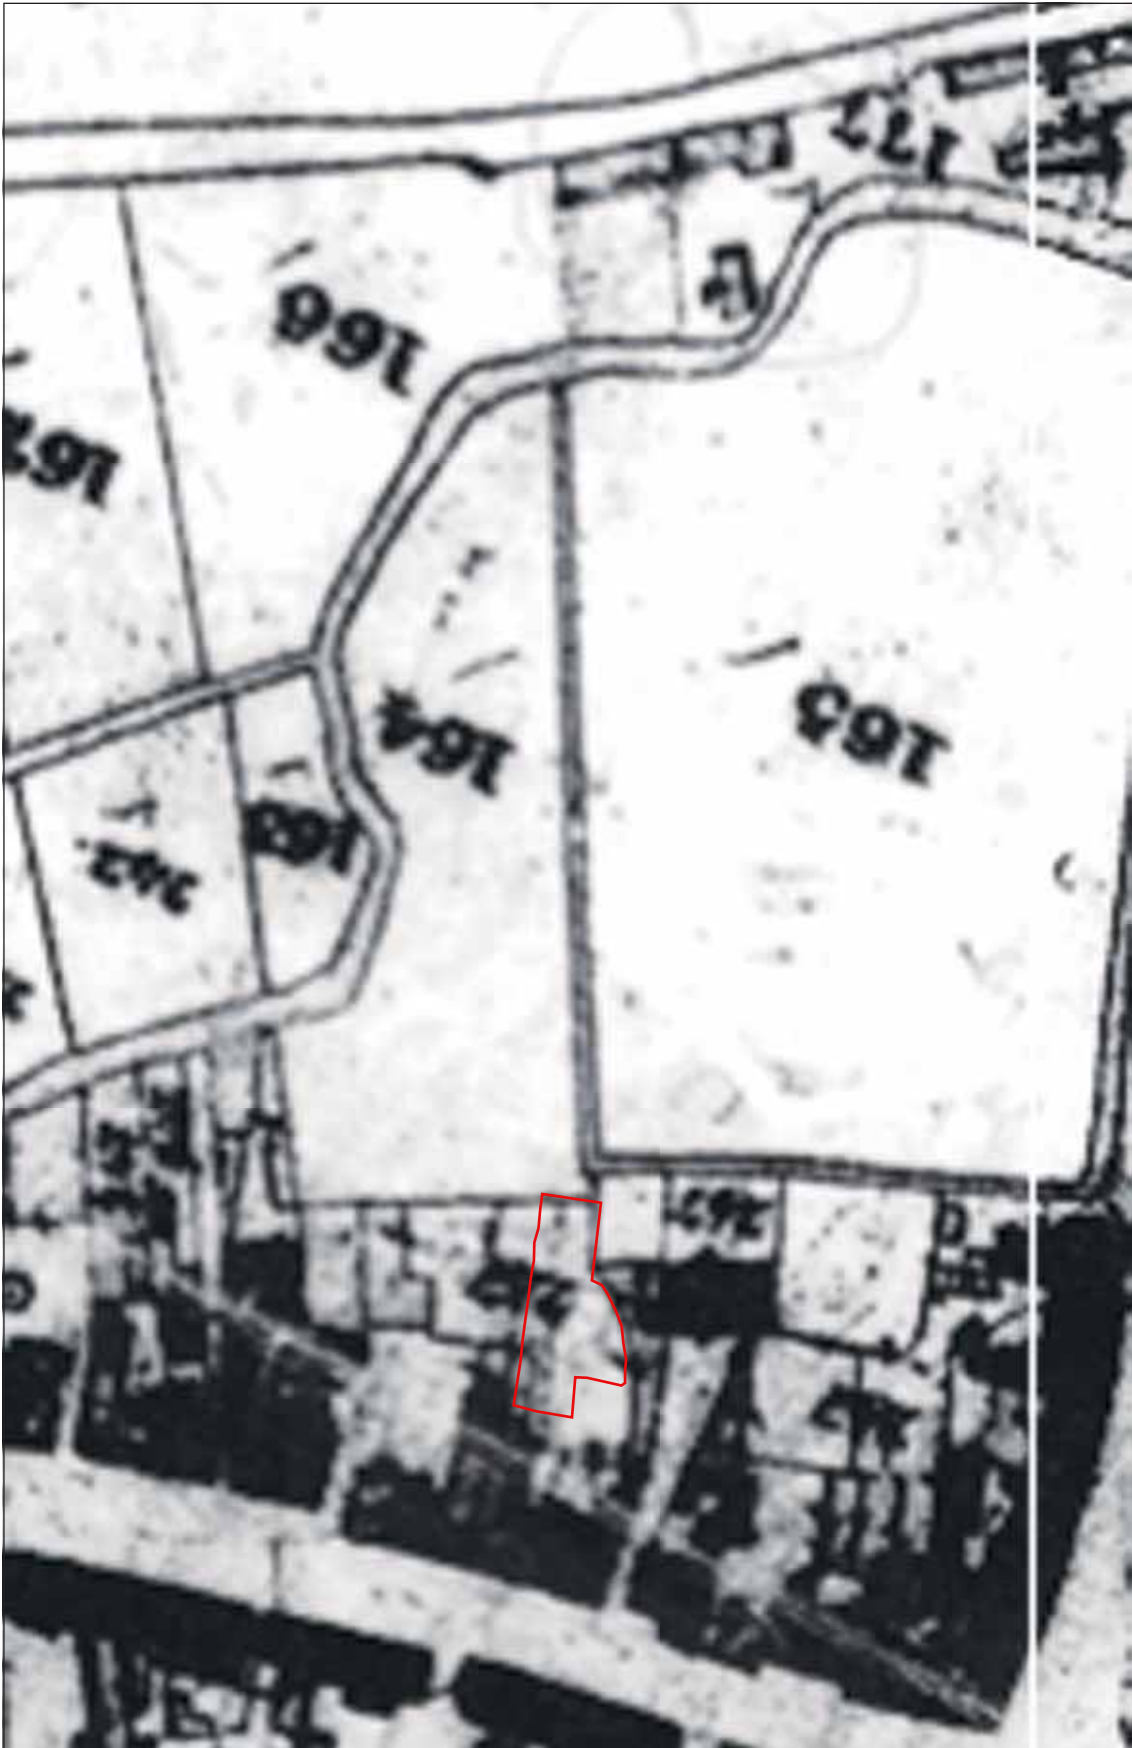
Figure 2: Extract from Saxmundham Tithe Map, 1840, showing approximate location of auction house site (red)

- 3.2.3 As the auction house was believed to be 19th century in date (Antrobus 2012), the earliest map consulted was the 1840 Tithe Map (Figure 2). This map shows the position of the White Hart Hotel and courtyard at the rear, however there is no suggestion of the presence of the auction house, bakery or outbuildings at this time. However, the

- 3.2.4 This map does show what appears to be the curving boundary wall which is still present and noted within a number of the rooms/buildings and was presumably utilised as the auction house site was built and developed.

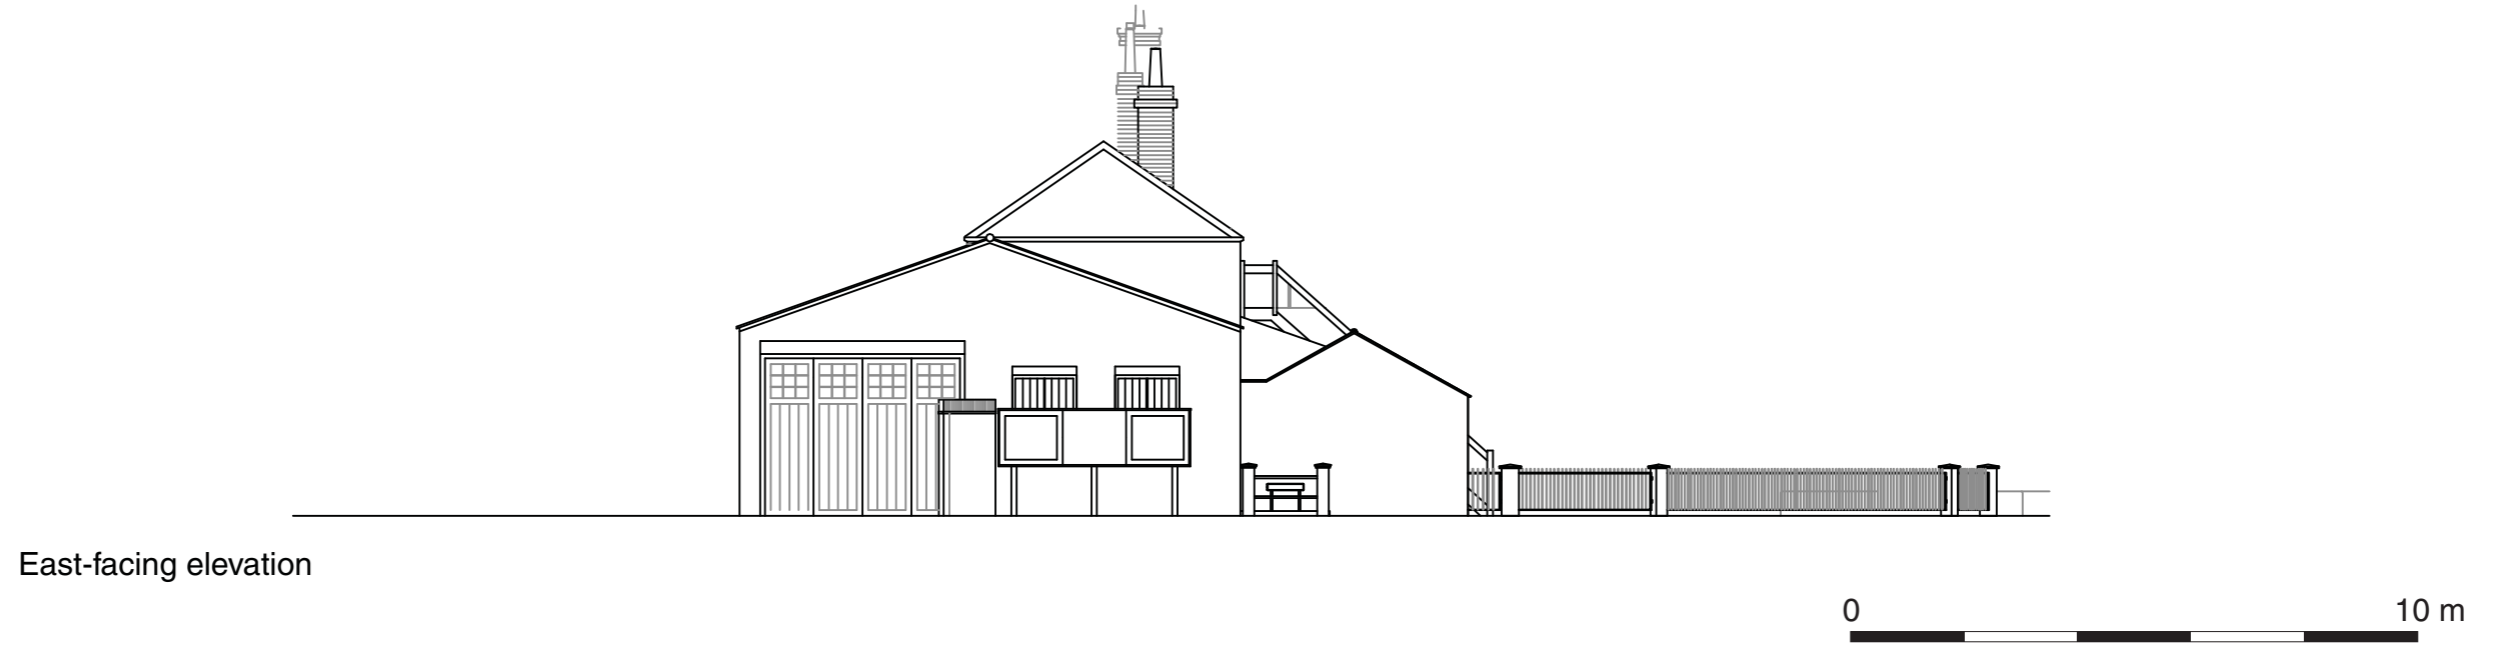
Figure 7: East and north-facing elevations (from data supplied by client)

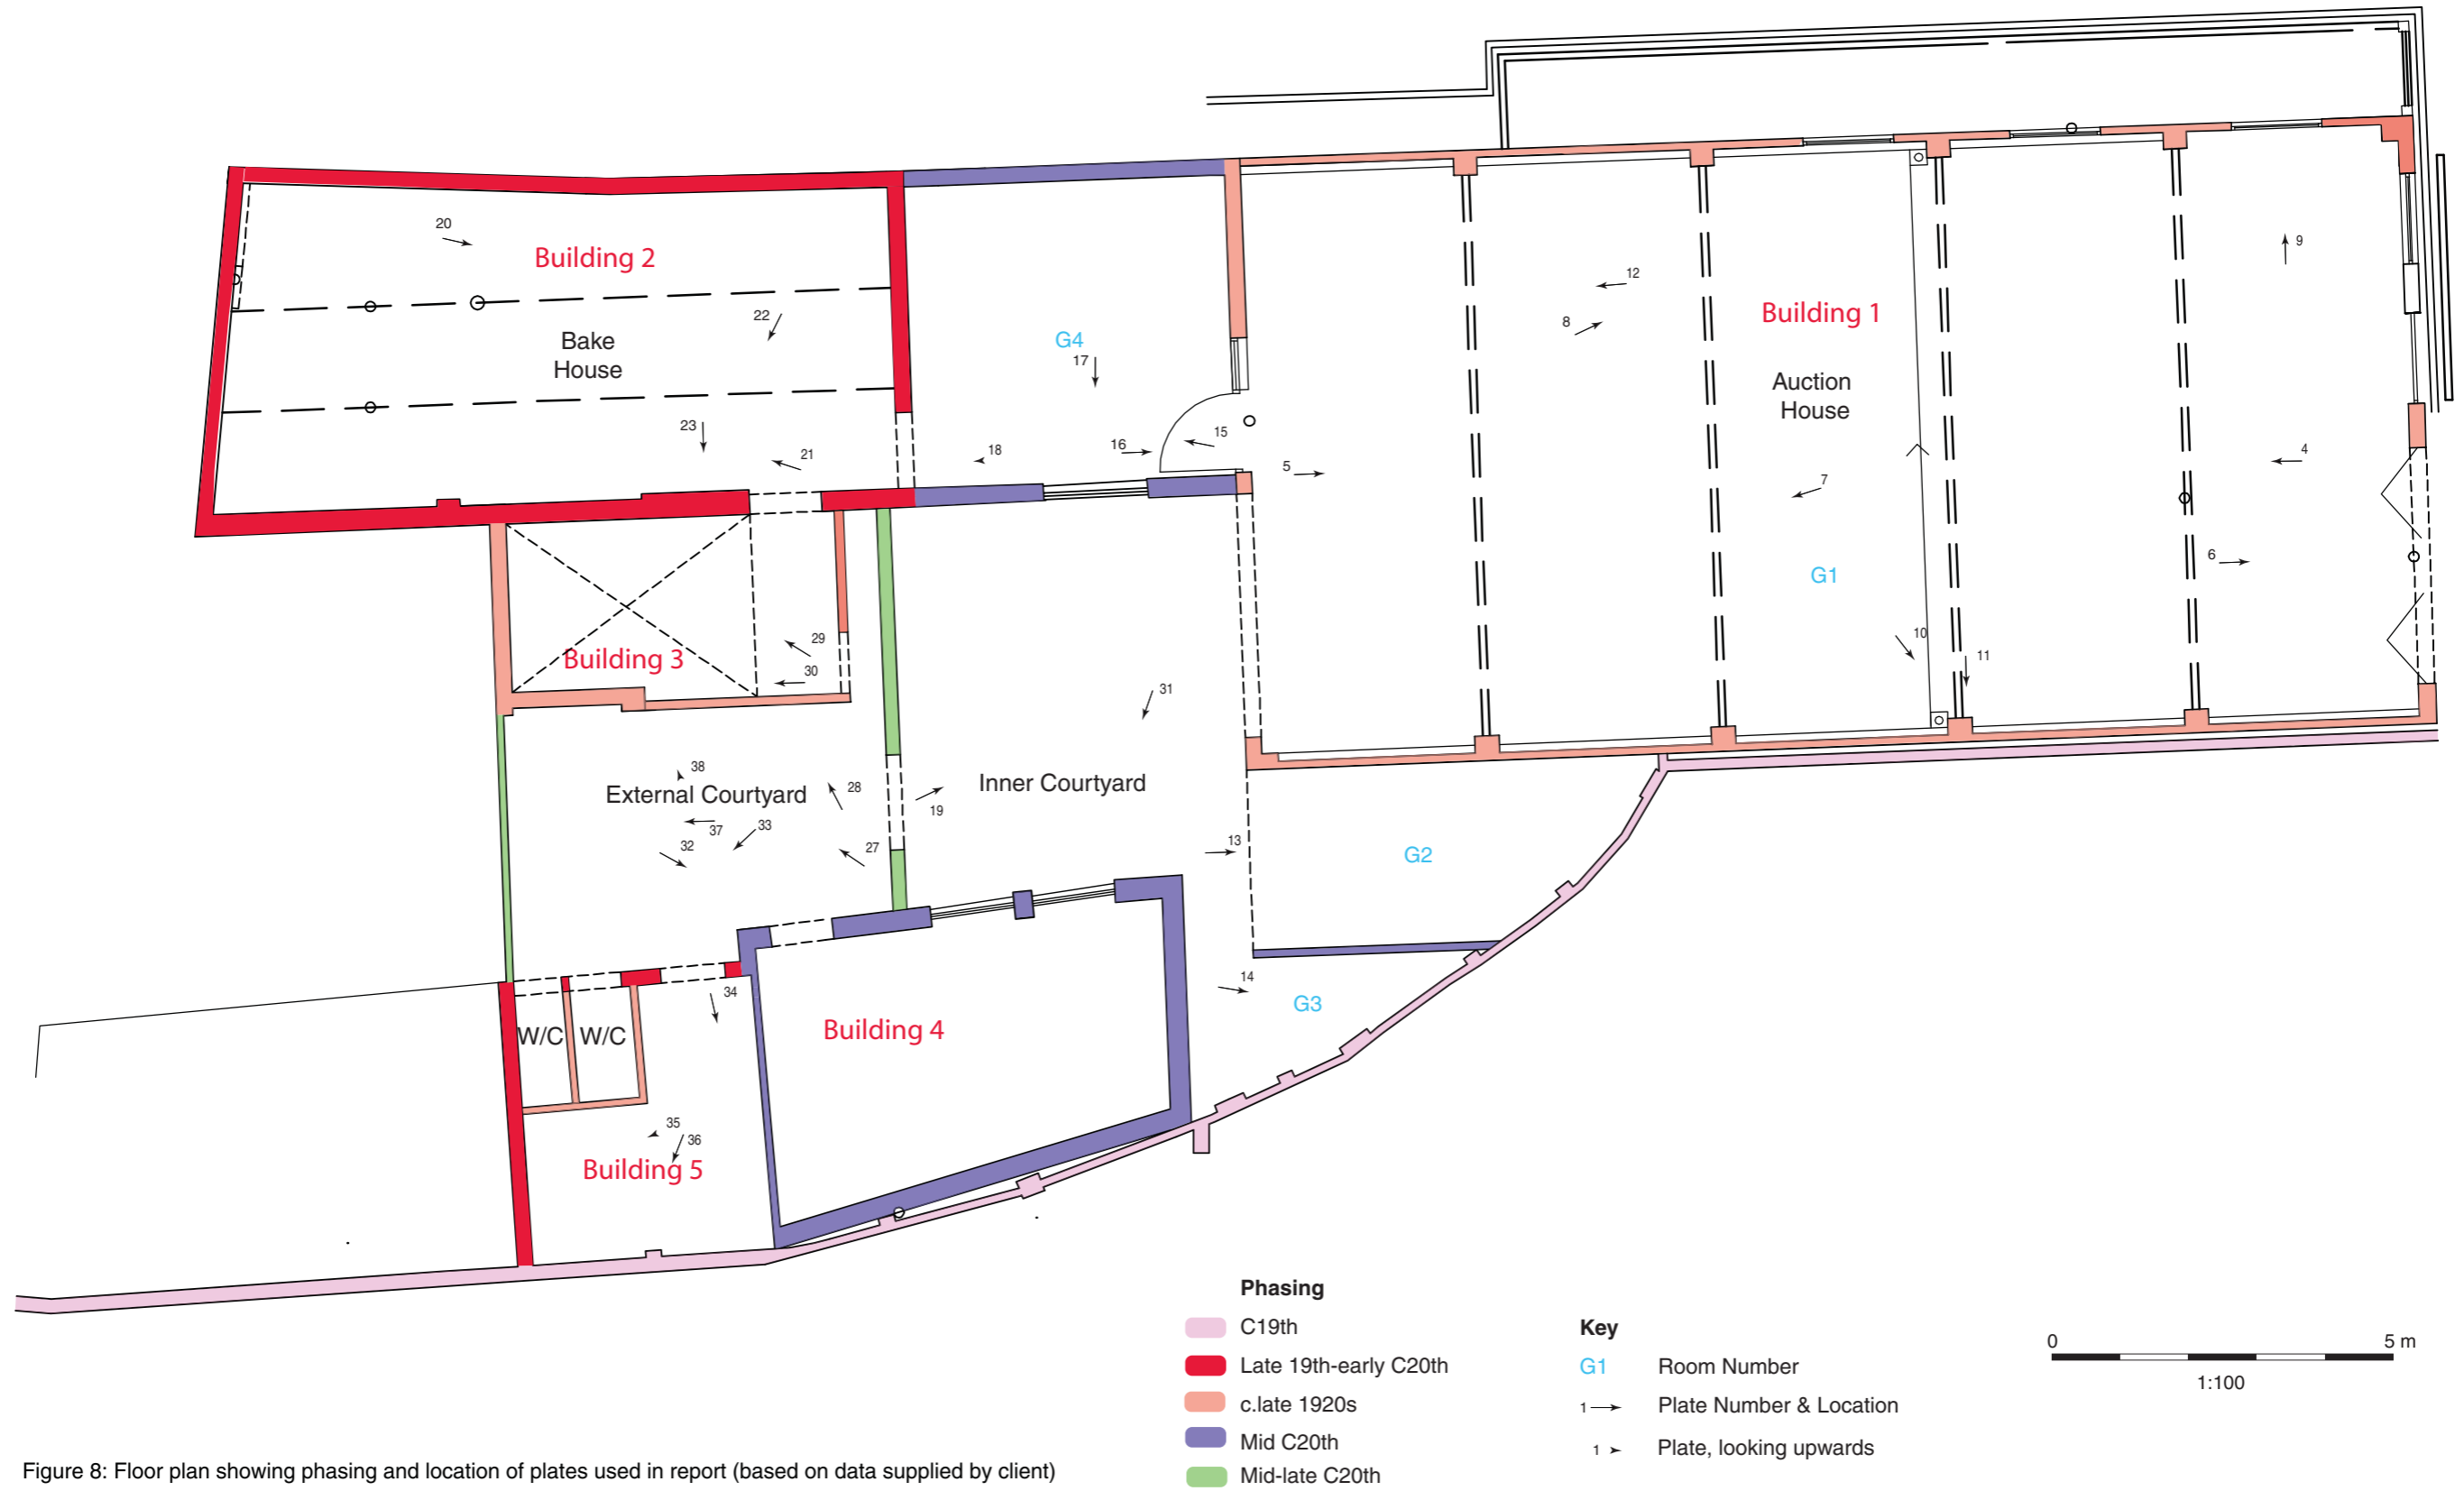
Figure 8: Floor plan showing phasing and location of plates used in report (based on data supplied by client)

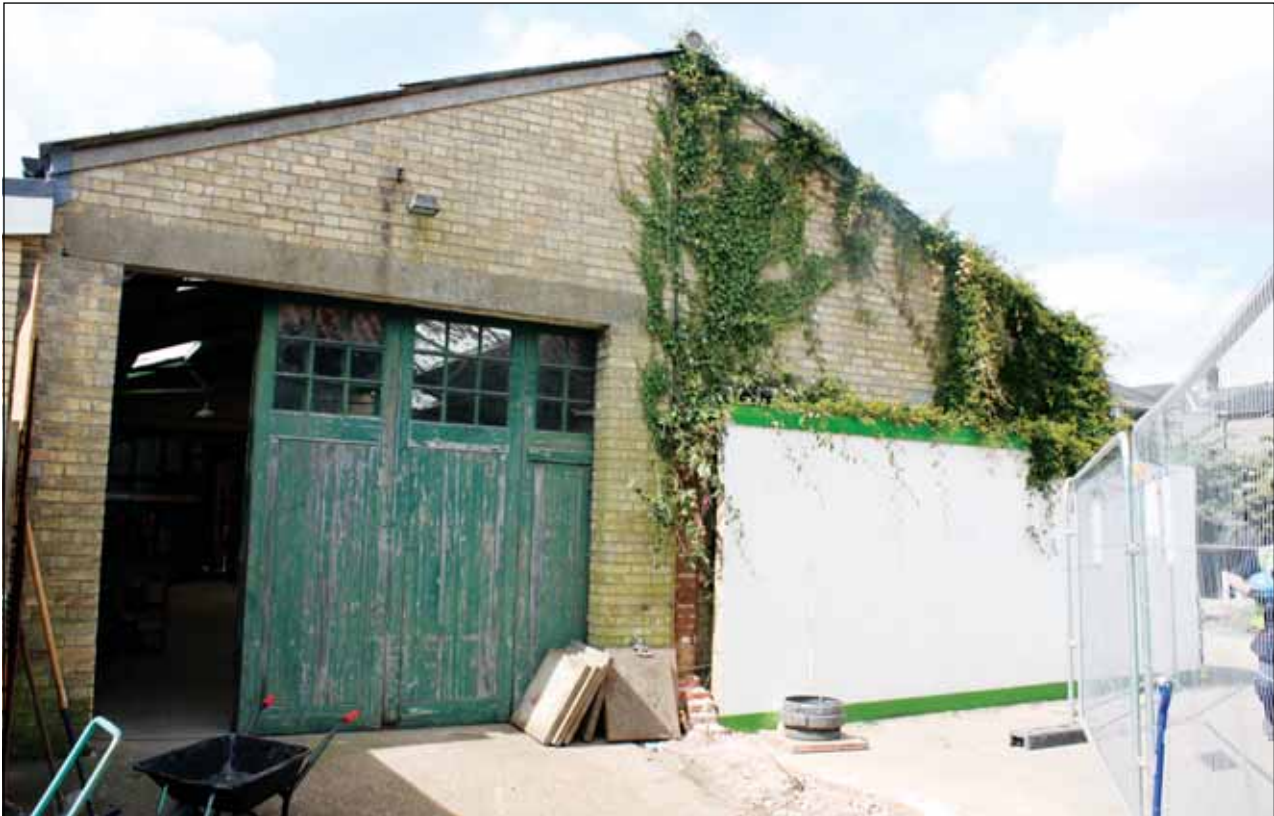
4.1.2 This elevation comprises the main entrance to the auction house (Plate 1). It is constructed using a buff coloured brick, laid in a Flemish bond with a light coloured mortar with crushed flint inclusions.

4.1.3 The main entrance has a large concrete lintel above and the doors comprise four panels, each made up of vertically laid boards and nine panes of glass above. At the time of the survey, part of this elevation was obscured with hoarding, however, the client's elevation drawing provided indicates that there are two windows behind (Figure 7). Plate 1 also shows a red brick-built wall located to the right of the door which had been removed prior to the start of the survey. The position of this wall corresponds to that present on the 1971 Ordnance Survey Map (Figure 6) which connects the auction house to the cattle market.

Plate 1: East-facing elevation of auction house

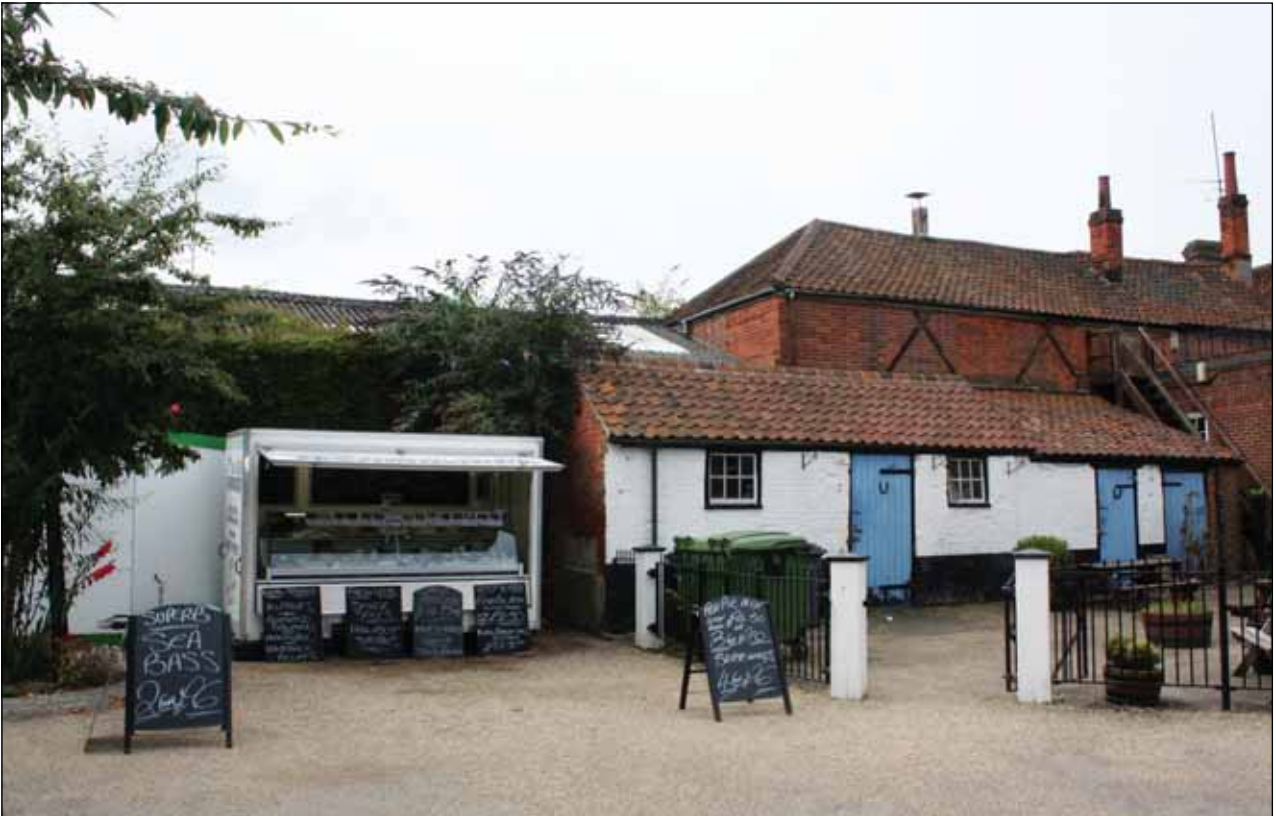
- 4.2.24 There is also a large iron hood and flue positioned in the middle of the room which is presumably the same one visible from outside (Plate 3). This may have been connected to the flue noted in the description of the steam oven in the ground floor room directly below and provided a way of releasing the steam in such a small and confined building.

Plate 3: North-facing elevation of outbuildings at rear of the White Hart with first floor of bakehouse behind

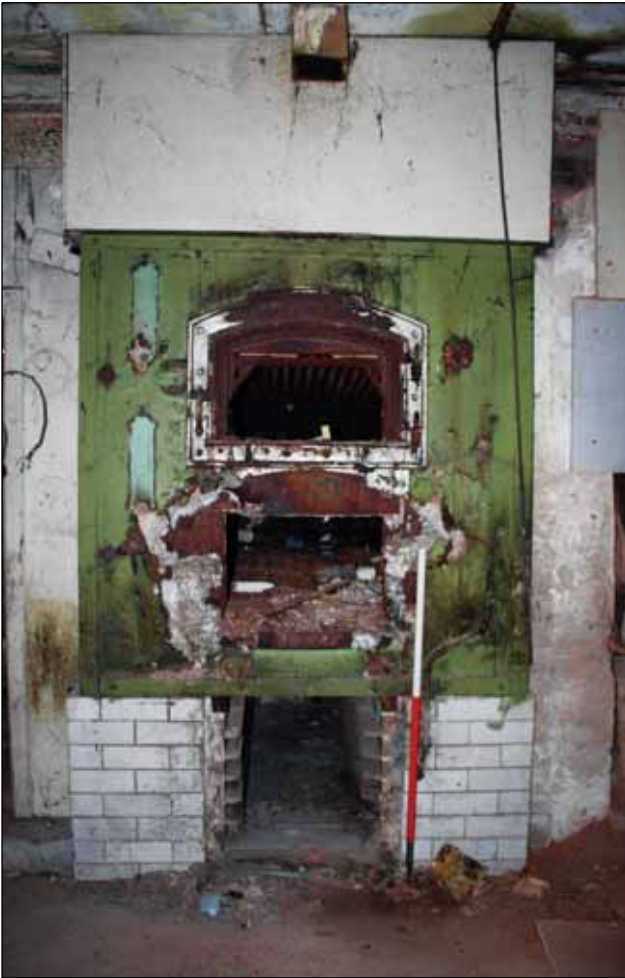
Plate 23: Detail of "Collins Steam Oven"

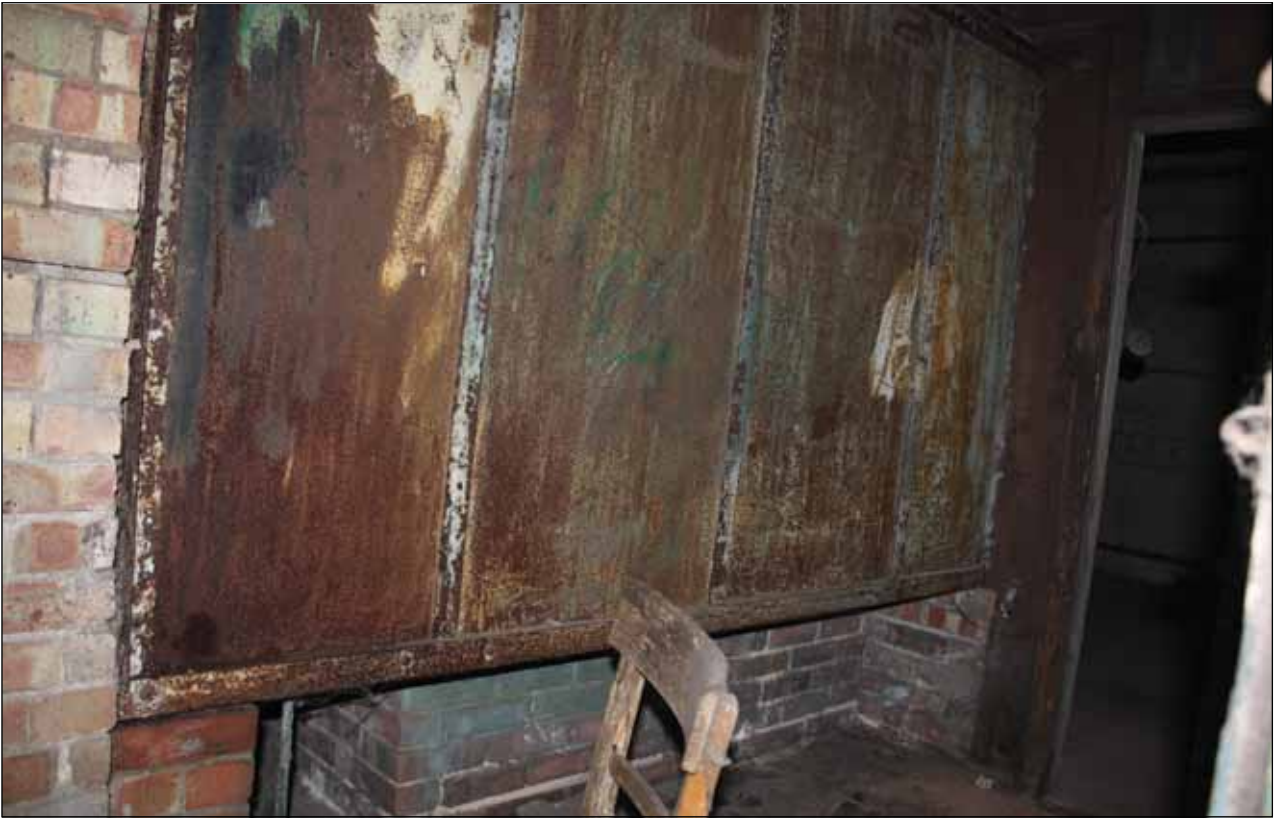
Plate 29: Detail of oven screen, Building 3

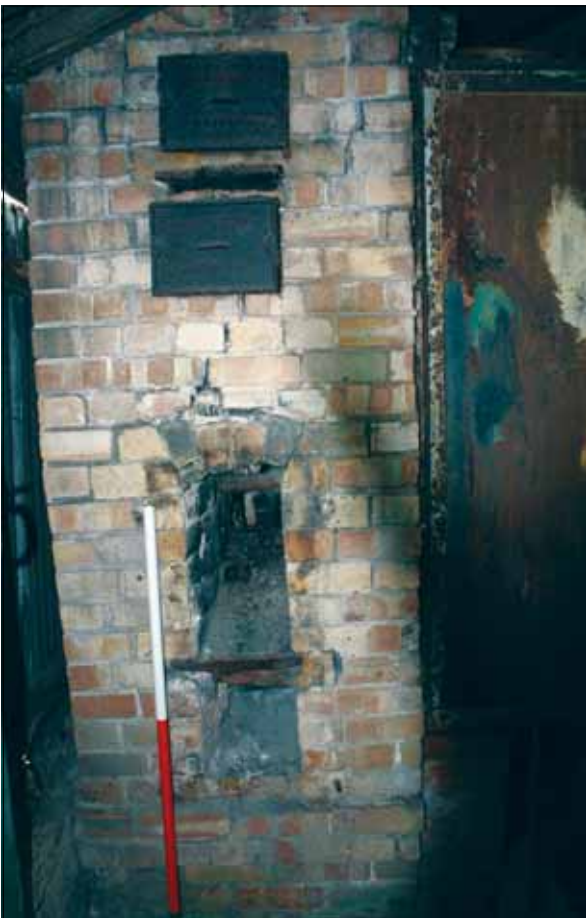
Plate 30: Detail of brick furnace (?), Building 3

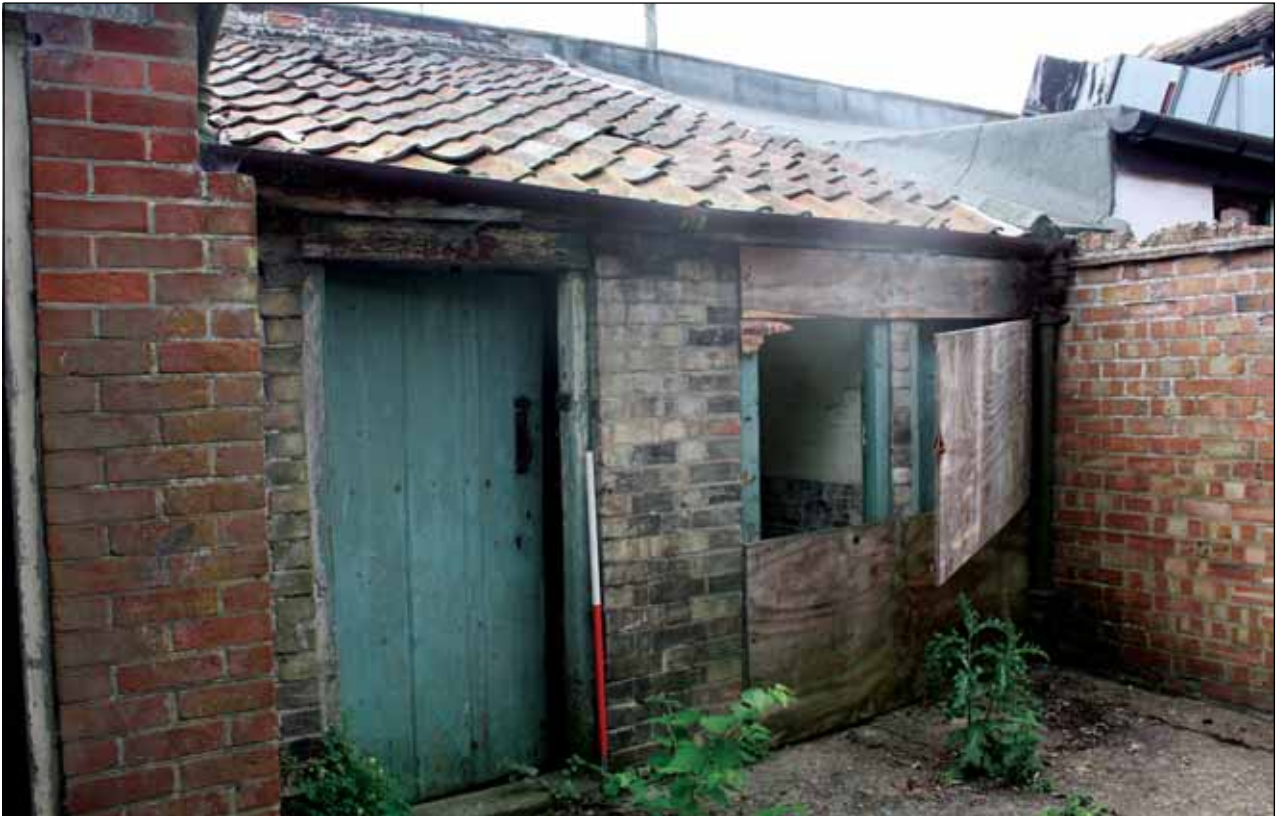
- 4.2.33 Located in and accessed from the external courtyard, this small building was empty at the time of the survey.. It is constructed from a buff coloured brick with an average dimension of 23cm by 10.5cm by 7cm, in a Flemish bond (Plate 33). It has a clay pantile mono-pitched roof and is accessed via a painted plank and batten door with original latch and handle typically late 19th century in date. There are two further doors which provide access to two small outside toilets. Although boarded-up, a brief inspection was made where a ceramic toilet and cistern were noted in each.

Plate 33: Building 5 as viewed from external courtyard

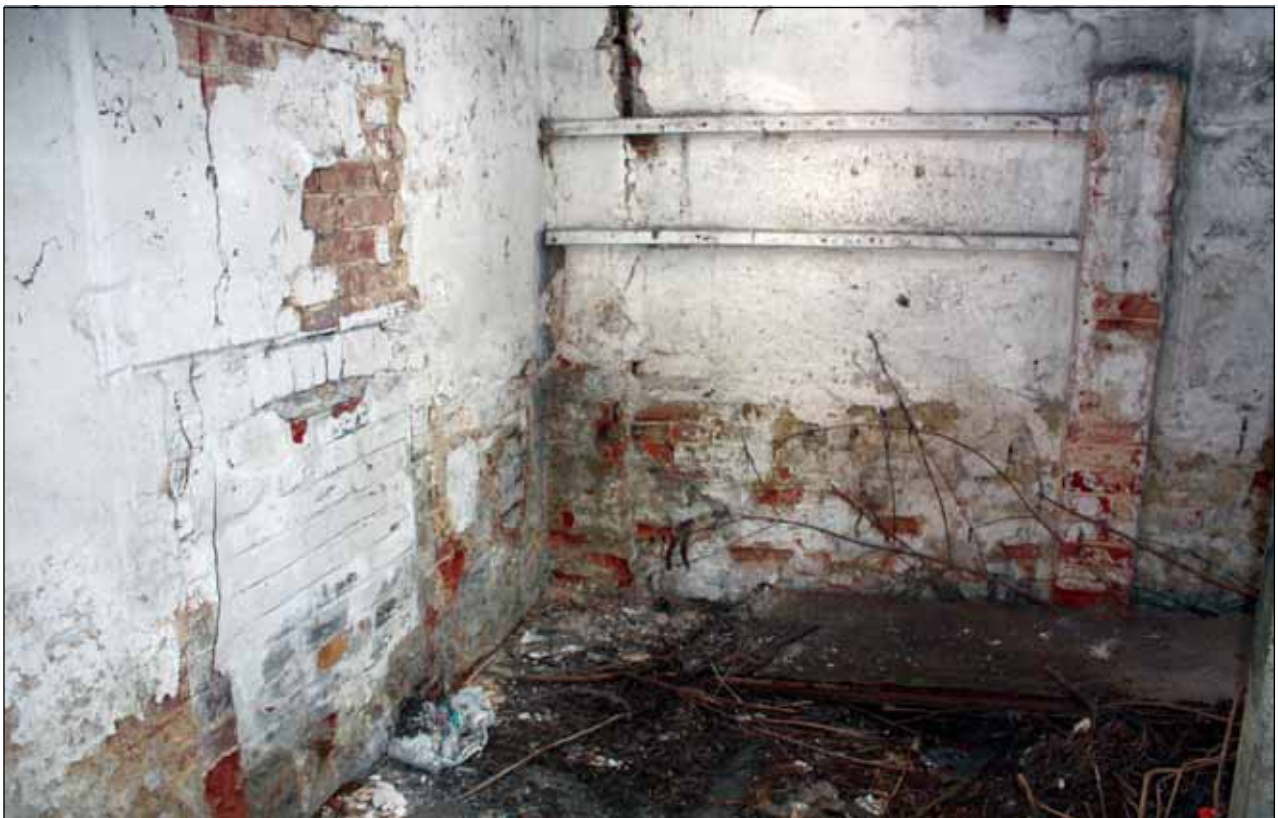
- 4.2.34 Inside, the walls are white painted brick and on the left on entering is a blocked-up fireplace (Plate 34) to which there is no corresponding chimney surviving externally. This building measures 3.78m by 3.55m with a concrete covered floor. The ceiling has suffered some damage where tiles have been lost (Plate 35), however a number of plasterboards remain. The rear wall (opposite on entering) appears to be a continuation of the curved garden/boundary wall as recorded in the auction house rooms G2 and G3. Within this section of earlier wall is a brick support buttress and a possible blocked-up door (Plate 36).

Plate 34: Interior of Building 5 showing blocked-up fireplace and wall support buttress

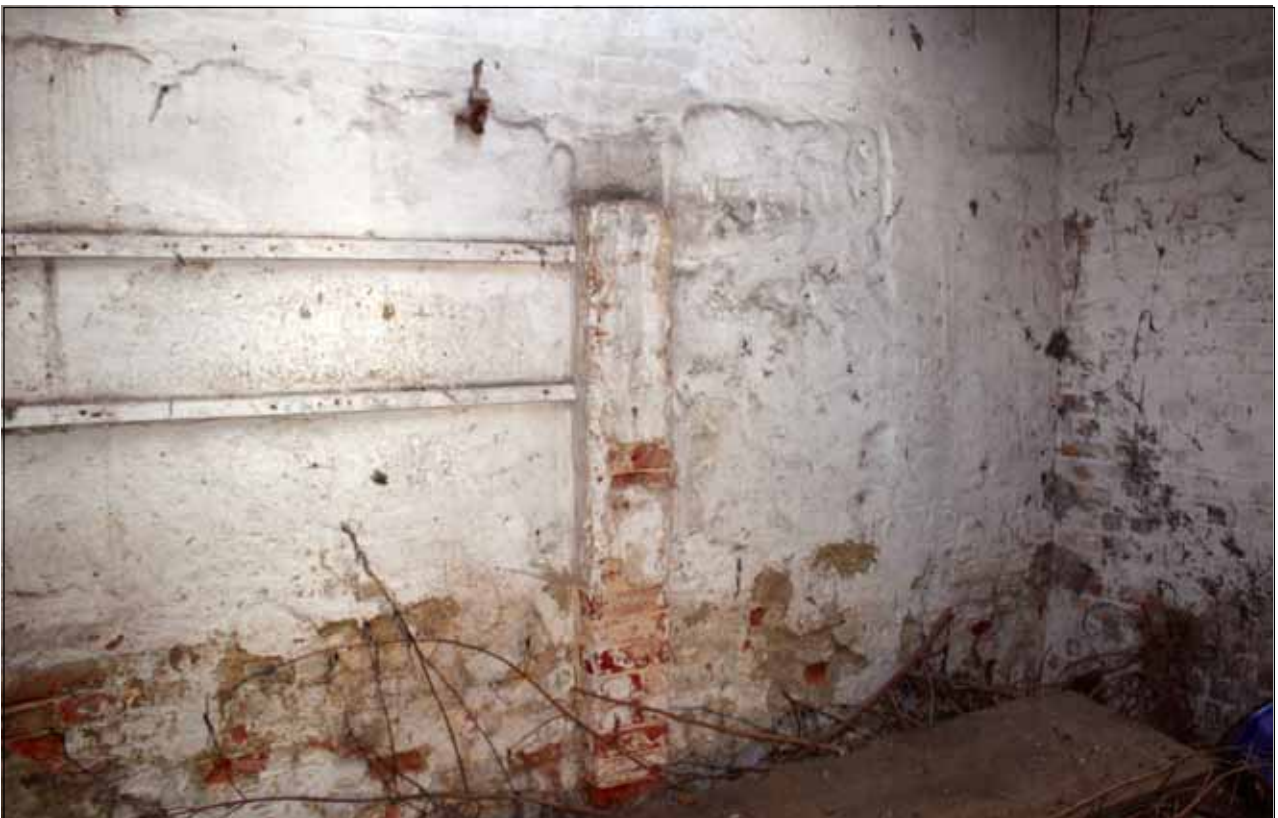
Plate 36: Detail of Brick buttress and possible blocked-up door, Building 5

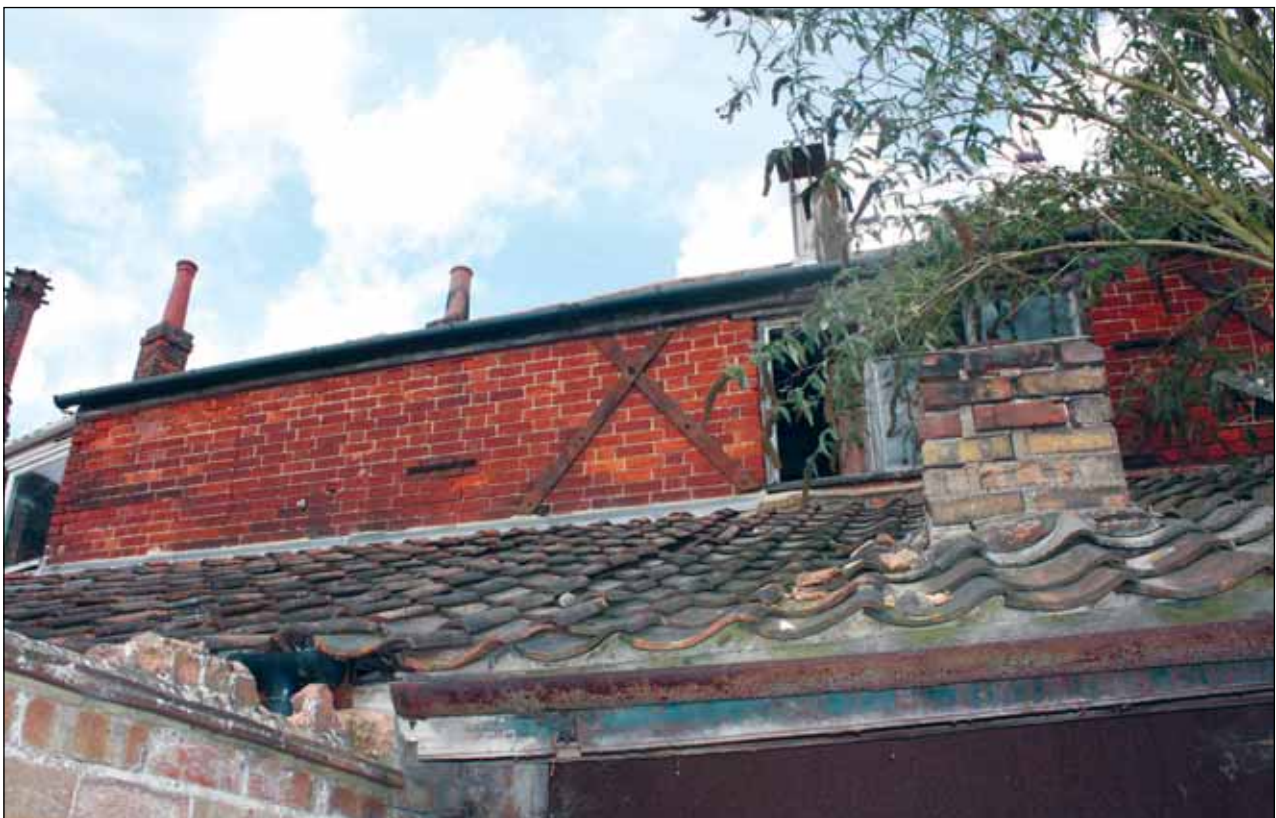
4.2.37 From the external courtyard, the first floor of the bakehouse can be viewed (Plate 38). The same structural support ties are present as noted on the opposite north-facing elevation. The building is constructed from an orange coloured brick laid in a Flemish bond. The roof is covered with clay pantiles and there is a tri-part wooden-frame casement window.

Plate 38: First floor of bakehouse, viewed from external courtyard
