# Land at Albion Place Oxford

## Archaeological Watching Brief Report

May 2008

**Client: Capital Shopping  
Centres**

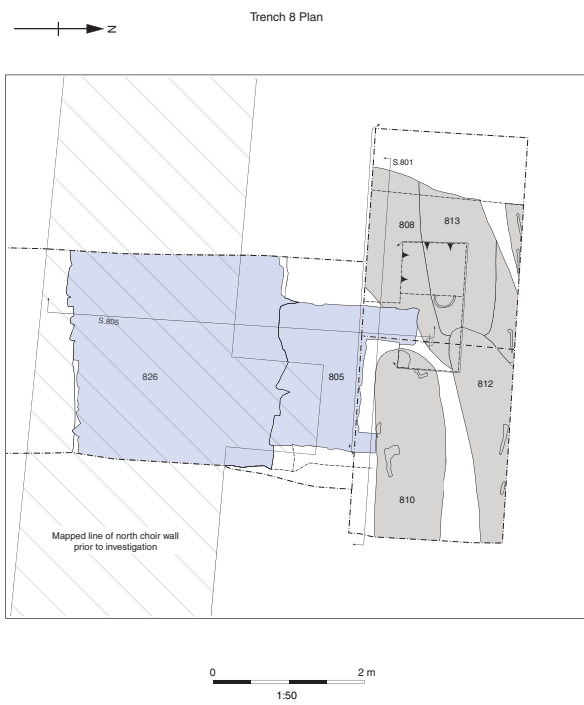
Figure 3 : Plan of Trench 8 and sections

7.4.1 This test pit was excavated in the north-central part of the site. The test pit measured 3.4 m x 1.6 m x 1.8 m depth. At least six approximately east-west aligned burials were revealed at the base of the test pit (at c 55.23 m OD). During cleaning of the grave cuts pottery was retrieved from four of the grave fills. This was generally of a 13th -14th century date (see Appendix 1 and Section 2.1).

7.4.2 A squared stone buttress (805) and east west aligned stone wall (826) were revealed to the south of the trench (see Fig.3). The buttress was found at 55.18 m OD and was at least 0.70 m deep. The structure had at least one (0.2 m) offset to the north and Grave 810 overlay this offset.

7.4.3 Wall 826 was 2.3 m wide (the depth was not revealed) and represents the north wall of the Priory Choir. A section across the test pit (Fig.3) shows the upper part of the wall has been robbed. The robbing infill (830) is sealed by 'garden soil' 804, which contained 18th-19th century pottery.

7.4.4 As a result of the Test Pit investigation proposed pile location 8 which would have impacted on the burials was moved to the south of the Priory wall. Here all deposits or structures internal to and related to the Priory choir had been truncated by modern impacts to the depth of sterile flood plain deposits at 54.85 m OD.
