Castle Hill Mound Cambridge

Archaeological Evaluation Report

Cambridge Castle Mound

Archaeological Test Pit and Borehole Evaluation

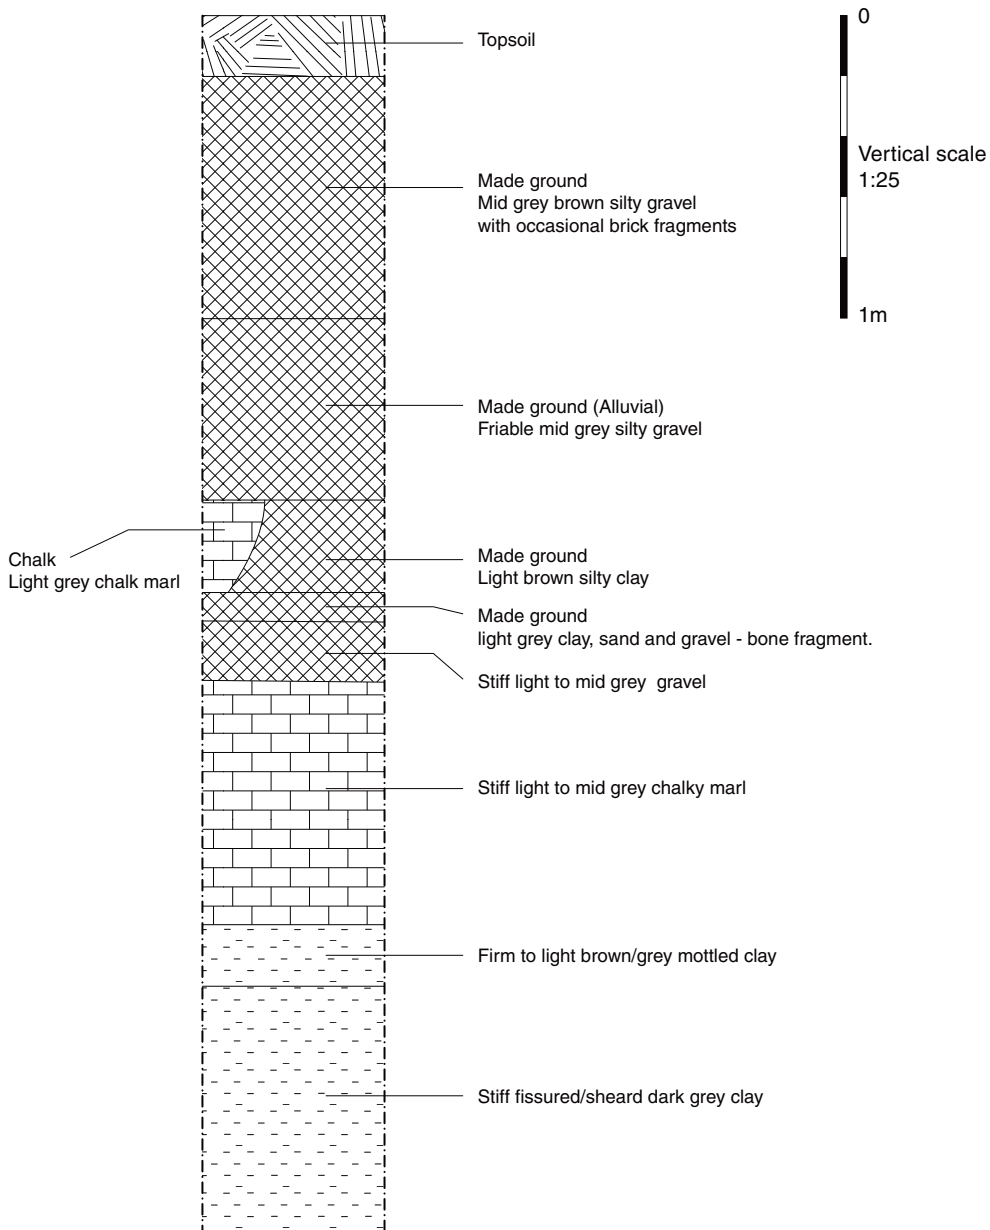
Figure 5: Bore Hole 5

Bore Hole 5 Section

- 3.6.6 Bore hole 4a was sunk to a depth 4.0m and showed made up ground to a depth of 1.0m and a mixture of redeposited chalk and gravel below this.
- 3.6.7 Bore hole 5 was the only sample to give any indication of a possible archaeological feature. This sample was sunk to a depth of 4m. With the top 2.20m consisting of made up ground. Between 1.60m and 1.90m a split between a grey chalky marl and an organic dark grey/ black material was encountered. Although it is impossible to interpret this as a definite feature it could be inferred that the edge of a trench or pit was glanced. Given the plan of the castle and the position of the motte it is possible that a ditch (the original Norman castle moat?) ran along the base of the mound in the area of bore hole 5.
