Osney Mill Mill Lane Oxford

Archaeological Watching Brief Report

Document Title: Osney Mill, Mill Lane, Oxford

Document Type: Watching Brief

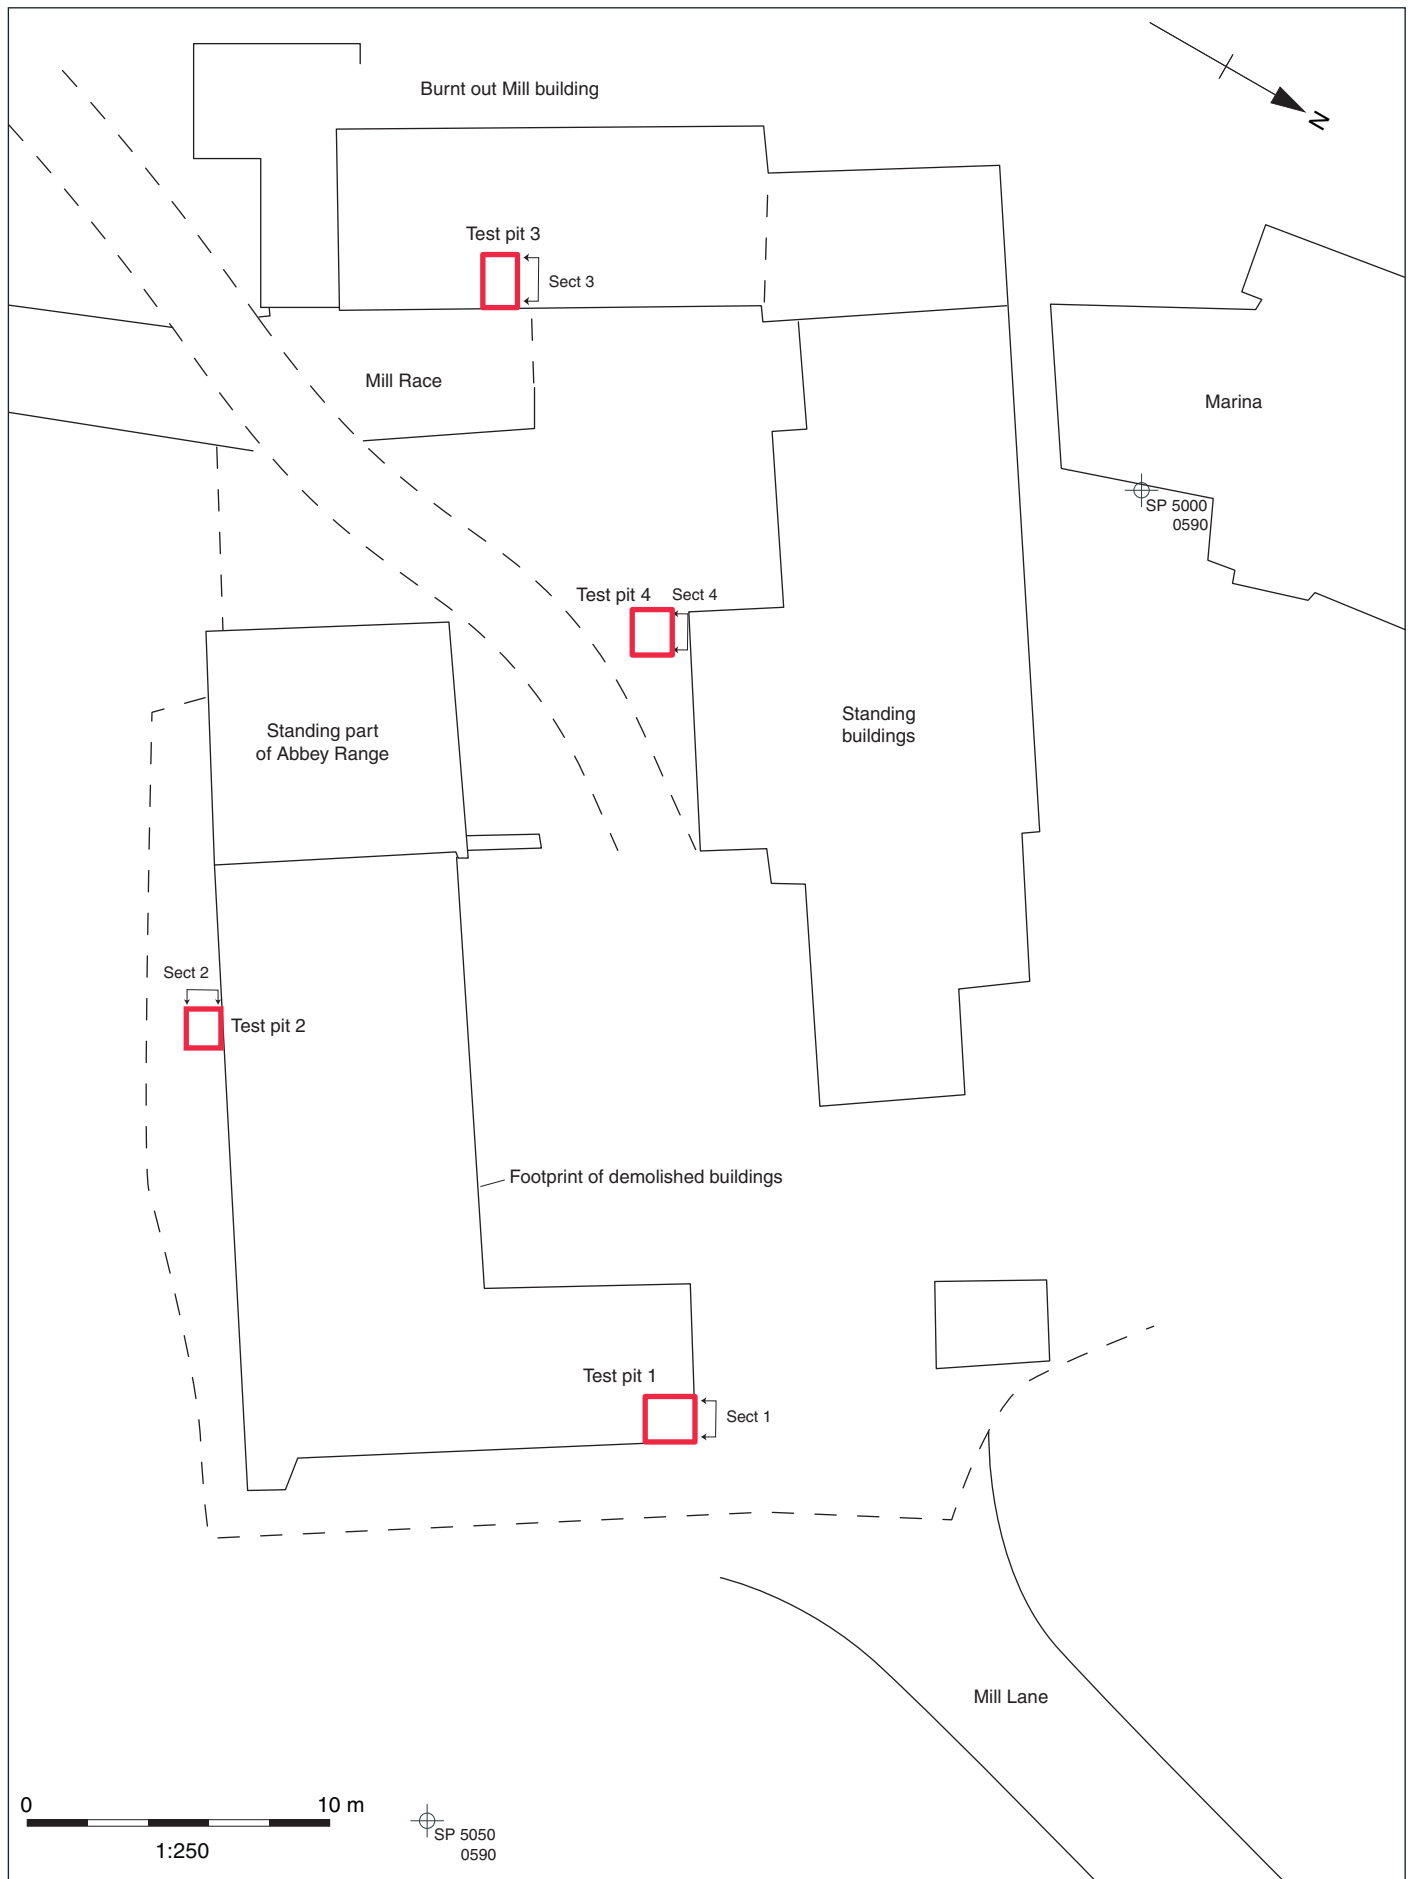
Figure 2 : Site plan

2.2.2 All the test pits and any archaeological features were planned at a scale of 1:100 (Fig. 2) and their sections drawn at a scale of 1:20. All the test pits, any archaeological features and recorded sections were photographed using colour slide and black and white print film. A general photographic record of the work was also made. Recording followed procedures detailed in the *OA Field Manual* (ed D Wilkinson, 1992).

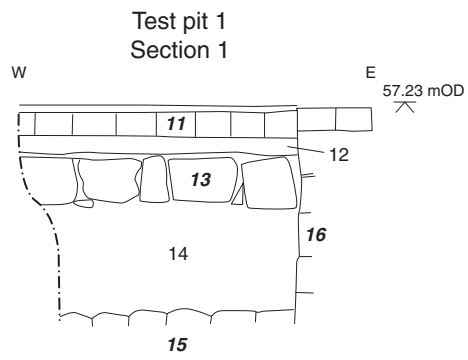
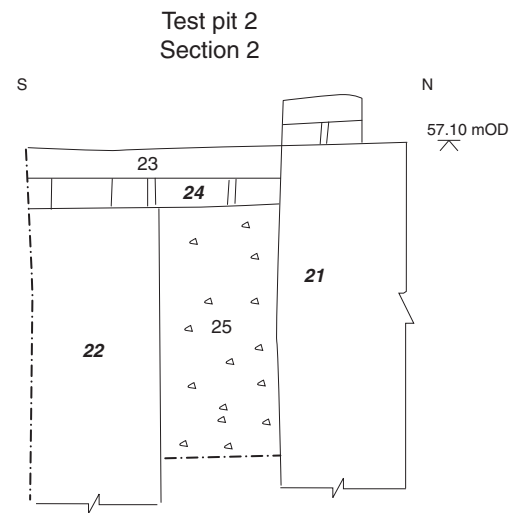
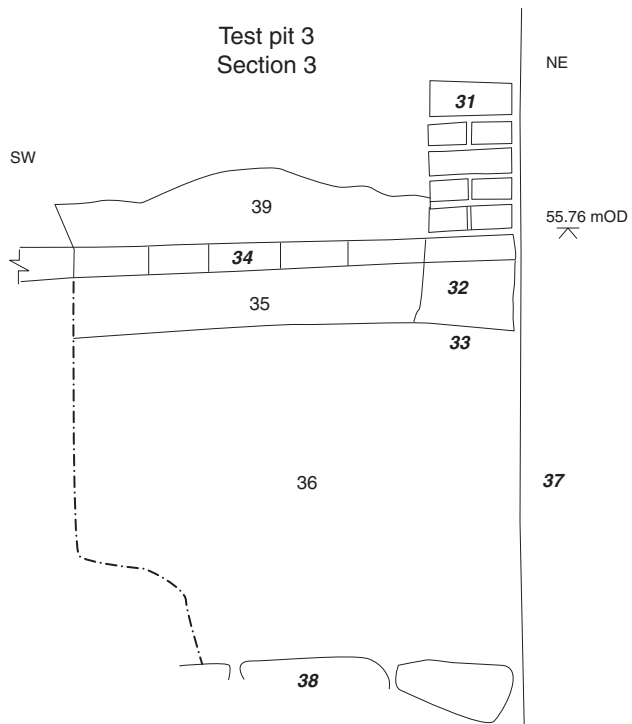
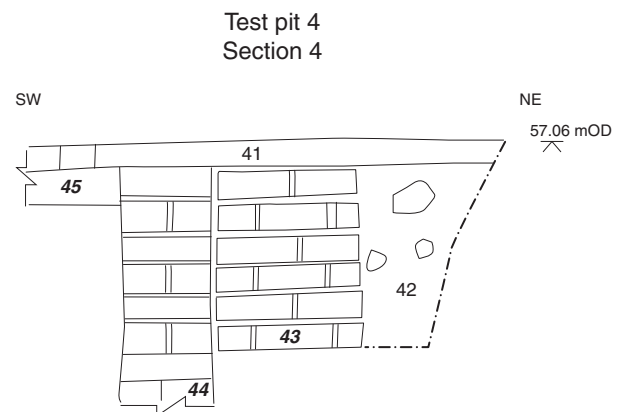
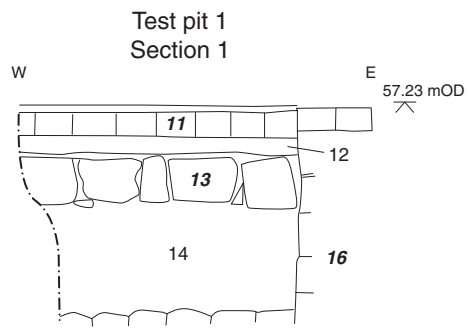
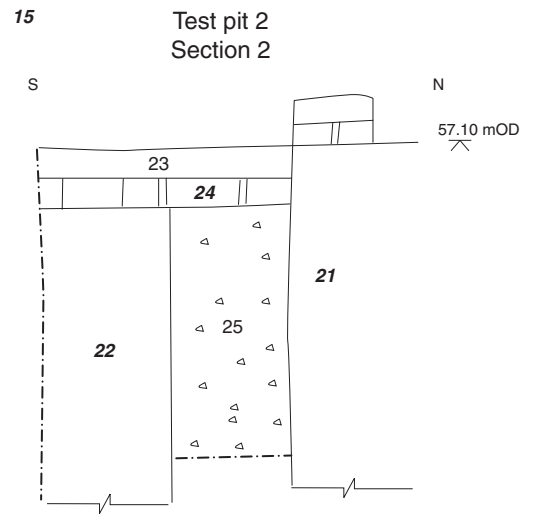
Figure 3 : Sections

3.1.2 A stone floor composed of rounded limestone blocks (15) was encountered at a depth of 0.7 m below the current ground level (Fig. 3, Section 1, Fig. 4, Plate 1). This feature butted up to the limestone block constructed wall (16) and may be contemporary.

- 3.1.5 This was located on the southern edge of a demolished two-storey brick building, and measured approximately 1 m square.
- 3.1.6 A standing brick wall (21) constructed using machine made bricks measuring 0.22m by 0.102 m by 0.072 m laid using English Stretcher bond defined the northern edge of the pit (Fig. 3, Section 2, Fig. 4, Plate 2). A second wall (22) running parallel with wall (21) 0.4 m to the south of similar construction was encountered during the course of excavation. Filling the space between these two walls was a very dark grey sandy silt (25). This was encountered at a depth of 0.2 m below the current ground level and was excavated to a depth of 1.2 m below ground level without determining its full depth.

- 3.1.8 This was located against the inside of the eastern wall of the main mill building, on the opposite side of the wall to the mill race channel (Fig. 3, Section 3, Fig. 4, Plate 3)

- 3.1.12 The top of a demolished south-east to north-west aligned wall (44) was encountered during the excavation of the test pit 0.1 m below the current ground level (Fig. 3, Section 4, Fig. 4, Plate 4). The alignment showed it to be a continuation of the west wall of the standing building and probably originally extending to meet the brick frontage added onto the northern wall of the medieval range. Butting up to the western side of this wall was a brick built foundation plinth (43). Built using machine made bricks laid using cement mortar excavation showed it to be 0.48 m wide and at least 6 courses of bricks deep. examination of the bricks when removed showed signs of heating and burning on some of the bricks.

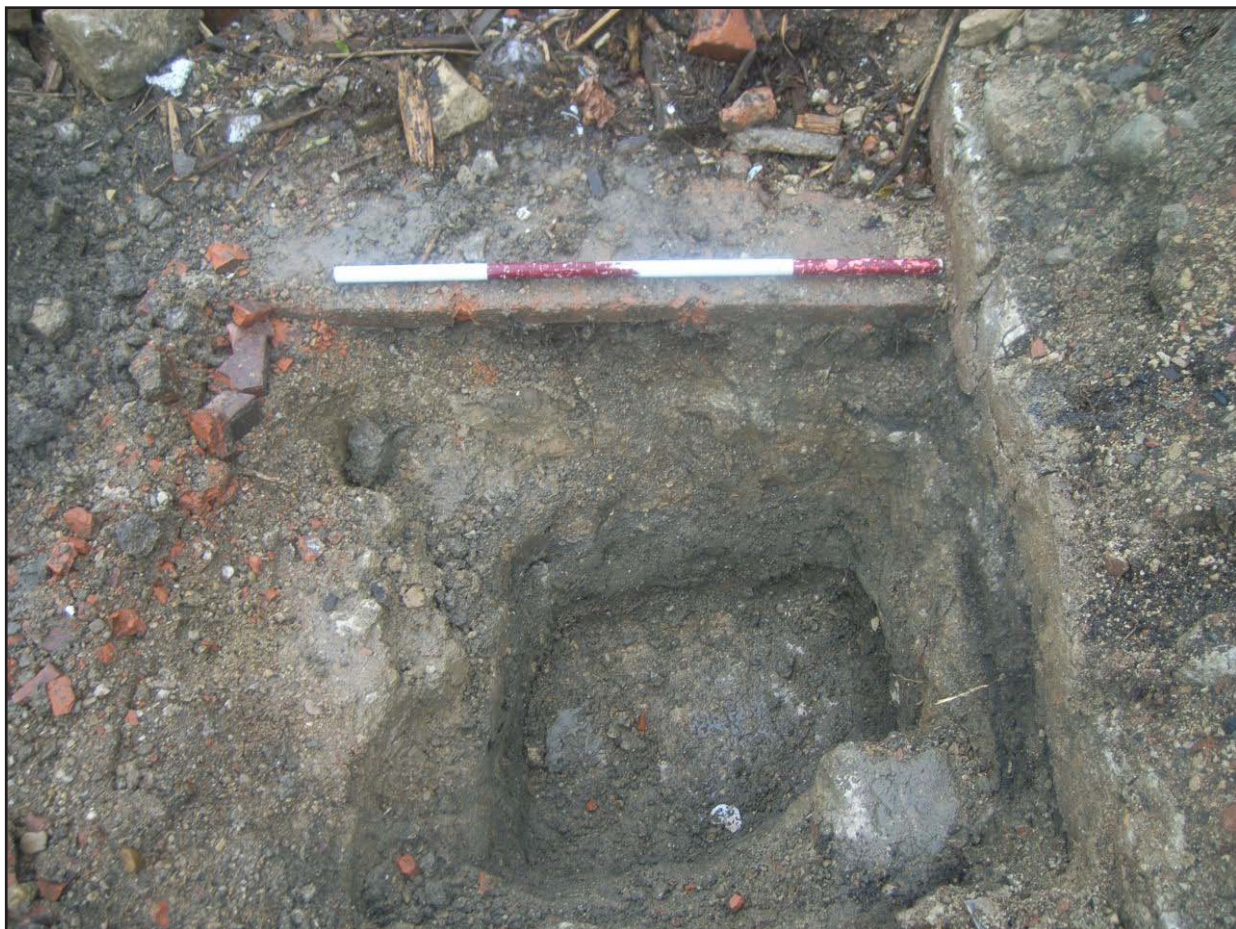
Plate 1 : Test pit 1

3.1.3 The floor was overlaid by a 0.35 m deep layer of grey-brown silt (14). This deposit produced fragments of stone and also fragments of pottery. Laid directly upon this layer was a second stone floor (13). This was constructed using blocks of limestone measuring approximately 0.3 m by 0.25 m by 0.2 m with only the top face levelled and the rest as quarried. The surface of the floor was very smooth and polished indicating a high degree of wear.

3.1.4 Overlying this floor was a layer of dark grey-brown clay silt (12) measuring between 0.07 m and 0.12 m in depth. this deposit formed a bed for the brick floor (11). This was constructed using frogless machine-made bricks measuring 0.225 m by 0.105 m by 0.072m laid using a simple overlapping pattern and no bonding material.

- 4.1.1 Exposed within this pit was the base of a limestone constructed wall (16) which had been used as the foundations for the brick walls of the demolished out building. The stone floor (15) exposed in the base of the pit is probably associated with this wall. No direct evidence for the date of construction of these features was observed during the course of the excavation, however Layer 14 which contained fragments of 18th and 19th century pottery lay directly over Floor 15. The absence of any intervening deposits containing earlier dating evidence may indicate that both the floor and the stone wall are post-medieval in date (possibly reusing stone recovered from the abbey buildings). The later stone floor (13), Layer 12 and the brick floor (11) are all 19th-century or later, and probably relate to the later industrial use of the site.

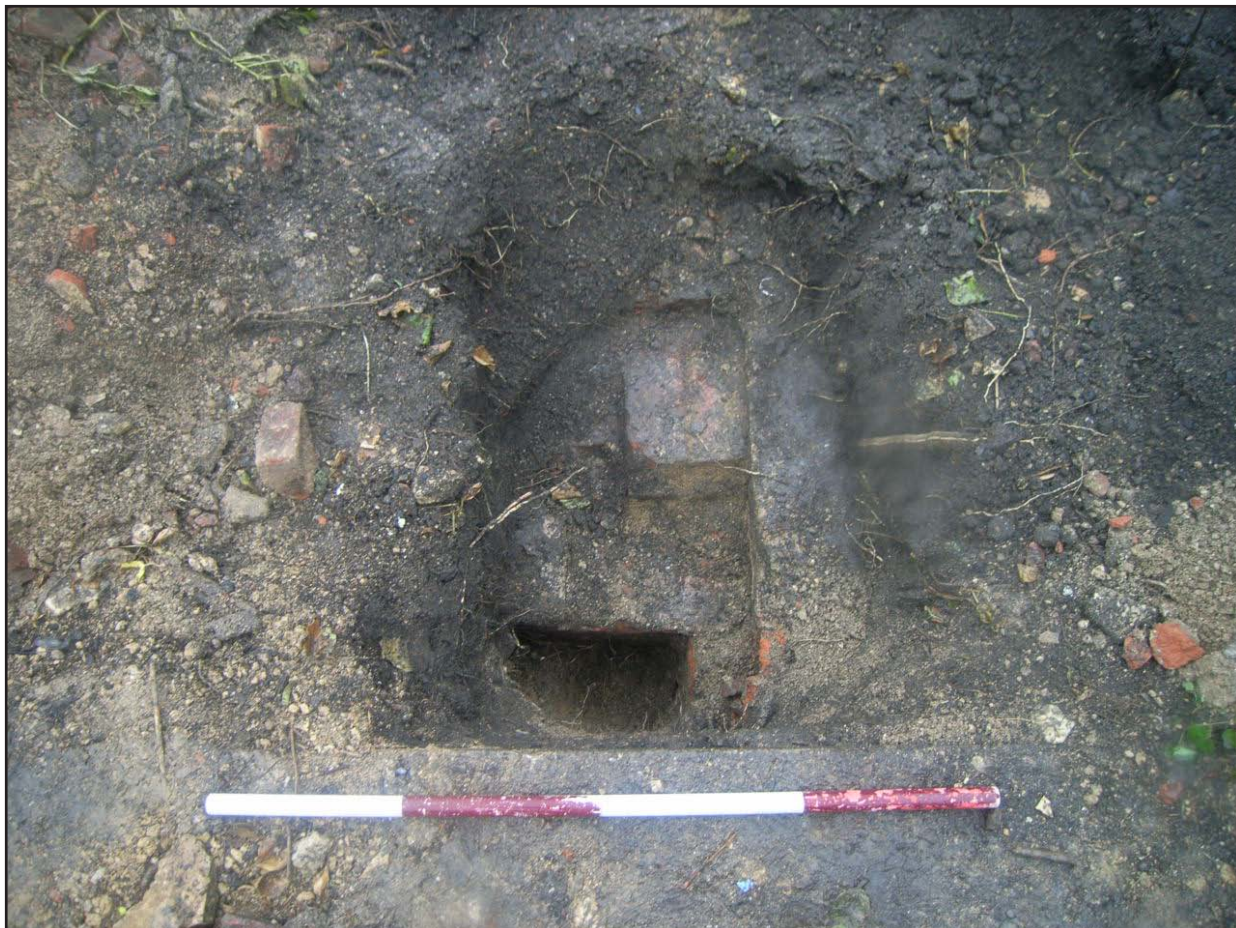
Plate 2 : Test pit 2

- 3.1.7 Laid directly onto deposit 25 and running over the top of Wall 22 was a brick floor (24). This was built using frogless bricks measuring 0.225 m by 0.105 m by 0.072 m. Overlying this floor and butting up to wall 21 was a 0.1 m deep layer of very dark grey-brown silt loam (23), an accumulation of leaf mould and organic debris.

- 4.1.2 The presence of the 19th-century brick walls (21) and (22) (dated by brick size) suggests that this area has been heavily disturbed. While Wall 21 appears to respect the alignment of the standing medieval building, no evidence for any earlier foundations was observed. As in Pit 1 the walls and the brick floor (24) probably relate to the 19th-century industrial use of the site.

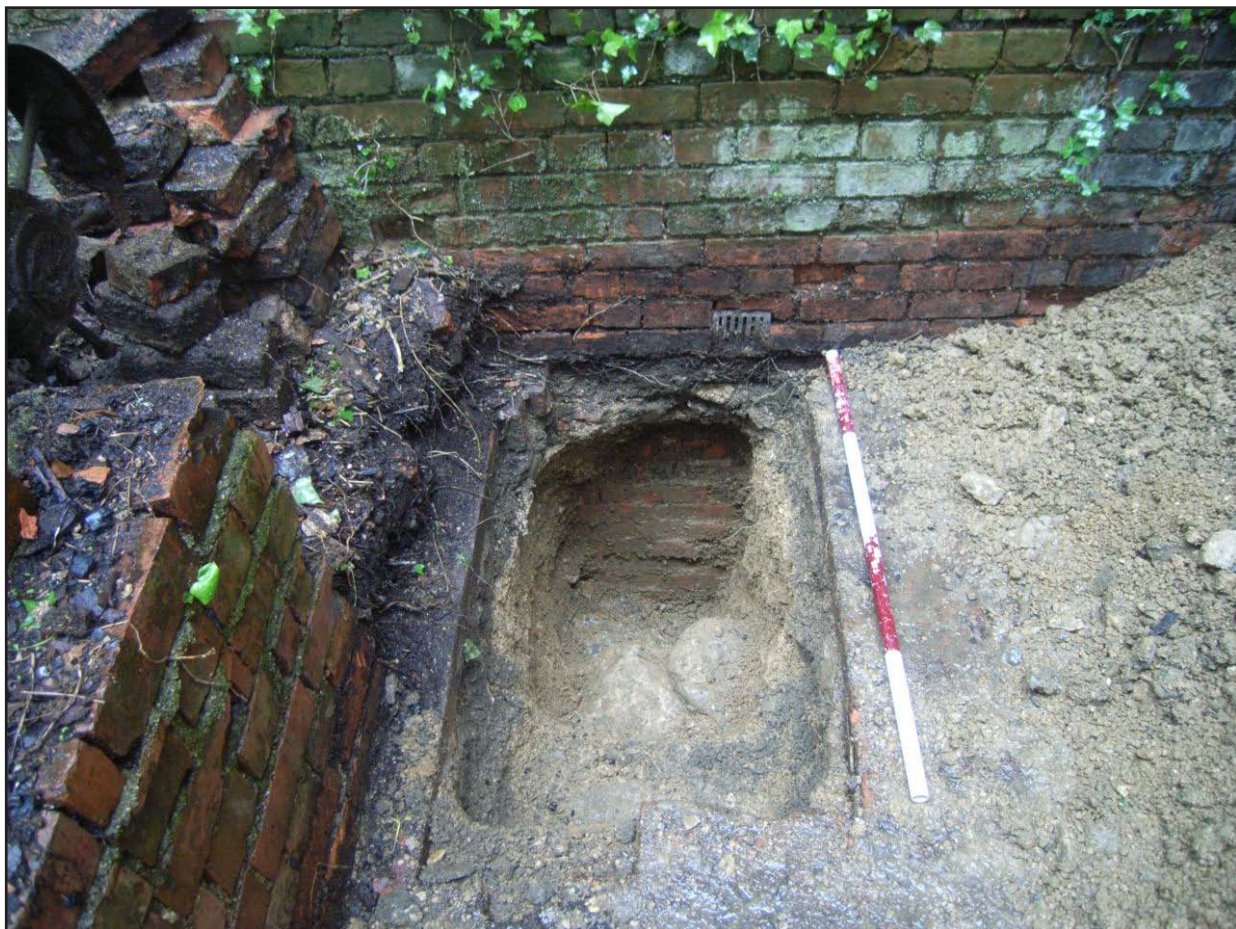
Plate 3 : Test pit 3

- 3.1.9 The eastern wall of the mill building (37) formed the eastern edge of the pit. Butting up to this wall at a depth of 1.5 m below the original floor level of the mill was a layer of large limestone boulders (38). This was constructed using as-quarried rocks laid adjacent to each other with no bonding material. Overlying this was a 1.1 m deep layer of imported yellow oolitic gravel (36). This was overlaid by a 0.15 m deep layer of dark grey-brown clay silt (35). Lying directly upon this deposit was a bed of lime mortar forming a base for the brick floor (34), built using machine made bricks measuring 0.22 m by 0.105 m by 0.072 m.

- 3.1.10 Cutting the eastern edge of this floor was a foundation trench (33), 0.2 m wide and 0.22 m deep and running parallel to Wall 37. This was filled by a weak lime concrete (32) forming the foundations for Wall 31, a brick built wall 9 courses high and a single bricks length wide, butting up against Wall 37. This formed a ledge supporting a later inserted wooden floor. Butting up to Wall 31 and overlying Floor 34 was a layer of black leaf mould and demolition debris (39), between 0.3 m and 0.5 m in depth.

- 4.1.3 This Pit exposed details of the initial construction of the main 19th-century mill building, together with later alterations.
- 4.1.4 Neither the foundations or base of the eastern external wall (37) were observed. The layer of limestone boulders (38) butting up to this wall were probably placed as a drainage layer to enable rising ground/flood water to drain quickly from the inside of the building when the river was in spate. The layer of gravel (36) has been imported both to raise the internal level of the building above the water table and also to aid drainage of any water ingress. The brick floor (34) probably represents the original floor level of the mill.

- 4.1.5 The brick stub wall (32) and (33) is part of a later refitting of the mill with a raised suspended wooden floor being inserted into the building. This work seems to be contemporary with the insertion of the substantial brick machinery plinths (not illustrated) still to be seen in the main mill building and is probably late 19th or early 20th-century in date.

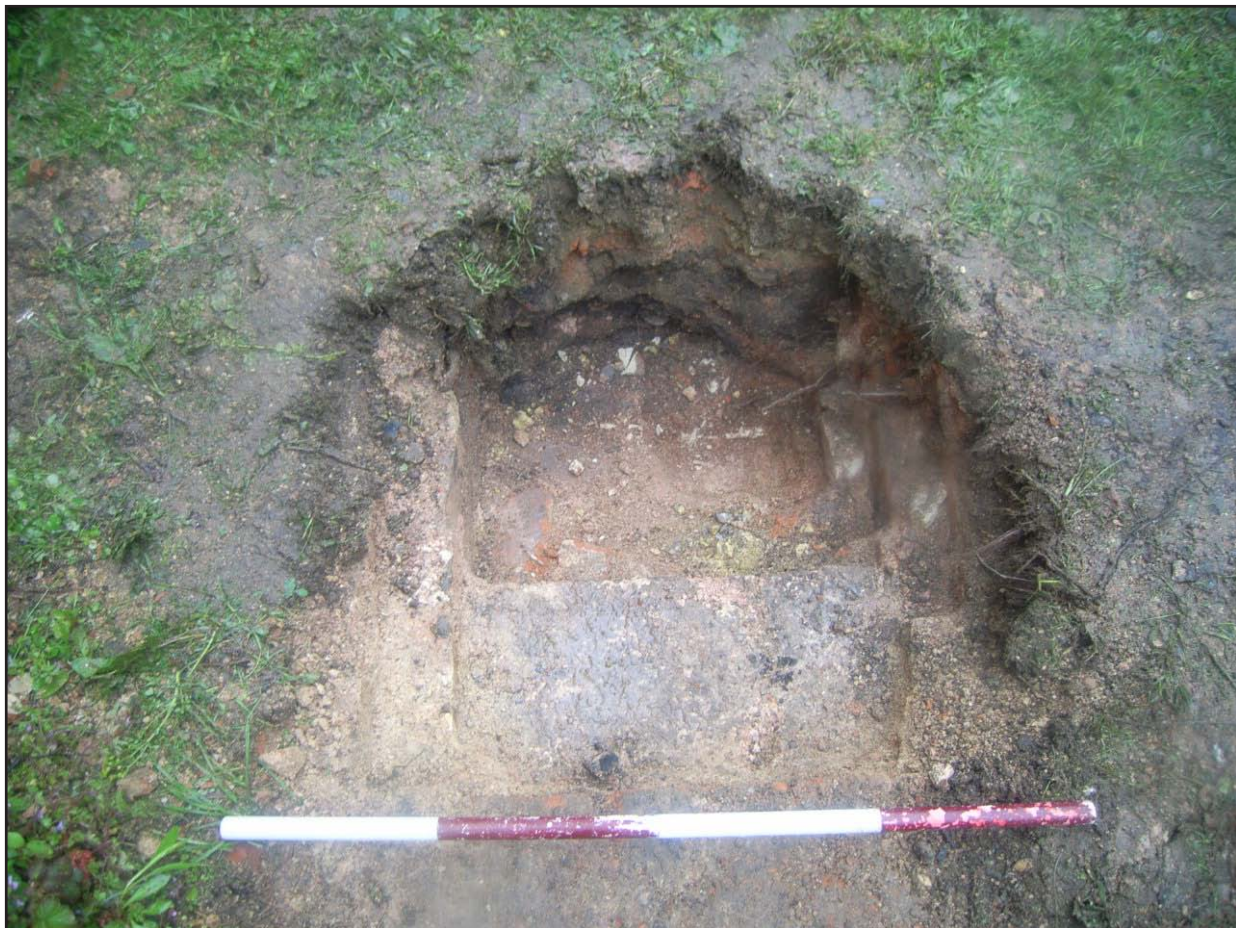
Plate 4 : Test pit 4

- 3.1.13 Butting up against this feature was a layer of black gritty silt (42). This deposit appeared to have a clinker and ash content consistent with the evidence of burning, possibly suggesting a hearth.

- 3.1.14 Butting up to the western side of wall 44 was a layer of concrete 0.15 m deep (45), which was left in situ. Overlying concrete 45, walls 43 and 44 and layer 42 was a 0.1 m deep layer of grey-brown clay silt (41), an accumulation of leaf mould and flood deposits.

- 4.1.7 This pit was located on the projected alignment of the west wall of the standing medieval building, although no evidence for the continuation of the building was exposed. There is the probability that the building material, including the foundations, had been robbed out leaving no positive evidence. The construction of the 19th-century brick wall (44) on the same alignment would have disturbed or destroyed any evidence of a robber trench.
- 4.1.8 The brick-built structure (43) probably represents the base of a hearth or fireplace; its substantial construction would have allowed it to support the weight of a chimney stack. The presence of the clinker within deposit (42) would support this conclusion.
