KELMSCOTT MANOR BARN KELMSCOTT OXFORDSHIRE

ARCHAEOLOGICAL BUILDING RECORDING

NGR: SU2510 9891

Oxford Archaeological Unit
August 2001

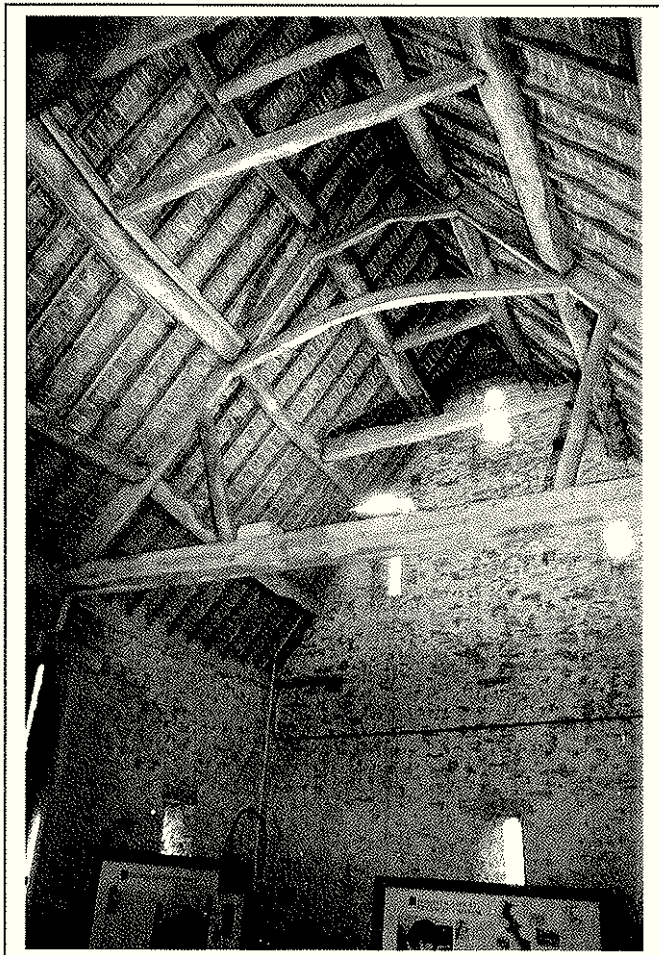
Plate 4: stone flag floor in main barn

- 2.2.2 The main barn is four bays wide with a single threshing floor located in the second bay from the north. Although the threshing floor was obscured at the time of the survey by matting (together with the rest of the north half of the barn) it was apparent that it is not raised as is frequently the case. There is a step close the central line of the barn with the floor raised to the south formed of large irregularly shaped stone flags (Pl. 4).

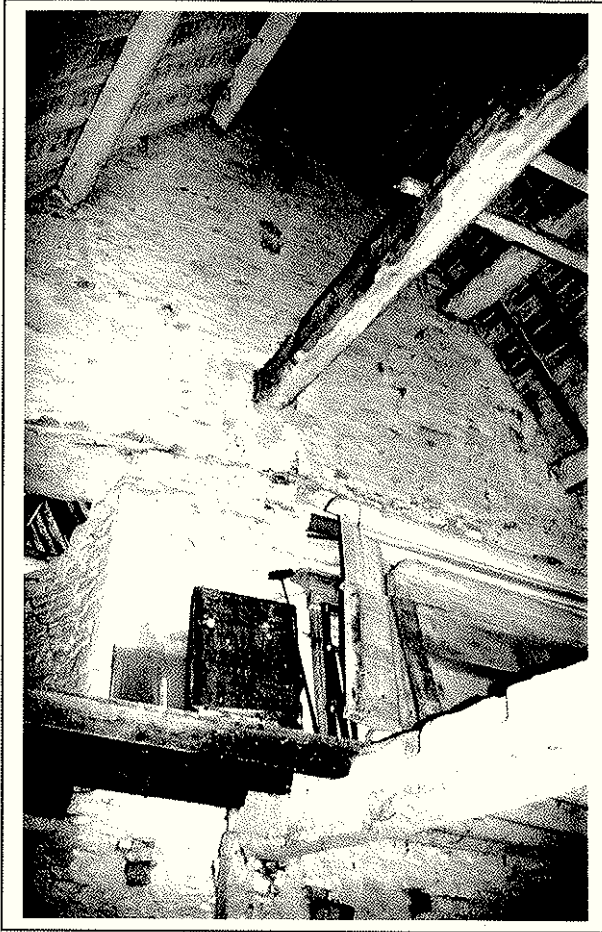
Plate 9: View of upper part of Area 2 looking north showing primary principal joist and later landing

- 2.2.10 Three secondary common joists survive to the west of the principal joist, at the northern end of the room, which forms a small first floor landing at the top of the curved staircase.

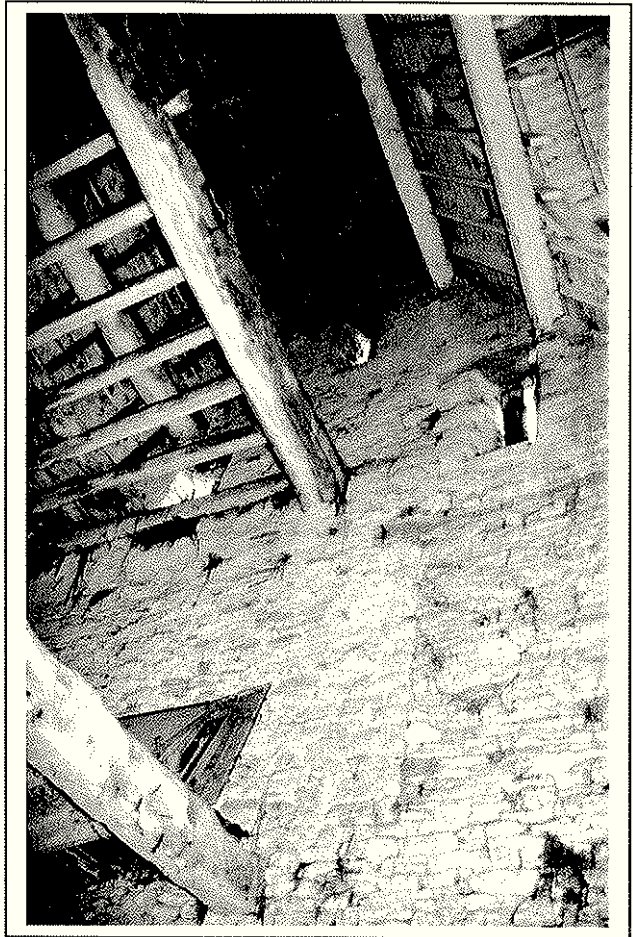
Plate 10: South gable of Area 2 showing partially surviving second floor

- 2.2.11 The walls at first floor were white washed similarly to those at ground floor and there was a blocked doorway (blocked with stone) in the south wall in the western half of the main body of the building and where there is no first floor (Pl. 10). The doorway within the stone cross wall at the head of the curved stone stairs is formed by a long reused elm lintel set at a substantial slope.

- 2.2.13 A north-south principal joist survives at **second floor** in line with the spine of the building and with the first floor principal joist. The joist is c.25 cm x 25 cm and is again of elm with chamfered edges to the underside. Seven common joists survive tenoned into the east face of the joist, at the south-east corner of the building, but no floor boards survive. The east ends of the common joists are lapped over the upper face of the lowest purlin. Empty mortices in the west face of the joist confirm that the second floor formerly continued across Area 2 and this is being reinstated in the current development reusing the existing principal joist.

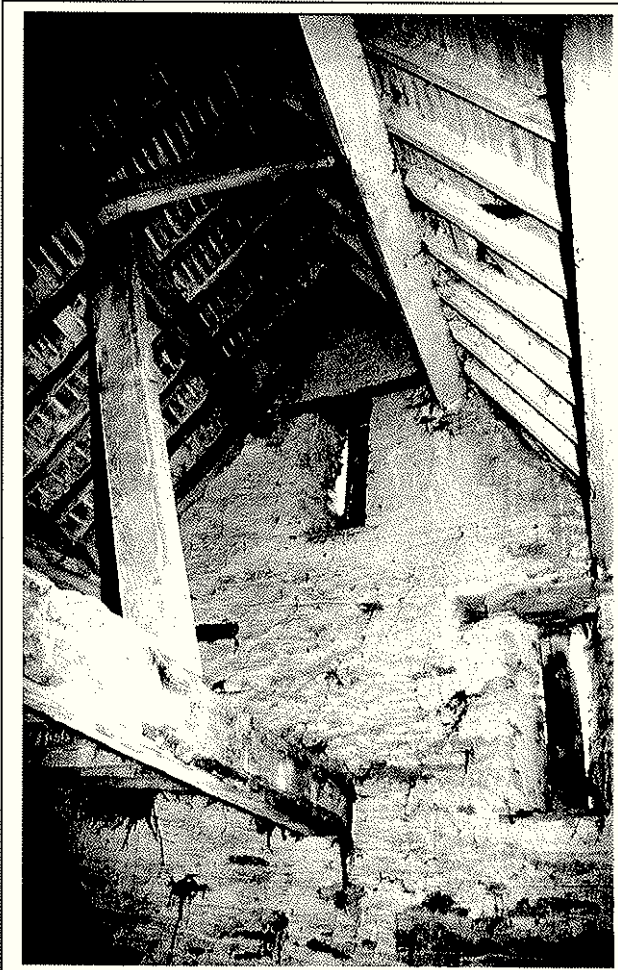
Plate 11: Southern gable and second floor principal joist

- 2.2.14 The walls were again white washed and there were three vertical slit vents in the south gable with splayed jambs similar to those in the main barn (Pl. 11). There was a single similar opening towards the apex of the north wall, dividing Areas 1 and 2, with the wider splayed side to the north face of the wall.
