The Late 17th Century Red Lion Public House Middleton Cheney Northamptonshire

Historic Building Recording

November 2011

OA East Report No: 1310

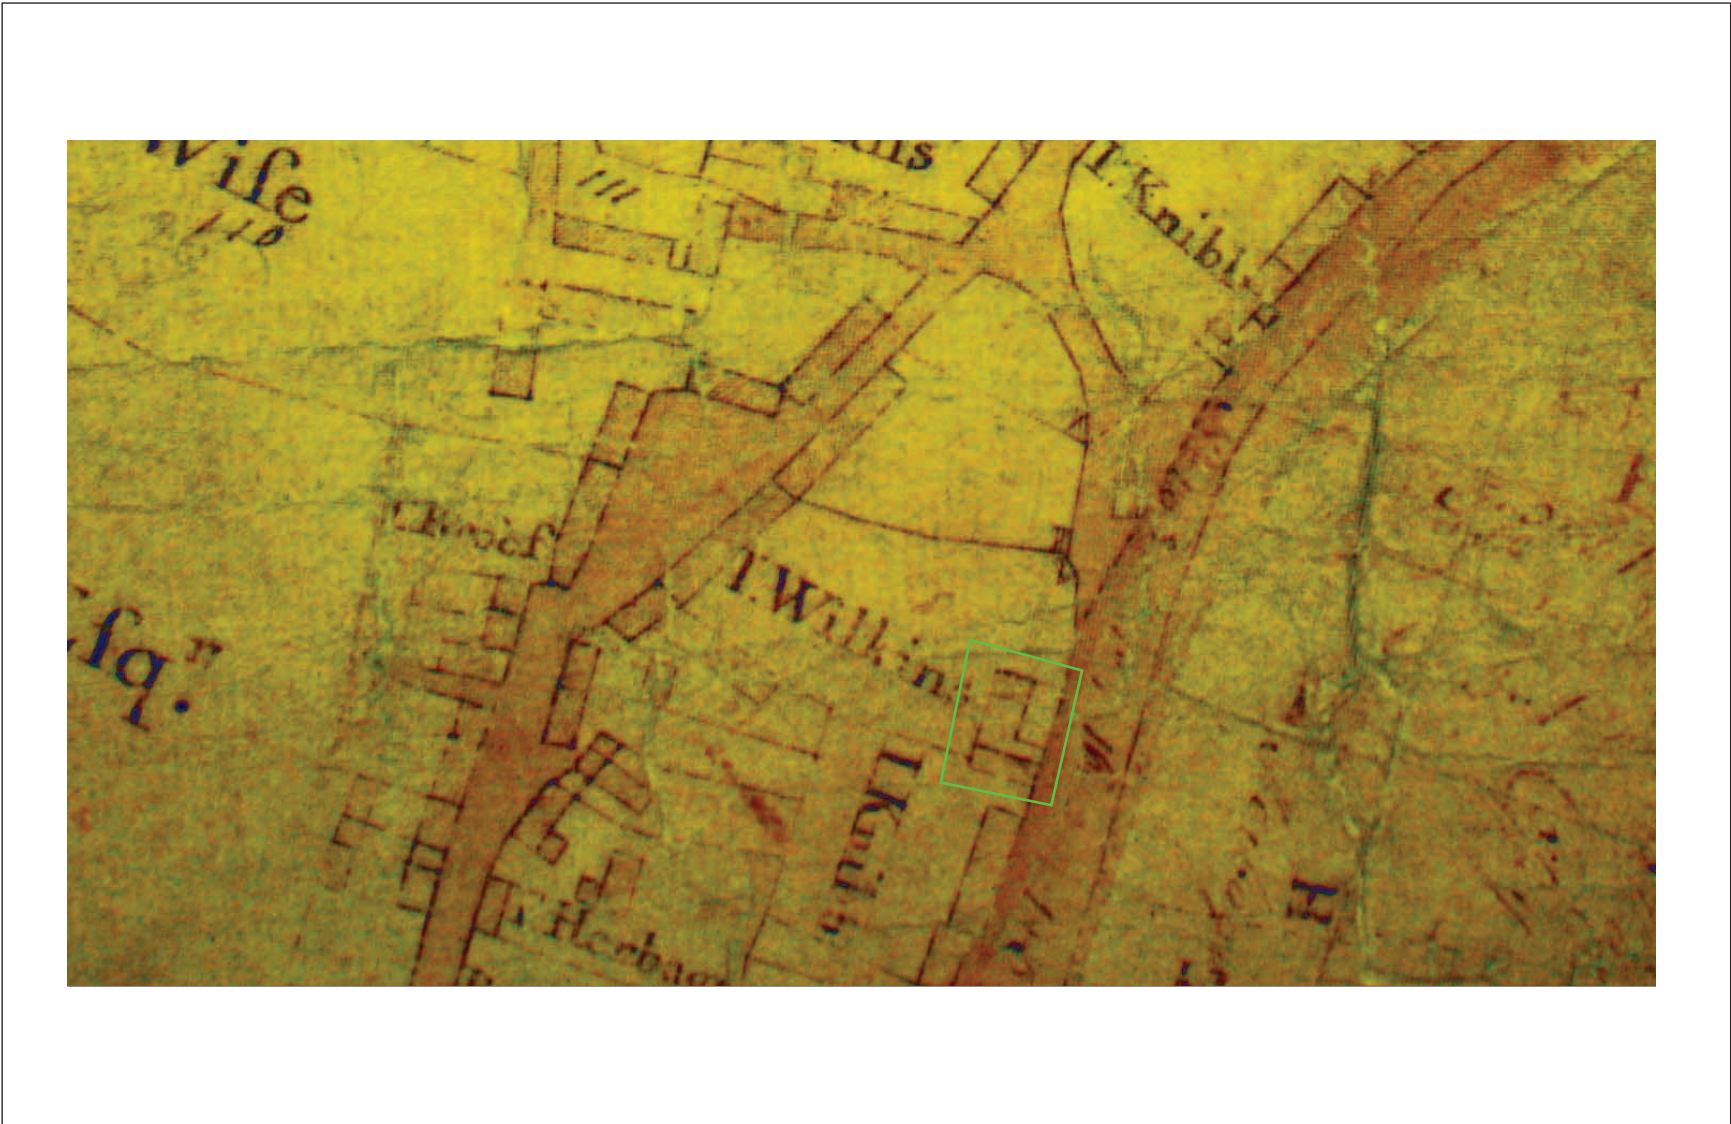
Figure 3: Extract from Middleton Cheney Inclosure Map, 1770 showing location of The Red Lion

- 3.1.1 The earliest visual evidence of the building is found on the Inclosure map for Middleton Cheney drawn up in 1770 (Figure 3). This map depicts an L-shaped building in the location of the current site, with the associated land seemingly owned or rented by I. Wilkins. The building which is depicted does not front onto the street as all other depicted buildings do and seems to be attached to another long rectangular building leading back from the road. Given the unusual shape of this building, that it does not front onto the street and considering the next available map, an exact copy of the Inclosure map made in 1838 (Figure 5), it could be suggested that the Inclosure map is inaccurate. The date-stone above the door states it was constructed in 1696 and there is no reason to believe this is not the case. Also, the 1838 copy depicts the same layout, using the same lines (presumably representing walls) but the shading of solid buildings is different and would in fact match the layout of part of the building as it exists today, fronting onto the High Street.

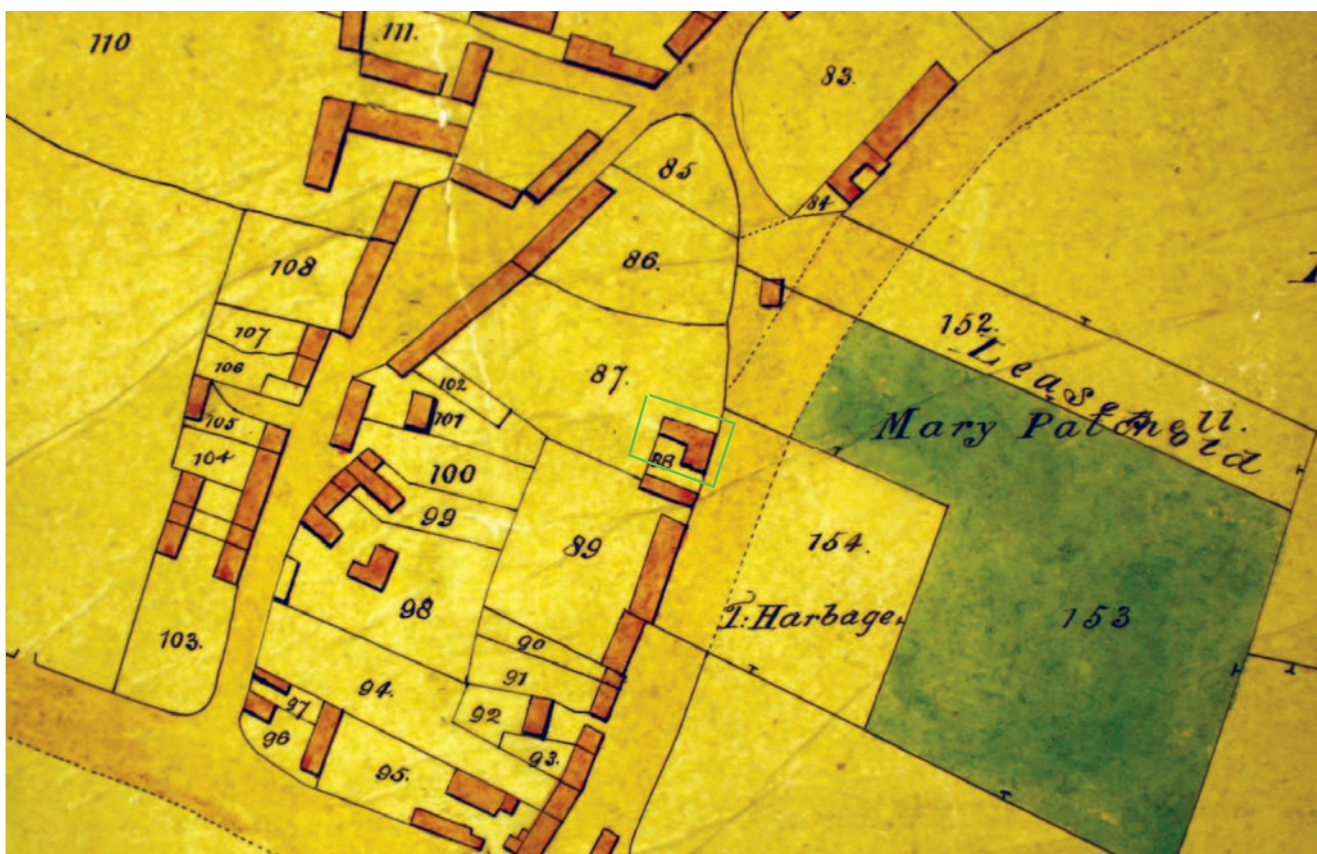
Figure 5: A copy of the original 1770 Inclosure map of Middleton Cheney, made in 1838 (NRO ref. Map 4788), showing location of the Red Lion (green)

- 3.1.3 A copy of the 1770 Inclosure Map made in 1838 is the next available map evidence of the site. It shows an L-shaped building, which may represent the northern part of the building still in existence today. As discussed in Section 3.1.1, this is likely to be the earliest part of the building as seen on the 1770 map, but with a correction of the earlier map to accurately depict the building by applying colour to the correct elements. It should be noted that this is an exact copy of the earlier map and not a depiction of the site in 1838.

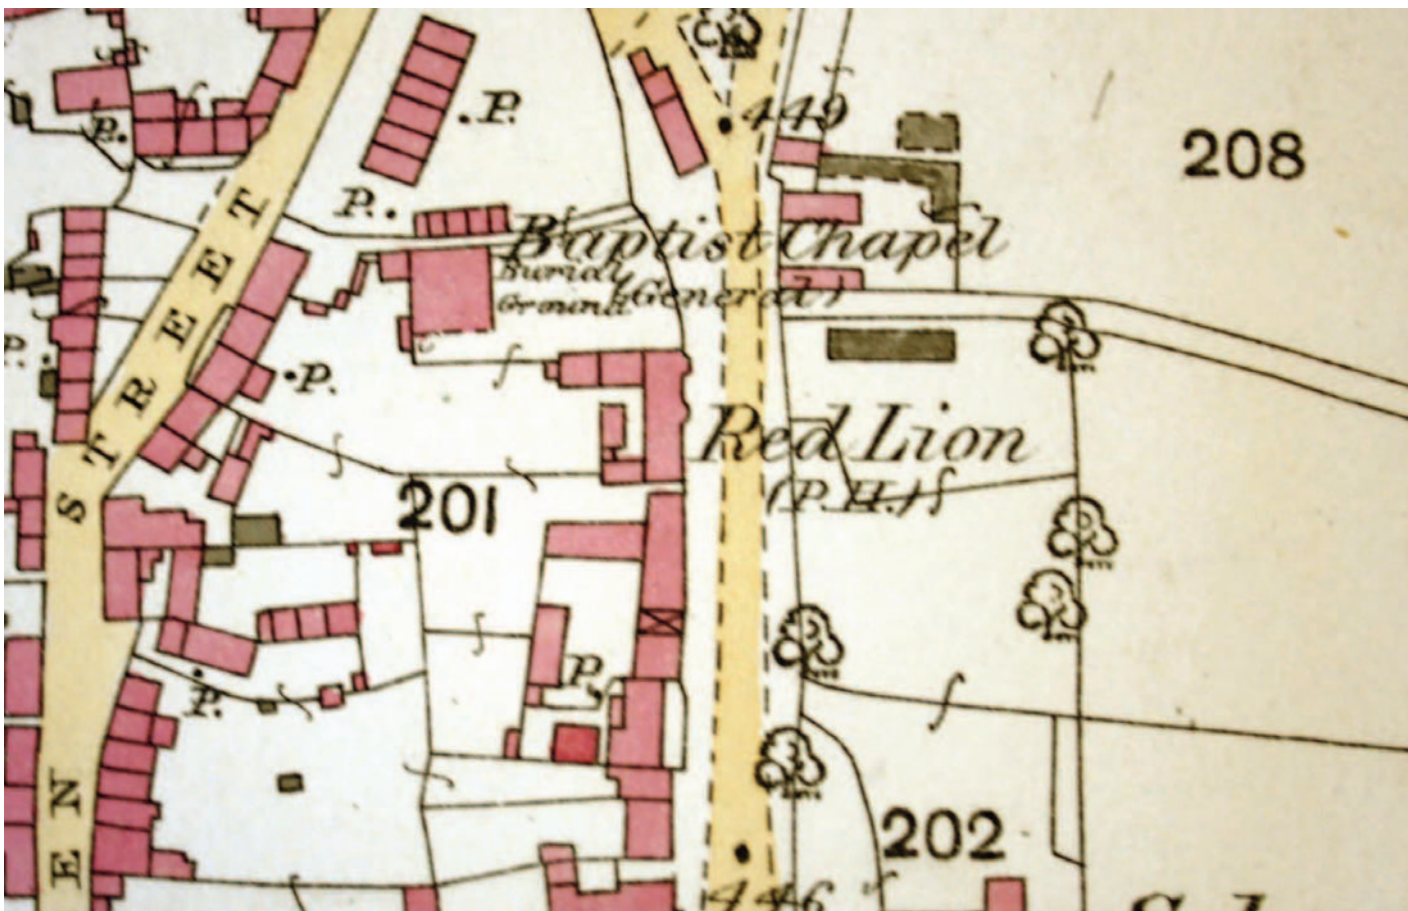
Figure 6: 1st Edition Ordnance Survey map (25" to 1 mile) 1885

- 3.1.4 By the time of the 1st Ordnance Survey Map created in 1885, the layout of the building is broadly similar to today. Since the late 18th century (Figures 3 and 5), the previously noted building has been extended to the south and bay windows added to the front elevation. Another extension has also been added to the north-facing elevation which extends to the rear of the original building and an additional building has also been added at the rear. The Red Lion is labelled as a Public House (P.H.) and with the building extended to the north and south boundaries of the plot it is difficult to establish how rear access was gained.

- 3.1.5 Within the plot of land in which the building stands, a Baptist Chapel has been built with a burial ground directly in front. The village website states this was constructed in 1806 (www.middletoncheney.org/the-baptist-curch), confirming again that the 1838 copy of the Inclosure Map was not updated.

- 3.1.6 This map also shows the road has been narrowed to allow for a pavement on either side. Interestingly there is no street name given at this time. The census records for 1841 show that the main road now called High Street was known as Red Lion Street at this time (www.ancestry.co.uk).

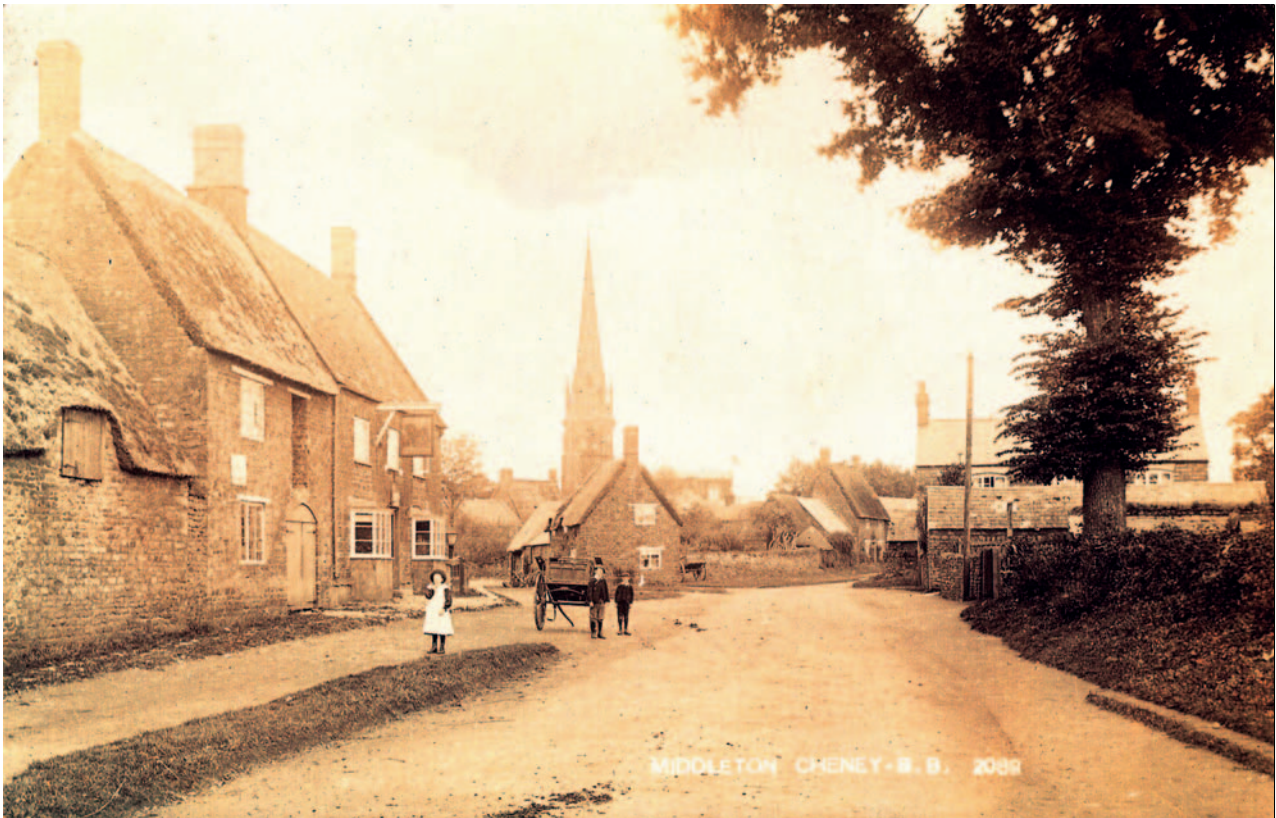
Figure 8a: Photograph of Red Lion Street c.1900 (with kind permission from Middleton Cheney Parish Council)

- 3.1.9 The earliest photograph dates to around the turn of the century (Figure 8a) and from its title (as supplied with the image), it is of Red Lion Street. This is the first record of a street name, obviously prior to it becoming High Street later in the century. This image clearly shows the two main phases as depicted on the earlier maps which front onto the street, with a single-storey thatched building adjoining. The building, with the two main elements, appears very much as it does today, with the obvious difference of a double doorway in an arch with loading door above which is no longer present. It is difficult to say from this photograph what function this part of the building, which also appears to have a thatched roof) had and the 1885 map offers little suggestion. It may be that the doorway provided access to the rear and was for the delivery of barrels as the present

loading doors located within the street which deliver directly to the cellar does not appear to be present. It may be that the first floor provided accommodation, or was for an additional business or service for which supplies could be loaded directly up to this level. Close inspection would also suggest that the windows on the first floor of the earlier phase have recently been replaced, indicated by repair/refill of the stonework beneath.

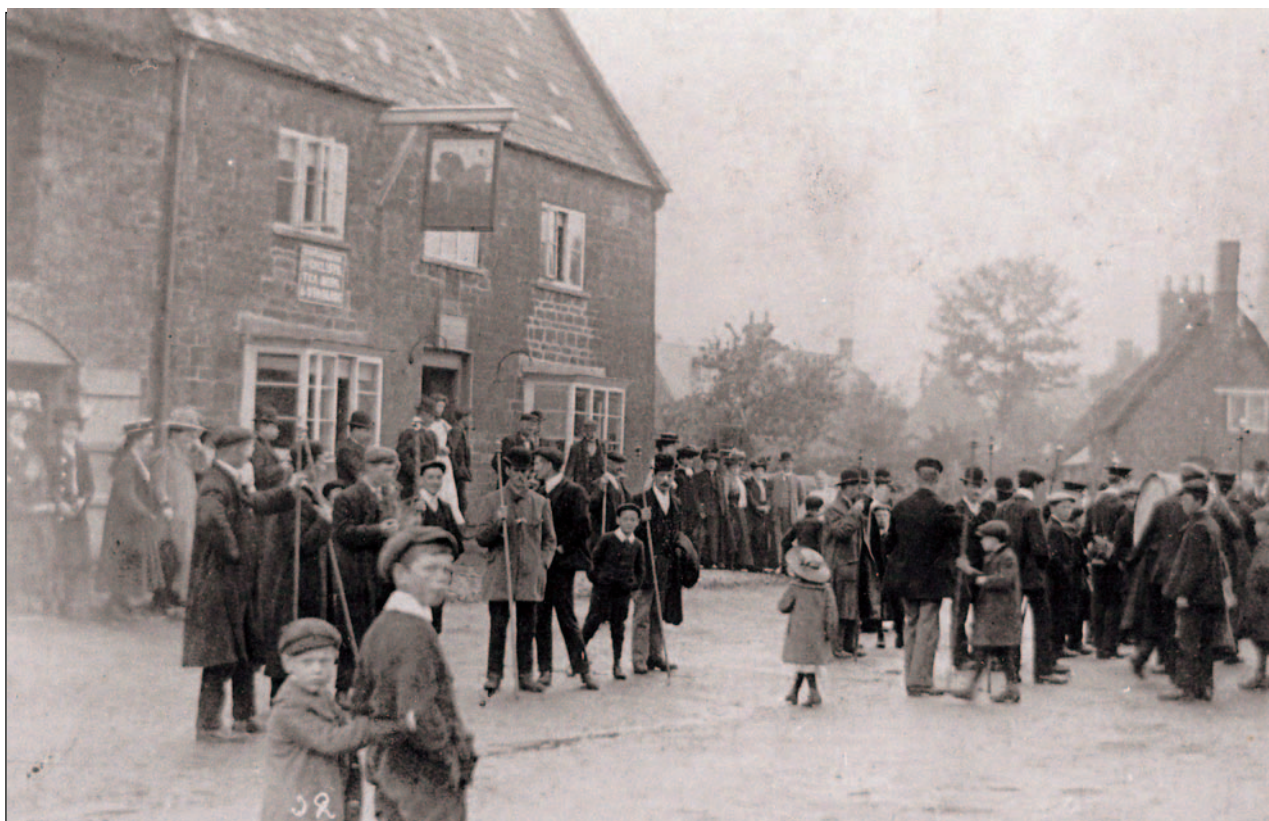
Figure 9b: Photograph of Club Meeting outside Red Lion 1907 (with kind permission from Middleton Cheney Parish Council)

- 3.1.12 Photograph Figure 9b shows the Red Lion in 1907. This image shows detail of the windows, which have since been replaced. It also shows what appears to be a board above the door which would have obscured the date-plaque; the door now also has a flat ironstone hood on brackets above. The doors within the now blocked up-archway are open, indicating this access/delivery door was still present and in use at the start of the 20th century.

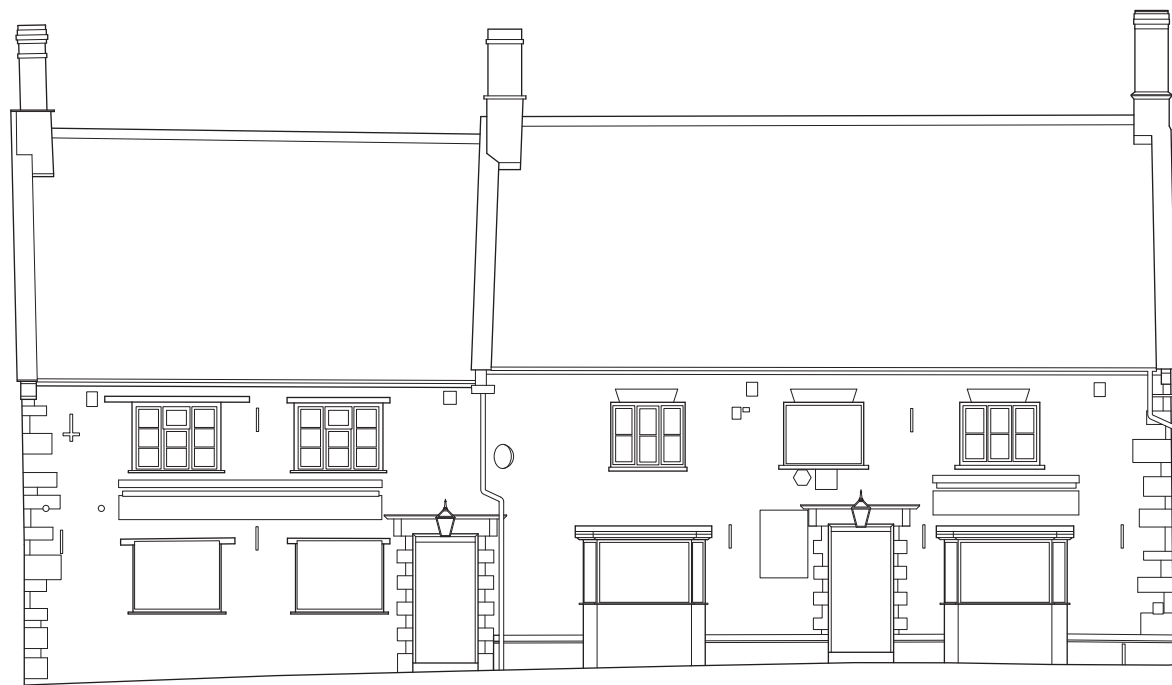
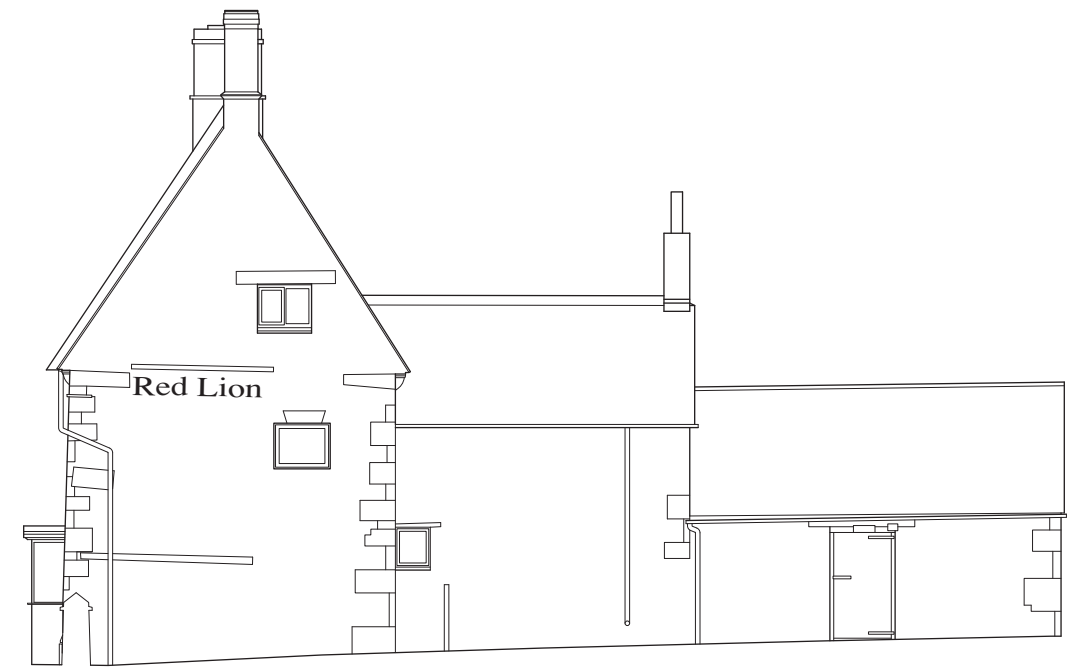
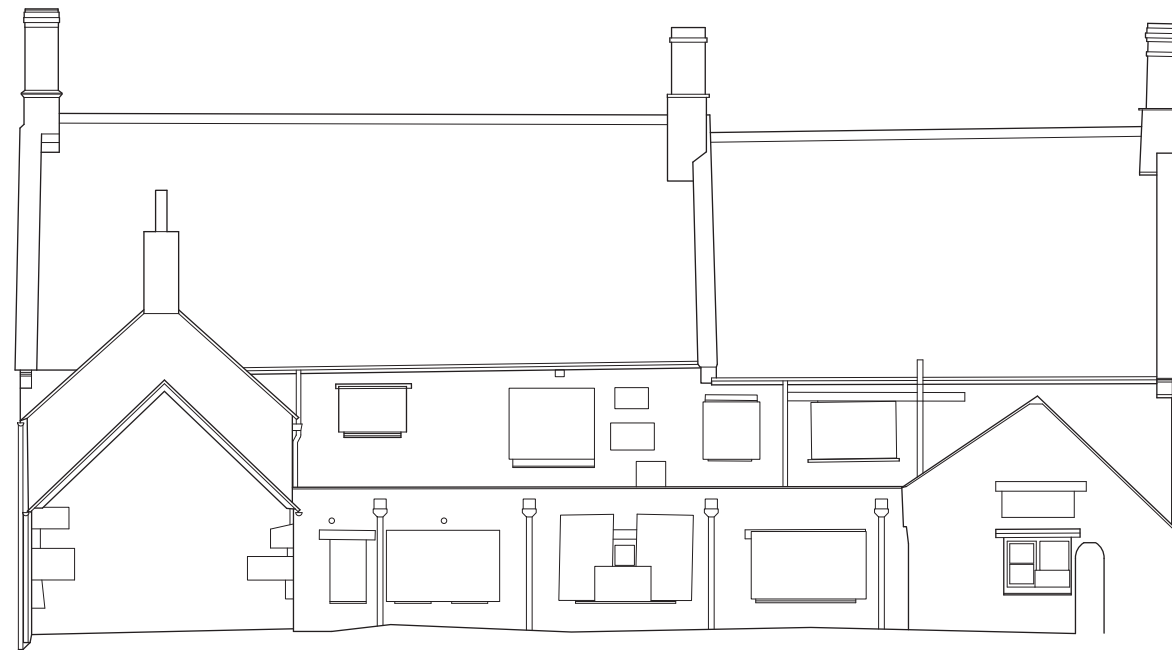
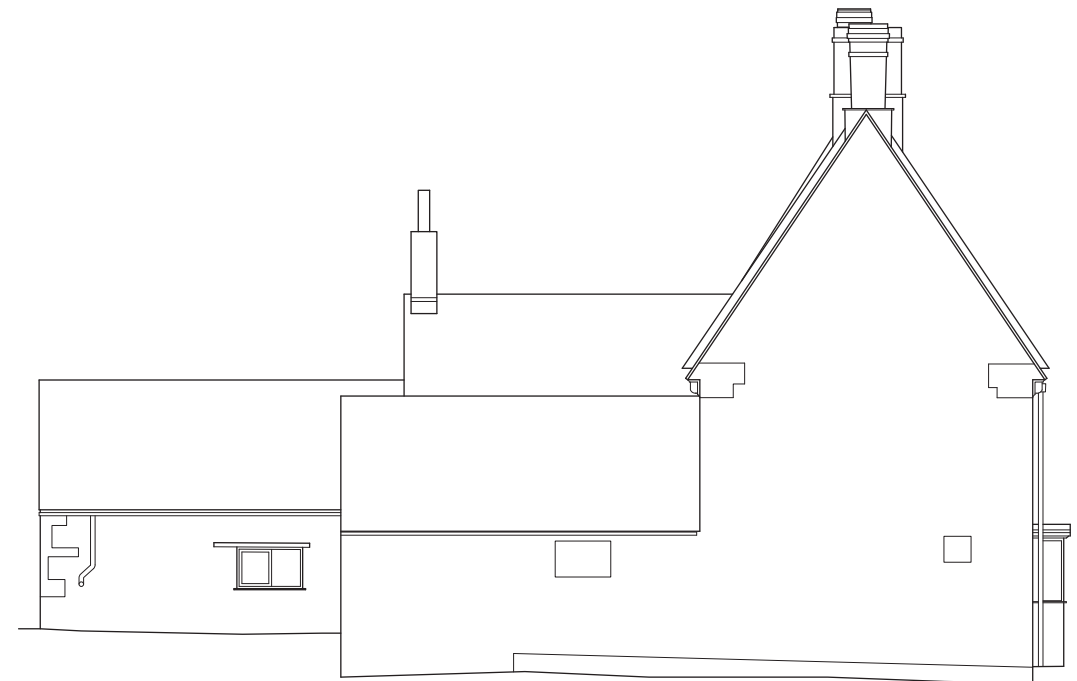
Figure 13: External elevations (from data kindly supplied by the clients architect)

- 4.2.2 The northern-most element is considered to be the original and earliest phase of the building (Figure 13; Plate 1). The roof-line is slightly higher on this side and covered in grey slate with two stone chimney stacks at either end, both of which have been raised with the same brick as noted at the southern end. At ground floor level there is a main door which is located right of centre, otherwise this elevation was constructed with perfect symmetry. A slight change in the colouration of the stone and mortar to the left of the door opening may imply it was larger or located more to the centre previously. The main entrance door is wooden, consisting of applied panels set within an arch, a horizontal panel at the base and a central window with brass letterbox beneath (Plate 3). The door is likely to date to the early 20th century. Above the door is a stone hood on brackets, over which is a date-stone with the initials "JHAS" (Plate 4) which may represent the names of the builders or the person/s for whom the building was constructed, and the year 1696. There are two bay windows, which appear to be a later addition (again indicated by a lighter coloured stone and mortar (Plate 5). The earliest representation of the bays windows is on the 1st Edition Ordnance Survey map indicating they had been added by 1885. At first floor level, there are three equally spaced three-part casement windows (Plate 1). The stones used on the surround above the window are narrower than the windows present which would indicate the original windows were narrower. The present windows are those shown on the 1907 photograph (Figure 9b) which also shows repair in the stonework below the window where narrower, longer windows had previously been.

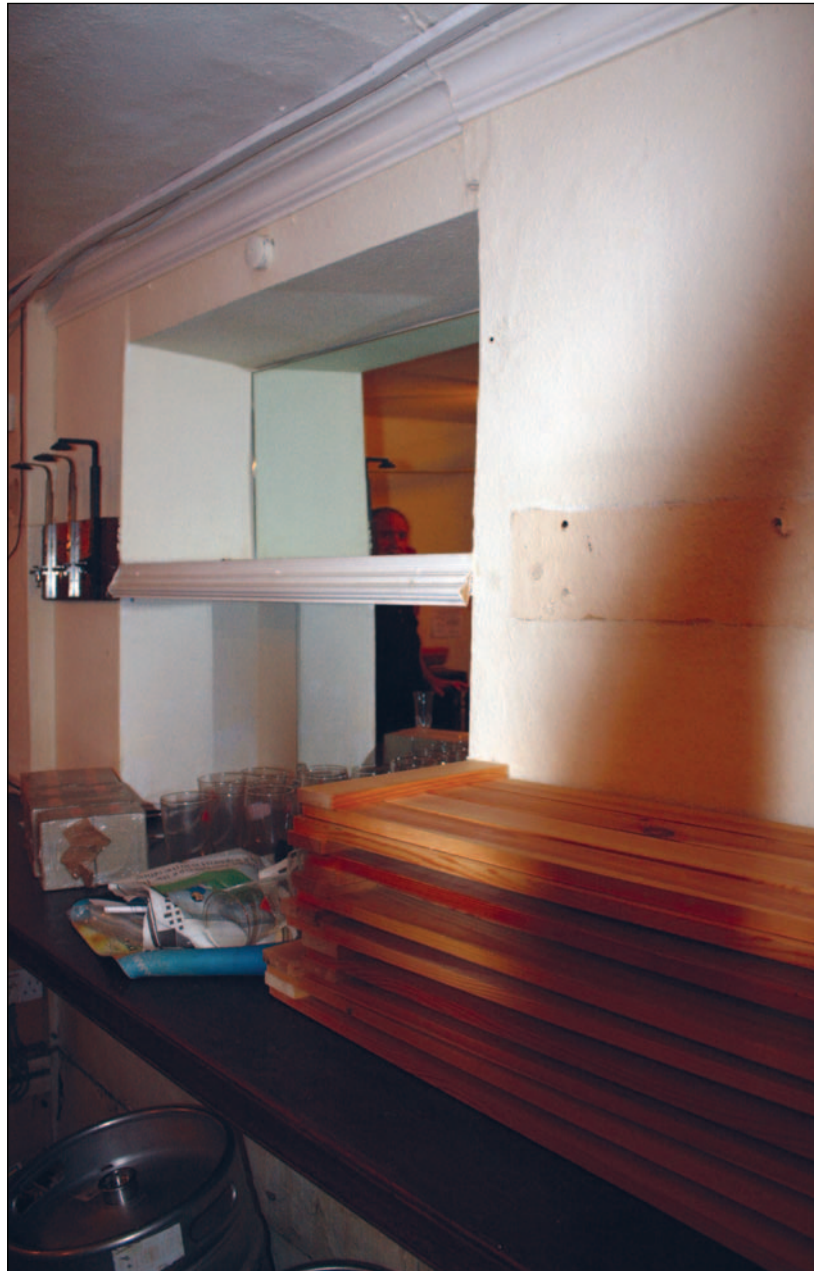
Plate 19: Recess in original wall behind bar, G2

- 4.3.68 On the opposite wall there is a small sloped void in the wall (Plate 57) which corresponds to the position of a bricked-up door recorded on the wall behind the bar in G2 (Plates 19 and 20). It is possible that this is an earlier barrel or coal chute which was in use when there was a rear access before the street-level cellar access was added. Rear access was gained via the alley-way noted on the photographs from the early 20th century (Figures 8a-10); and there is no obvious sign of the street-to-cellar access in these images.

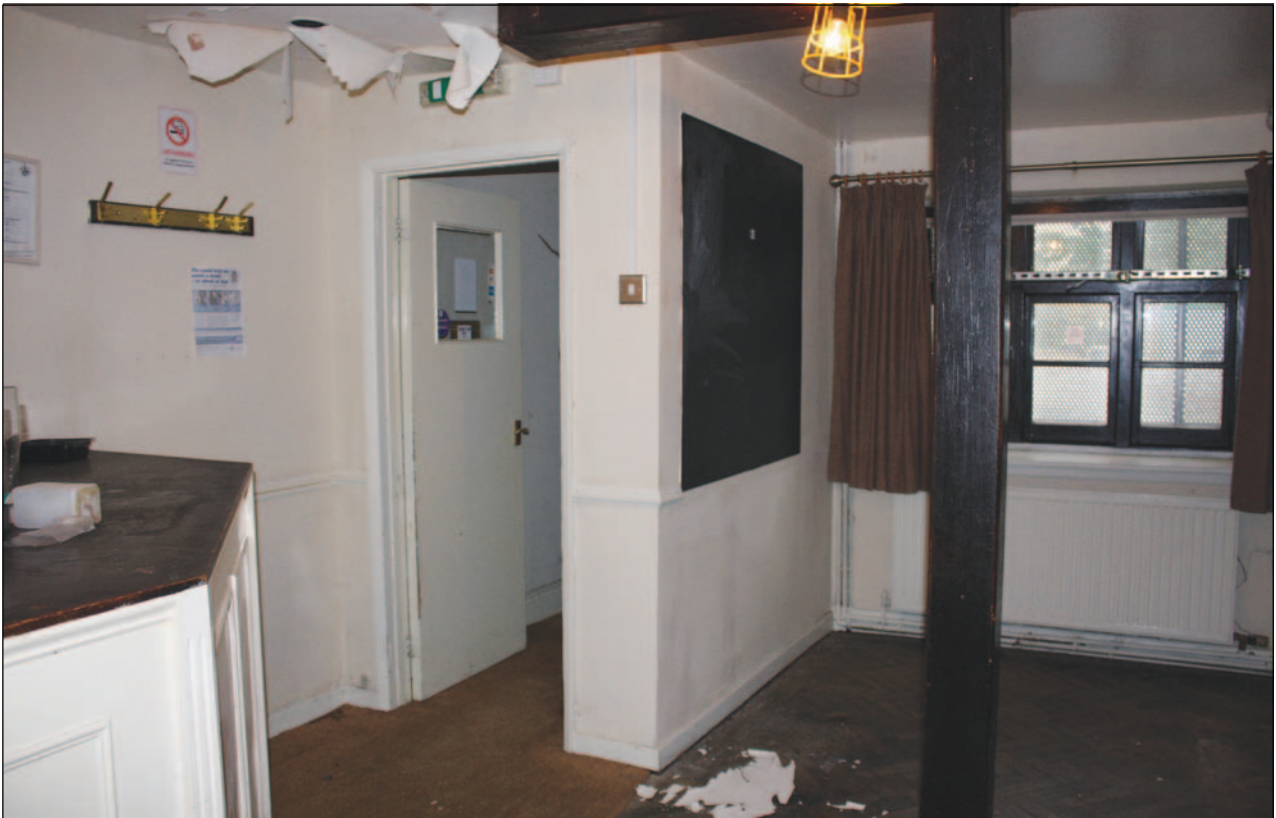
Plate 24: View of bar, entrance, stop-chamfered beam and support posts, G4

- 4.3.16 A chamfered beam spans the length of the room with two upright timber posts providing additional support. The beam runs from the chimney breast and stops in line with the entrance door (Plate 24). This may correspond with the location of the archway which was noted on the early 20th century photographs. If the archway provided an enclosed alleyway-type access to the rear of the building, then an exposed chamfered beam would not be expected or necessary. The position of the end of this beam is significant for the interpretation of an earlier alleyway as there is no other existing evidence other than that from the early photographs.

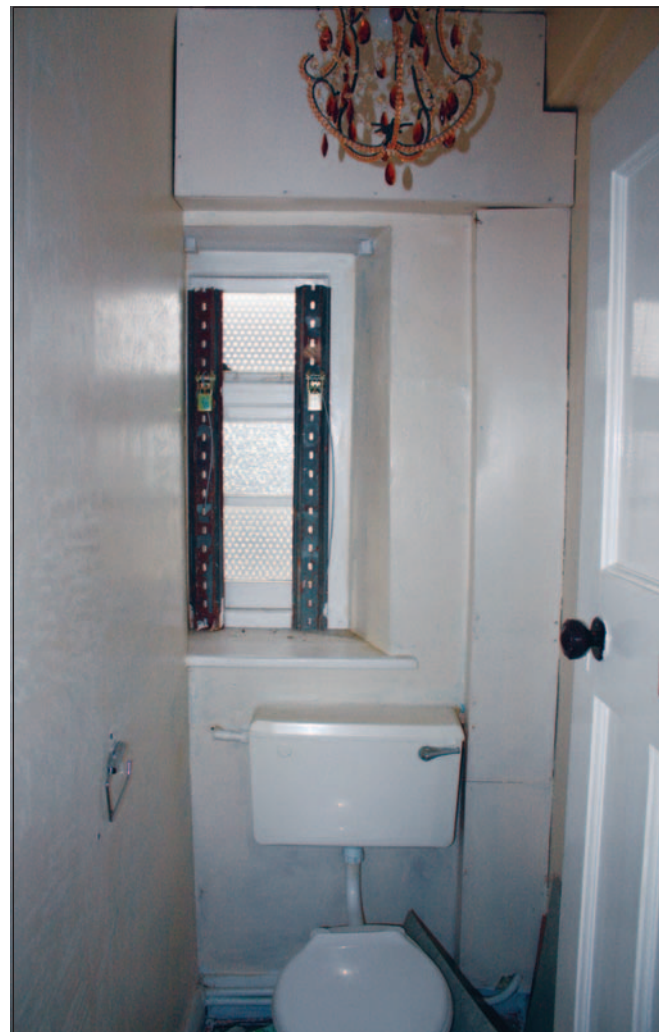
Plate 48: General room view, F5b

- 4.3.46 This area comprises a bathroom (F5a) and toilet (F5b). Both are accessed via the same 1930s style door as noted on F4 and share a three-part window as recorded in F4, however the glass is dimpled for privacy and the upper panels in all three parts open. The bathroom suite, fixtures and fittings are thought to date to the late 20th century (Plate 47). Wooden floorboards which span the width of both F5a and F5b are continuous and exposed.
- 4.3.47 F5a contains a bath and sink unit and has partially wooden panelled walls (Plate 47). This room measures approximately 2.0m by 1.56m.
- 4.3.48 F5b measures approximately 1.55m by 0.89m and contains a toilet. The walls are painted off white (Plate 48).

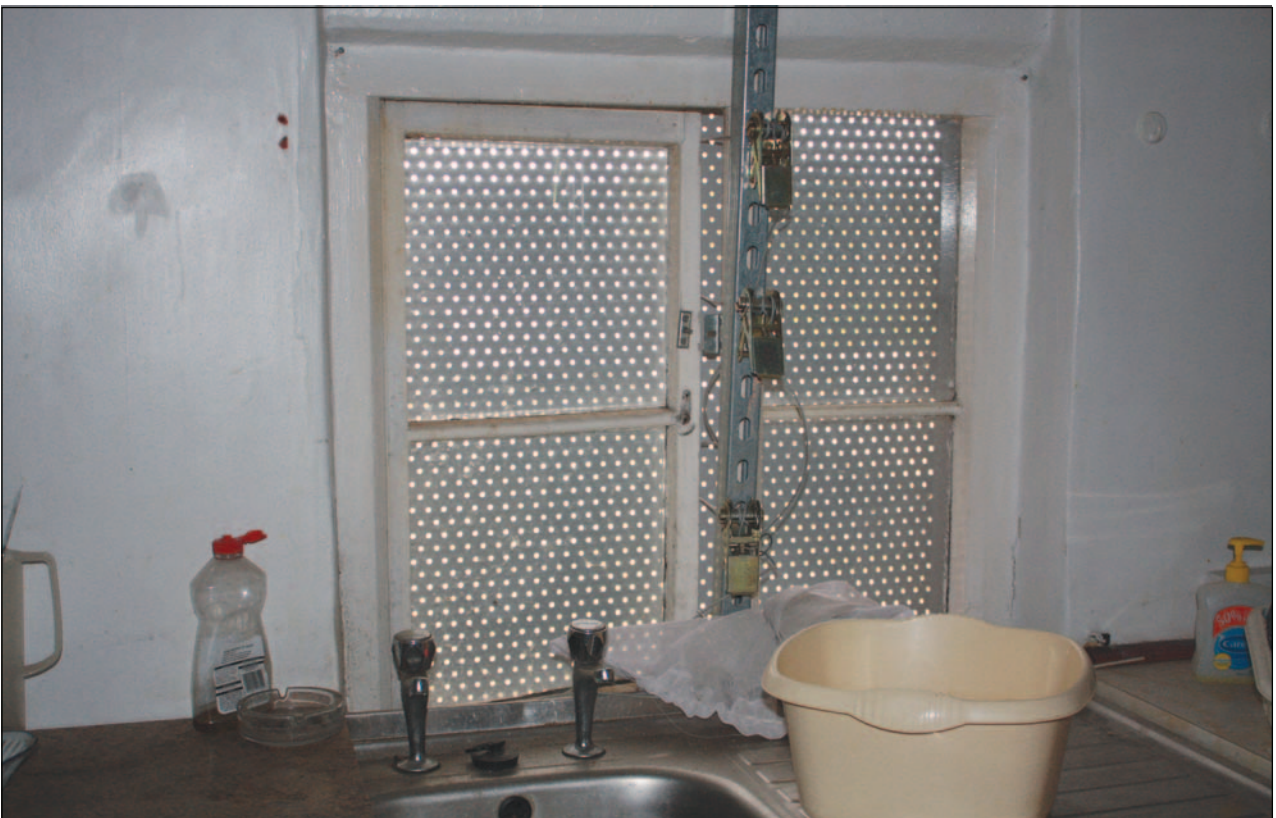
Plate 51: Window, G7

- 4.3.53 At the far end of the room, against the external wall of this extension, is a stone plinth above which is an area which has been panelled in which, on knocking is hollow. This area corresponds to the location of a fireplace as recorded in G3 directly below, however there is no evidence of what may be behind this panelling.
- 4.3.54 The external wall on the left on entering is thinner than the other walls of this room. This is because this elevation has been re-built with red brick as noted in Plate 8. It should also be considered that the roof-line of this building has been altered as shown in Plate 7) so there is a possibility the plinth is associated with the remnant of the earlier roof-line. Within this re-built brick wall is a small two-part casement window with wooden frame and glazing bars (Plate 51), likely to be mid-late 20th century in date.

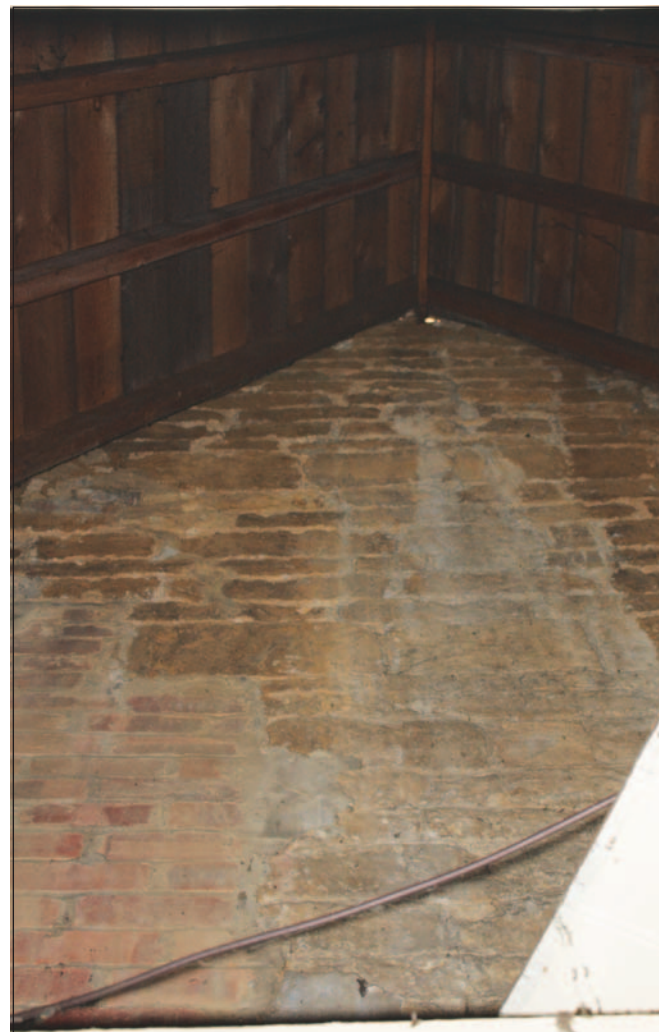
Plate 55: Detail of external gable end from within adjoining roof space

- 4.3.65 The south-facing gable end of the earliest phase of building was visible and shows a continuation of the same ironstone as recorded on the other external elevations (Plate 55). There is a blocked-up window in this elevation which corresponds to that recorded in S1. The brick used is the same as that used on the chimney-breast opposite and is considered to be 20th century in date. The reinforced steel joists noted in G3 below are also secured within the bricked-up window.

- 5.6.3 The fireplace was re-built in G4 and chimney-breast replaced as noted in the roof-space. A new roof was also added and the window (long out of use) within the attic space (S1) was bricked-up. A reinforced steel joist was added for structural support between the two major phases of building construction, and secured within the bricked-up window.

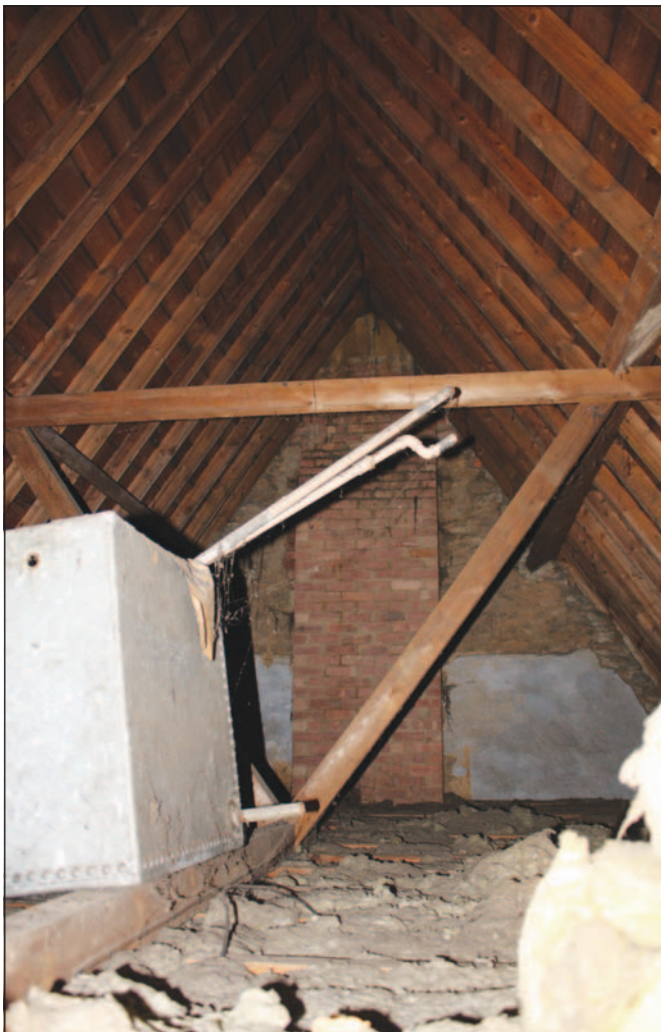
Plate 54: Roof space above F3-7

- 4.3.62 This area comprises the roof-space located over F3-F6 (Figure 2), accessed via a small hatch in the ceiling in F3. It measures approximately 8.67m by 5.81m and due to restricted access and for health and safety reasons was not entered, but photographed through the hatch.
- 4.3.63 The roof structure comprises common rafters and purlins, all of which are machine-cut and considered to be replacements, possibly within the last 50 years. The roof itself is covered with horizontal boards which support the slates above (Plate 54).
